Underwater Bark Debris Survey
Two Moon Bay Log Storage Facility
Cordova, Alaska
March 1998

Subject: Two Moon Bay dive survey; EPA Permit AK-004560-8.

3/25/98 Two Moon Bay Underwater Bark Debris Survey

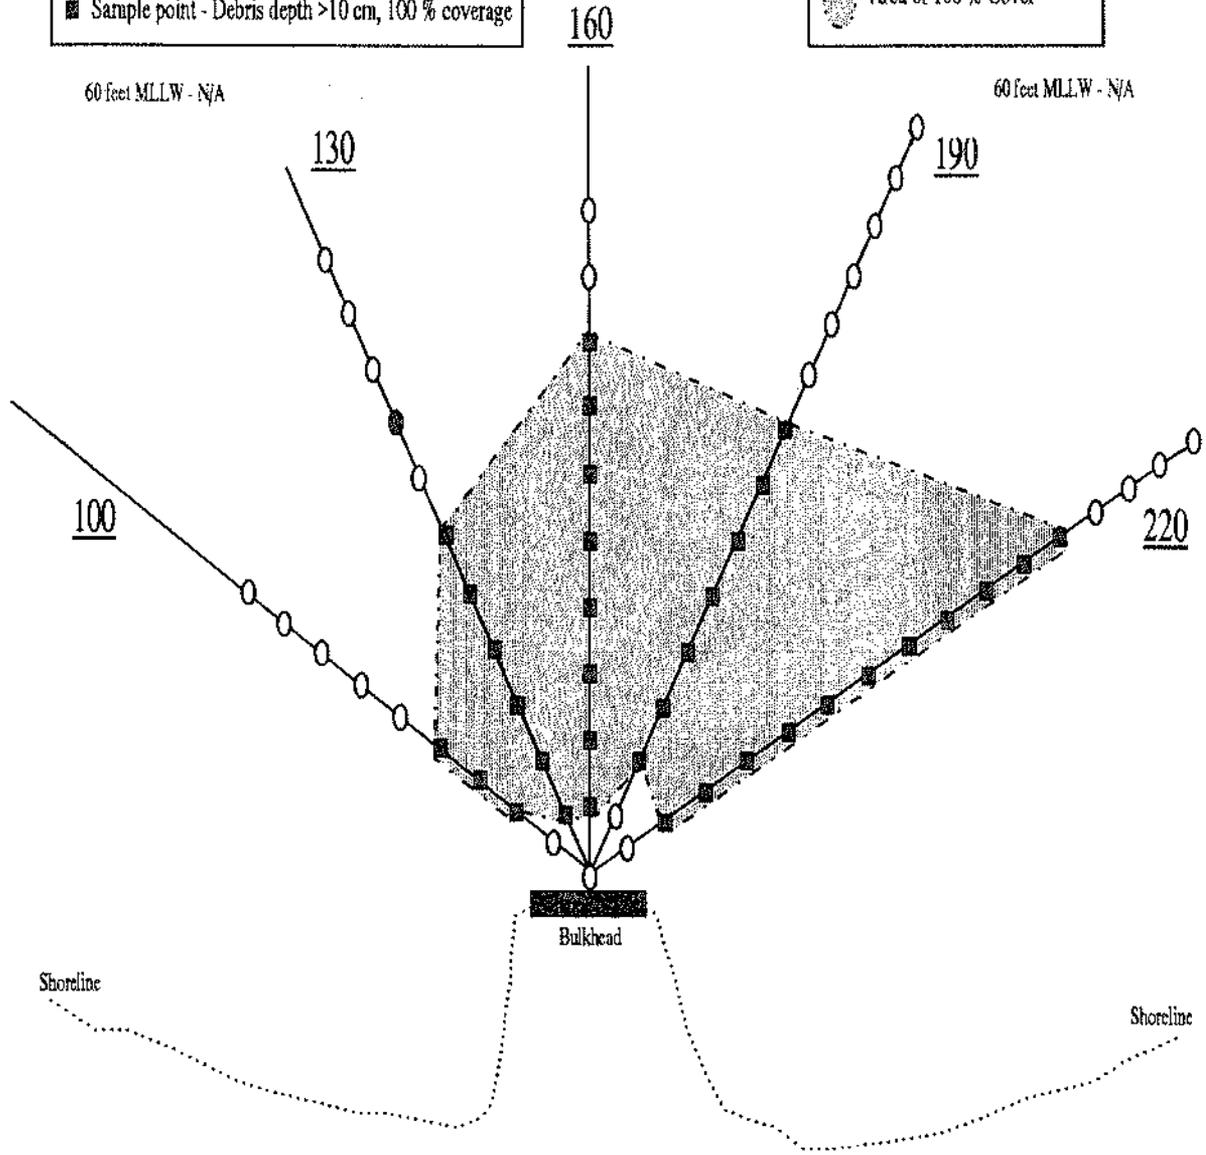
- Sample point - No debris
- Sample point - Debris present
- Sample point - Debris with 100 % coverage
- Sample point - Debris depth >10 cm, 100 % coverage

Not to Scale
 Sample Point Interval = 5 m
 ● Area of 100 % Cover
