**WESTWARD SEAFOODS, INC.
DUTCH HARBOR, ALASKA**

**BAILEYS LEDGE
SEAFLOOR INSPECTION
CAPTAINS BAY, ALASKA**

**FINAL REPORT
1993 SURVEY**

FINAL REPORT
WESTWARD SEAFOODS, INC. -- CAPTAINS BAY, ALASKA
SIDE SCAN SONAR AND BATHYMETRY INVESTIGATION
REPORT No. WC93A06.1

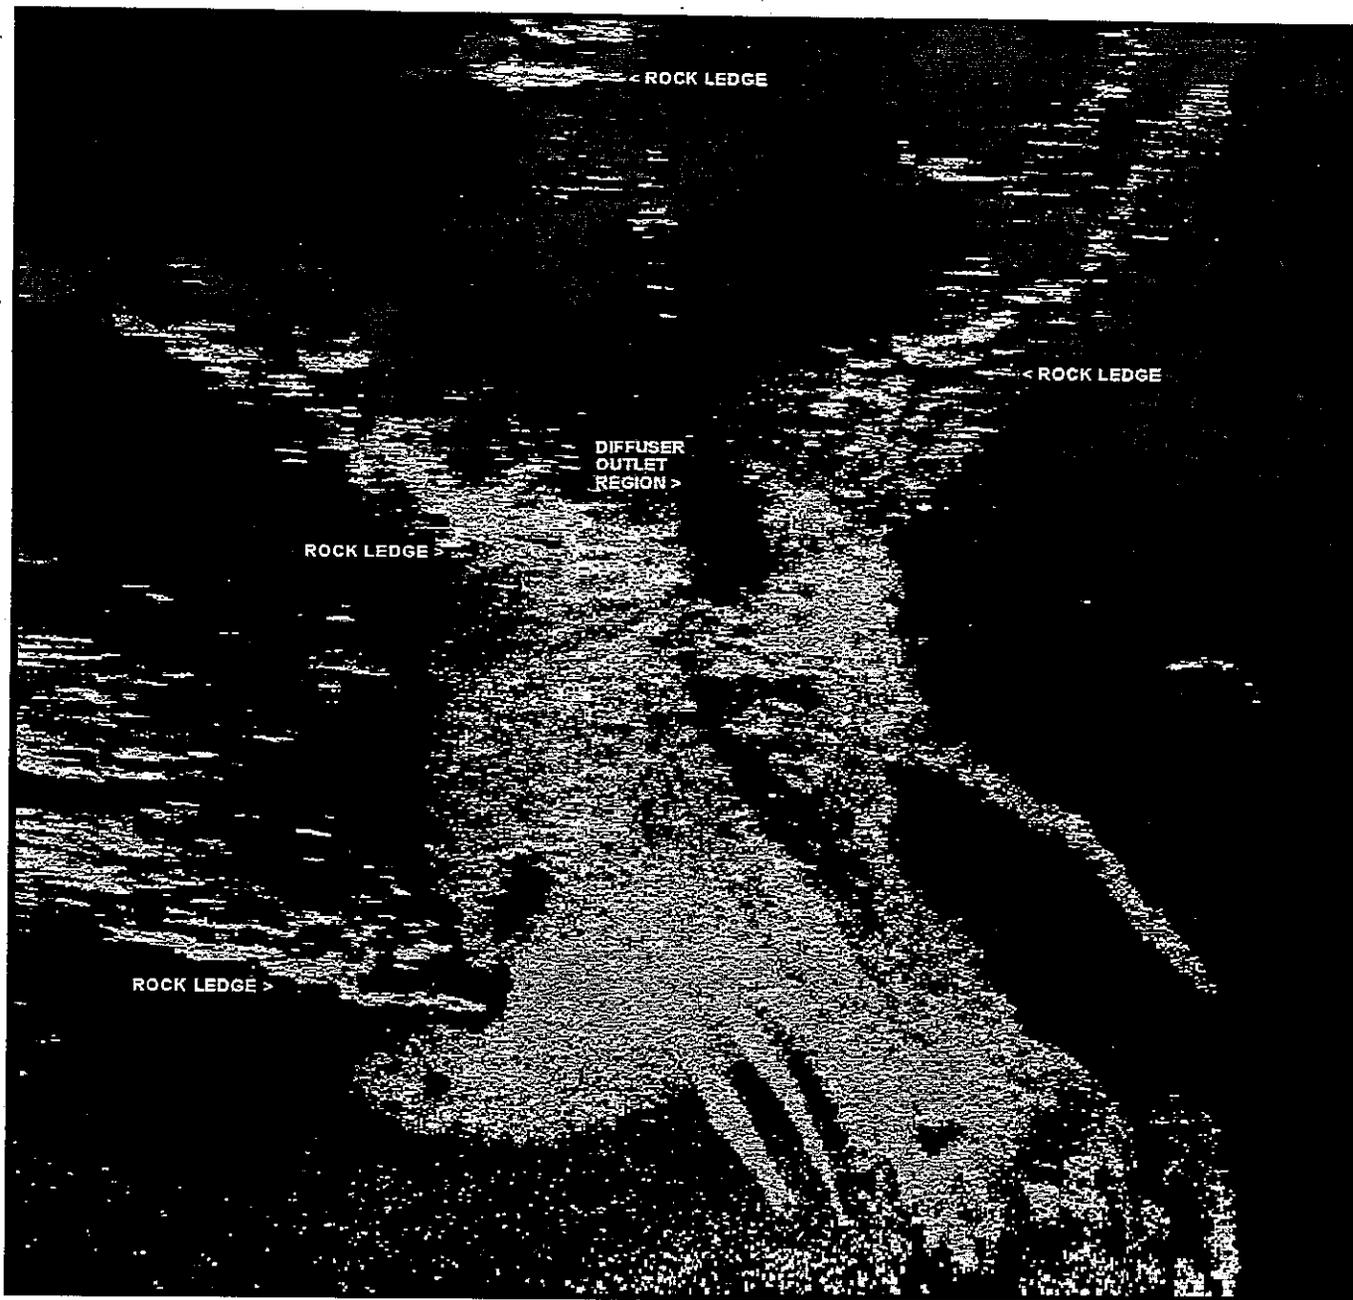
WATSON COMPANY ANCHORAGE, ALASKA	Prepared For: WESTWARD SEAFOODS INC.	Survey Dates: Sept 30 - Oct 6, 1993
	Location: CAPTAINS BAY, ALASKA	FIGURE 4

The geologic structure of Baileys Ledge is a rock outcrop (figure 4) that has a very high density. These hard reflectors yield high density returns. Utilizing the WSMS Image Processor the side scan sonar imagery in figure 4 highlights the rock outcrops of Baileys Ledge. The predominant geologic angle of repose of the ledge average from 20 to 40 degrees. The steepness and shape of the ledge dictate, to a large degree, the flow of the seafood processing waste away from the outfall.

BAILEYS LEDGE SEAFLOOR SONAR IMAGE
 2 Dimensional View
 Image Size 150 x 150 Meters (approx.)

The seafloor materials located with the side scan sonar in the immediate proximity of the diffuser and immediately down slope of the diffuser, was found to be of a different density than what was found in the surrounding region (figures 4, 6 and 7). The "light

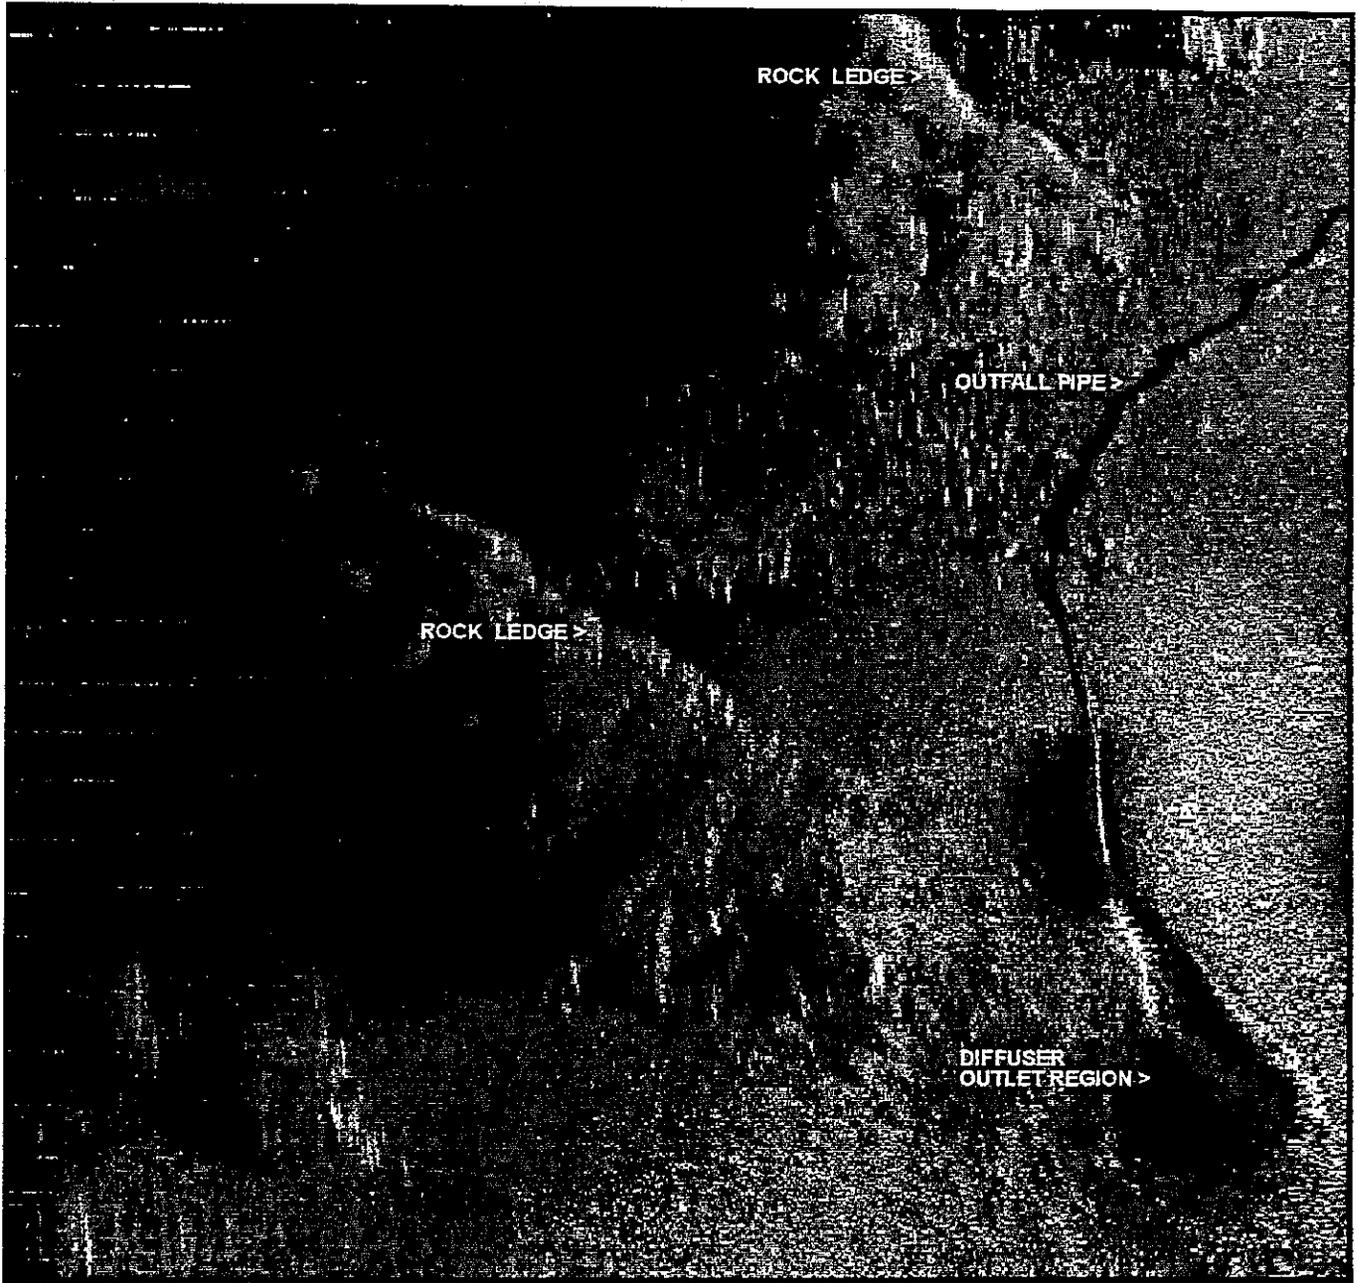
WATSON COMPANY ANCHORAGE, ALASKA	Prepared For: WESTWARD SEAFOODS INC.	Survey Dates: Sept 30 - Oct 6, 1993
	Location: CAPTAINS BAY, ALASKA	FIGURE 5

As can be observed in figure 5, Westward Seafood's Outfall Pipe traverses the shallows on the south side of Baileys Ledge and bends to the Northwest where it terminates. The shadows are caused by the steep rock outcrops, that block the path of the acoustic energy. The abandoned outfall location was to the Northeast of the present diffuser location at a distance of approximately 25 meters.

BAILEYS LEDGE SEAFLOOR SONAR IMAGE
 2 Dimensional View
 Westward Seafoods Outfall Pipe & Diffuser Outlet Region
 Shadows On Left Due To Rock Outcrops

bulb" shaped region is classified as the "Diffuser Outlet Region". Apparent seafood processing waste is contained within this region. A zoomed segment of the sonar image of the diffuser outlet region is displayed in figure 5. Due to surface floats it was not possible to transit completely across the waste pile as was done during the 1992 survey. For this reason it is not possible to estimate the depth of the apparent seafood processing waste pile based on the predominant angle of repose.

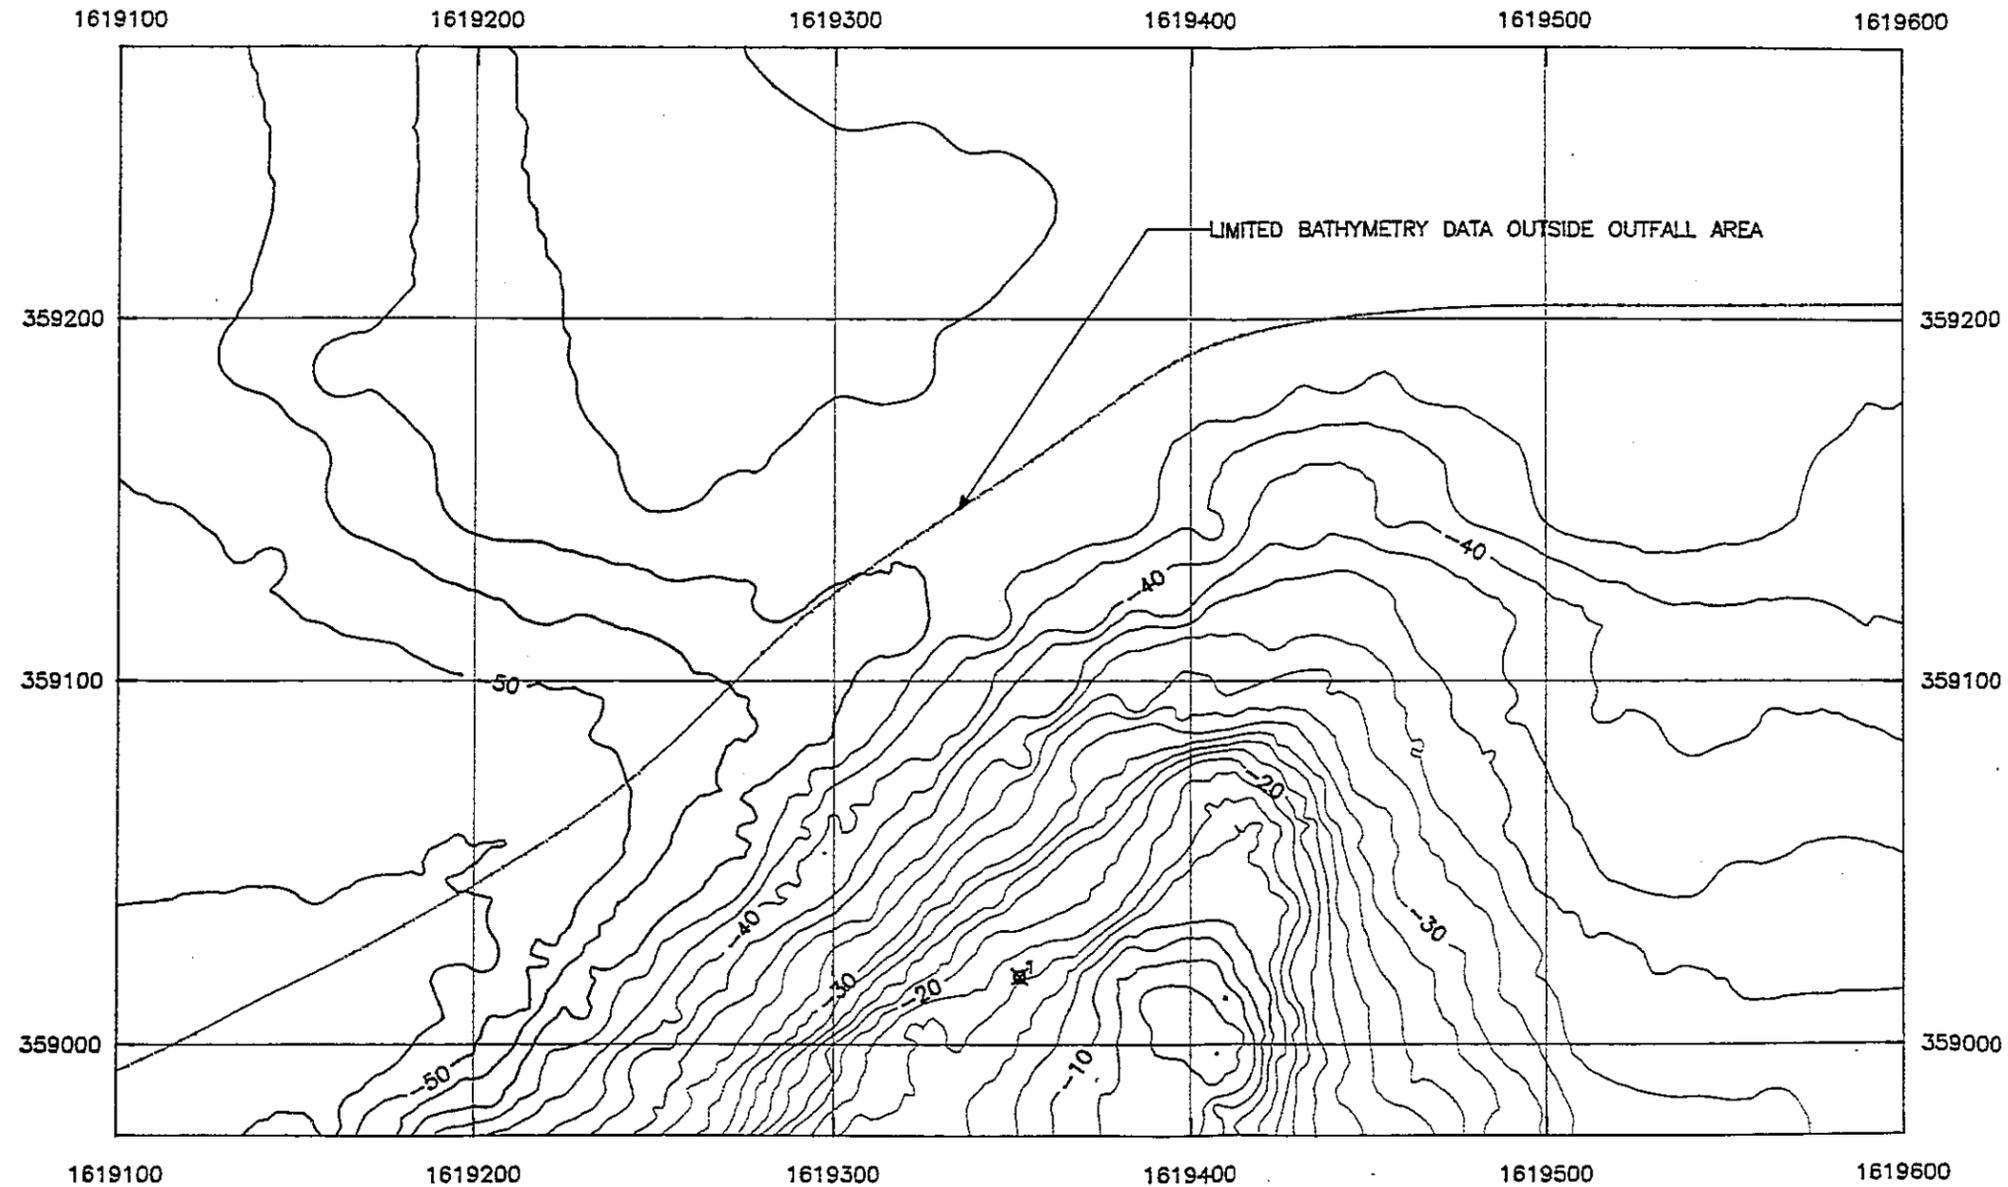
FIGURE 2	SCALE: 1:2000	DRAWN: GA
----------	------------------	--------------

A bathymetric contour map was created in part to correlate the imagery from the side scan sonar with the depth data. This map (figure 2) has contours every 2 meters and labeled contours at 10 meter intervals. As can be observed during review, the ledge extends further to the North on the eastern side of Baileys Ledge. Figure 3 is a bathymetric 3-dimensional projection of the area of investigation. From this figure it can be seen that the outfall site is a steep and complex geologic structure. Figure 3 is tilted at a 30 degree angle for a more complete perspective of the seafloor topography.

The outlet of the diffuser is in approximately 17 meters of water, as can be seen in figure 2 and 3. The water depth at the base of Baileys Ledge ranges from 45 to 57 meters. During the data reduction for the 1992 survey the diffuser end was assumed to be up slope, at the beginning of the "light bulb" shaped area. During the reduction of the 1993 data it was observed that the diffuser end is apparently midway into the "light bulb" area. The data reduction is referenced from this point, and an offset of the 1992 coordinates is noted. The below coordinates are the approximate location of the outlet of the diffuser end and the Day Marker for Baileys Ledge.

**BAILEYS LEDGE OUTFALL SURVEY
 SEAFLOOR BATHYMETRY**

In figures 2 and 3 the colors represent discrete depths of water. The following is a list of those depths:

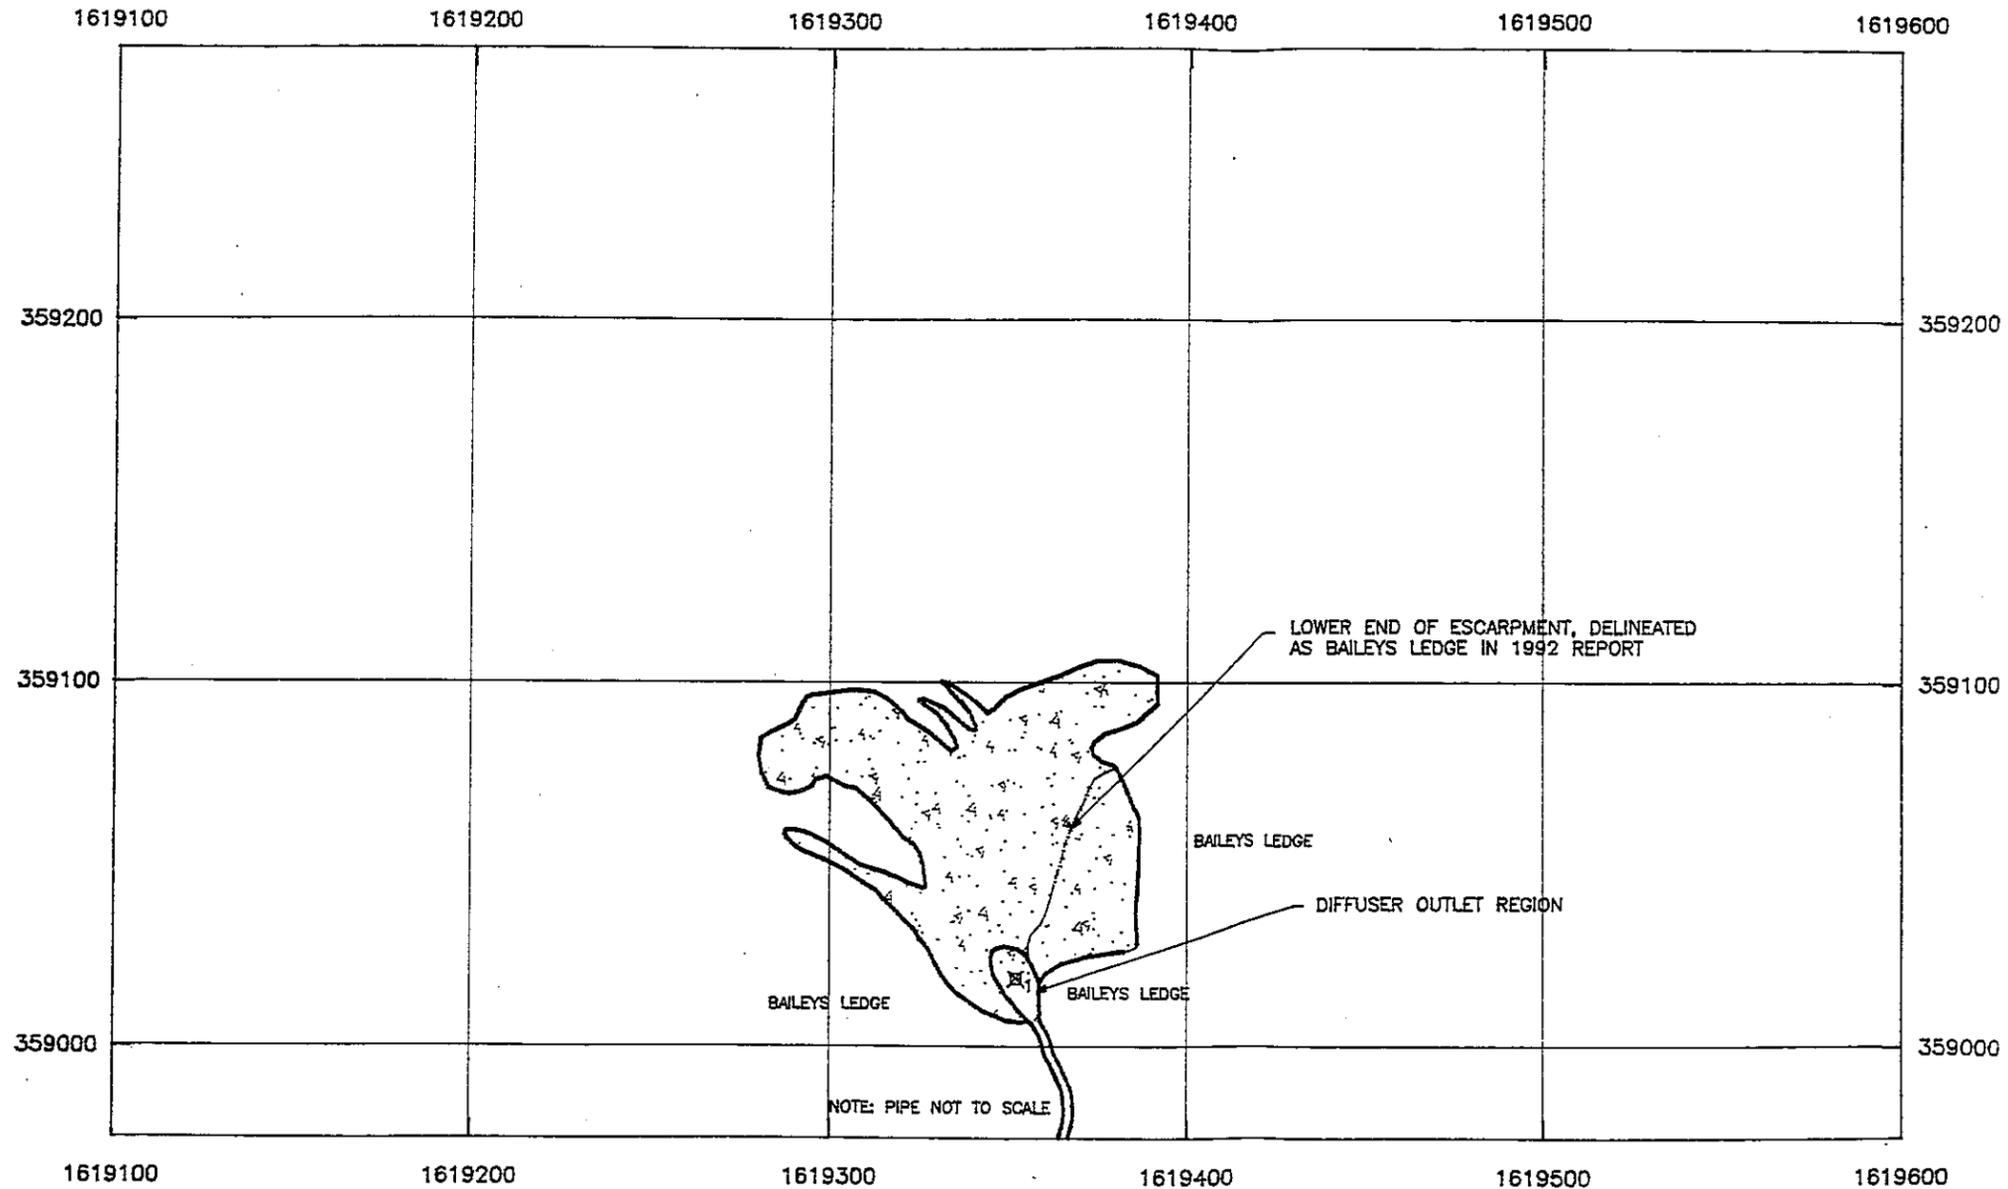
FIGURE 8	SCALE: 1:2000	DRAWN: GA
----------	------------------	--------------

In composing the seafloor analysis drawing (figure 8), sonar imagery was delineated according to the density of seafloor materials. The diffuser outlet region is surrounded by seafloor materials having a higher density signal return than this area, but less than the geologic structure of Baileys Ledge in approximately nine meters of water. This material is also delineated as apparent seafood processing waste in figure 8.

A region that was not investigated during the 1992 outfall survey but has been included in the 1993 study is the area where an abandoned outfall, May 1991, was located. This region is southeast of what has previously been delineated as Baileys Ledge. This region has a similar acoustic impedance to other locations designated as apparent seafood processing waste area and is delineated as the same.

The apparent processing waste area is approximately 6200 square meters. This area is the accumulation of apparent seafood processing waste overlying consolidated and unconsolidated materials. In figure 8 this region is classified as "Apparent Seafood Processing Waste Area." This finding requires verification using a grab sampler.

BAILEYS LEDGE OUTFALL SURVEY
 SEAFLOOR ANALYSIS

that because of the extreme relief and complexity of the area it is recommended that on the succeeding survey efforts, additional bathymetry data be gathered particularly in areas of high relief. It is further recommended that grab samples be taken to verify survey results.
