ENVIRO -TECH DIVING INC.

NPDES SURVEY
WESTWARD SEAFOODS, INC.

February 15 through March 15, 1995

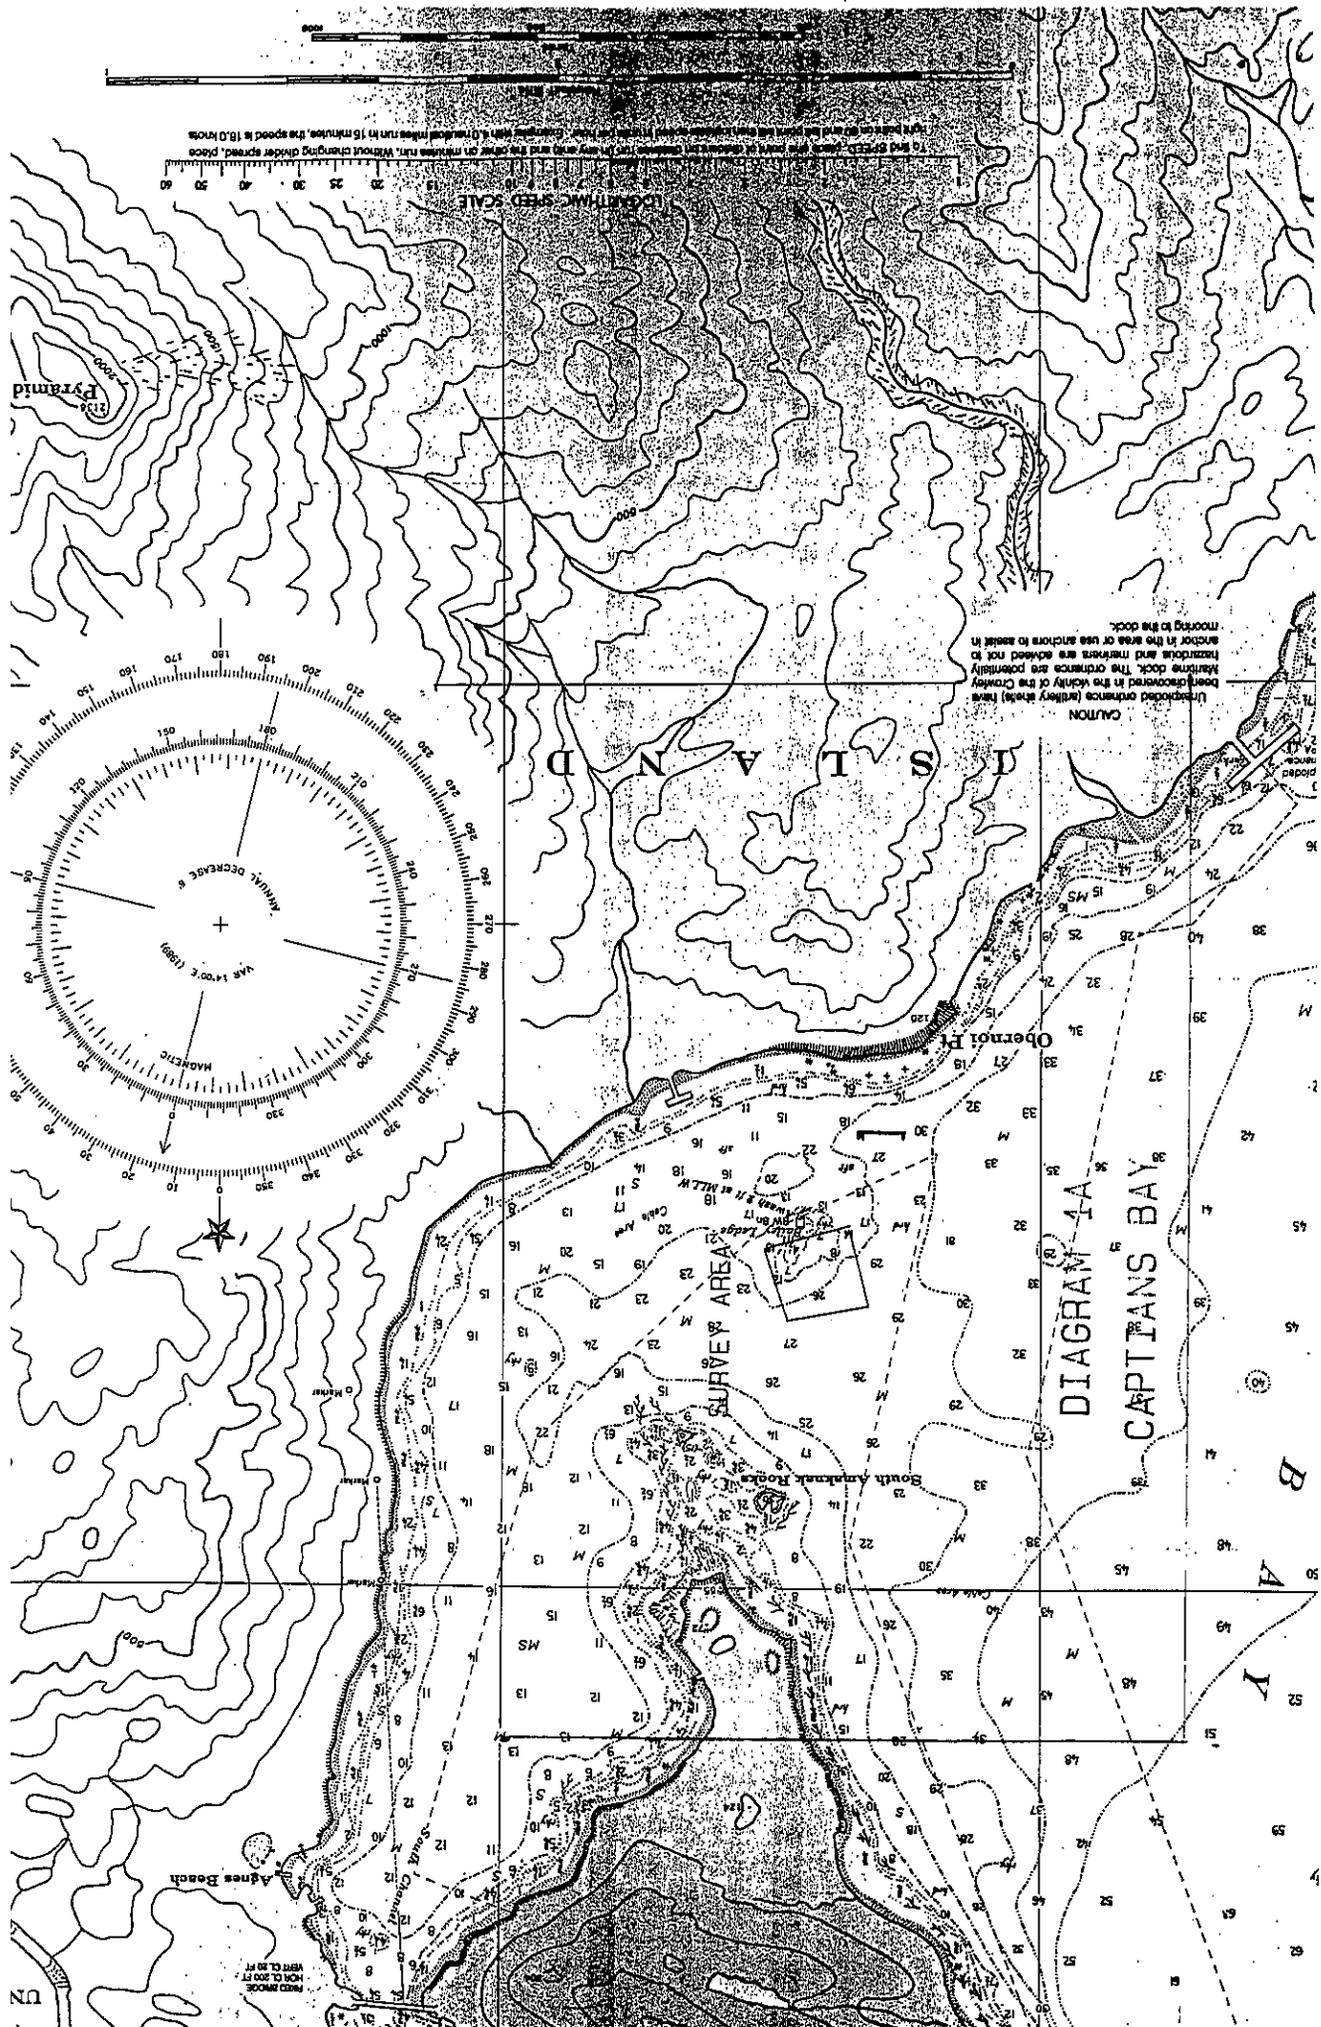
DIAGRAM 1A
CAPTAINS BAY

A series of four grids, two hundred feet by two hundred feet, were established around the Westward Seafood's outfall line located in Captains Bay (Diagram 1a). A total of 13 monuments were placed by Watson Co. on 7/21/94 using a Mini-Ranger system and referenced to state plane coordinates north of Baileys Ledge (Diagram 1b). These grids will be referenced as grids sections, one through four in this report. All of the grids as seen in Diagram 5 are interconnected. The north and south grid lines are set on an azimuth of 0° \longleftrightarrow 180° True, with the east and west grid lines set on an azimuth of 90° \longleftrightarrow 270° True. Each grid had a temporary grid reference line extended between the permanent monuments. This grid reference line had a reference mark every twenty feet. During the survey times divers extended a line reel with data marks every twenty feet between the corresponding reference marks on the grid reference line (Diagram 2).

- PERMANENT MARKERS
- 40 DATA POINTS
- 40 GRID LINE WITH REFERENCE MARKS

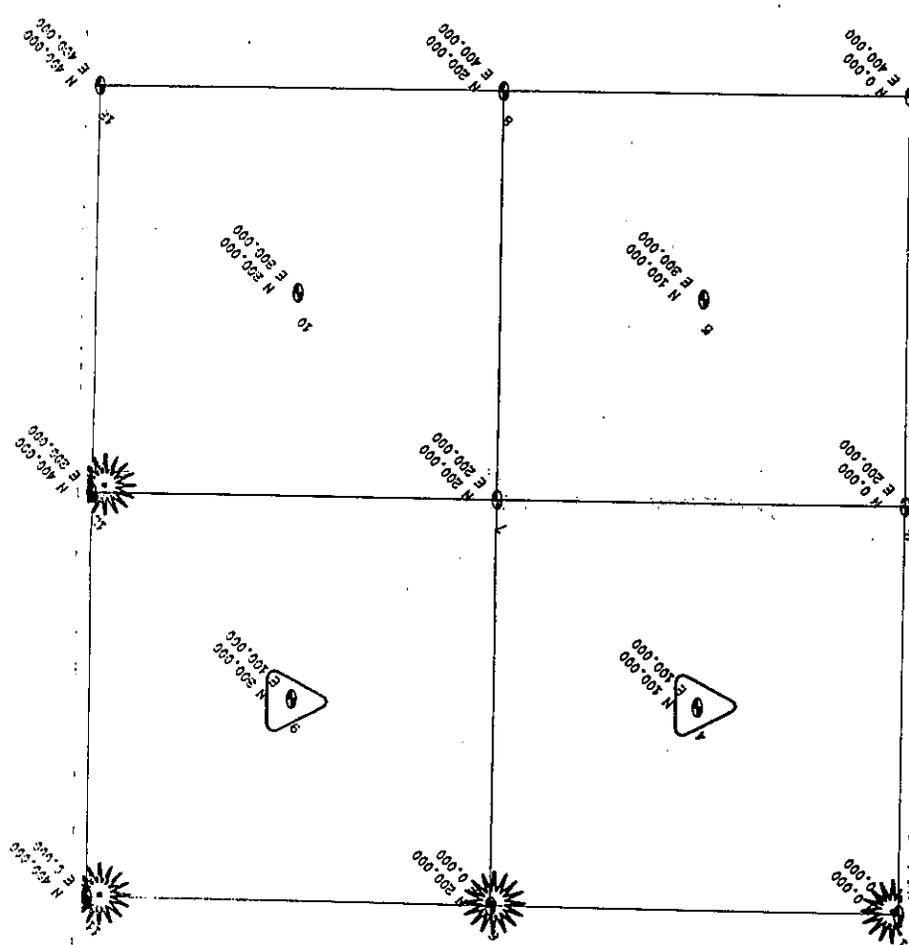
DIAGRAM 6

REPOSITIONED MONUMENTS

MISSING MONUMENTS

DISTURBED MONUMENTS

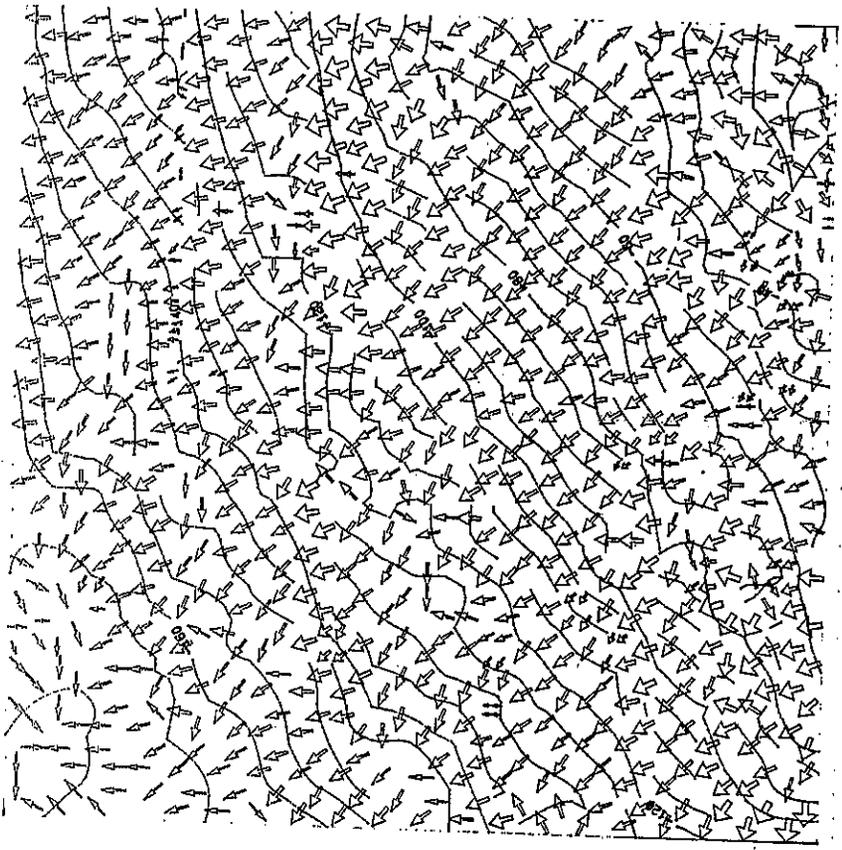
DIAGRAM 8

This section has extensive coverage in the southeast portion of the survey area. The processing waste depths in the southeast corner reach 1.8 feet and decrease as you travel to the north. The processing waste flow appears to be in a northwest direction (Diagram 9) that follows the natural topography of this survey site. This is consistent with the flow analysis of the bottom topography (Diagram 8). Many of the waste measurements on the edge of the processing waste are very difficult to determine due to the soft substrate and waste composition. The depths along this edge range from .1 to .3 of a foot. Although waste in small amounts extended slightly past the northwest boundary divers did not survey this area due to increasing water depths. Water depths reach over 170 feet at the northwest corner with water depths at the northeast corner being 162 feet. Marine life in this area is very minimal with the exception of the occasional flat fish. It should be noted that divers observed crab in this area, either *Opolio* or small *Baradi* crab.

FLOW ANALYSIS W/ TOPOGRAPHIC

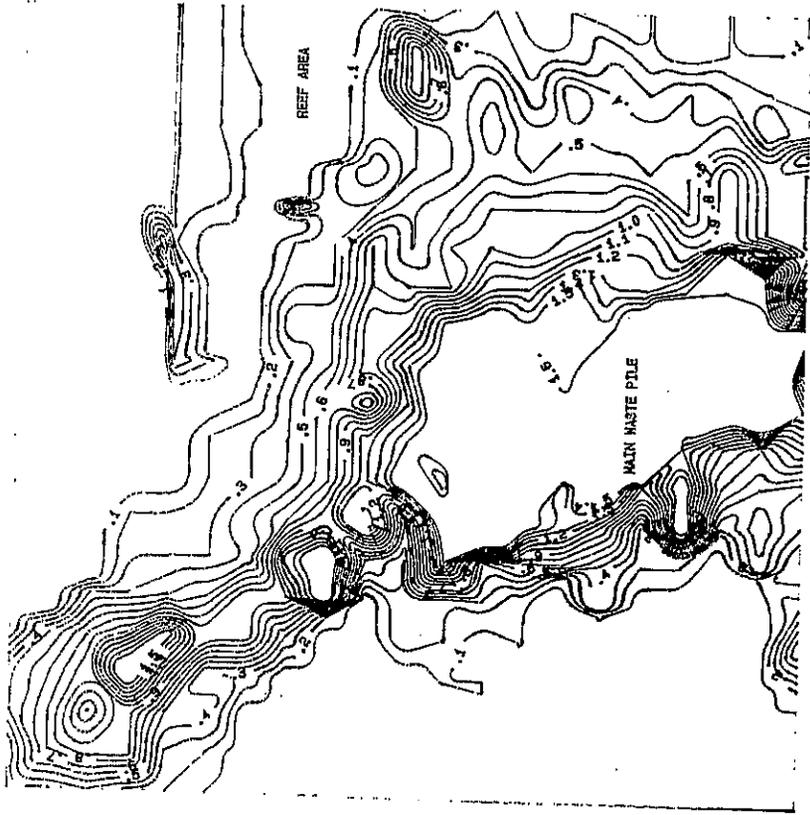
DIAGRAM 9

This section is dominated by the caldera shaped waste pile (Diagram 7) just five feet east of the eastern boundary and eighty feet from the southern boundary formed by the discharge at termination of the old outfall. This caldera is forty feet long and fifteen feet wide that lays in a northwest direction. Waste at the deepest point is 12.1 feet, at a depth of sixty three feet below the surface. The sides of the caldera's waste is two to three feet deep with the deepest area at the far northwest end. The sides of the caldera on the northwest end have steeply sloping sides that sit on a steep natural slope. The center of the caldera has only small amounts of waste and in some areas are completely clear due to the high volume flow from the diffuser. Again the waste is very fine processing waste with no particles larger than .5 inches. The waste flow travels in a northwest direction and has diminished to a little more than two feet by the time the northern boundary of this section is reached (Diagram 9). Waste depths diminish rapidly as divers traveled to the west.

WASTE EXTENT

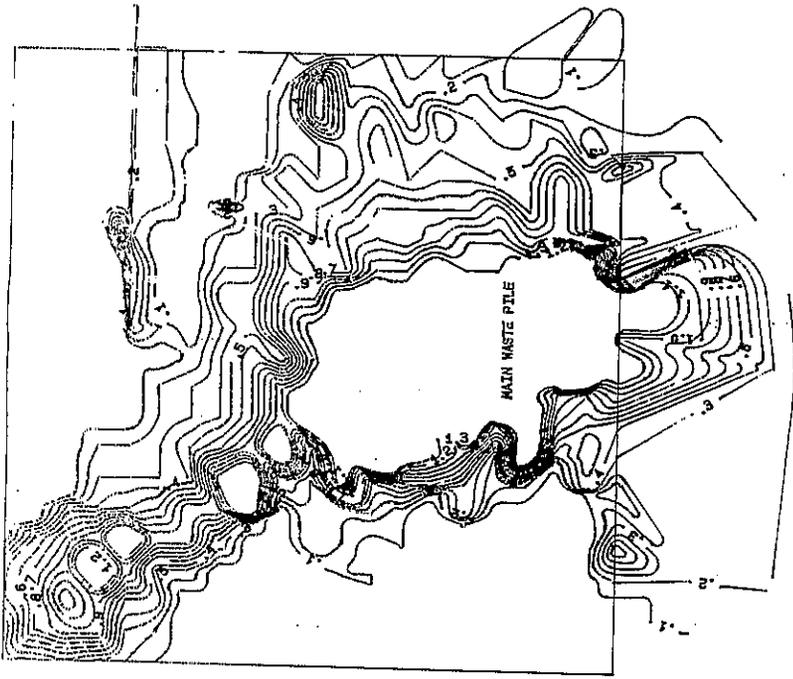
DIAGRAM 11

TOTAL WASTE COVERAGE 157,931 SQ. FEET
3.63 ACRES

IN AREAS OF WASTE COVERAGE .72 FEET
WASTE GREATEST DEPTH 12.1 FEET

WASTE EXTENT ENTIRE AREA

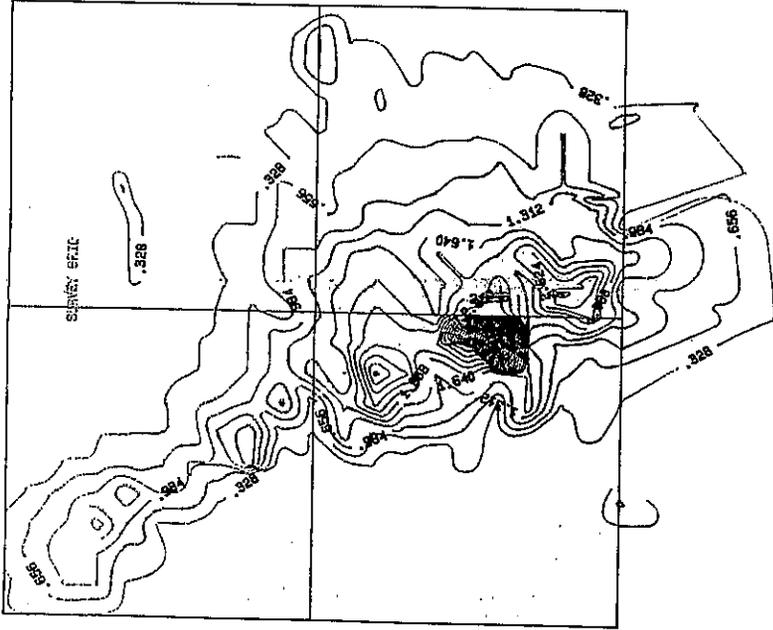
DIAGRAM 12

TOTAL WASTE COVERAGE 108,824 SQ. FEET
2.50 ACRES

WASTE EXTENT ENTIRE AREA

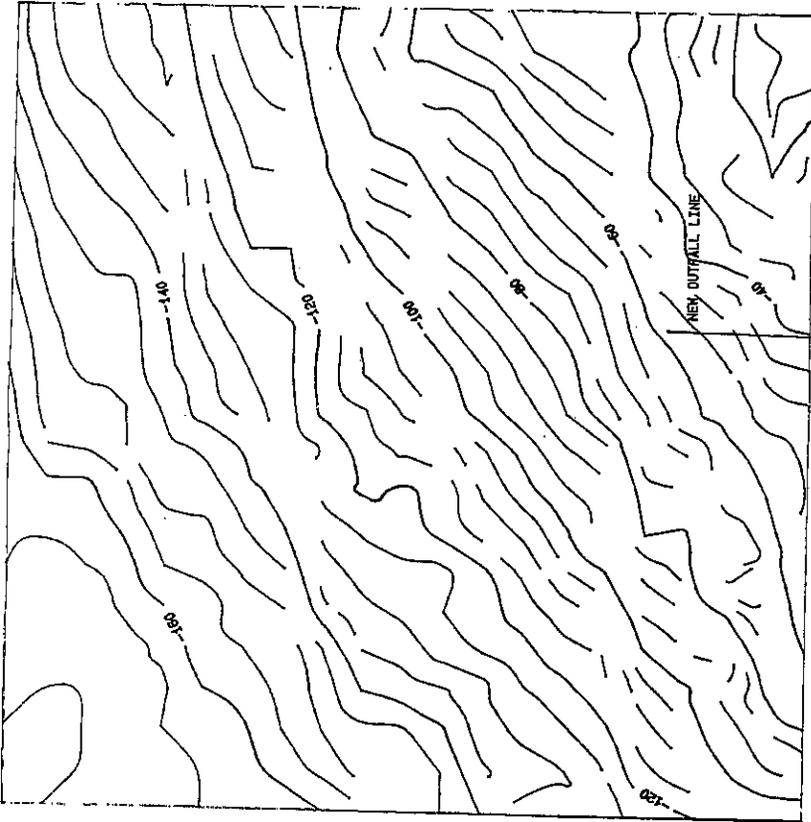
BOTTOM ONLY

TOPOGRAPHIC MAP

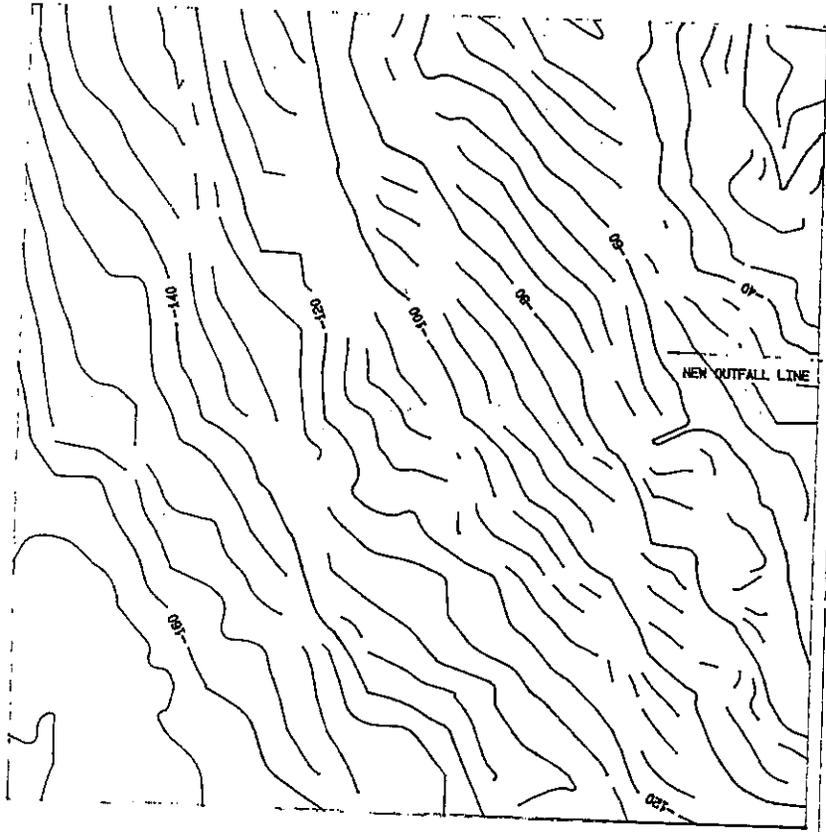
BOTTOM WITH WASTE
TOPOGRAPHIC MAP

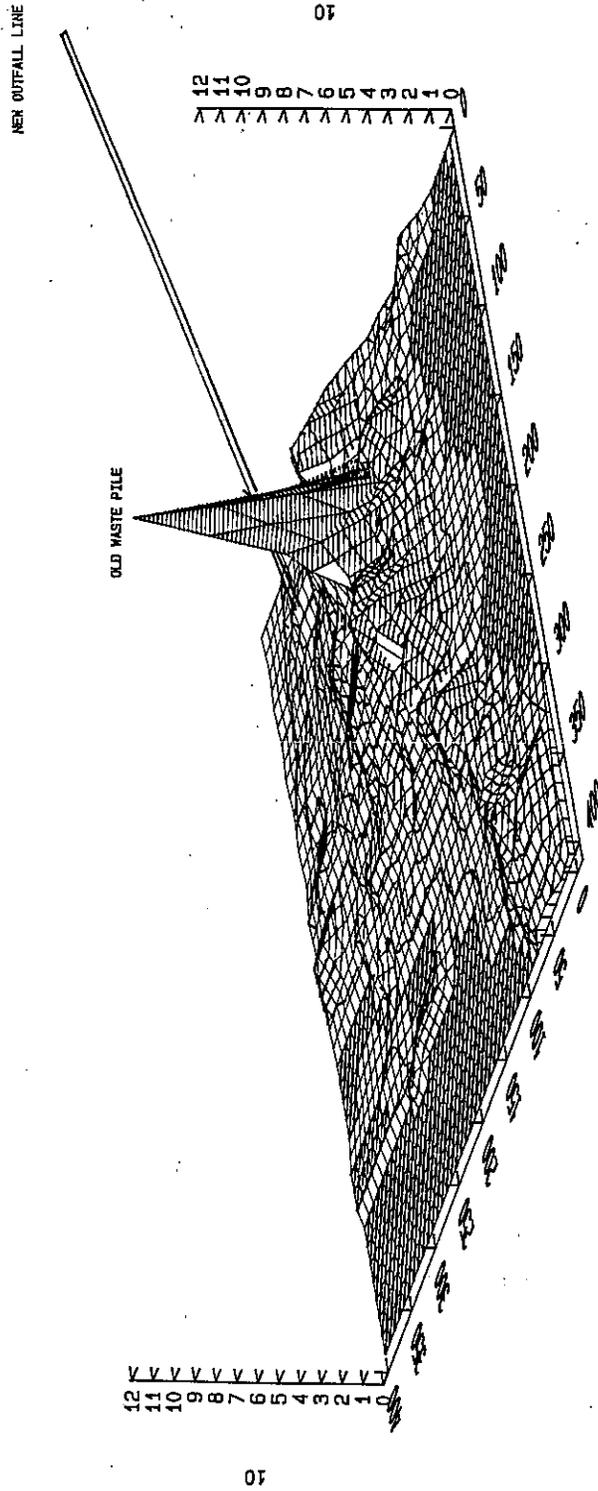
WASTE HEIGHT IS EXAGGERATED 40 TIMES TO SHOW WASTE COVERAGE OF MINOR DEPTHS IN SURVEY AREA

3-DIMENSIONAL MAP W/ TOPOGRAPHIC

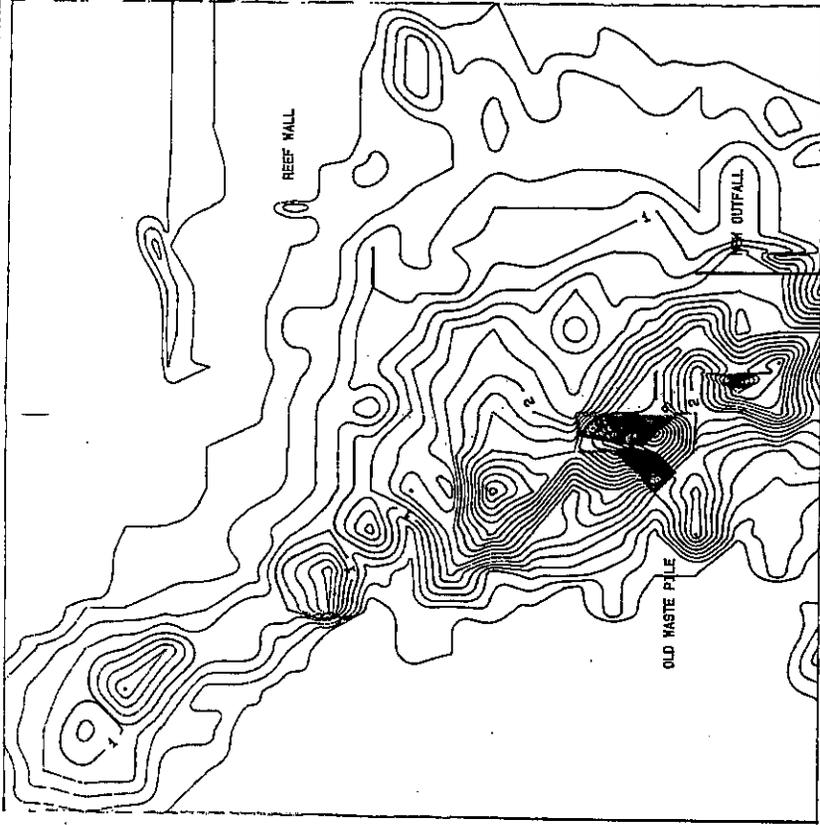
WASTE

TOPOGRAPHIC MAP

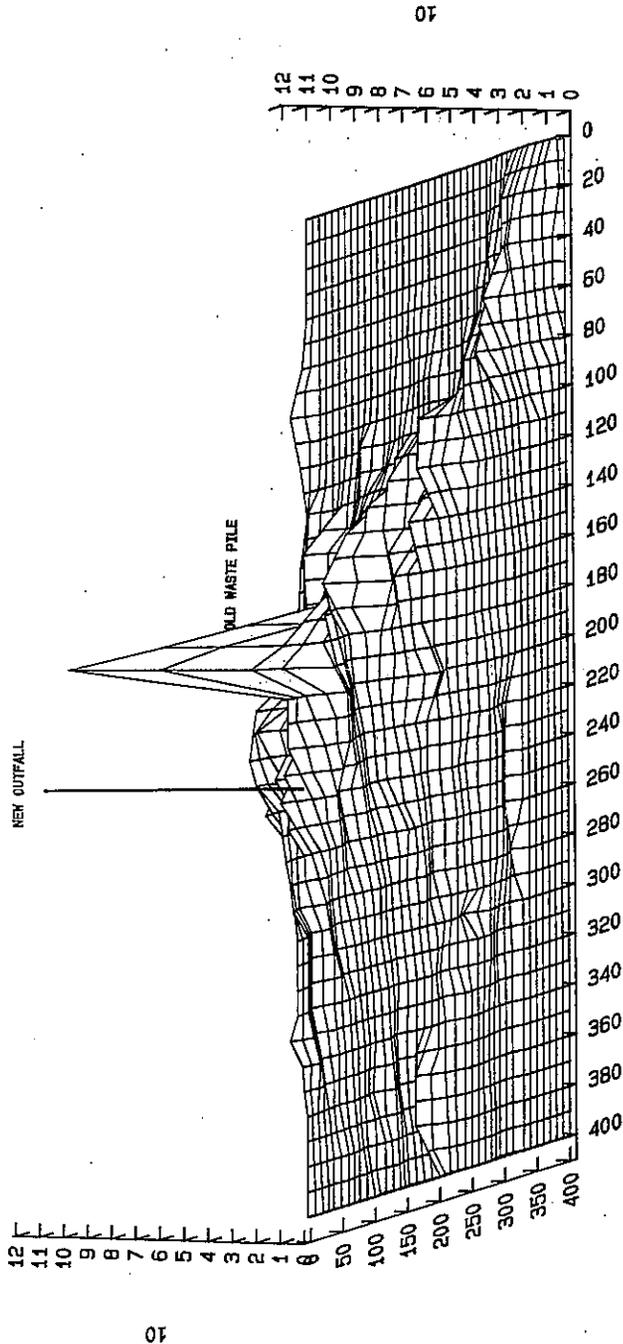
WASTE HEIGHT IS EXAGGERATED 10 TIMES TO SHOW WASTE COVERAGE OF MINOR DEPTHS IN SURVEY AREA

THREE DIMENSIONAL MAP
