# MEMORANDUM

1986/87  
State of Alaska

SUBJECT: Seward Peninsula  
Field Trip,  
6/22-26/87

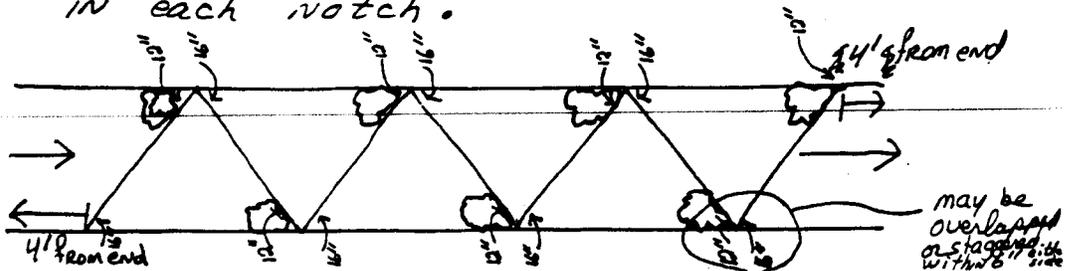
ONE CMP set @ thalweg

Baffle system installed in fish passage CMP (depressed invert) consisting of rebar baffles with hand placed CLASS II RIP RAP set in each notch.

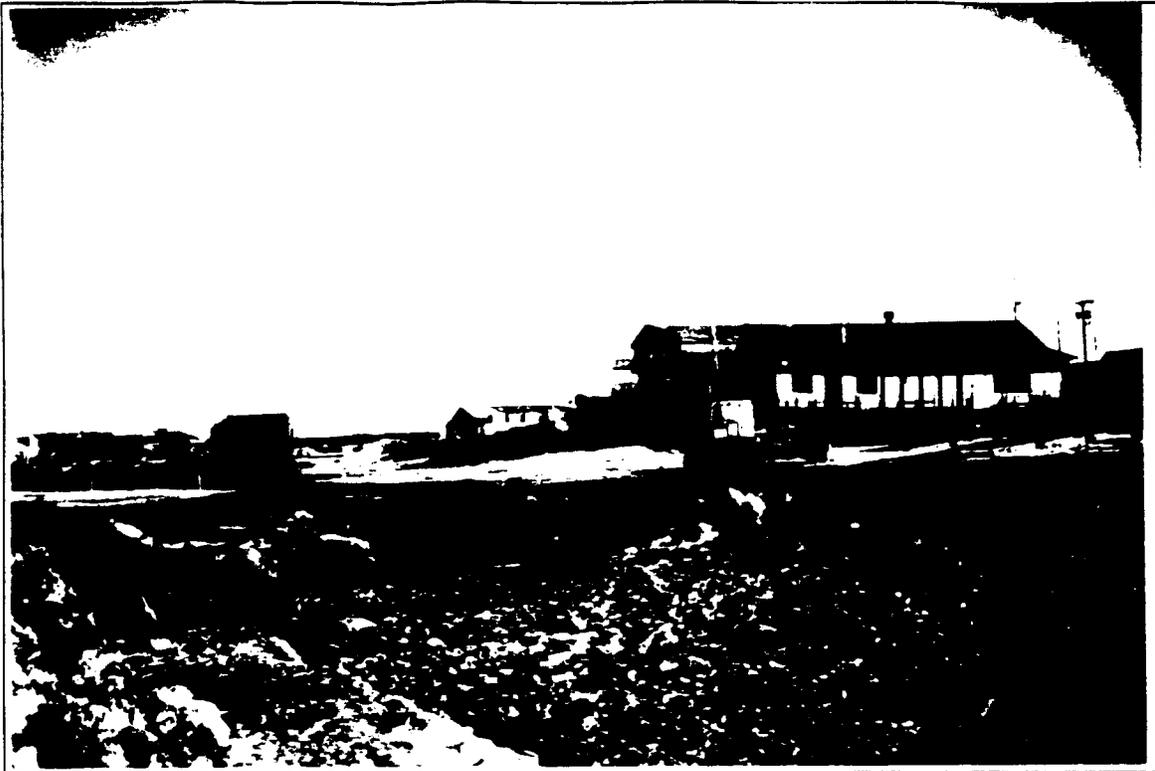
Photo 1: Nome Small Boat Harbor Project. Looking west. Photo taken at SE corner of excavation. Task: hauling ice to river.
