DEPARTMENT OF THE ARMY
U.S. ARMY ENGINEER DISTRICT, ALASKA
P.O. BOX 898
ANCHORAGE, ALASKA 99506-0898
JULY, 30 1997

This is a Notice of Alleged Violation involving noncompliance with the terms and/or conditions of Department of the Army (DA) permit number 4-960826, Snake River 10, issued to the City of Nome (City) on February 10, 1997. The permit authorized the City to dredge up to 56,000 cubic yards of material from 5.6 acres of waters of the United States (U.S.), including the existing boat harbor, a 200' X 100' X 10' channel within the Snake River, and a creek channel at the north end of the project area. In addition, the permit authorized the construction of sheet pile retaining walls, the installation of two seasonal floating docks, and the placement of up to 18,625 cubic yards of dredged, gravel, and riprap fill material into 1.2 acres of tidelands for harbor stabilization and/or future development activities. The harbor is located at Nome, Alaska, within sections 26, and 35, T. 11 S., R. 34 W., Kateel River Meridian.

Subject: City of Nome Small Boat Harbor Project
 Permit Number 2-960826
 Notice of Alleged Violation

NOPE SMALL BOAT HARBOR

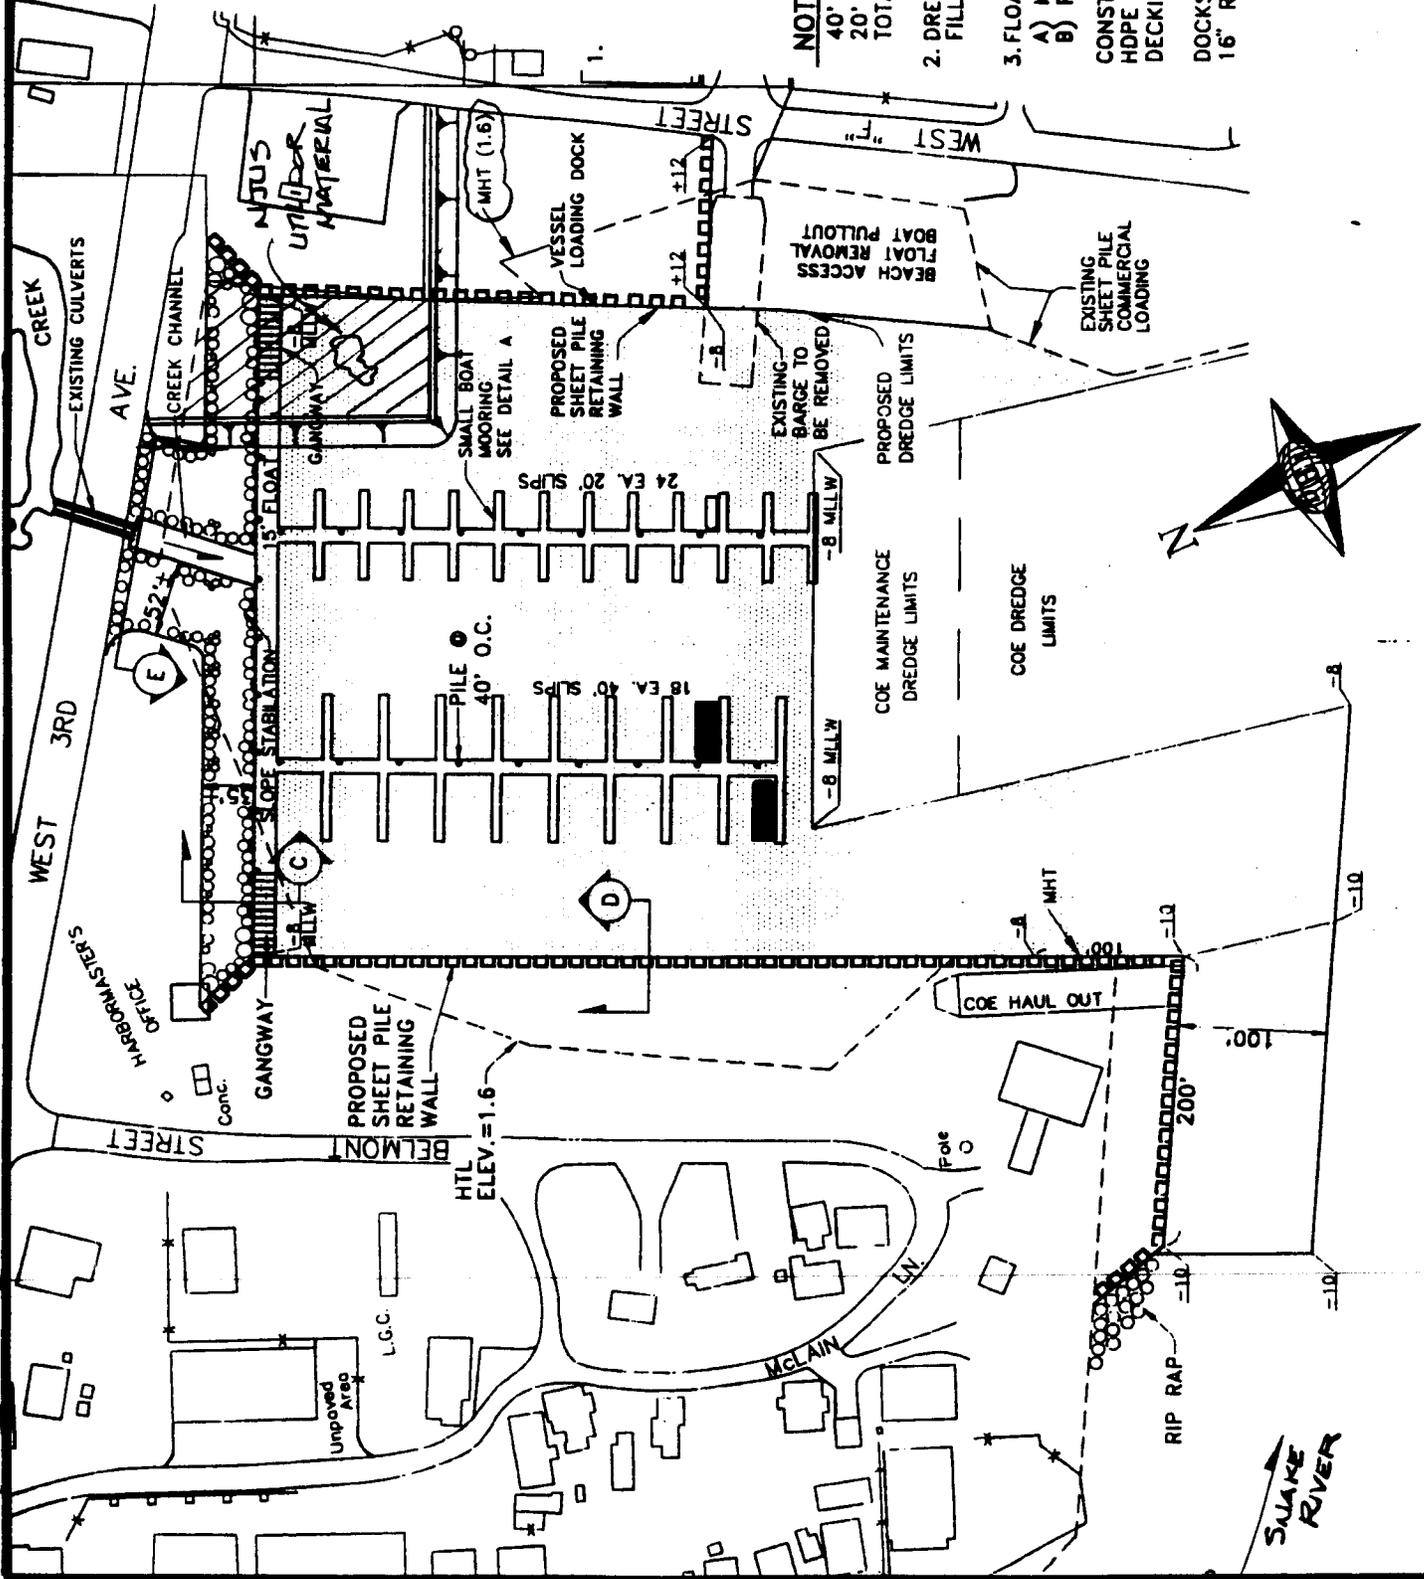
CONCEPTUAL PLAN

40' SLIPS	36
20' SLIPS	48
TOTAL SLIPS	84

2. DREDGE = 41,000 TO 65,000 C.Y.
 FILL 55,000 TO 65,000 C.Y.

3. FLOATIN DOCK:

- A) MAIN DOCK - 15' WIDE
 - B) FINGER DOCKS 8' WIDE
- CONSTRUCTION WILL CONSIST OF HDPE OR STEEL FLOATS W/ WOOD DECKING (NON TREATED)
- DOCKS WOULD BE ANCHORED WITH 16" ROUND STEEL PILE.

Beginning about July 5, and continuing to August 9, 1997, approximately 6,600 cubic yards of this material was trucked directly from the excavation sites shown on Attachment B and placed within the Permit area behind a rock containment dike in the northeast corner of the small boat harbor. Attachment A indicates where this fill area is located.

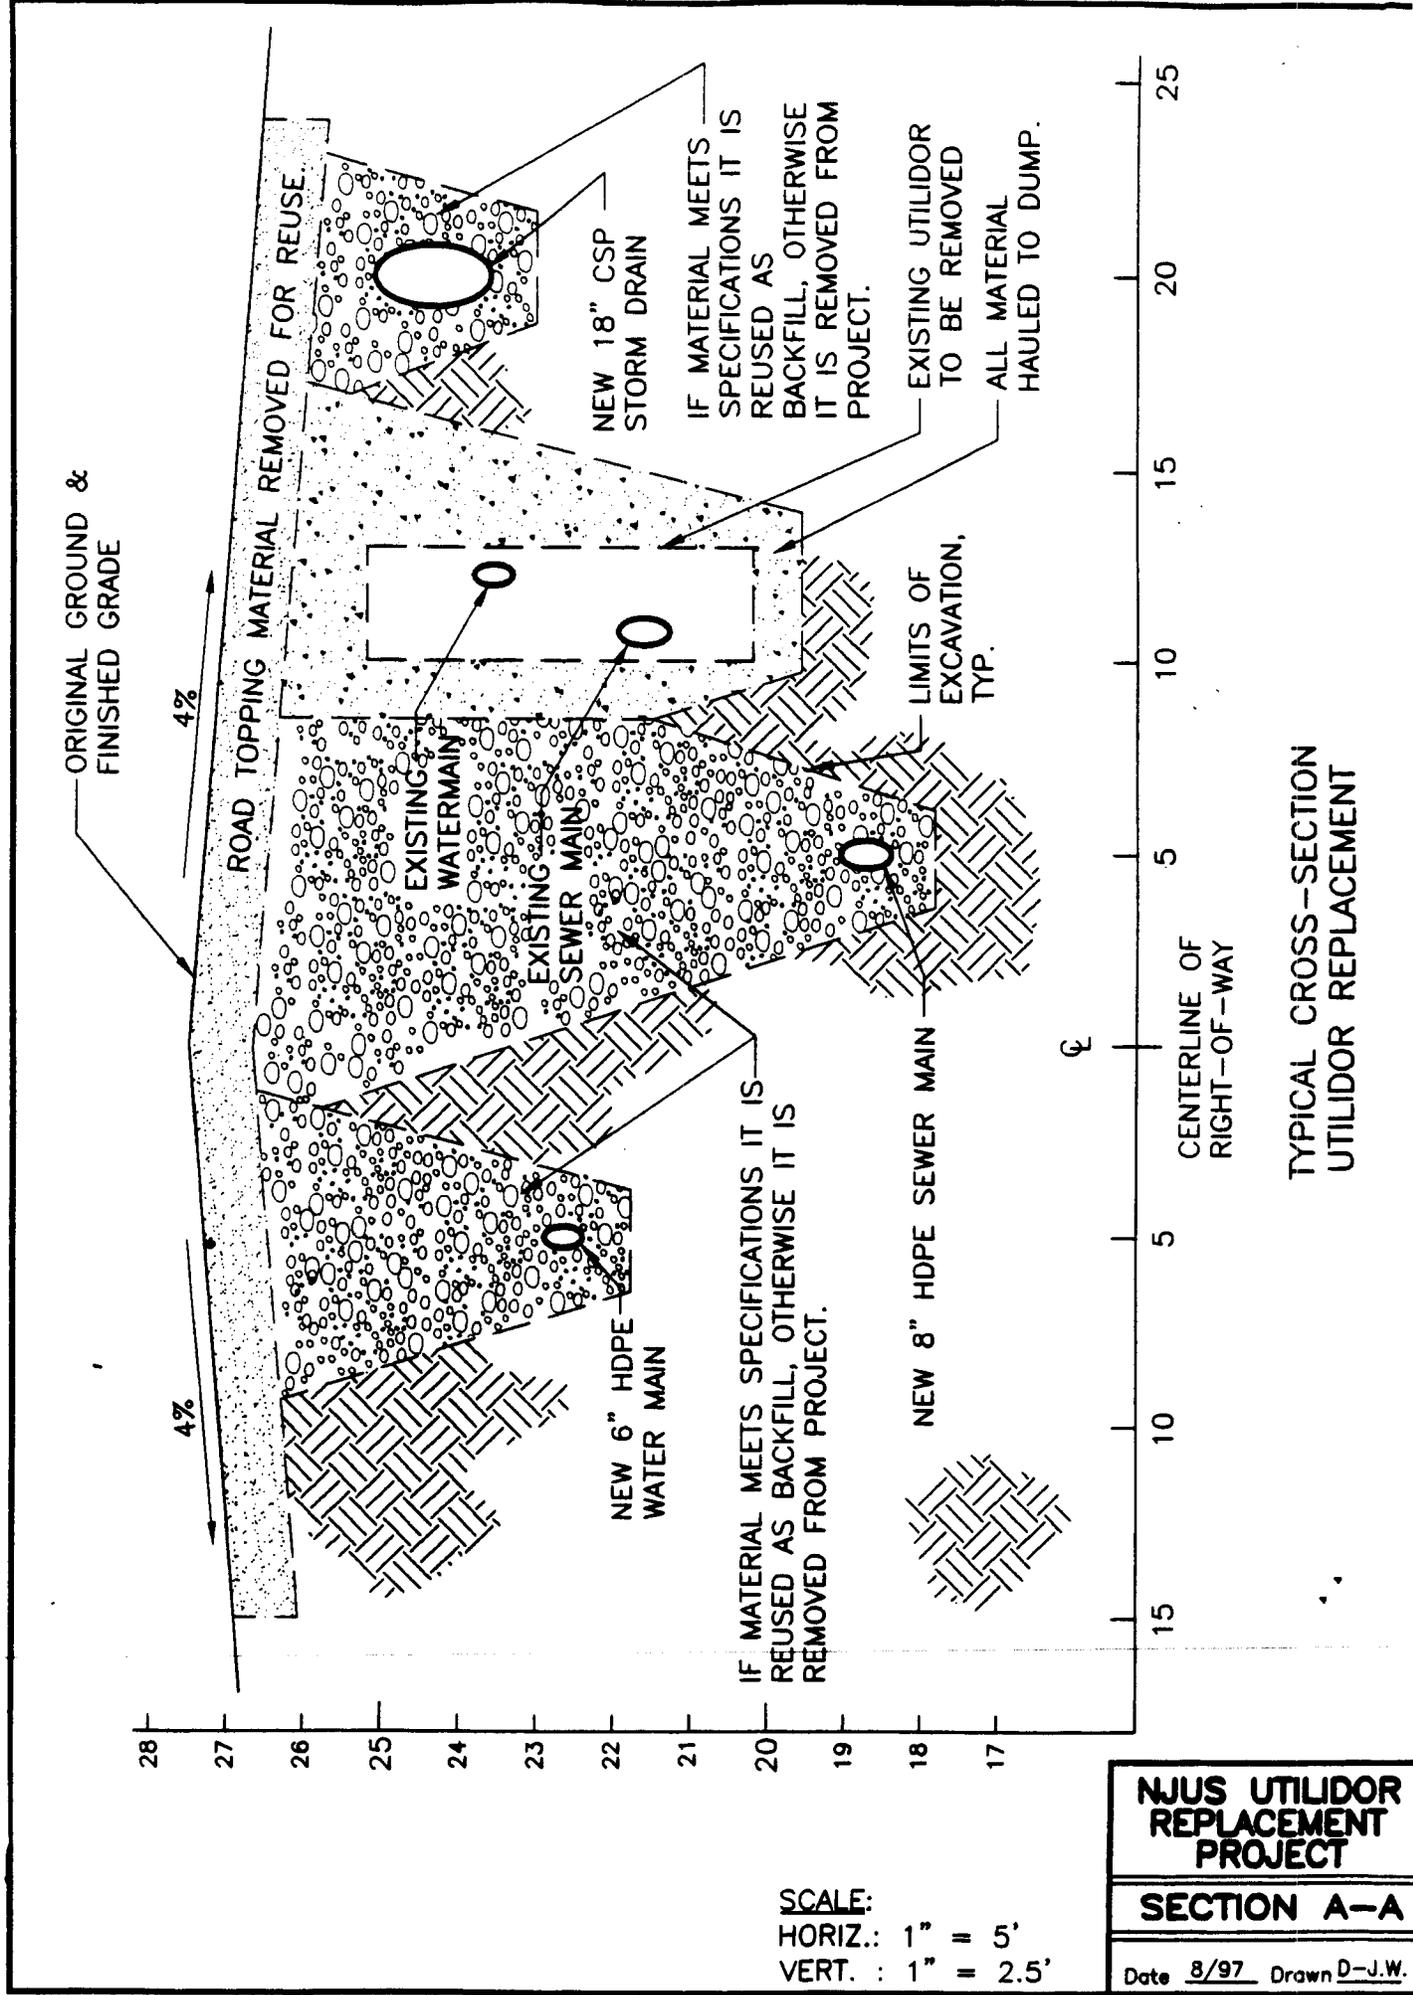
Attachment (C): NJUS Utilidor Replacement Project Typical Cross-section

IF MATERIAL MEETS SPECIFICATIONS IT IS REUSED AS BACKFILL, OTHERWISE IT IS REMOVED FROM PROJECT.

EXISTING UTILIDOR TO BE REMOVED ALL MATERIAL HAULED TO DUMP.

TYPICAL CROSS-SECTION UTILIDOR REPLACEMENT

facility. If the material does not meet trench backfill standards, and does not contain utilidor materials, it has been used for general fill at other City jobs including the small boat harbor.

These materials were exclusively clean, native soils suitable for small boat harbor fill. The composition is gravel (6-inch minus) and sand, with some limited silts or organics. Some of the materials were frozen at the time of deposit.

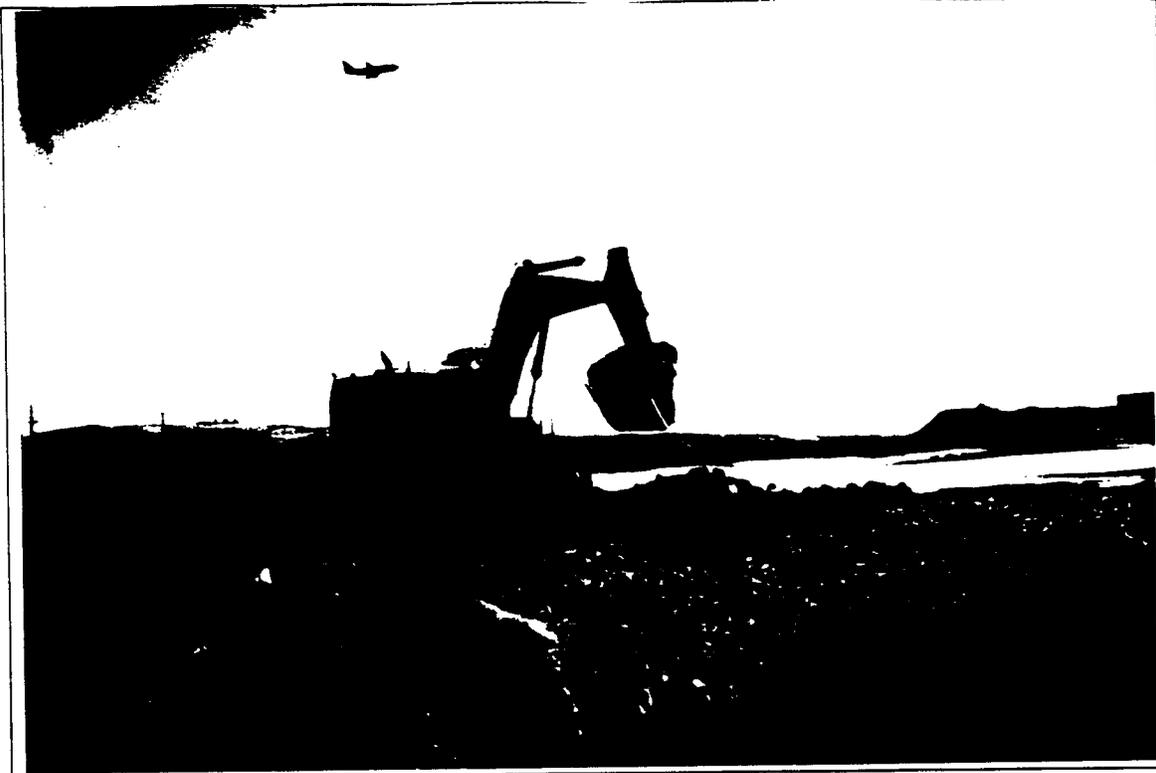
Photo 3: Nome Small Boat Harbor Project. Looking north. Photo taken at SW corner of excavation. Task: removing ice before dredging.

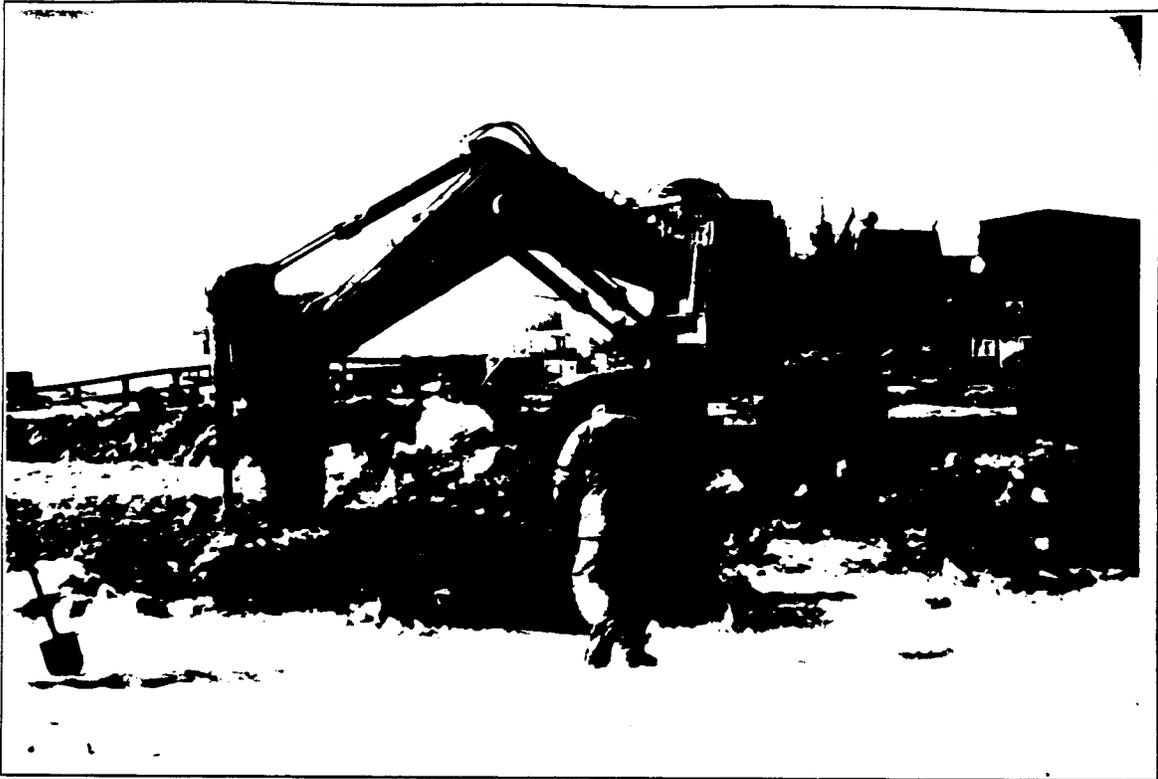
Photo 5: Nome Small Boat Harbor Project. Looking SW. Photo taken at new anchor location. Task: relocate anchor.

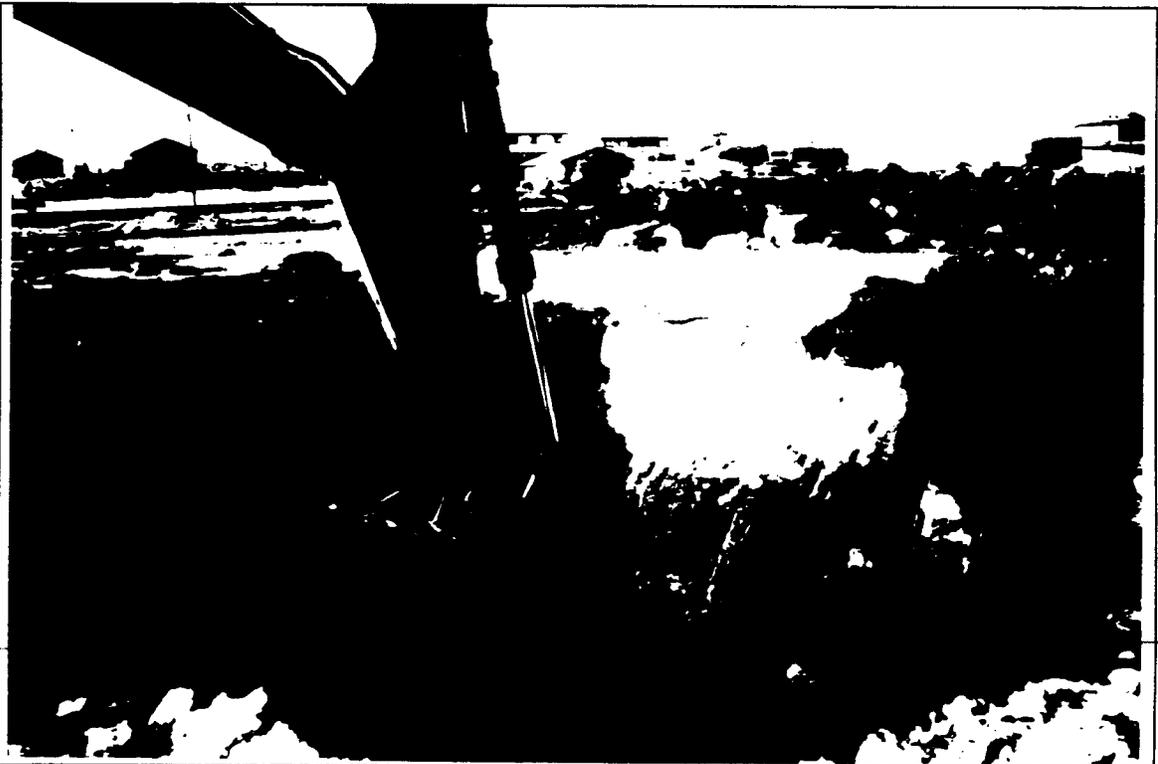
Photo 6: Nome Small Boat Harbor Project. Looking WNW. Photo taken at east limit of dredge area. Task: dredging. Note buffer zone between dredge stockpile & dredging area.

The material characteristics at the time of excavation were very dense and/or frozen. The method of excavation, using a large backhoe in winter rather than a cutter/suction dredge or dragline, resulted in highly manageable, virtually dewatered materials being extracted. The materials were then end-dumped and dozed into the stockpile. All materials were placed beyond a buffer zone of at least 50 feet from the edge of the excavation, to prevent material from reentering the excavation site.
