Underwater Bark Debris Survey
Rowan Bay Log Transfer Facility
Kuiu Island, Alaska

Submitted to: USDA Forest Service, Region 10
Ketchikan Area, Tongass National Forest
Federal Building, 648 Mission Street
Ketchikan, AK 99901

Prepared by: Craig's Dive Center
P.O. Box 796
107 Main Street
Craig, AK 99921

June 12, 2001

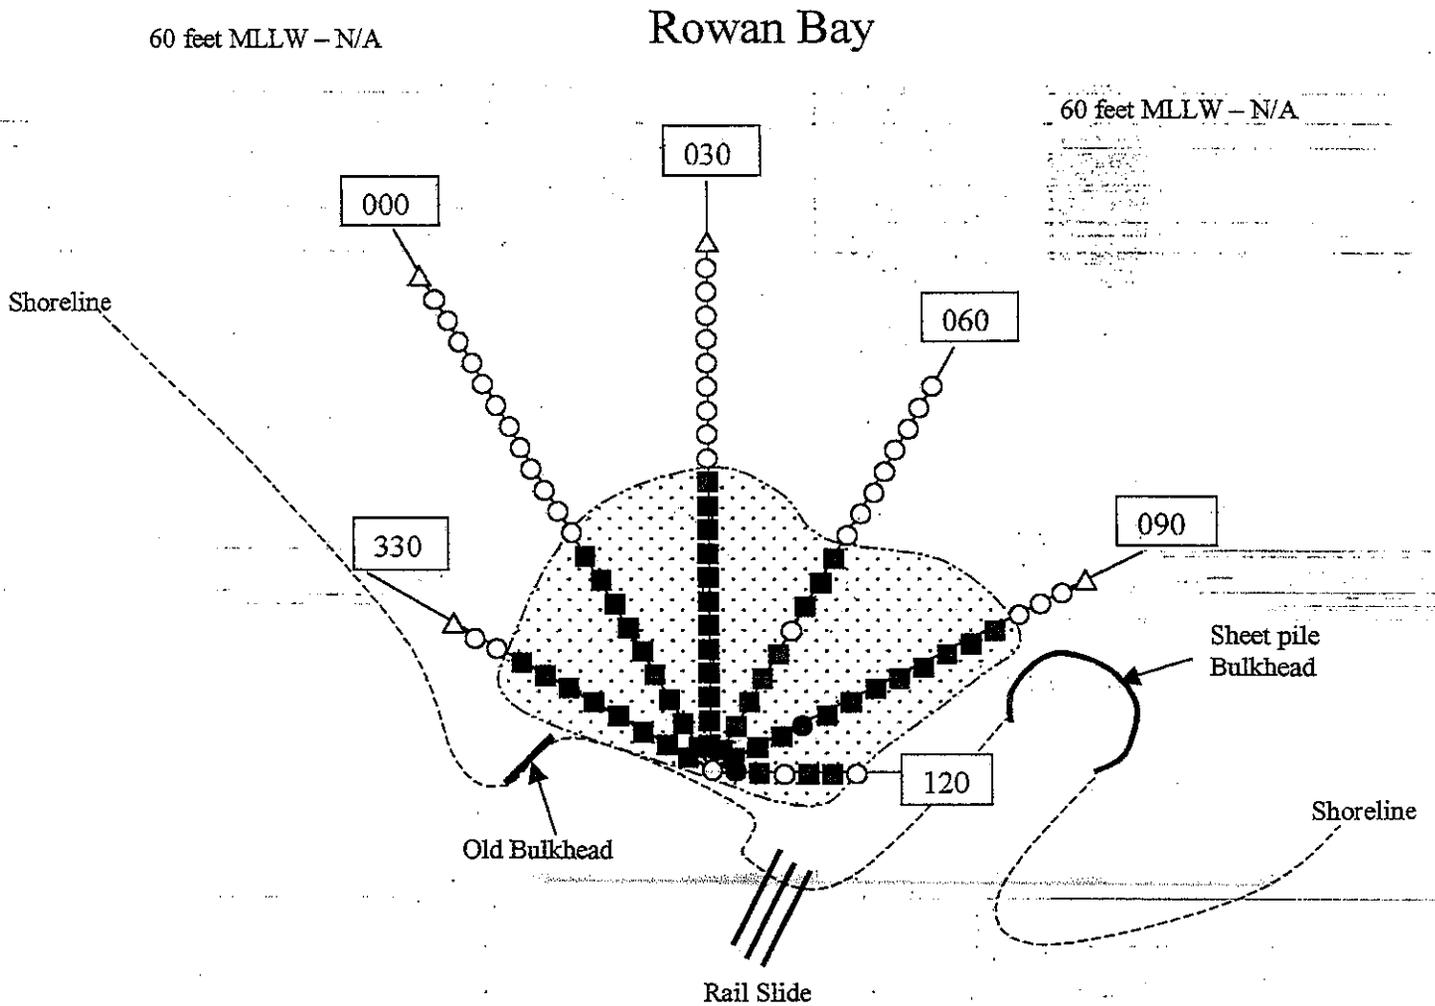
Diagram Not To Scale

Key to Substrate Type	
Brk	Bedrock
Gr	Gravel
Rk	Rock
Sa	Sand
Sh	Shell
Si	Silt

△ Sample Point with Insignificant Bark Debris
□ Sample Point with No Debris
○ Sample Point with Debris Present
● Sample Point with 100% Bark Debris Cover
■ Sample Point with 100% Cover & Debris Depth > 4 in
⊙ Area of 100% Bark Cover
