FY 2006
FINAL REPORT

PROJECT #: ACWA-06-11

**Watershed Protection and Recovery for
Pederson Hill Creek, Juneau, AK**

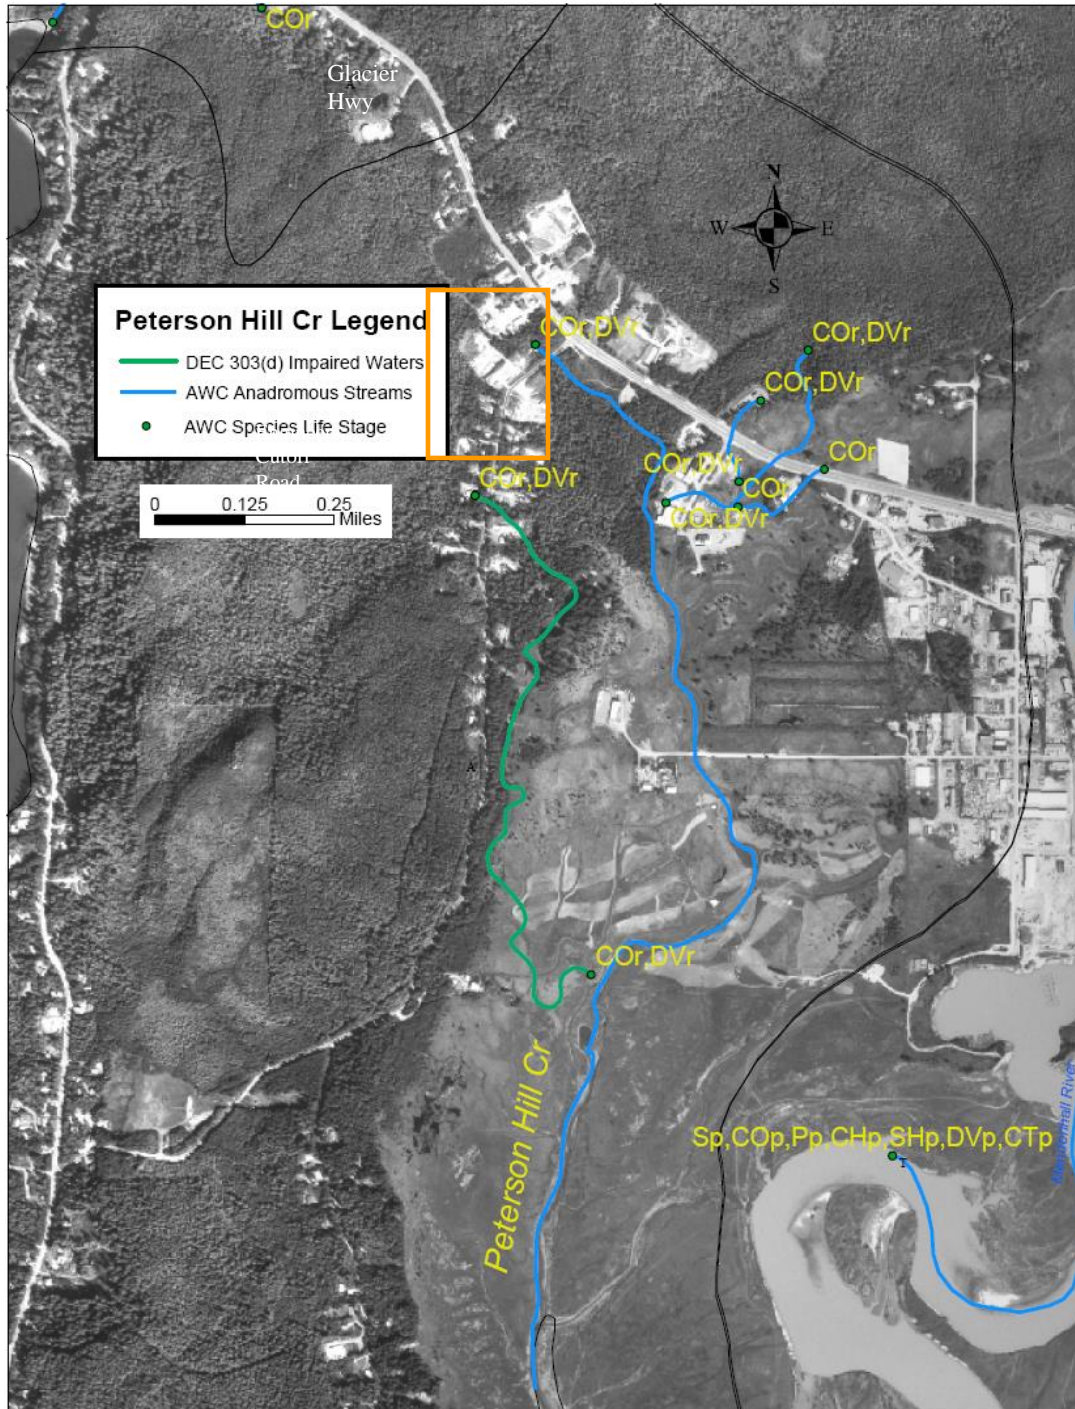
Figure 2. Labeled aerial photograph of Pederson Hill Creek. Sampling for this project was concentrated in the upper east fork section of the stream, in the orange box inset (see Figure 2). The large river on the lower right is the Mendenhall River. Coding along the stream is from the ADF&G Catalog of Waters Important for Spawning, Rearing, or Migration of Anadromous Fishes (Johnson and Weiss 2006) and specifies species of fish present (S=sockeye salmon, CO=coho salmon; P=pink salmon, CH=chum salmon, DV=dolly varden, CT= cutthroat trout). Map template courtesy Lori Sowa of ADEC.

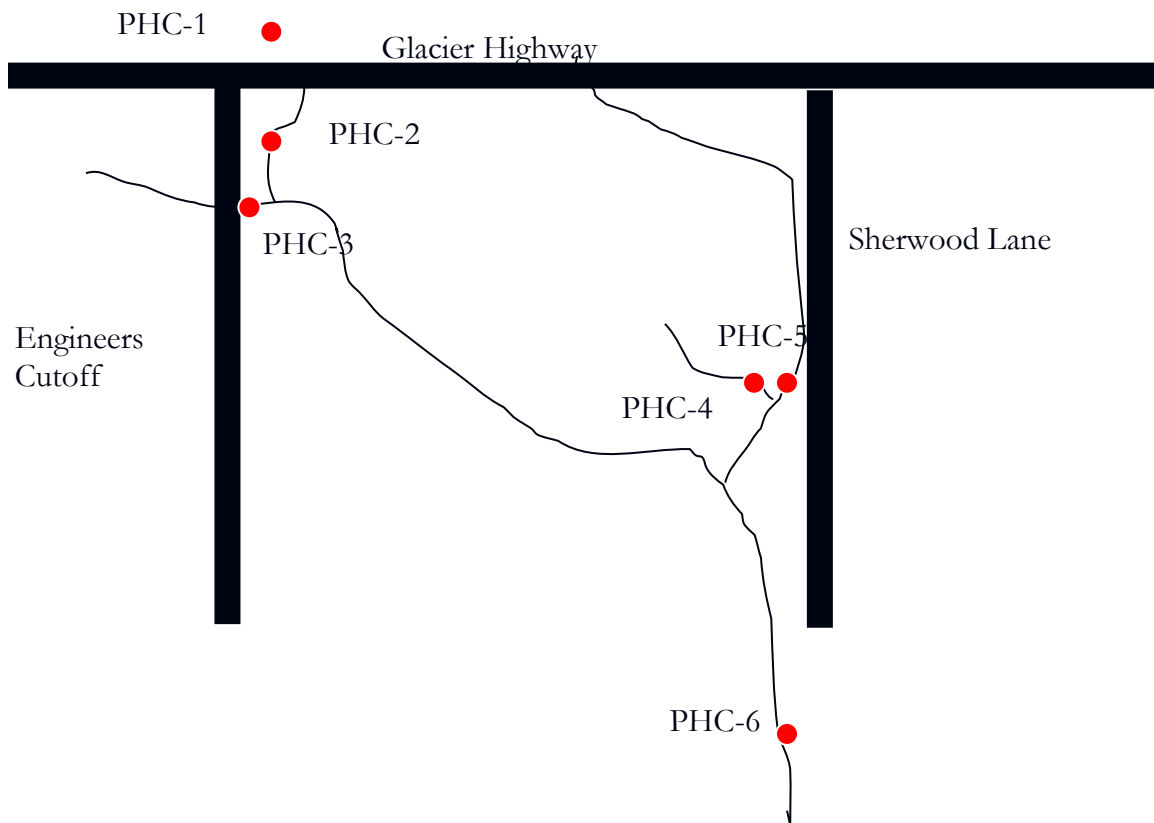
Figure 3. Sketch of location of sampling sites along Pederson Hill Creek. The area shown above is equivalent to the orange inset in Figure 2.

Specific site location descriptions are below:

- Site PHC-1: Uphill of the Baptist church near the intersection of Glacier Highway and Engineers cutoff road. The area has dense brush and many areas of stagnant flow.

- Site PHC-2: Directly across Glacier Highway from the Baptist church is a small tributary that runs parallel to the highway and is fed by the water source for site #1 and other drainage. It runs under the highway through a culvert. This site represents water runoff from the drainage ditches on both sides of the highway.

- Site PHC-3: This sampling site was selected because of historically high measurements of fecal coliform bacteria in past studies. The source is primarily a residential development across Engineers Cutoff, runs under the road through a culvert. Accessible on the maintained nature trail in this area. (Photo: Figure 4)

- Site PHC-4: In between two office buildings, one housing the DMV, the other the USDA Forestry Sciences Laboratory, there is ready access to the stream on the edge of the parking lot. This site was chosen to test the tributary (the west fork in the stream), which emerges from an area of wetlands.

- Site PHC-5: The east side of the fork described in PHC-4 was selected again due to historically high reports of fecal coliform bacteria. It contains the runoff from the parking lot and office buildings on Sherwood Lane. (Photo: Figure 5)

- Site PHC-6: This site is reached by driving to the end of Sherwood Lane. The road goes to gravel, and has a small turn around. A short walk through tall grass leads to a footbridge, the sampling site. This is the lowest point in the stream used for collection, and has higher flow levels than the upper sites. (Figure 6)

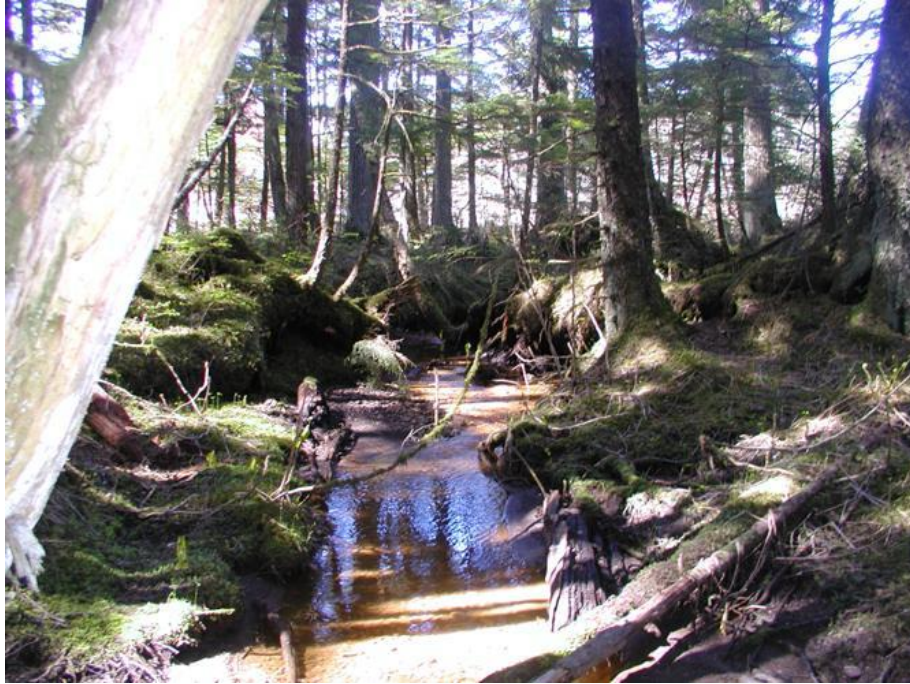
Figure 4. *Pederson Hill Creek at site PHC-3, near the intersection of Glacier Highway and Engineers Cutoff Road; site accessible on the nature trail footpath. May, 2006.*

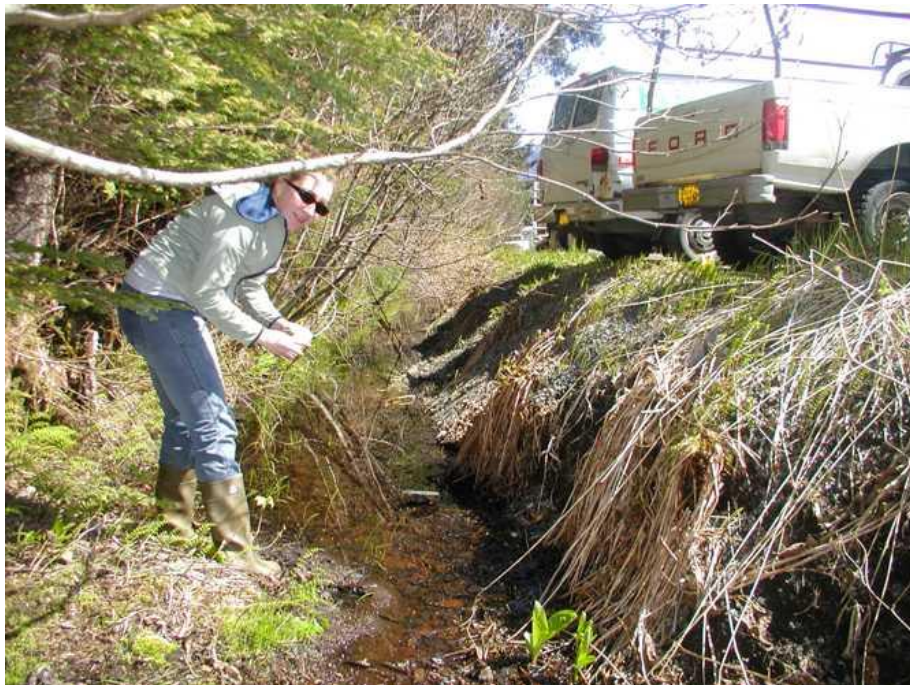
Figure 5. *Pederson Hill Creek at site PHC-5, flowing along the edge of the parking lot for the office buildings on Sherwood Lane. May, 2006.*

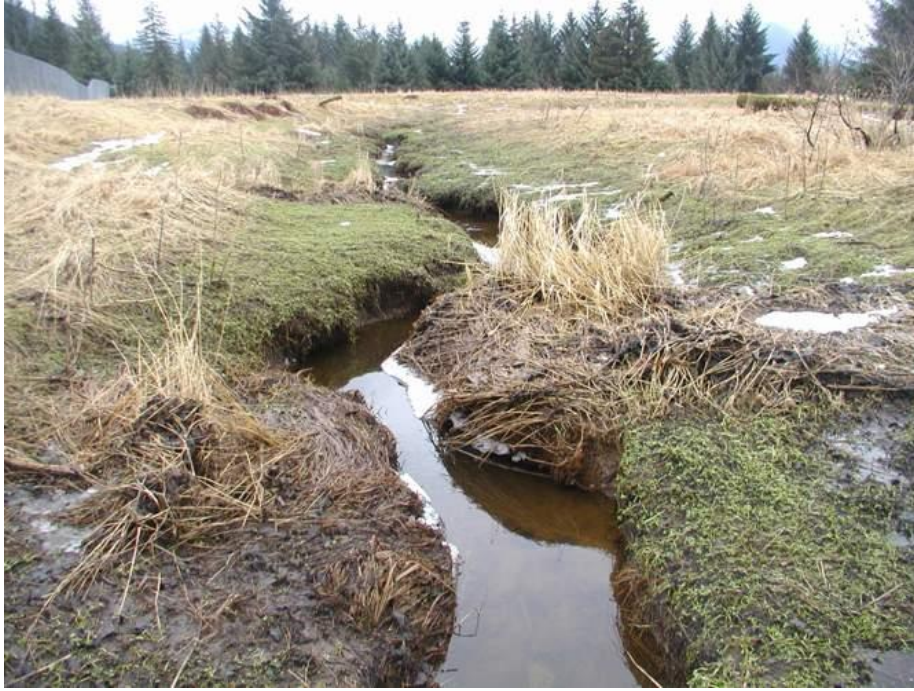
Figure 6. *Pederson Hill Creek- Downstream view from the footbridge at PHC-6. February, 2006.*
