**UNITED STATES AIR FORCE
JOINT BASE ELMENDORF-RICHARDSON, ALASKA**

MILITARY MUNITIONS RESPONSE PROGRAM

**SITE CLOSURE REPORT
Suspected Skeet Range (TS003)**

March 2014

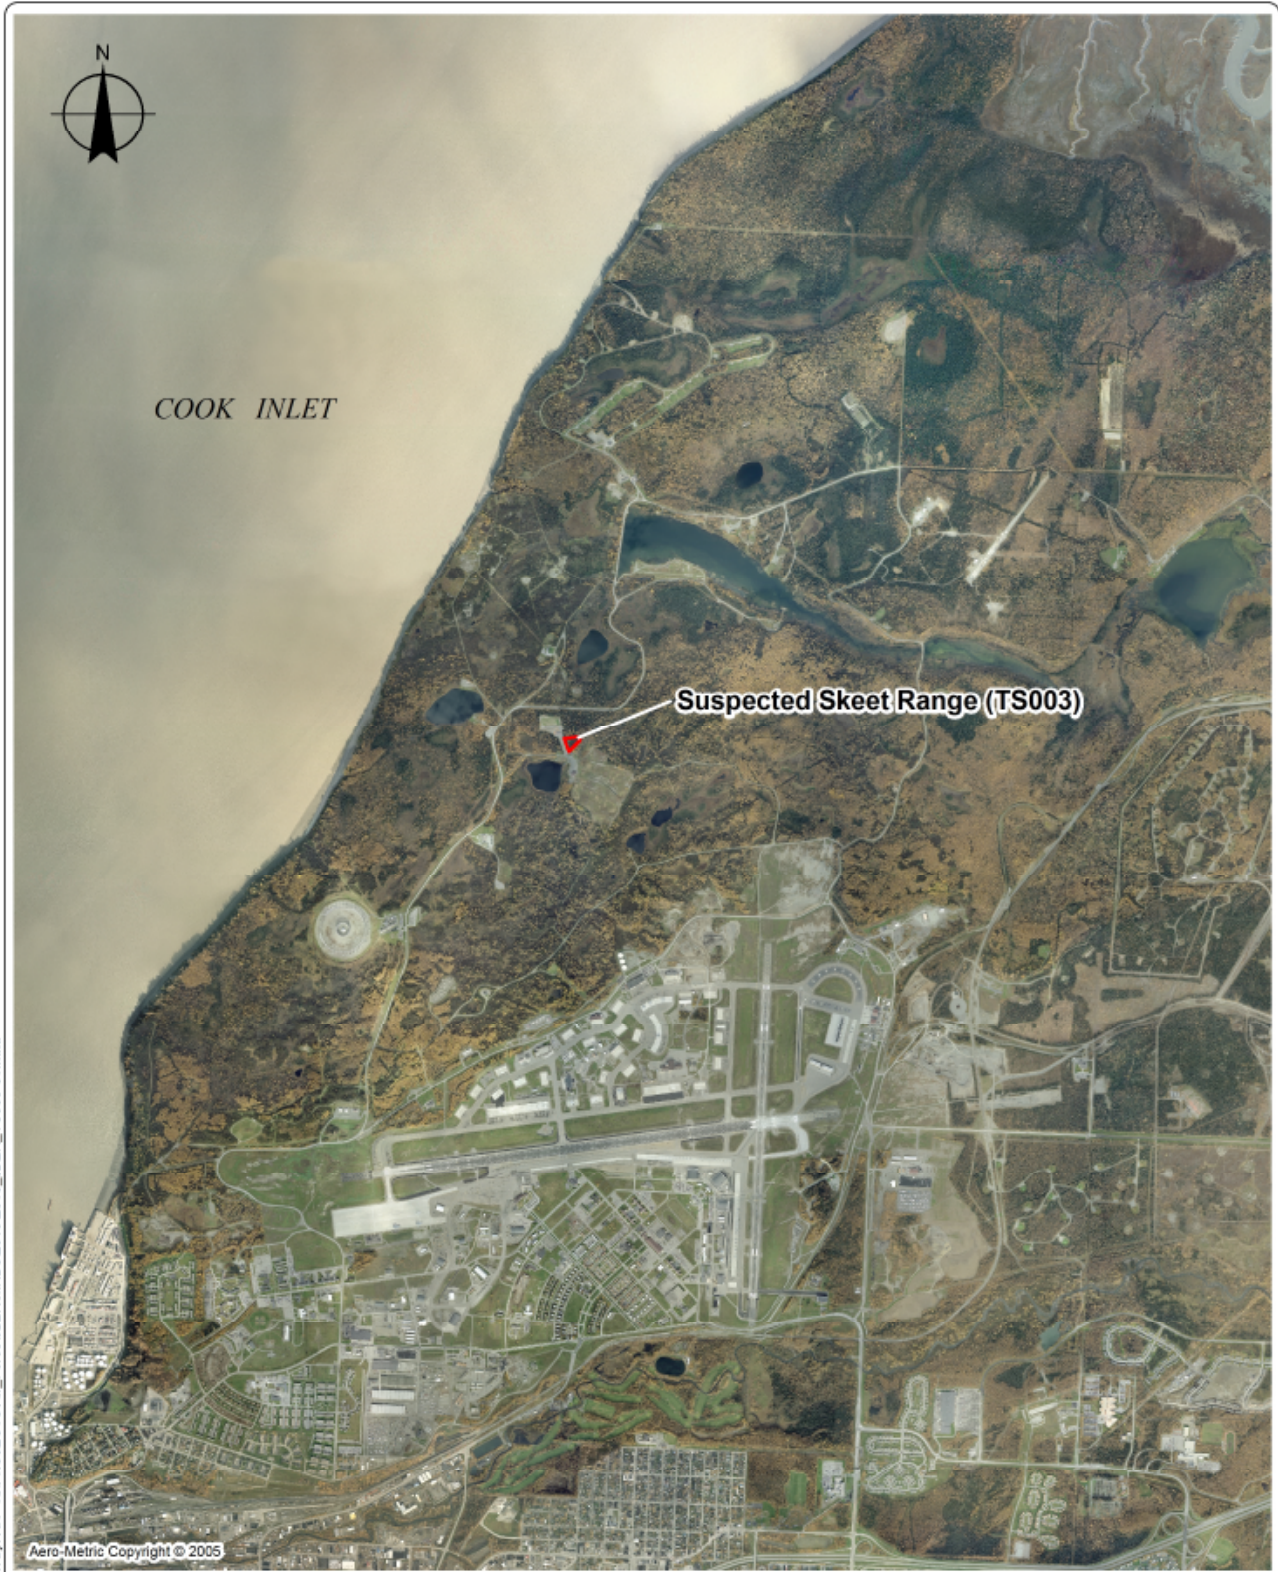
Figure
2-1

The SSR encompasses about one acre and is located at 6796941 Northing and 348775 Easting (Universal Transverse Mercator, Zone 6 North, World Geodetic System 84 meters). The MRS is located near the ski area on base and is accessed from 41st Street. The site is heavily vegetated with tall grasses and alder and is surrounded by mature trees. A small clearing, which appeared to have been made by a bulldozer, was located in the center of the site. An all-terrain vehicle and horseback riding trail also crosses through the northern portion of the site. The topography of the immediate area of the SSR is gently rolling, transitioning to a hilly and marshy area behind the ski area maintenance facility. The location of the MRS is depicted in **Figure 2-1**. The site is within the boundary of JBER-Elmendorf, which is a fenced and security-patrolled installation with limited public access.

SUSPECTED SKEET RANGE (TS003)
