Re: Phase 2 evaluation, Uganik Bay

**Phase I Environmental Site Assessment
Uganik Bay Processing Plant
Kodiak Island, Alaska**

**Phase II Environmental Site Assessment
Uganik Bay Processing Plant
Uganik Bay
Kodiak Island, Alaska**

June 18, 2002

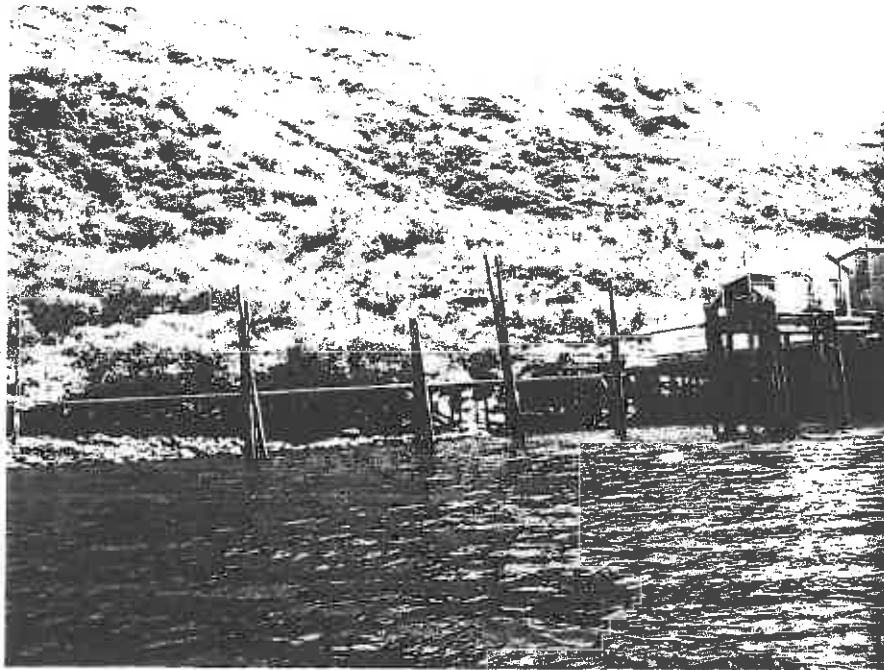
View from Uganik Bay looking southeast at the old rectangular ASTs in the center of the picture and the five 20,000 gallon ASTs on the right side.

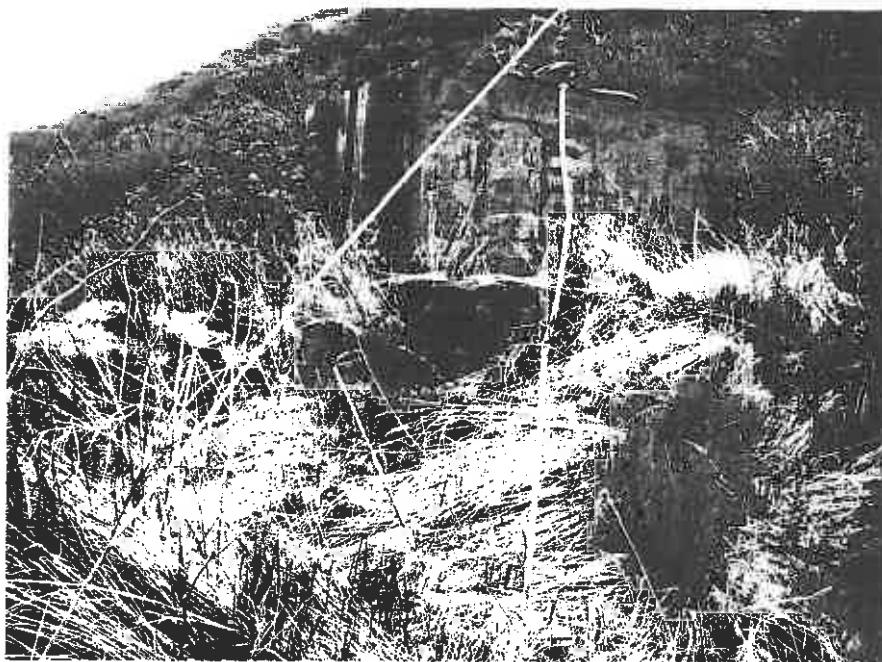
View looking north-northeast at the old rectangular ASTs. HA-1 was located below the valve seen in the foreground, and HA-2 was directly below the valve of the third tank which was moved to the 20,000-gallon tank containment structure.

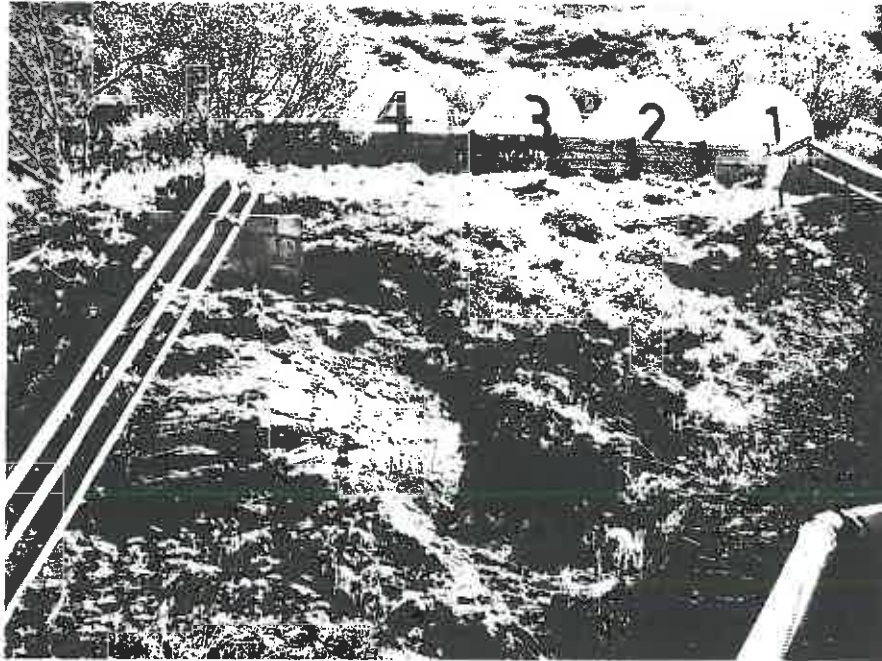
View looking east at the five 20,000-gallon ASTs that contain diesel in Tanks 1 through 4 and gasoline in Tank 5. In the upper left corner is the old rectangular AST that was moved into the containment structure seen in front of the ASTs. HA-5 was located about halfway between Tank 3 and the top of the stairs.

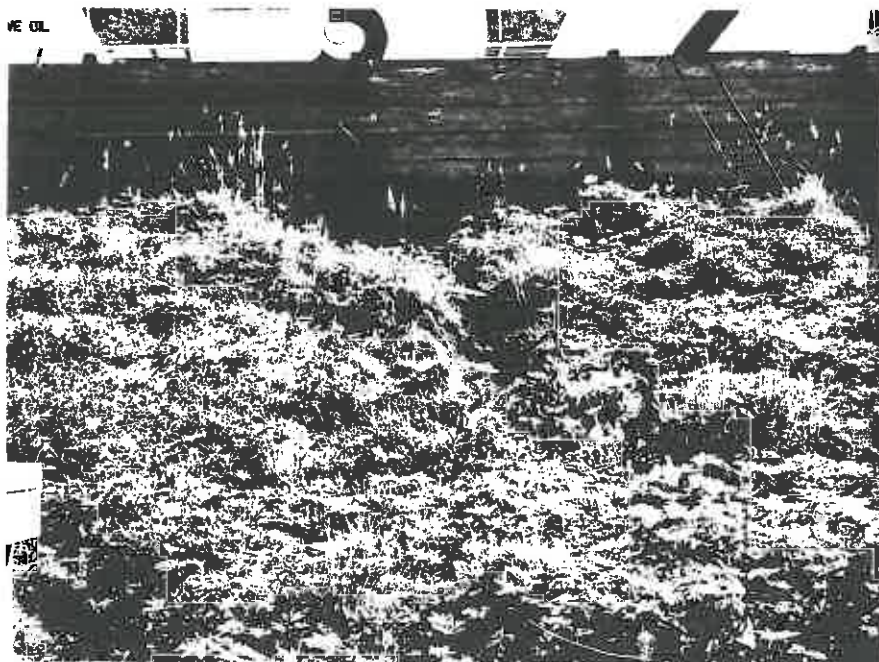
View looking east from the top of the stairs shown above, looking at HA-5 in the center of the picture.

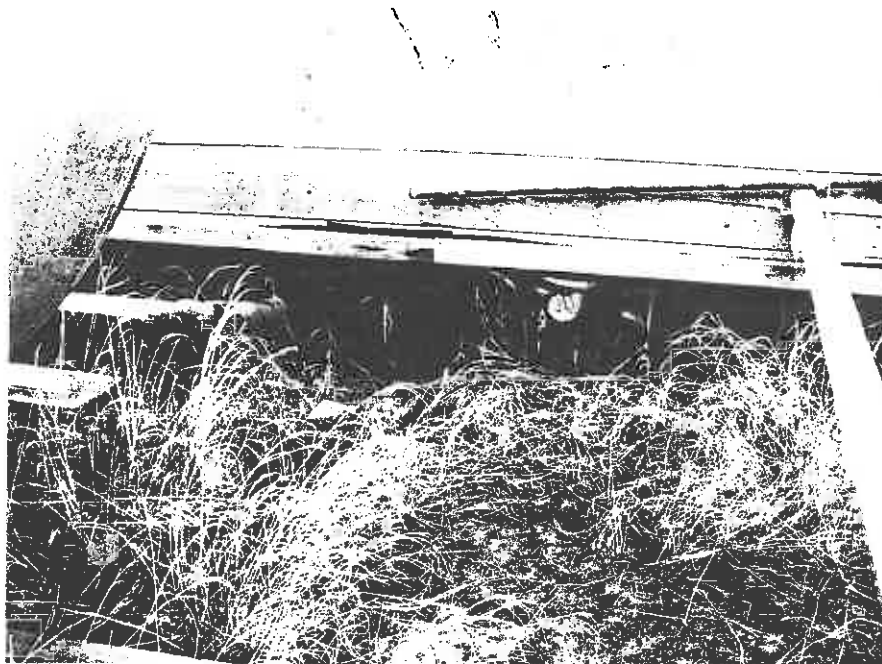
View looking west from inside the containment structure with part of Tank 4 on the left. Note the hole in the liner and containment structure.

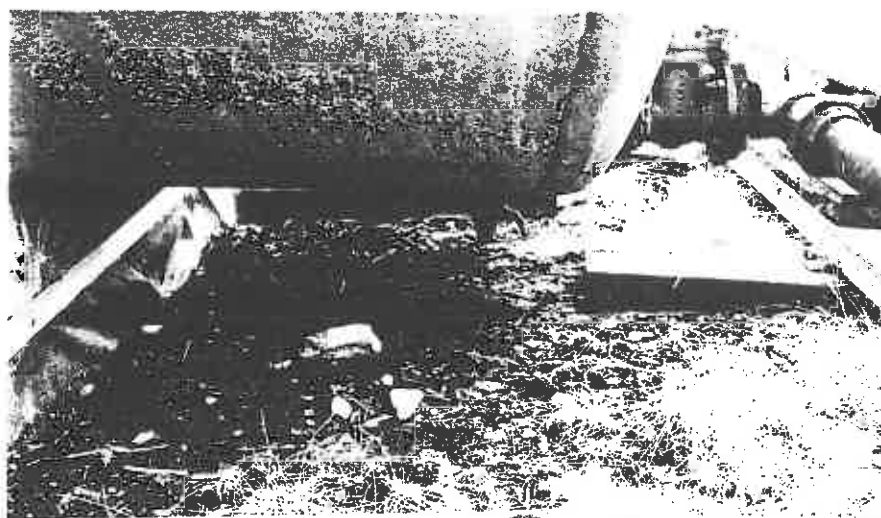
View looking south at the bottom of Tank 4. Note surface staining below the tank.

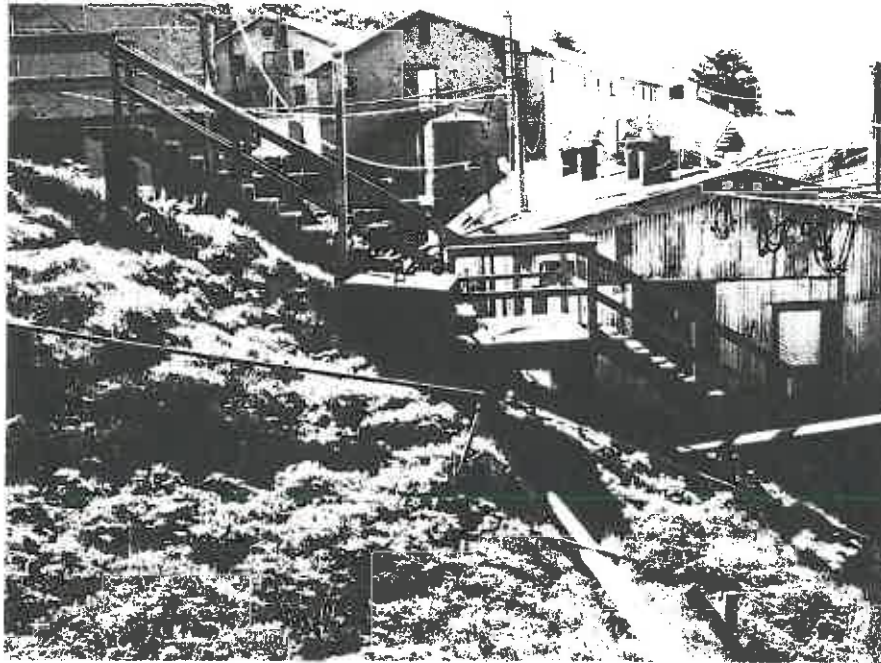
View looking south at the 400-gallon stove oil AST that supplies the generator building in the background. HA-7 was located near the end of the 1-foot-wide plank on the right side of the picture.

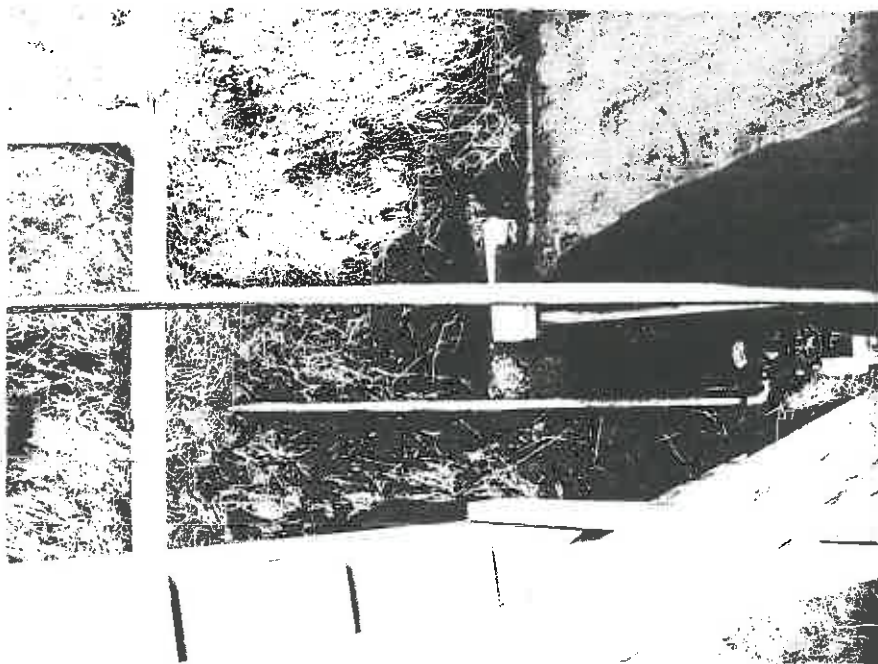
View looking down from the top of the stairs shown above at the valve of the AST and surface staining below the outflow pipe.

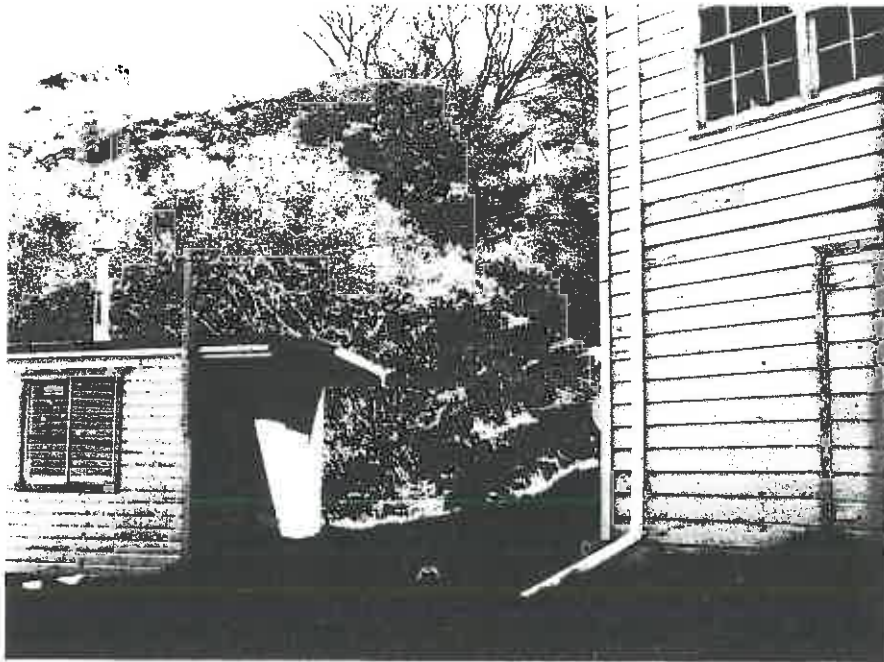
View looking northeast at the green 8,000-gallon stove oil tank that is up on the hill.

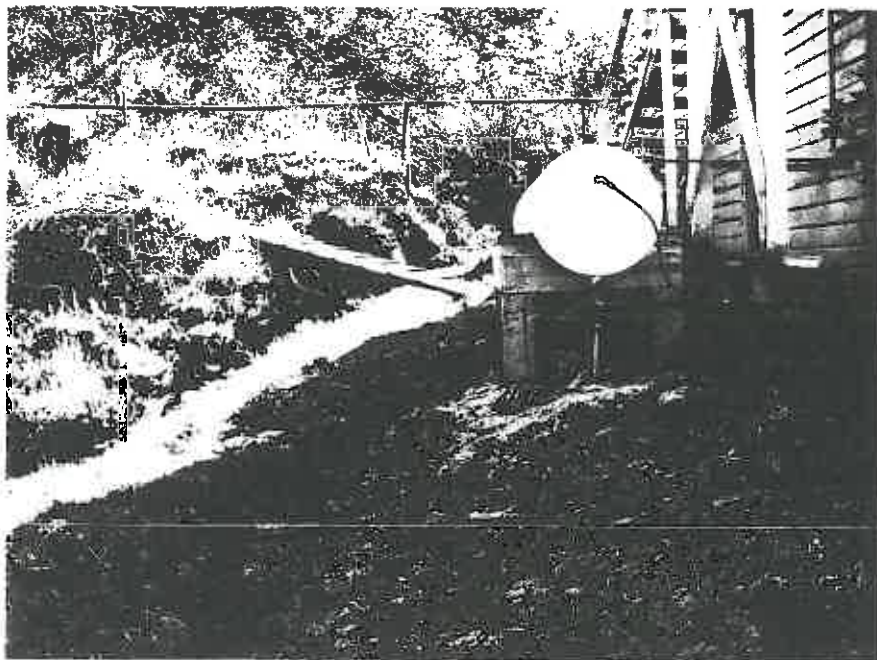
View looking east at a typical day tank that supplies the building on the right with heating oil. Also pictured is a typical stream flowing through the site in close proximity to the day tank.

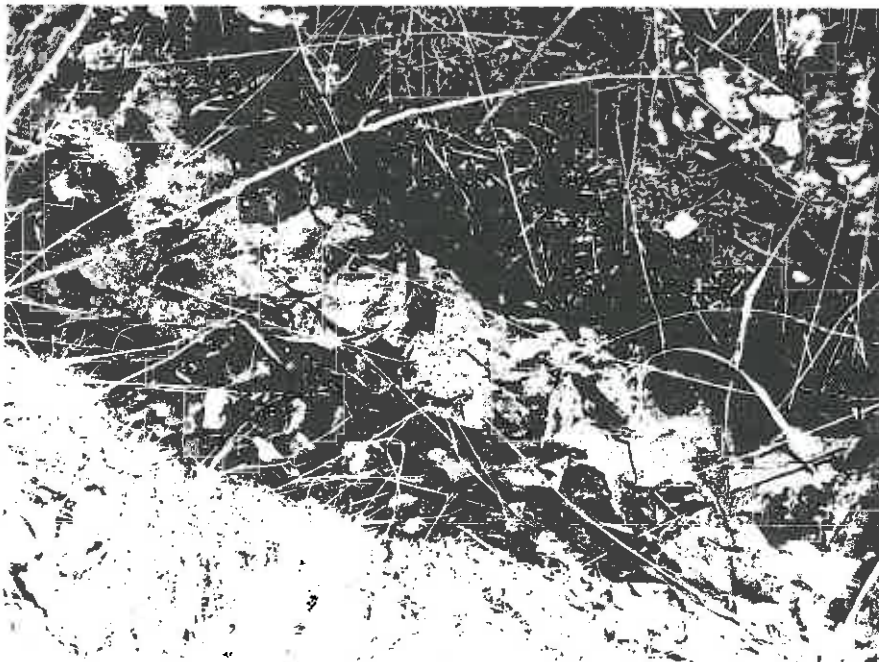
Close-up of surface water with visible sheen below the 1,000-gallon AST shown above.

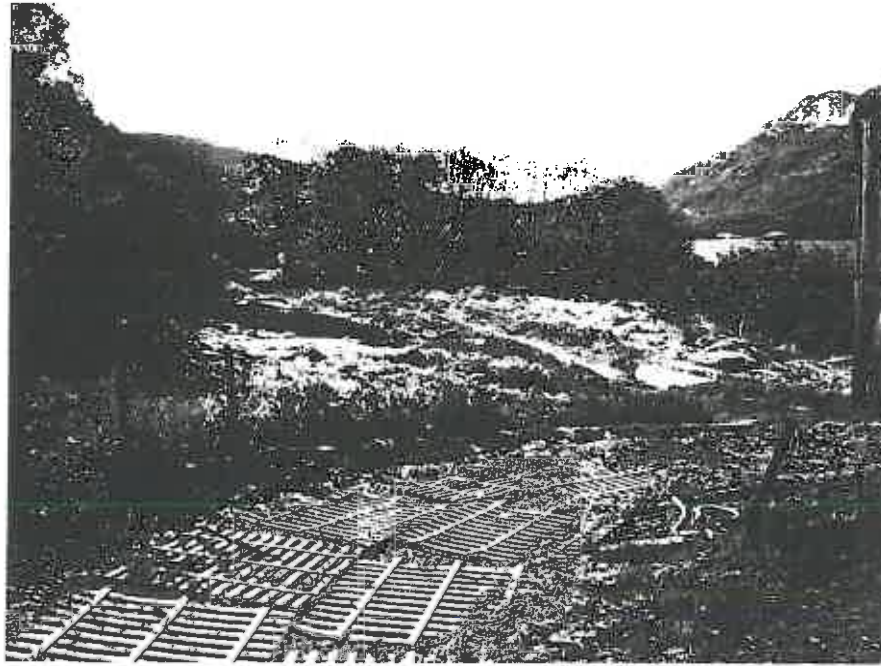
View looking south at the landfill area with the burn pit on the right.

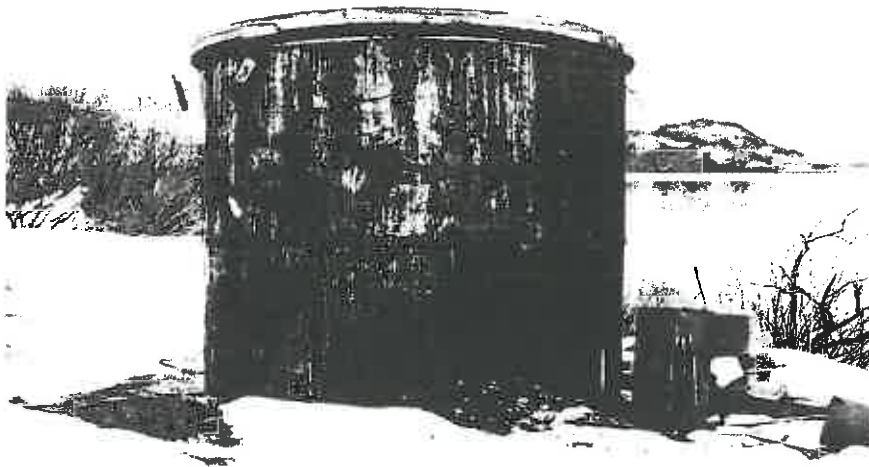
View looking southwest at the landfill area with the solid waste incinerator in the foreground.
