## **ANALYSIS OF BROWNFIELDS CLEANUP ALTERNATIVES**

**Keku Cannery  
Kake, Alaska  
March 19, 2018**

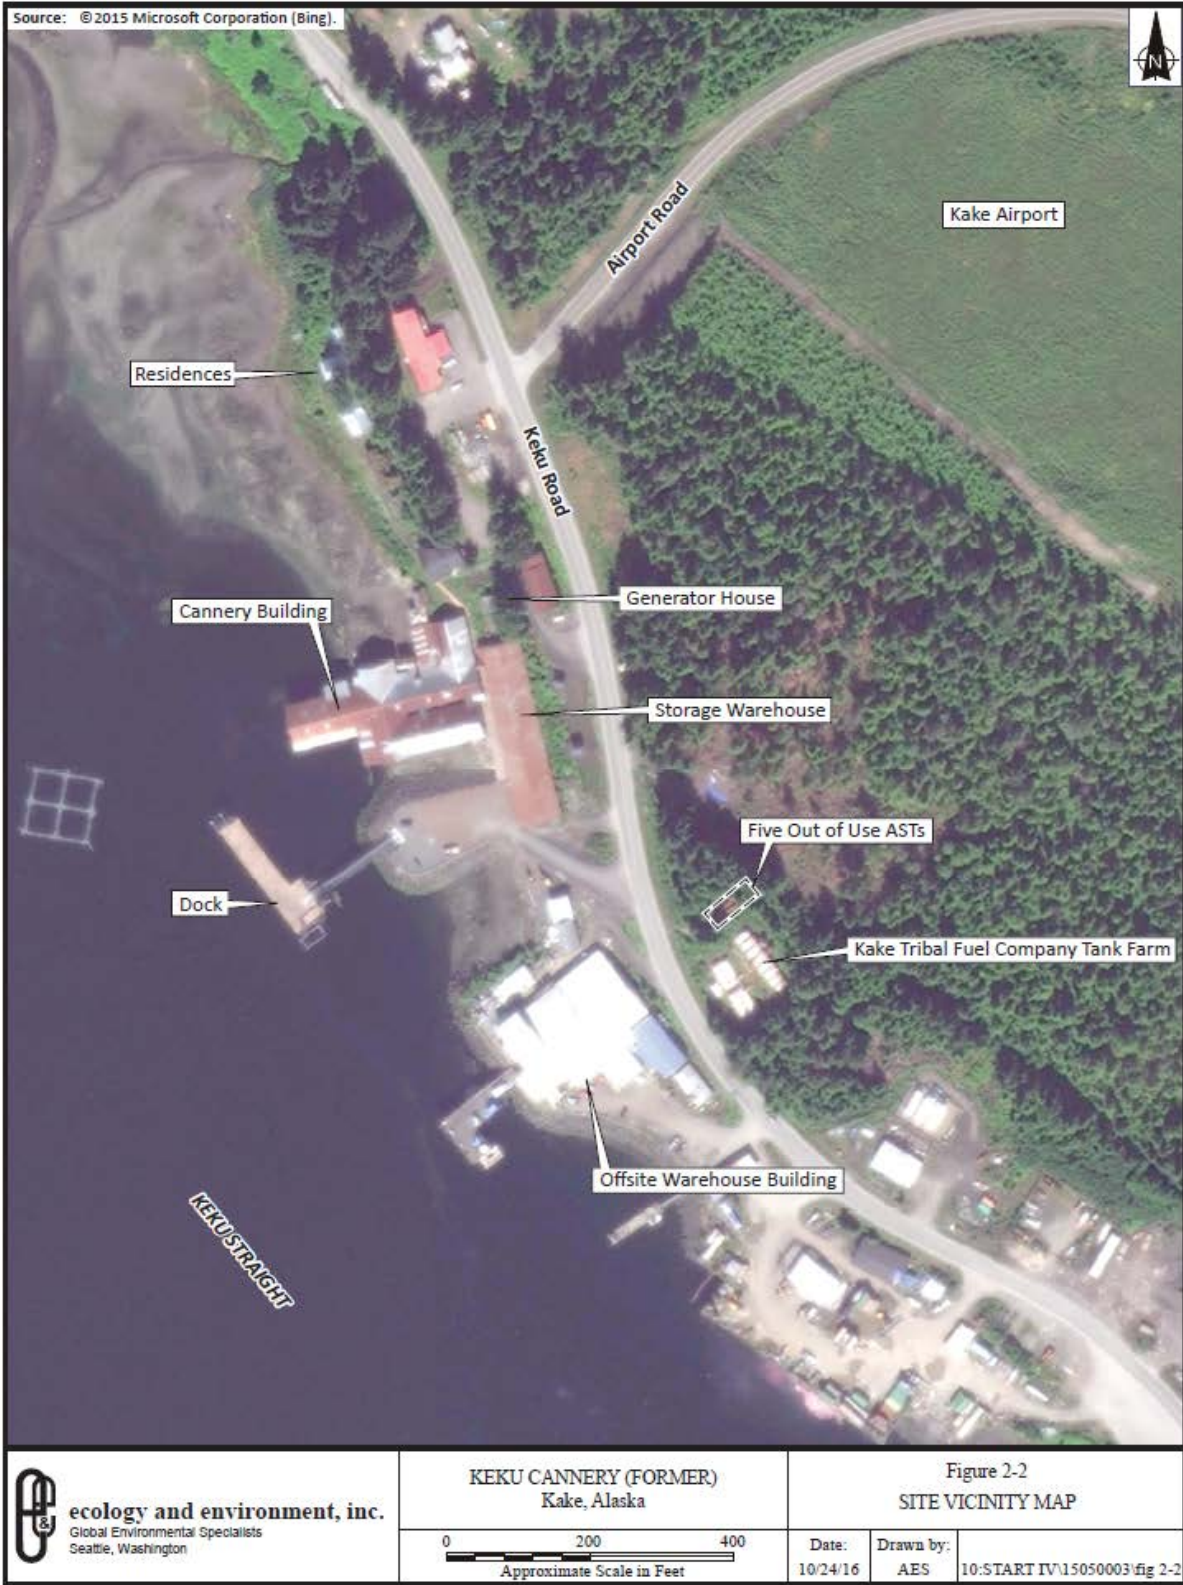
### **6.0 Figures**

The Keku Cannery is located at 541 Keku Road, Kake, Alaska and is owned by the Organized Village of Kake (OVK). Specifically, it is located at 56° 57' 12" N and 133° 55' 34" W. The subject property is located within Section 25, Township 56 South, Range 72 East, Cooper River Meridian (please see Figure 1.).

The Keku Cannery consists of a single 14-acre parcel of land comprising what has been referred to as the "cannery district," a complex of what had included 18 buildings constructed between 1912 and 1940 (S&W 2014). The main cannery building was constructed in 1912 and operated from that time until its closure in 1977. Over time, the building was expanded and/or updated, adding a fish sorting area, boiler house, machine shop, egg room, store room, and retorts. Cannery structures that were included in a recent TBA, and will subsequently be addressed as part of this hazardous materials abatement effort, consist of the large over-water cannery building constructed on pilings, along with the attached former diesel house and blacksmith shop, a large storage building constructed in the upland area immediately east of the cannery building, and an electrical generator house containing four generators that had been fueled by diesel. The location of the site and select buildings are depicted in figure 2 and 3. (EPA TBA, 2015)
