**KWIGILLINGOK SITE RECONNAISSANCE
AND RECOMMENDATION REPORT
KWIGILLINGOK, ALASKA
FINAL**

**ADEC Aboveground Storage Tank Program
410 Willoughby Avenue, Suite 105
Juneau, Alaska 99801-5207**

**Bristol Environmental & Engineering Services Corporation
2000 W. International Airport Road, #C-1
Anchorage, Alaska 99502
(907) 563-0013**

January 2001

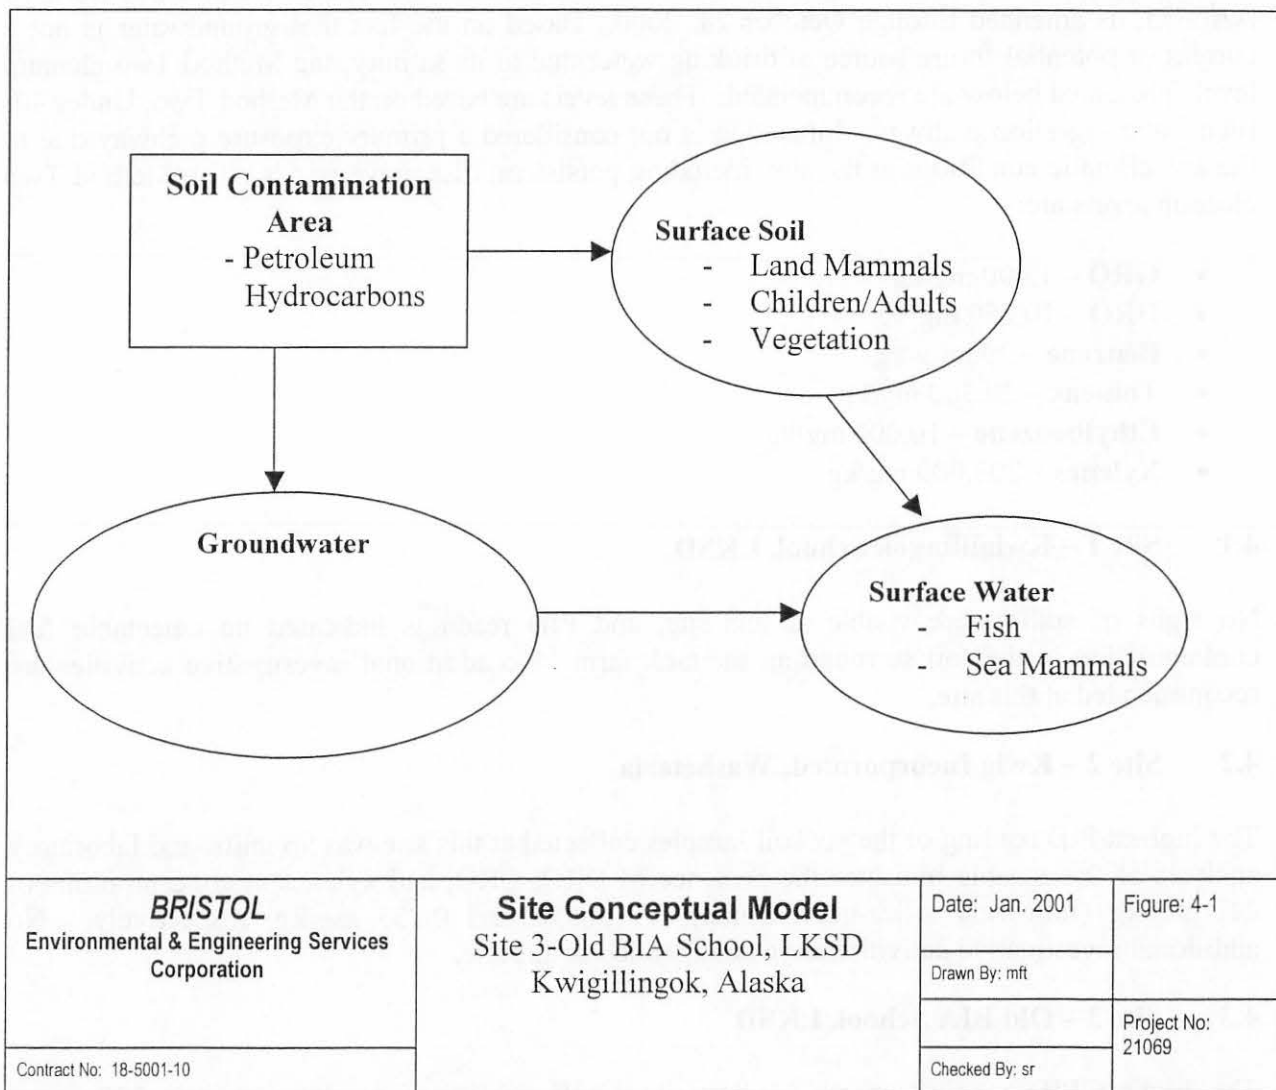
xylenes. Concentrations of DRO (16,700 mg/kg) and GRO (1,810 mg/kg) were detected at elevated concentrations and at concentrations exceeding the cleanup level for ingestion. The site was visibly stained with petroleum, and a sheen was visible on the surface water.

Based on data collected during the site reconnaissance, the conceptual model (Figure 4-1) showing potential contaminant sources and receptors has been developed.

Given the concentration of contaminants detected in the soil sample, elevated PID readings, presence of soil staining and surface water sheen, and the proximity of the site to the Kwigillingok River, additional investigative activities are recommended at this site. These activities include collecting and analyzing groundwater, surface soil and surface water samples for DRO, GRO and BTEX. The location and rationale for collecting and analyzing these samples are presented in Table 4-1.

Based on the site conceptual model shown above, the following types of samples, general sample locations and rationale, are presented:

The site conceptual model (Figure 4-1) for Site 3 also applies to this site. Also applying to this site is the information in Table 4-1 for Site 3 showing the types of samples, general sample locations and rationale for recommended future sampling.

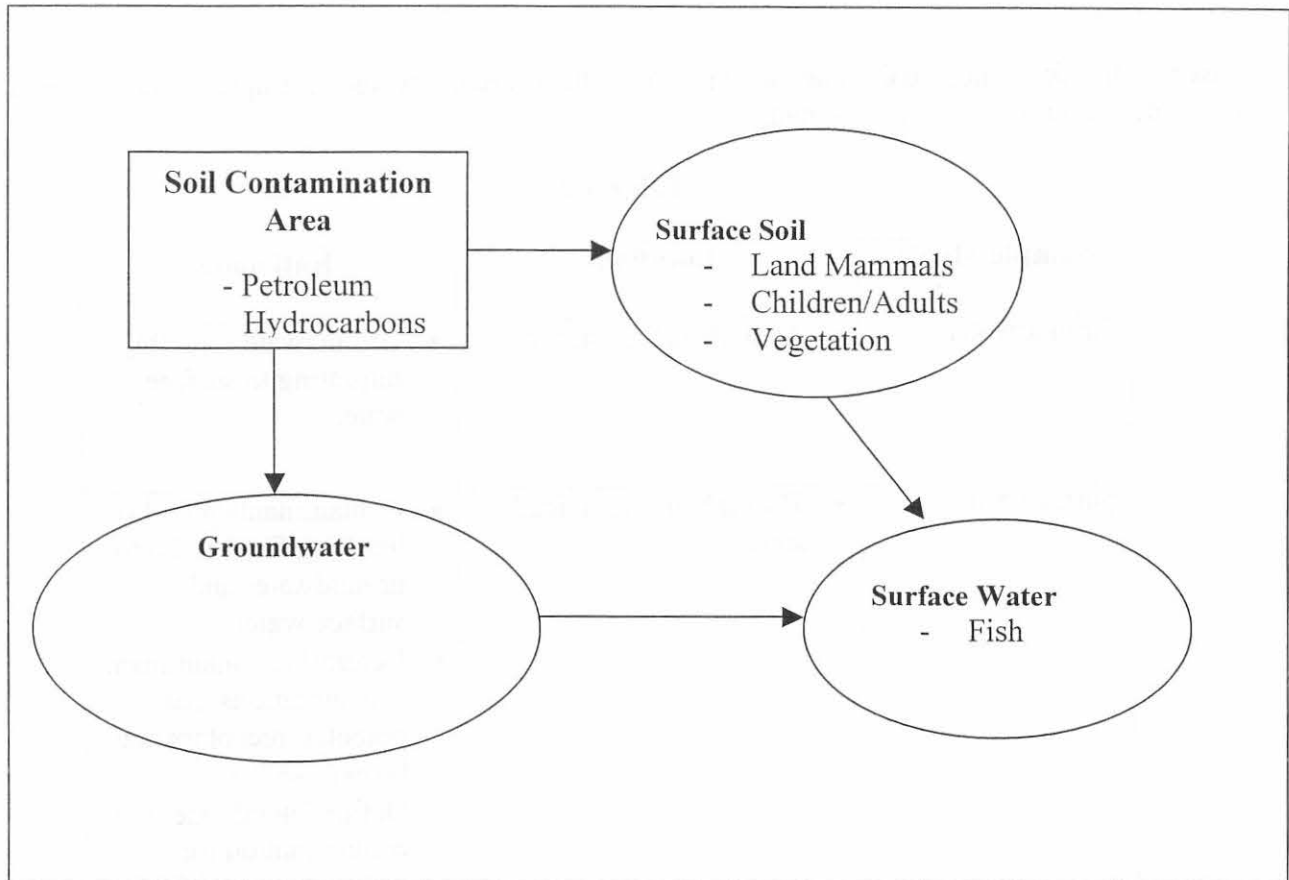
BRISTOL Environmental & Engineering Services Corporation	Site Conceptual Model Pipeline Spill Kwigillingok, Alaska	Date: Jan. 2001	Figure: 4-2
		Drawn By: mft	
Contract No: 18-5001-10		Checked By: sr	Project No: 21071

The highest PID reading of the seven soil samples collected at this site was 234. Laboratory analysis of this sample indicates the presence of DRO, GRO, toluene, ethylbenzene and xylenes. While concentrations of toluene, ethylbenzene and xylenes are relatively low, DRO (90,700 mg/kg) was detected at concentrations exceeding the cleanup level for ingestion. The site was visibly stained with petroleum.

Based on data collected during the site reconnaissance, the conceptual model (Figure 4-2) showing potential contaminant sources and receptors has been developed.

Given the concentration of contaminants detected in the soil sample, elevated PID readings and the presence of soil staining, additional investigative activities are recommended at this site. These activities include collecting and analyzing groundwater, surface soil and surface water samples for DRO, GRO and BTEX. The location and rationale for collecting and analyzing these samples are presented in Table 4-2.

Based on the site conceptual model shown above, the following types of samples, general sample locations and rationale, are presented:

Sample Media	Location	Rationale
Groundwater	<ul style="list-style-type: none"> • Area of surface staining. 	<ul style="list-style-type: none"> • Groundwater possibly migrating to surface water.
Surface Soil	<ul style="list-style-type: none"> • Throughout the stained area. 	<ul style="list-style-type: none"> • Contaminants possibly leaching from soil into groundwater and surface water. • Determine contaminant concentrations that potential receptors may be exposed to. • Define lateral extent of contamination for purpose of potential remedial activities.
Surface Water	<ul style="list-style-type: none"> • Downgradient from source area. 	<ul style="list-style-type: none"> • Determine if contaminants are migrating toward Washeteria lagoon. • Determine contaminant concentrations that potential receptors may be exposed to.
	Kwigillingok River	<ul style="list-style-type: none"> • Determine contaminant concentrations that potential receptors may be exposed to.

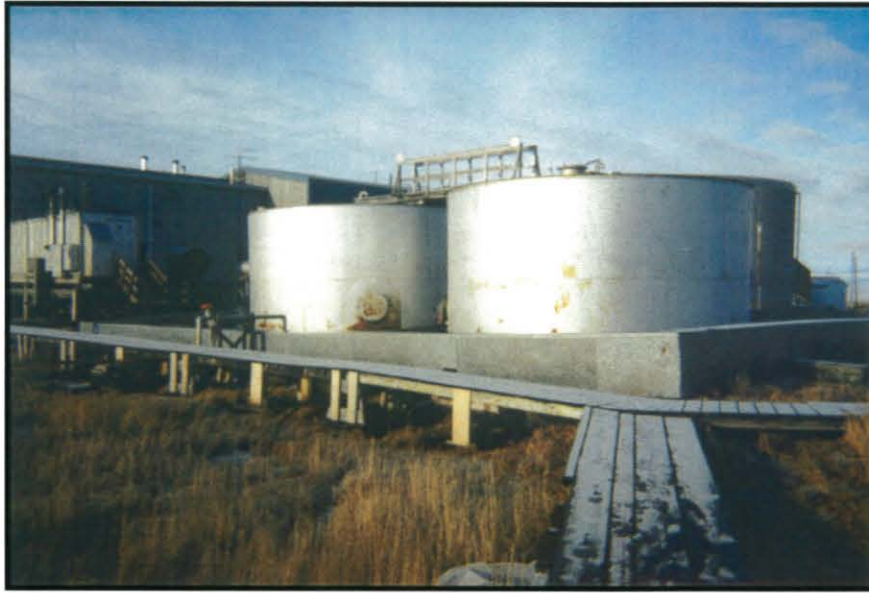
Photo 1

Village: Kwigillingok
ADEC Site Number: 1
Site Name: Kwigillingok School, LKSD
Direction: NW
Description: Two ASTs at the school's tank farm.

No signs of spills were visible at this site, and PID readings indicated no detectable fuel contamination in the soil surrounding the tank farm. No additional investigative activities are recommended at this site.

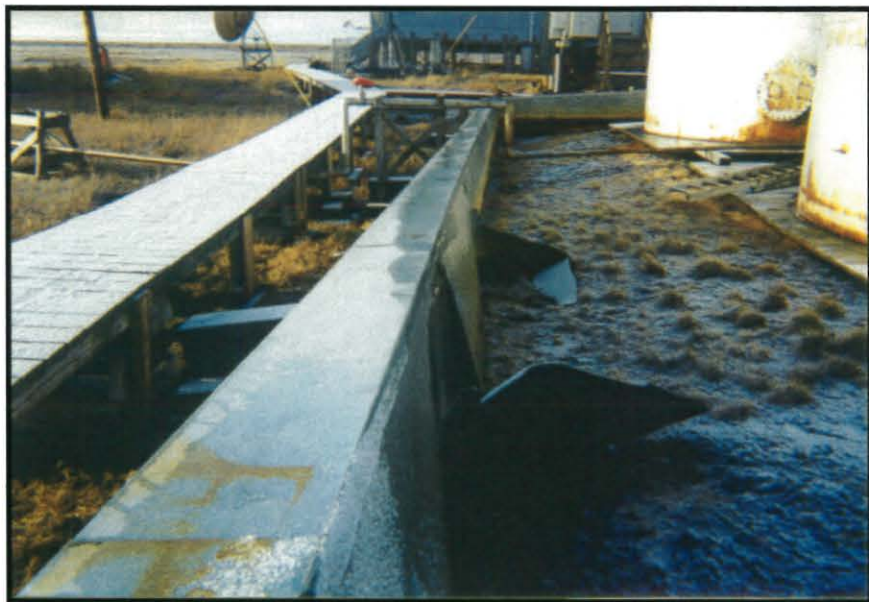
Photo 2

Village: Kwigillingok
ADEC Site Number: 1
Site Name: Kwigillingok School, LKSD
Direction: W
Description: South side of tank farm.

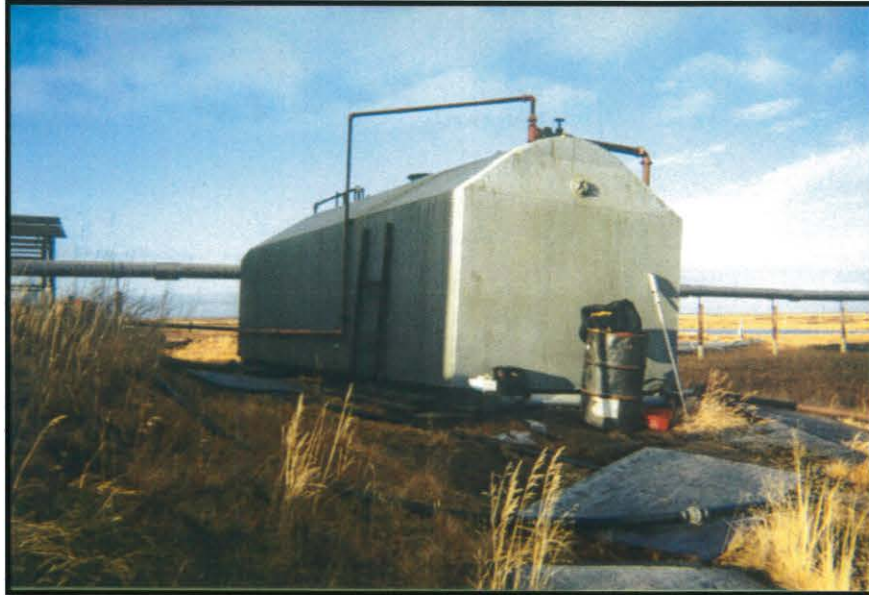
Photo 3

Village: Kwigillingok
ADEC Site Number: 2
Site Name: Kwig Incorporated, Washeteria
Direction: NE
Description: 10,000-gallon AST on east side of the Washeteria.

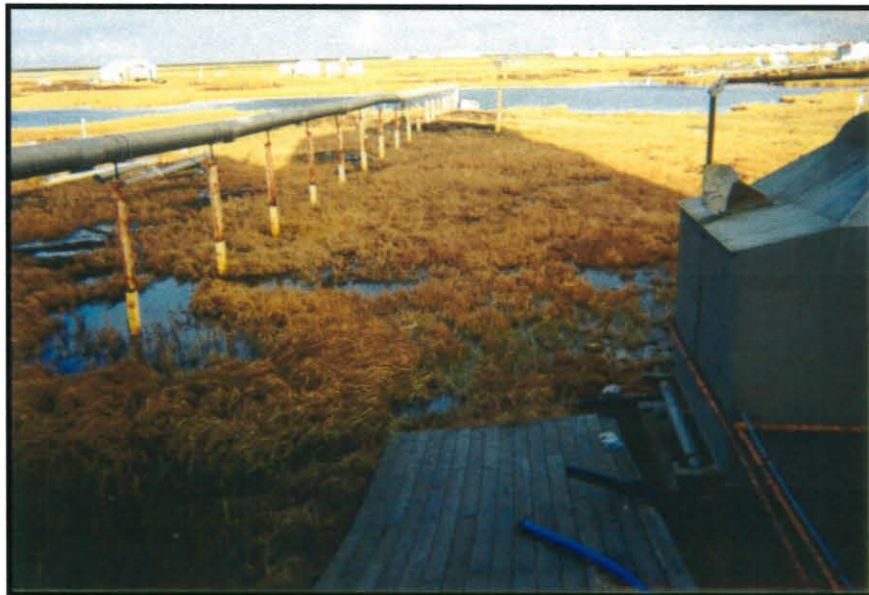
Photo 4

Village: Kwigillingok
ADEC Site Number: 2
Site Name: Kwig Incorporated, Washeteria
Direction: E
Description: North end of the AST. The Washeteria lagoon is in the background.

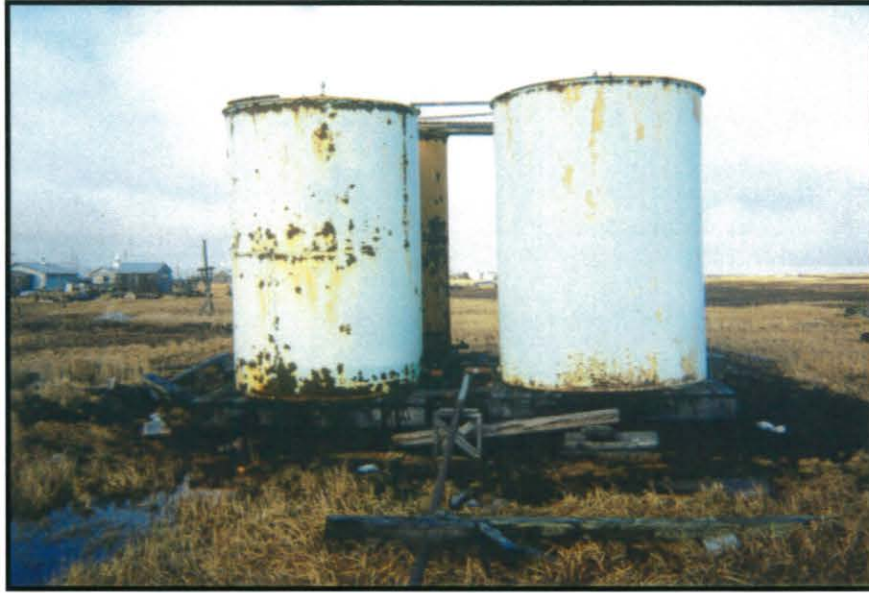
Photo 5

- *Soil staining observed:* The only area of firm ground observed at this site was the mound on which the tanks are located. The area surrounding this mound was marshy with standing water. Staining on the ground surrounding the tanks is extensive (photographs 5, 6, 7, and 8), and extends from the tanks to the mound/surface water interface. Staining was also extensive on the timber foundation, although this discoloration may be creosote from treating the wood.

Village: Kwigillingok
ADEC Site Number: 3
Site Name: Old BIA School, LKSD
Direction: N

Description: Four ASTs at the tank farm. Note black staining surrounding the tanks. The Kwigillingok River is approximately 400 feet to the east (right).

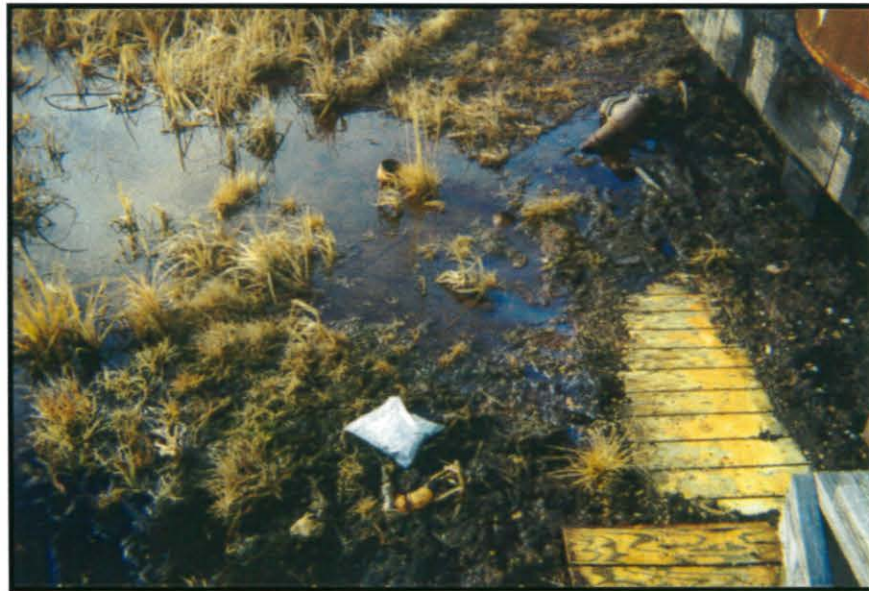
Photo 6

- *Sheen on water observed:* A sheen was observed in several places on the surface water surrounding the tanks. The sheen was especially noticeable at the mound/surface water interface. At that location, the sheen could be seen from the interface extending in a direction outward from the mound (photograph 6 and 7), as the fuel appeared to be seeping into the surface water.

Village: Kwigillingok
ADEC Site Number: 3
Site Name: Old BIA School, LKSD
Direction: W

Description: On the south side of the tanks. The plastic bag marks the location of auger location number 2. Note the sheen on the water along the right side of the photo where the water meets the tank farm mound.

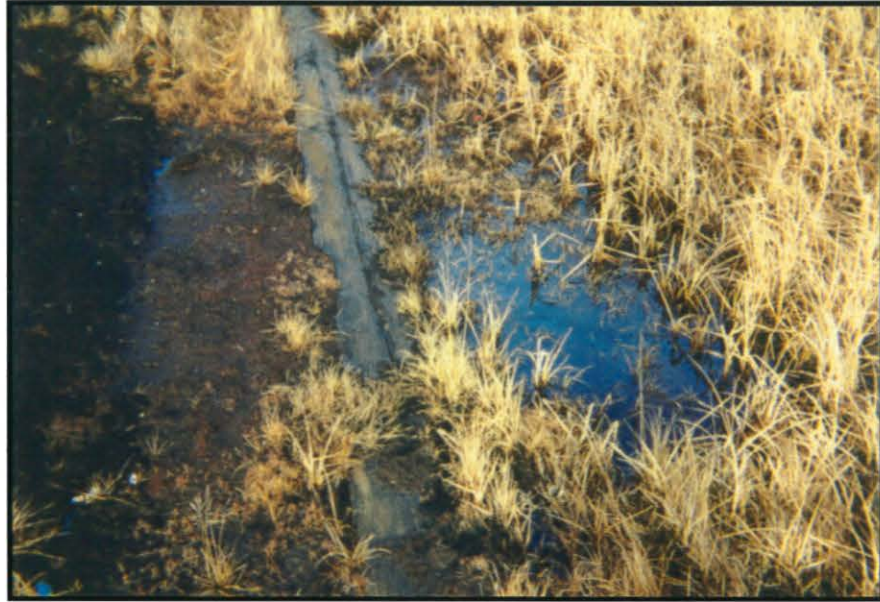
Photo 7

Village: Kwigillingok
ADEC Site Number: 3
Site Name: Old BIA School, LKSD
Direction: N

Description: On the east side of the tanks. Note the black staining on the surface of the tank farm mound. A sheen can be seen on the water where the mound meets the water.

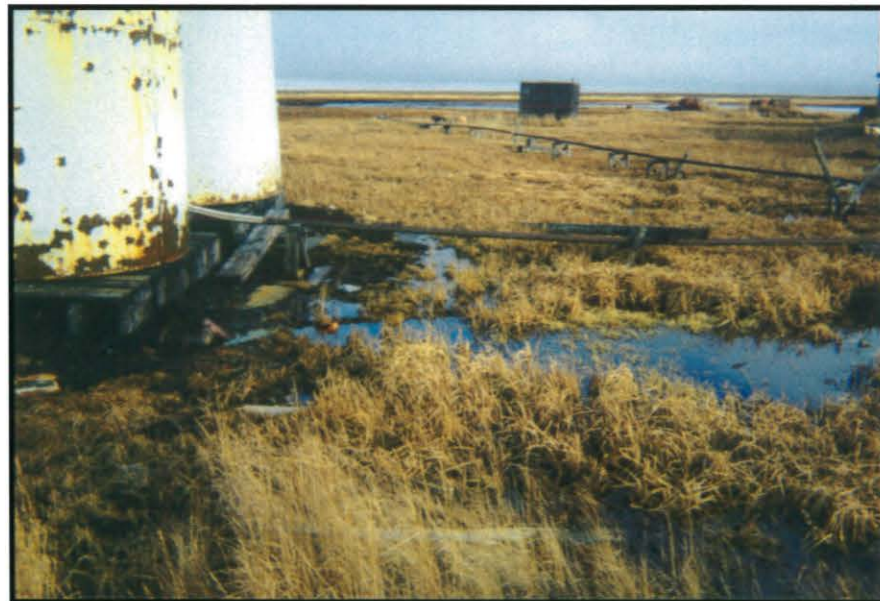
Photo 8

- *Estimated direction of surface water and groundwater flow:* East, toward the Kwigillingok River, located approximately 400 feet from the tank farm (photograph 8). Although the surface water and groundwater would generally be expected to flow eastward, this direction may change because of the relatively flat topography and influence of seasonal flooding or rainfall.

Village: Kwigillingok
ADEC Site Number: 3
Site Name: Old BIA School, LKSD
Direction: E

Description: On the south side of the tanks, looking toward the Kwigillingok River. Note the black staining near the tanks. A sheen is visible on the water adjacent to the tanks.

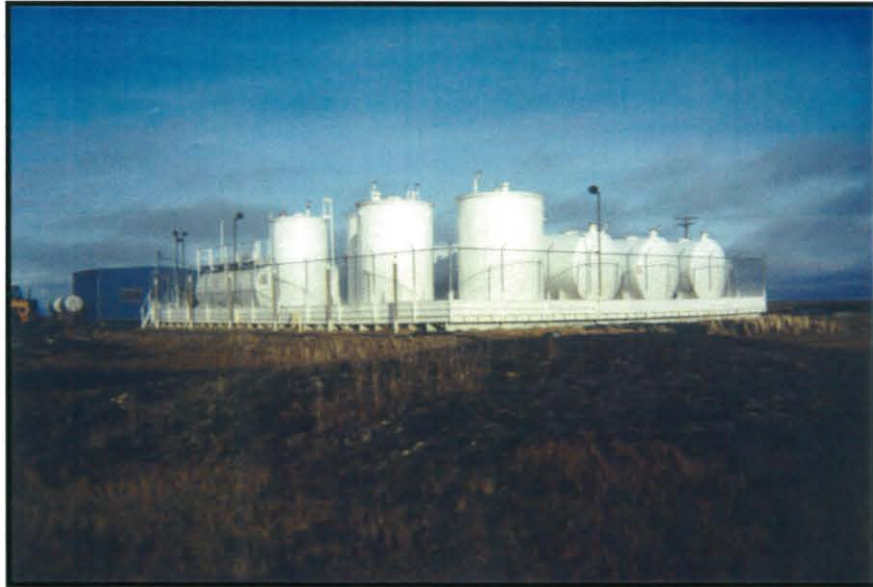
This consolidated tank farm (see Figure 6) is new and consists of twelve ASTs ranging in capacity from 4,300 gallons to 23,500 gallons. The fuel is used for storage, supply, and dispensing of gasoline and diesel fuel to the village residents and to supply diesel for the powerhouse. Because of time constraints during the site reconnaissance and the age of the tank farm, ADEC did not require that soil samples be collected at this site. However, a visual site inspection was performed and video and photographs of the site were taken (photographs 9 and 10).

Village: Kwigillingok Photo 9
ADEC Site Number: 4
Site Name: Kwig Incorporated & Kwigillingok Village Council, Powerhouse
and Retail Sales
Direction: SE
Description: Tank farm. The Kwigillingok River is located approximately 400
feet east of the tank farm.

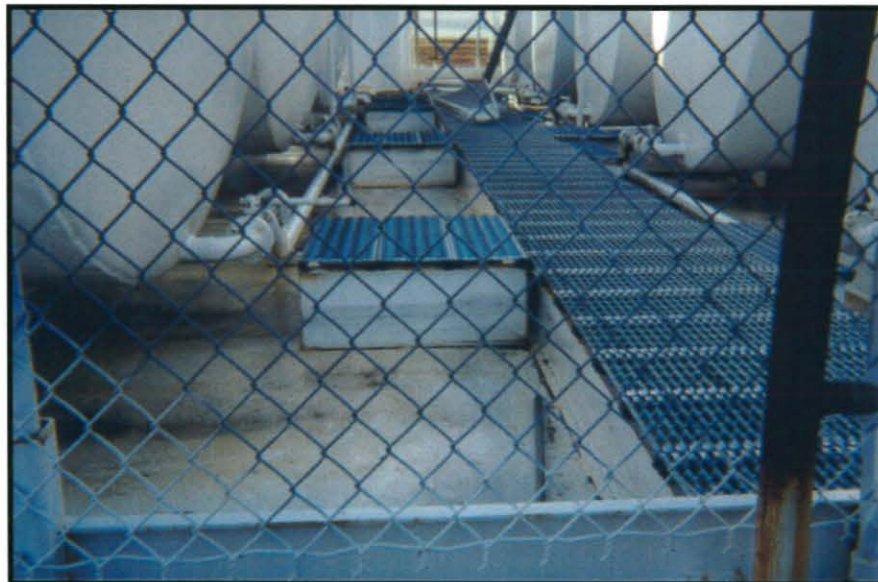
Village: Kwigillingok Photo 10
ADEC Site Number: 4
Site Name: Kwig Incorporated & Kwigillingok Village Council, Powerhouse and
Retail Sales
Direction: E
Description: The floor of the tank farm. No spills or leaks are visible.

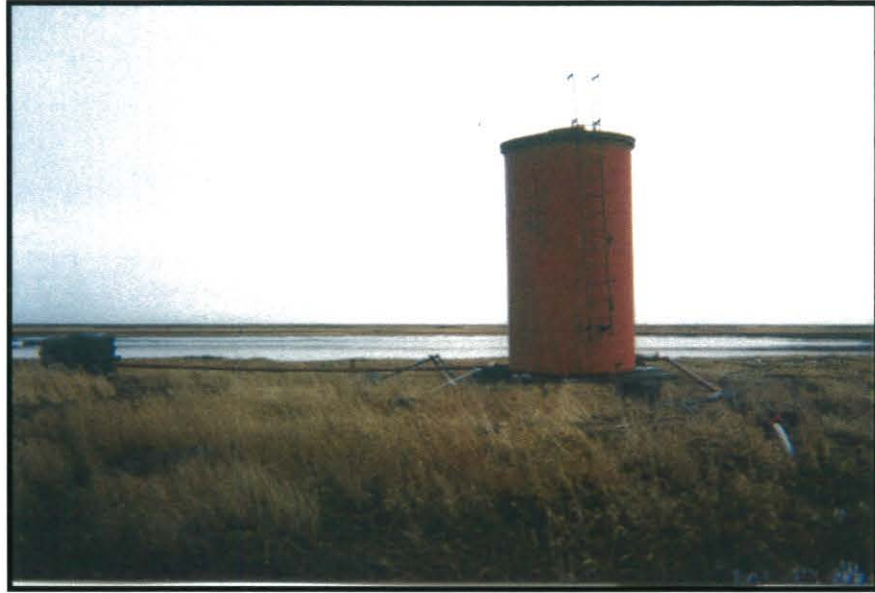
Photo 11

Village: Kwigillingok
ADEC Site Number: 6
Site Name: Kwig Incorporated, Storage
Direction: E

Description: AST located on the south end of the former tank farm. The Kwigillingok River is seen approximately 150 feet beyond the tank.

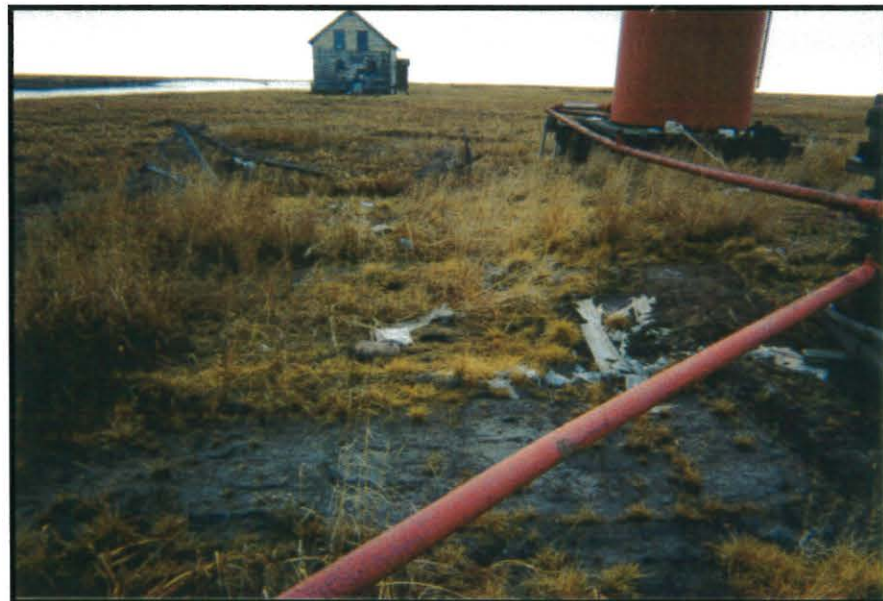
Photo 12

Village: Kwigillingok
ADEC Site Number: 6
Site Name: Kwig Incorporated, Storage
Direction: S

Description: Three boring locations are marked with plastic bags. From foreground to background are boring locations 9, 8 and 7. The ground surface is covered with burlap and visqueen.

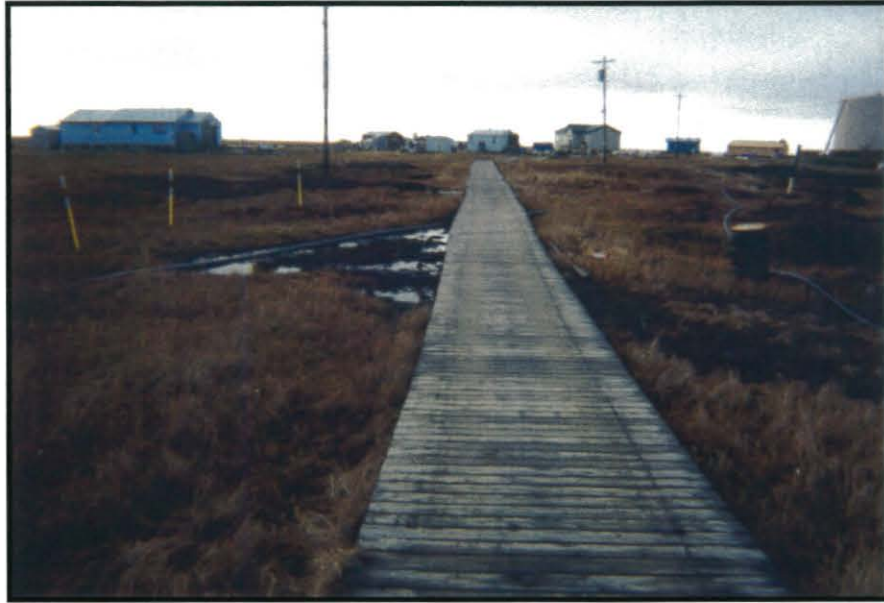
Photo 13

Village: Kwigillingok
Site Name: Pipeline Spill
Direction: SW

Description: The main area of the 1999 pipeline spill. Black surface staining is visible on both sides of the boardwalk. A spill kit drum is visible to the right of the boardwalk.

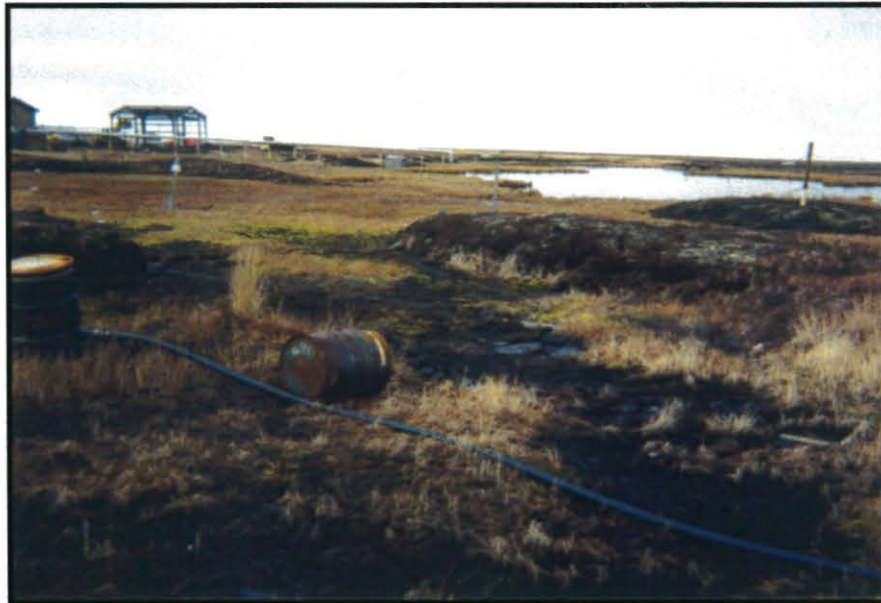
Photo 14

- *Soil staining observed:* Extensive staining was observed throughout the spill area, especially in the low-lying areas north of the boardwalk (see Figure 8 and photograph 14). Staining was also visible south of the boardwalk, along the length of the section of pipeline that was replaced since the spill. Staining was not present on the areas of "high ground" in the area.

Village: Kwigillingok
Site Name: Pipeline Spill
Direction: W

Description: View from the boardwalk. The spill kit drum is visible on the left. The line running through the stained area is a water line. In the low-lying area of staining beyond and to the right of the drum that is on its side, a sheen on the water was created when the vegetation (mostly peat) was disturbed. The Washeteria lagoon is visible in the background.

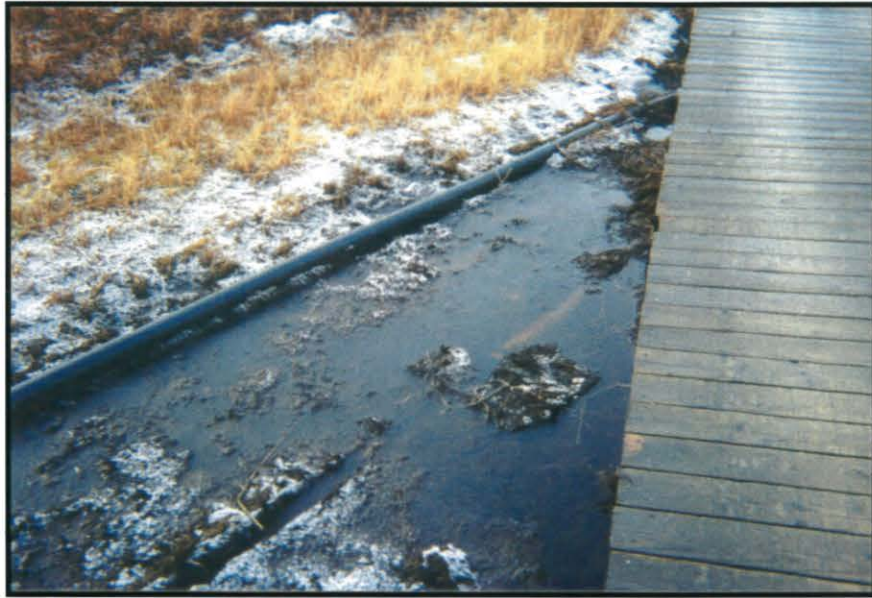
Photo 15

Village: Kwigillingok
Site Name: Pipeline Spill
Direction: SW

Description: The former metal fuel pipeline is seen to the right of the new fuel pipeline. A depression can be seen where a section of the former pipeline was removed. Black surface staining is present throughout this low-lying area.

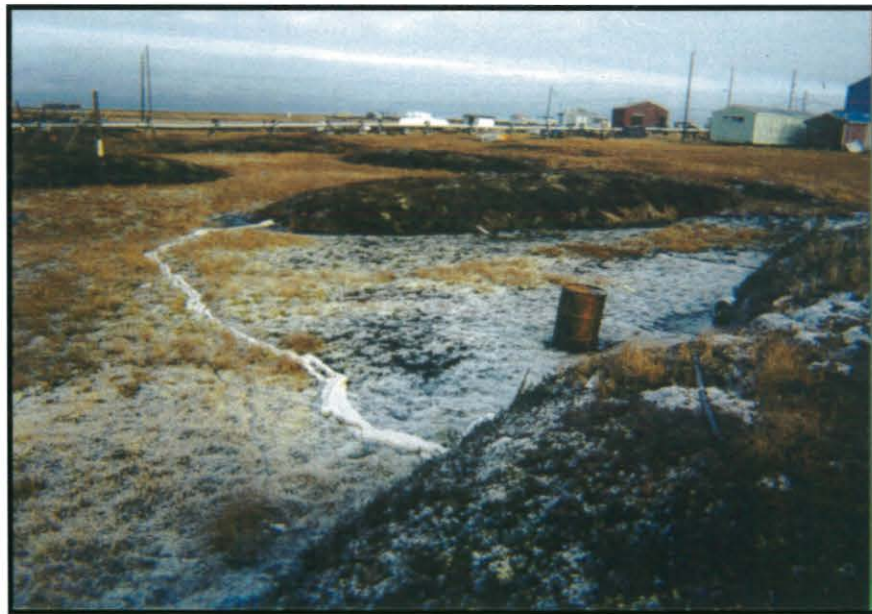
Photo 16

Village: Kwigillingok
Site Name: Pipeline Spill
Direction: NW

Description: Two booms (left and right of the drum) are still in place from the fuel recovery effort in 1999. This low-lying area leads to the Washeteria lagoon.
