Third Quarter 2018 Groundwater Monitoring

Former Unocal Service Station #4854 2730 Spenard Road Anchorage, Alaska

ADEC File ID: 2100.26.116

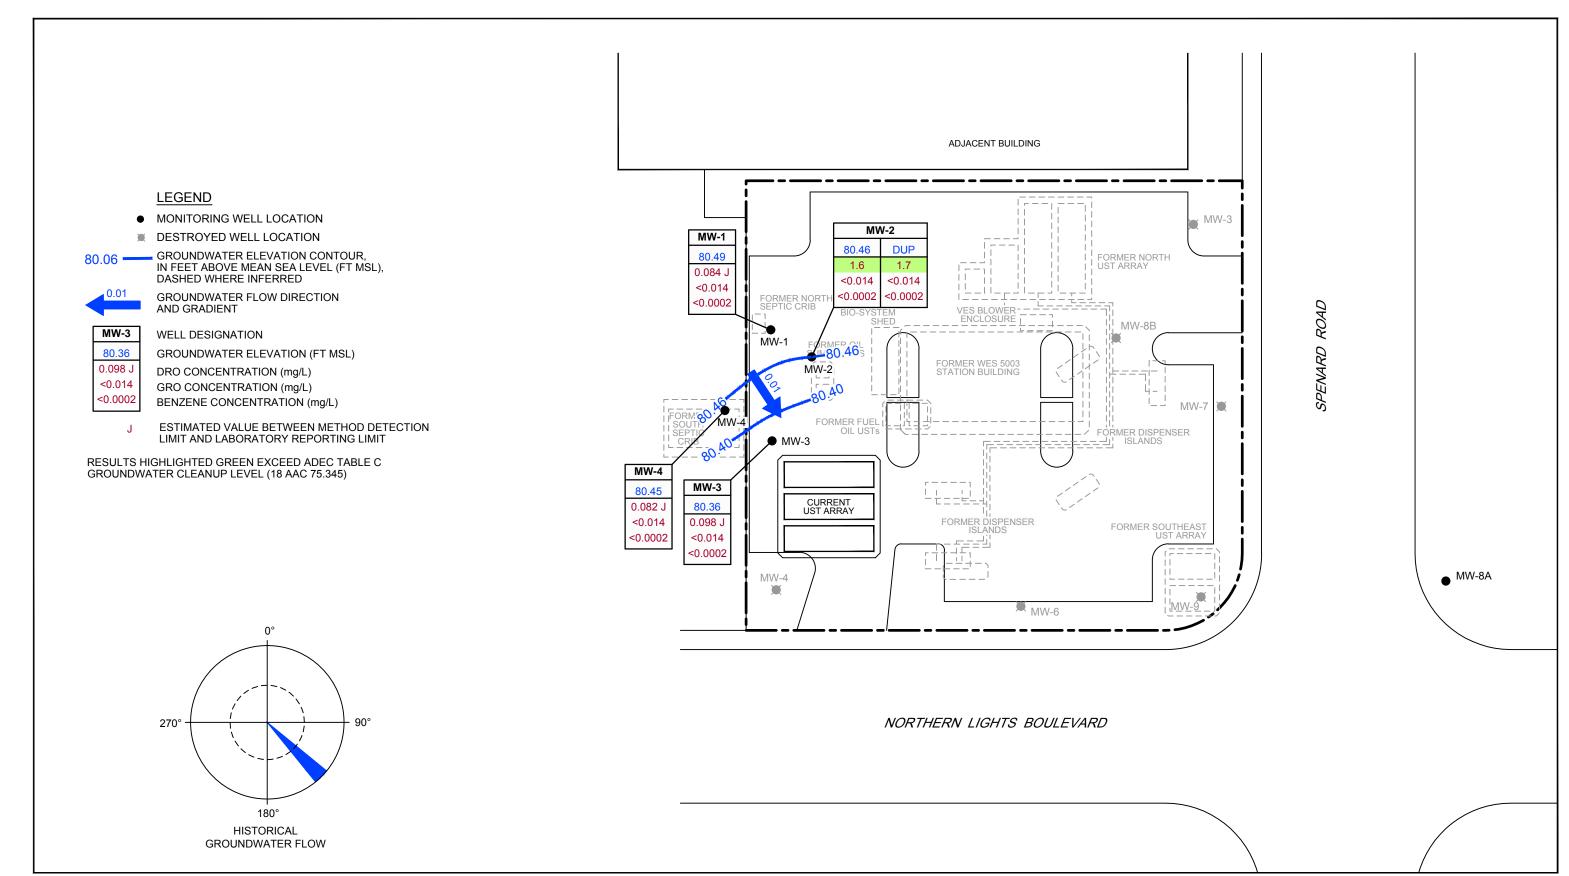
FIGURE 2

GROUNDWATER ELEVATION AND HYDROCARBON CONCENTRATION MAP - AUGUST 9, 2018

The site is located in south central Alaska, southeast of the northern Knik Arm of Cook Inlet. Historical groundwater depths have ranged between 17.17 and 18.41 feet below top of casing (ft btoc) since September 2017. Static groundwater depths ranged from 16.85 (MW 4) to 17.60 ft btoc (MW 1) on August 9, 2018. Groundwater flow was to the southeast with a gradient of 0.01, which is consistent with historical data (Figure 2).

DRO was detected above the cleanup level in MW-2 at 1.6 mg/L (MW-2 Duplicate sample reported DRO at 1.7 mg/L). No RRO, GRO, or benzene was detected above ADEC Table C Groundwater Cleanup Levels in any sample collected. Current groundwater analytical data is presented in Table 1 and on Figure 2. Historical groundwater analytical data is presented in Table 2. The laboratory

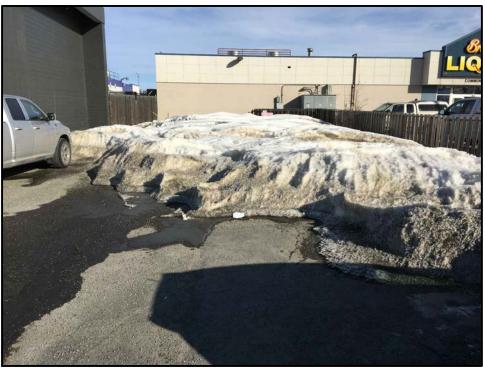
PHOTO 6 - MW-4 - FACING NORTH.
