**ANALYSIS OF BROWNFIELD CLEANUP ALTERNATIVES**

**DELTA JUNCTION TRESPASS SHOOTING RANGE BROWNFIELD  
REVITALIZATION  
DELTA JUNCTION, ALASKA**

**ADEC HAZARD ID 25391  
ADEC FILE NO, 120.38.017**

**DECEMBER 28, 2018**

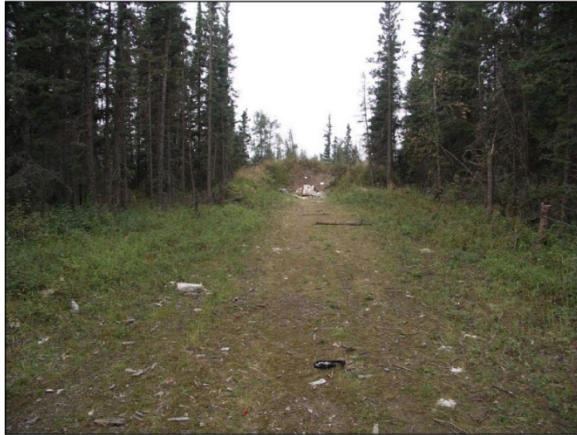
Photo 1: Impact Berm from 50 Yards Downrange (SLR, 2009)

The impact berm is U-shaped and consists of three parts: backstop berm flanked by two berm arms, one on the south (southern berm) and one on the north (northern berm) depicted on Figure 3. A mound of soil is present within the U-shape of the impact berm that is presumably comprised of soil scraped off the range floor, although this is unconfirmed and the date at which it occurred is not known<sup>1</sup>. In July 2018, ADNR conducted a survey of the impact berm to determine the location of the property boundaries. The northern berm is within Tract 8A on CDJ property, but the southern berm extends onto ADNR property to the south (Figure 2, Berm Area Inset). The survey also estimated the volume of soil in the entire berm at 320 bank cubic yards, with 210 bank cubic yards on CDJ property and 110 bank cubic yards on ADNR property. The impact berm is now heavily overgrown with brush, grasses, and small trees.

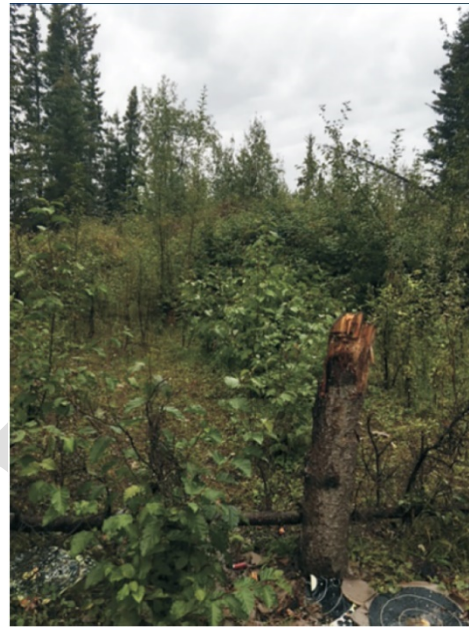
Photo 3: East Side Impact Berm (E&E, 2017)

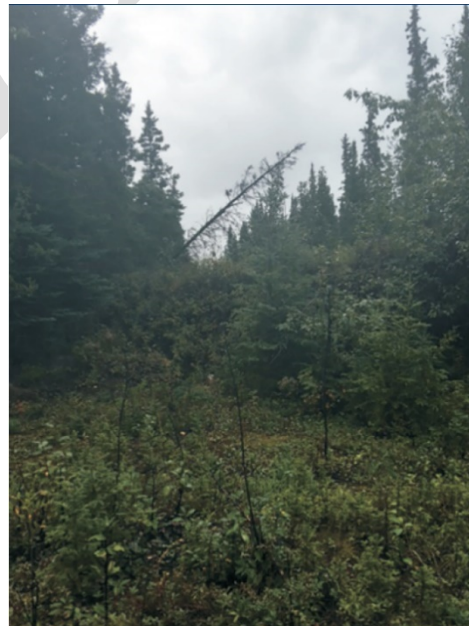
Photo 4: West Side Impact Berm (E&E, 2017)

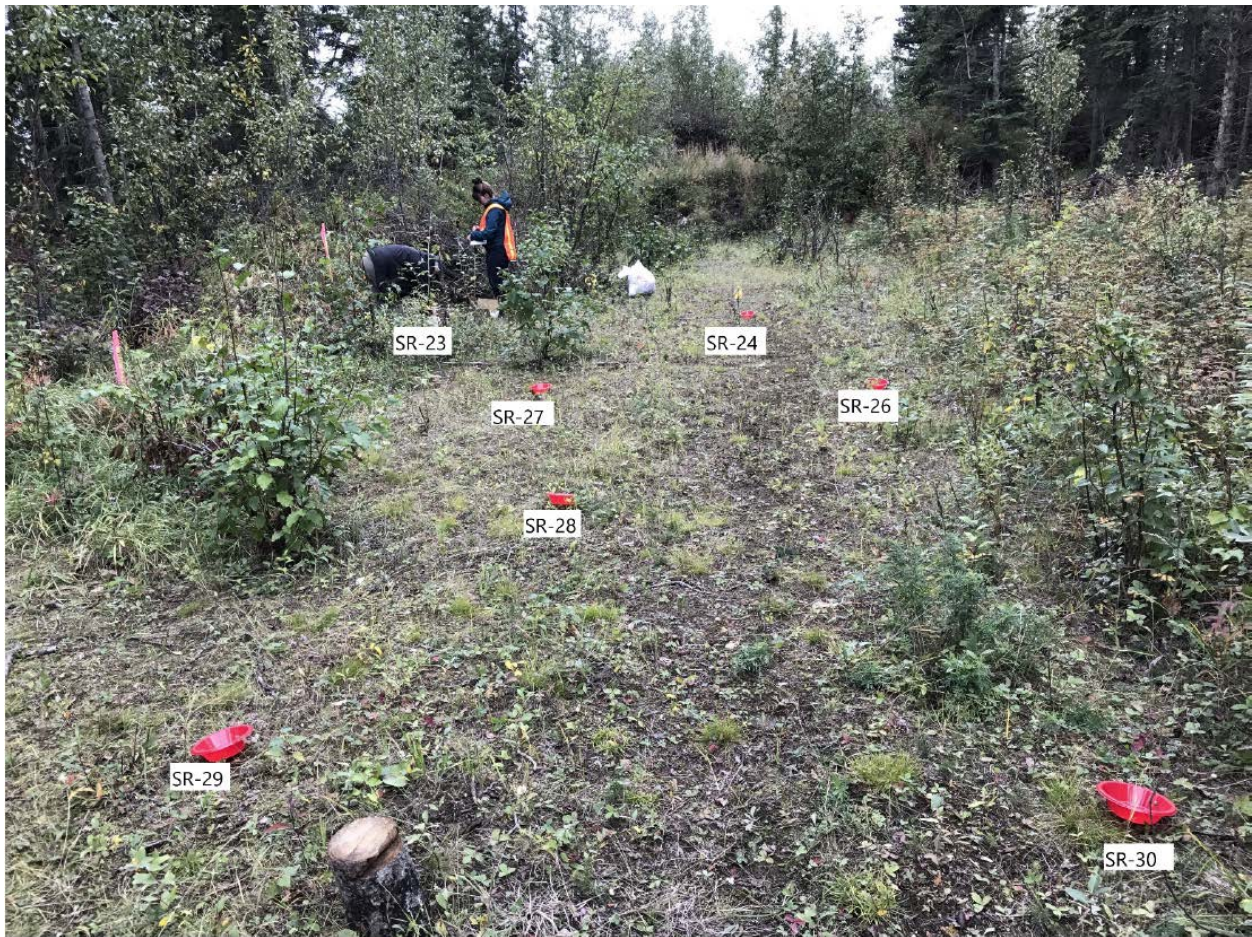
Photo 5: Range floor samples with ADNR property boundary stakes visible at left. (ADEC, 2018)

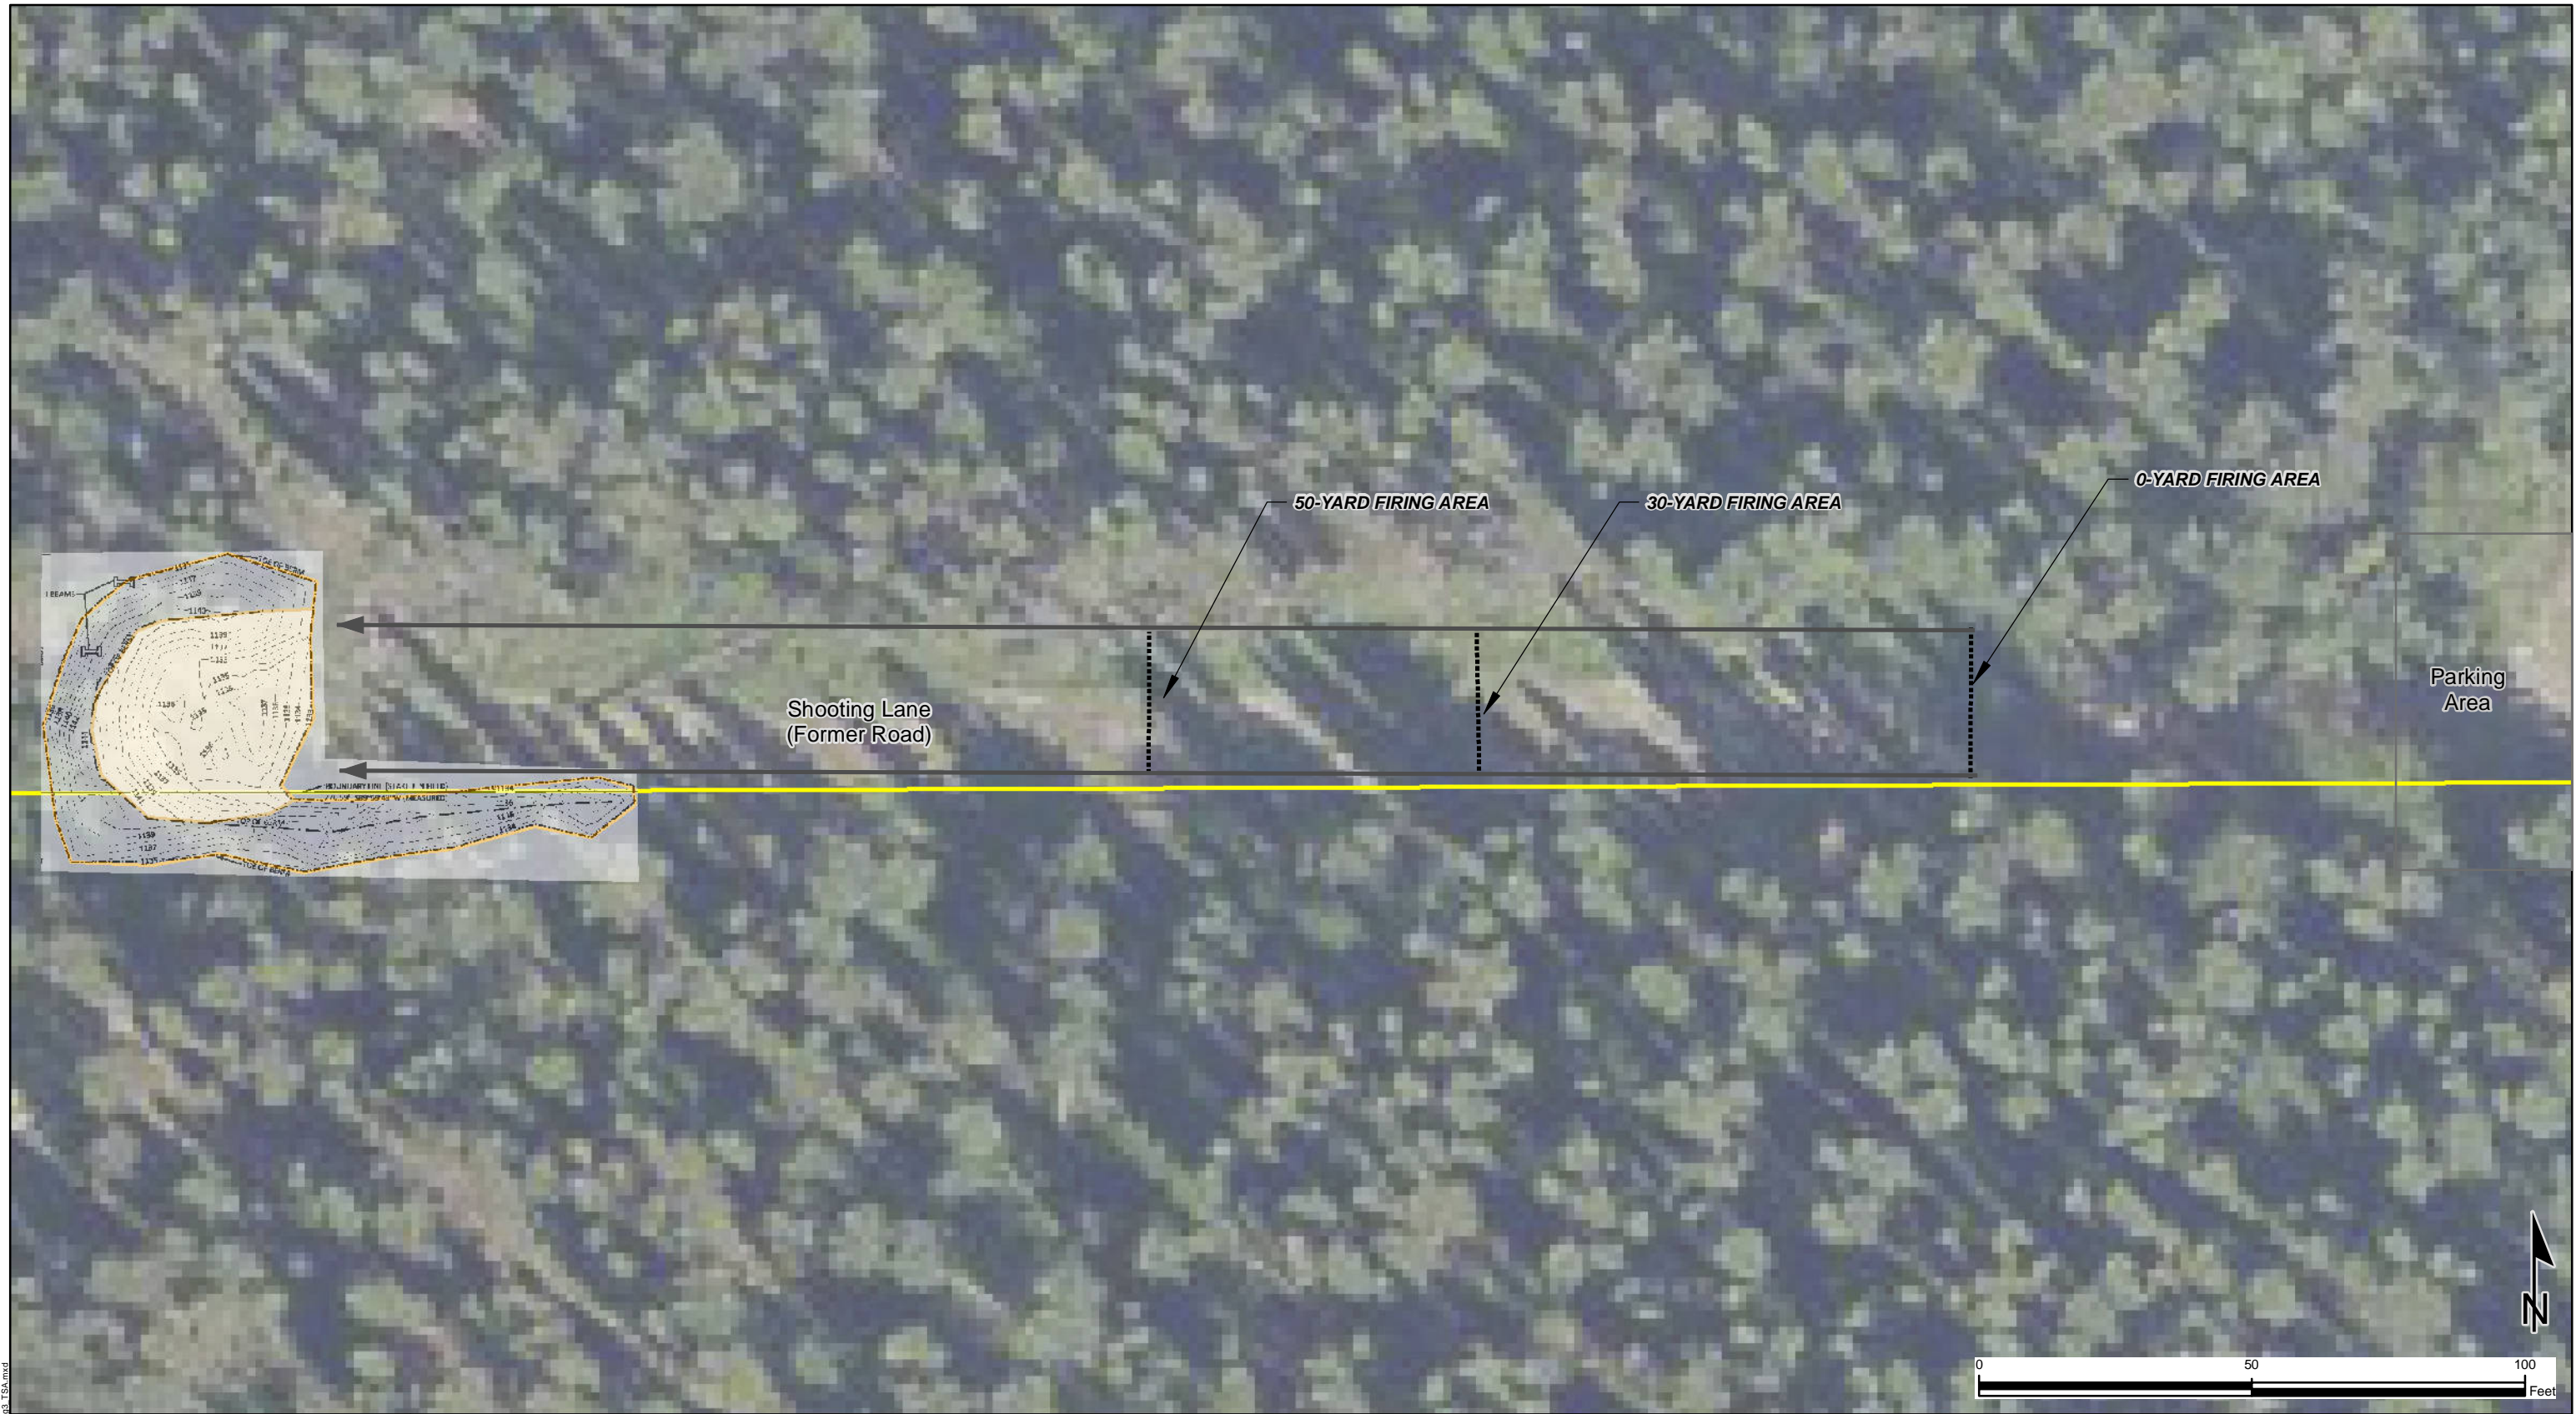
Project Number: 20301.003	<b>Figure Number: 3</b>
Date: 12/27/2018	
Drafted By: L.D.

**TRESPASS SHOOTING AREA SITE**
