RE: June 2013 Decommissioning Report
Former Tesoro Northstore # 11, 317 Muldoon Road, Anchorage, Alaska
Lot 2 Nevilla Park Subdivision
ADEC Facility ID #1502; ADEC File #2100.26.085

This letter report provides the notice of completion of decommissioning 12 ground water monitoring wells, five soil vapor extraction (SVE) wells and piping, three vapor stripping and circulation (VSC) wells, and three circulation wells at the above referenced site. The Alaska Department of Environmental Conservation (ADEC) issued a corrective action complete determination document for this site on August 3, 2012.

Former Tesoro Northstore #11 – June 2013 Decommissioning Photos

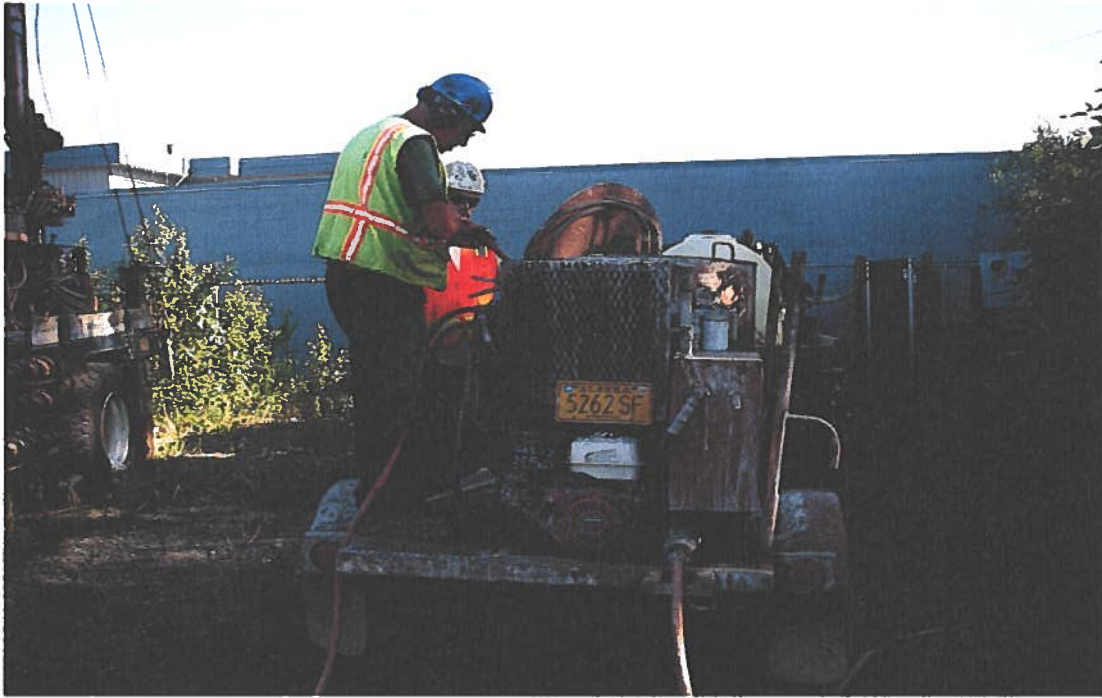
1. Grout plant with 240-gallon hopper that was used for mixing bentonite during decommissioning of TNS-11.

- A tee bracket and the drill rig's hydraulic rams were used to remove the protective vault cover. In some instances a 580M Case backhoe was used to remove the 48-inch, high-density polyethylene (HDPE) vaults.
- The casing was typically lifted 12 inches using a threaded bell cap or a double taper tap. A pointed drill rod was lowered into the well to break out the well casing bottom. In some cases, the drill rig's 300-pound hammer was used to drive the drill rod through the casing bottom.
- The well casings were filled with Casing Seal™ bentonite grout. This grout was hydrated and mixed in a 240-gallon, hydraulically-driven grout plant (Photos 1 and 2).

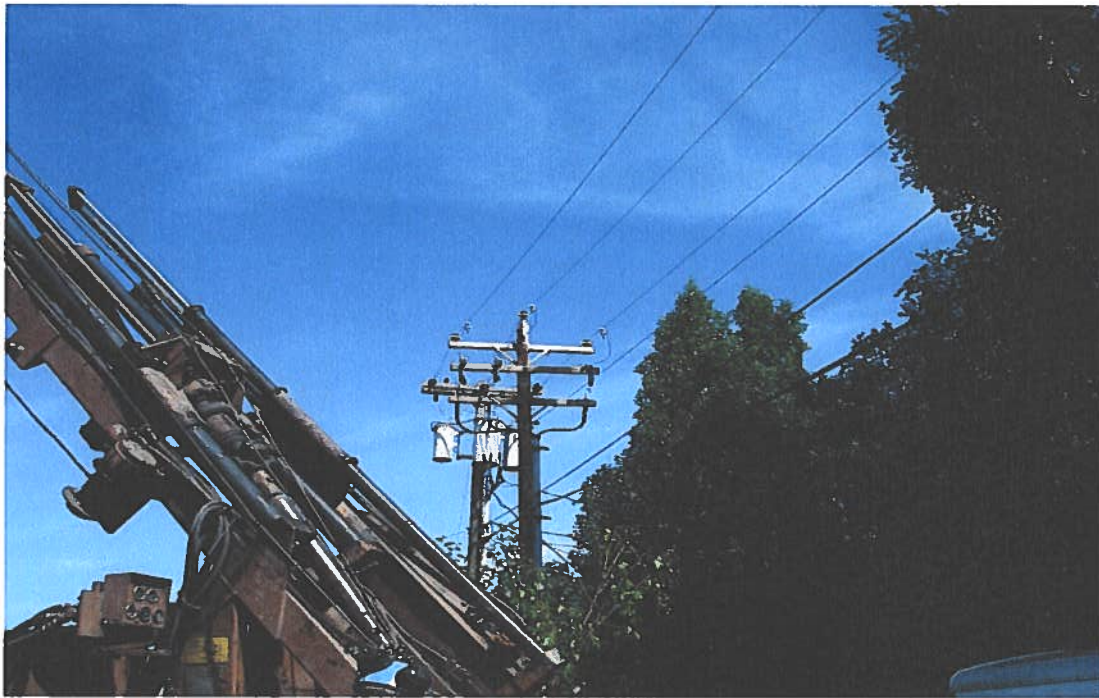
3. MW-1 Due to the close proximity of overhead power lines, the drill rig's mast could not be raised to pull the well.

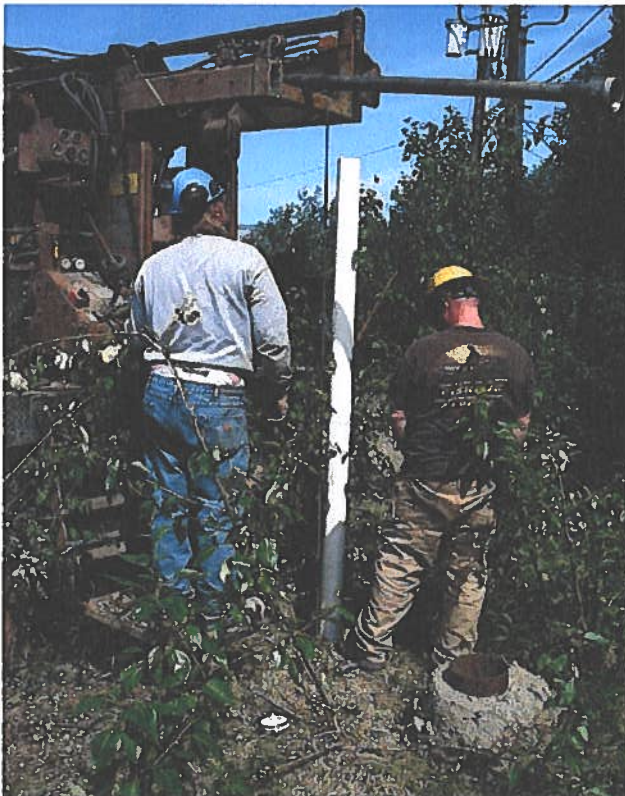
4. MW1 Pulling well casing with mast down.

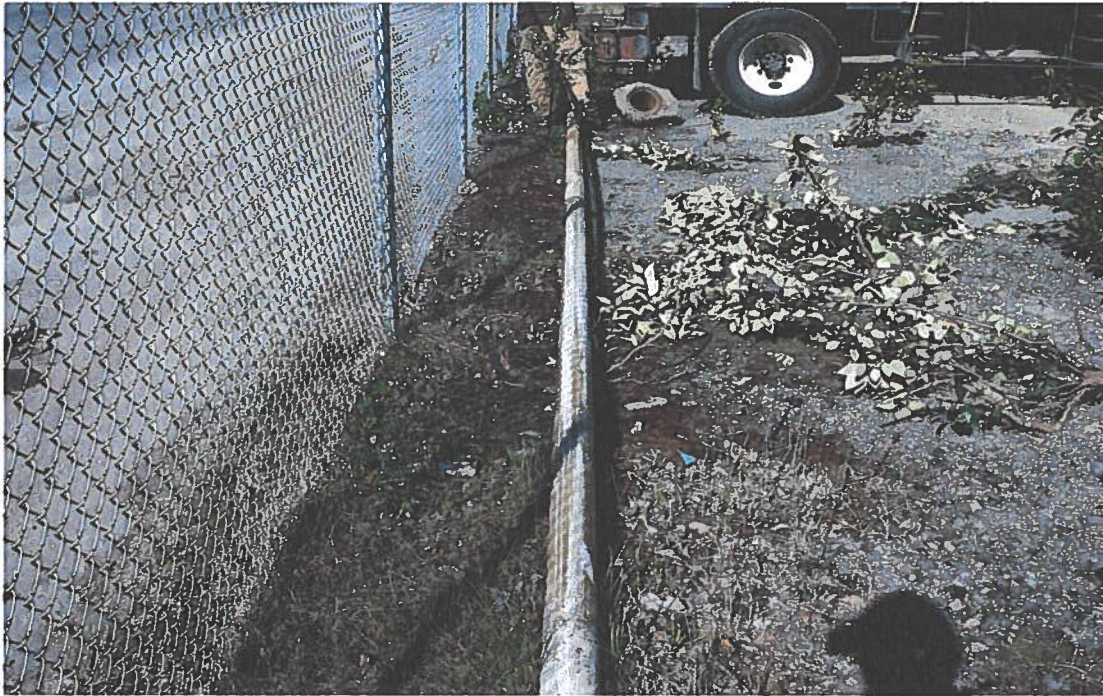
5. MW-3 Pulled well casing.

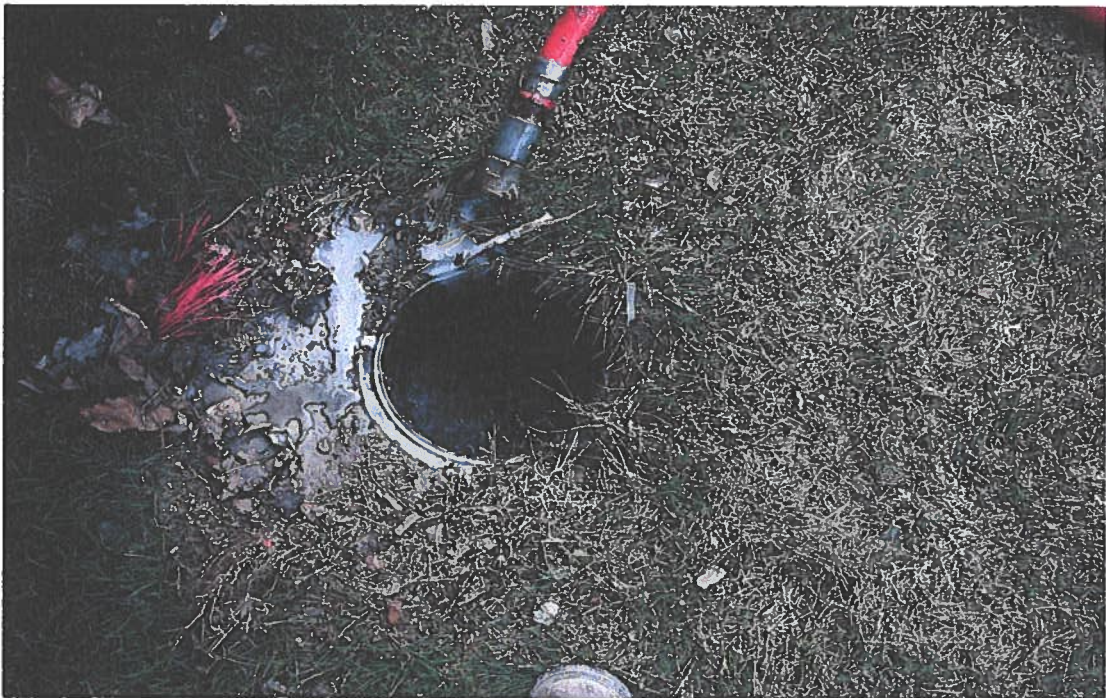
7. MW-4 Stabilized grout in bore hole.

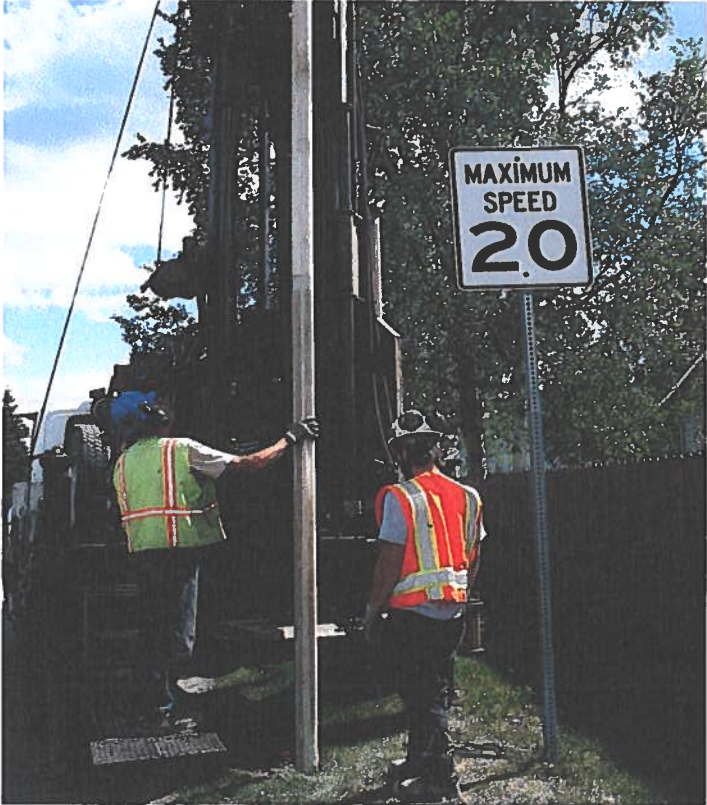
8. MW-4 Pulling well casing .

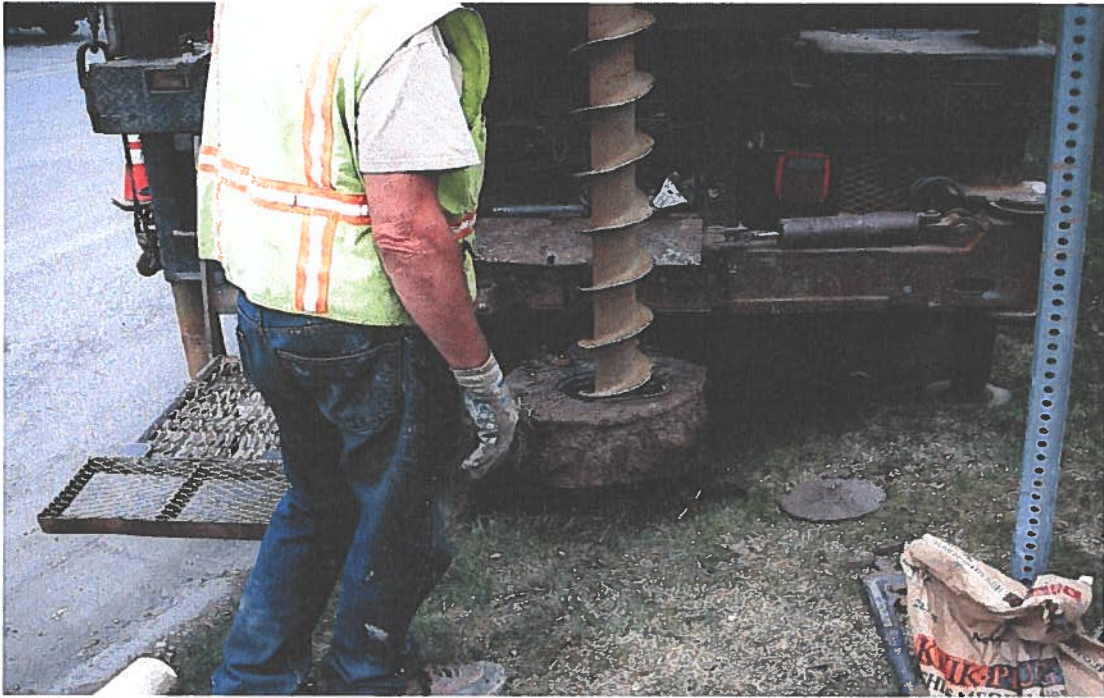
9. MW-4 Removing cement encased protective vault with drill rig's auger.

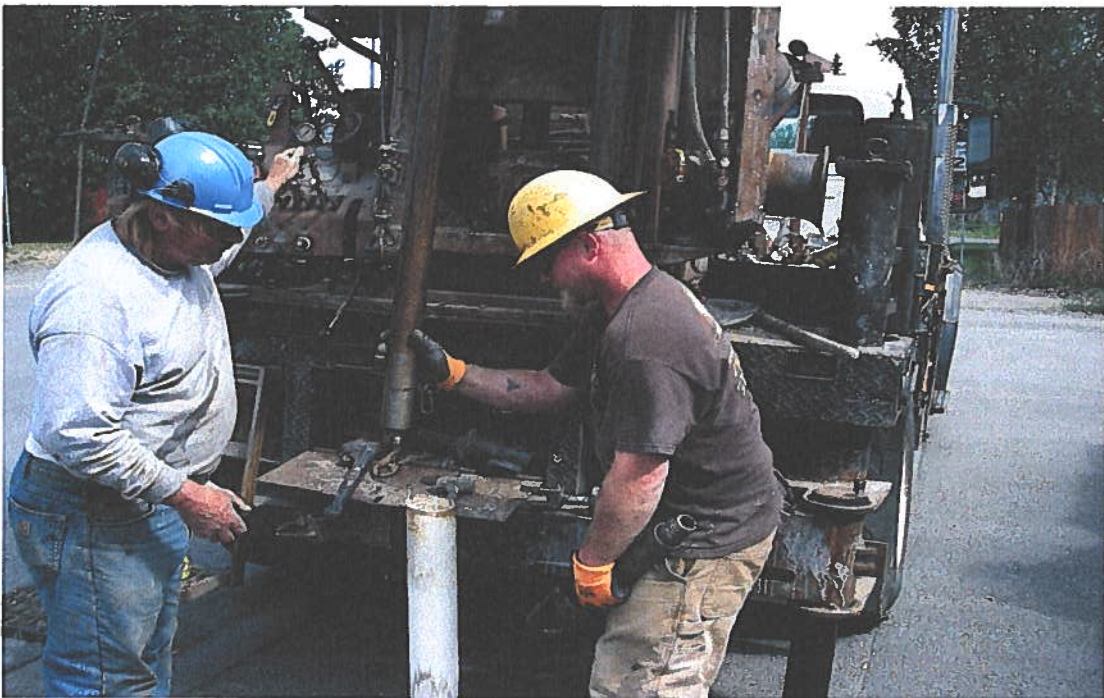
10. MW-5 Using the drill rig's center rod to knock out the bottom of the well casing.

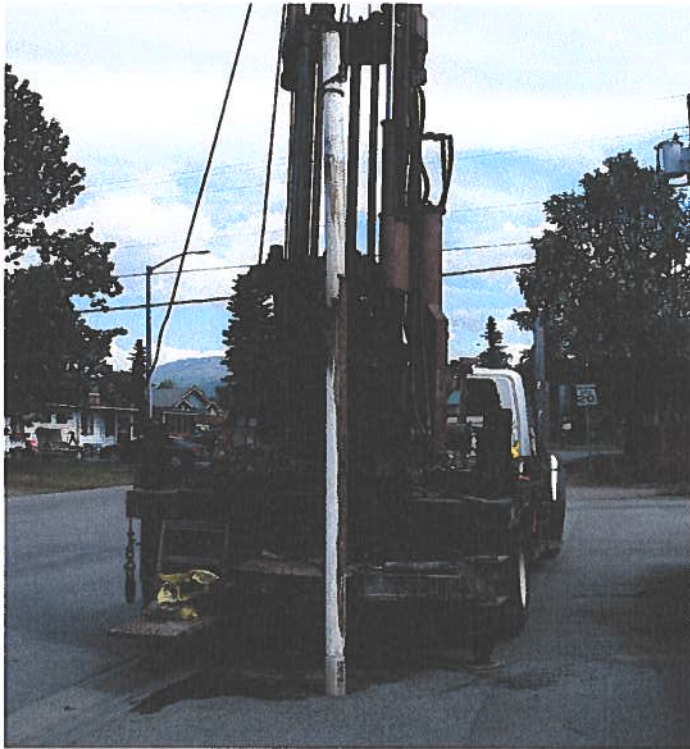
11. MW-5 Pulling the well casing.

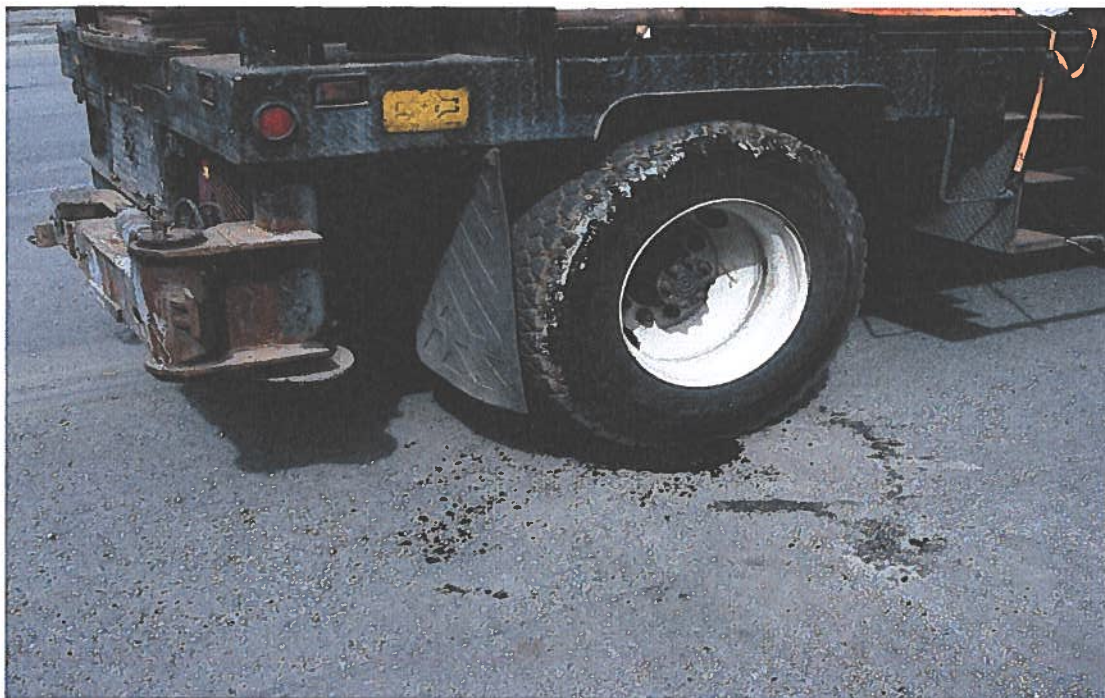
12. MW-5 Using the drill rig to compact the asphalt cold patch.

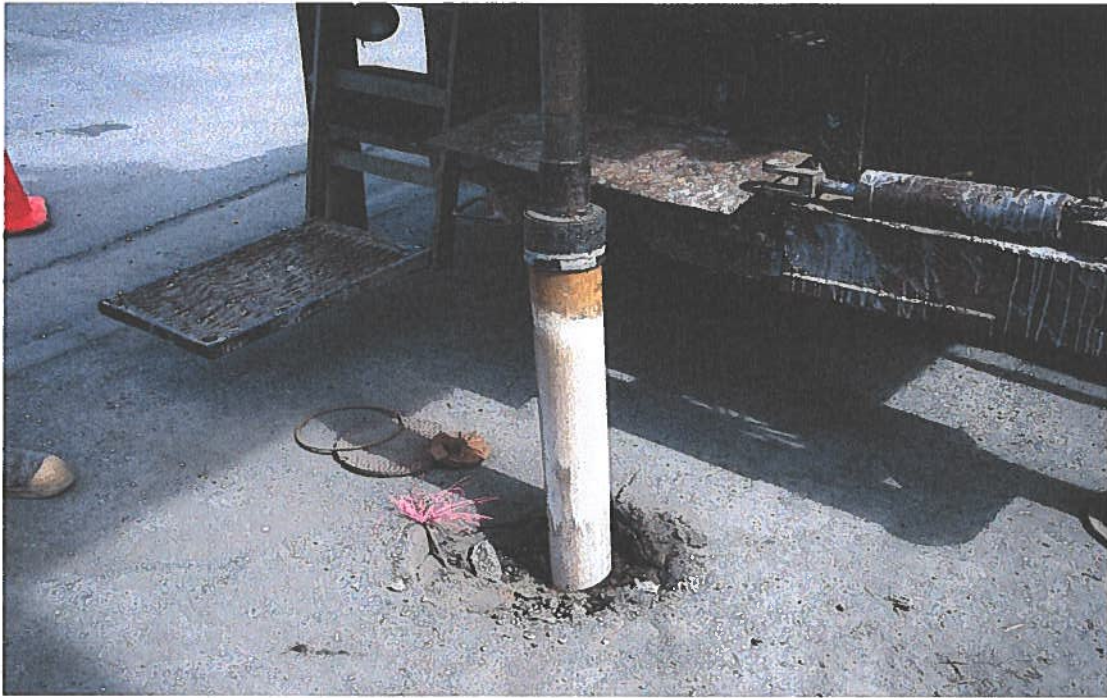
13. MW-6 Pulling the well casing with a threaded bell cap .

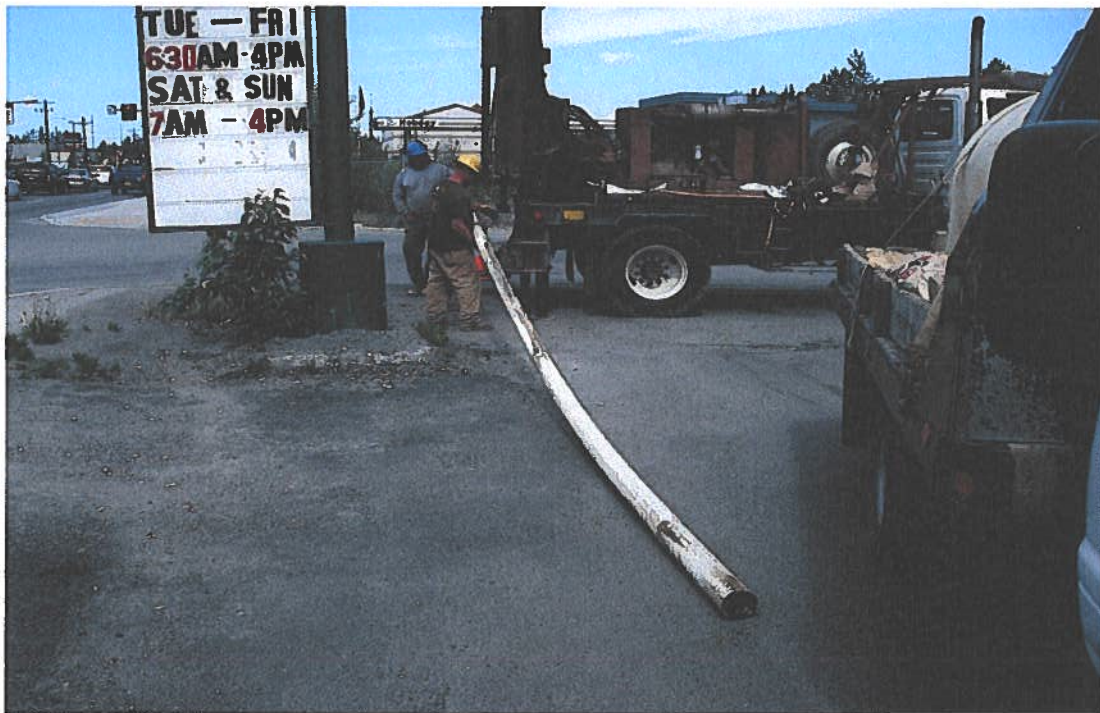
14. MW-6 Showing the well casing bottom cap knocked out.

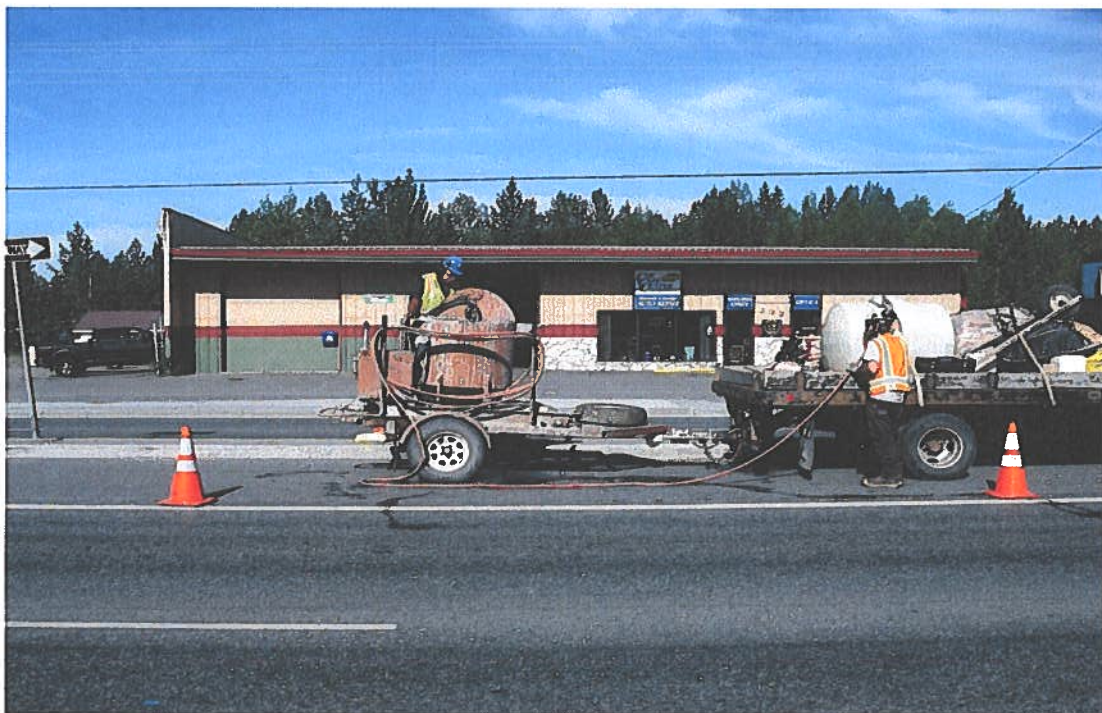
16. MW-7 Showing the grout plant in position .

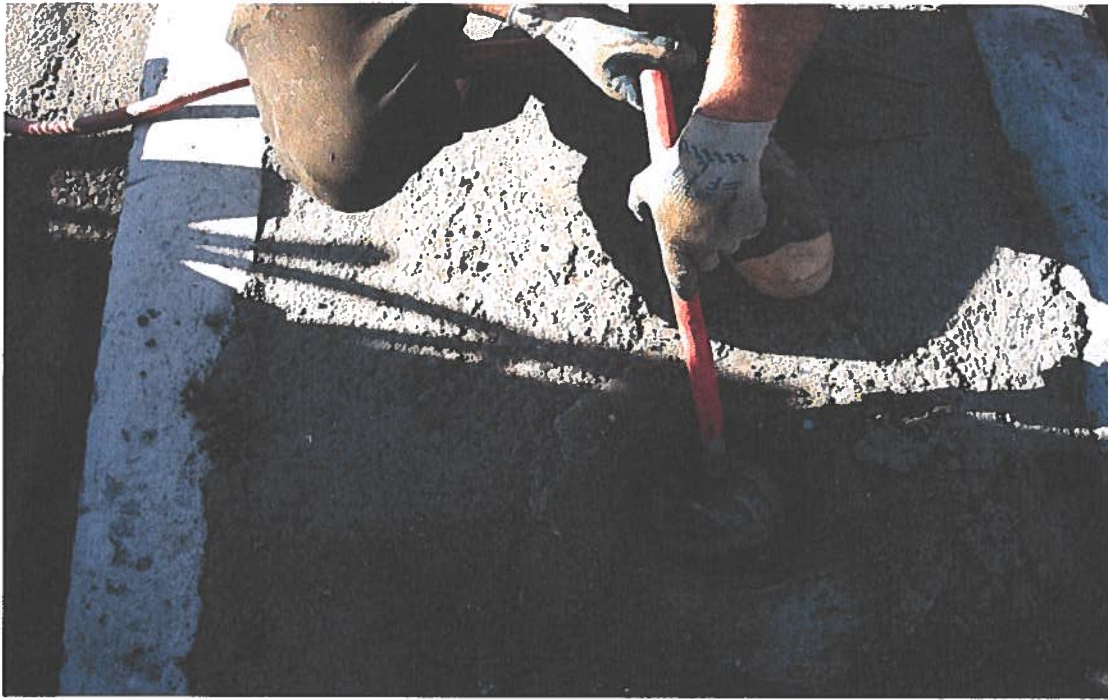
17. MW-7 Topping off the well bore with grout.

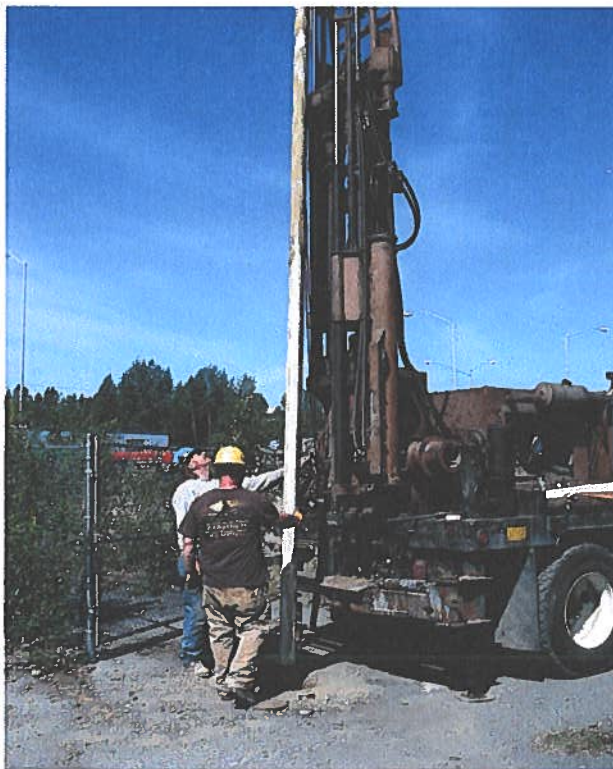
18. MW-8 Pulling the well casing.

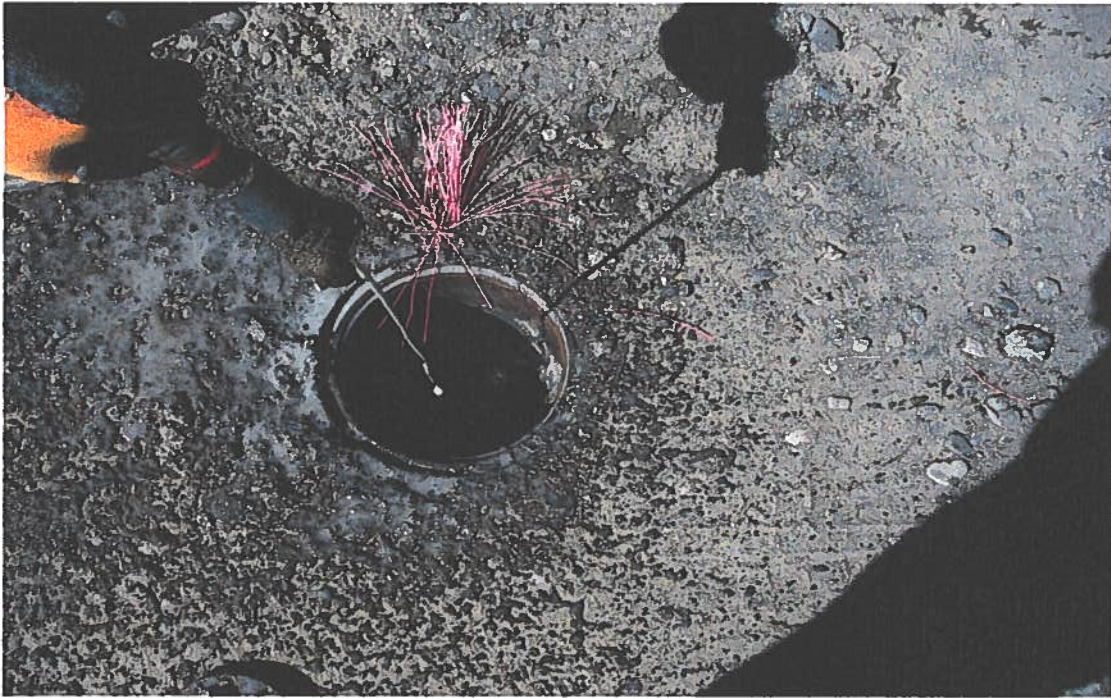
19. MW-8 Topping off the well bore with grout.

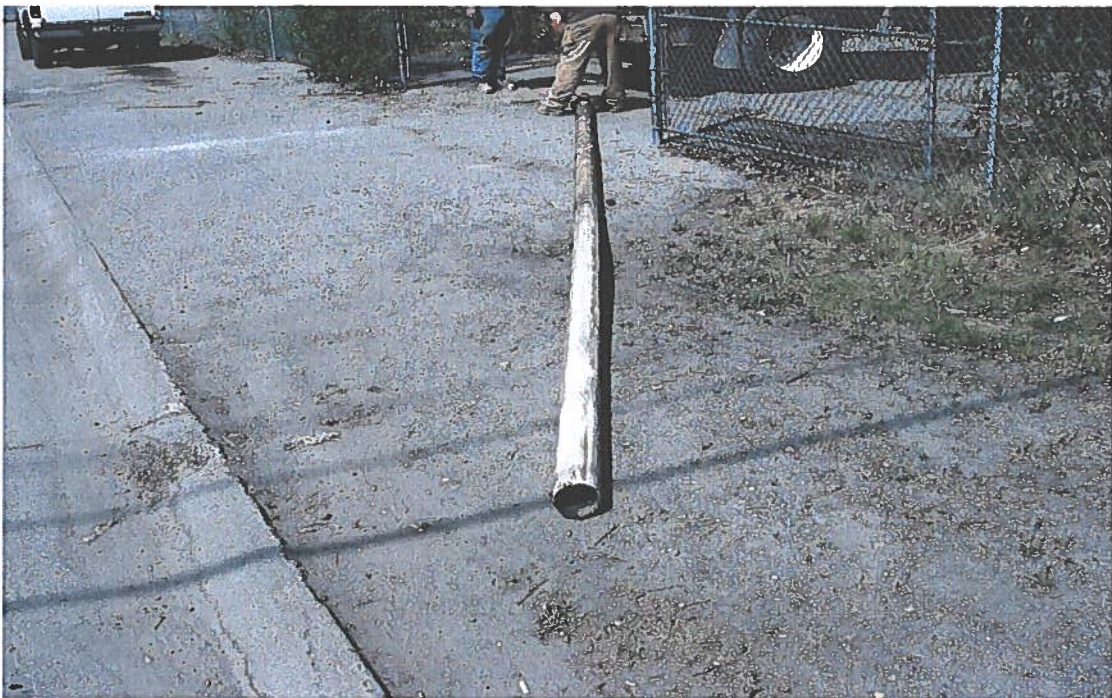
20. MW-8 Pulled well casing with bottom knocked out.

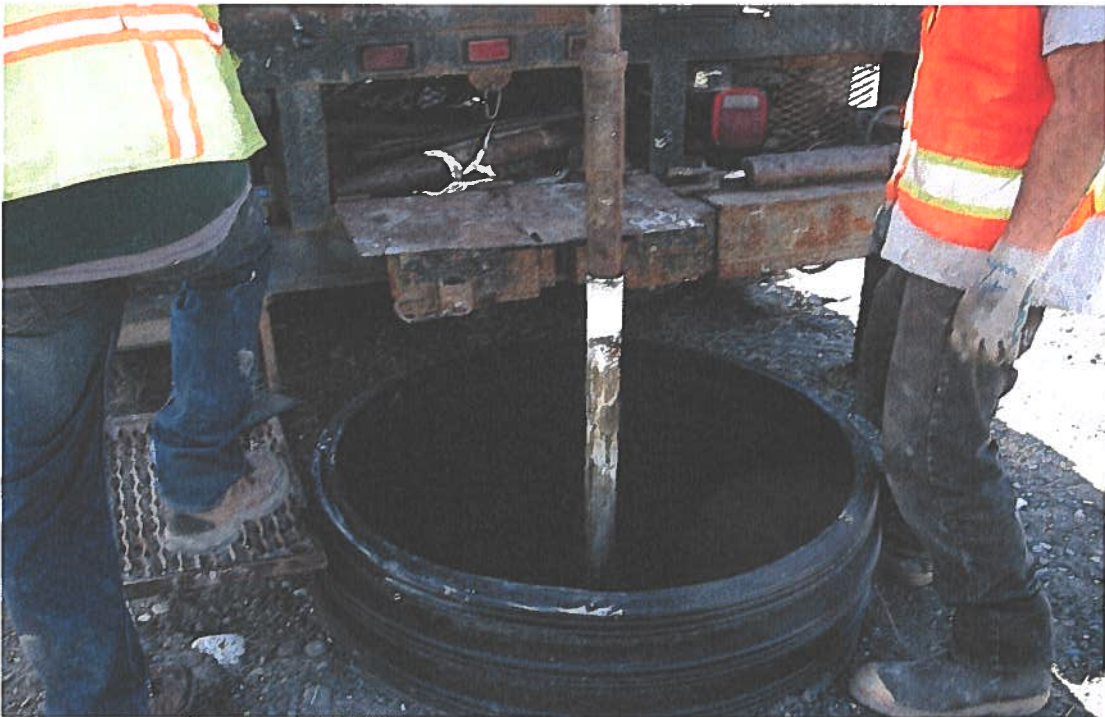
21. MW-14 Pulling the well casing with a taper tap.

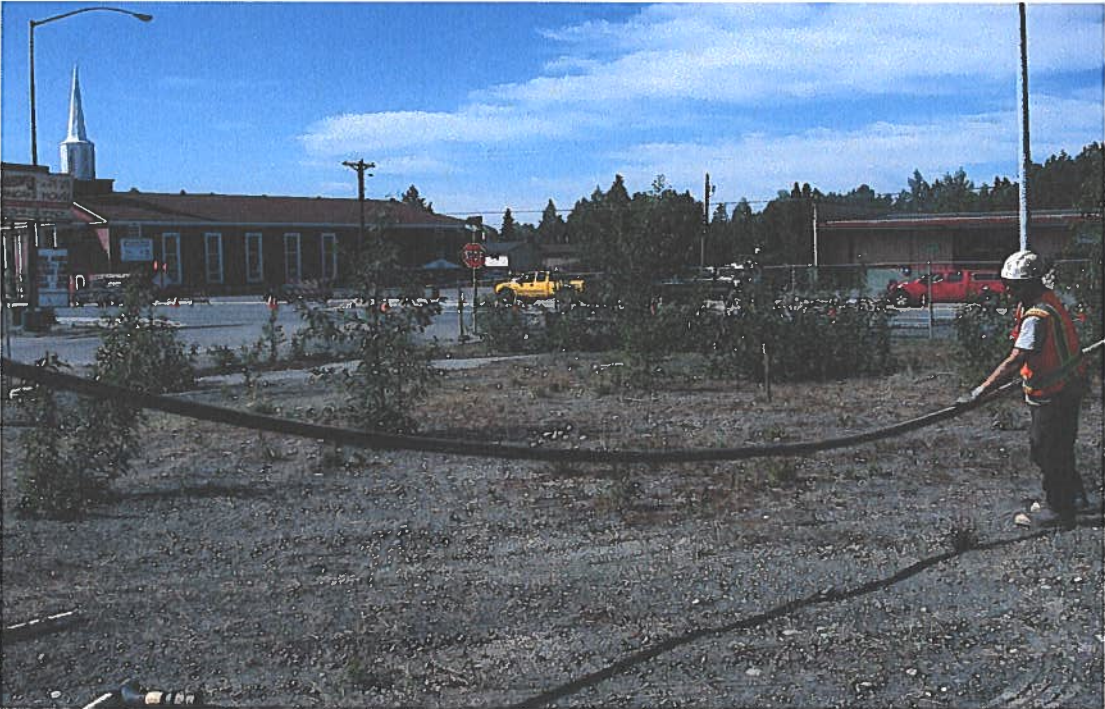
22. MW-14 Pulled well casing.

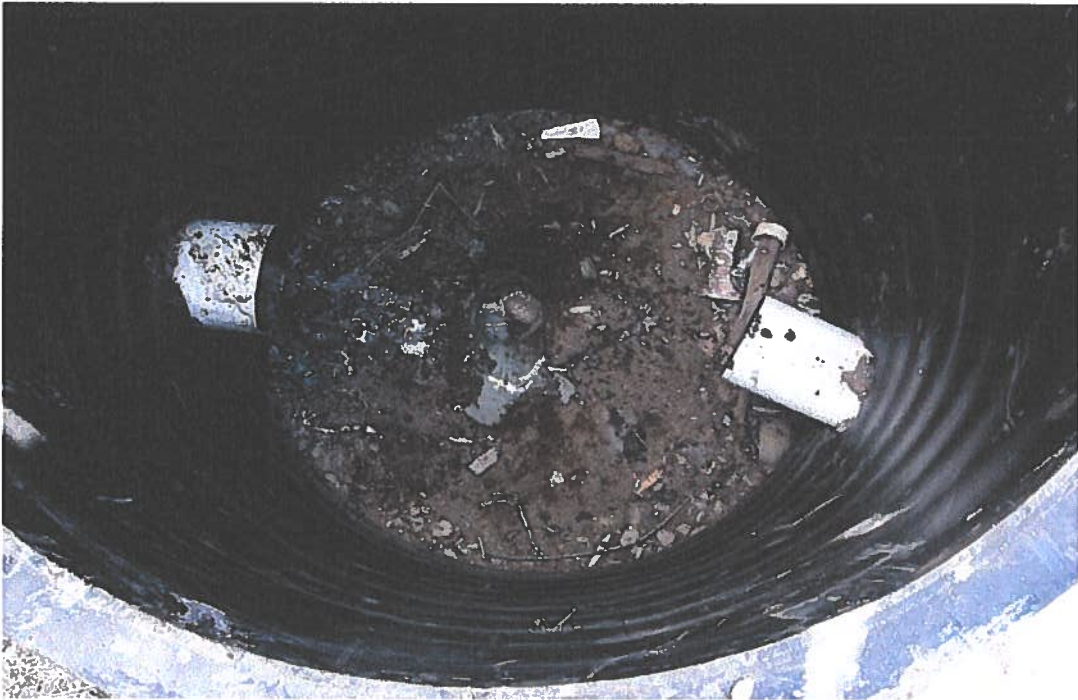
23. MW-14 Former well topped off with grout.

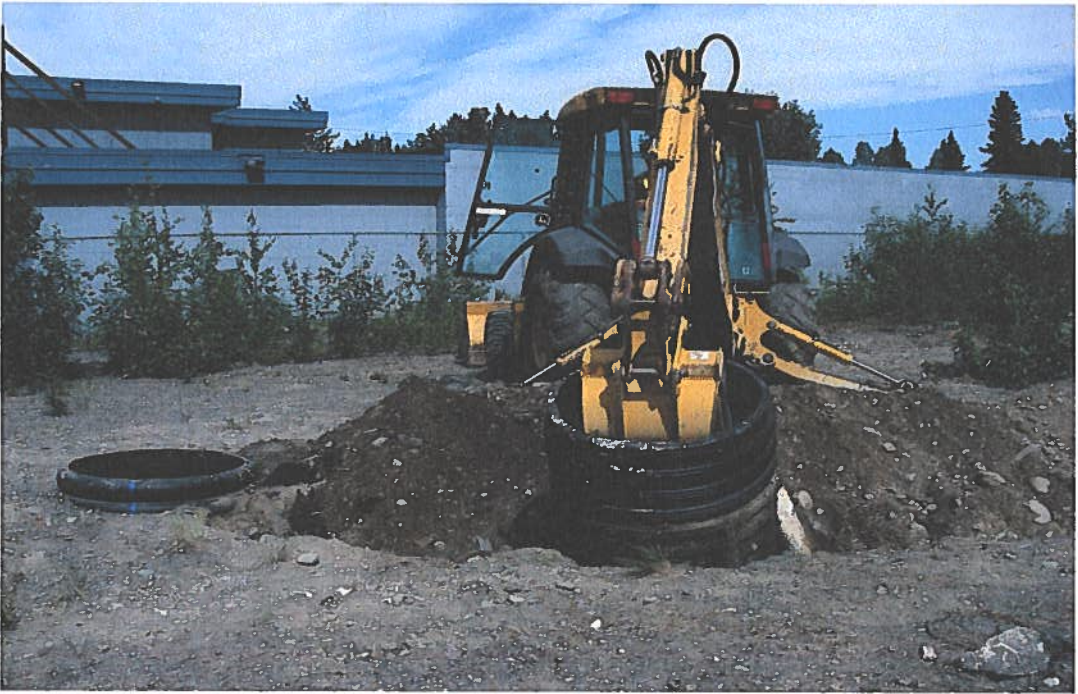
24. MW-14 Removing the protective vault; Circulation Well CW-2 vault to left.

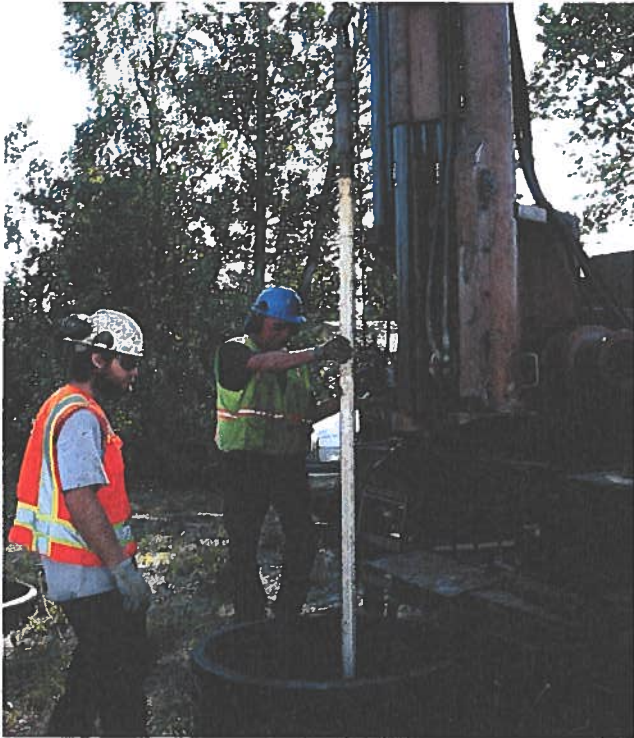
25. MW-15 Pulling the well casing with a taper tap.

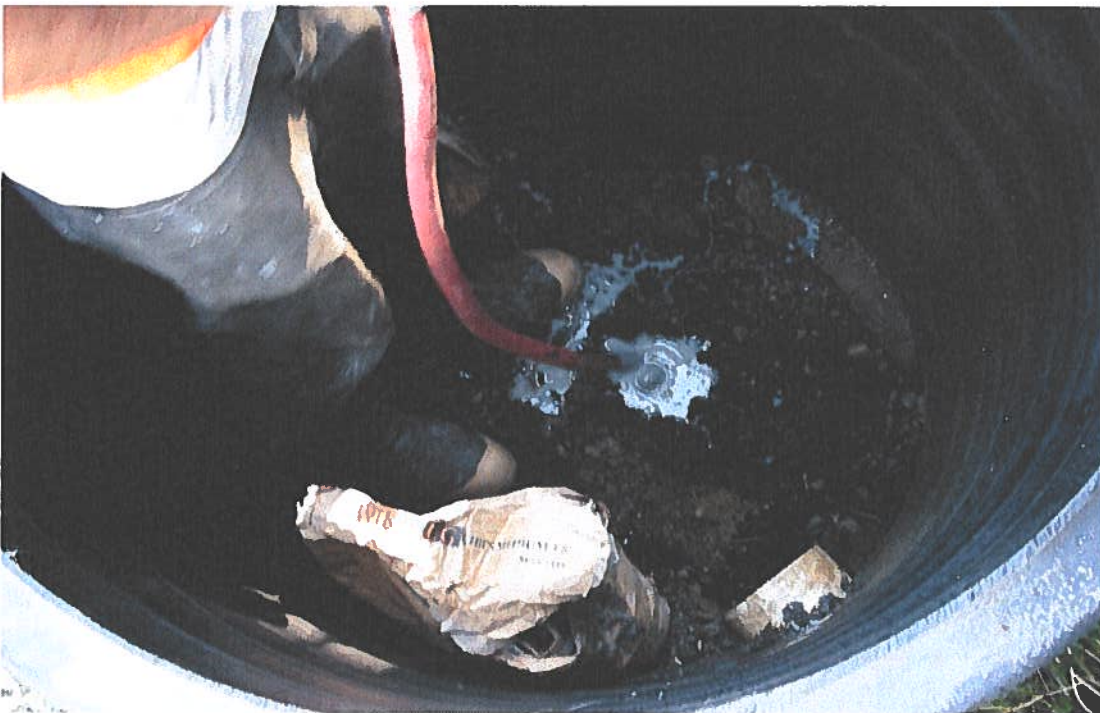
26. MW-15 Topping off the well with grout.

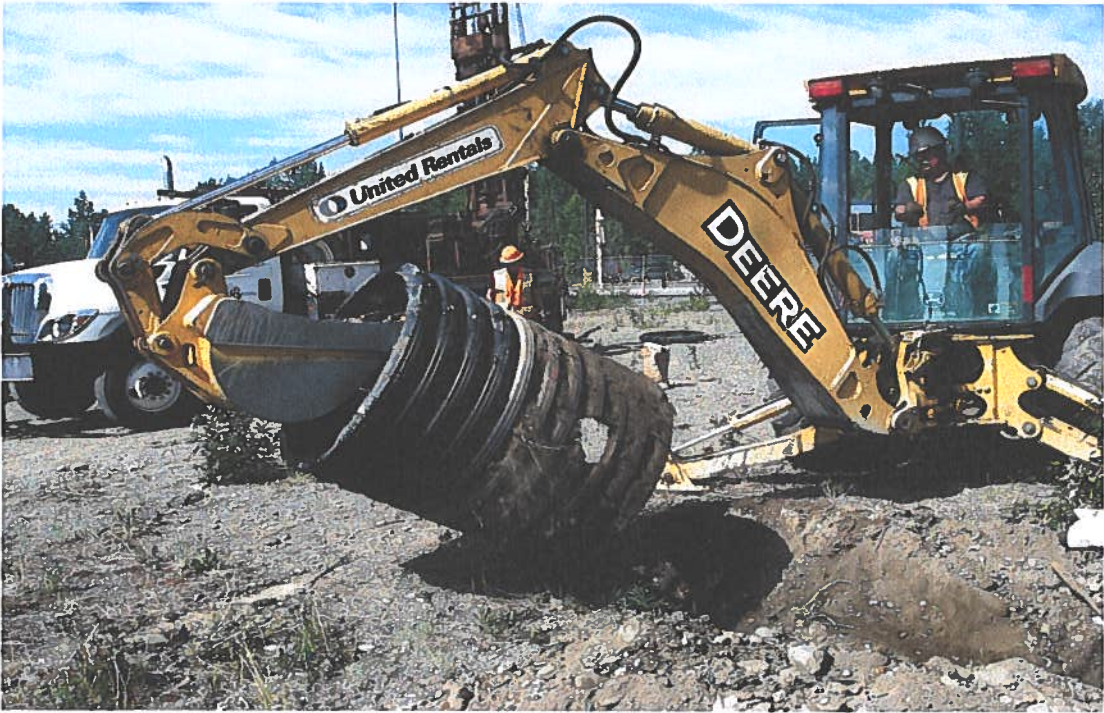
27. MW-15 Removing the protective vault and associated conduit.

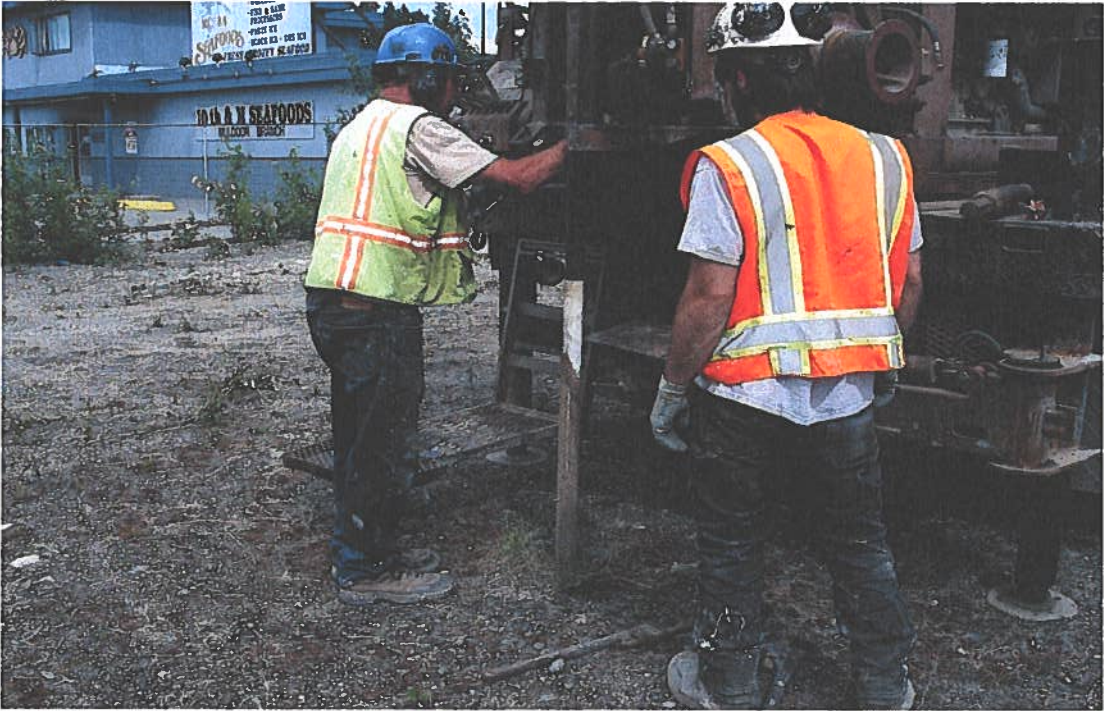
28. MW-16 Pulling the well casing with a taper tap.

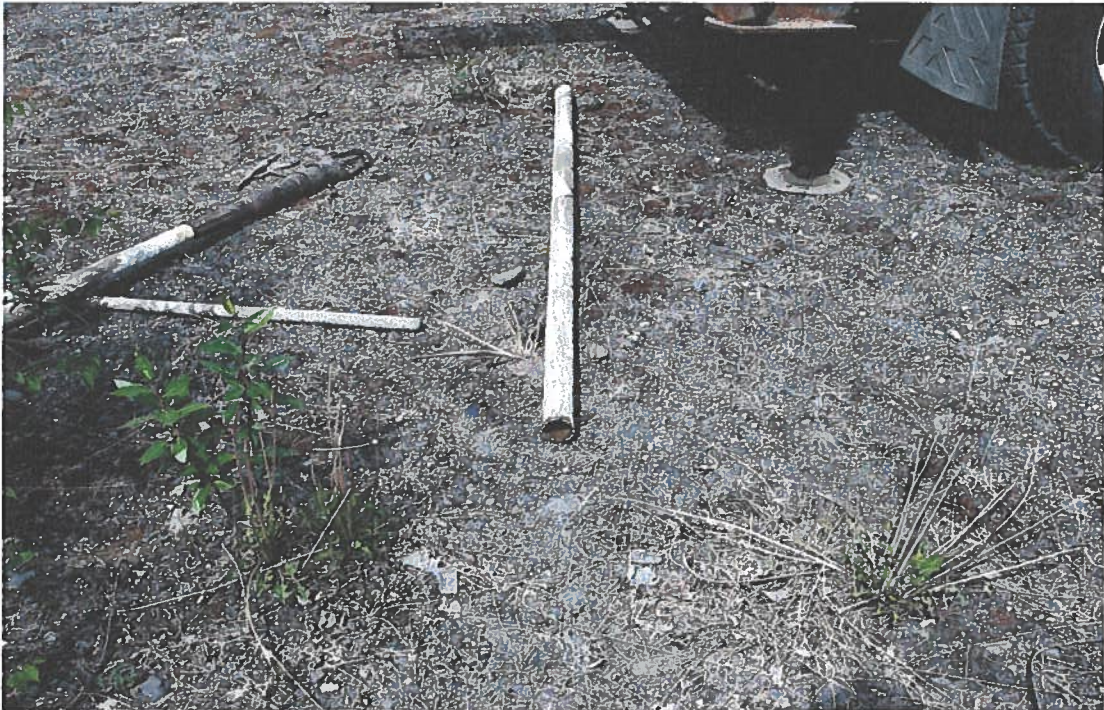
29. MW-16 Removed well casing with bottom broken out.

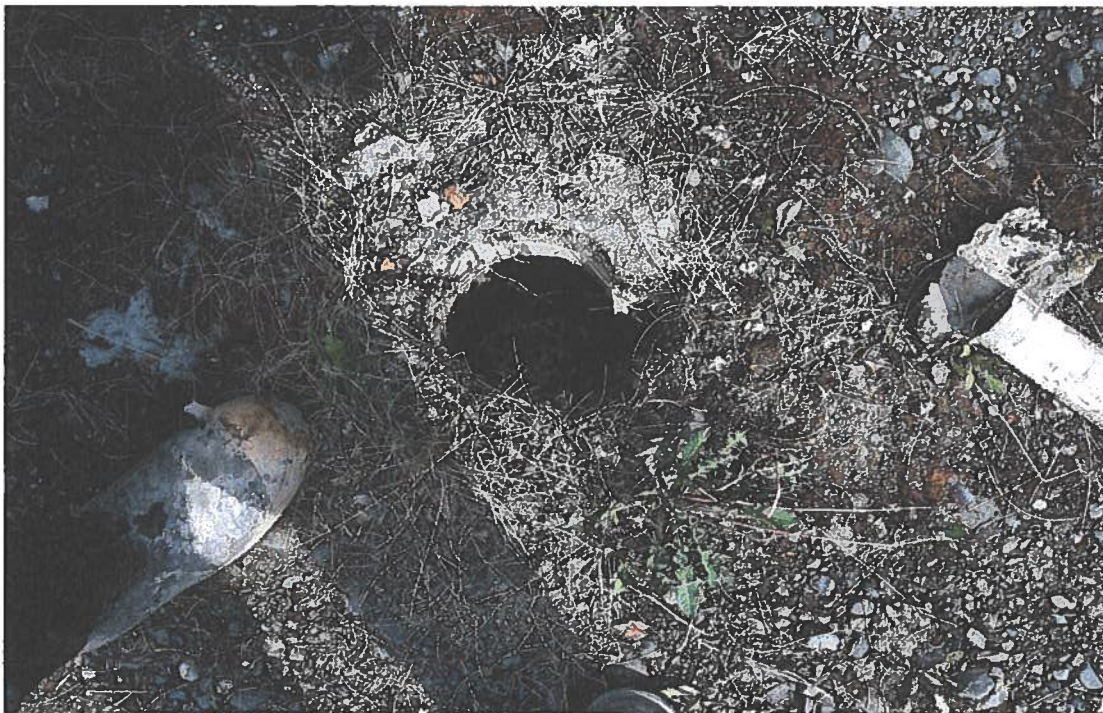
30. MW-16 Topped off well with grout.

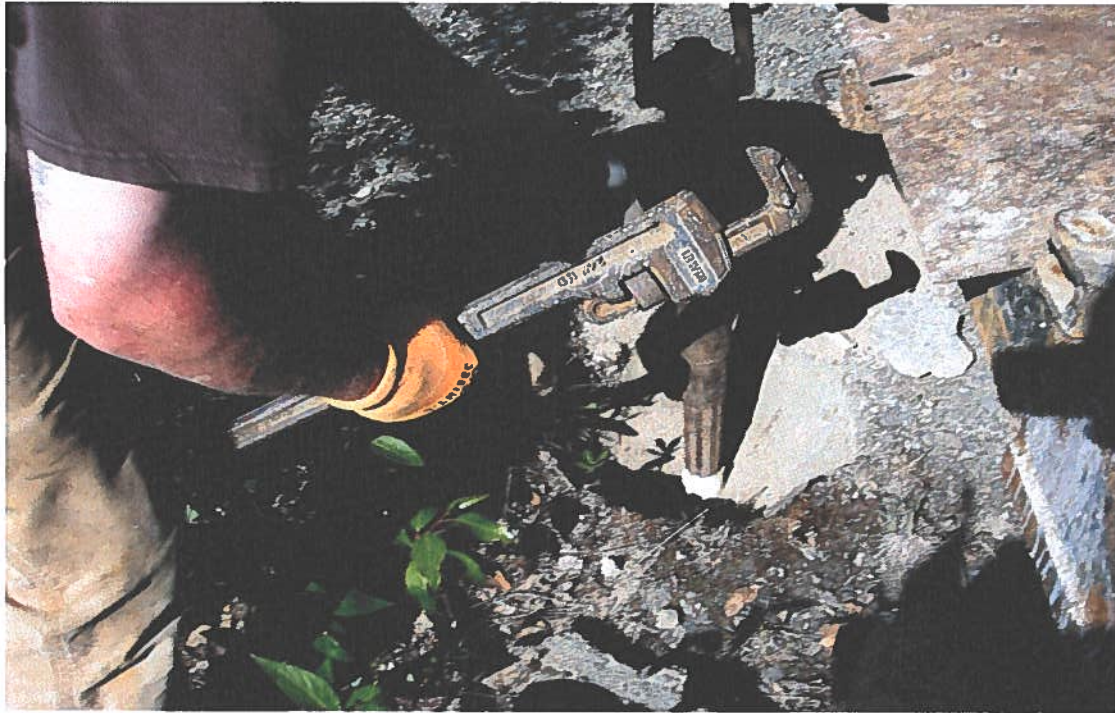
31. MW-17 Driving a taper tap in preparation of pulling.

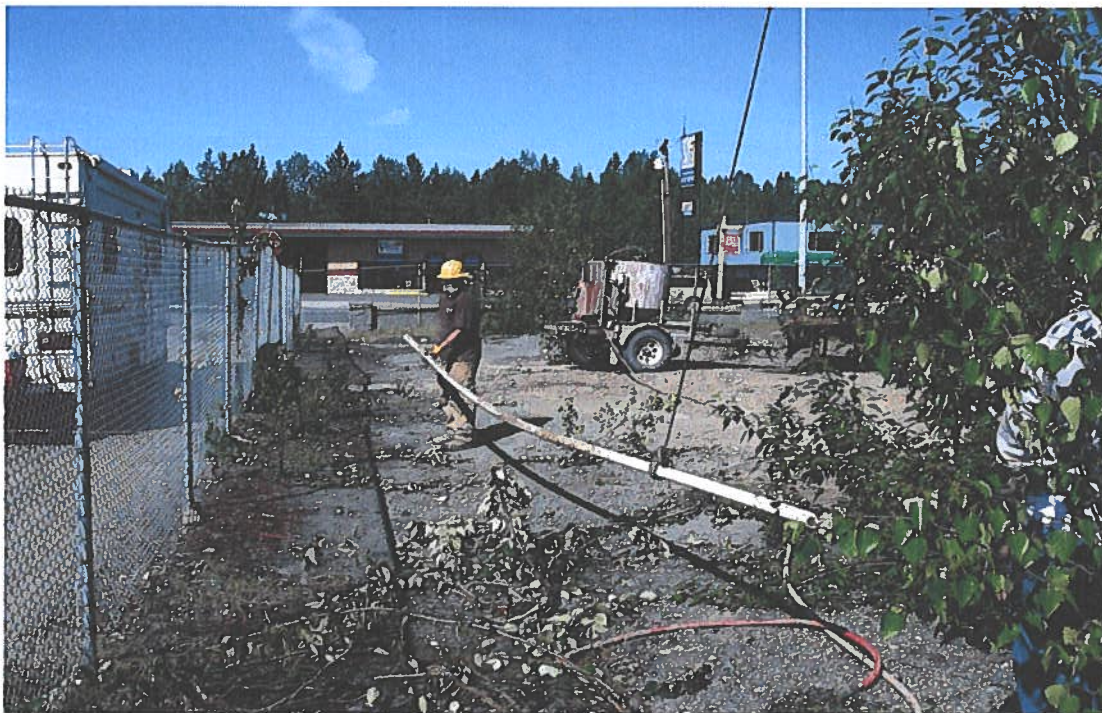
32. MW-17 Walking out well casing, grout line in the foreground.

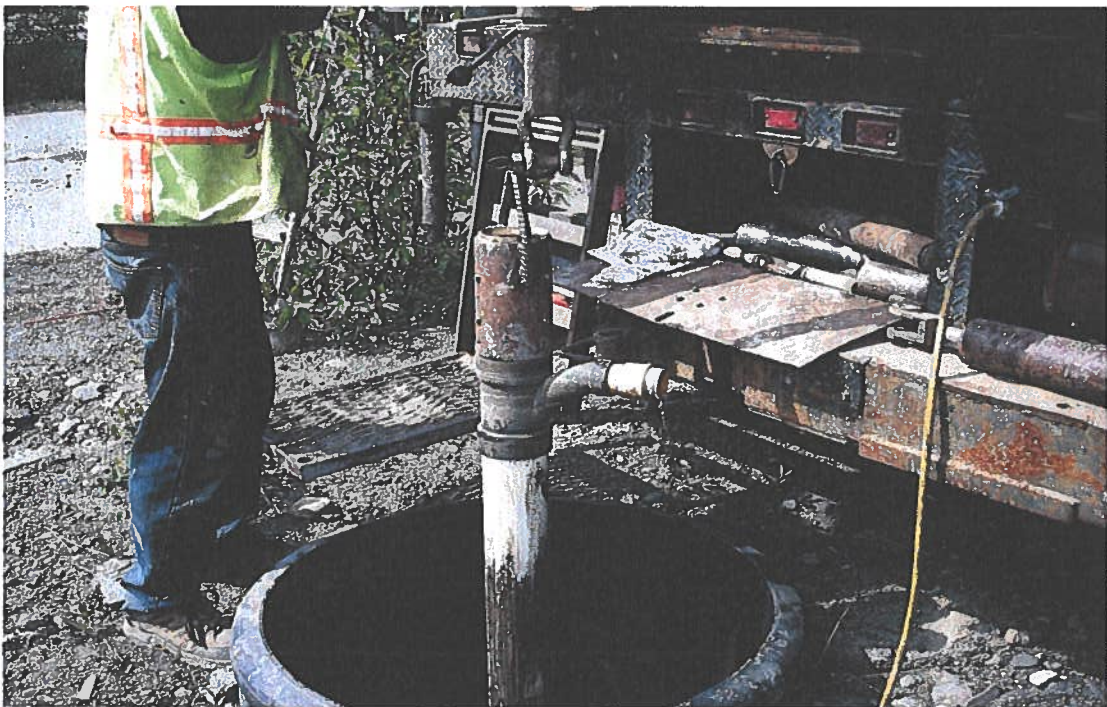
34. CW-1 Pulling the well casing with a fabricated metal sleeve and self tapping screws .
