RE: June 2013 Decommissioning Report
Former Tesoro Northstore # 11, 317 Muldoon Road, Anchorage, Alaska
Lot 2 Nevilla Park Subdivision
ADEC Facility ID #1502; ADEC File #2100.26.085

This letter report provides the notice of completion of decommissioning 12 ground water monitoring wells, five soil vapor extraction (SVE) wells and piping, three vapor stripping and circulation (VSC) wells, and three circulation wells at the above referenced site. The Alaska Department of Environmental Conservation (ADEC) issued a corrective action complete determination document for this site on August 3, 2012.

Former Tesoro Northstore #11 – June 2013 Decommissioning Photos

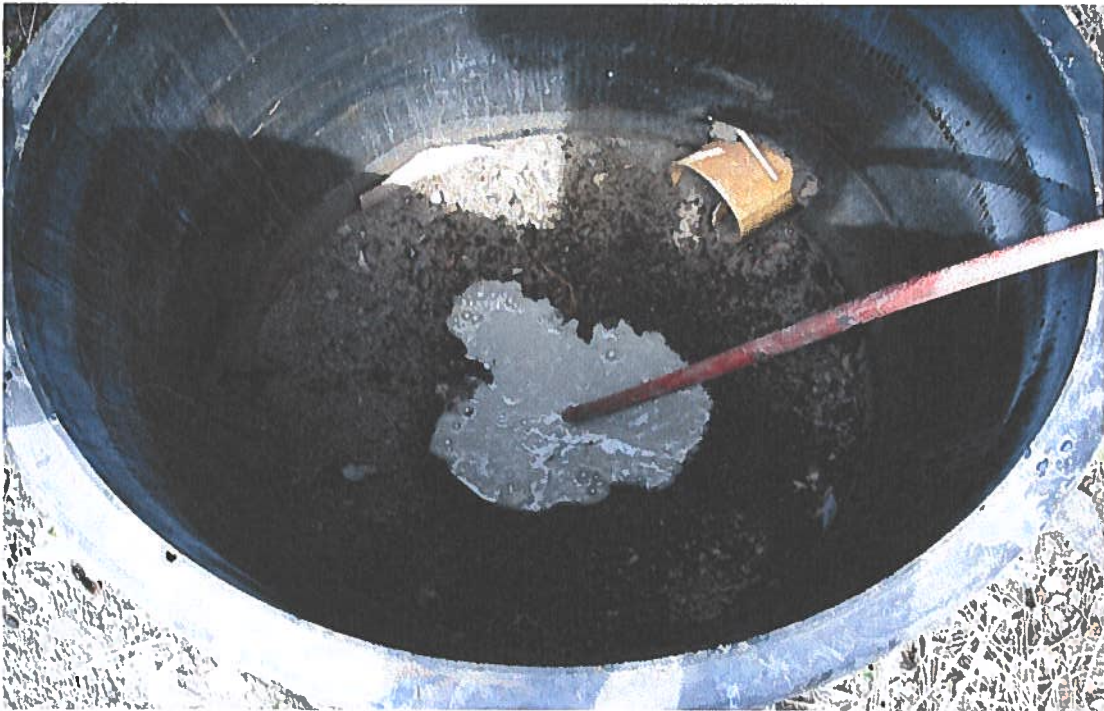
35. CW-1 Grouting the former well.

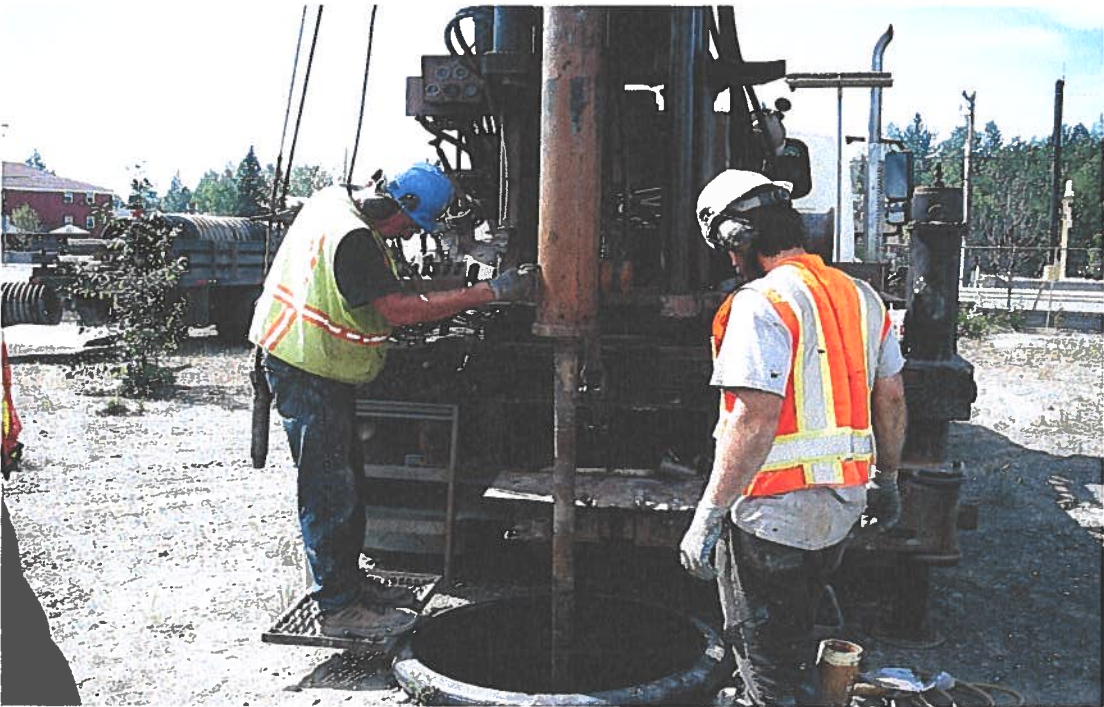
36. CW-2 Knocking the bottom out of well casing with a drill rod.

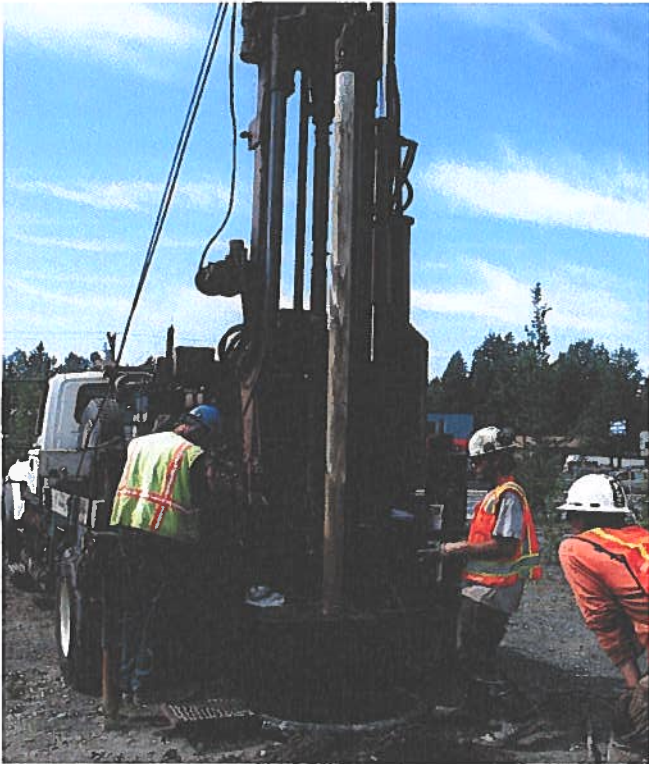
37. CW-2 Casing broke off at screen, 12 feet below ground surface.

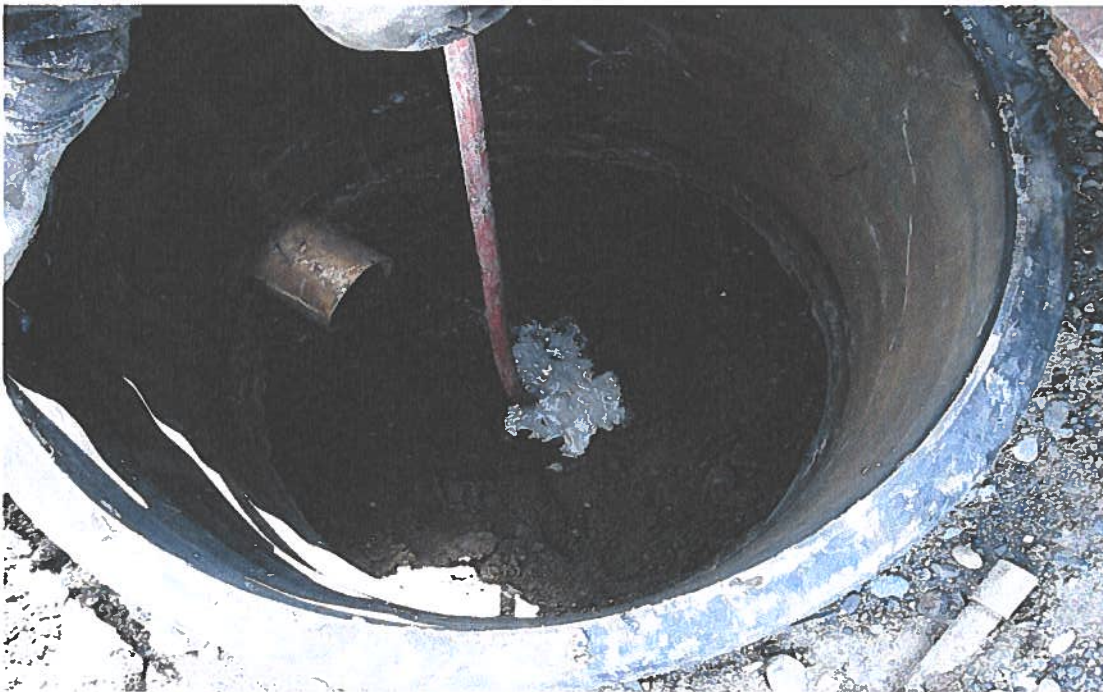
38. CW-2 Former well void filled with grout.

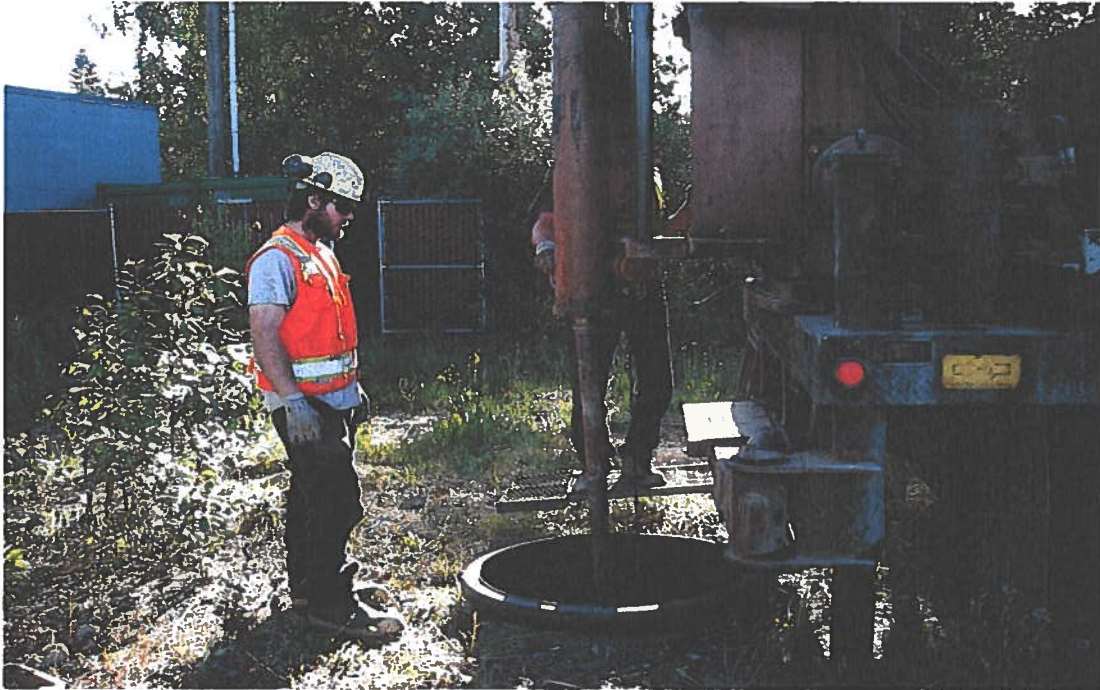
39. CW-3 Breaking out the bottom of the well casing.

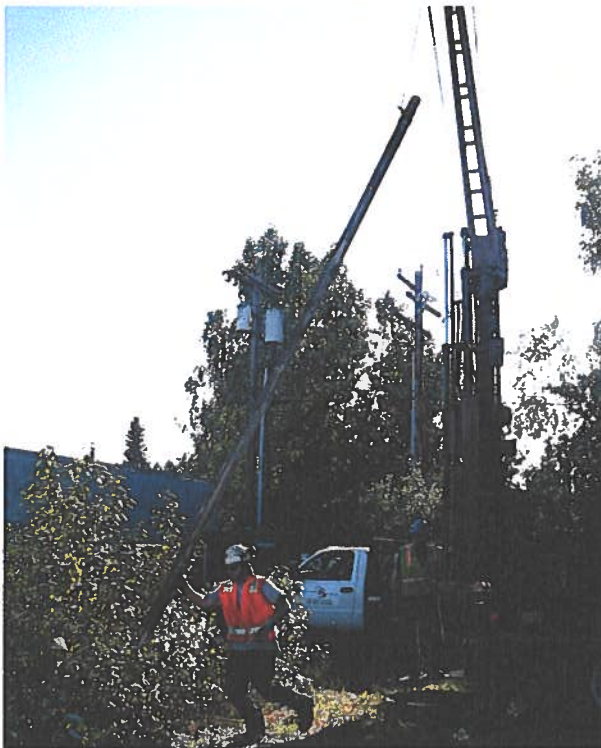
40. CW-3 Removed well casing being walked out.

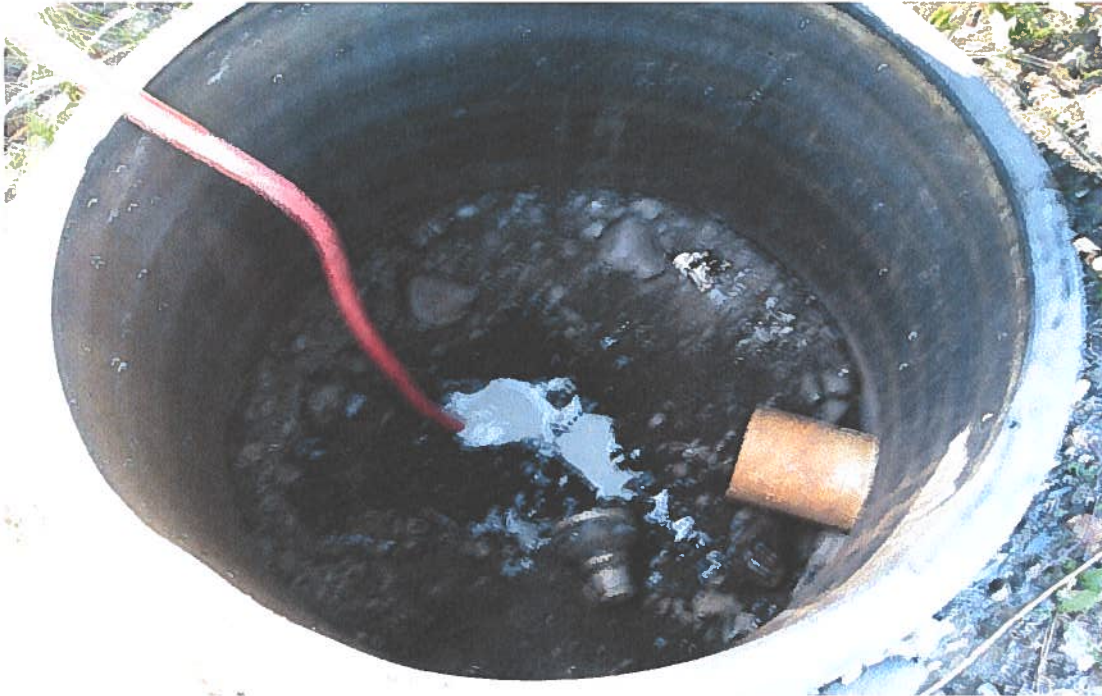
41. CW-3 Grouting the former well.

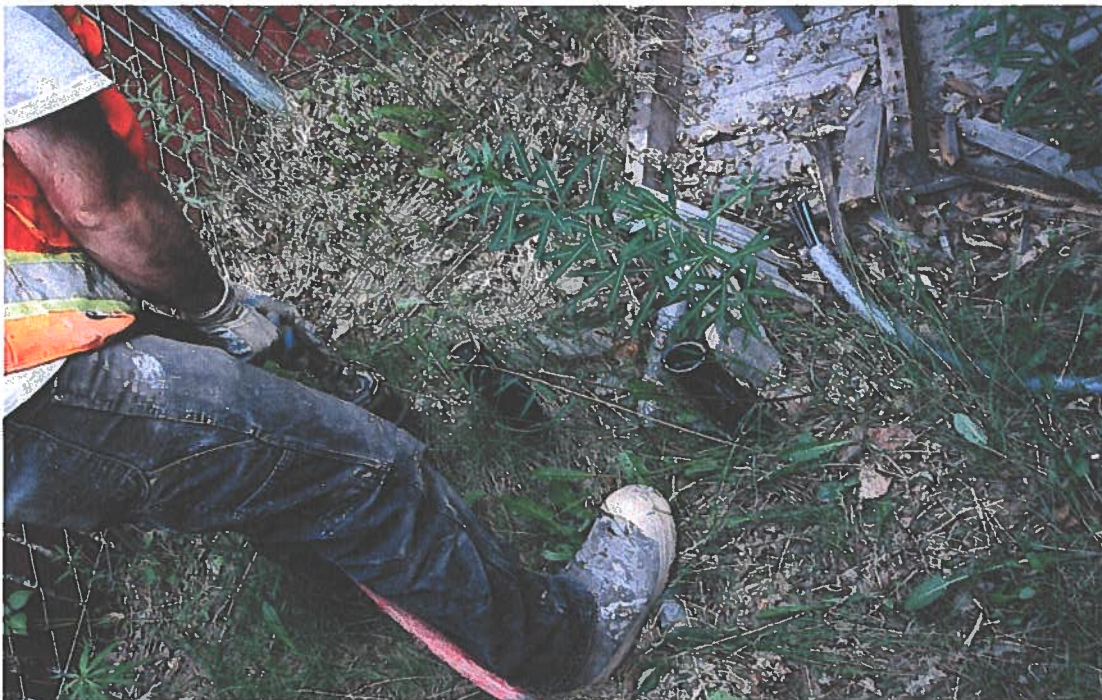
42. Pressure grouting the SVE lines next to the Remediation Shed.

- The piping runs were pressure grouted at the Remediation Shed with bentonite slurry until the grout levels stabilized in the pipes. The piping was then cut off at ground level.
- The protective cover plate was removed at the well head.
- Each SVE well was filled with grout and pulled with a taper tap.
- The screened sections of two wells (SVE-2 and SVE-4) were buried with no surface connection. When these two wells were pressure grouted, a pool of grout formed on the ground surface, indicating that the wells screened sections were filled with grout (Photos 46 and 48).
- Bentonite chips were used to stabilize the top of the well annulus for the pea gravel.
- An 8-inch layer of pea gravel was added and compacted in the void left by the protective vault.
- The well was finished by adding surrounding native soil.

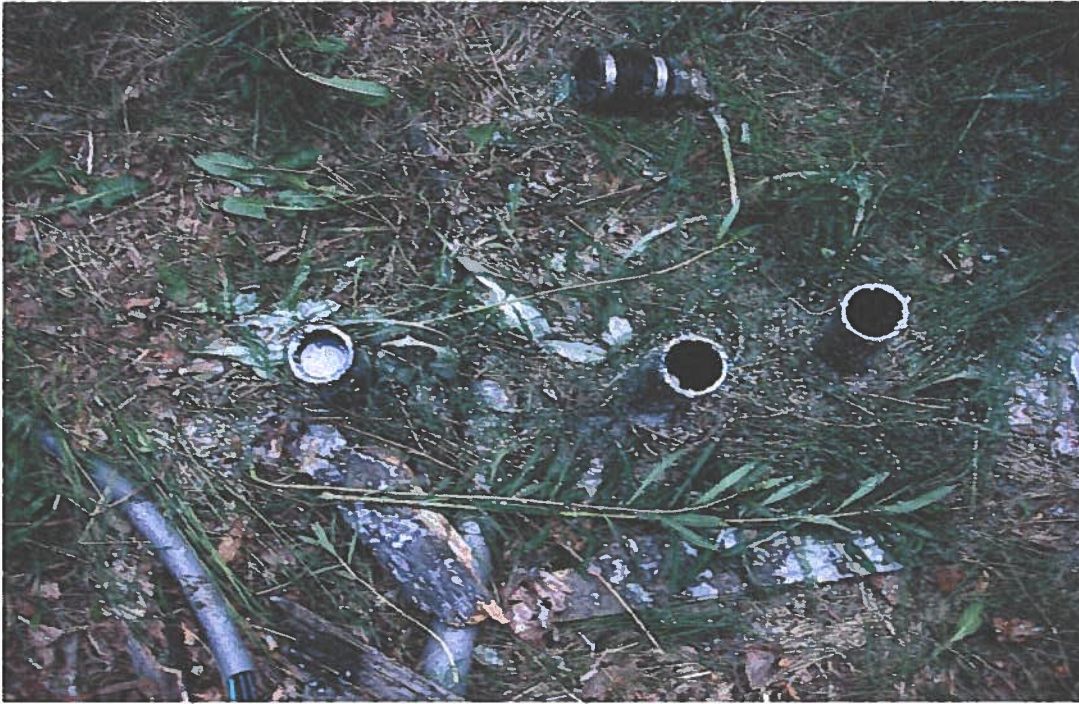
43. SVE lines stabilized; these lines were later cut off flush with the ground surface.

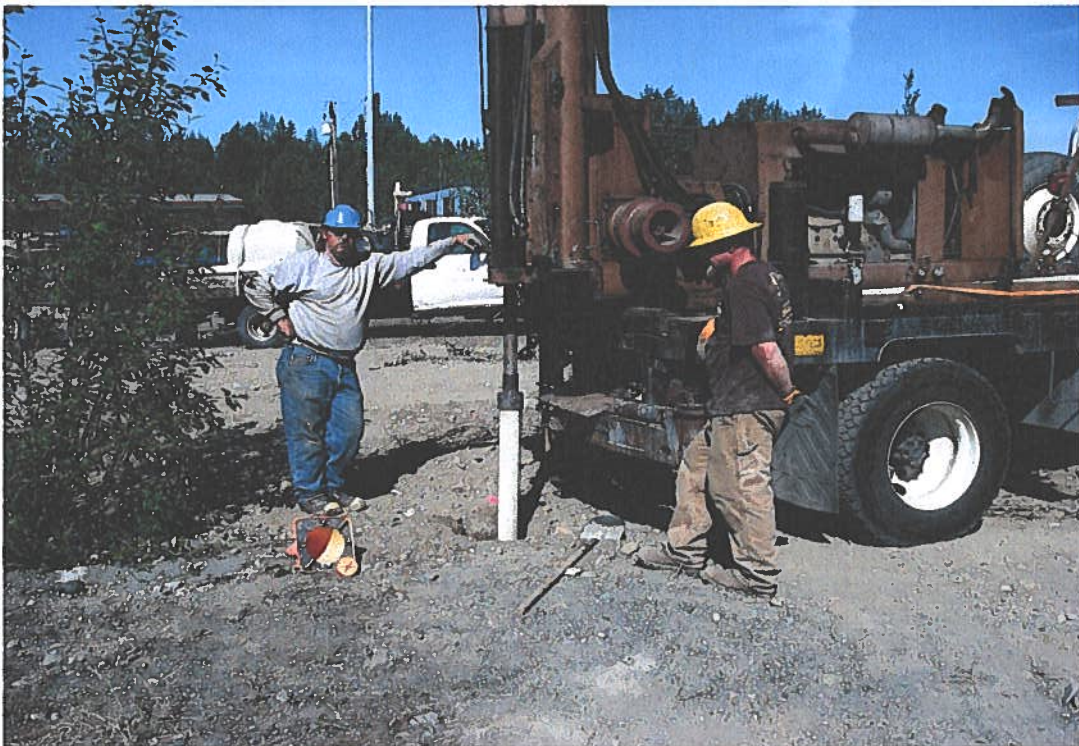
44. SVE-1 Pulling well casing with threaded bell cap .

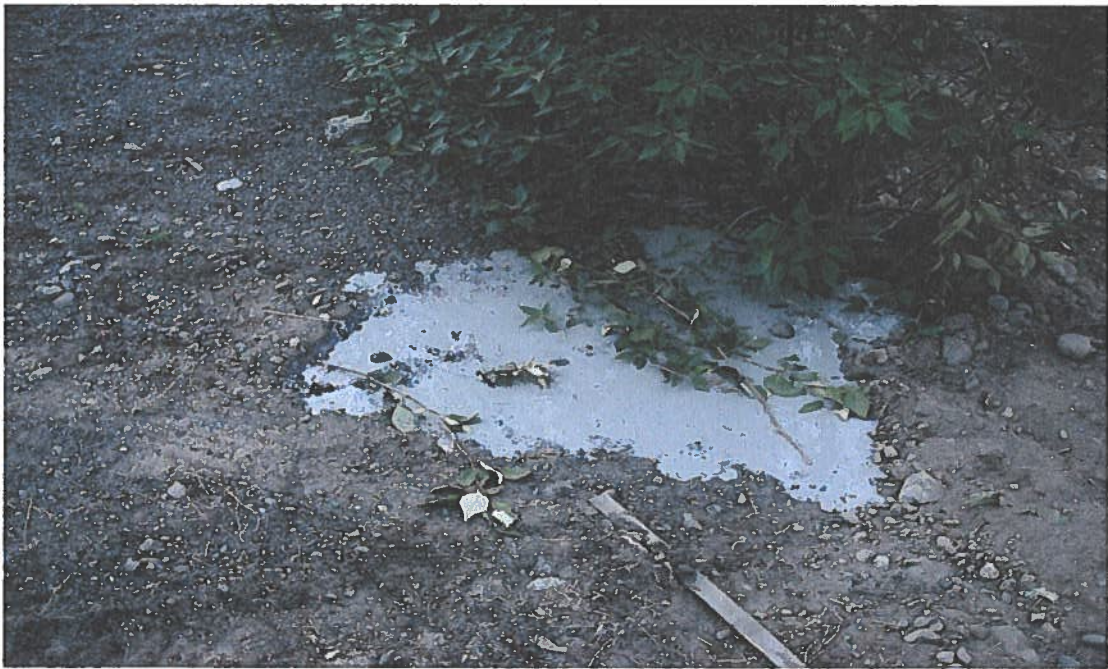
46. SVE-2 Location of horizontal well where grout daylighted by pressure.

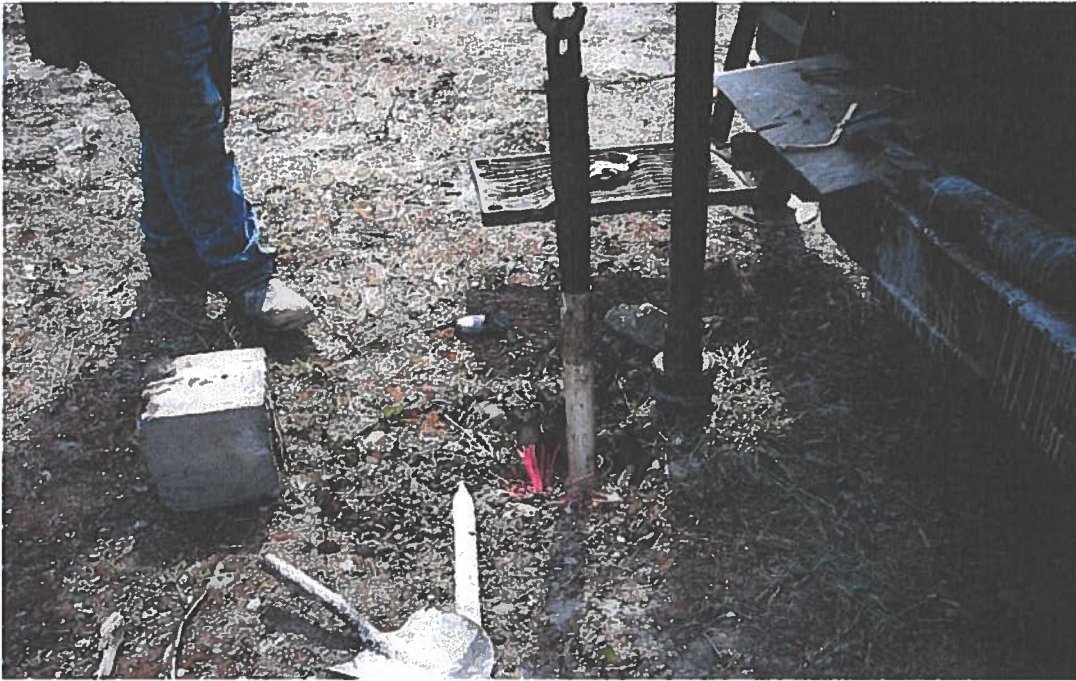
47. SVE-3 Pulling well casing with a taper tap, protective vault to left.

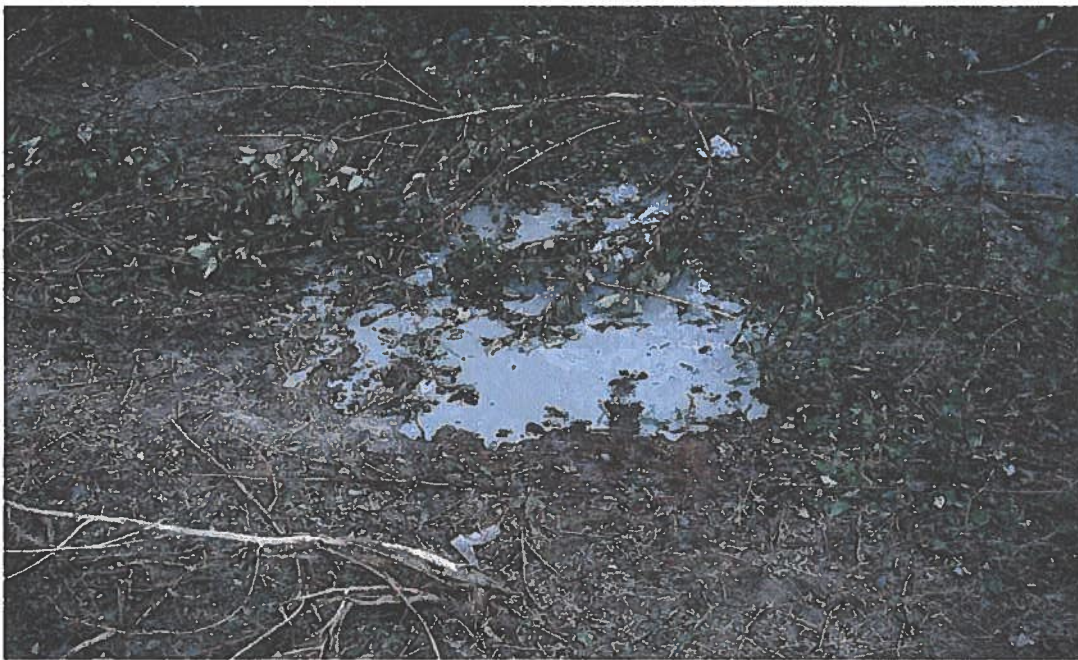
48. SVE-4 Location of horizontal well where grout daylighted by pressure.

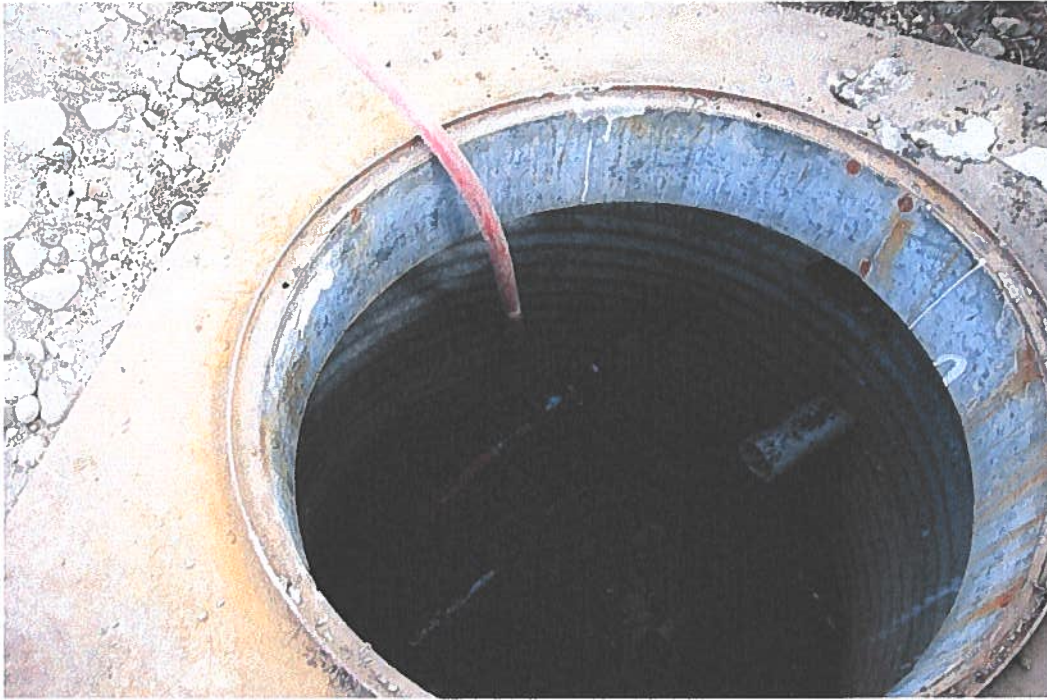
51. VCS-1 Pressure grouting air line from the vault to Remediation Shed.

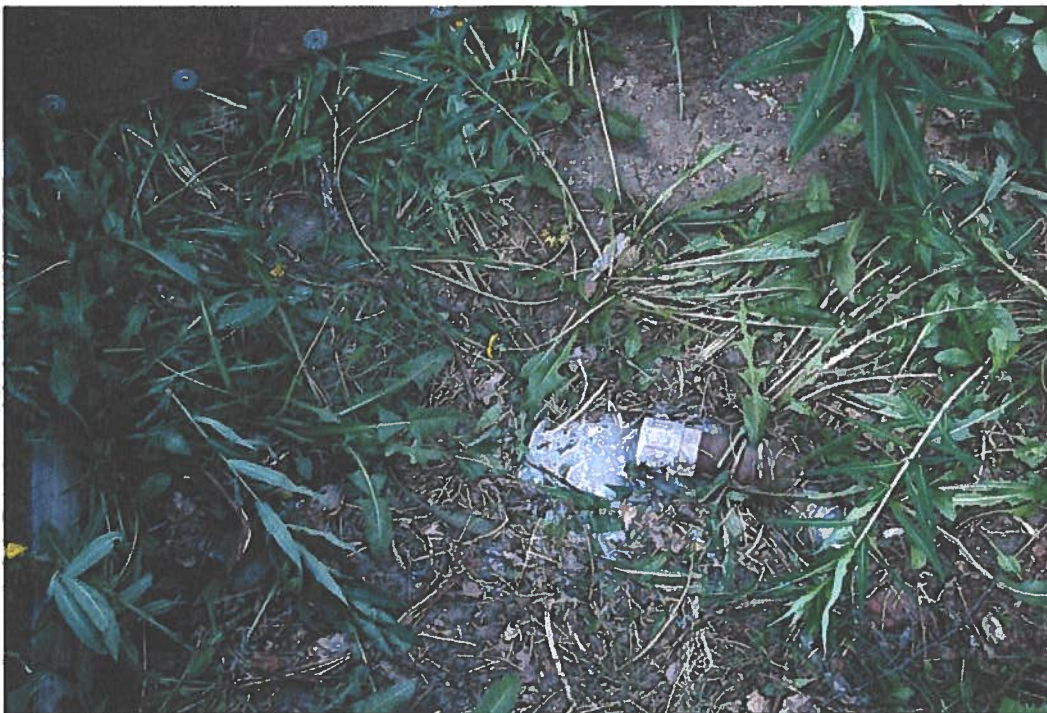
52. VSC-1 Grout-filled air line at Remediation Shed.

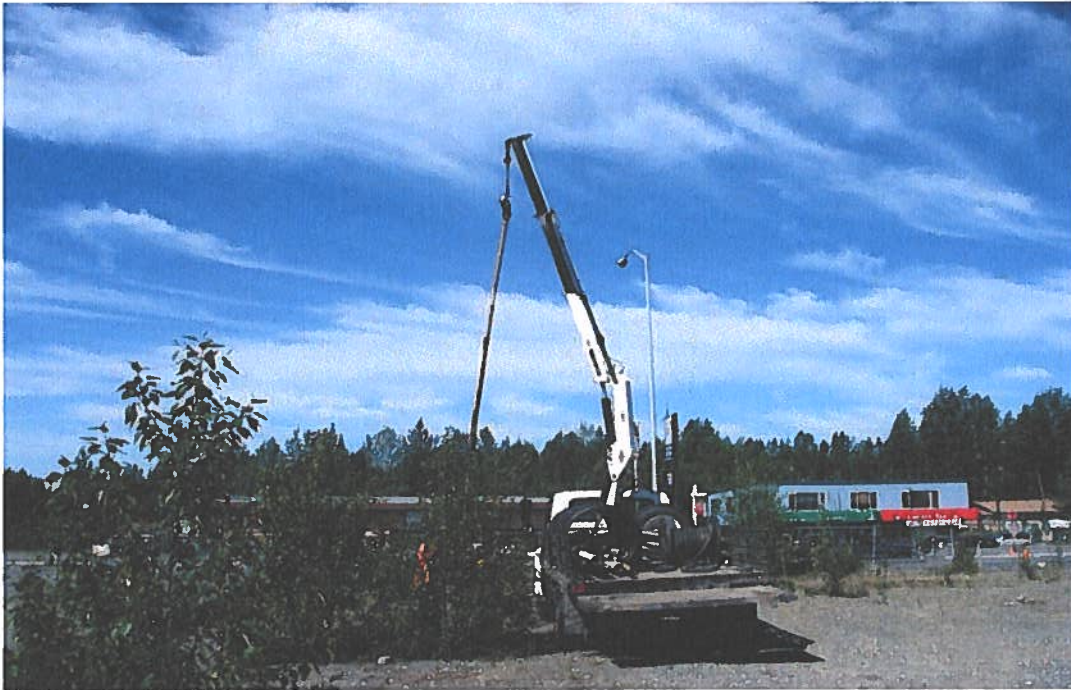
53. VSC-1 Pulling eductor piping with a boom crane.

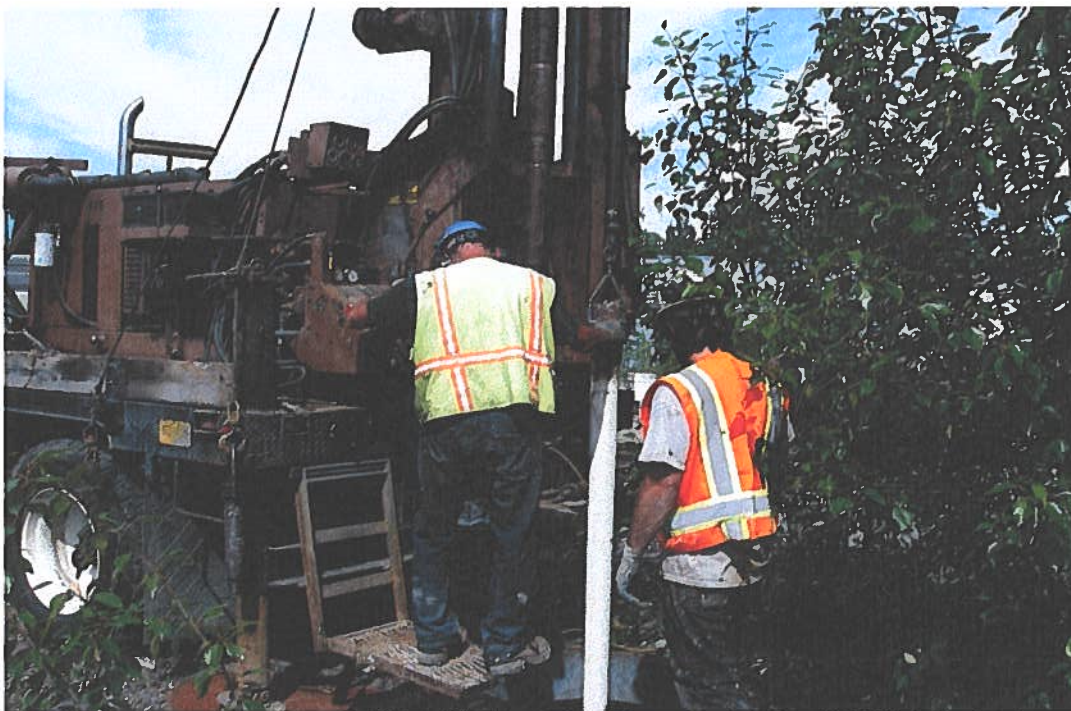
54. VSC-1 Pulling well casing.

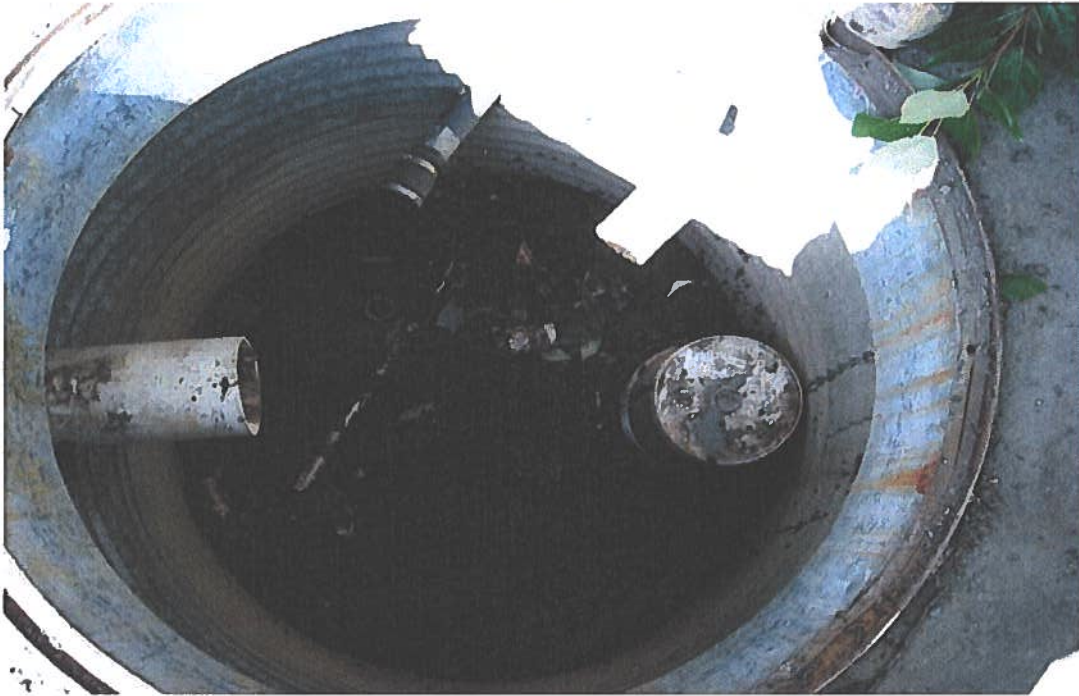
55. VSC-1 Grout stabilized after removing well casing.

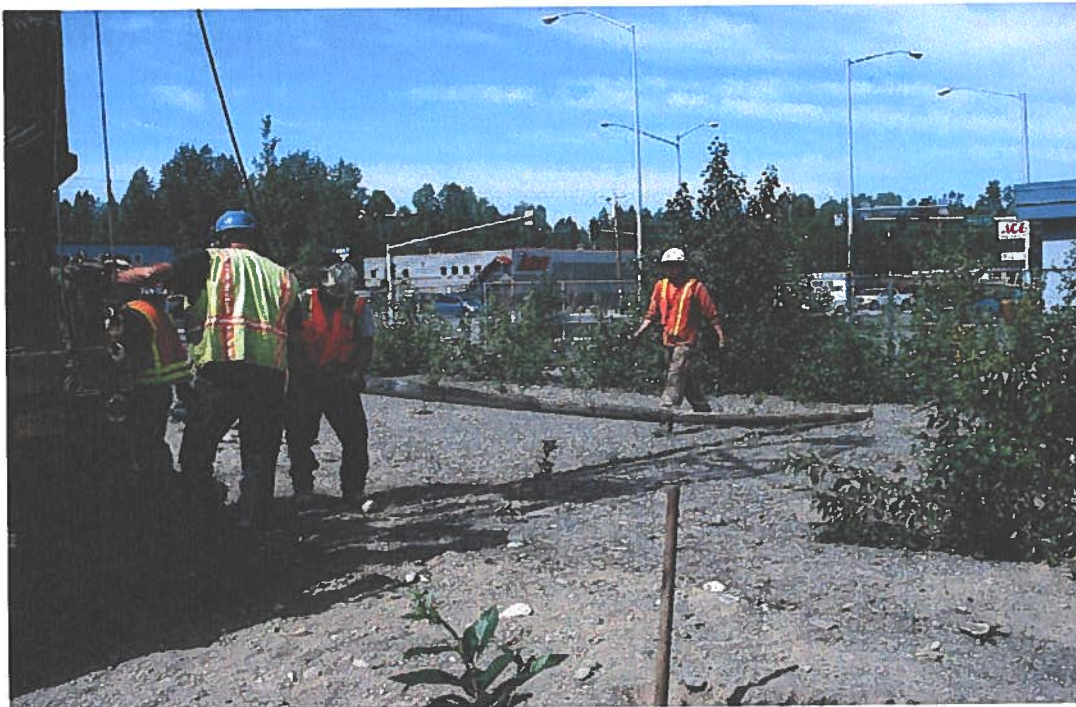
57. VSC-2 Pulled well casing.

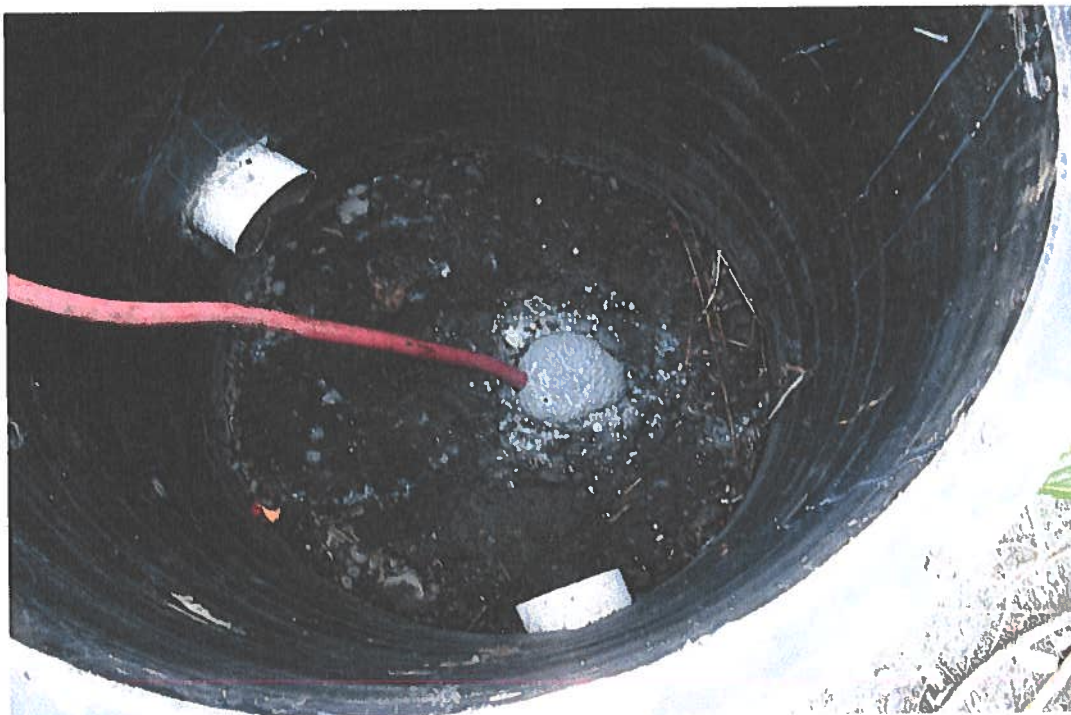
58. VSC-2 Grout stabilized in bore hole .

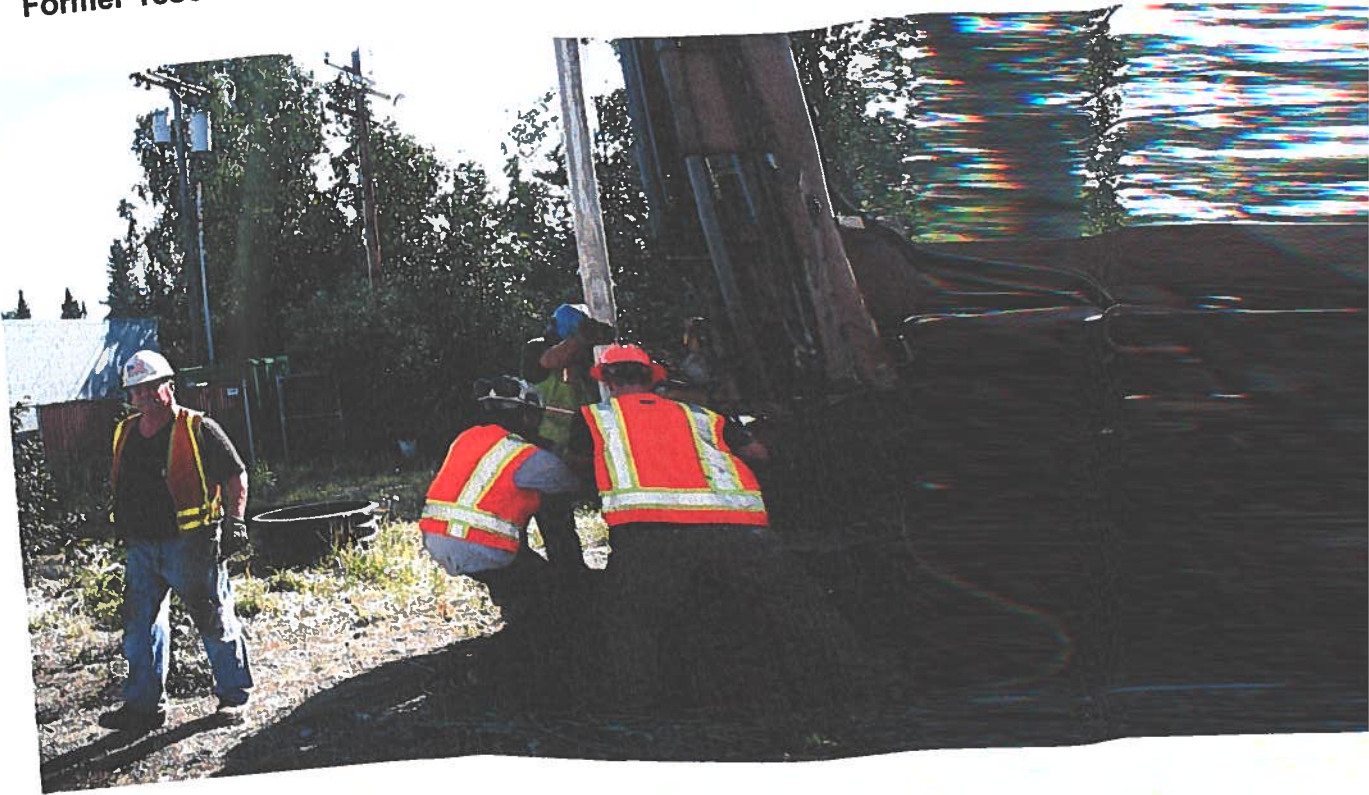
59. VSC-3 Pulling the well casing.
