**PRELIMINARY SITE CHARACTERIZATION REPORT
DIESEL CONTAMINATION SITE ASSESSMENT PROJECT**

TATITLEK, ALASKA

AUGUST 28, 2006

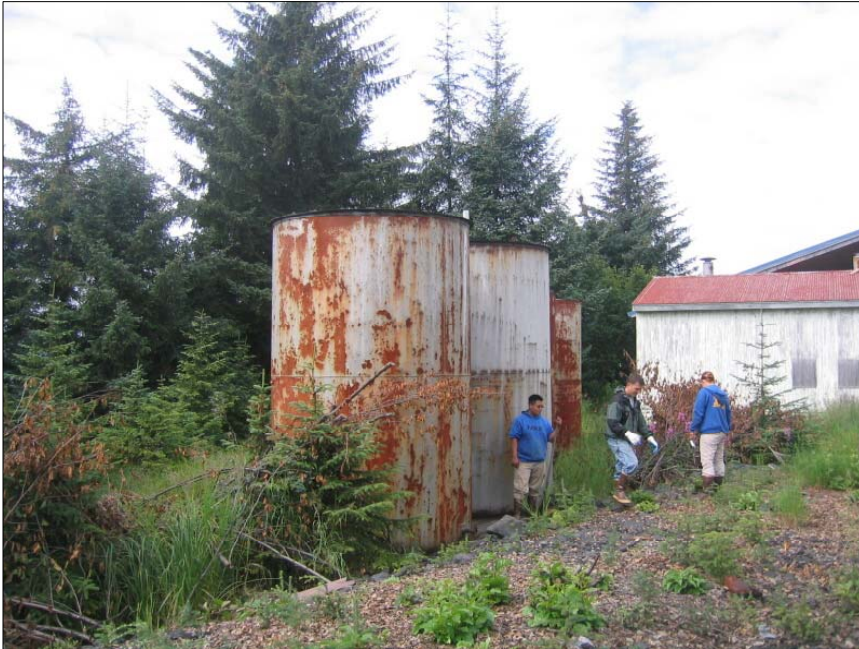
Four vertically-mounted above ground storage tanks (ASTs) are located at Area A (Photos 1 and 2). The tanks are mounted on wooden platforms above the tundra with two tanks on each of two platforms. The two tanks on the northern platform have an estimated gross capacity of 3,000 gallons each, while the two tanks on the southern platform have an estimated gross capacity of 5,000 gallons each. These tanks were reported by Tatitlek Environmental personnel to have been out of service for approximately thirty years.

The ground surface covering most of Area A is primarily comprised of "spongy" moist tundra vegetation surrounded by shrubby vegetation intermixed with spruce and alder trees (Photos 1 and 6). Near surface groundwater was present at a depth of approximately 6 to 14 inches below the ground surface (Photo 7). Surface water was observed at several locations immediately west of the old AST's. Flowing surface water was observed between the northern tank platform and the warehouse building to the north and east. Flowing surface water was also observed emanating from the southwestern corner of the shot-rock pad beneath the current generator building complex. Surface water flows towards the bluff to the west. This corresponds with the ground surface gradient which also slopes to the west.

PHOTO 1 Old Tanks at Area A looking northwest. Generator complex "shot rock" pad in foreground.

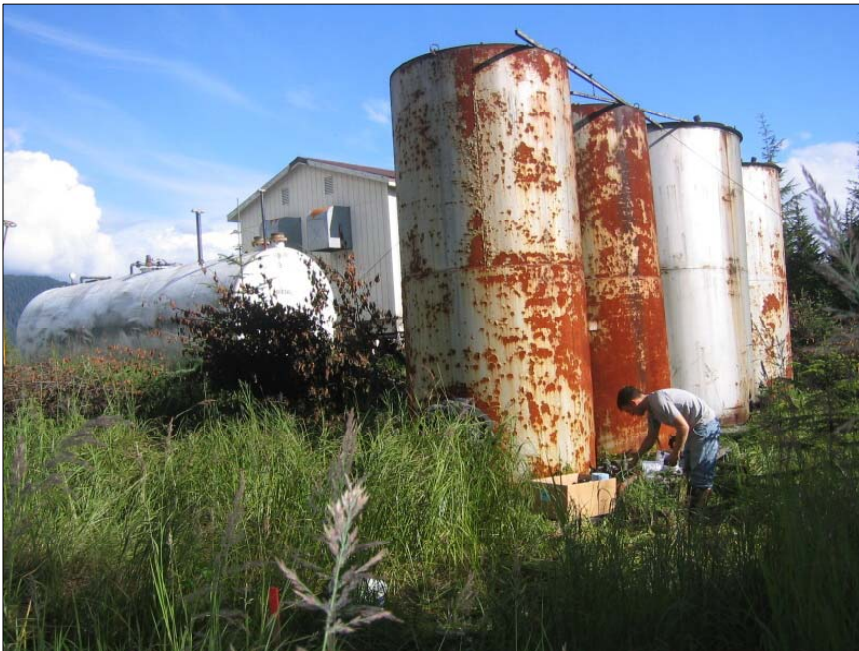
PHOTO 2 Old Tanks at Area A looking southeast. New 10,000 Gal AST and generator building in background.

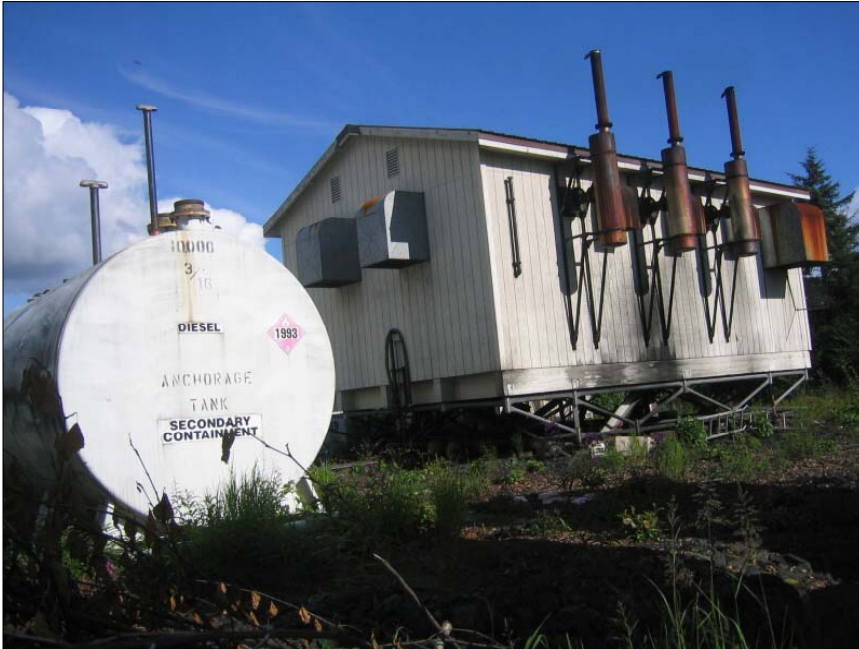
PHOTO 3 New 10,000 Gal AST and generator building looking south east from edge of old tanks.

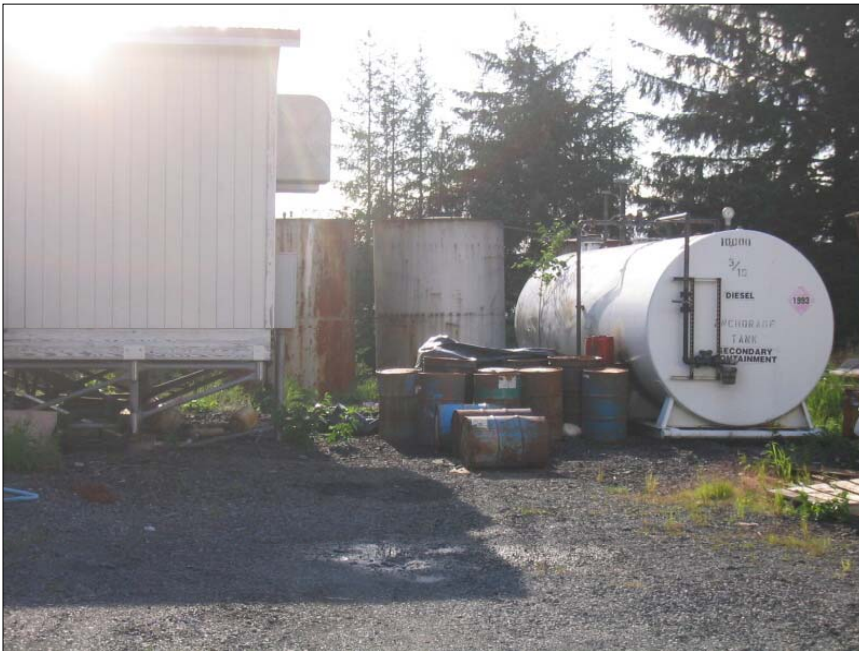
Obvious POL contamination was observed where the water emanates from the southwestern toe of the shot rock pad (Refer to Photos 9 and 10). In addition, significant surface staining of the shot rock pad was observed west of the current generator building. Smaller areas of surface staining were also observed in the vicinity of the new 10,000 gallon AST. Numerous steel drums were noted in this location as well (Photos 4-5).

PHOTO 4 New 10,000 Gal AST and generator building in background looking west. Note drums near the AST

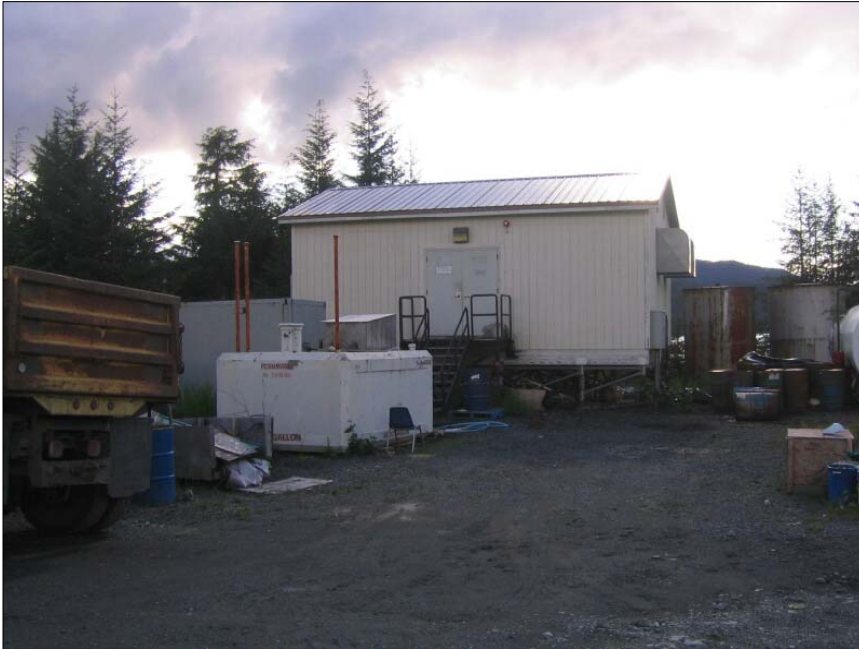
PHOTO 5 New generator building looking west. Note 2,000 Gal. vaulted AST in foreground.

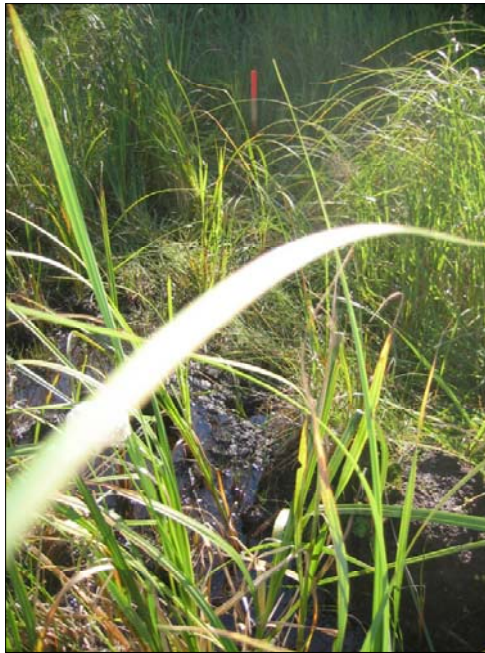
PHOTO 6 Surface conditions at Area A. Note standing water.

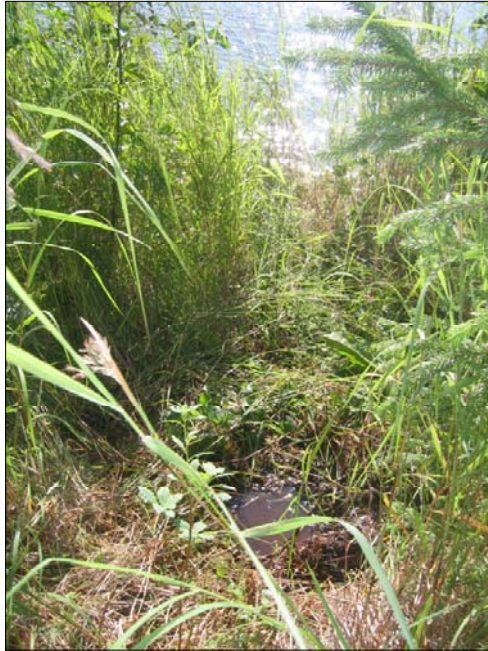
PHOTO 7 Screening location 17 at Area A looking west. Note proximity to edge of bluff and near surface water in shallow pit.

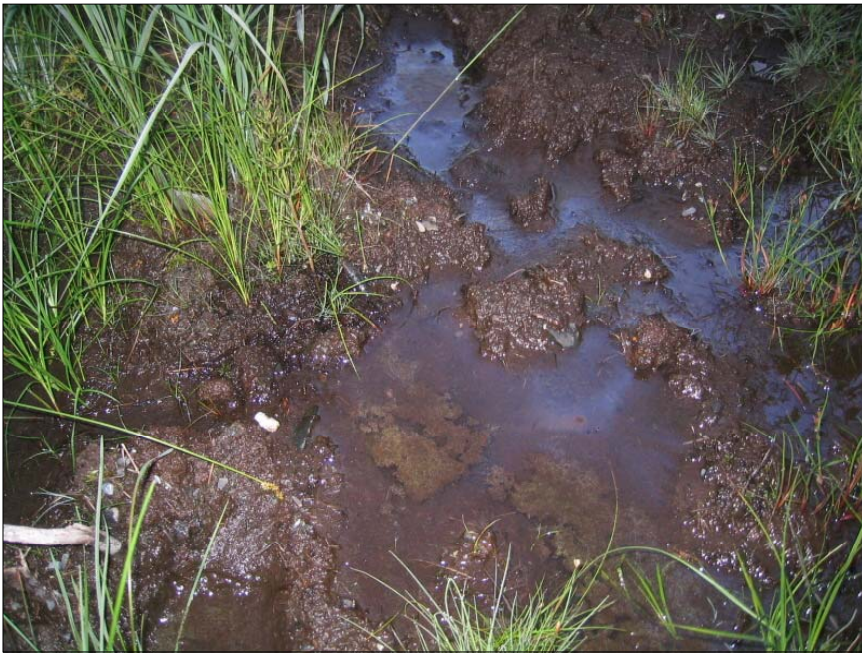
PHOTO 8 Standing water east of Area A. Note biogenic sheen present on water surface.

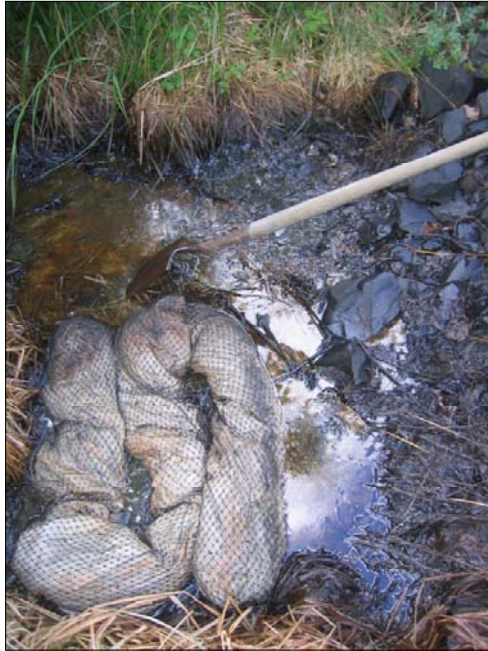
PHOTO 9 POL contamination of surface water emanating from beneath southwest corner of shot rock pad at generator complex.

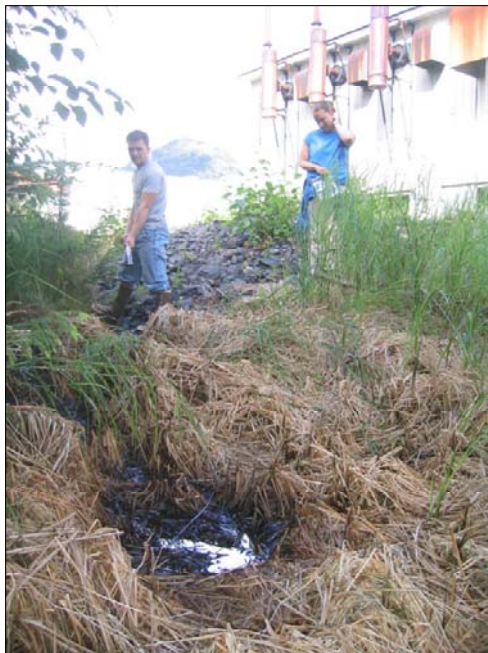
PHOTO 10 Area of stressed vegetation down gradient from southwest corner of shot rock pad at generator complex.

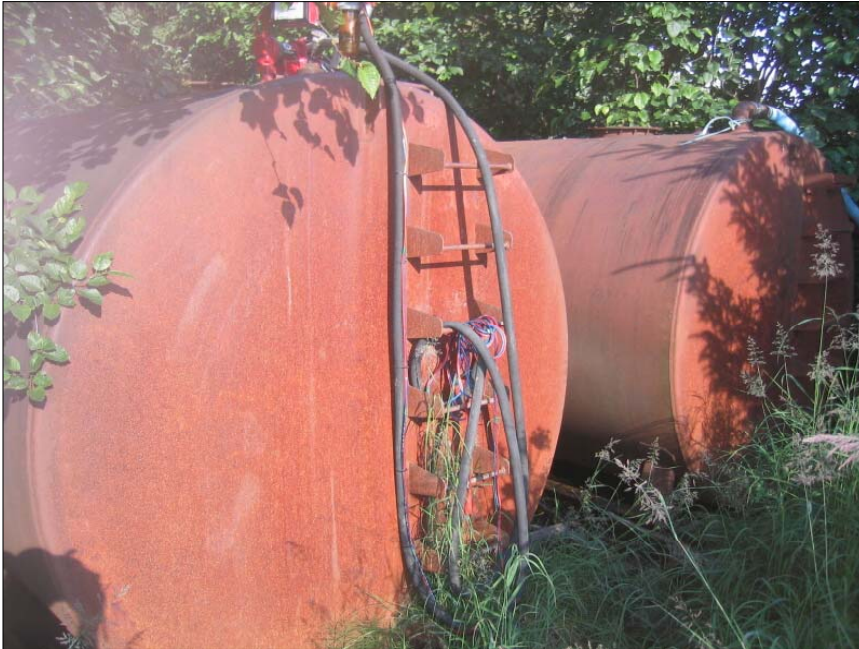
A total of four above ground storage tanks were observed in this area. Two of the tanks were contained within an area surrounded by a plastic-lined earthen berm (Photo 11). Measurements of these tanks indicate a gross capacity of 10,000 gallons each. The other two AST's were located outside the southern limits of the containment berm. These tanks had an estimated gross capacity of at least 2,500 gallons. These tanks reportedly had been previously utilized for the storage of used oil. Both of these tanks had been built on wooden cribs above the ground surface. At the time of the site visit, one of the crib structures was observed to have partially collapsed with a portion of the

PHOTO 11 10,000 Gal. AST's at Area B looking looking east.

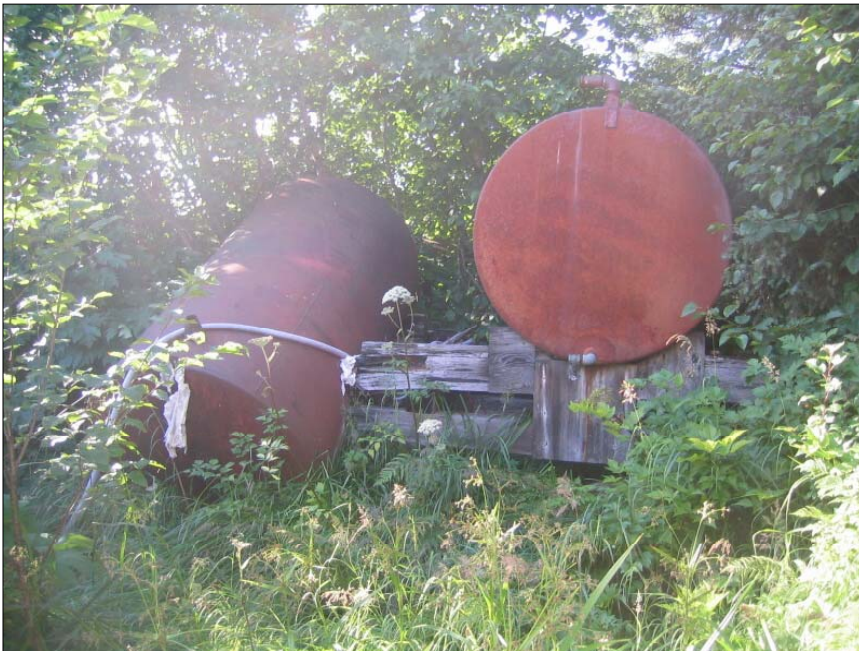
tank resting on the ground surface (Photo 12). The age of these tanks is not known, but it has been estimated that they had not been used for more than a decade.

PHOTO 12 Former Waste Oil AST's at Area B looking looking northwest.

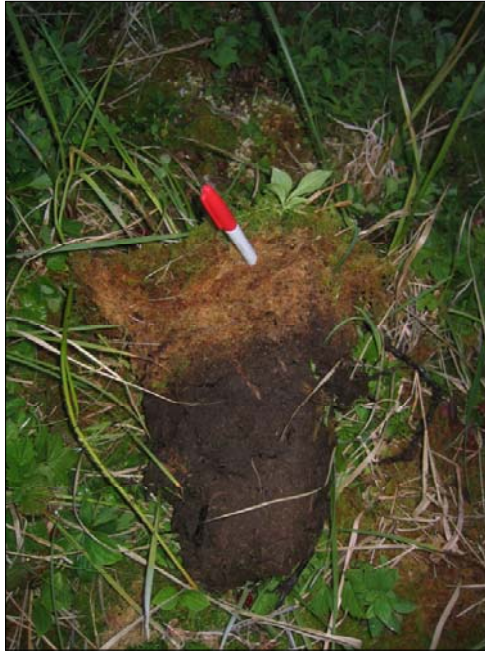
The ground surface at Area C was generally flat and covered in low growing tundra vegetation (Photos 13 and 14). Standing water was encountered at a depth of approximately 10-12 inches below the ground surface. No olfactory or PID evidence of POL contamination was noted during the screening effort. Biogenic hydrocarbon odors were observed in the samples collected from this area. Visual evidence of what appeared to be biogenic hydrocarbons were also noted upon the water surface at each sampling location as well as during the sheen testing of the soil samples.

PHOTO 13 Screening Sample from Area C typifying wet tundra conditions with moss at surface and high organic soil beneath.

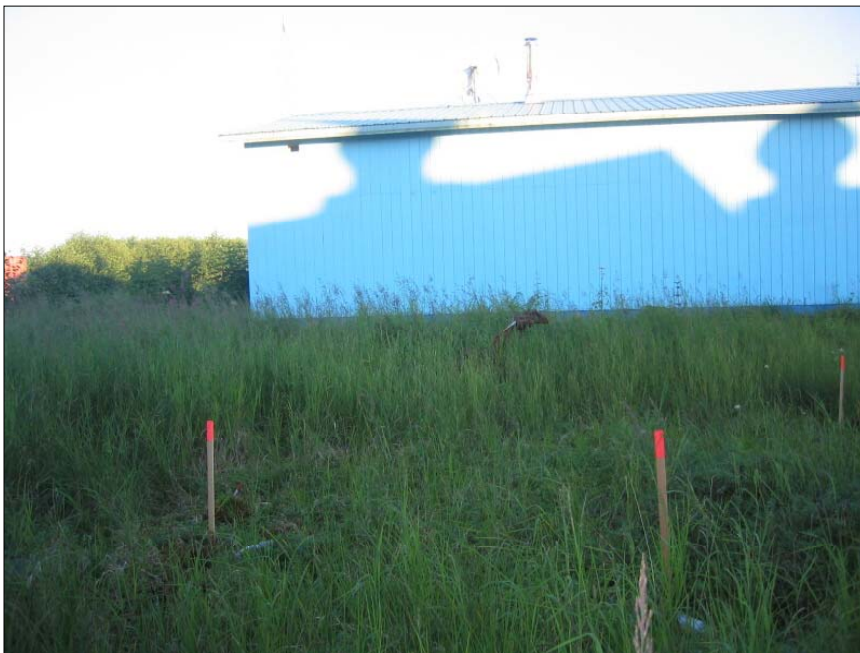
PHOTO 14 Control site (Area C) looking east-southeast, with VPSO building in background.
