**AGRA EARTH & ENVIRONMENTAL, INC.  
SUMMARY REPORT FOR TANK CLOSURE  
GOLD HILL LIQUOR AND GROCERY  
FAIRBANKS, ALASKA**

**November 1994  
32-01110-00**

**AGRA EARTH & ENVIRONMENTAL, INC.  
SUMMARY REPORT FOR TANK CLOSURE  
Gold Hill Liquor and Grocery**

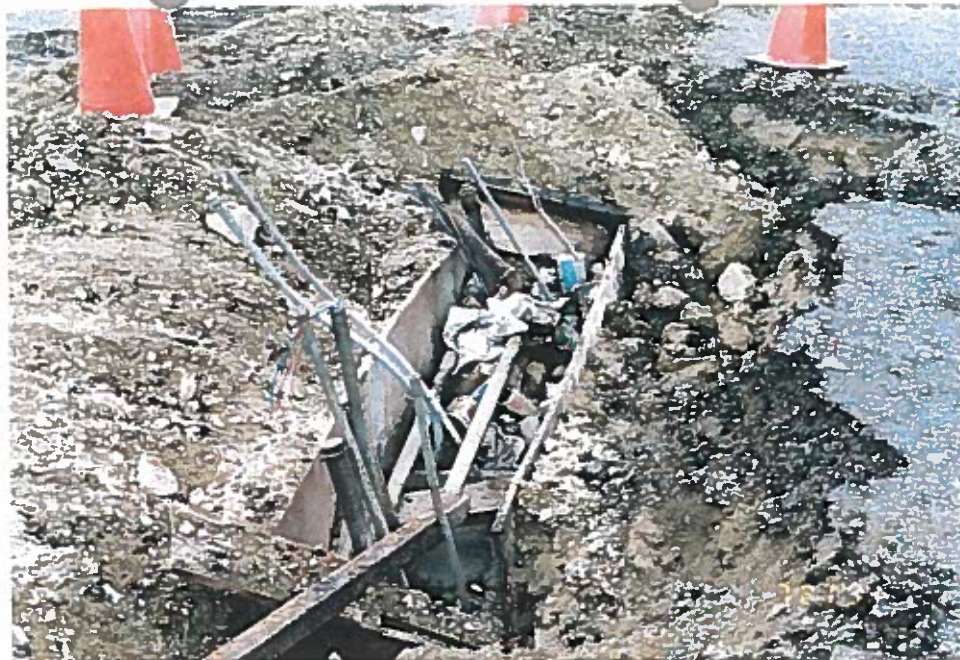
Upon removal of each tank, AGRA personnel inspected the tank metal and associated piping. AGRA observed that the removed piping was in fair condition with no noticeable wetted joints or unions, or other signs of potential leakage. The piping appeared to be intact prior to cutting and removal; however, the piping showed appreciable surface rusting. The tanks were in good to fair condition with moderate surface corrosion and no apparent holes or leaks. Tank No. 2 indicated moderate to heavy corrosion of the tank base metal on the underside of the UST. Tank No. 3 was observed to have heavy surface corrosion on an attached 24-inch manway. The photographs included with this report show the conditions of the USTs upon removal. The excavation was terminated at the soil/groundwater interface located at approximately 16.5 feet below surface grade.

Photo 5: Close-up view of dispenser area underground piping.

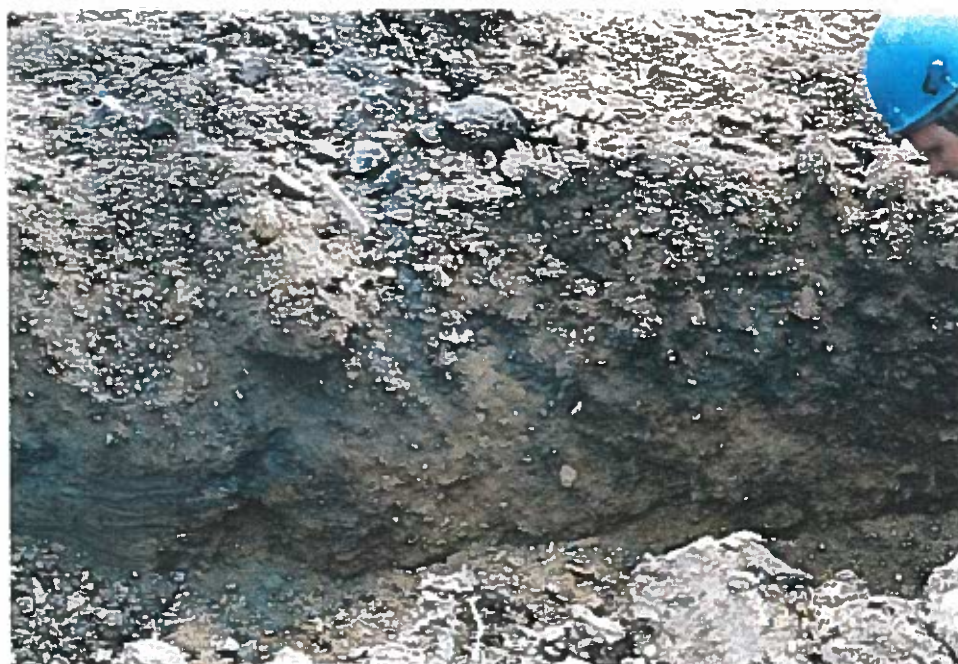
In the former fill area, AGRA observed grey-stained sandy soils, starting at a depth of 3 feet below ground surface and extending from the eastern edge of the excavation near Tank No. 3 to approximately 10 feet west of the store building along the piping trench. OVM measurements recorded for these stained soils ranged from 450 to greater than 2,000 ppm. The stained soils continued vertically to the pit base and apparently extended beyond the excavation limits (see photographs in Appendix A).

Photo 8: Grey staining was evident at the location of the tank fill piping.

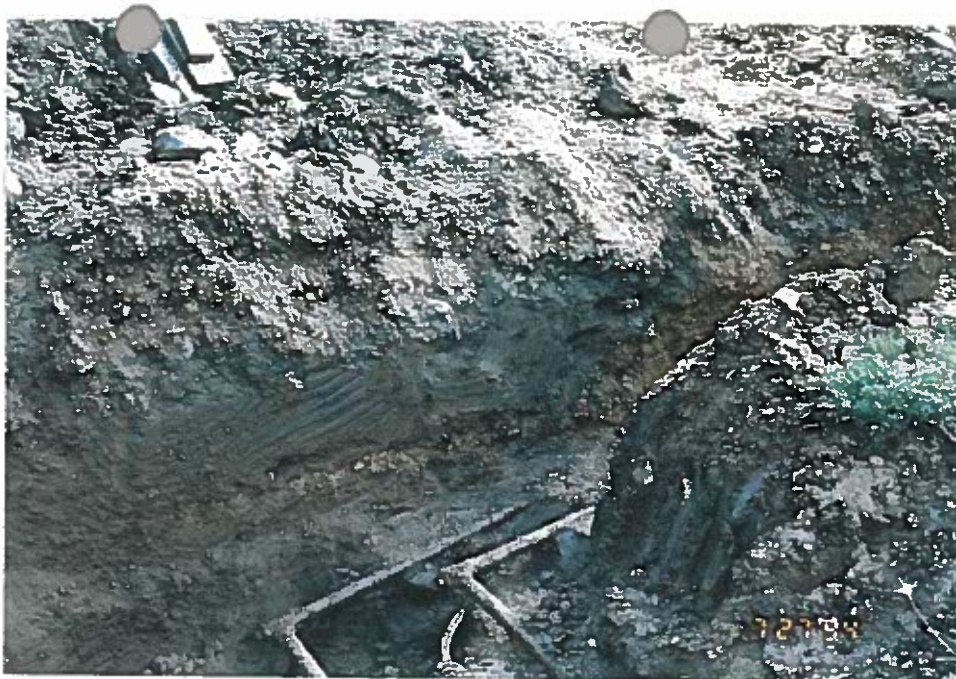
**Photo 9: Grey-stained soils were observed to extend to approximately 8 feet below grade, dissipating laterally away from the fill piping area.**

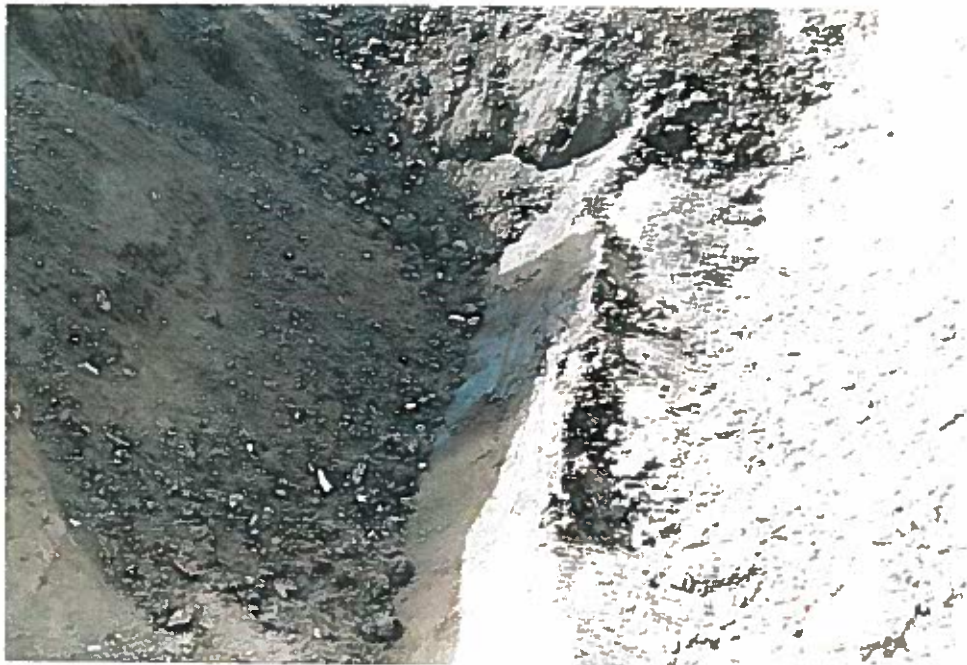
Soil samples collected from the base of the excavation indicated levels of hydrocarbon impact above Level A cleanup criteria. Benzene levels were highest in sample GHE-1, collected beneath the former fill piping of Tank No. 1, at a concentration of 10 mg/kg. Total BTEX concentrations ranged from 0.044 mg/kg in sample GHE-3 to 812 mg/kg in sample GHE-1. This sample (GHE-1) also reported the highest GRPH concentrations at 4,200 mg/kg. The calculated mean level of GRPH across the excavation bottom was 895 mg/kg.

Photo 18: Excavation bottom, directly beneath Tank No. 1.

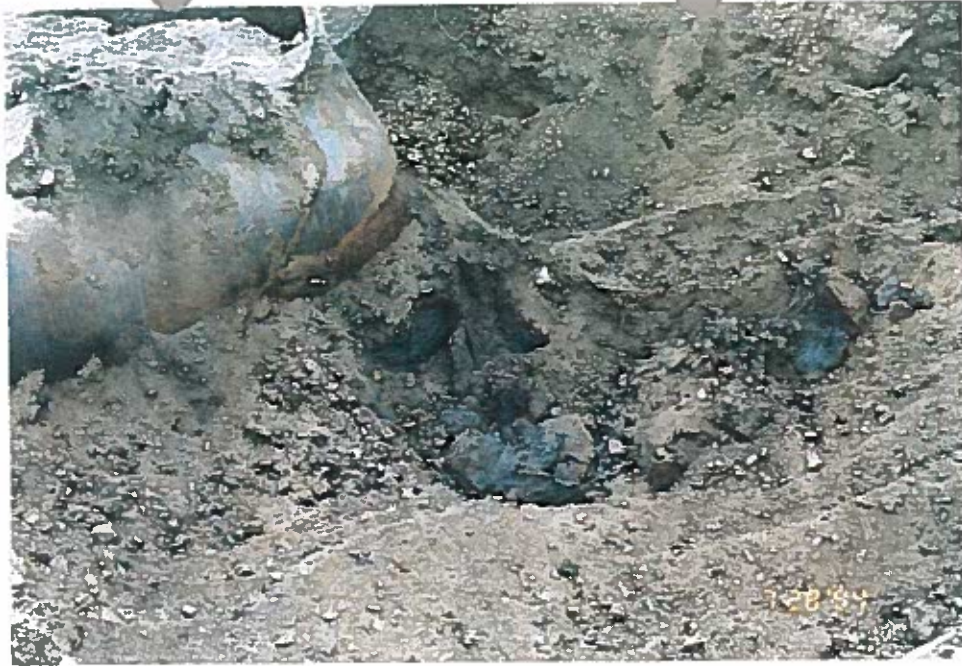
**Photo 21: Grey-stained soils were observed on the vent end of Tank No. 2.**

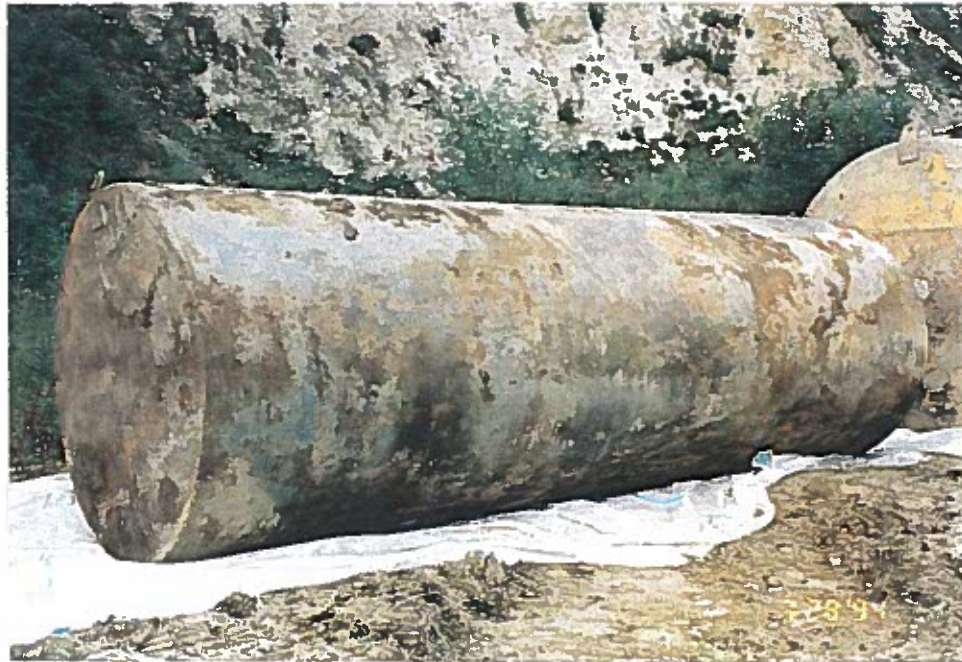
**Photo 22: General condition of Tank No. 2.**

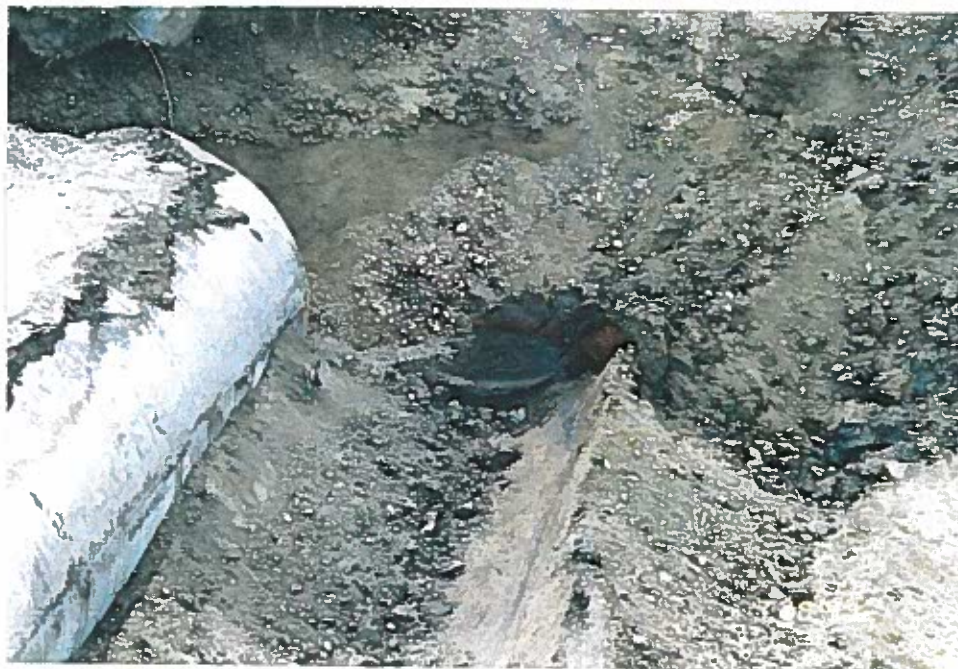
Photo 20: Excavation bottom, directly beneath Tank No. 2.

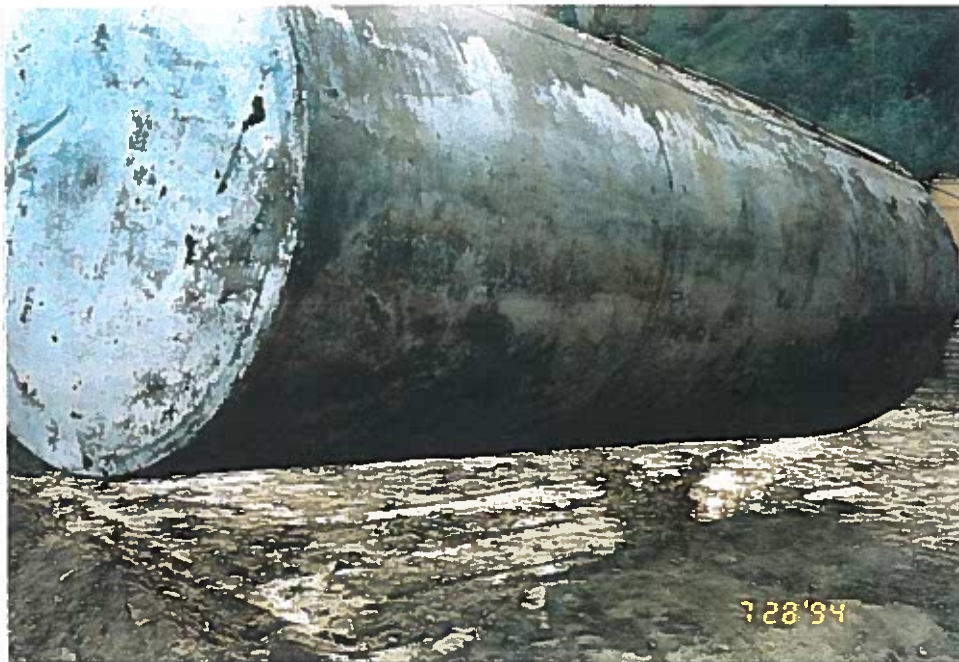
Photo 24: Close-up view of the bottom of Tank No. 3.

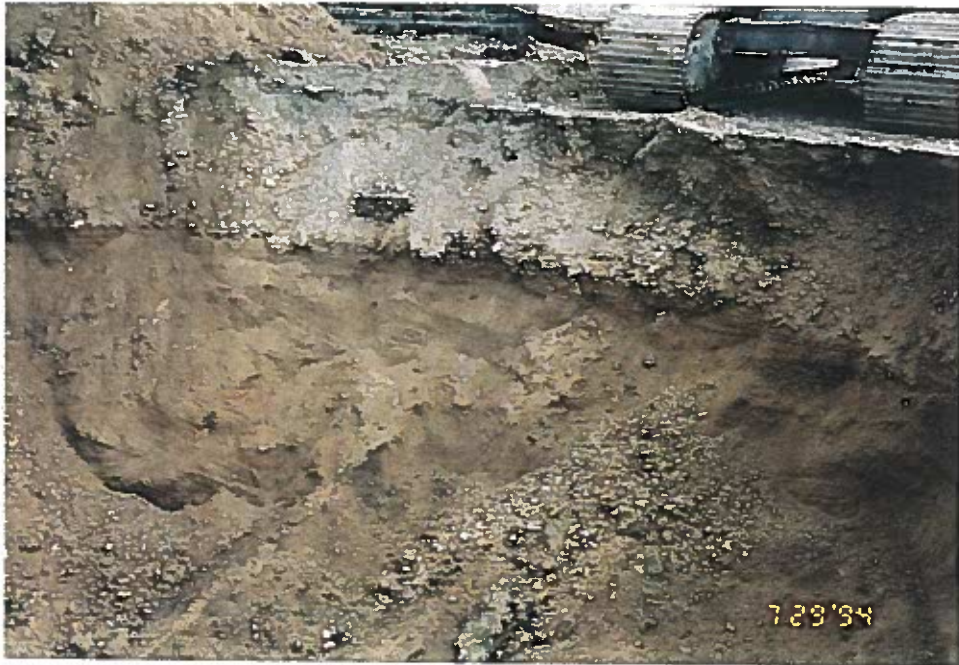
Results obtained for sidewall samples indicated definite trends in the tank excavation area. Shallow samples collected at a depth of 4.5 to 6.5 feet below grade exhibited either non-detectable or minor concentrations of gasoline range hydrocarbons along the north, south, and

**Photo 26: Soil conditions along the eastern sidewall of the tank excavation area.**

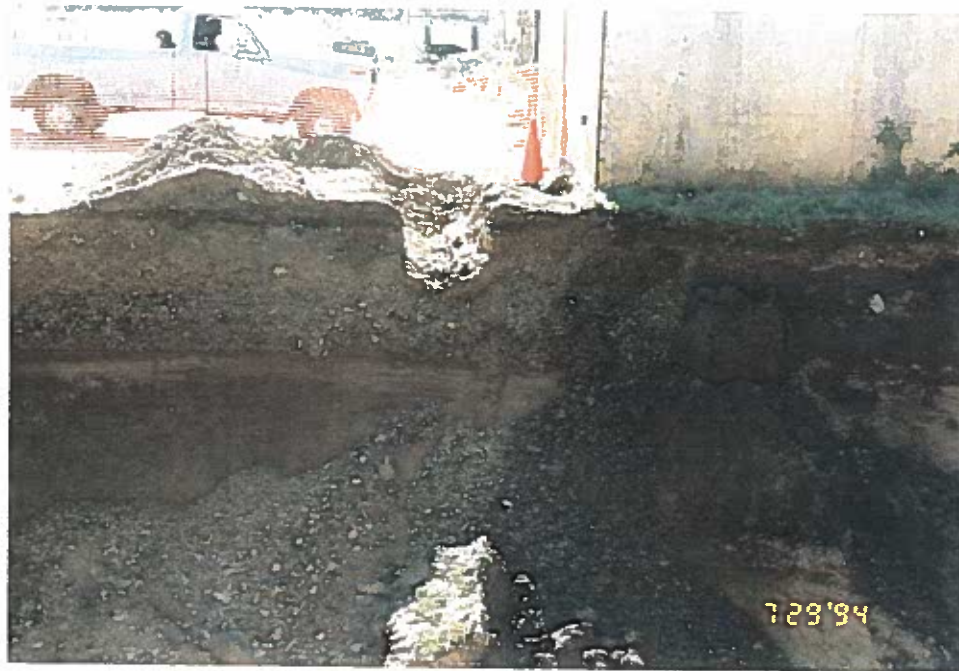
east sidewalls. The western sidewall, adjacent to the store building, reported significant benzene, total BTEX, and GRPH levels in these shallow soils. Probable causes for this contamination can include both defective piping and surface spills.

**Photo 27: Soil conditions along the western sidewall of the tank area, adjacent to the store building.**

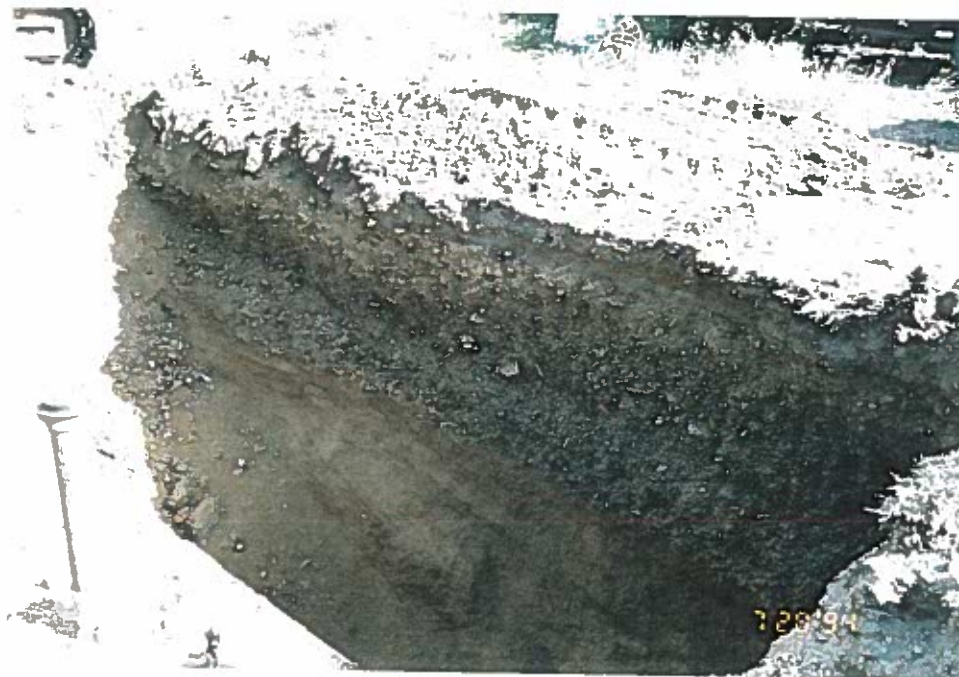
**Photo 28: Subsurface conditions along south sidewall of tank area.**

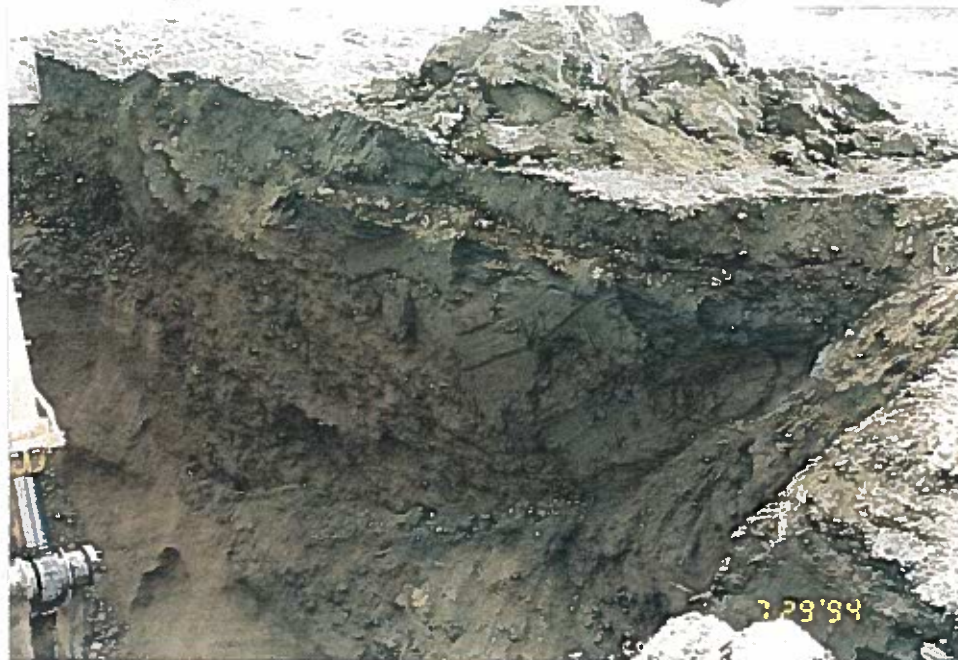
**Photo 29: View of tank area south sidewall during contaminant tracking. Note highly variable conditions.**
