**OLD NULLAGVIK HOTEL  
SITE CHARACTERIZATION AND REMEDIATION  
SHORE AVENUE AND TUNDRA WAY  
KOTZEBUE, ALASKA 99701**

Project Number  
1080-38

December 20, 2012

This Release Investigation Report has been developed in compliance with the provisions of  
18 AAC 78 *Underground Storage Tanks, the Draft Field Sampling Guidance, and .*

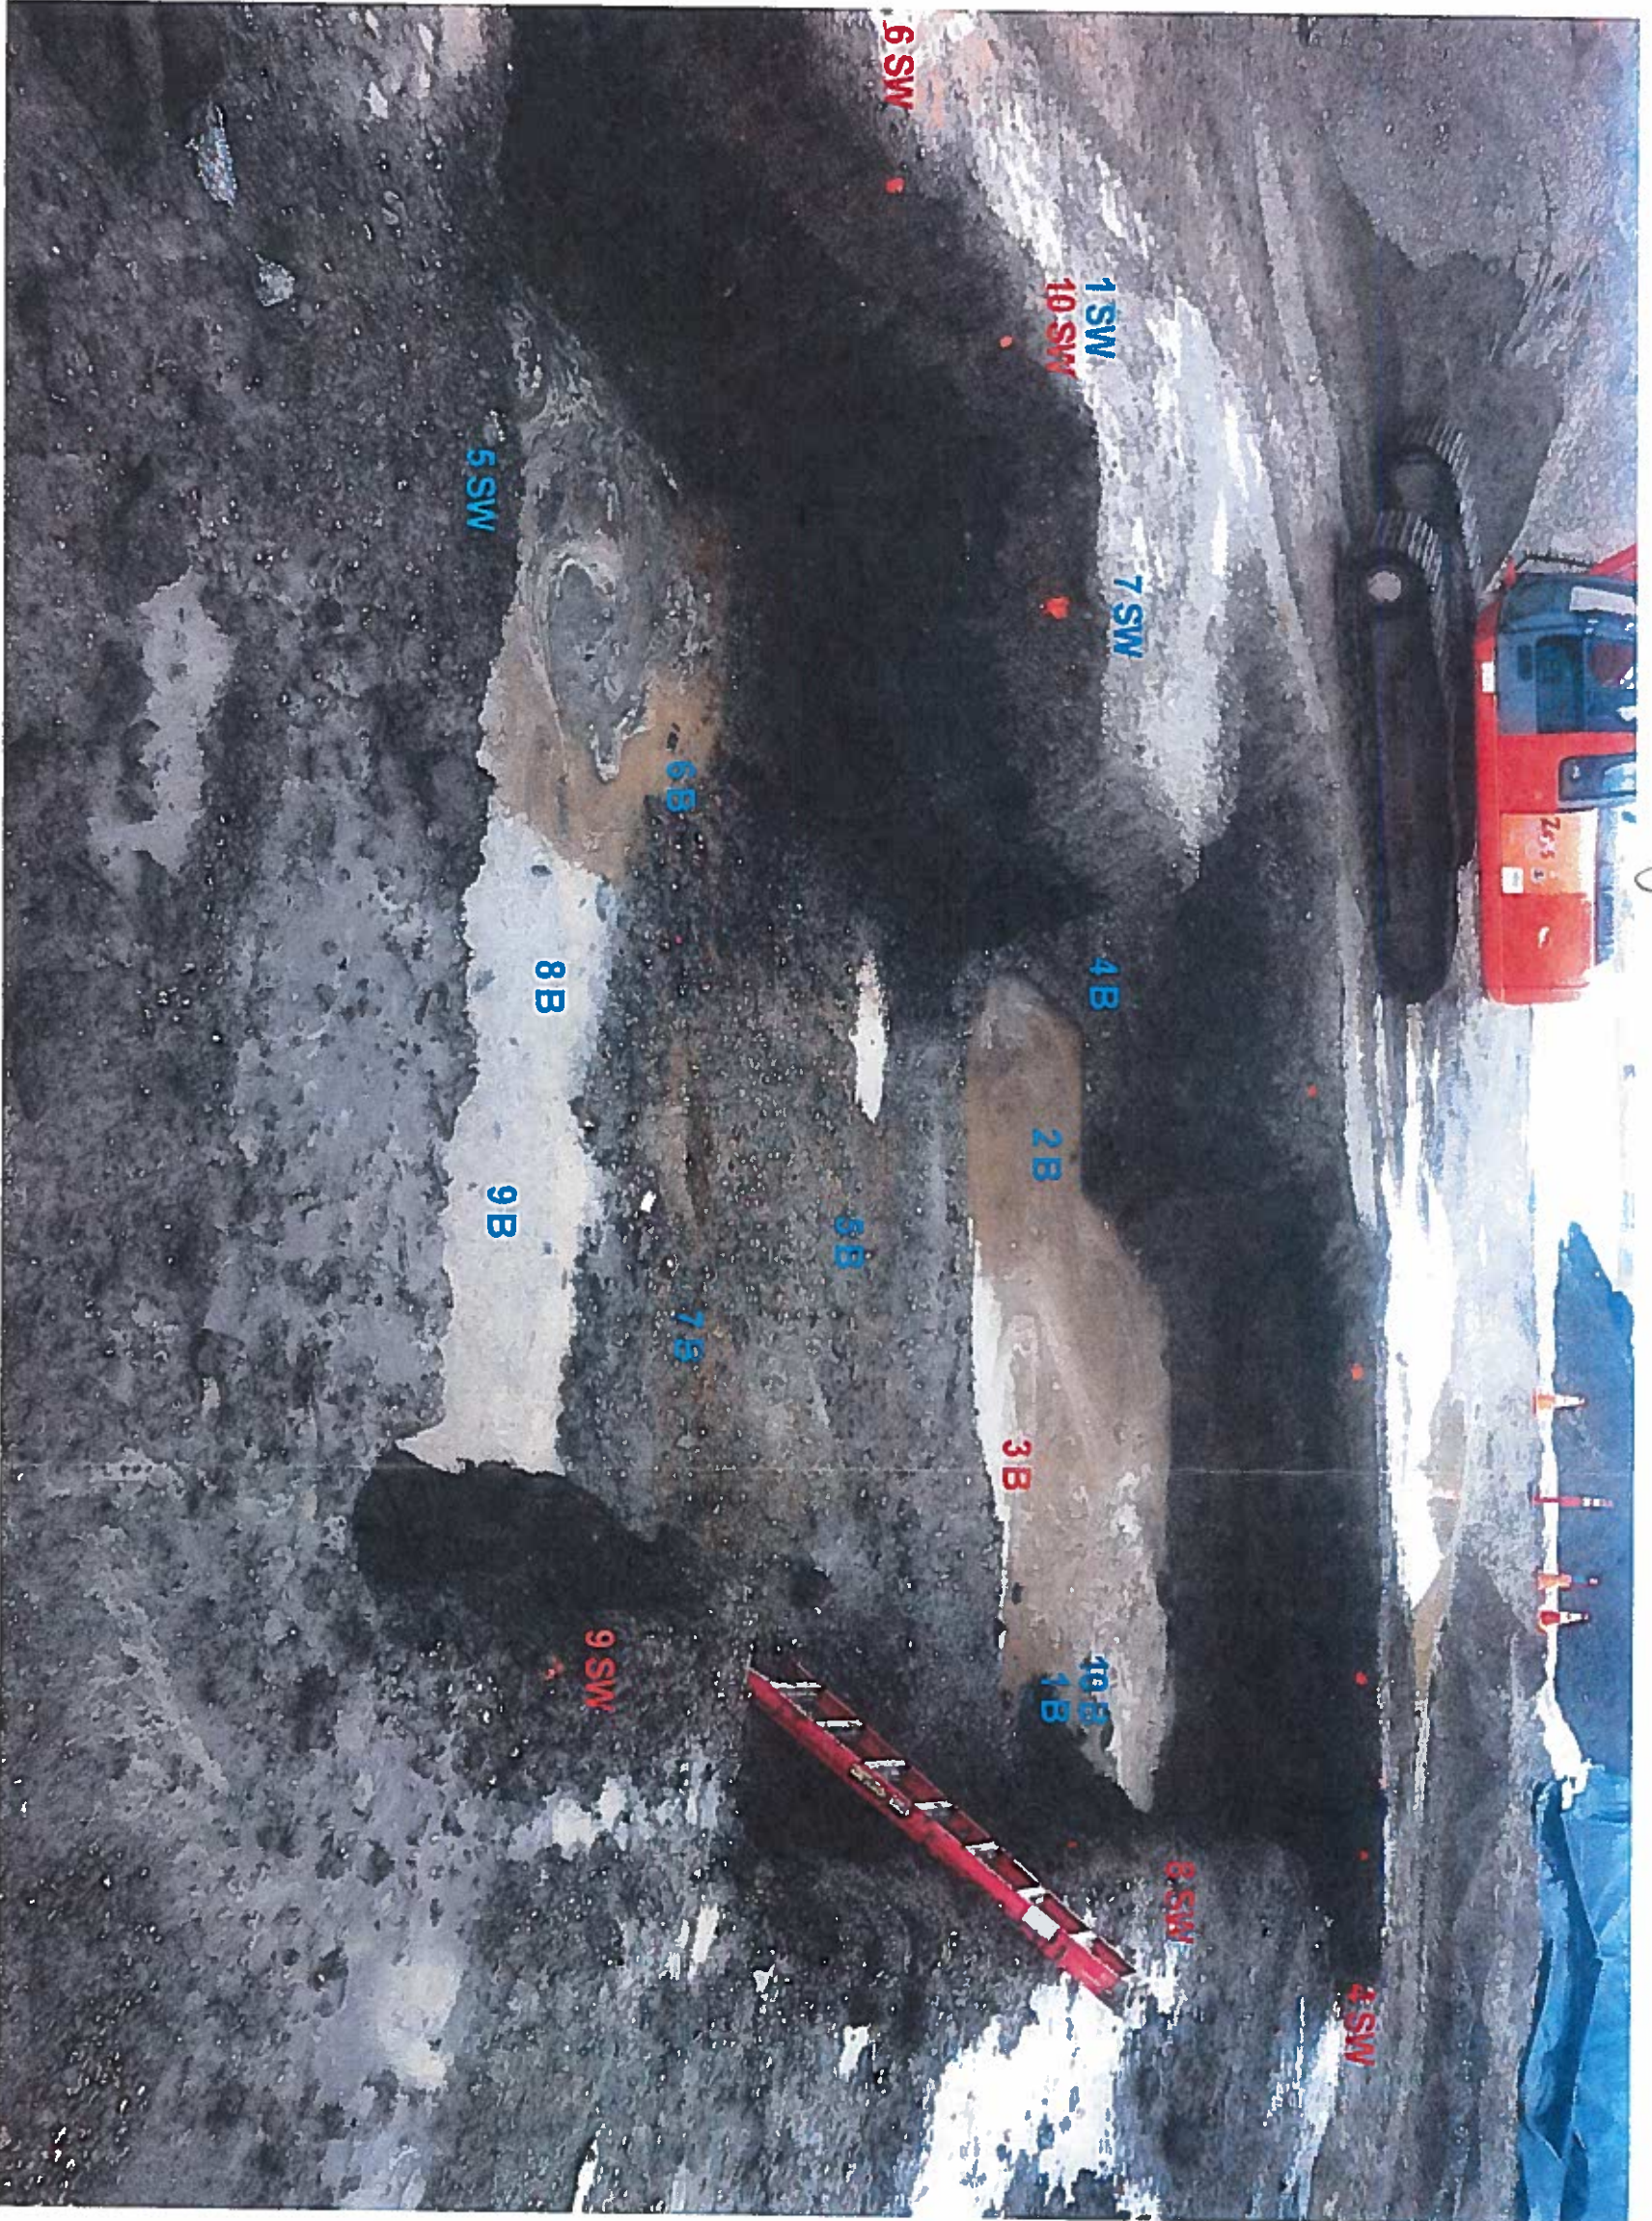
Excavation: 500 gallon tank HST

- - Below cleanup standards
- - Above cleanup standards
- SW - Analyticals from excavation sidewalls
- B - Analyticals from excavation base
- 10SW / 10B - Duplicates
- 3B - DRO: 544 mg/Kg
- 4SW - DRO: 526 mg/Kg
- 6SW - DRO: 421 mg/Kg
- 8SW - DRO: 371 mg/Kg
- 9SW - DRO: 586 mg/Kg
- 10SW - DRO: 473 mg/Kg

NOTE: AVERAGE DEPTH FOR ALL SIDEWALL SAMPLE LOCATIONS WAS 5.0 FT BELOW THE TOP OF THE EXCAVATION IN THE DARK PEAT LAYER.

(PID readings between 100-200 ppm were found approximately five feet below ground surface (bgs) when excavation began near the old 500 gallon HOT. As contamination was discovered along sidewalls and base of the excavation, it was removed and stockpiled in a lined and bermed containment cell located on site. Excavation continued until clean sidewalls were found on all sides. The total depth of the excavation was approximately nine feet, with some areas below groundwater.

A peat layer, approximately six inches thick, was present throughout the excavation at a depth of five feet. This layer appeared to be saturated with fuel. Clay or coarse gravel underlies the peat. Clean limits were eventually established using headspace analysis on all sides of the excavation. With few exceptions, the contamination was confined to the peat layer and soil above. The total depth of the excavation was approximately eight feet with groundwater exposed in most areas. A slight sheen could be seen on the exposed groundwater. The excavated area was nearly 4.5 feet

long by 25 feet wide. Once clean limits were established using headspace analysis, analytical samples were collected. The majority of the analytical samples from sidewalls were collected at a depth of five feet, within the peat layer, focusing on the most contaminated areas. Figure 4 in Appendix A shows the extent of the excavation and corresponding analytical results.
