**REHABILITATION REPORT FOR KUPARUK RIVER STATE #1
EXPLORATORY WELL SITE
PRUDHOE BAY OILFIELD, ALASKA**

**KRS 33-12-16, API No. 50029-2002-00
USACE Permit No. 071-0026-0**

**Prepared by
ABR, Inc.—Environmental Research & Services, Fairbanks, AK
and
BP Environmental Studies Group, Anchorage, AK**

30 December 2008

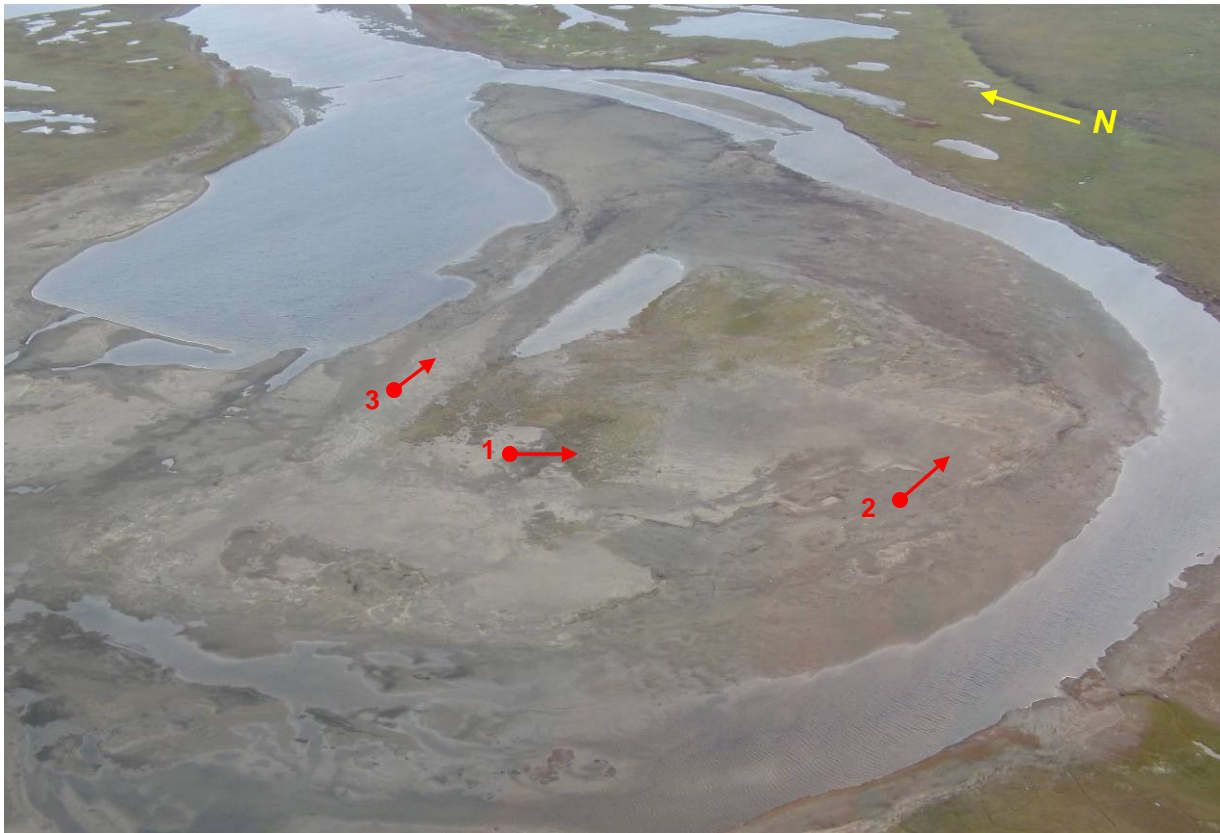
SITE DESCRIPTION: The site is located in a braided river channel of the Kuparuk River, and consists primarily of gravel and sand deposits. As a result of annual flooding, the outline of the gravel pad and airstrip is barely visible (Figures 1 and 2). In areas that are infrequently flooded, trace cover of a variety of plant species is present, including *Artemisia* (wormwood) sp., *Salix ovalifolia* (oval-leaf willow), *Astragalus alpinus* (alpine milkvetch), and several grasses. A photographic log of site conditions is provided in Appendix A.

Figure 1. Aerial view of Kuparuk River State showing locations of photographic points, 12 August 2008.

ELEVATION MONITORING: No quantitative monitoring of elevation was conducted in 2008. Based on qualitative assessment of surface elevation characteristics, the site continues to be modified by riverine processes and is almost indistinguishable from the surrounding terrain (Figures 1 and 2).

Based on the conditions at the site on 12 August 2008, we believe that the performance standard of integration of Kuparuk River State with the surrounding terrain has been mostly achieved, and will be maintained to the end of the performance period (2012) and beyond.

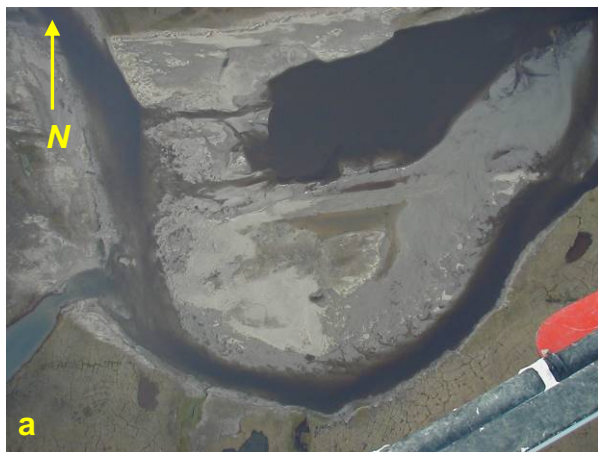
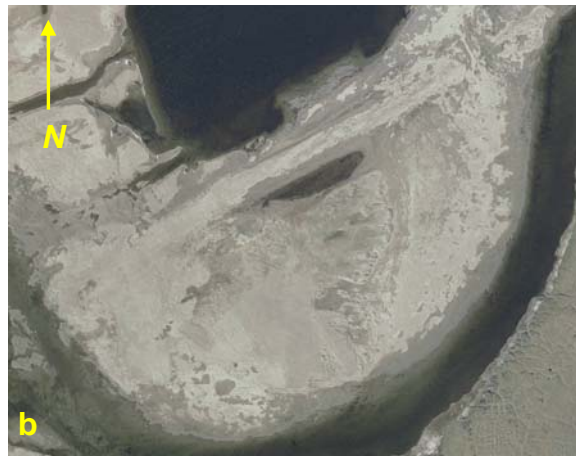
Figure 2. Aerial views of Kuparuk River State, (a) 23 August 2000 and (b) 3 July 2008. (2008 photograph provided by AERO-METRIC, Inc.)

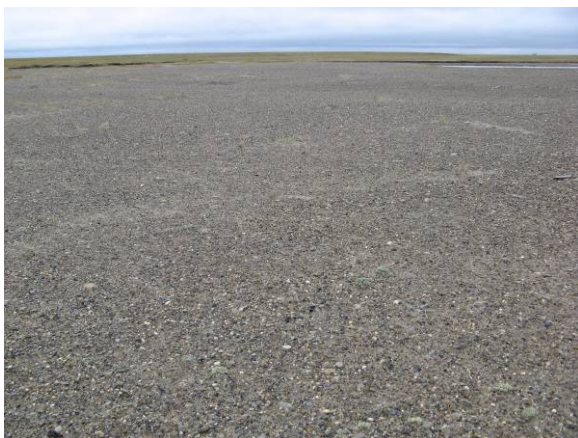
Figure A1. View (from photo point 1) of former gravel pad, 12 August 2008.

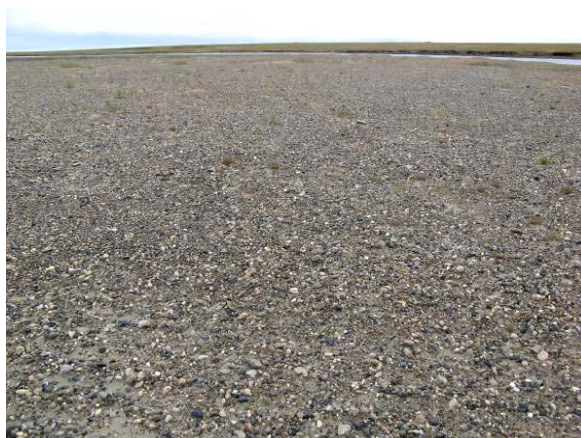
Figure A2. View (from photo point 2) of former gravel pad, 12 August 2008.

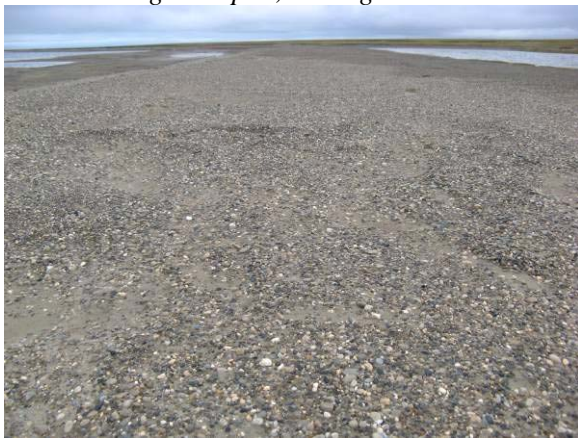
Figure A3. View (from photo point 3) of former airstrip, 12 August 2008.

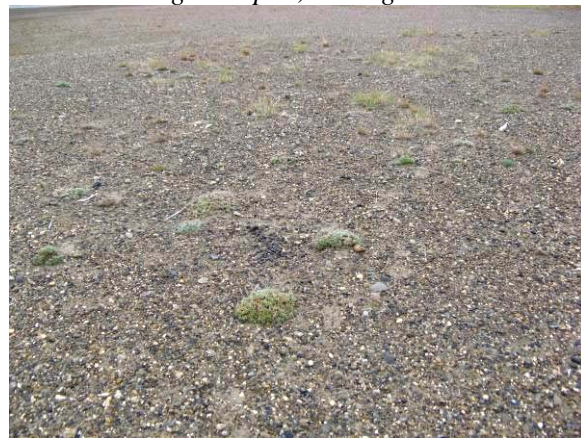
*Figure A4. View of plant species colonizing former gravel pad area, including *Artemisia glomerata* and *Elymus arenarius*, 12 August 2008.*
