UST SYSTEM UPGRADE SITE ASSESSMENT

Kasilof Riverview

Tract E & F, Harley Fellars Subdivision
Mile 109.5 Sterling Highway, Kasilof, Alaska
ADEC UST Facility #384

GE²T Project #98013

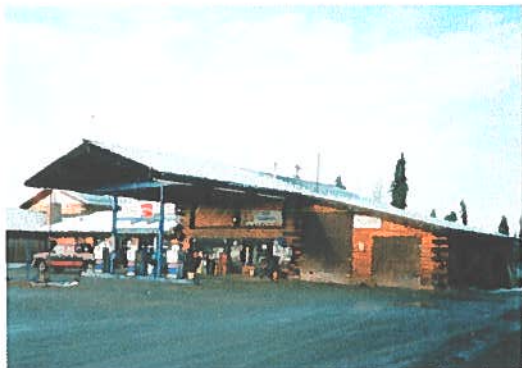
Gasoline dispenser island and canopy.

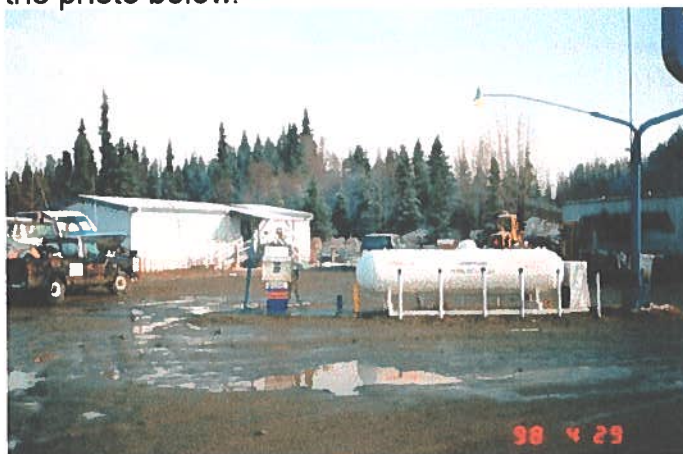
Diesel dispenser island.

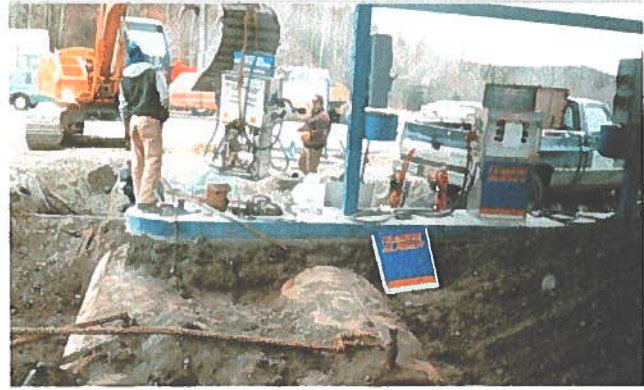
USTs as they are being uncovered.

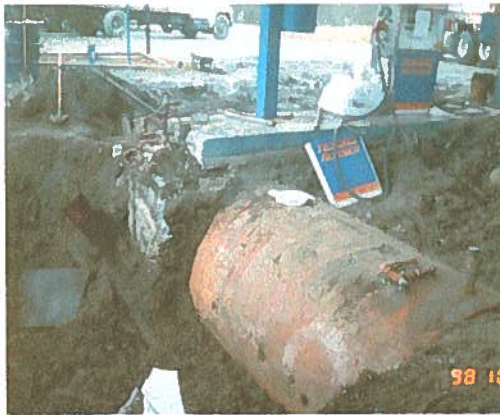
Excavation shows concrete that was poured around the 2,000 gallon UST.

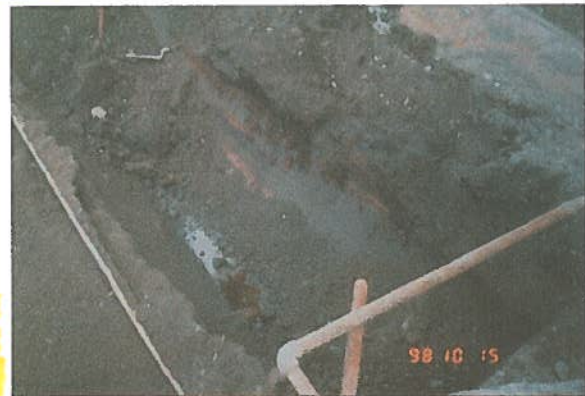
Pooled product in bottom of heating oil UST excavation.

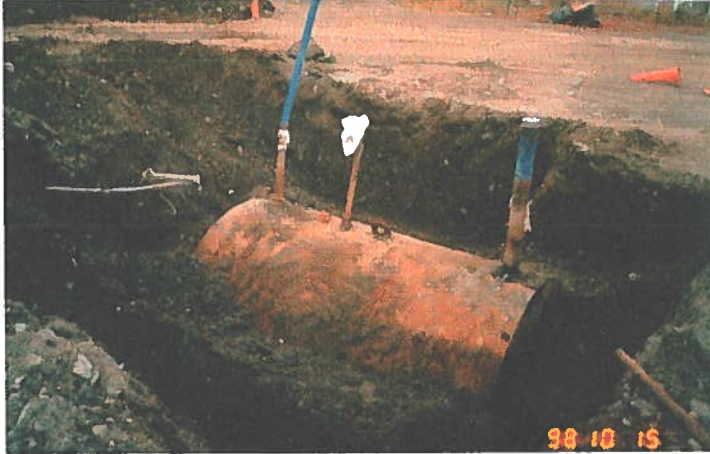
2,000-Gallon Diesel UST - A small amount of diesel contaminated soil was encountered around the top of the diesel UST. The contamination did not appear to extend much further than a couple feet horizontally from the UST and the deepest vertical extent was approximately 3 feet below the top the tank (near the fill port). The limits of excavation around the diesel UST are shown in Figure IV. Except for approximately three feet of sandy/silty gravel immediately below

Looking north at 2,000-gallon diesel UST excavation.

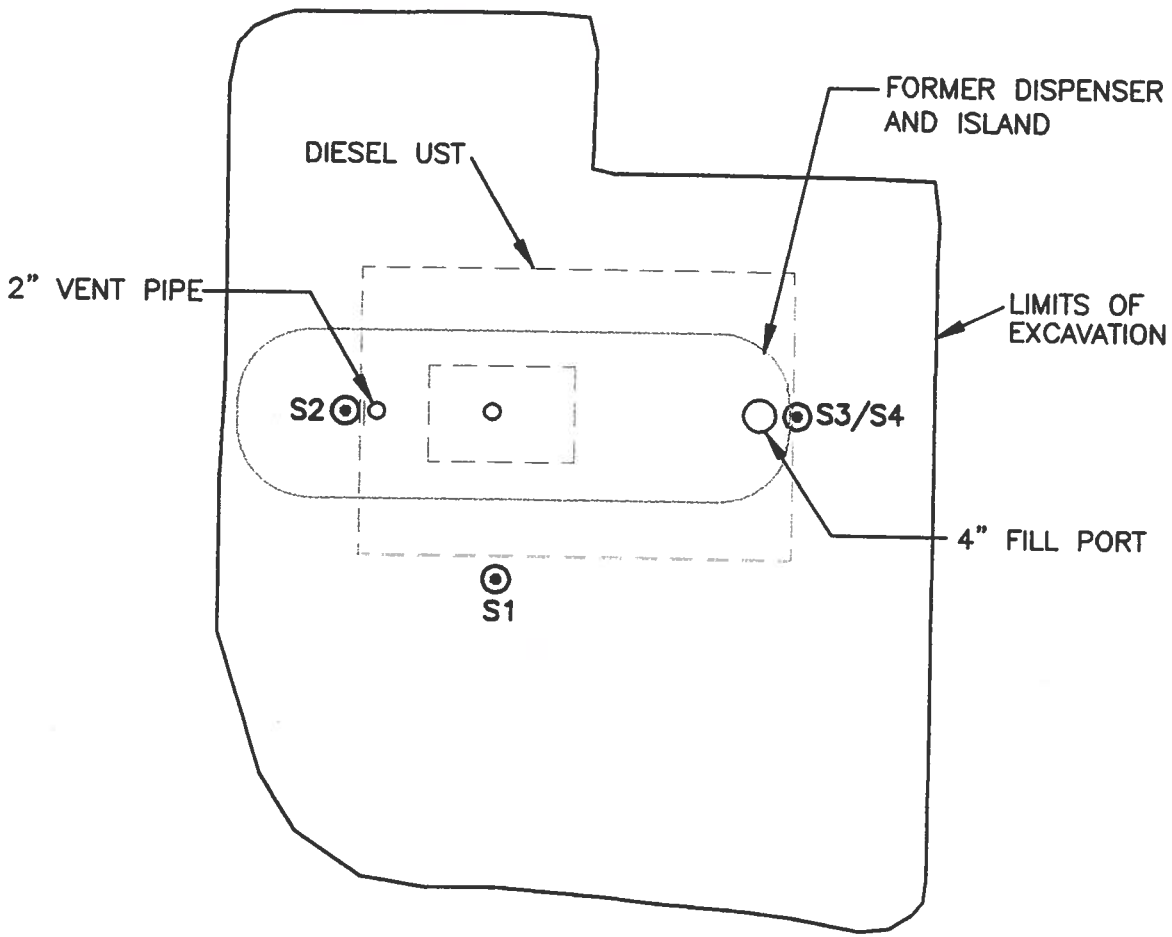
FIGURE IV: KASILOF RIVERVIEW - DIESEL UST SAMPLE ANALYTICAL RESULTS

As shown in Table 1, analytical results for samples S1 through S4 from the diesel UST excavation indicated that DRO concentrations were below the

Lacking BTEX Analysis

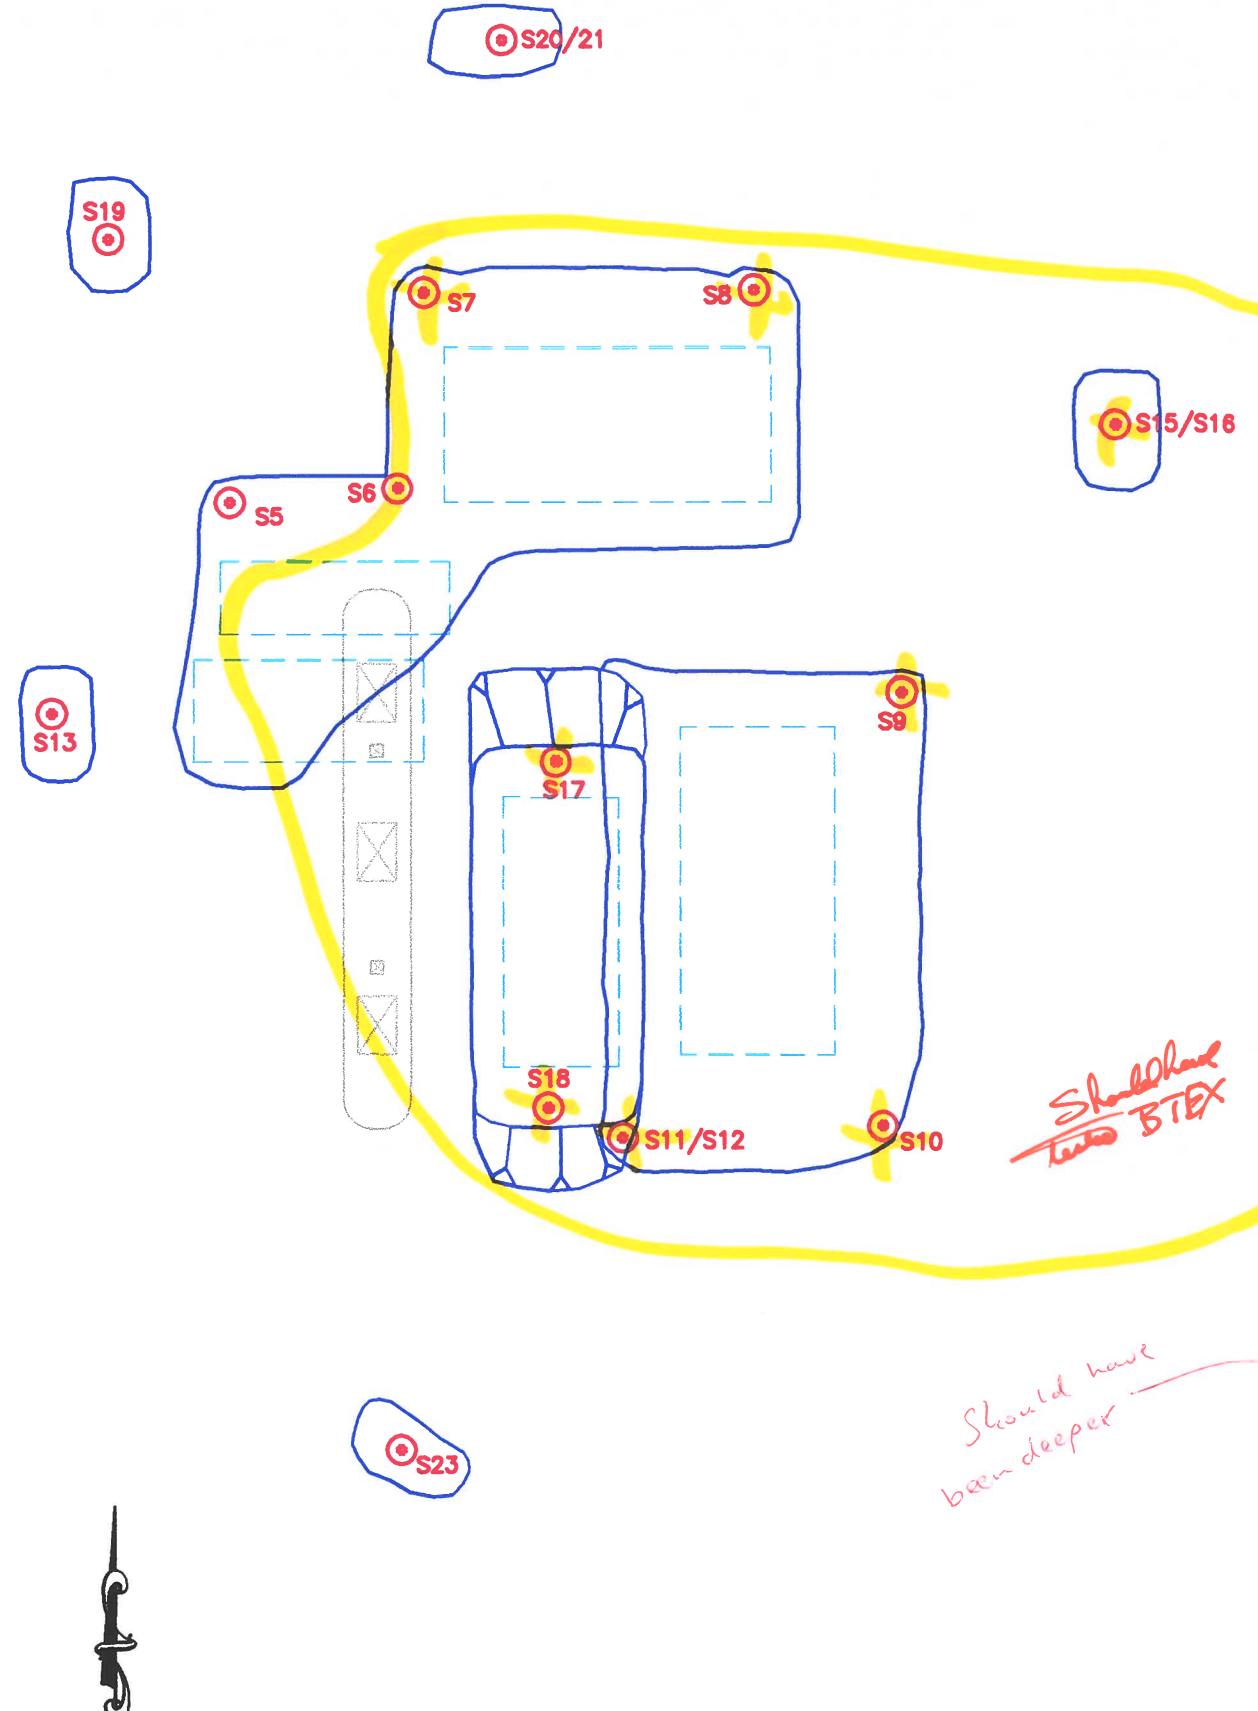
Sheet No. **FIGURE-V**

Samples S7 through S12 were collected from the sidewalls of both of the 6,000-gallon gasoline UST excavations. Results for these samples indicate that BTEX and GRO concentrations in this area exceed the cleanup levels.

The results from samples S13 through S16 (collected from test pits around the USTs) indicate that benzene was the only contaminant to exceed cleanup levels in these locations. Samples S17 and S18 were collected from both ends of the newly installed 3,000-gallon gasoline UST excavation and levels of BTEX and GRO were above cleanup levels.

The remaining soil samples (S19 through S23) were collected from test pits around the USTs. Results were mixed for these samples, but most of them were found to contain benzene at concentrations exceeding cleanup levels.

Should have tested BTEX

Should have been deeper

Note: Numbers in red exceed cleanup levels.
