PHASE I ENVIRONMENTAL SITE ASSESSMENT

**HIPAS OBSERVATORY
7795 CHENA HOT SPRINGS ROAD
FAIRBANKS (TWO RIVERS), ALASKA**

JANUARY 14, 2009

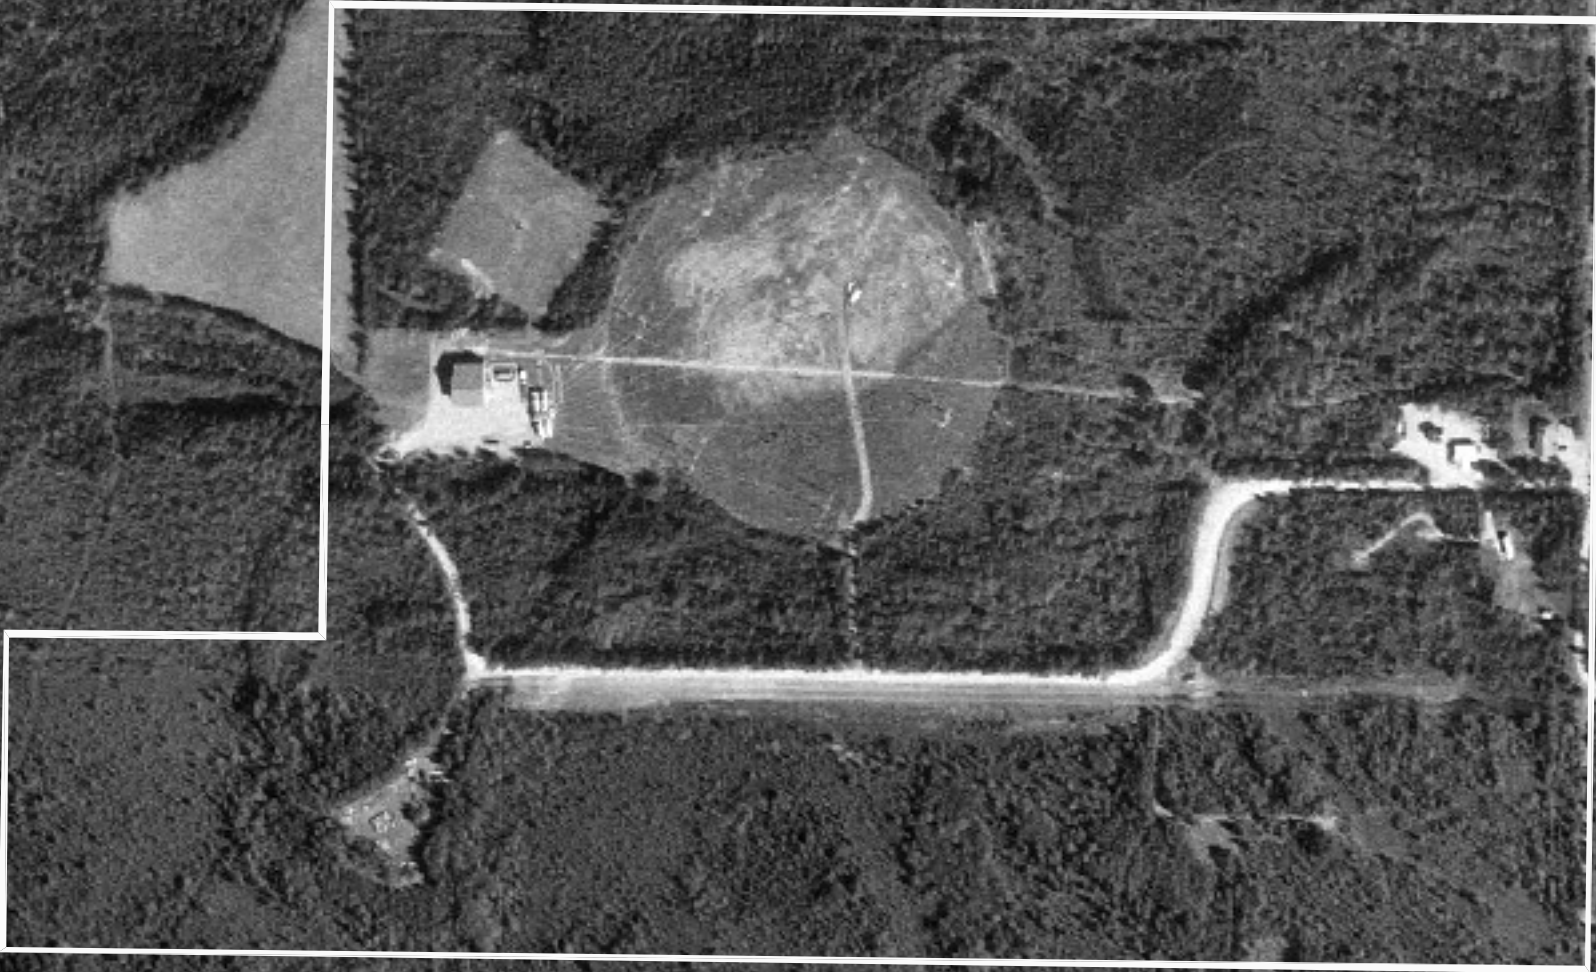
FIGURE
10

1999 Aerial Photo (Figure 10): This photo shows the Site more clearly and several changes to building configurations are visible. These include the addition of southern portion of the LIDAR Building, the installation of the ATCO unit and associated antenna south of the Shop, and the square clearing for the antenna north of the Generator Building. This photo also clearly shows the aboveground diesel storage tank for the generators. Additionally, the small Transmitter Building appears to have four trailers setup around it with hardware trails that lead from these trailers to the antennas. The previous clearings in the southeastern portion of the Site appear almost completely overgrown. The property adjacent to the southwest corner of the Site has been cleared on both the south and west sides.

1999 Aerial Photo
HIPAS Observatory
Fairbanks (Two Rivers), Alaska

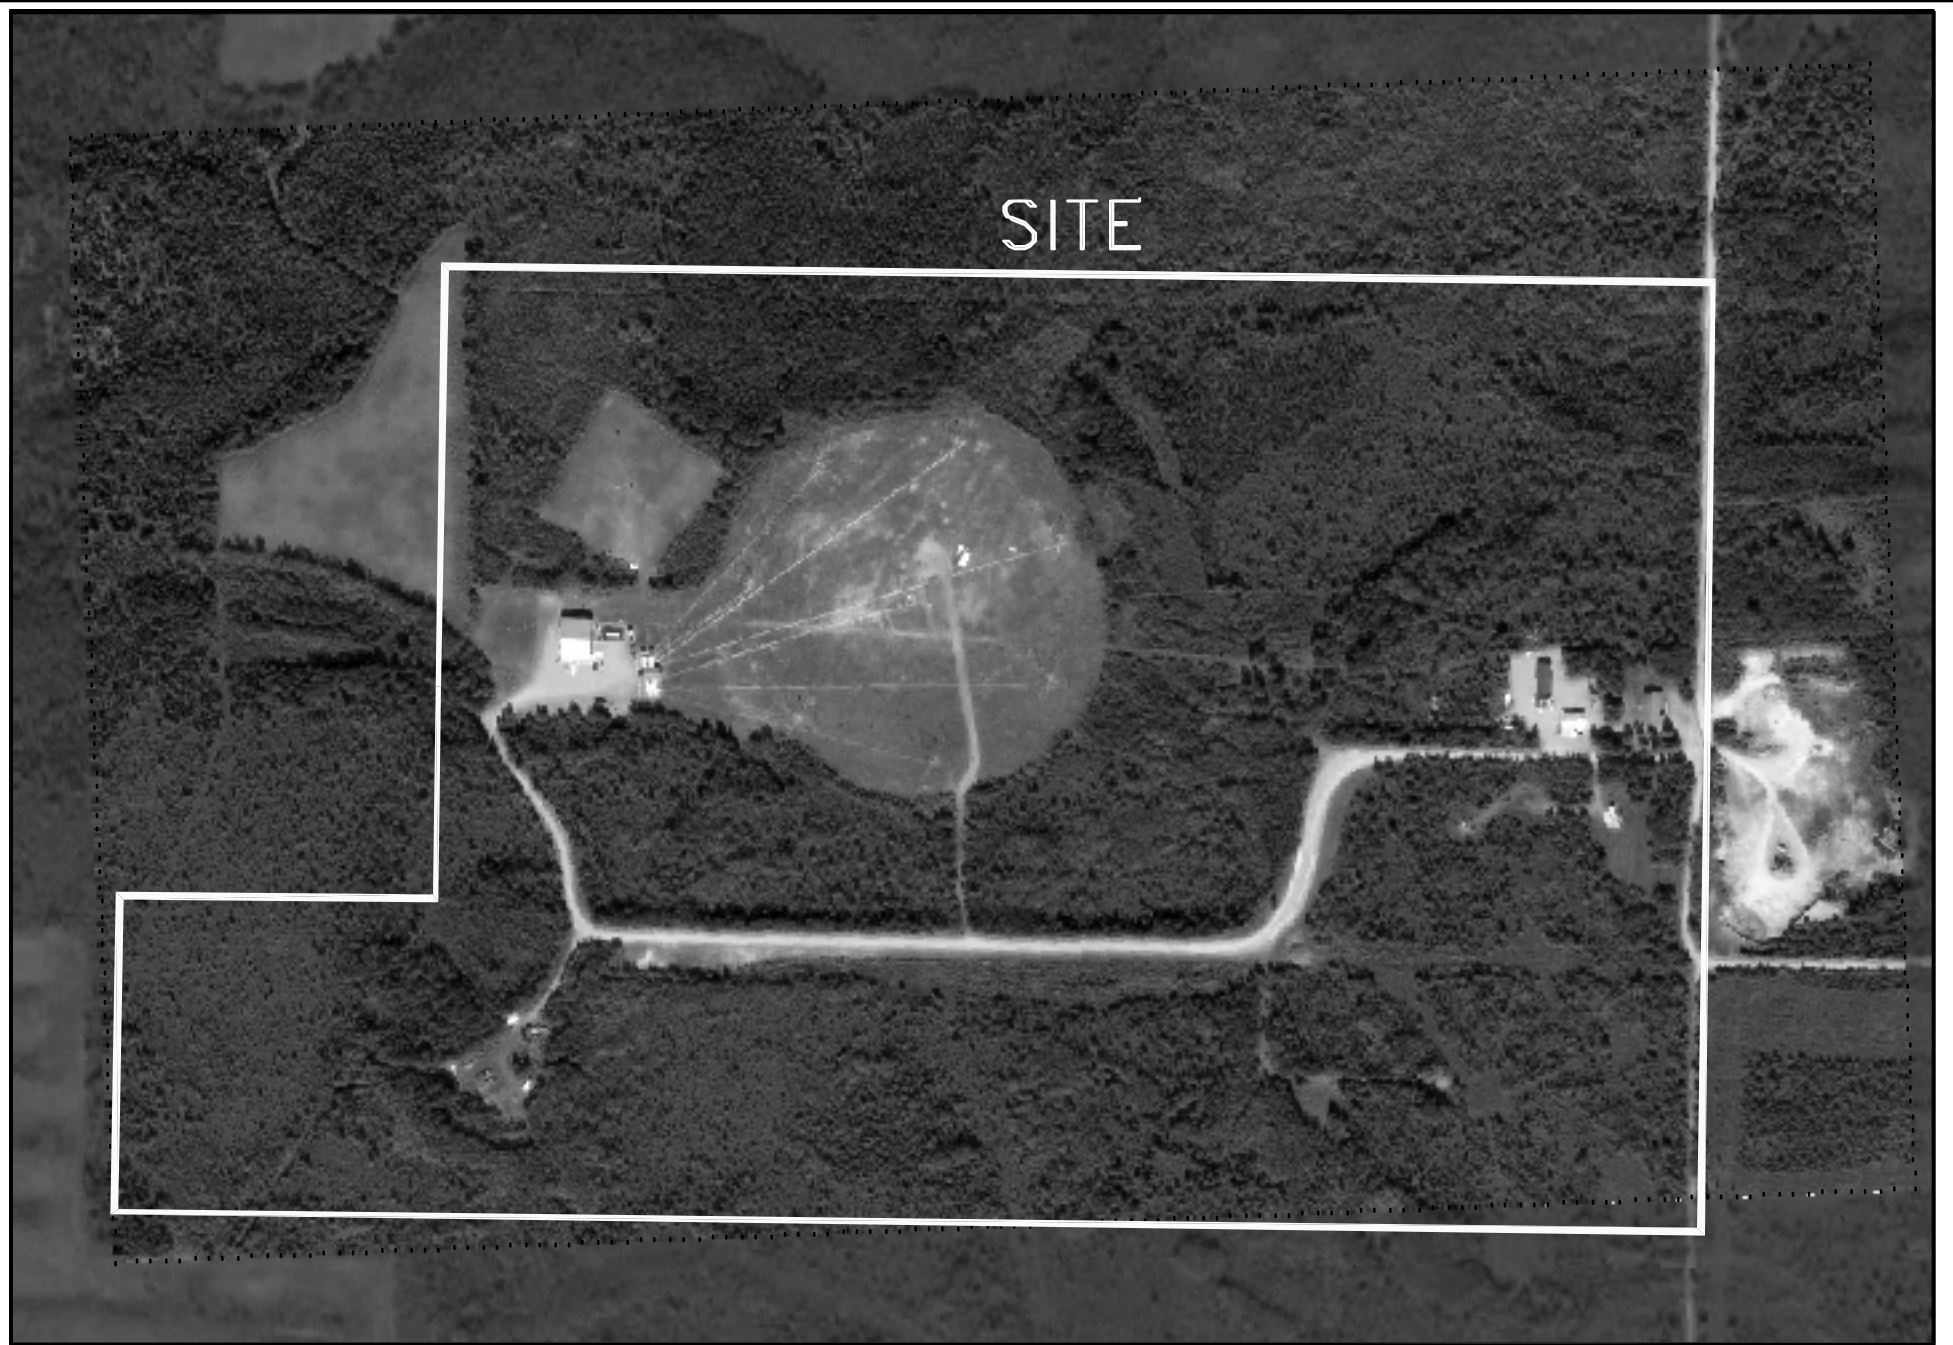
FIGURE
11

2002 Aerial Photo (Figure 11): This higher resolution image of the Site shows most of the basic configuration that is present today. Each of the buildings on the eastern portion of the Site (Bunkhouse, Shop, LIDAR, and ATCO) is the same general size and shape as today. The Generator Building and storage tank with the dark liner of the containment structure are also clearly visible. The transmitting equipment appears to remain in the trailers, which is the primary difference in structures from the current configuration. The boneyard area appears to be generally the same size and shape as previously observed and the southeastern portion of the Site remains generally overgrown.

2002 Aerial Photo
HIPAS Observatory
Fairbanks (Two Rivers), Alaska

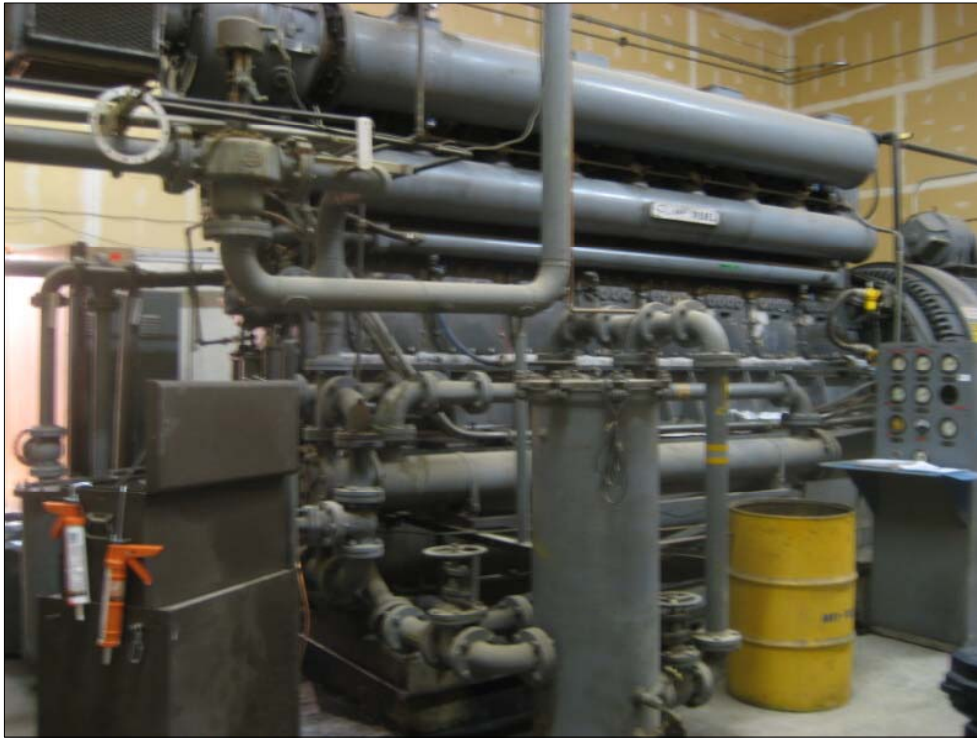
Photo 01 - One of two generators inside generator building; both appear well maintained with minimal staining around the oil and glycol (yellow drum) filters and reservoirs

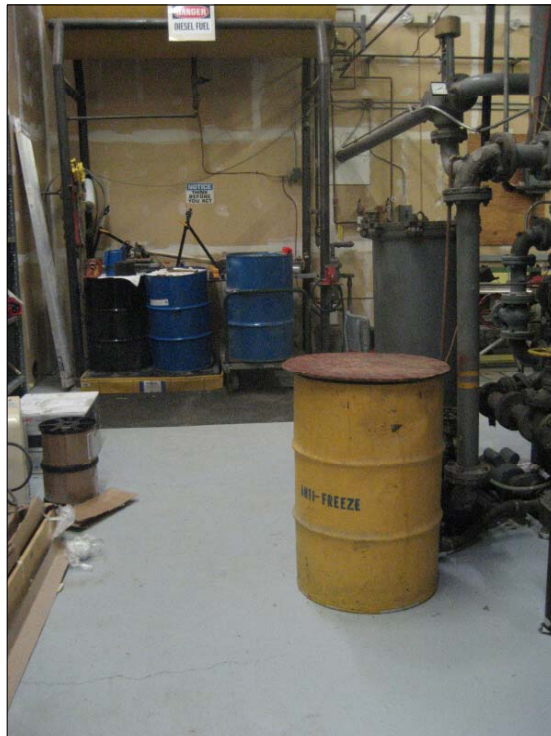
Photo 02 - Oil and coolant storage inside generator building: coolant overflow from generator in foreground, used and new coolant and oil in drums on spill pallet, and fuel storage "day tank" above drums

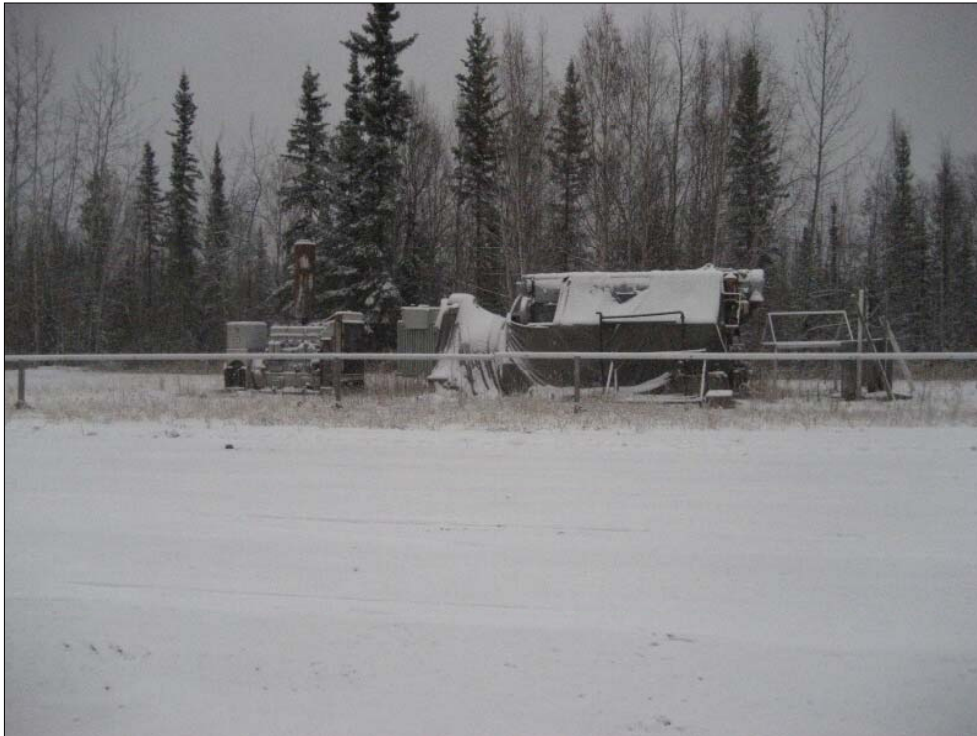
Photo 03 - Unused generators stored to south of the Generator Building; smaller unit has been removed from the Site

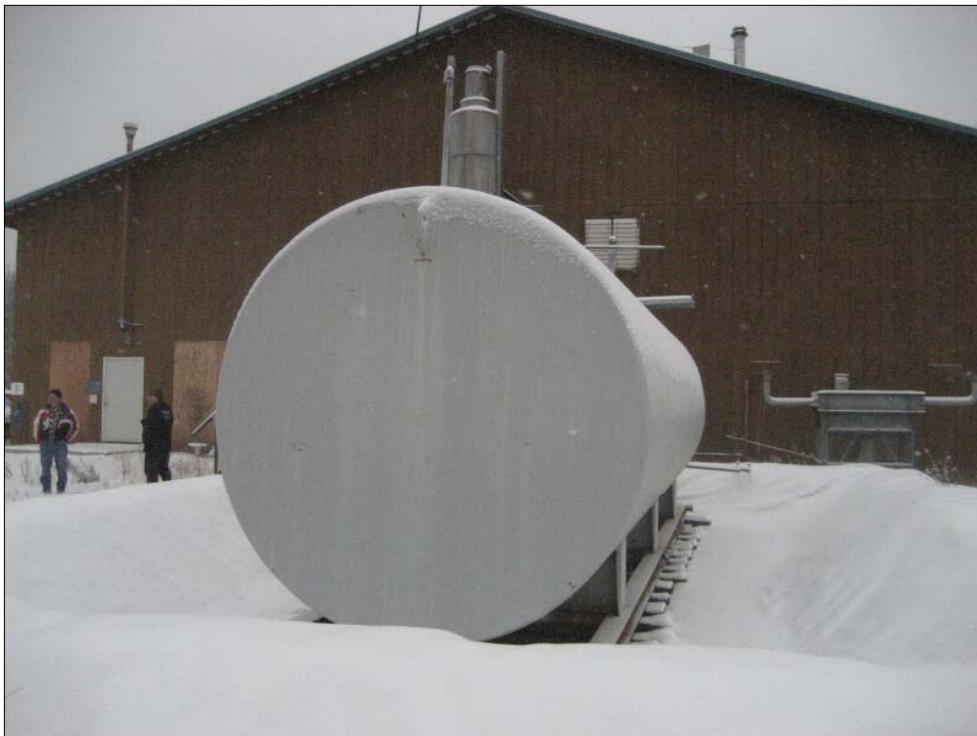
Photo 04 - 10,000 gallon diesel/heating oil storage tank in secondary containment on east side of Generator Building that supplies fuel to the generators and furnaces in both the Generator and Transmitter Buildings

Aboveground storage tanks (ASTs) for heating oil are located adjacent to each heated structure. The exception is the Generator and Transmitter Buildings which share a tank that is also used to fuel the generators. The facility exceeds the minimum aboveground storage threshold within the SPCC Plan regulations and an SPCC Plan has not been developed for the facility. Development of an SPCC Plan is recommended if portions of the facility will continue operation. Each AST installation was observed to need one or more upgrades to comply with the SPCC regulations, including secondary containment and/or appropriate engineering controls. Replacement of several of these tanks may be more cost-effective than trying to upgrade the units. The ground surface beneath each tank should be inspected for potential contamination during removal or upgrades and all fuel lines should be inspected for potential leaks and weeping. The drum used as a gasoline dispenser by the Shop should be removed.

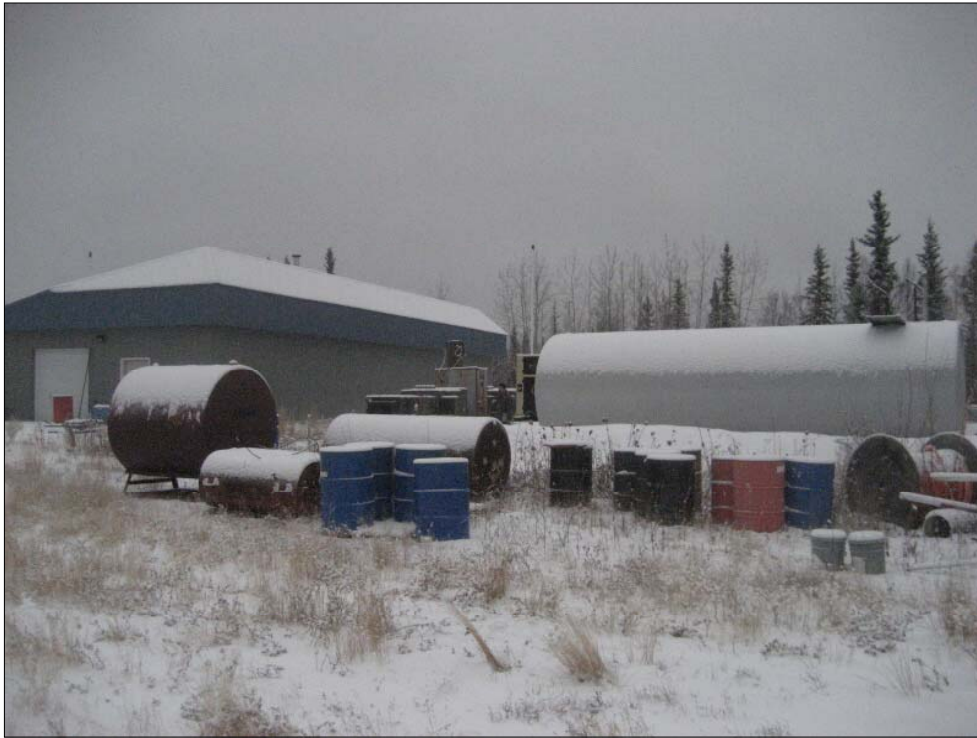
Photo 05 - Tank and drum storage north of 10,000 gallon tank; smaller tanks are empty and drums have been characterized for disposal (new and used antifreeze, lubricating oil, and dielectric oil)

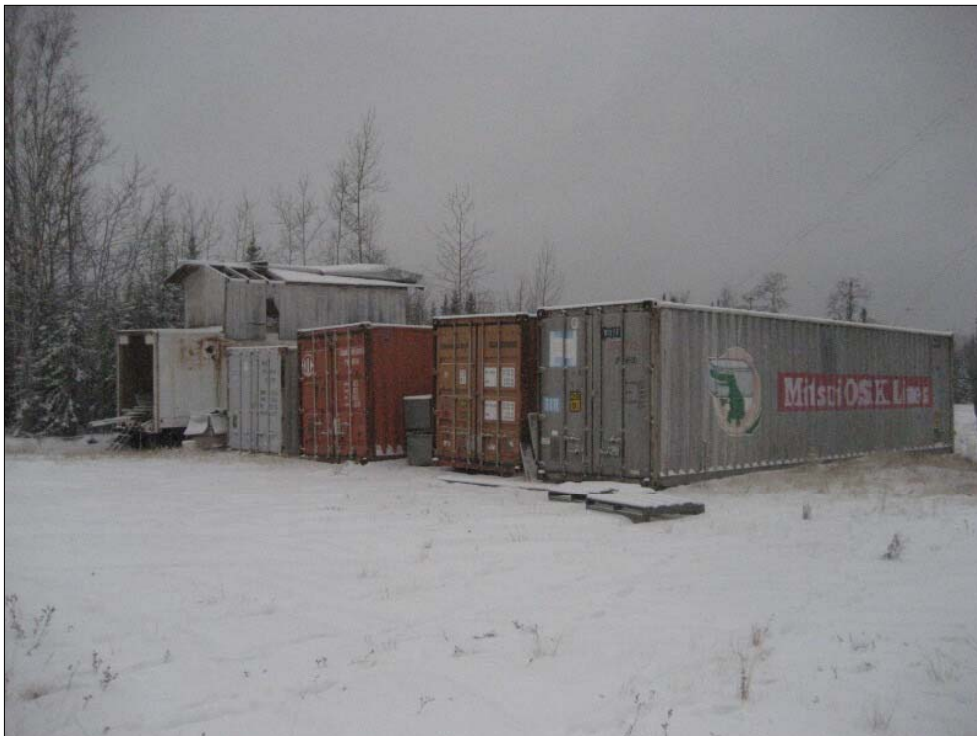
Photo 06 - Storage containers and one transmitter trailer located north of the Generator Building; at least one of the containers has been removed since the initial inspection

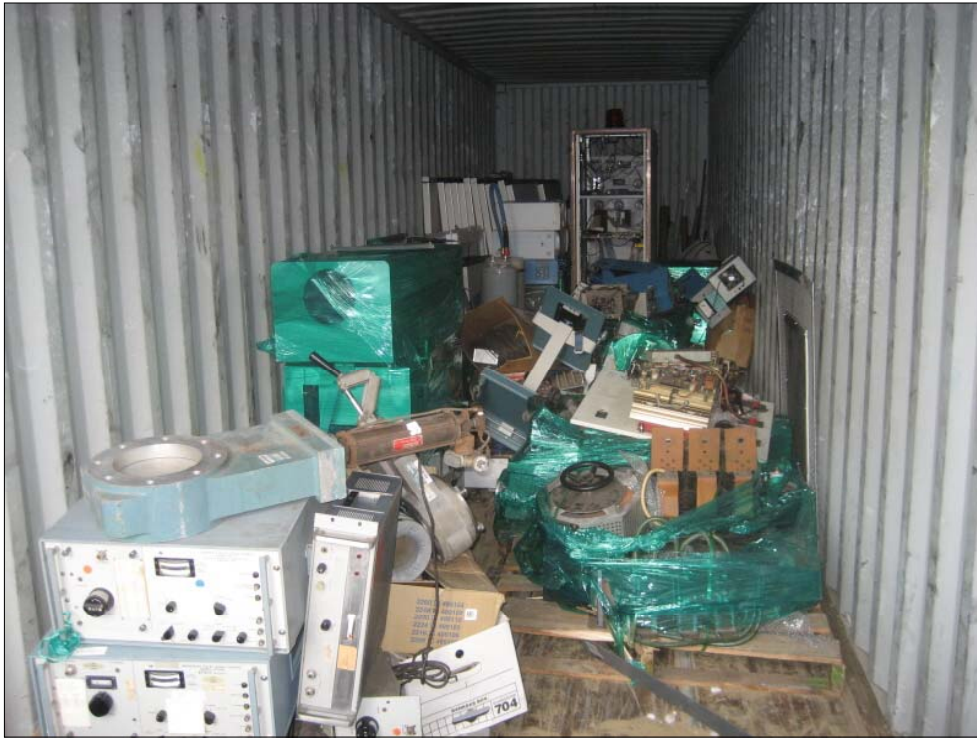
Photo 07 - Electrical equipment stored in one of the containers

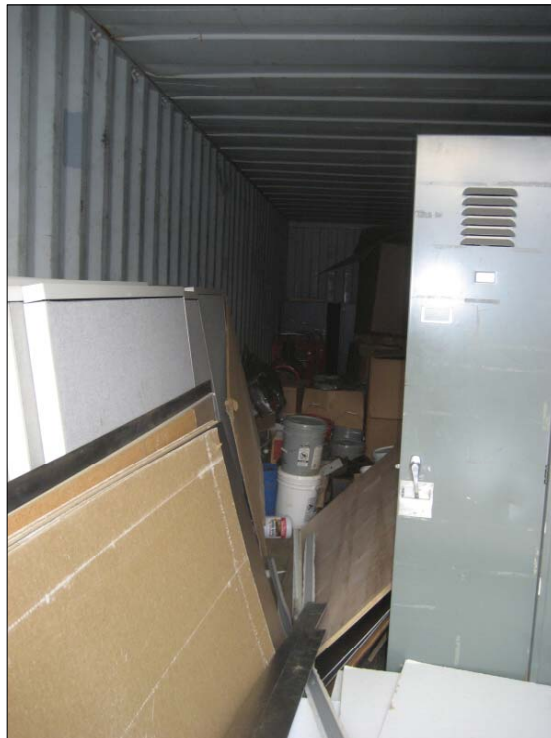
Photo 08 - Miscellaneous material stored in another container, including 5-gallon buckets of unidentified materials (inspection not possible due to poor stability of stored materials)

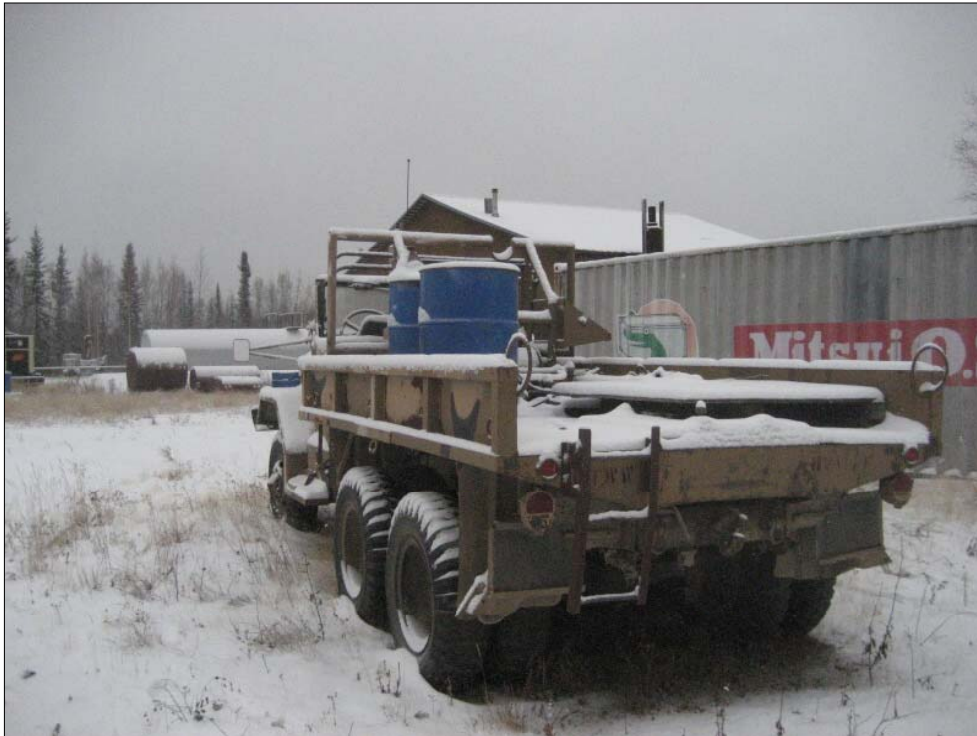
Photo 09 - Vehicle with drums stored adjacent to storage containers; drums have been characterized and vehicle did not appear to be leaking

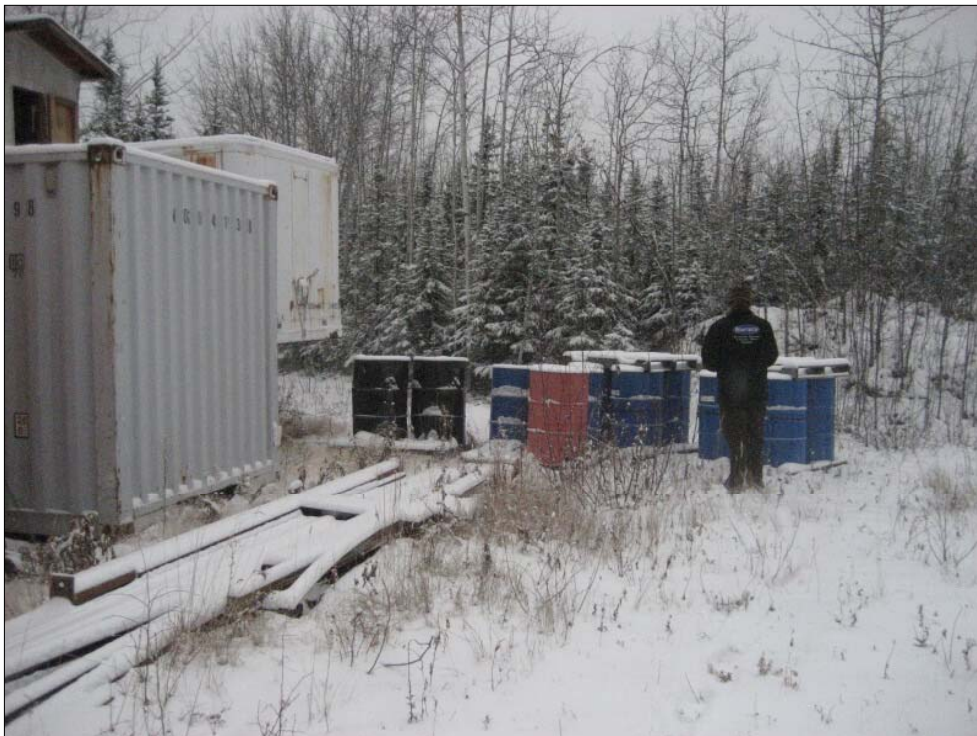
Photo 10 - Drums of unopened product, primarily motor oil drums with a few dielectric oil and glycol drums, located north of storage containers

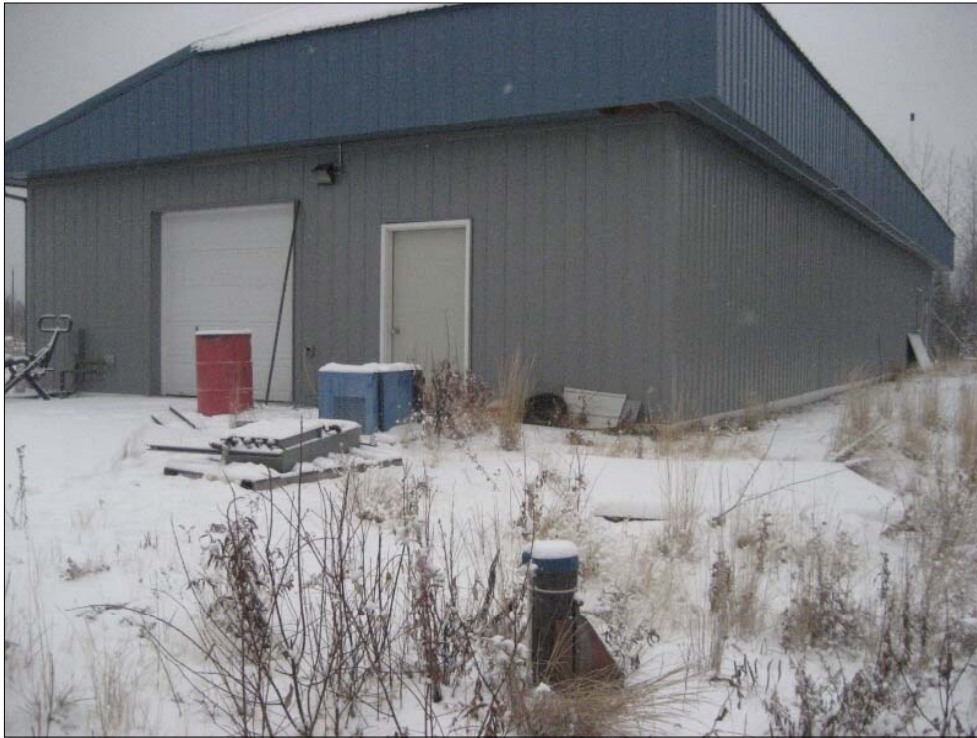
Photo 11 - North and west sides of transmitter building with water supply well in foreground and drum of used dielectric oil near overhead door

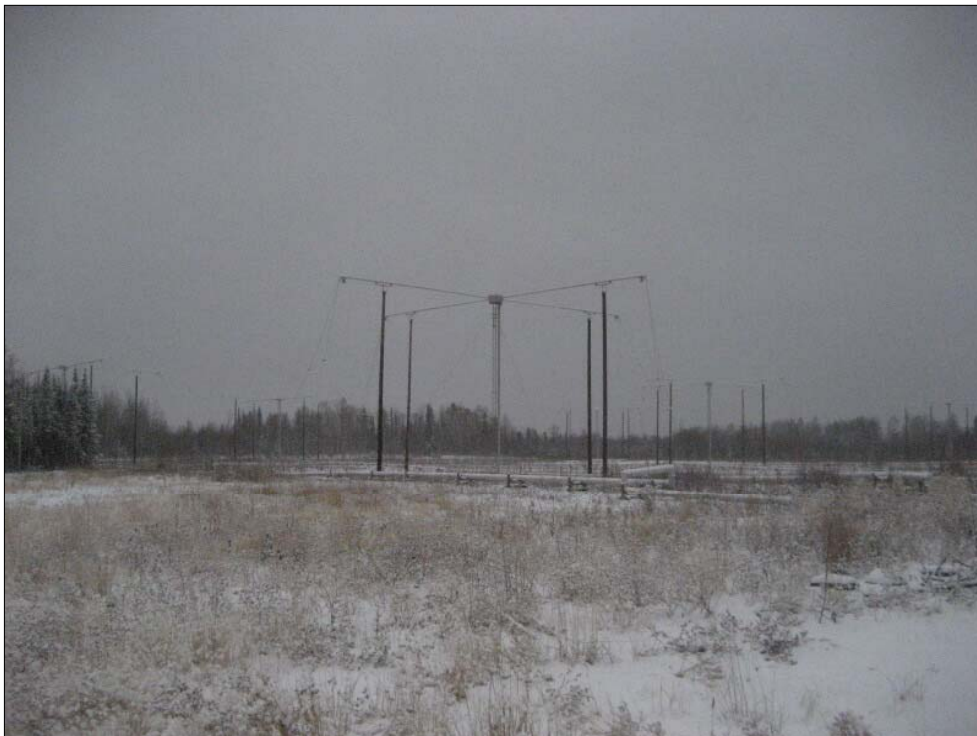
Photo 12 - Primary circular antenna array northeast of the Transmitter Building

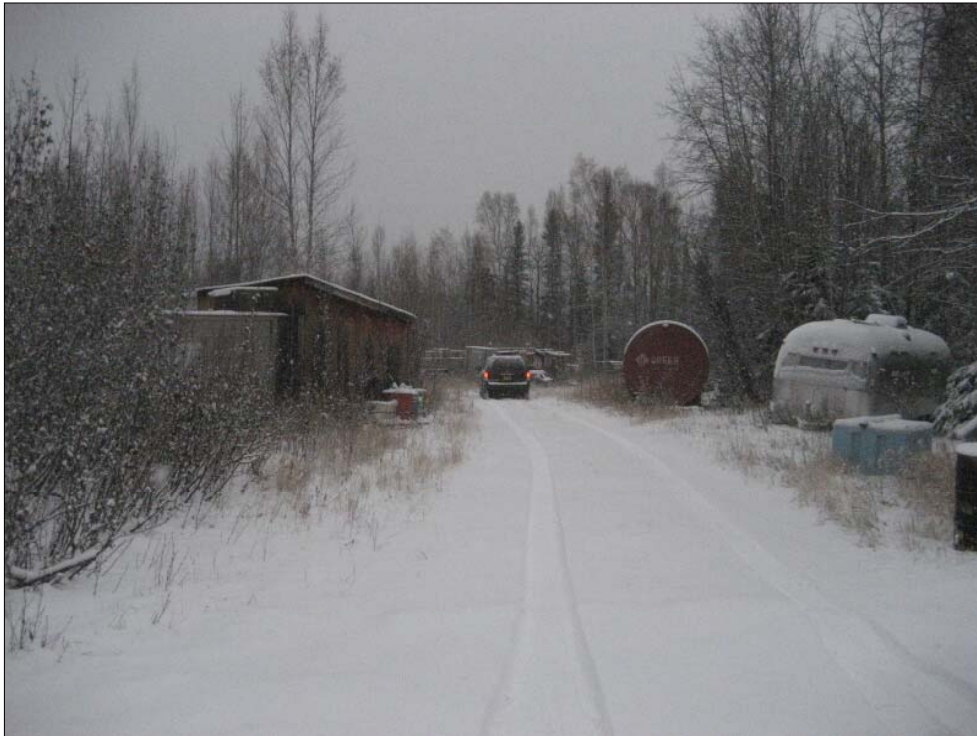
Photo 13 - Driveway into boneyard area with large tank (reported empty) and other newer equipment on right, older electronic/transmitter related to Chena Valley Radio operation on left, and general storage in background

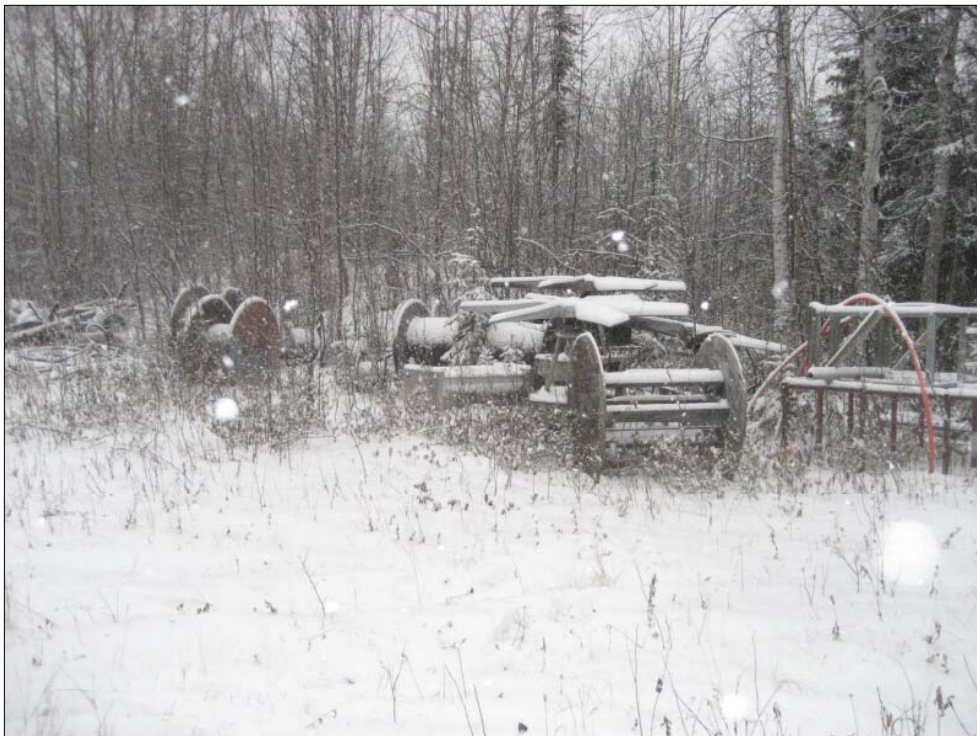
Photo 14 - Typical storage of spools, cable, and other materials in boneyard

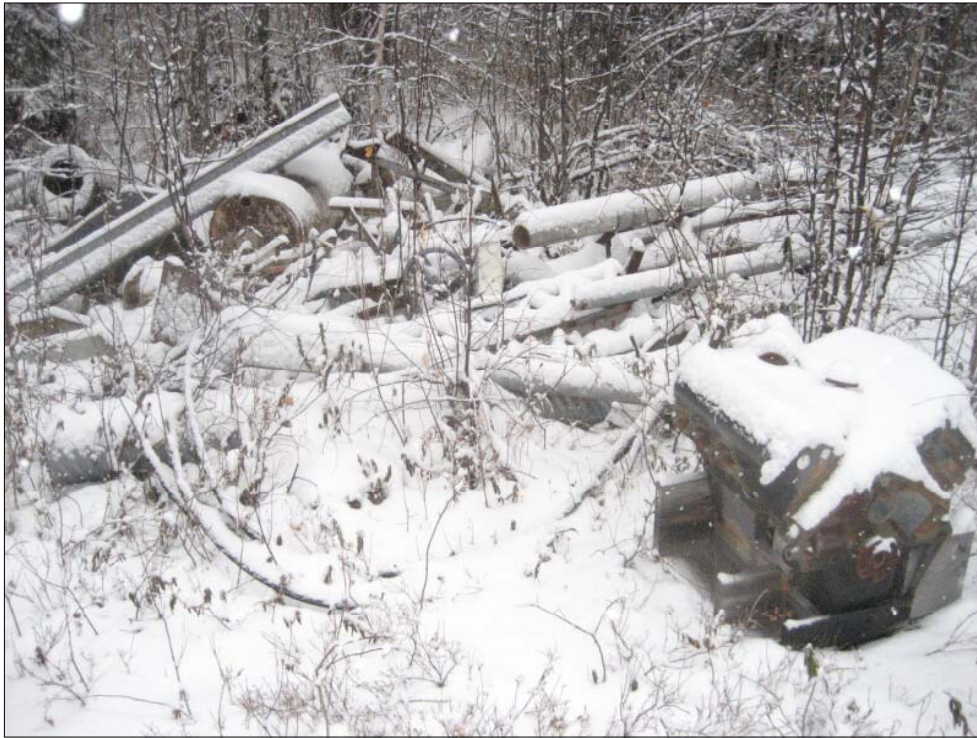
Photo 15 - Typical storage of smaller pieces of material, including tubing, culverts, and other equipment in boneyard (the item in the upper left is a boiler, not a drum)

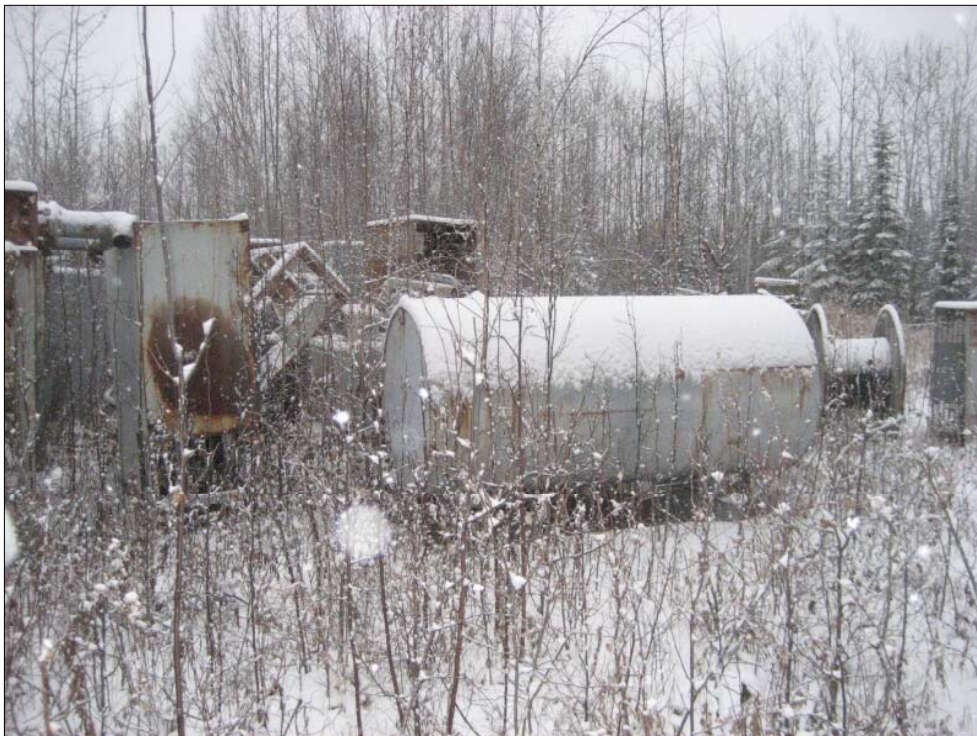
Photo 16 - Typical storage of larger equipment and materials in boneyard (the use of the item in the center was not identified, but it was not a fuel tank)

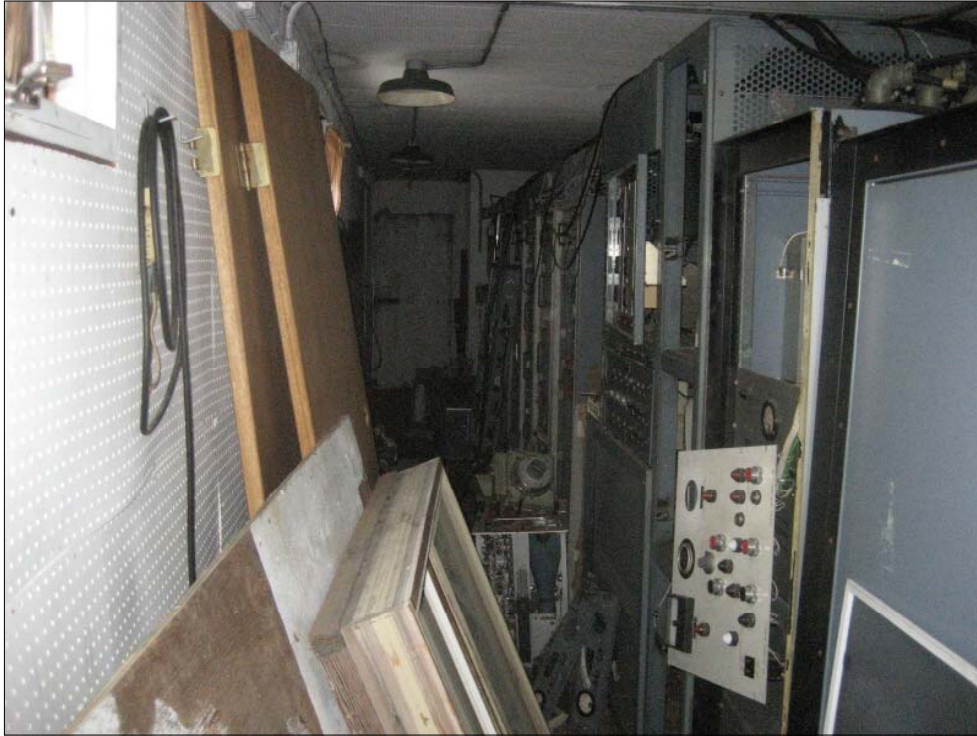
Photo 17 - Old electronic equipment inside the trailer structures located in the boneyard and believed to have been used by the Chena Valley Radio facility in conjunction with the collapsed dish nearby

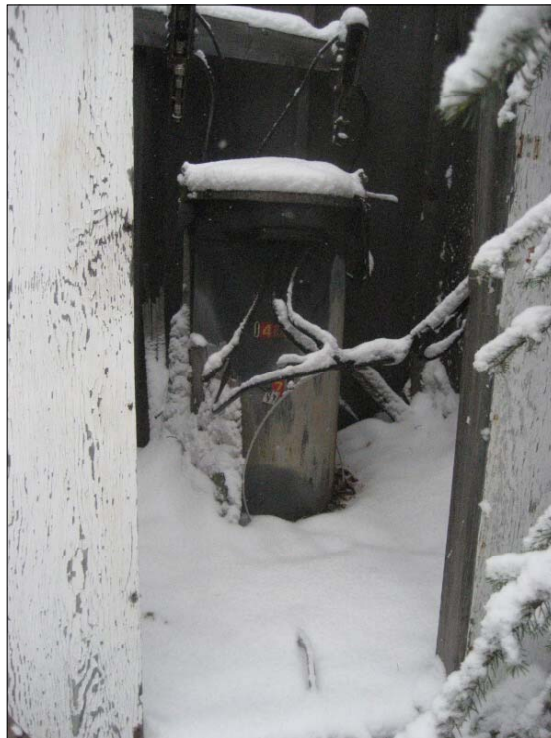
Photo 18 - Exterior electrical transformer believed to have powered the equipment in the Chena Valley Radio trailers in the boneyard (this unit is not believed to be powered currently)

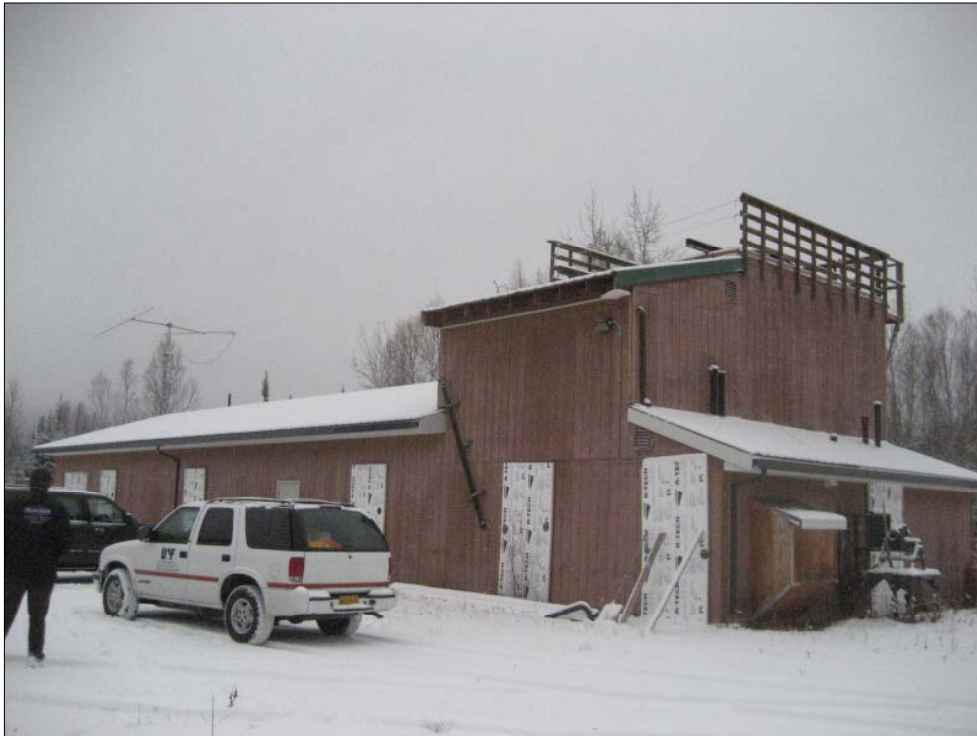
Photo 19 - Looking northeast at the exterior of the LIDAR Building

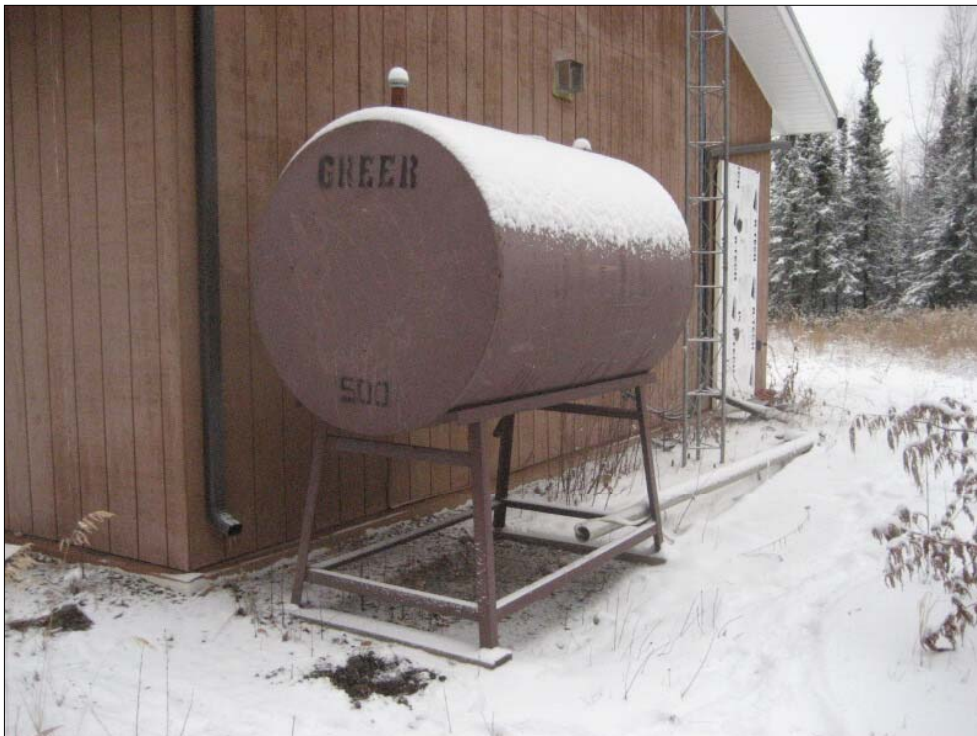
The ESA has identified two recognized environmental condition at the property, both of which are located at the LIDAR Building. The first is the reported accidental overfilling of the heating oil tank, which resulted in a release estimated to be more than 10 gallons and less than 150 gallons. No assessment or corrective action was conducted and the release has not been reported to ADEC. The tank should be removed and the release area assessed to identify vertical and horizontal limits of contamination and the potential for contamination beneath the building slab. This assessment data should be used to develop a corrective action plan. The corrective action plan should be submitted to ADEC as notification of the release and for approval of the proposed corrective action.

Photo 20 -Heating oil storage tank near northeast corner of LIDAR Building, which was reportedly overfilled but has not been reported to ADEC

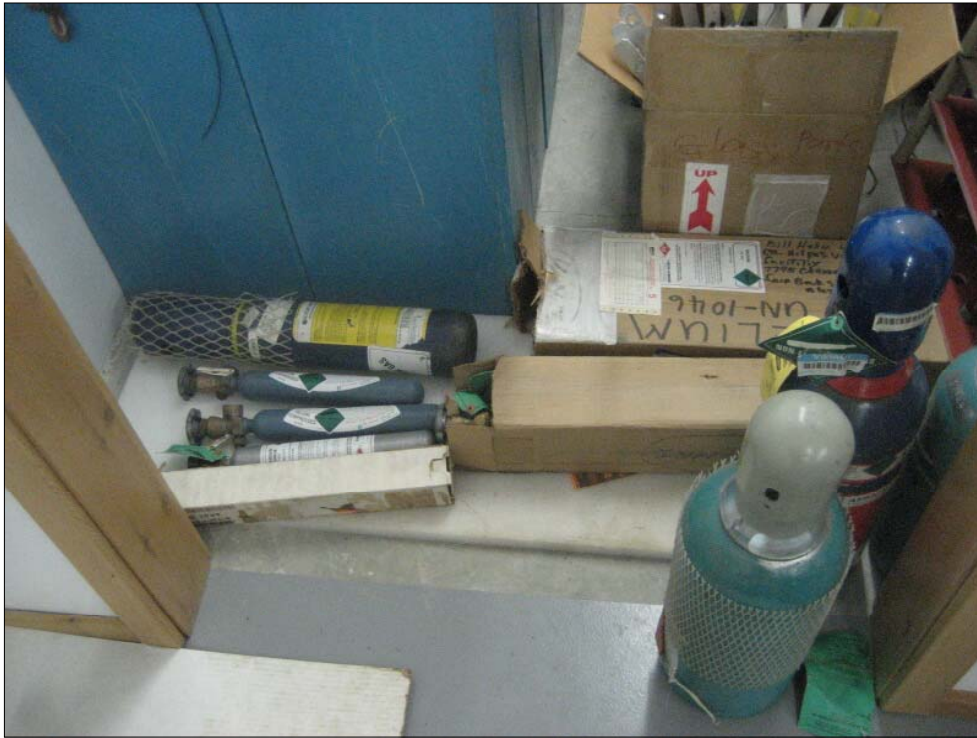
Photo 21 - Gas cylinders of various size and content located inside the LIDAR Building; several of the larger tanks have been removed while smaller tanks remain in the building

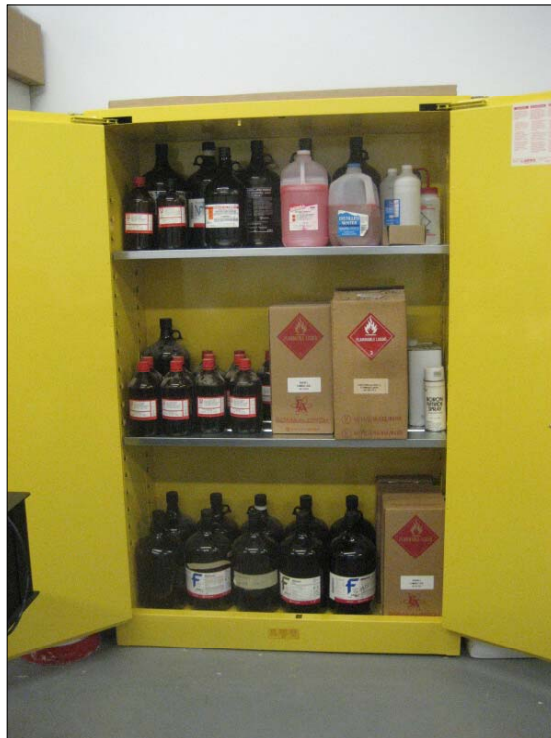
Photo 22 - Chemical storage locker inside LIDAR Building; reported to be central collection point for chemicals and not all chemicals were used in the LIDAR Building

The facility also has a variety of chemicals and cylinders stored in the buildings across the Site. In general, the research related chemicals have been consolidated in the LIDAR Building and these chemicals have been inventoried for disposal in early 2009. A central chemical storage location for the facility, such as the LIDAR cabinet, is recommended and access to this storage area should be limited. In addition to the research chemicals, small containers of paints, cleaners, and other chemicals were observed in each building. These appeared appropriate for the operation and maintenance of equipment in the area. Many of these items appeared to be old and the materials currently present should be consolidated and disposed of appropriately. New materials should be purchased and appropriate storage cabinets should be provided as necessary if the facility continues operations.

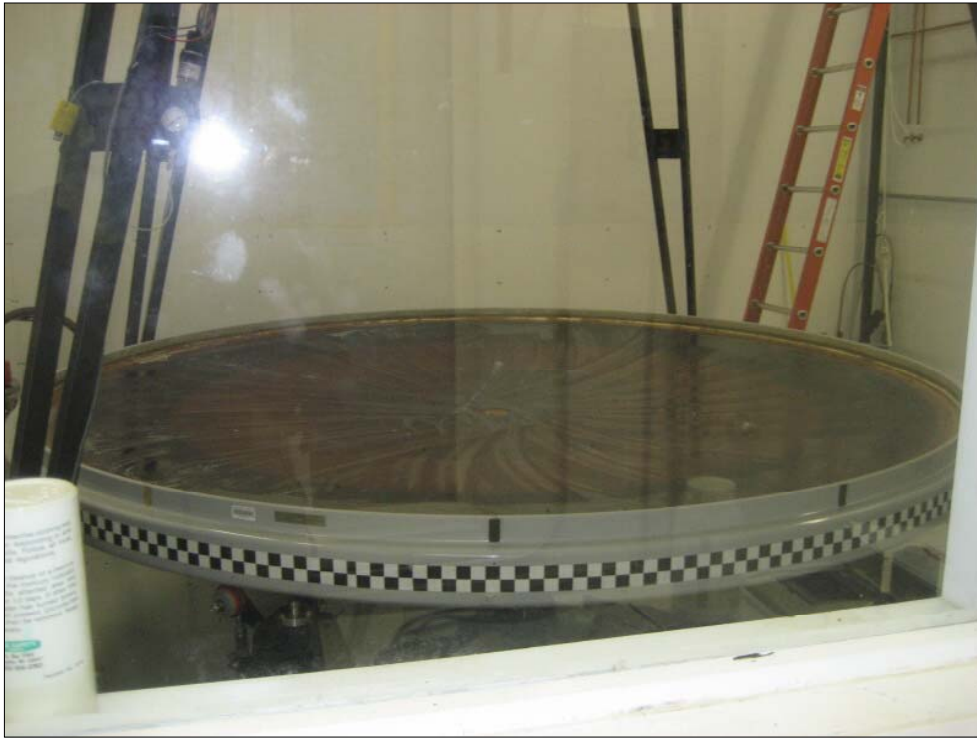
Photo 23 - Rotating mirror in sealed mirror room of LIDAR Building without mercury reflecting surface

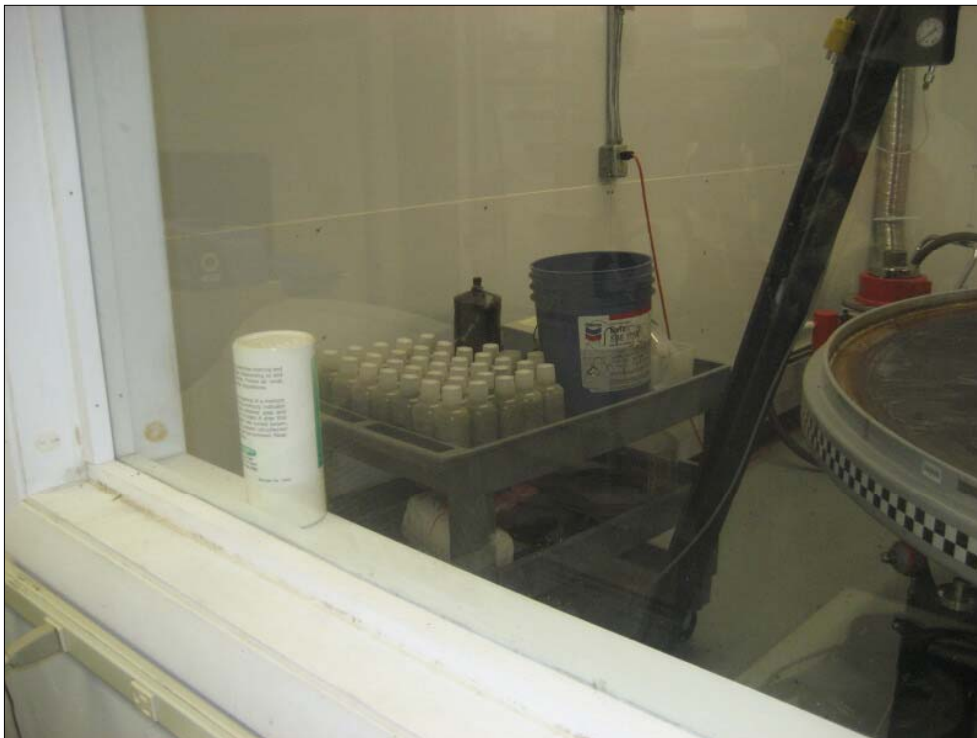
Photo 24 - Containers of mercury stored inside the sealed mirror room within the LIDAR Building
