PHASE I ENVIRONMENTAL SITE ASSESSMENT

**HIPAS OBSERVATORY
7795 CHENA HOT SPRINGS ROAD
FAIRBANKS (TWO RIVERS), ALASKA**

JANUARY 14, 2009

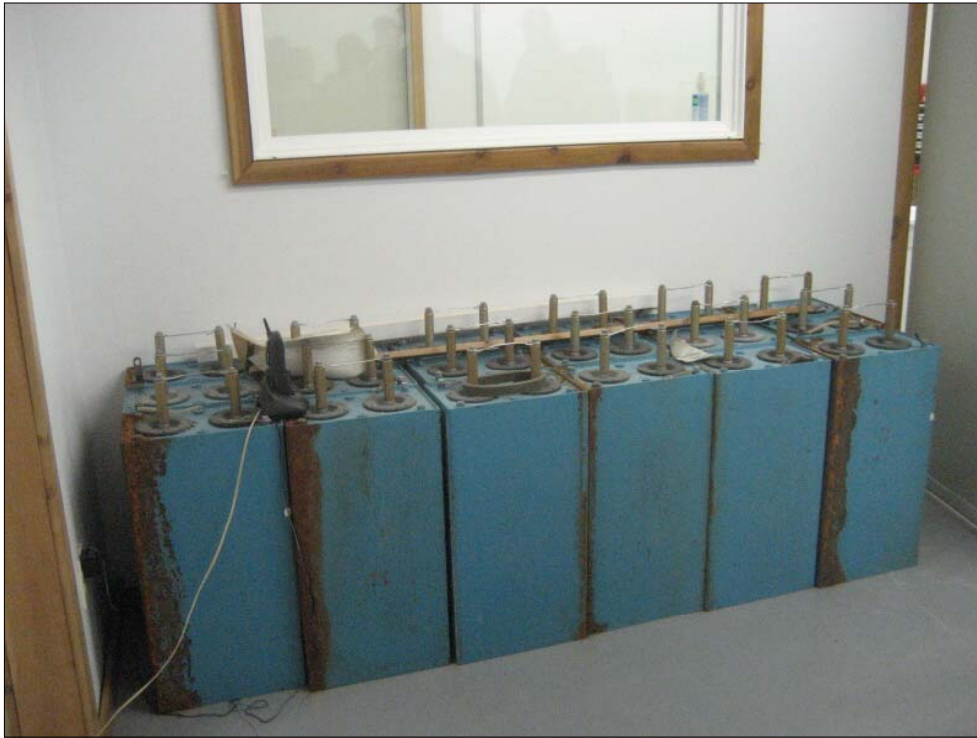
Photo 25 - Typical capacitors stored inside the LIDAR Building; similar capacitors also installed or stored in most other buildings

A wide variety of electronic equipment is present across the Site. Some units are known to contain lubricating fluid, cooling fluid, dielectric fluid, and/or other potentially hazardous substances. Proper maintenance of these items is necessary to prevent future releases during operation of the units and some units may be subject to transportation and disposal restrictions. As mentioned above, most electronic equipment is expected to have to be transported outside of Alaska for disposal if the facility is decommissioned.

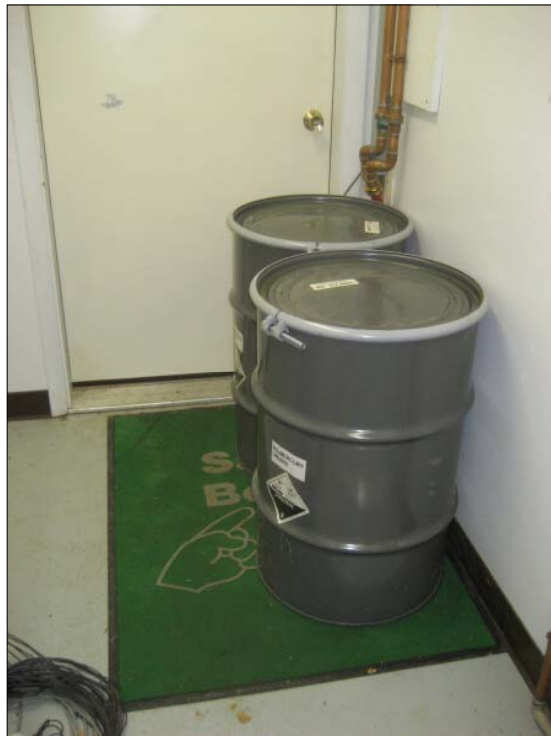
Photo 26 - Drums reportedly used as shipping containers for mercury switches related to laser installations inside the LIDAR Building

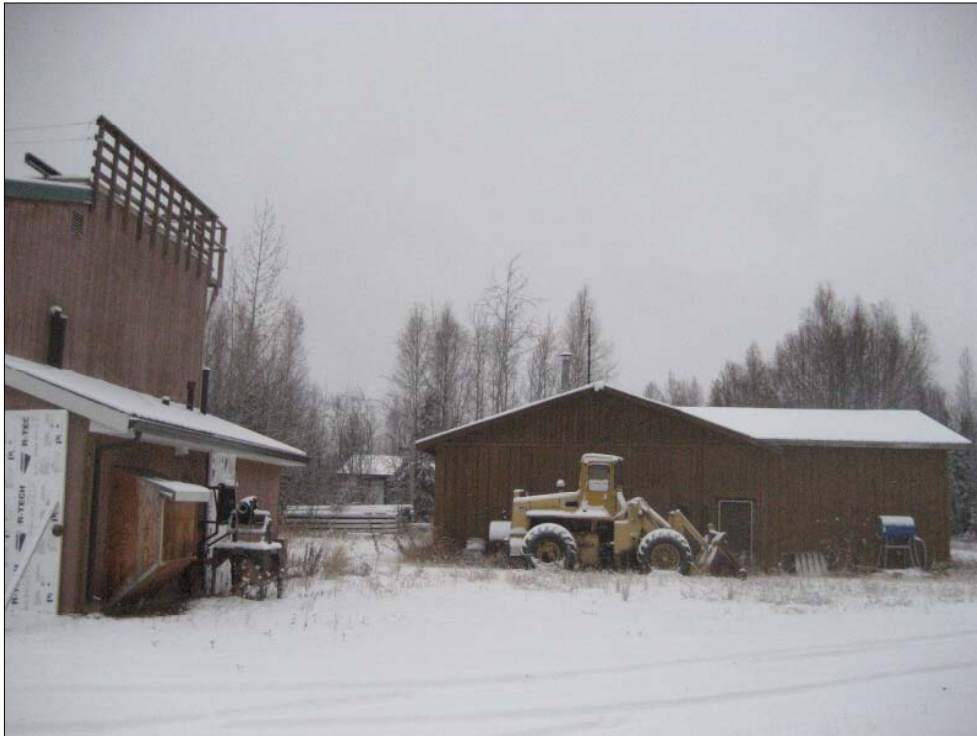
Photo 27 - Looking east across the front of the LIDAR Building at the west side of the Garage/Shop with fuel drum and heating oil tank visible

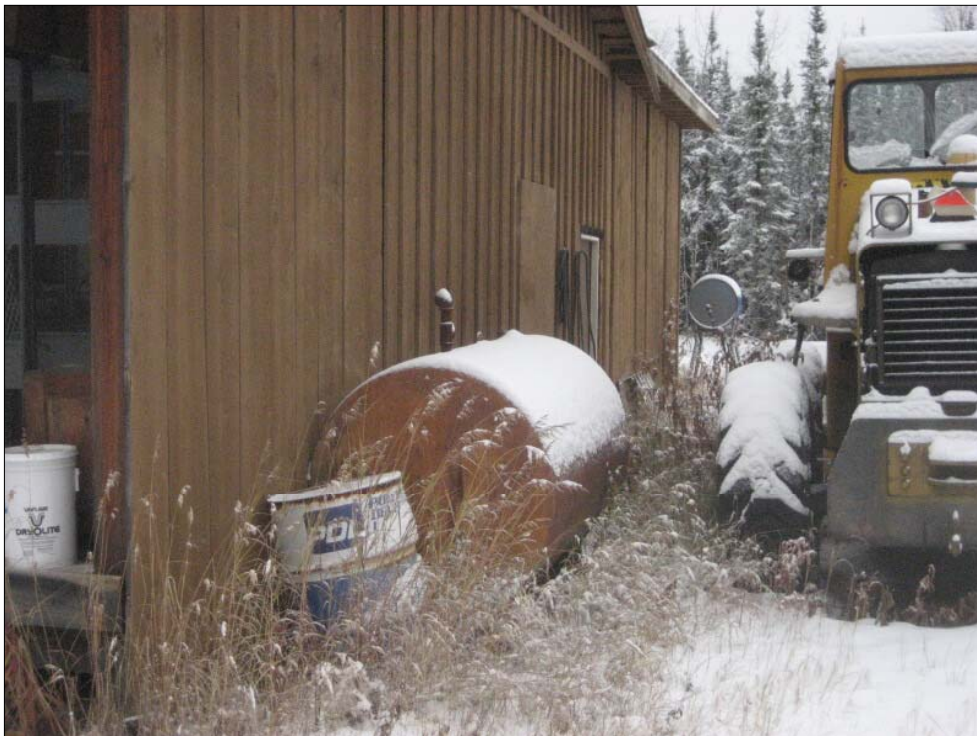
Photo 28 - Detail view of heating oil tank on west exterior wall of Garage/Shop with fuel dispensing drum in background

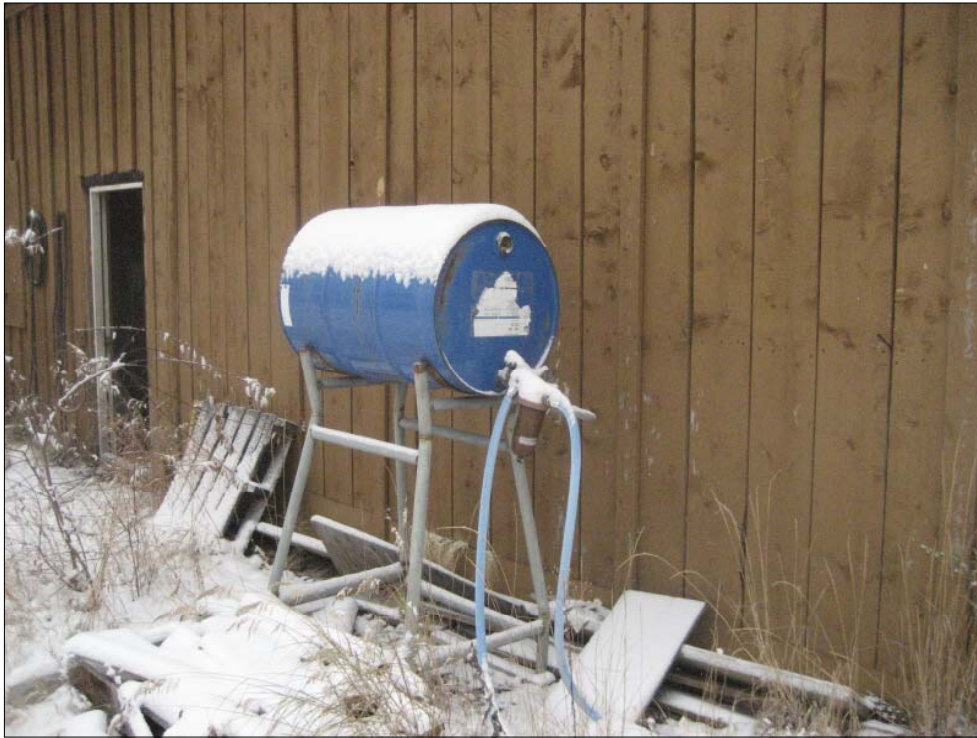
Photo 29 - Drum used as gasoline fuel dispenser along west exterior wall of Garage/Shop

Aboveground storage tanks (ASTs) for heating oil are located adjacent to each heated structure. The exception is the Generator and Transmitter Buildings which share a tank that is also used to fuel the generators. The facility exceeds the minimum aboveground storage threshold within the SPCC Plan regulations and an SPCC Plan has not been developed for the facility. Development of an SPCC Plan is recommended if portions of the facility will continue operation. Each AST installation was observed to need one or more upgrades to comply with the SPCC regulations, including secondary containment and/or appropriate engineering controls. Replacement of several of these tanks may be more cost-effective than trying to upgrade the units. The ground surface beneath each tank should be inspected for potential contamination during removal or upgrades and all fuel lines should be inspected for potential leaks and weeping. The drum used as a gasoline dispenser by the Shop should be removed.

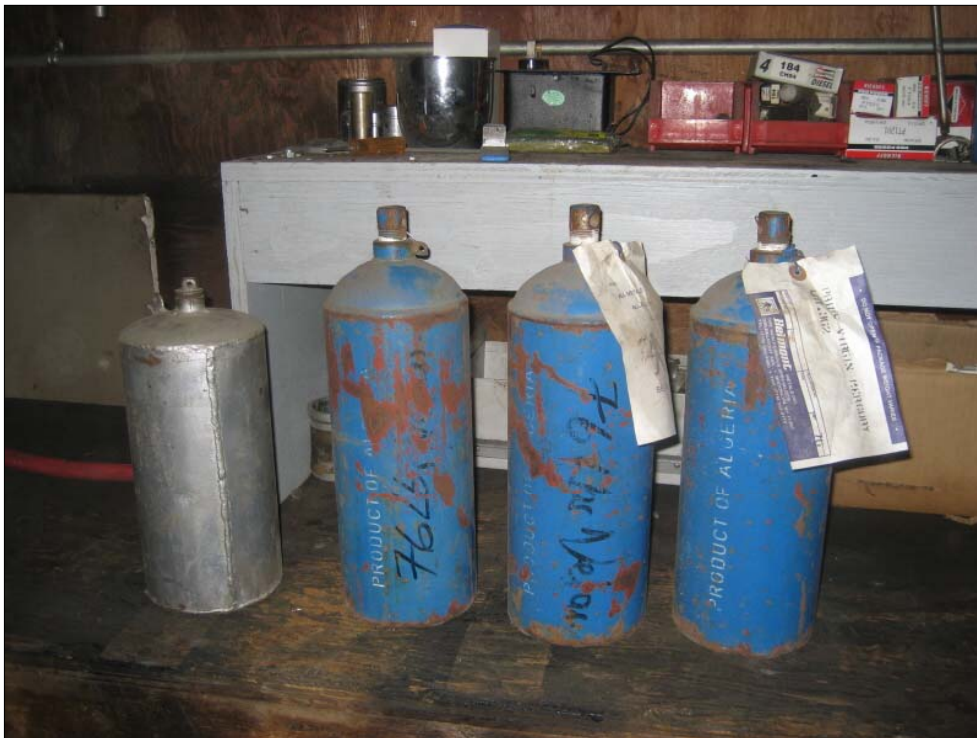
Photo 30 - Steel cylinders (empty) used for transportation/delivery of mercury located inside the Garage/Shop

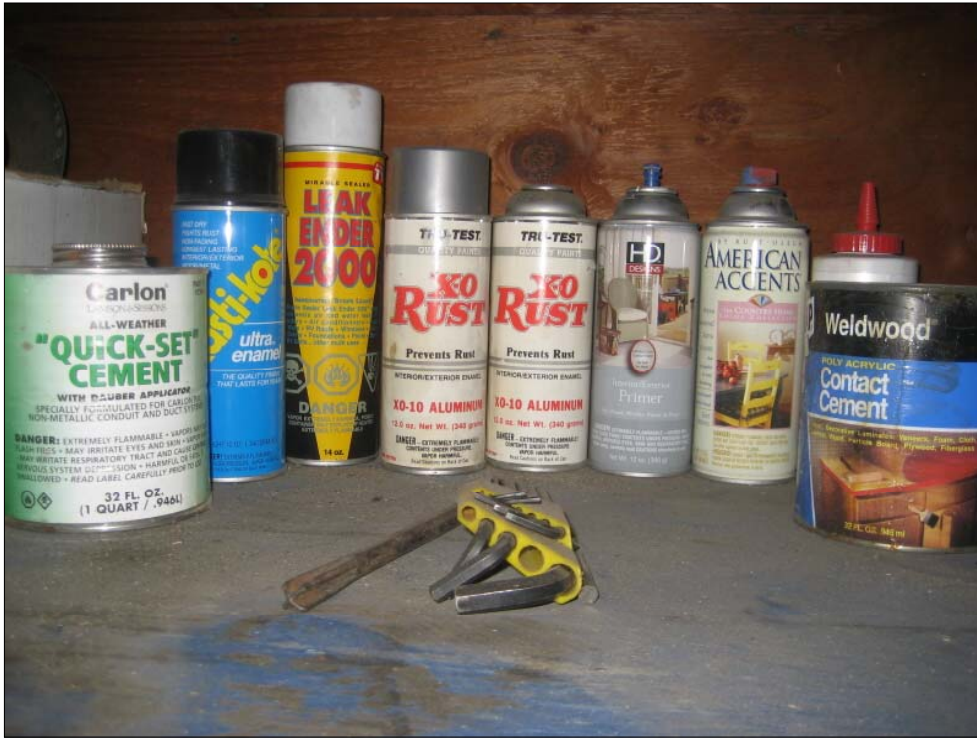
Photo 31 - Typical storage of miscellaneous materials (paint and cement in this image) inside the Garage/Shop; similar materials stored in the Generator Building and likely to be present in other buildings

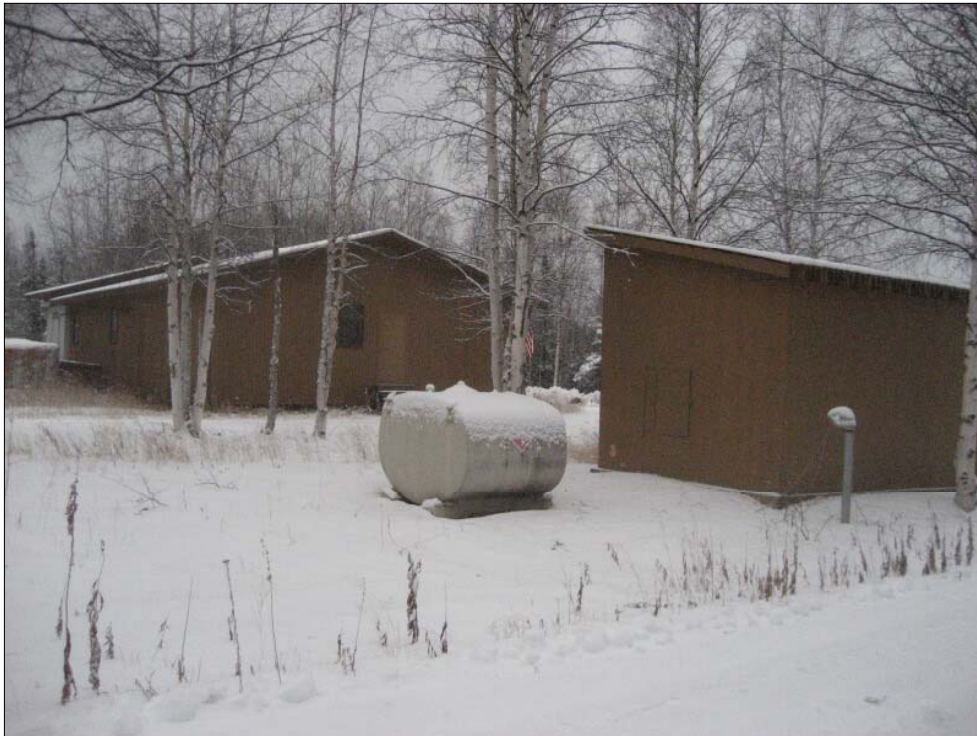
Photo 32 - Looking north the emergency generator building (foreground right) and associated fuel storage tank with at the Bunkhouse in the background

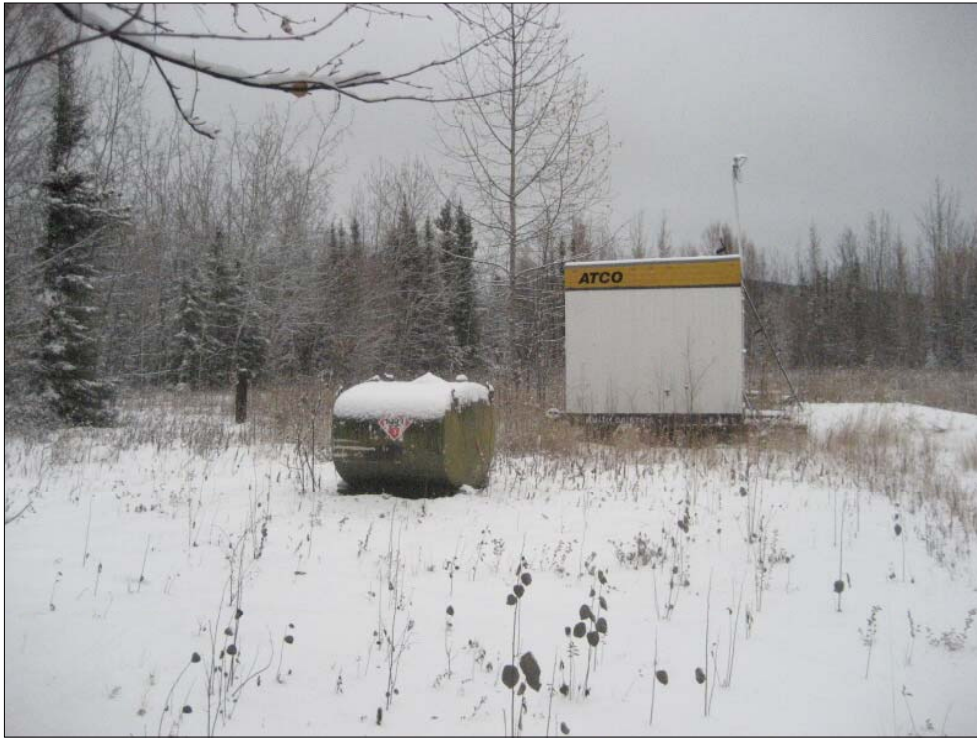
Photo 33 - Looking south at the ATCO unit and associated fuel storage tank

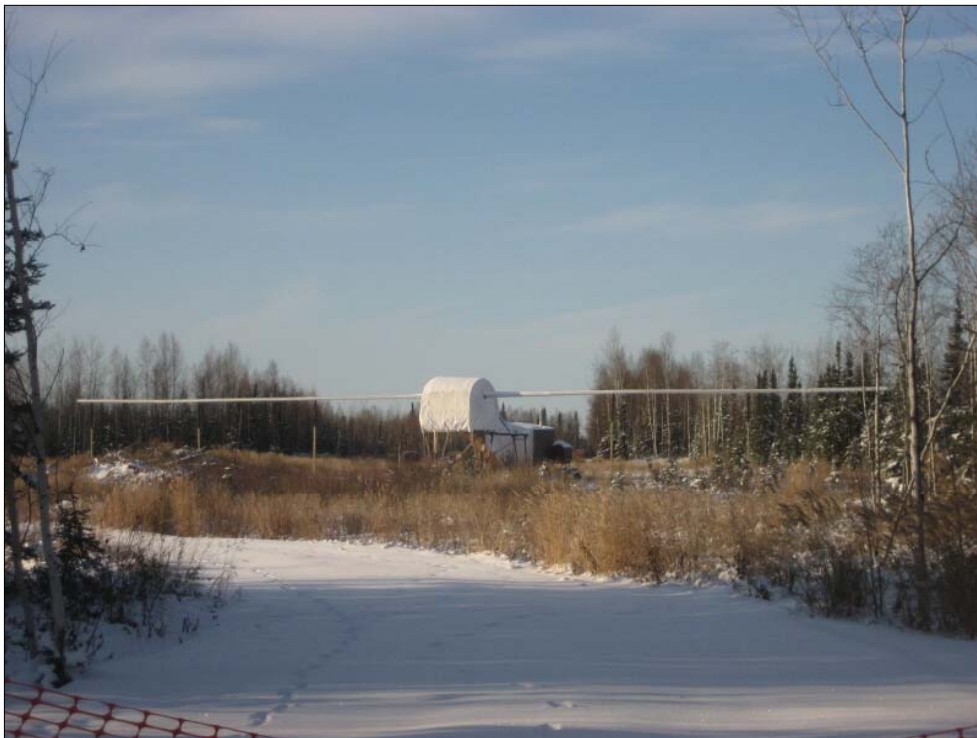
Photo 34 - Looking west at the more recent Dipole Antenna and associated structure, that includes a heating oil storage tank located to right of the small building
