CRREL REPORT

# Preliminary Assessment of Sedimentation and Erosion in Eagle River Flats, South-Central Alaska

Daniel E. Lawson and Bruce E. Brockett

December 1993

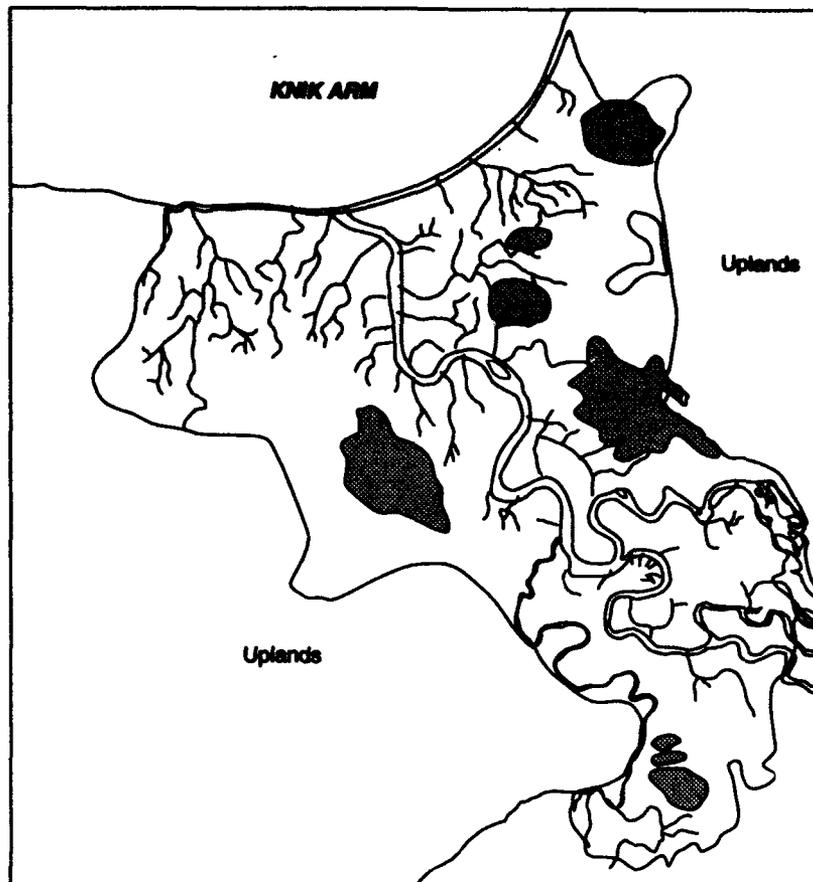
*Figure 3. General distribution of ponds (shaded area) and the primary drainage system of gullies and vegetated channels within ERF.*

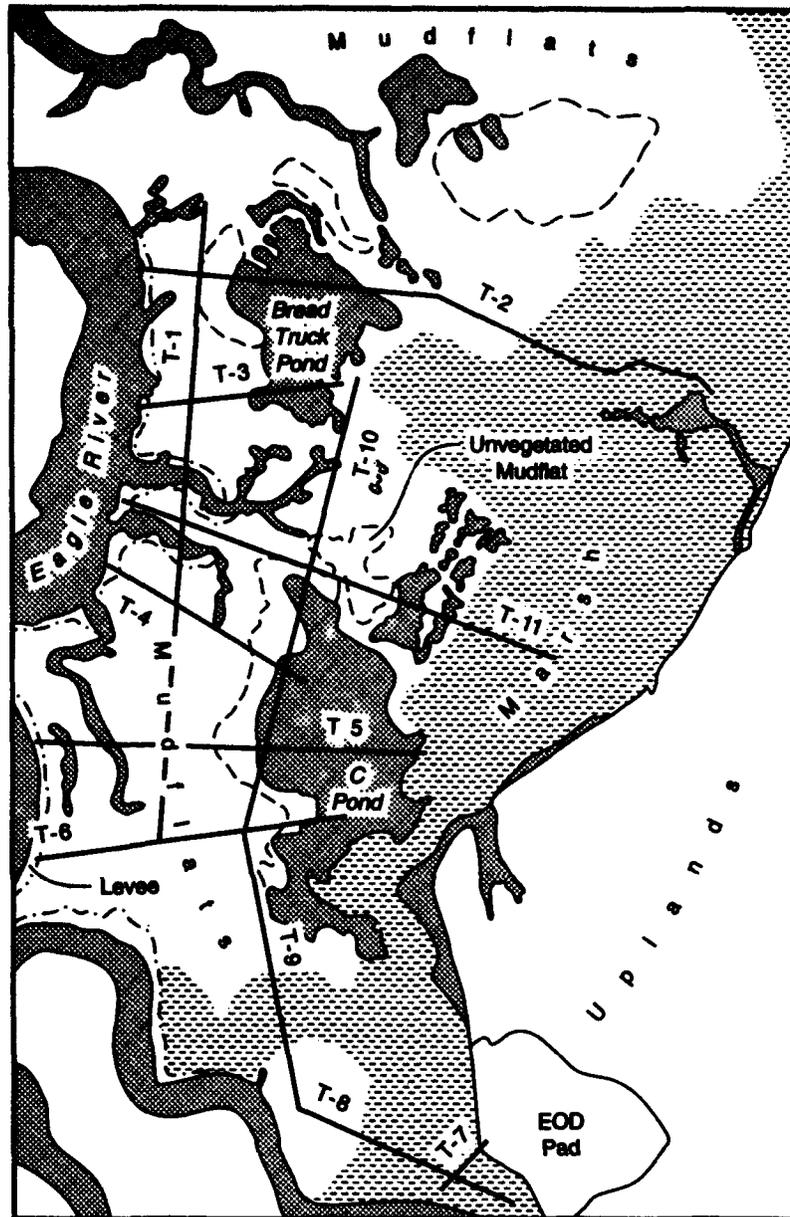
Figure 4. Location of surveyed transects within the areas around the C and Bread Truck ponds.

Our study focused on the central area of ERF, east of the Eagle River in the vicinity of Bread Truck Pond and Pond C (Fig. 4). The basic morphological terrain units here include levees, gullies, upper vegetated mudflats, lower unvegetated mudflats, ponds and marshes. These morphological units were defined by combining ground ob-

Morphological terrain units in the study area are generally distributed relative to the Eagle River and the adjacent uplands (see Fig. 4). As with vegetation, a zonal pattern exists, with the following general sequence: levees, mudflats, unvegetated mudflats, intertidal ponds and marshes. Freshwater dominated ponds about the uplands in several areas where stream and groundwater-fed springs discharge. There are significant levee deposits along the Eagle River and adjacent to gullies near their juncture with the river. Gullies extend generally eastward toward the uplands, joining vegetated drainage channels on the upper mudflats that extend into the ponds and marshes.

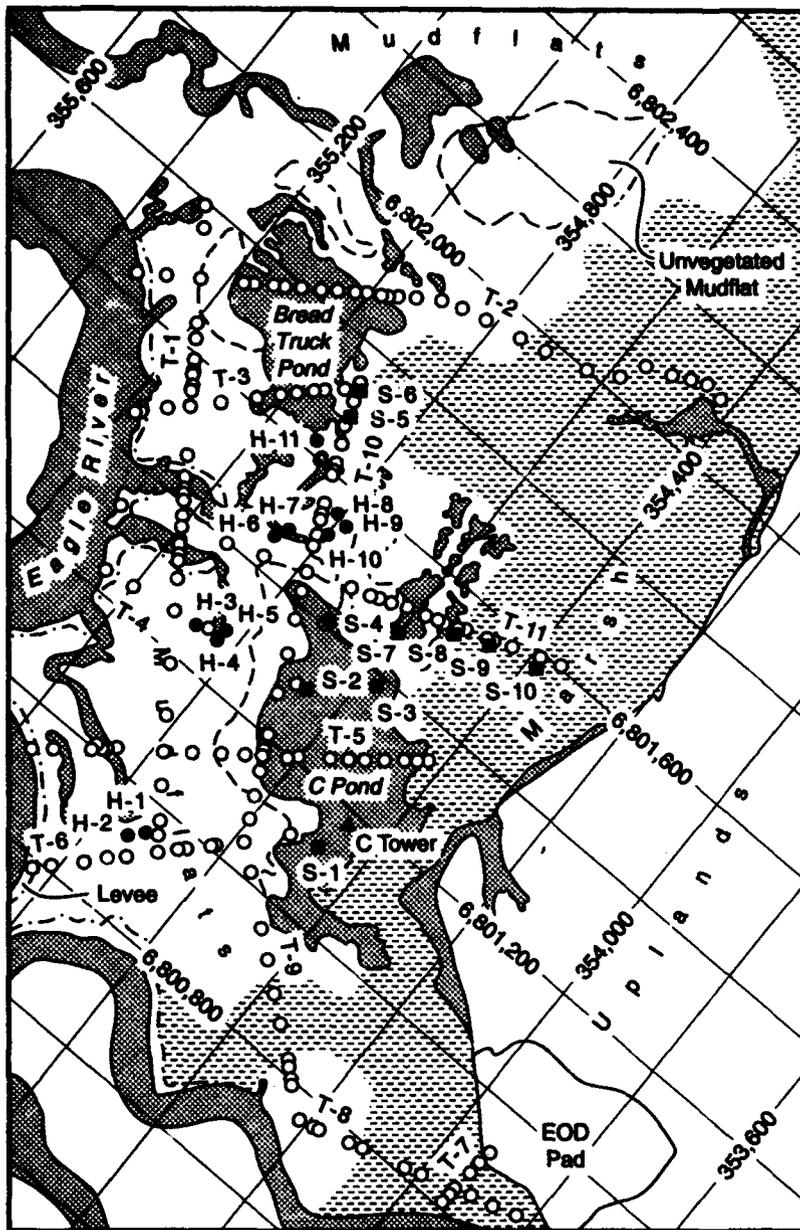
Figure 5. Surveyed locations of 156 surface grab samples on 11 transects east of Eagle River (open circles) relative to UTM grid. Open circles also mark locations of sedimentation stakes. Also located are 10 sediment (S-no., filled squares) and 11 gully headwall erosion measurement sites (H-no., filled circles).

surveyed and sampled 156 locations along 11 transects (Fig. 5).

Sedimentation rates were also measured at 10 sites located within several of the ponds (Fig. 5). We expected these rates to be extremely low and possibly affected by resuspension of bottom sediments during the process of obtaining data. It was therefore unclear to us what relatively simple method would produce reasonably accurate results within the ponds; therefore, we used three methods at each site.

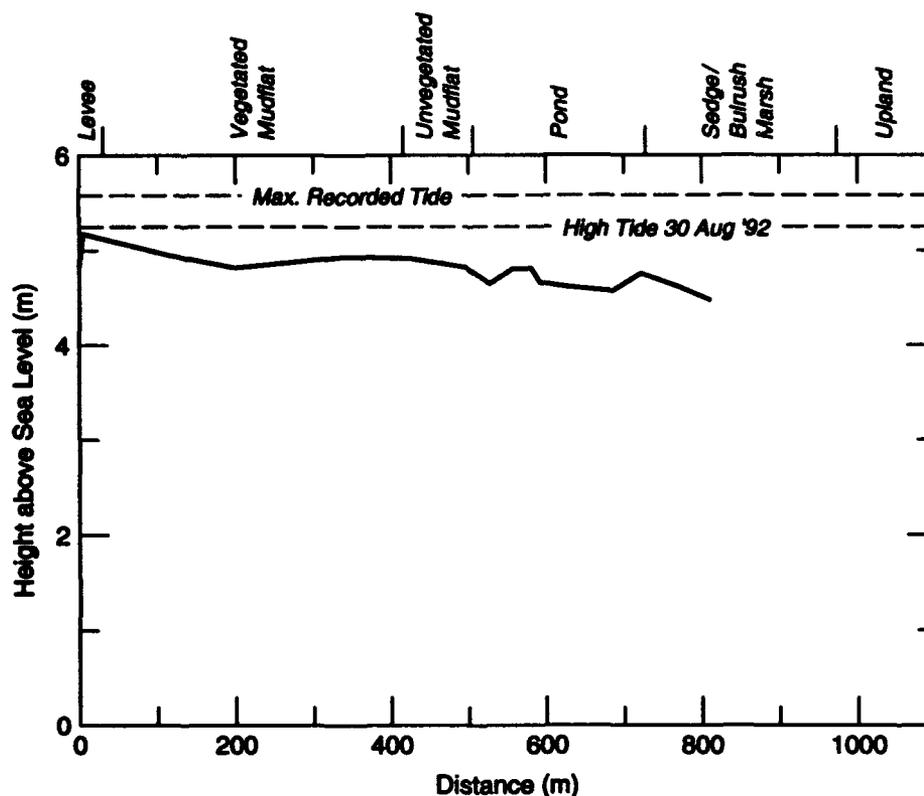
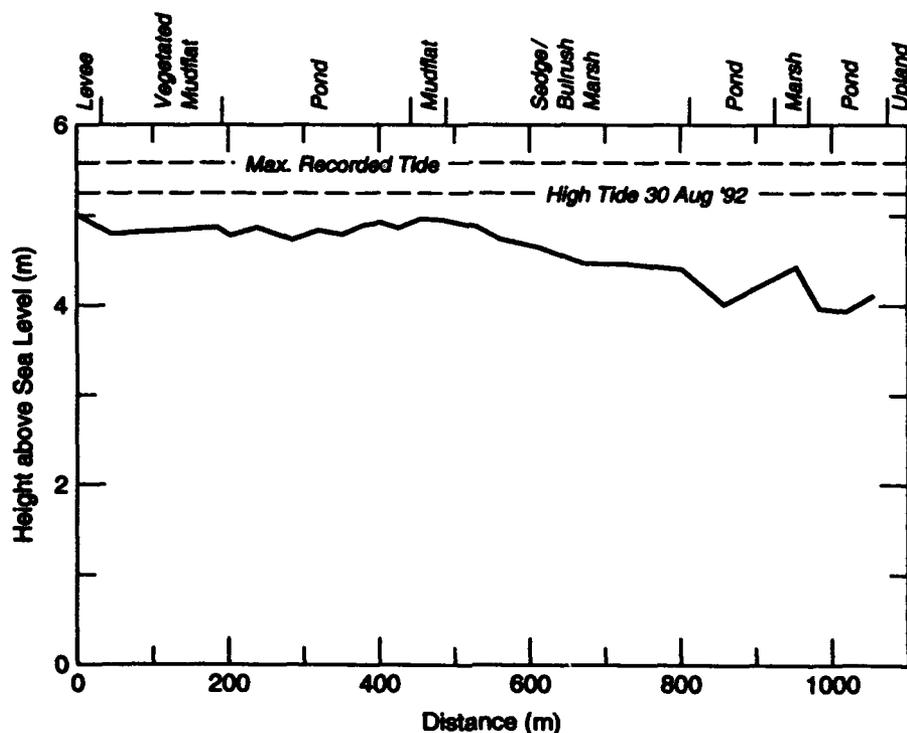
a. Transect 11.

Figure 9. Transects with approximate boundaries of morphological units.

Excluding gullies, the distribution of morphological units is related to elevation (Fig. 9). Elevation generally decreases as much as 1.0 m from the tops of levees along Eagle River to the bottoms of marshes next to the uplands. Levee surfaces lie about 5 m above the Eagle River bed. The active

Two tide levels, the maximum recorded and the highest tide during the period of study (10.12 m, Anchorage tide datum, 30 August 1992), are shown on Figure 9. Levee elevations suggest that only tides in excess of 10.09 m completely inundate the study area. This height, however, neither accounts for water discharging in the Eagle River nor the effects of a southeasterly prevailing wind during tidal flooding. If discharge is high, such as during spring when snowmelt runoff is at a maximum, or during a river flood, the combined backup and overflow of the river by tidal flood waters can effectively increase the volume of flood waters and result in inundation of a greater area of ERF than tide levels alone suggest.

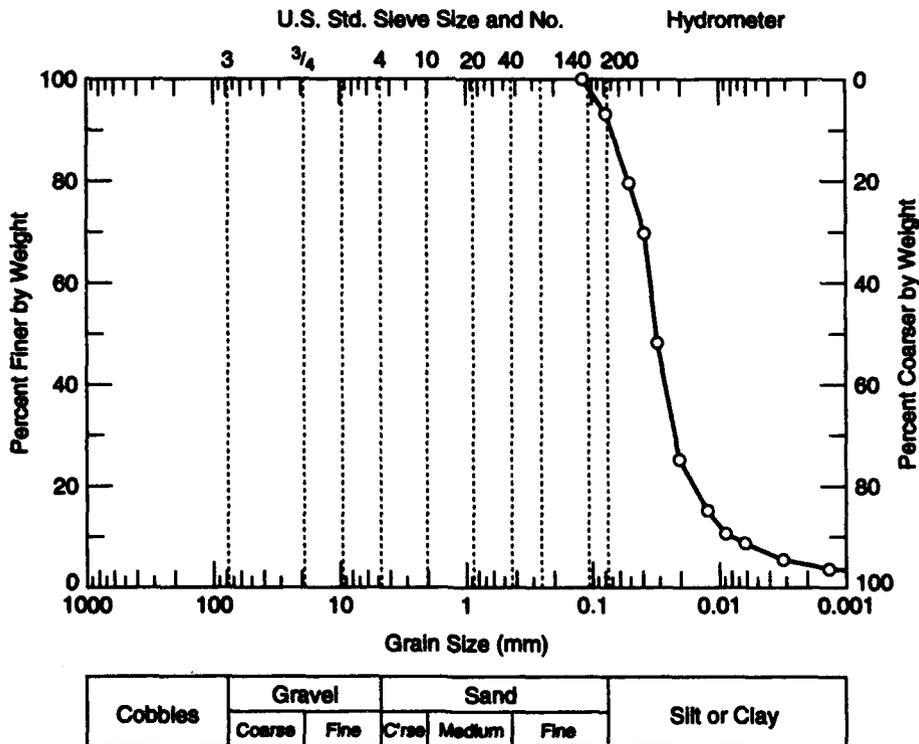
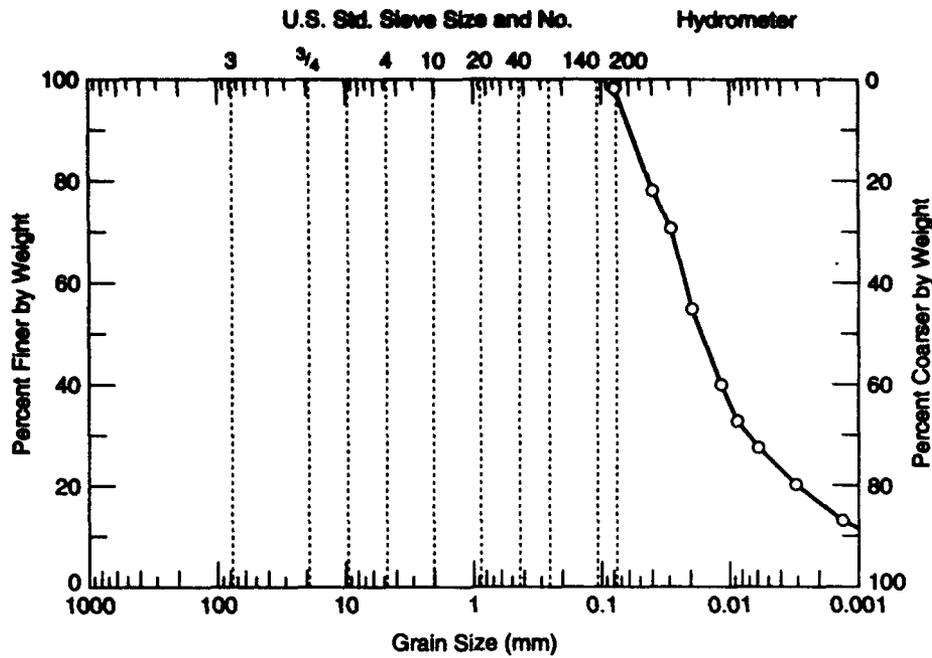
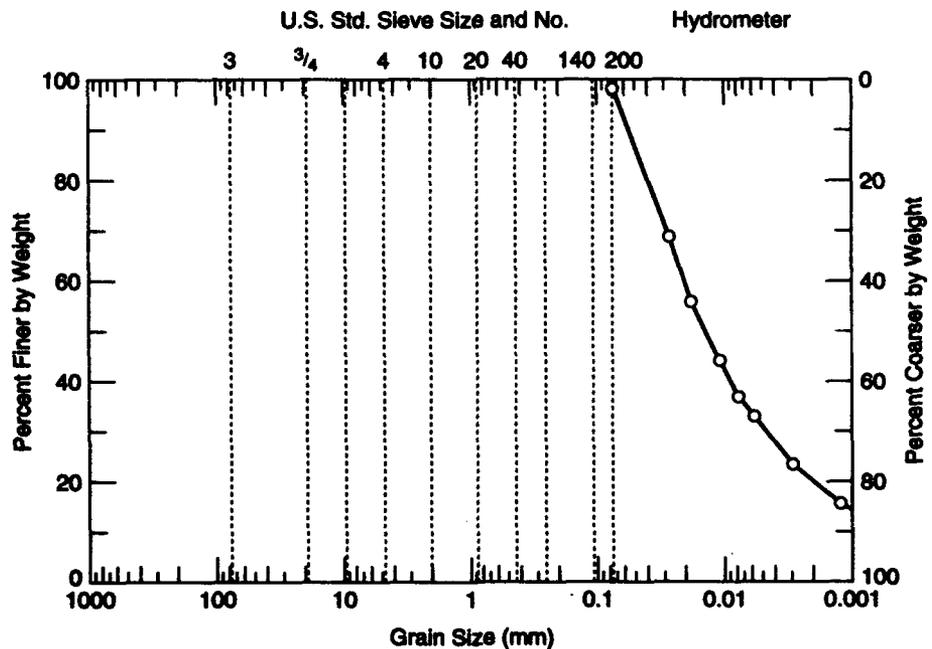
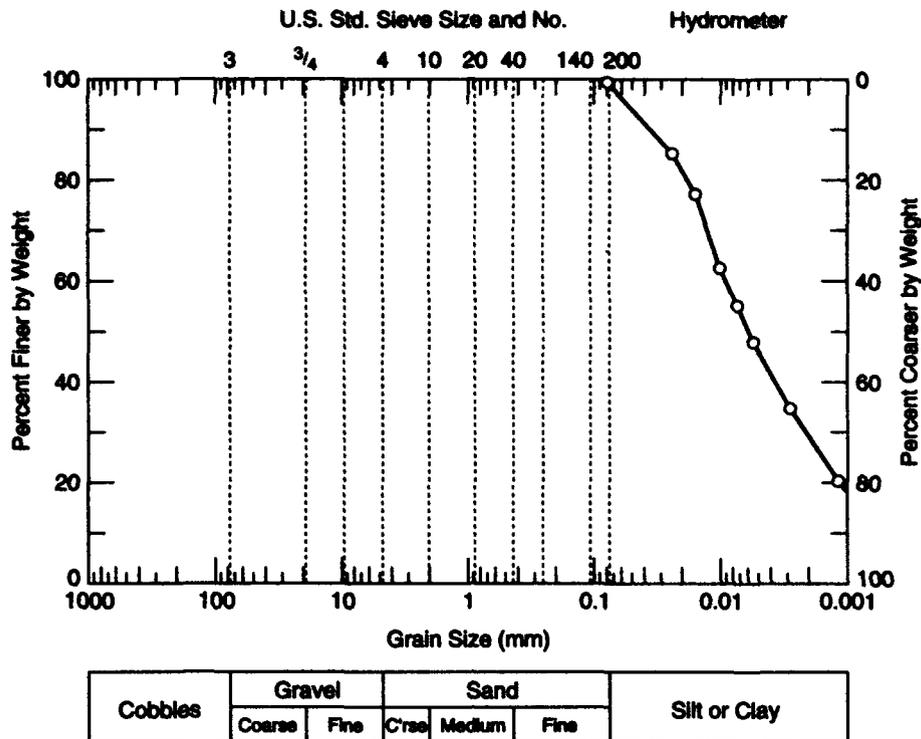
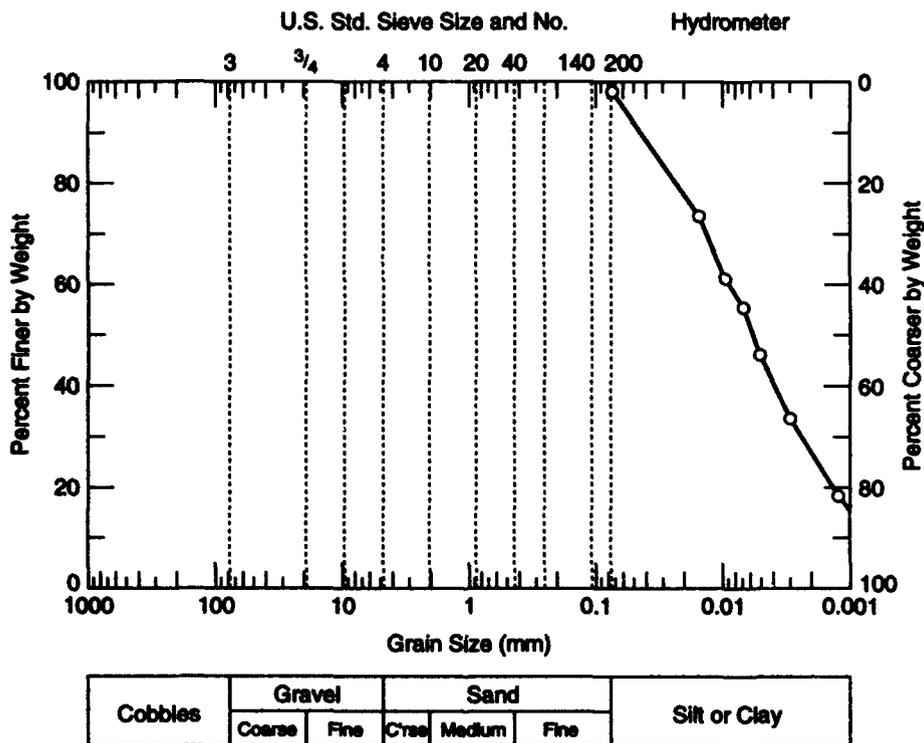
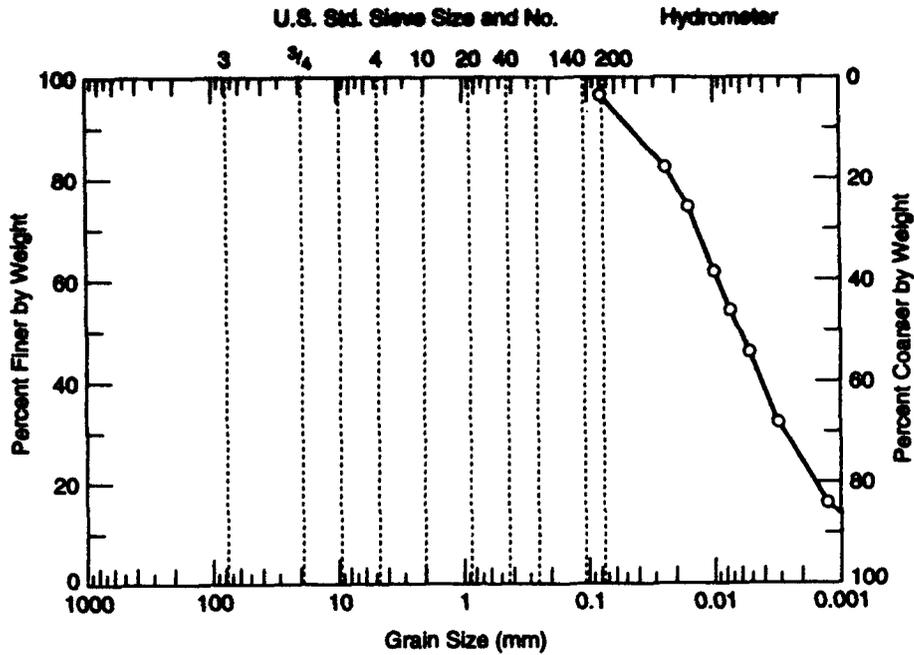
a. Levee.

Figure 10. Representative cumulative curves of grain size distribution for morphological units.

The grain size distribution of surface materials also varies with morphology. Sediments generally are silt- and clay-size, with fine sand (less than 3%) present only in levee deposits. The primary modal fraction typically ranges from medium to fine silt (0.04 to 0.02 mm) but may be clay-size in some pond samples. Organic content is typically less than 5%. Figure 10 presents cumulative grain size distribution curves representative of the 156 samples analyzed from the 11 transects.

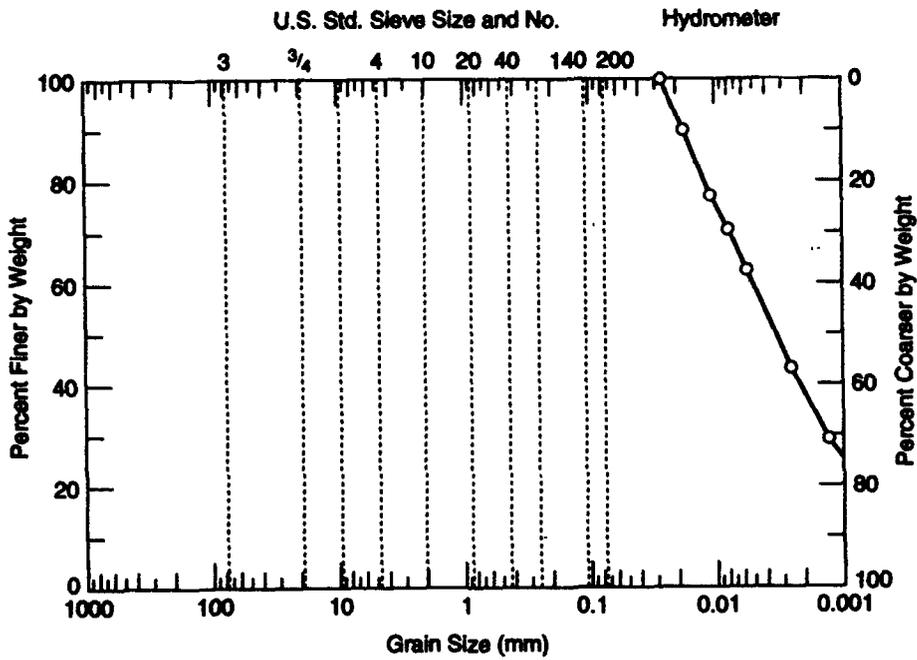
*g. C pond.*

*Figure 10 (cont'd).*

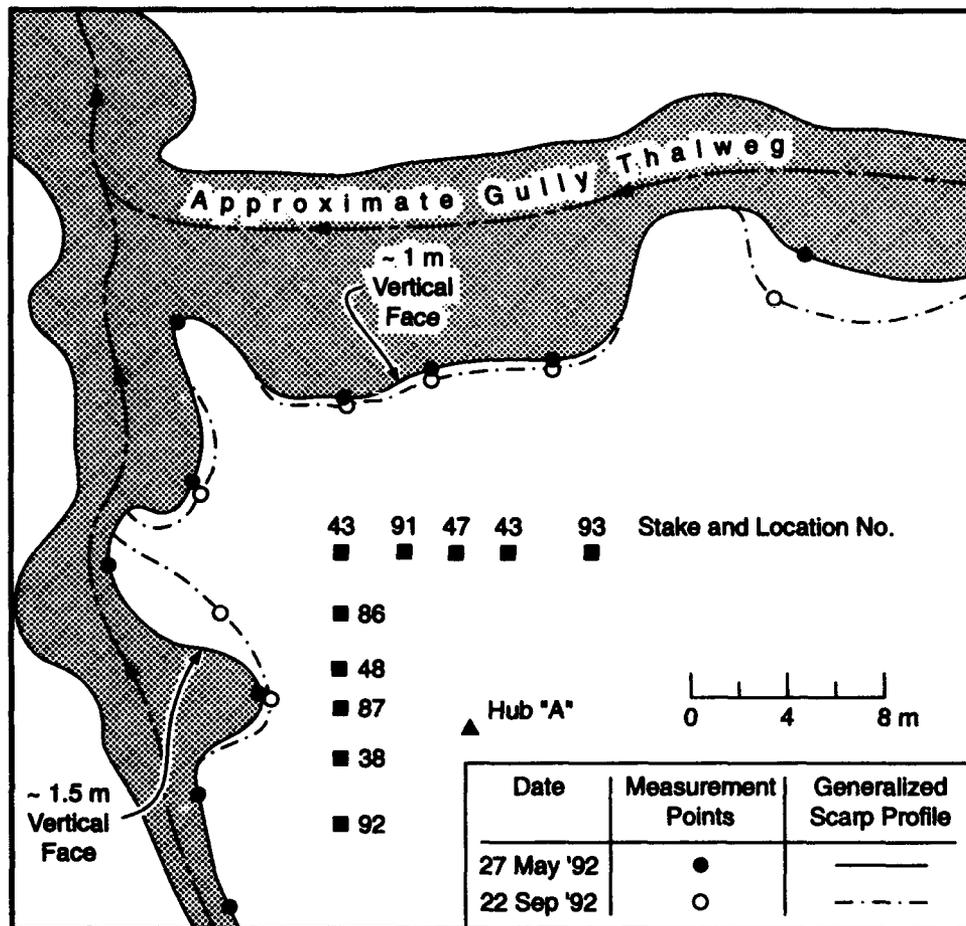
Figure 11. Schematic of gully headwall erosion site illustrating the variability in location and rate of recession common to each of the 11 sites analyzed in 1992 from 28 May to 22 September.

We measured the composite rates of recession resulting from erosion of the gully headwall and adjacent lateral wall for 28 May to 22 September 1992. The amount of recession of the scarp crests was highly variable within a gully, as well as among the 11 headwall erosion sites (Fig. 11). Maximum rates at each site ranged from 0.2 to 3.9 m, while parts of each monitored headwall did not retreat (Table 4).

The variability in recession reflects the nature of the erosional processes. Recession is mainly caused by erosion by currents and the subsequent failure of the lower, unvegetated part of the near-vertical gully walls (Fig. 12). The uppermost 20 to 30 cm of material is consolidated and root-bound; this soil and root mat is undermined by current erosion and only fails after an approximately 0.5-m or deeper niche is cut below it. Block collapse follows and further action by currents eventually breaks

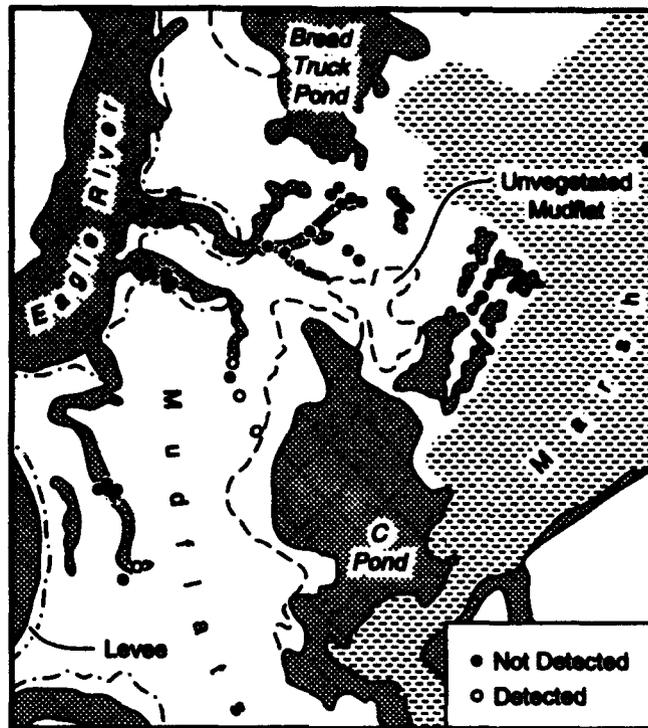
Figure 14. Location of gully samples analyzed for WP content. Three samples from pools within the thalweg tested positive for WP.

We obtained 25 samples of sediment from the bottoms of gullies following monthly tidal floodings (Fig. 14). These samples were taken from the most recent deposits within the gully channels, mainly those in pools within the channel thalweg that we thought were deposited from suspension by settling out of the ebb discharge. In some cases, however, these materials may have originated in part from local materials composing adjacent lateral slopes and headwalls of the gullies, rather than the ponds and mudflats.
