95-5

CRREL REPORT

# Initial Analyses of Eagle River Flats Hydrology and Sedimentology, Fort Richardson, Alaska

Prepared for  
U.S. ARMY ENGINEER DISTRICT, ALASKA

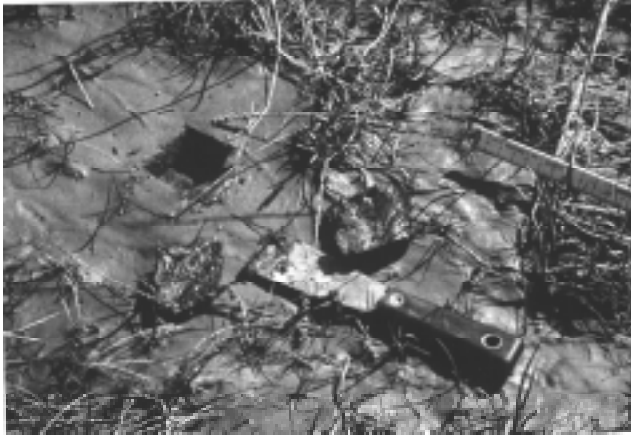
*Figure 6. Paint layer within block of sediment as measured to define sedimentation rates.*

We also monitored the amount of accretion at transect survey points by spraying an area (30 × 30 cm) on the ground surface with pavement marking paint and locating the corners of this area with wire survey flags. Net accumulated sediment is measured by cutting and removing a 2- × 2-in. (5- × 5-cm) block of sediment with a putty knife (Fig. 6). The thickness of sediment above the paint layer is then measured to the nearest 0.5

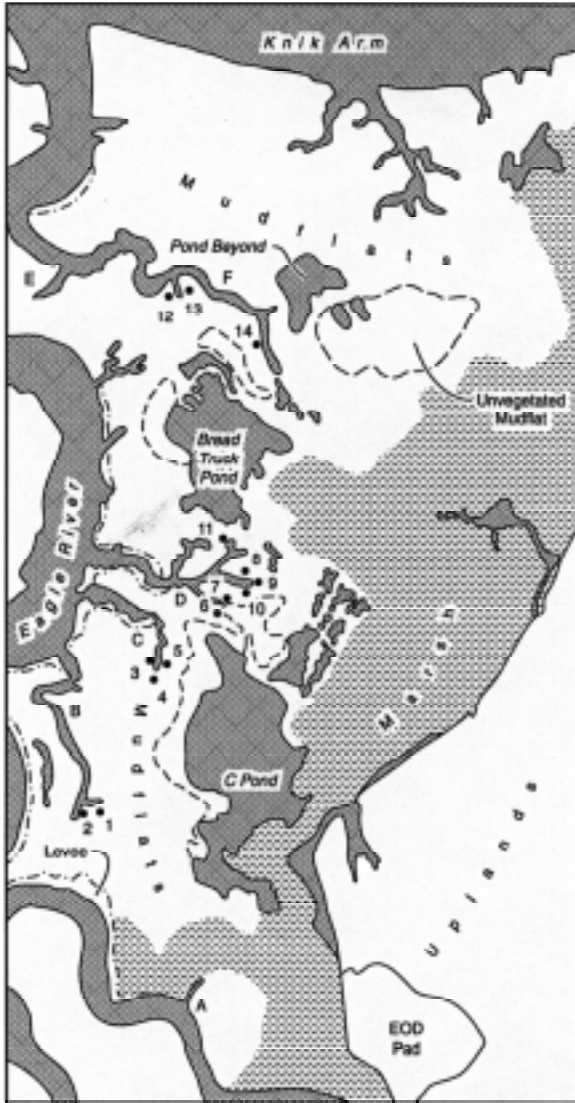
Figure 8. Location of gully headwall erosion study sites.

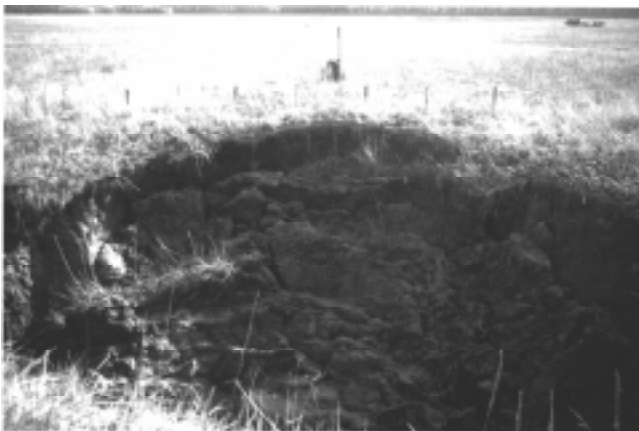
Figure 9. Headwall erosion study site. The line of stakes approximately parallels the gully crest. The hub stake is to the right of center behind the stake line.

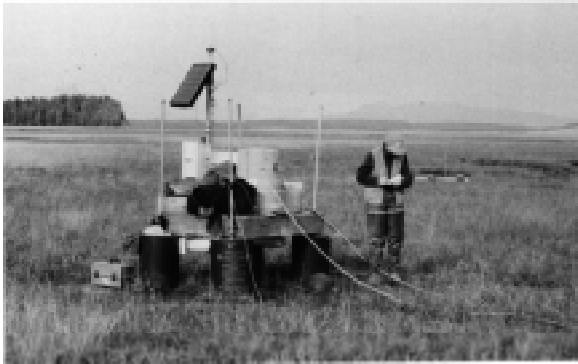
*a. Platform.*

*b. Sensor detail.*

**Figure 12. Platform and instrumentation measuring discharge characteristics at the Bread Truck gully location.**

5-ft (1.5-m) sections of 0.75-in. (2-cm) diameter steel pipe were mounted vertically in large cans filled with concrete, and the eyehooks mounted on the platform's wood frame were lowered over them. Foam filled the inner space of the deck framework and provided flotation so that the platform could move vertically up or down the steel pipes during tidal inundation and ebb. The platforms allowed us to establish monitoring stations without setting stakes or foundations in the ordinance-bearing mudflat sediments and, at the same time, keep the data loggers and related devices dry even under the highest flood levels.

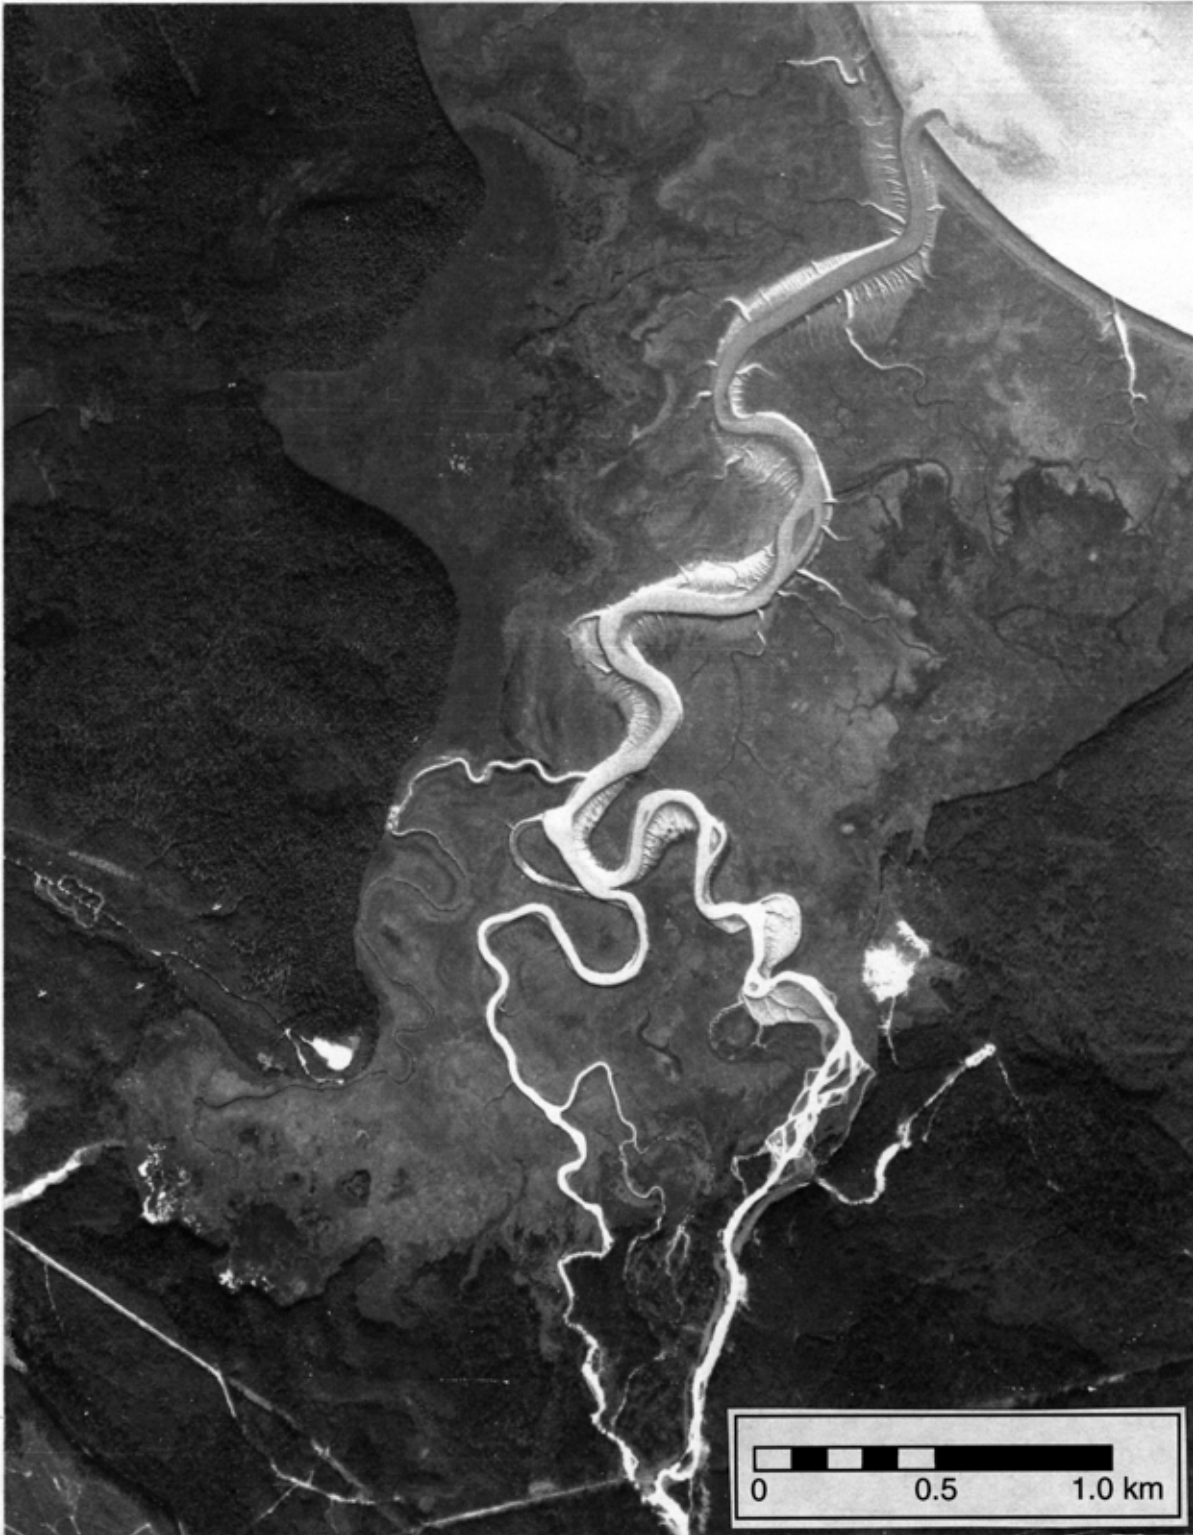
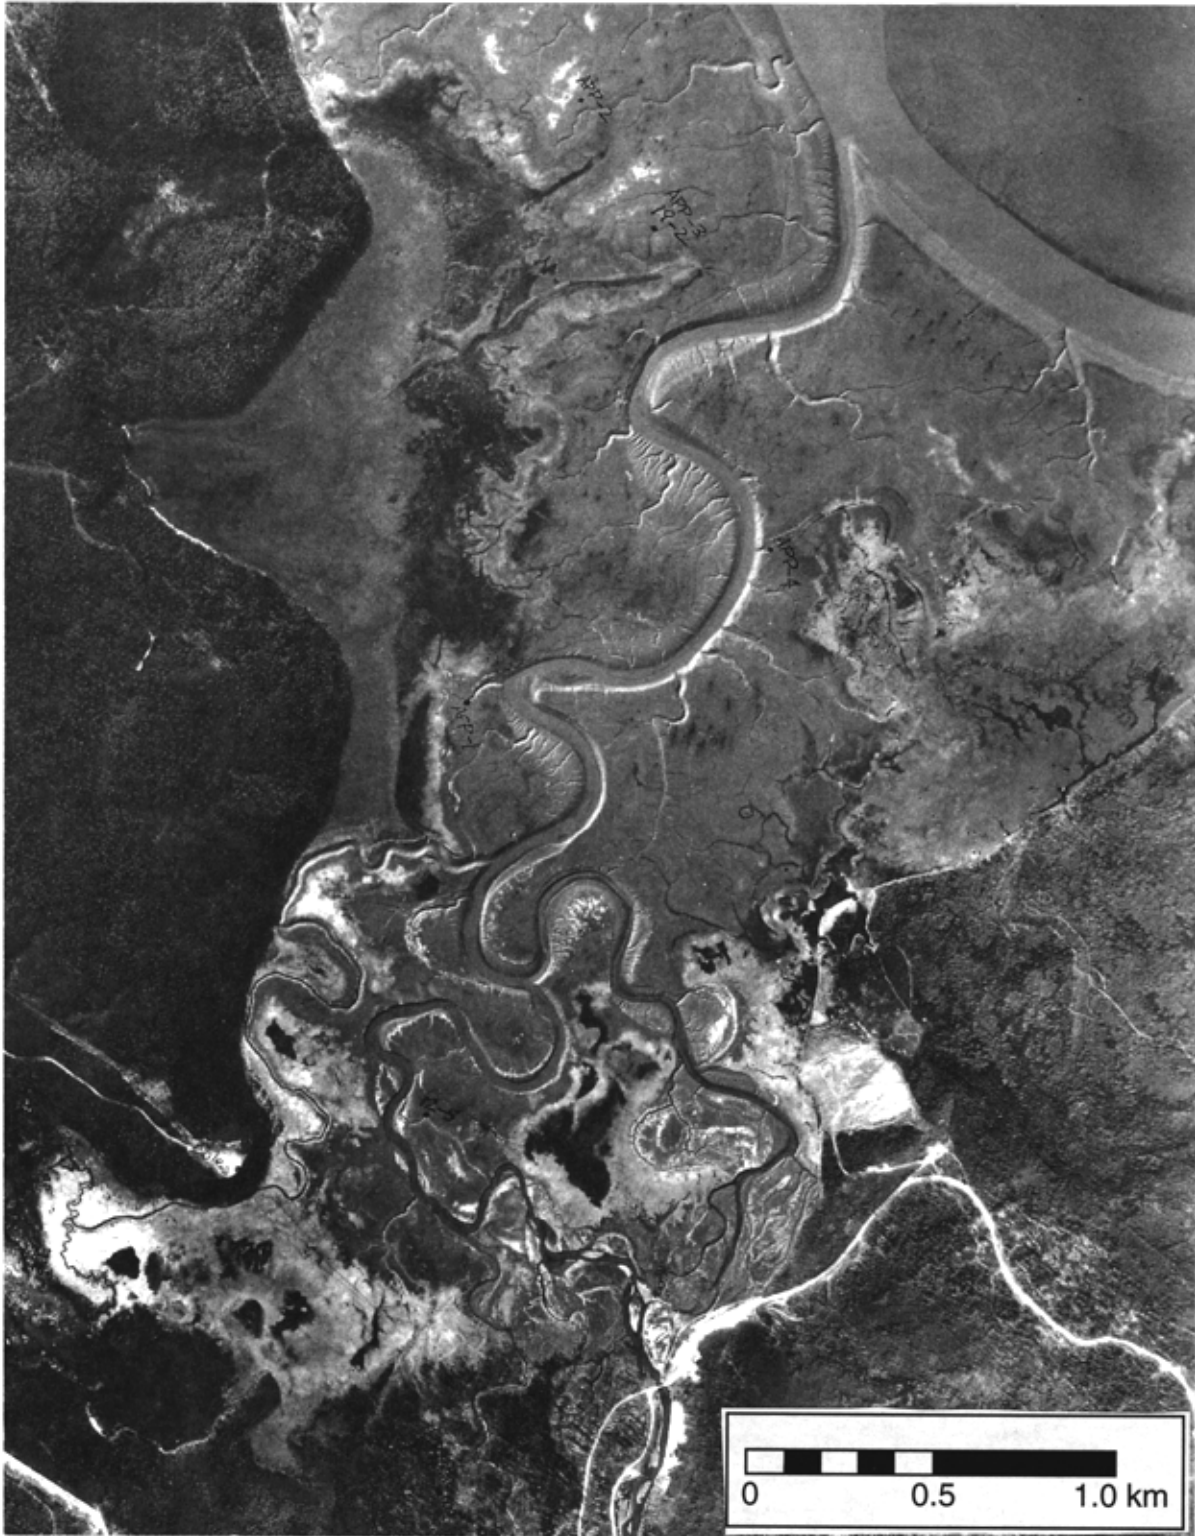
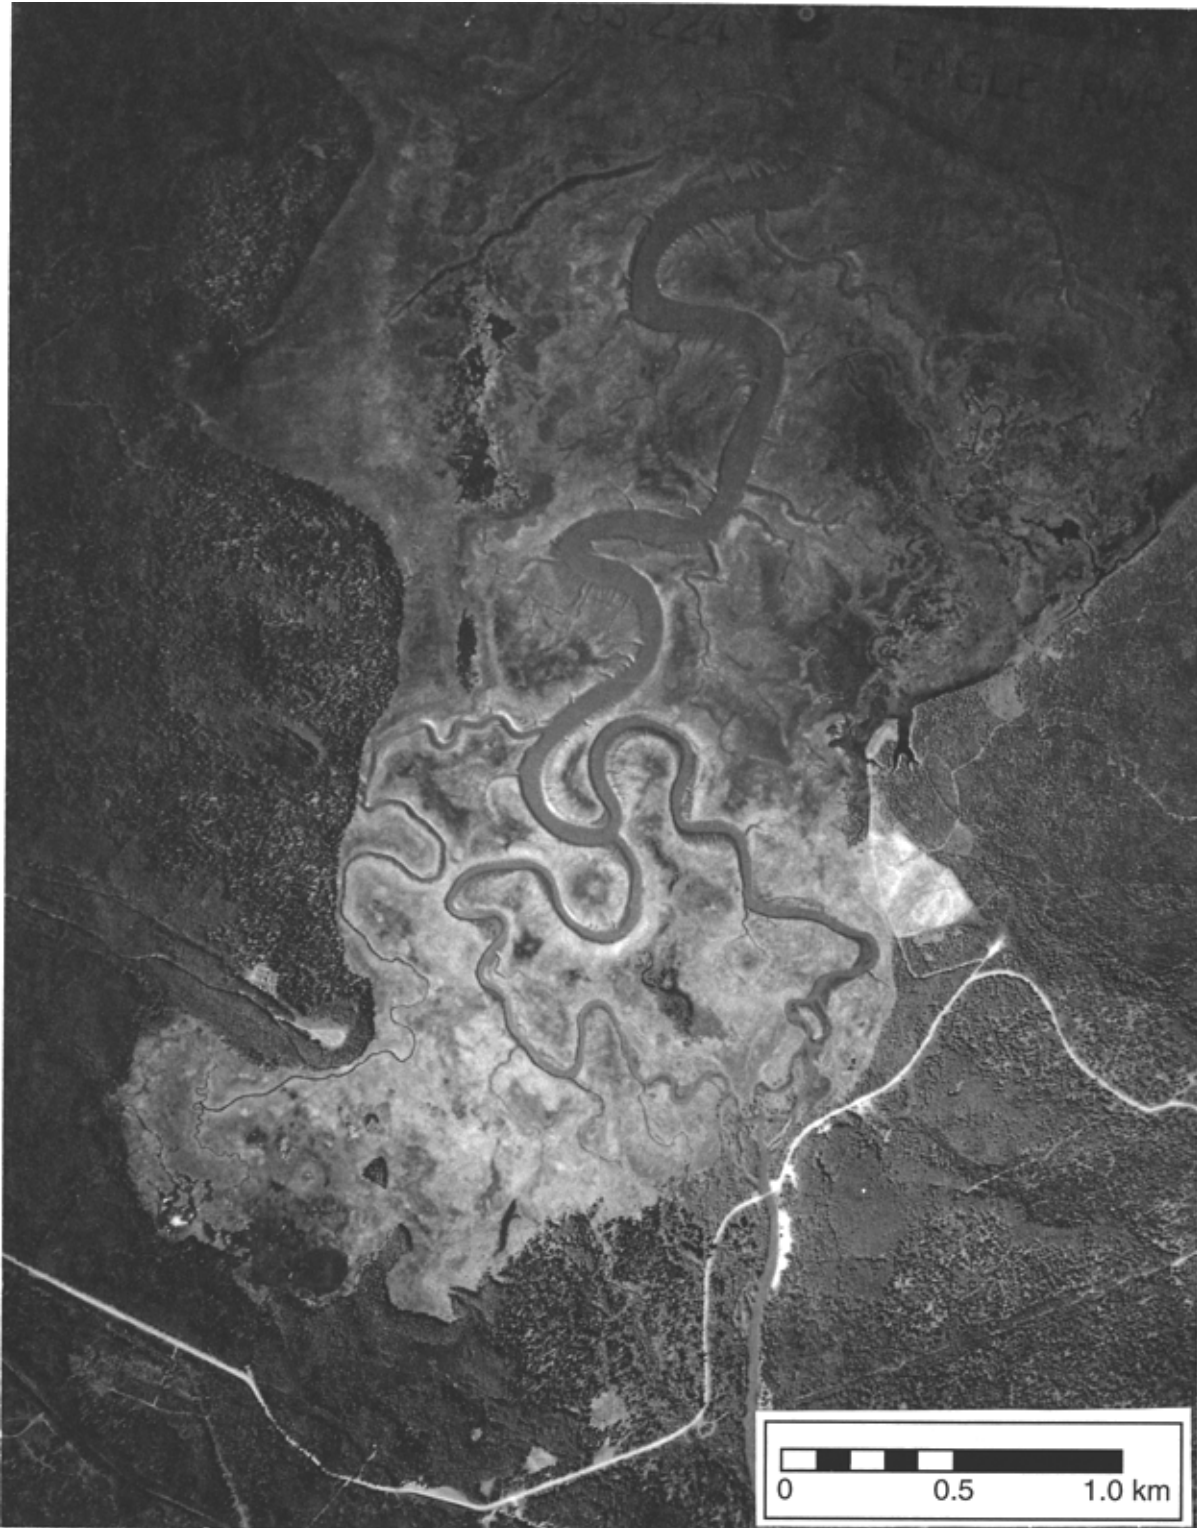
a. 1950.

*Figure 13. Aerial photographs of ERF.*

*b. 1967.*

c. 1993.

Aerial photographs from 1950, 1967 and 1993 reveal that the primary river channel (of three) was abandoned sometime between 1950 and 1967 (Fig. 13). By 1967, two channels diverged from Eagle River north of the Route Bravo bridge, the primary avenue of discharge now appearing to be the eastern course. Our initial review of these photographs does not reveal the cause of this change; however, it is clearly important to understanding the hydrology and sedimentology of the Flats.
