# Interagency Expanded Site Investigation

Evaluation of White Phosphorus  
Contamination and Potential Treatability  
at Eagle River Flats, Alaska

FY 95 Final Report

September 1996

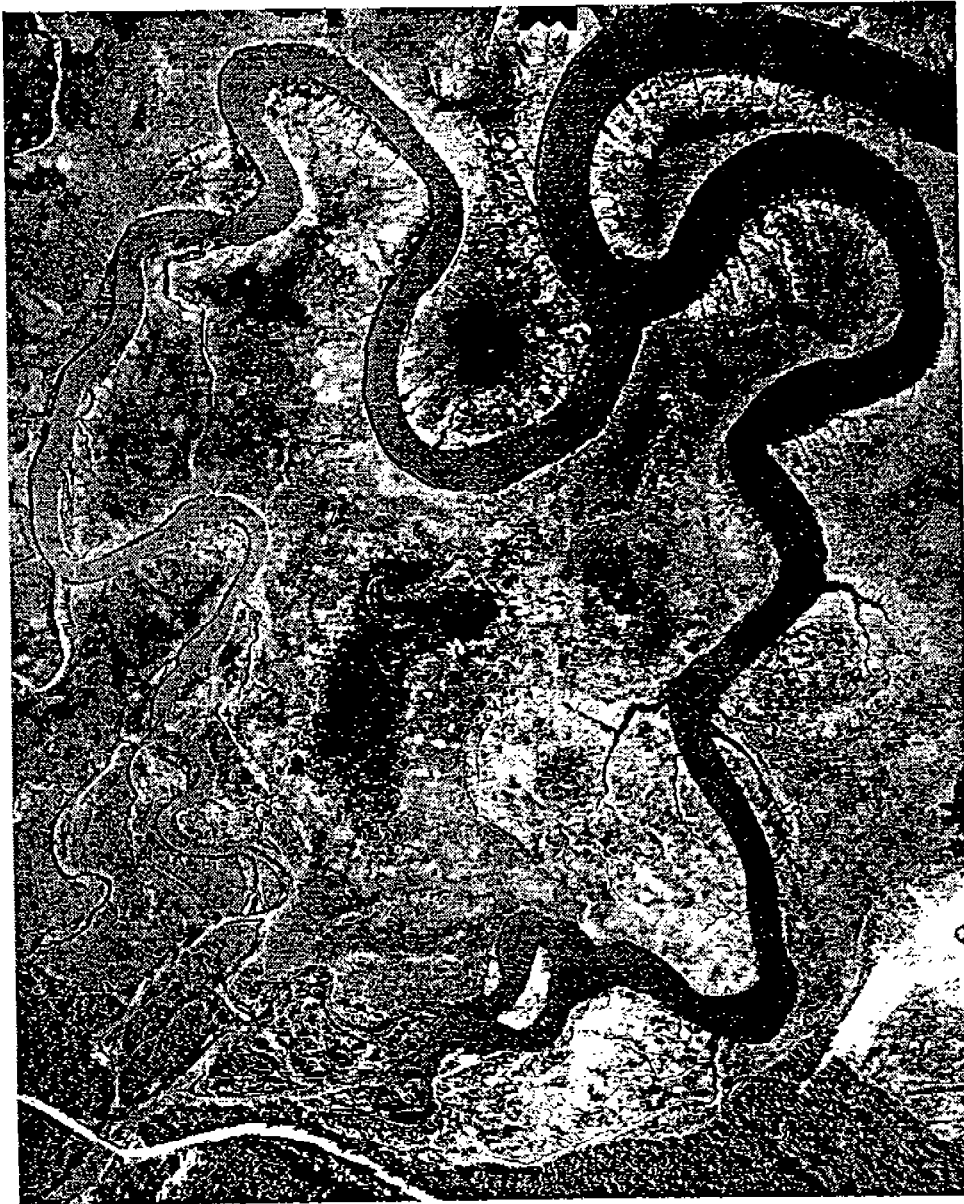
*Figure II-1-5. Aerial photograph of Racine Island taken 16 August 1995 showing remnant channel surrounded by overbank deposits.*

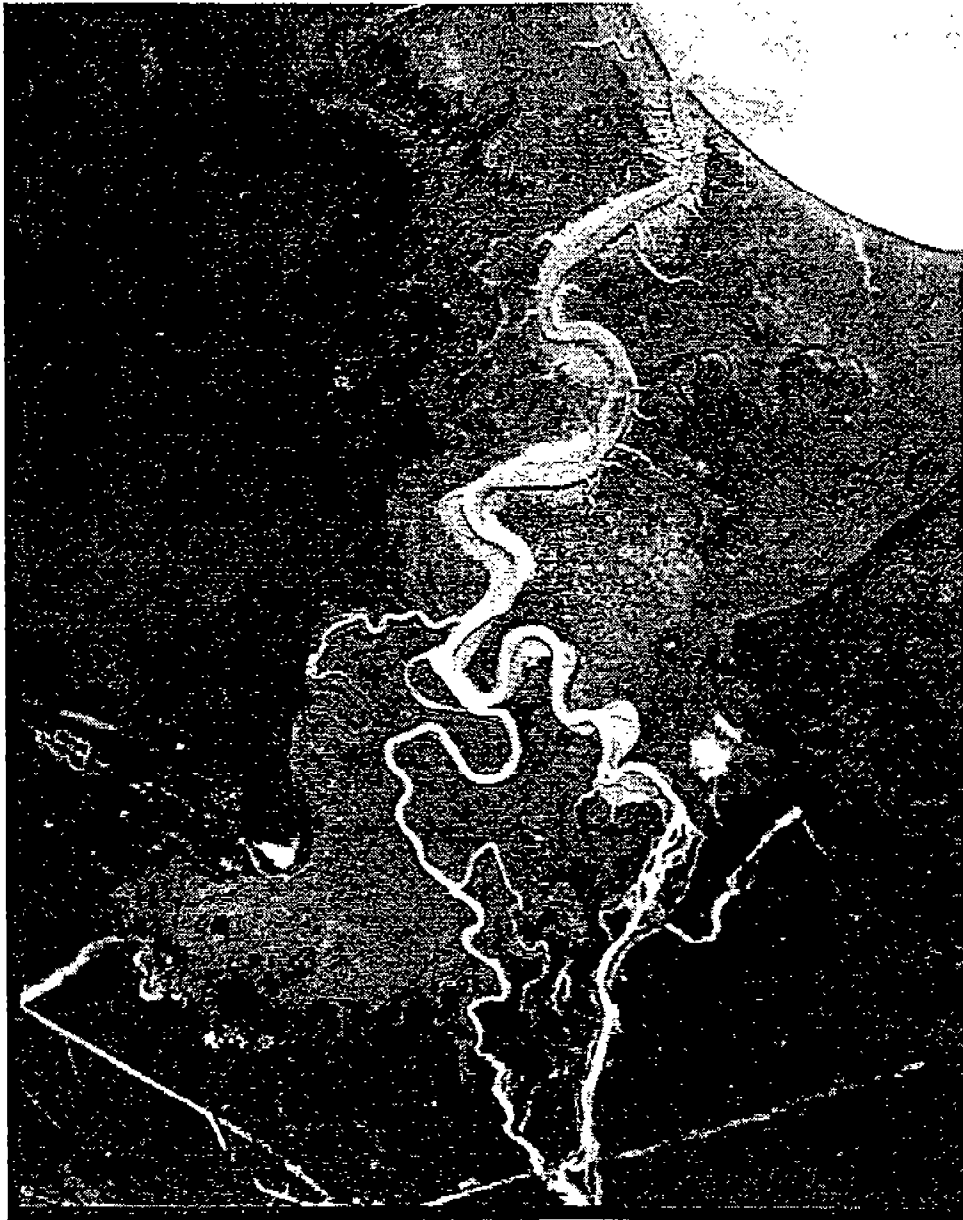
*a. 1950.*

Aerial photographs from 1950, 1967 and 1993 reveal changes in the distributary channel pattern entering ERF (Fig. II-1-6). Three main channels entered the Flats in 1950, but by 1967 the western most channel was abandoned and the eastern and middle channels diverged just northeast of the Route Bravo bridge. The two primary channels entering the Flats were characterized in 1967 by partial braiding and a divergent pattern characteristic of an alluvial fan (Fig. II-1-6b). Deposits in the fan area are relatively featureless overbank materials deposited by

*Figure II-1-6. Aerial photographs of ERF.*

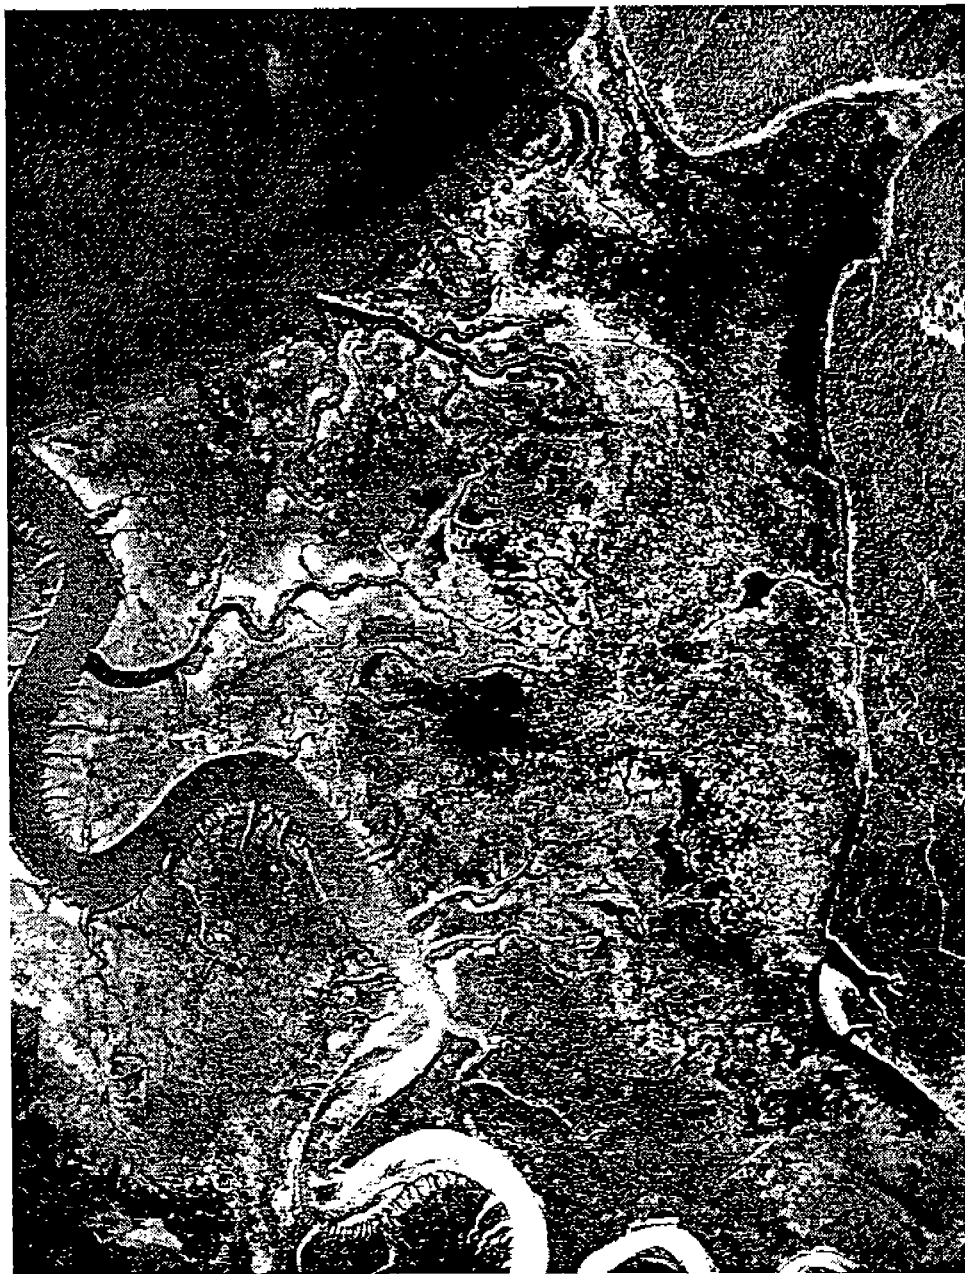
*Figure II-1-7. 1992 aerial photograph of northeastern ERF.*

Tributary channels with dendritic patterns, referred to as vegetated drainageways, drain water from the mudflats and ponds into the tidal gullies (Fig. II-1-3 and II-1-7). A second set of channels intercepted by the active tributary system

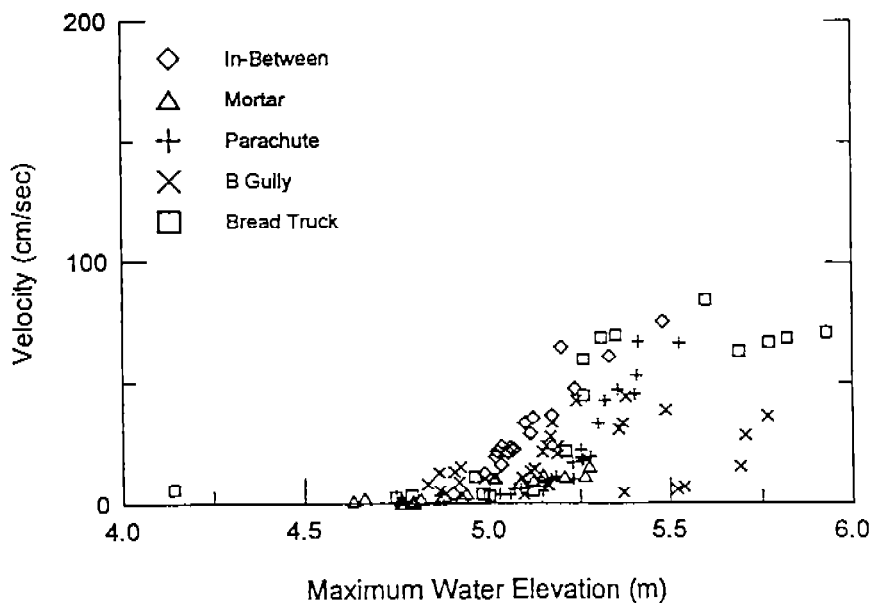
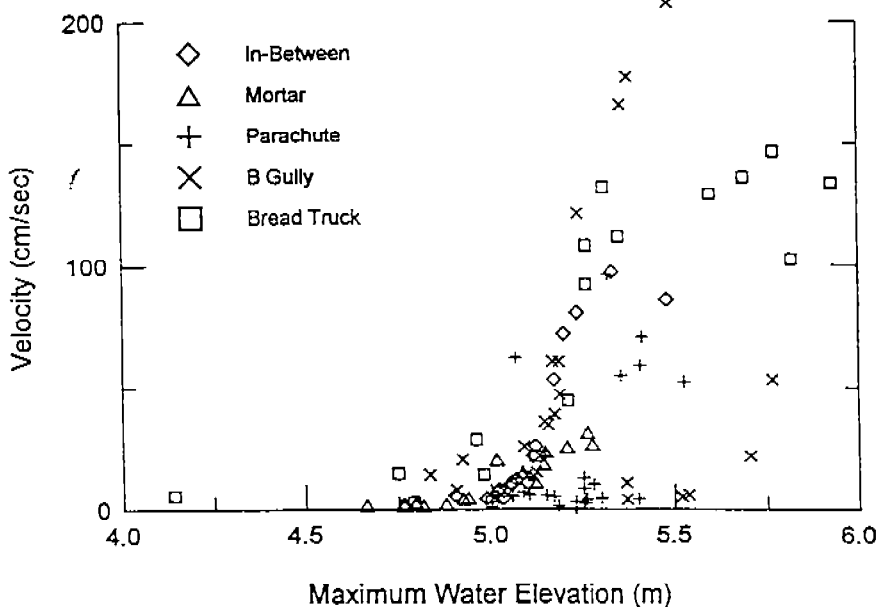
a. Flood currents

b. Ebb currents

Peak ebb velocity is greater than peak flood velocity (Table II-1-7, Fig. II-1-21). This asymmetry in flow velocities and therefore discharge determines when erosion and sediment transport will occur and to what magnitude. During tidal flooding, gully water levels rise passively before spreading out onto the mudflats. The suspended sediment load is directly related to the volume of sediment suspended in Knik Arm, except where river water is the primary source of flood.

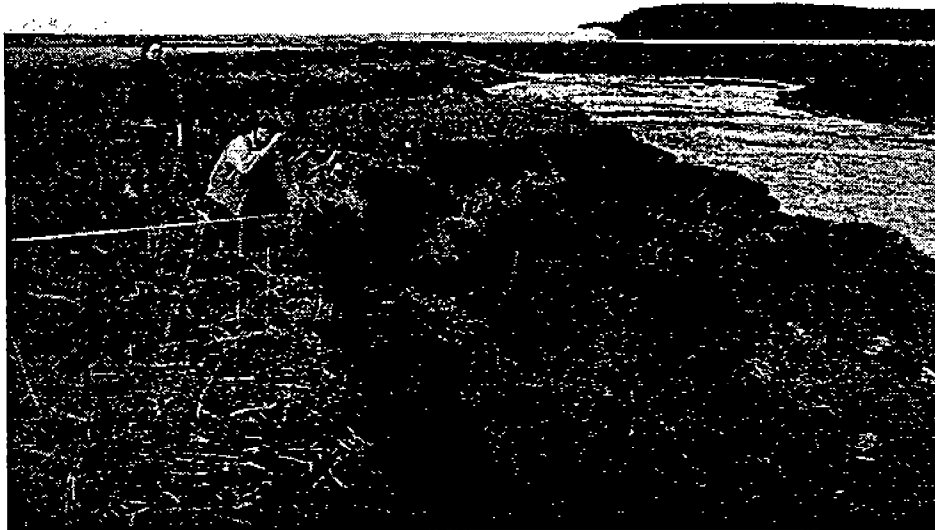
*a. North view showing extension crack in foreground.*

*b. Rotational slump blocks visible to right of scarp.*

*Figure II-1-23. Measurements of bank erosion along Eagle River at the River-North site.*

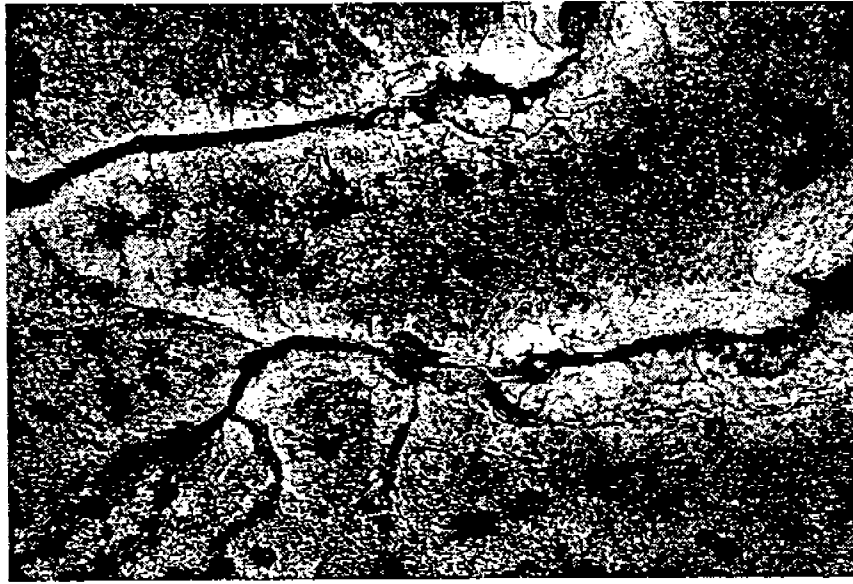
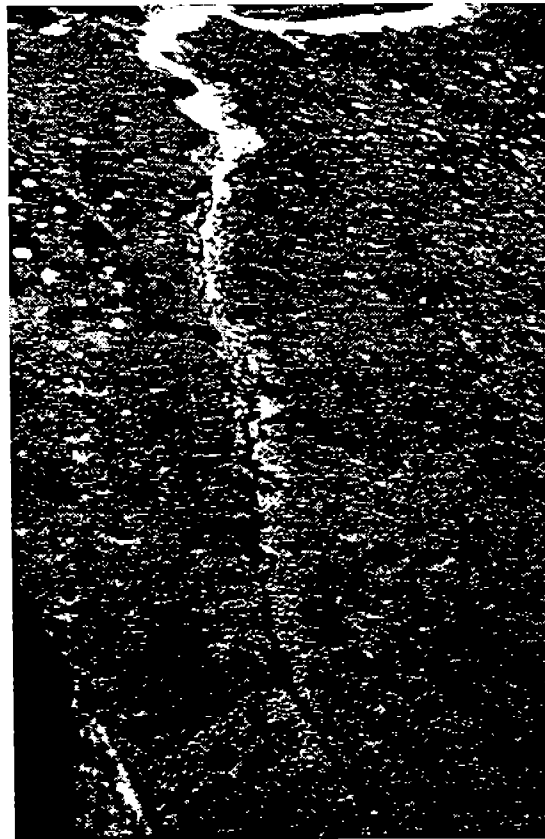
*a. Area A.*

*b. B-Gully.*

*Figure II-1-26. Aerial view of gullies where recession and ebb flow have been modified by surface craters.*

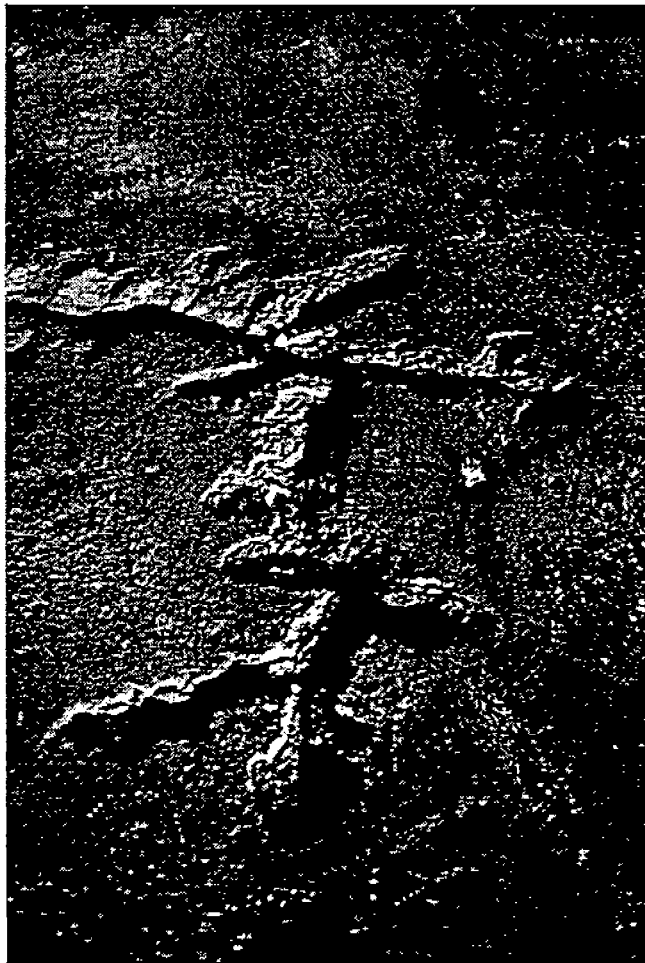
*Figure II-1-27. Aerial view of Bread Truck Gully in October 1995.*

Bread Truck and Coastal 5 gullies bracket the mouth of the Eagle River and are the sites with the maximum rates of headward recession (Fig. II-1-14, II-1-22a, II-1-22c). Bread Truck Gully (Fig. II-1-27 and II-1-22a) was first monitored in 1993

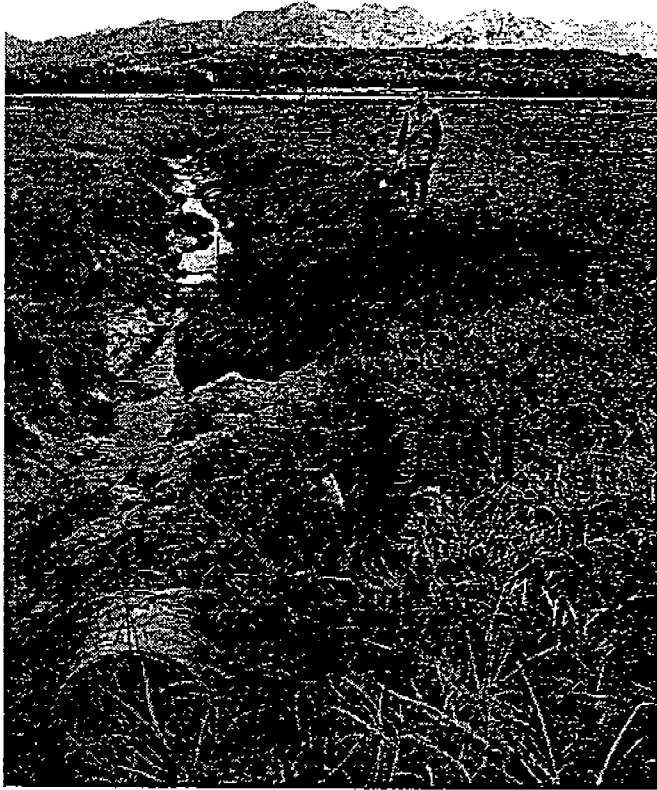
Figure II-1-28. Eastward view of eroding cusped embayments at B-Gully.

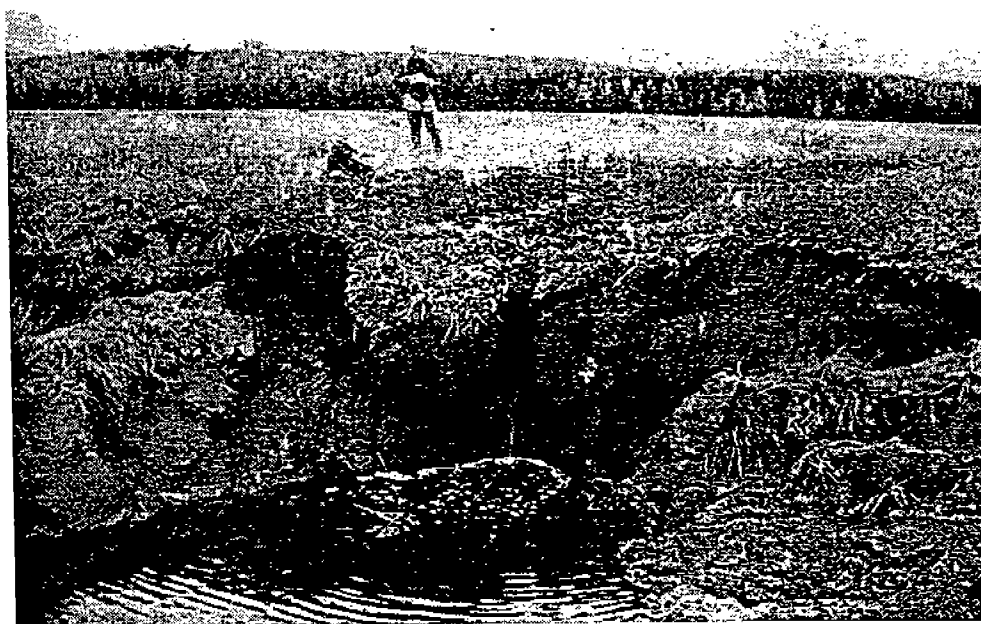
*Figure II-1-30. Thick laminated peat layer at Coastal 6 forms the threshold to channel downcutting and headward recession.*

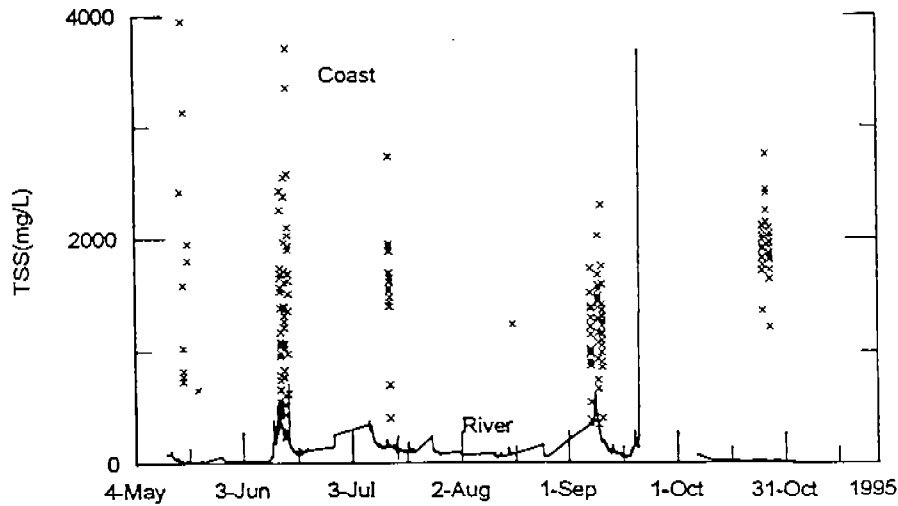
Figure II-1-42. Coastal versus river TSS measurements.
