Physical System Dynamics and White Phosphorus Fate and Transport, 1994, Eagle River Flats, Fort Richardson, Alaska

96-9

CRREL REPORT

Abstract: Eagle River Flats (ERF) is a subarctic estuarine salt marsh where human and natural forces are causing significant changes in the environment. Multiple internal and external forces govern the physical and chemical processes by actively altering surface conditions, sometimes in unpredictable ways. ERF is also used as an artillery range by the U.S. Army, where past use has resulted in white phosphorous (WP) contamination of the sediments within ponds and mud-

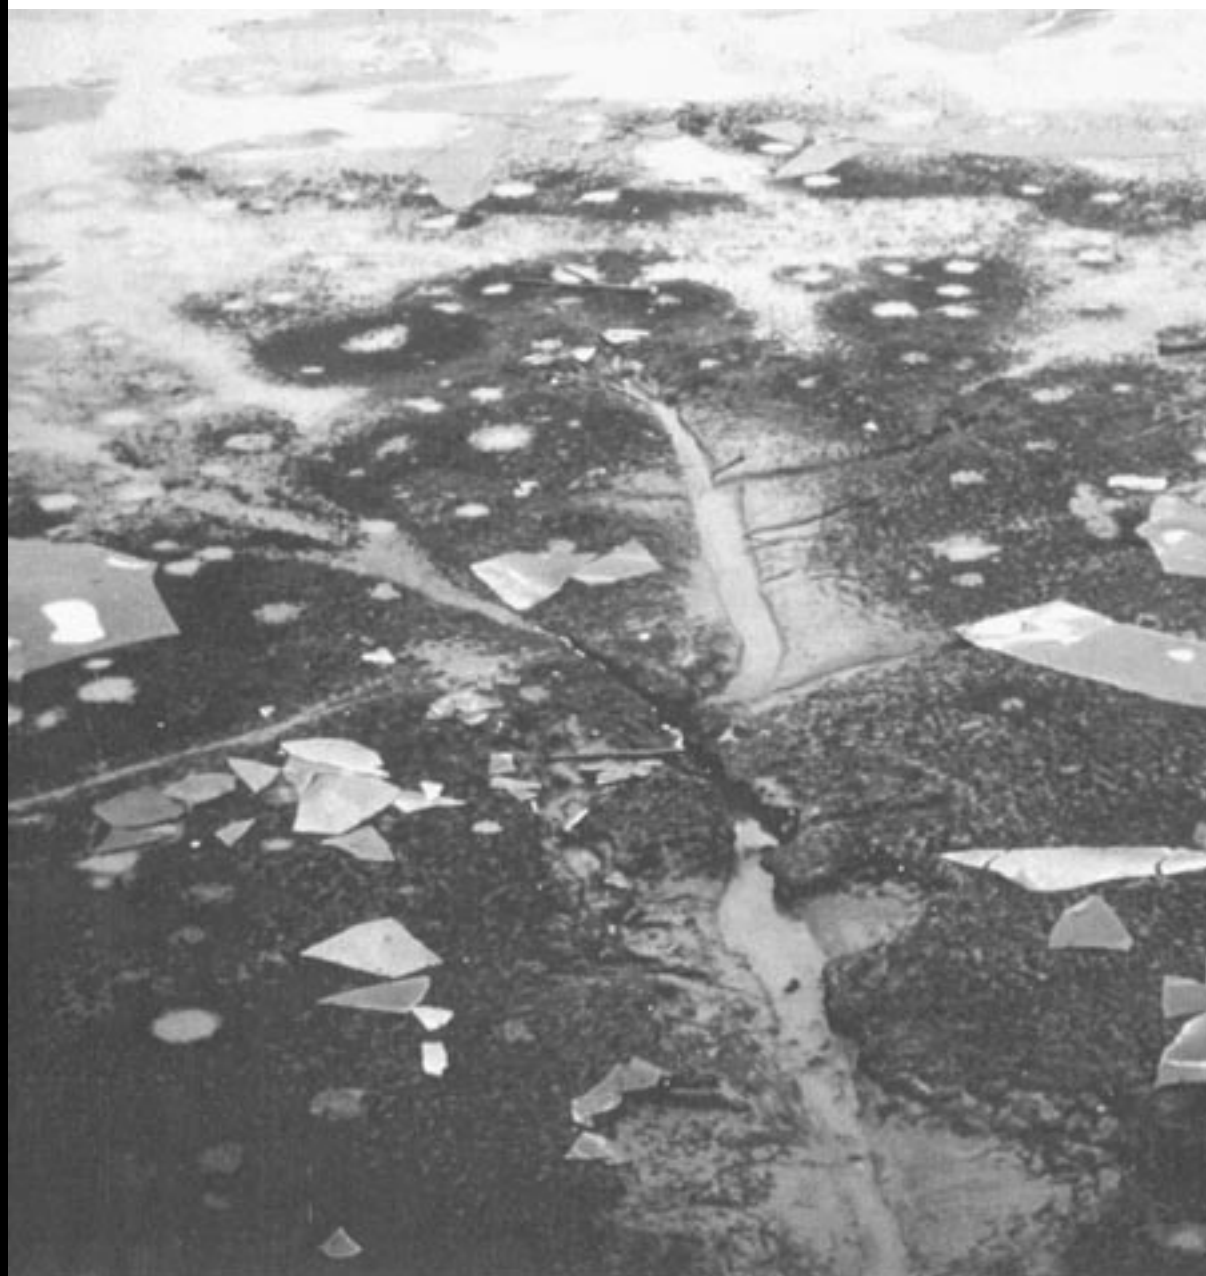
Cover: Aerial view of In-Between Gully (center) with stranded ice floes adjacent to it. WP-contaminated sediments can be transported by ice pulled from ponds during tidal flooding.

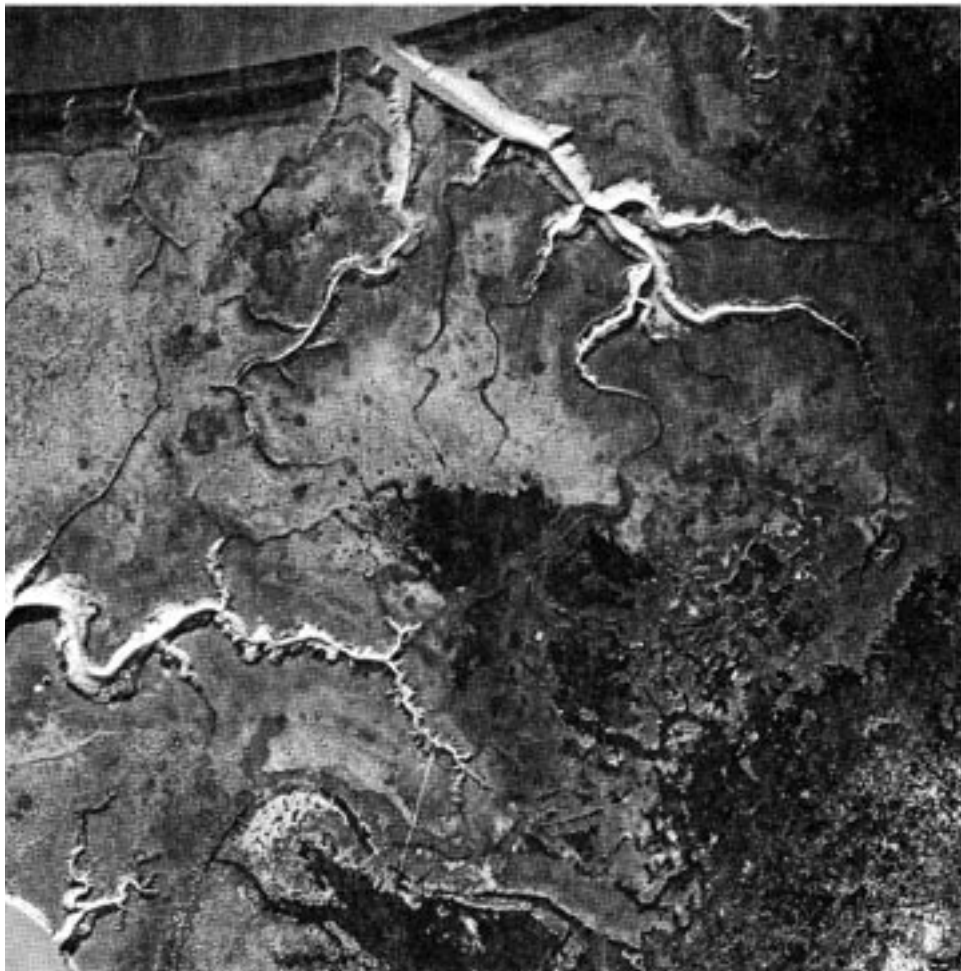
Figure 4. 1994 aerial photographs of ERF (originally color infrared).

a. Typical active gully erosion following courses of relief drainageways.

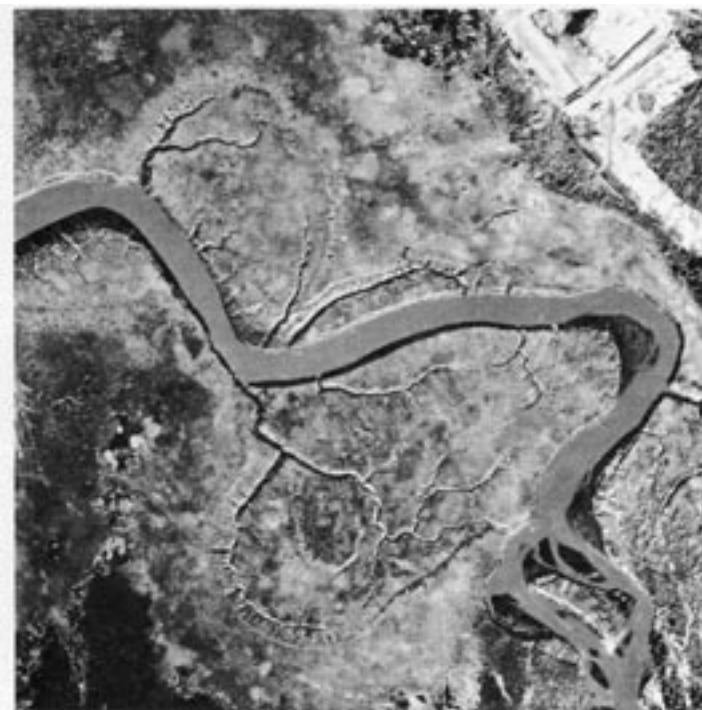
Figure 4 (cont'd).

b. Meander scars along the side of the Eagle River.

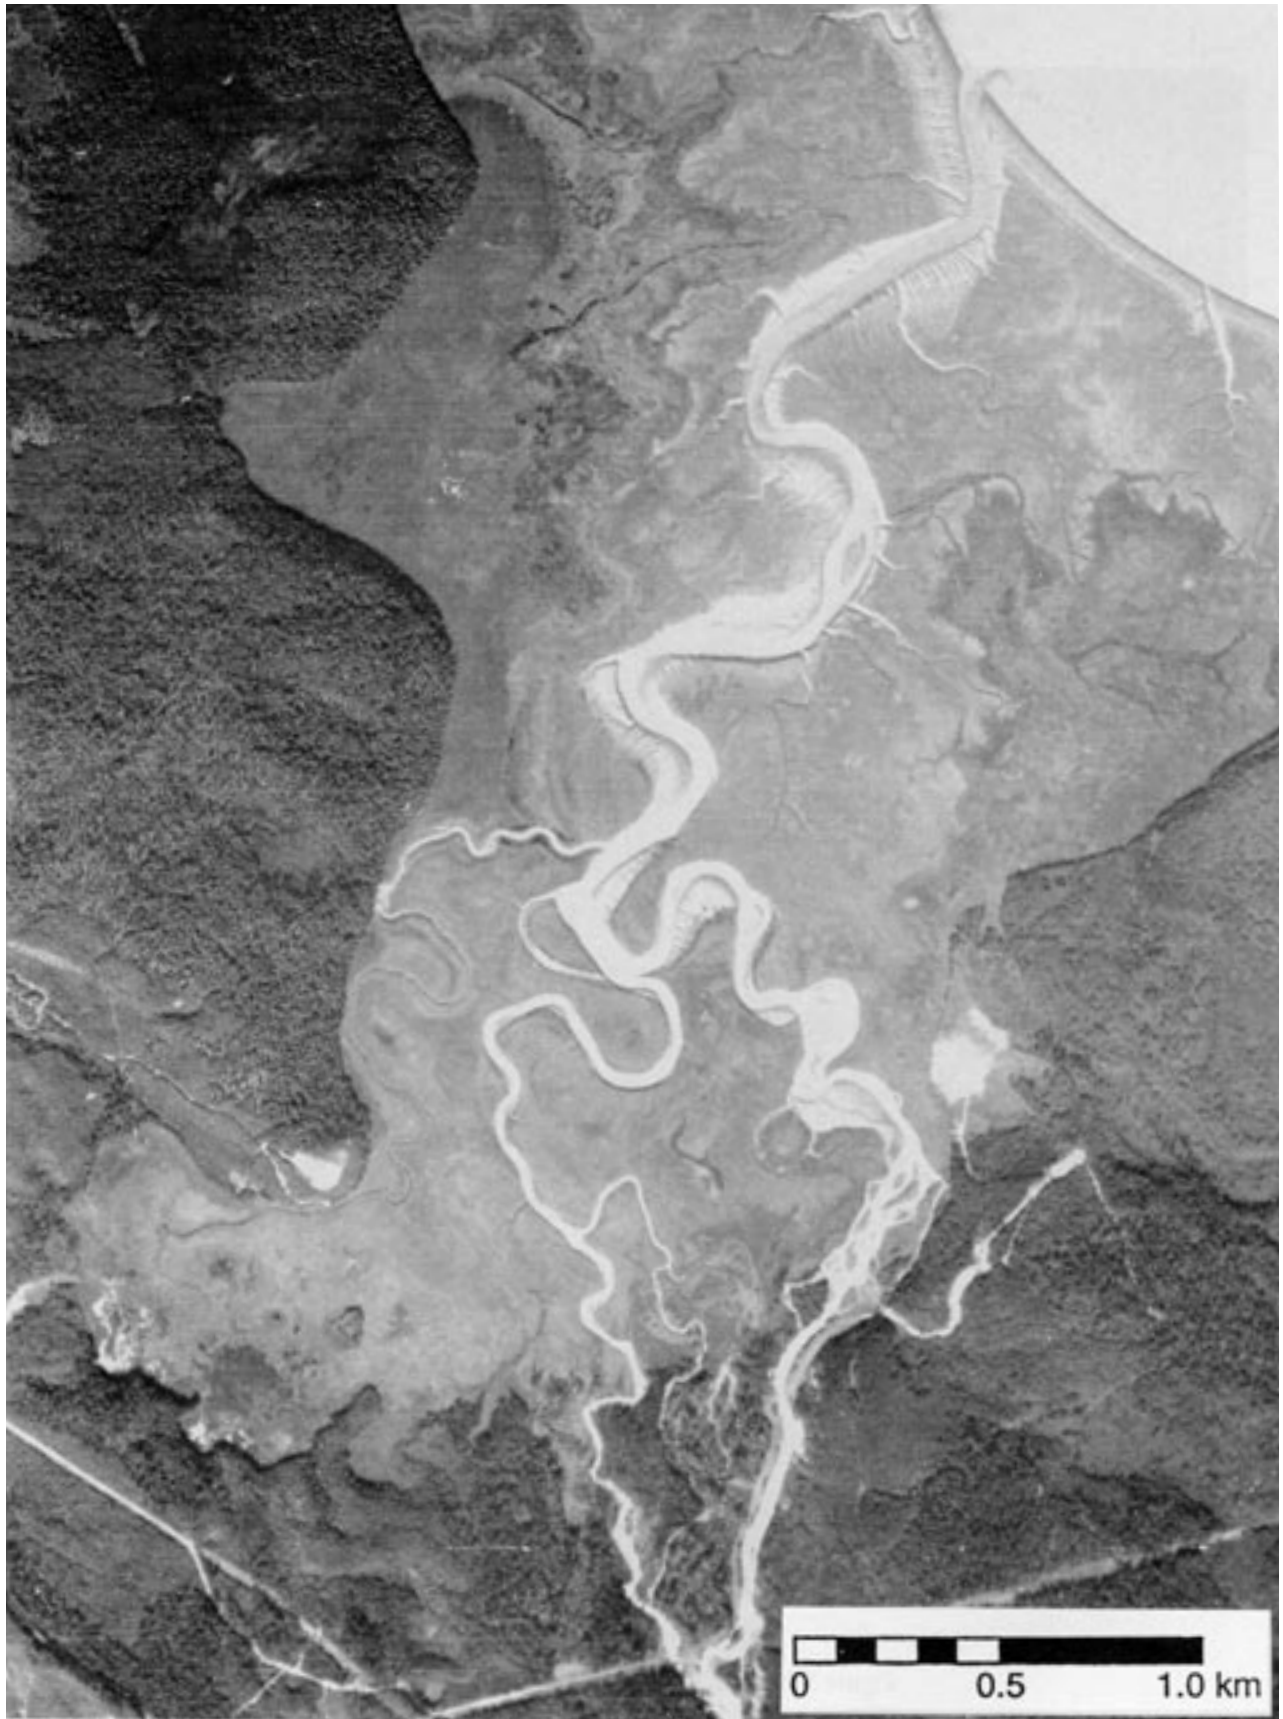
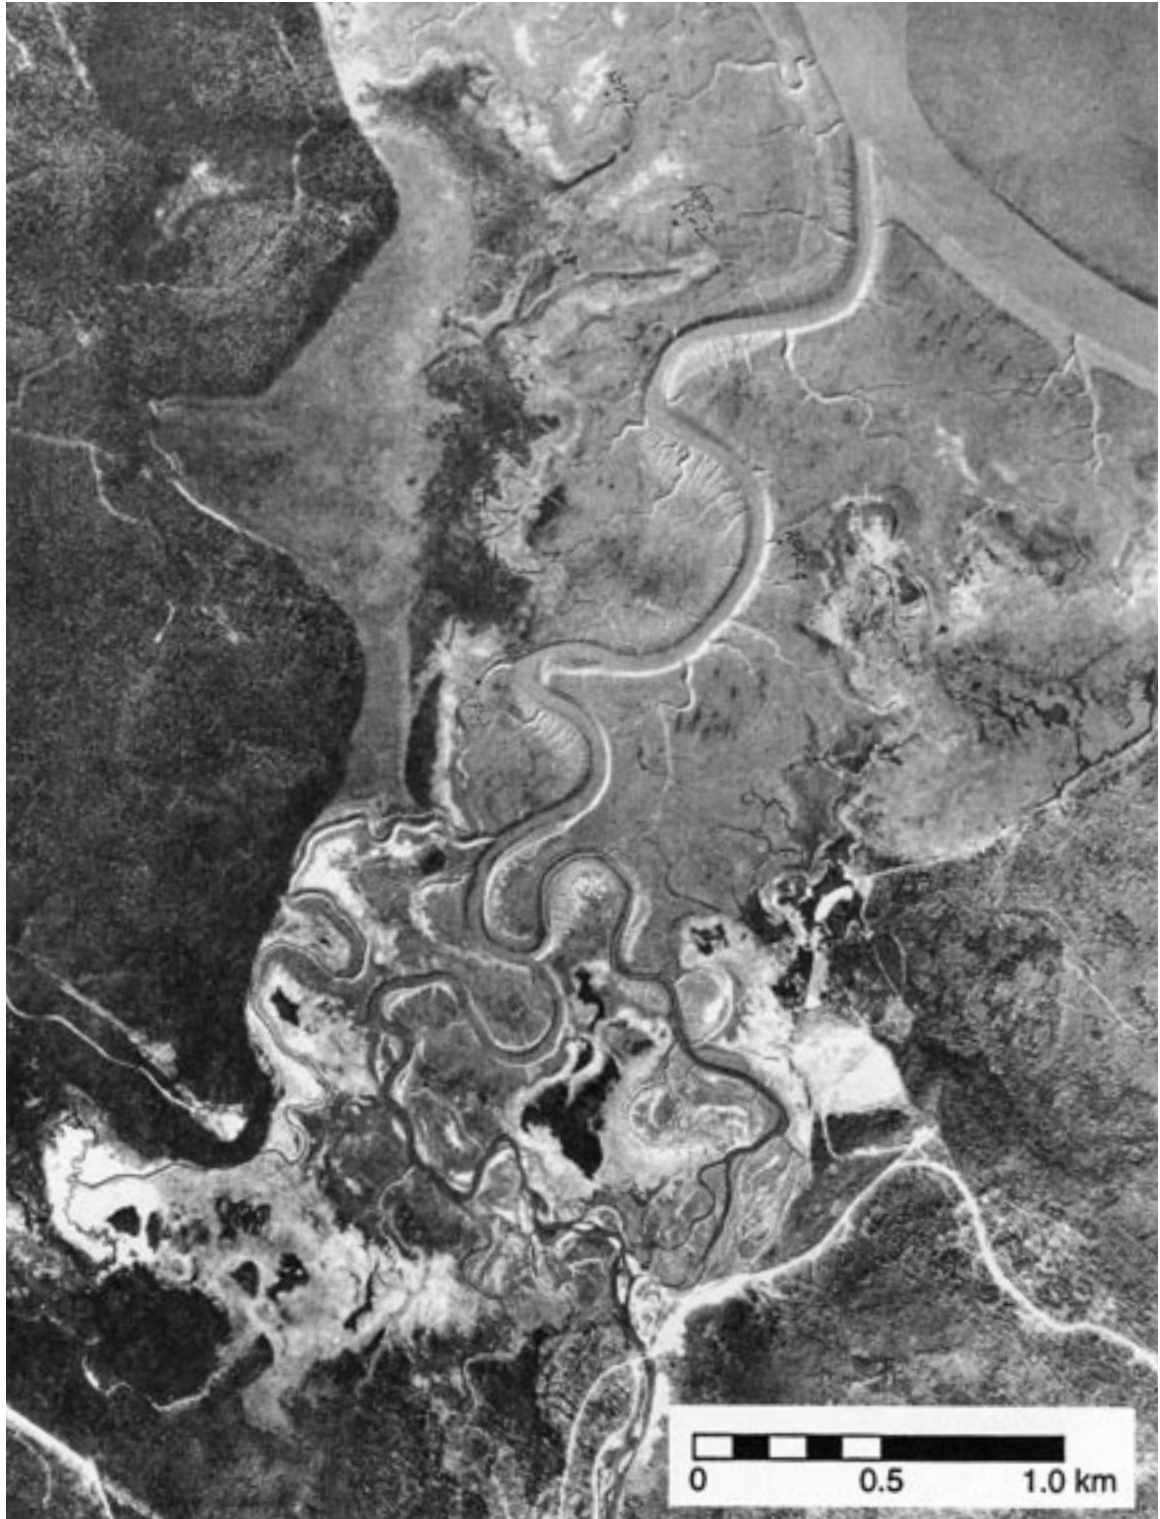
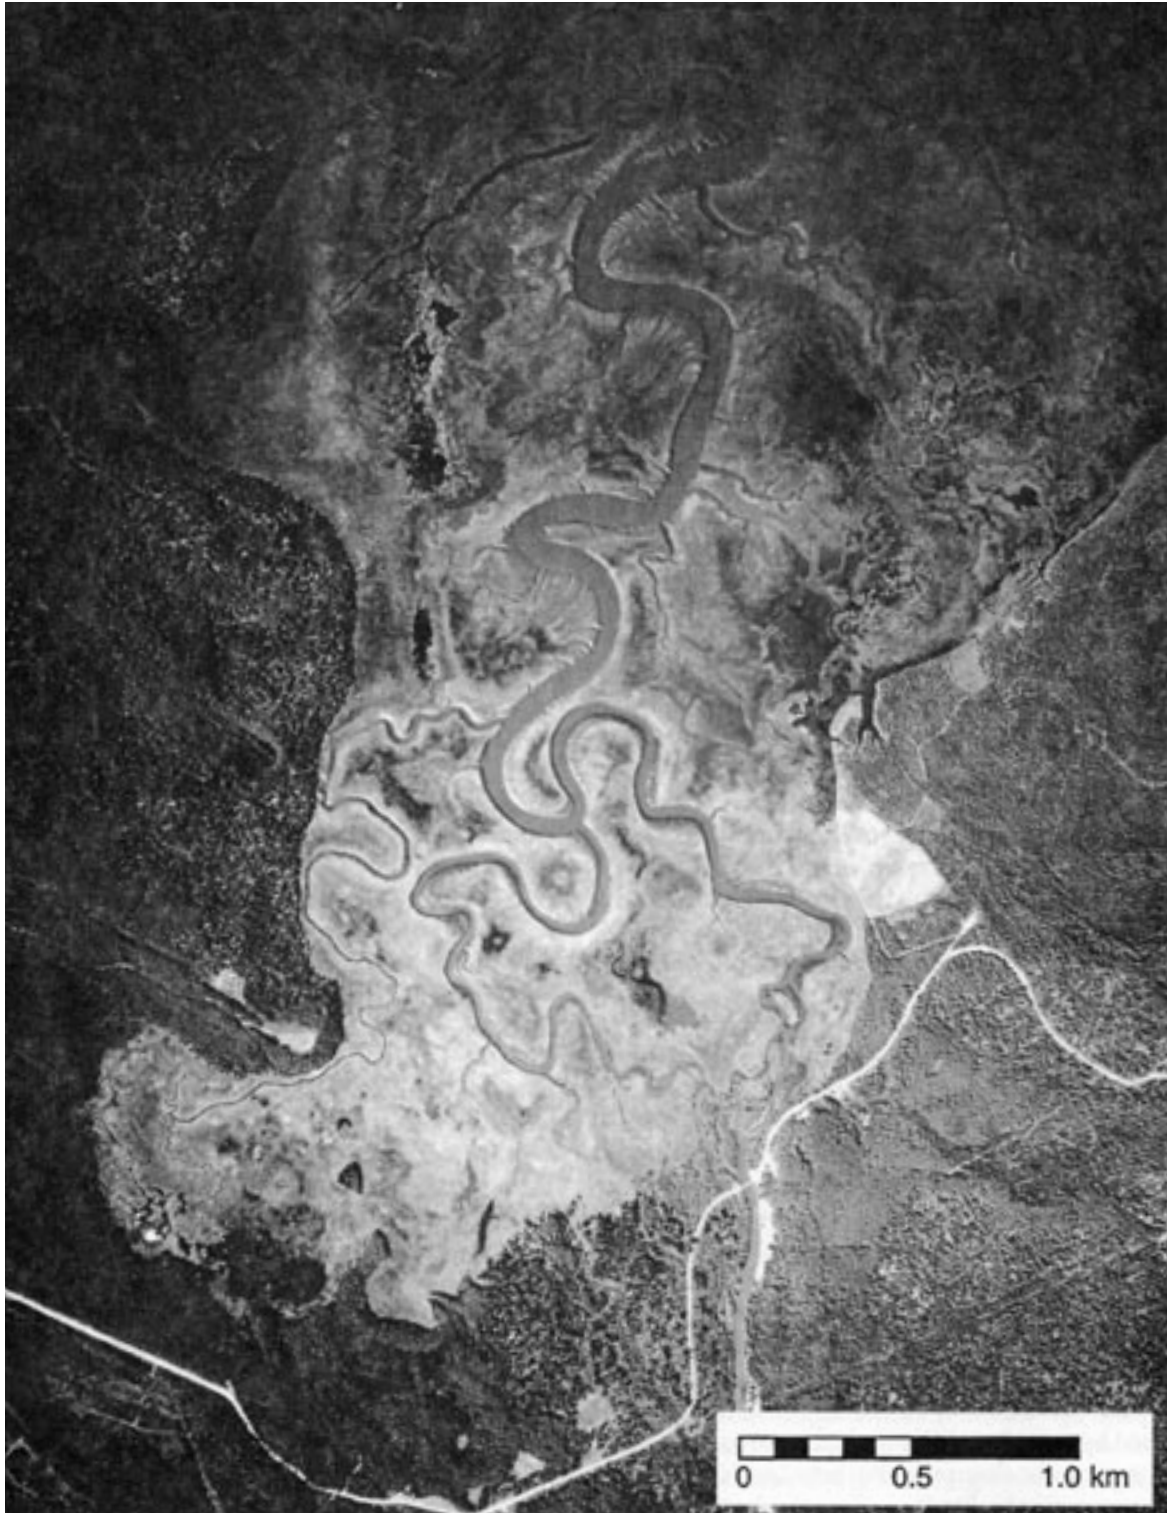
Figure 5. Aerial photographs of ERF.

doned point bars are common along the length of the active channel and are especially evident in photographs of the southern reaches of the Flats (Fig. 5c). Channel changes are a natural progression resulting from the erosion and recession of the outer banks of meander bends, deposition of sediments as point bars in the inner parts of each bend, and a general downstream migration of the channel (e.g., Allen 1982). At some locations, a breaching of tight meander loops causes their abandonment.

Gullies in the mudflats have also lengthened and deepened during the last 40 years, in some cases extending over 200 to 300 m. A significant extension of gullies toward the ponds and marshes is particularly evident in Figures 5b (1967) and 5c (1993). Headwalls recede during flood or ebb flow, as water is funneled into and out of the ponds and mudflats through the drainage system. The cause of gully expansion is not proven. But the tectonic activity during and following the 1964 Alaskan earthquake or large-scale river channel changes caused by flooding can cause the gully expansion. We must further quantitatively analyze historical aerial photographs and deposits in the alluvial landforms to find its cause.

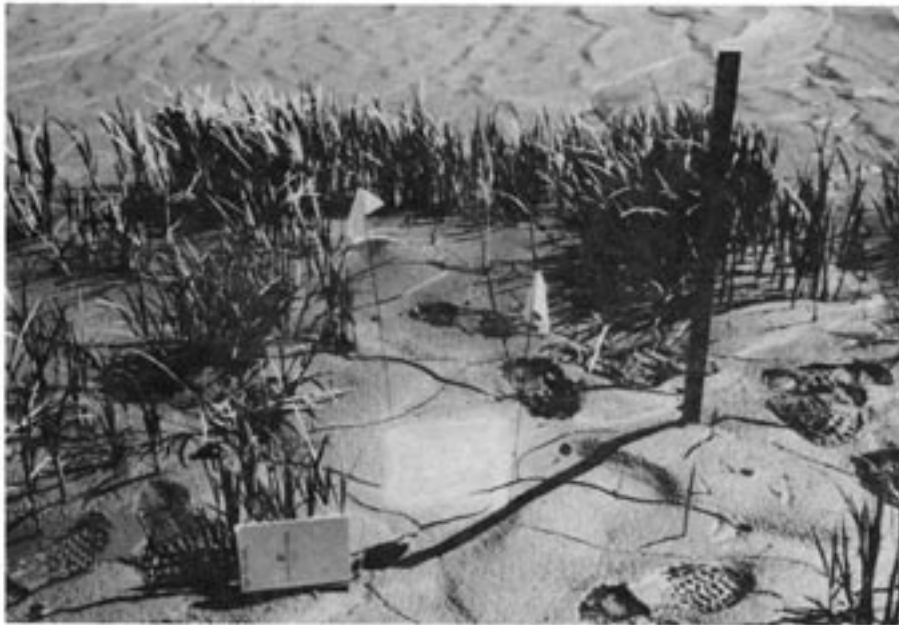
a. Sedimentation stake with plate that slides freely on the rod.

Figure 8. Sedimentation measurement techniques.

b. Wire flags mark an area of painted ground.

We used "sedimentation stakes" to measure erosion and deposition at transect points where the surface was wet or standing water was present (Fig. 8). These stakes consist of a rod and a square, rigid plate (about 7 cm²) that slides freely on the rod as used by Ovenshine et al. (1976a,b) in Turnagain Arm, Alaska. Erosion depth is defined by the increase in distance between the top of the rod and the top of the plate, as measured periodically.

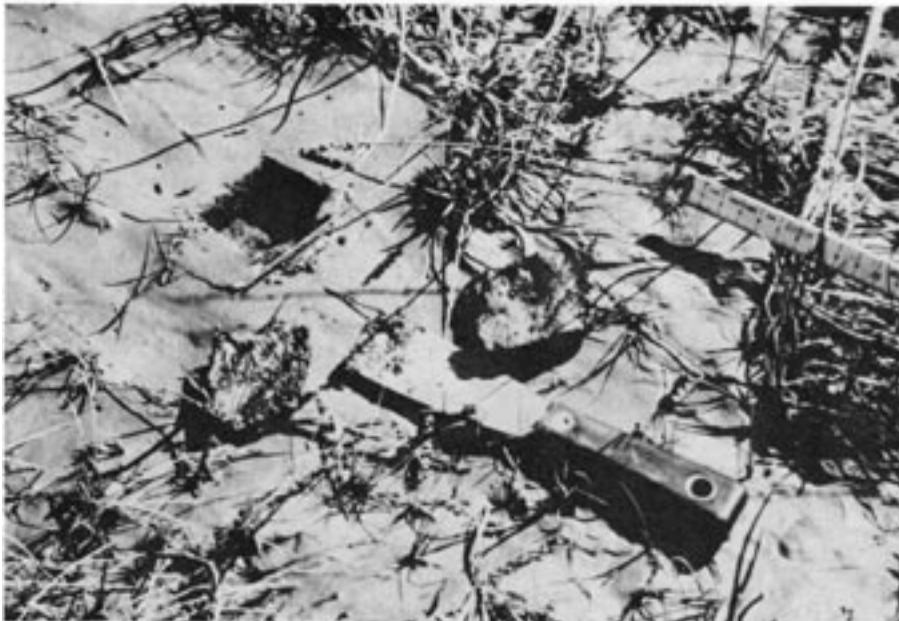
Figure 9. Paint layer depth within block of sediment is measured to define sedimentation rates.

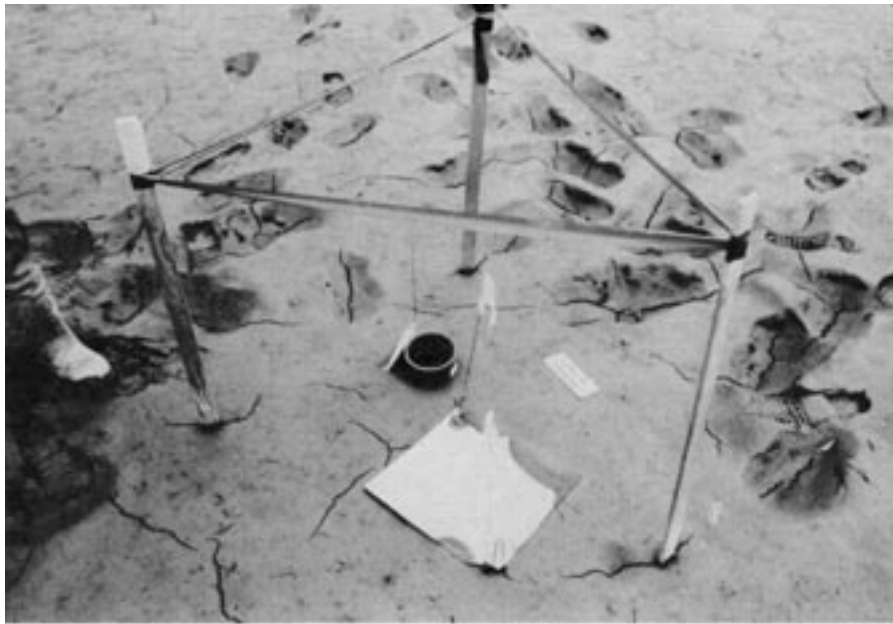
Figure 12. Example of sedimentation station at intermittent pond location showing layout of cup and plate sampler.

diam.) schedule-40 PVC pipe. The pipe was inserted into the pond until the bottom of the cup was in contact with the bed (Fig. 11b and 12). Sediment trapped in the cup includes new sediment brought into the ponds by tidal inundation and river currents, and materials resuspended by wind waves, dabbling ducks or other mechanisms.

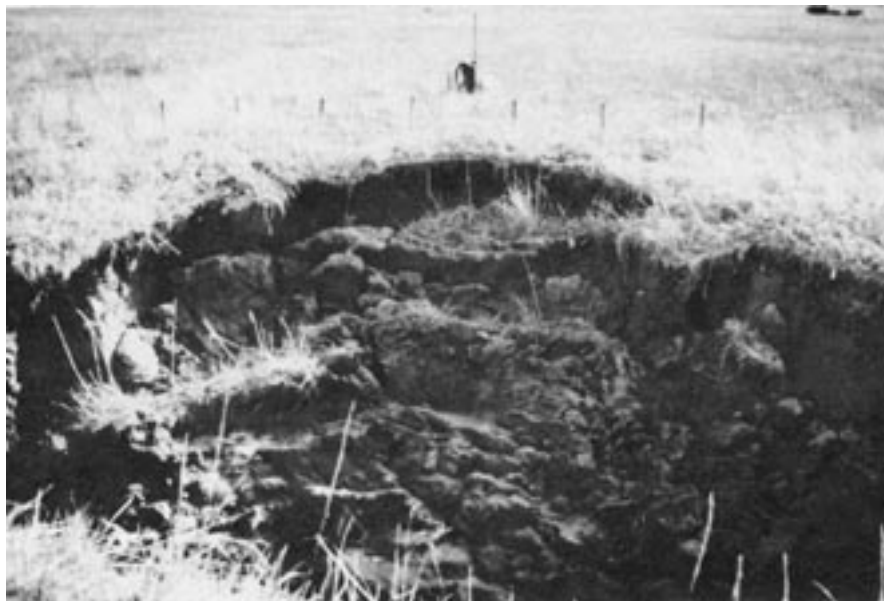
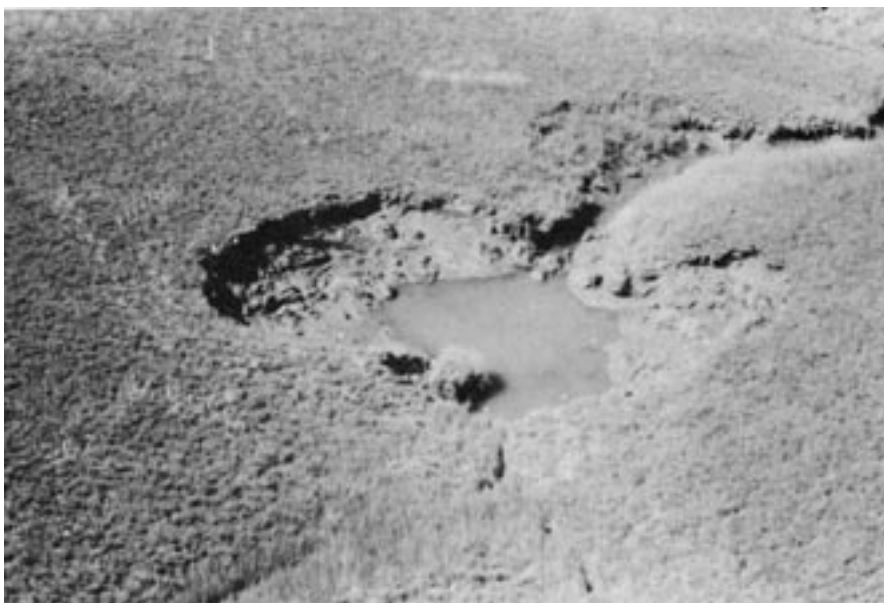
a. B-Gully

b. Aerial view of Coastal 6 Gully.

Figure 14. Examples of gully erosion sites. Line stakes are established along a line approximately parallel to the gully scarp. Hub stakes are located away from the line stakes and were used as the origin of measurements to scarp.

Gullies draining the ponds and mudflats are actively extending inland by headwall and lateral wall erosion. We established 57 sites to evaluate retreat rates (Fig. 13)—11 sites were established in June 1992, 3 in June 1993, 3 in September 1993,

1 in May 1994 and 39 in July 1994. At each site, stakes were driven into the ground along a straight line at known distances from one another and from the crest of a gully scarp (Fig. 14). A “hub” stake was set at a known distance from this stake line. The distance between the hub and the crest

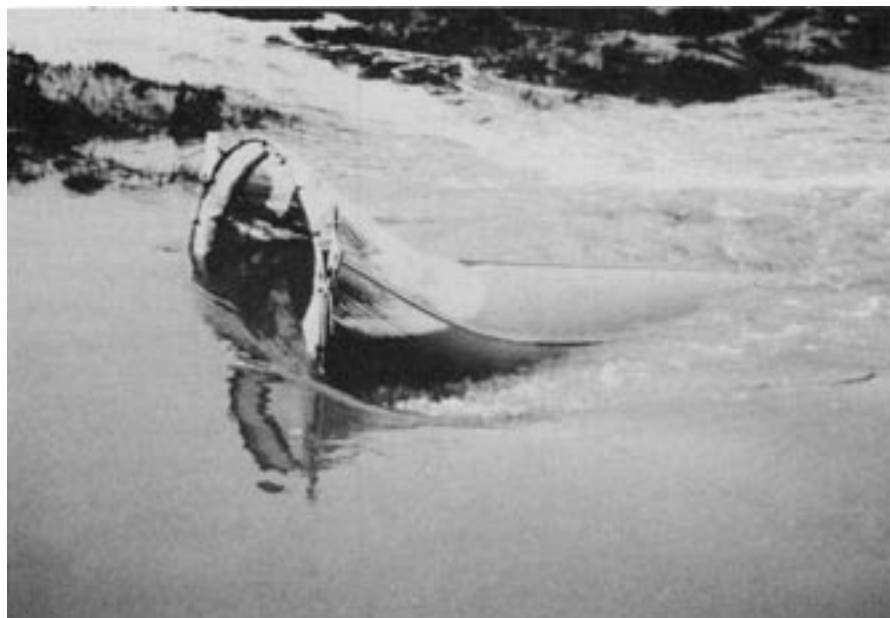
Figure 20. Plankton net used for collection of WP in transport through gullies.

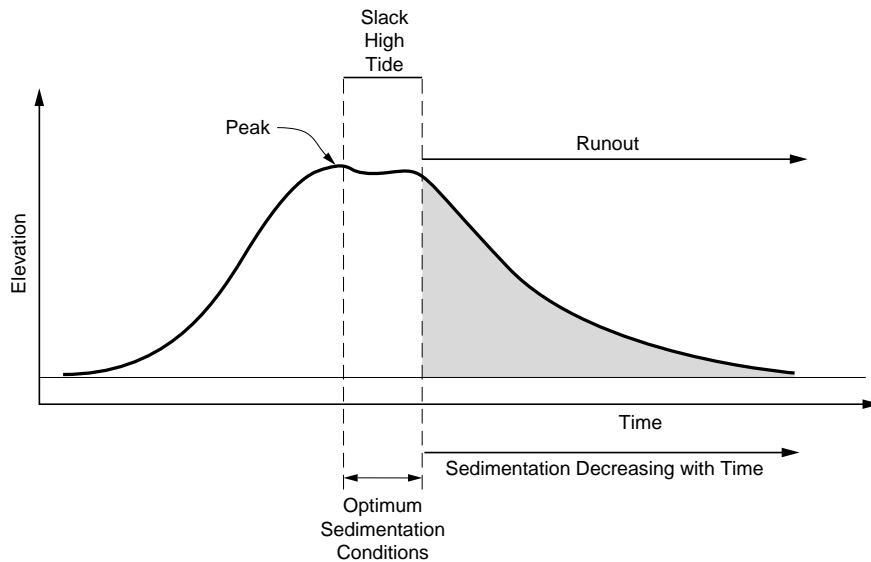
Figure 22. Typical high-tide curve showing period of sedimentation.

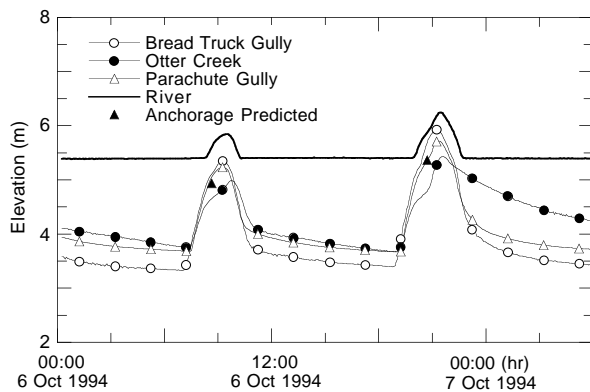
Figure 23. Water elevations as measured by pressure transducer for two flooding tide events.

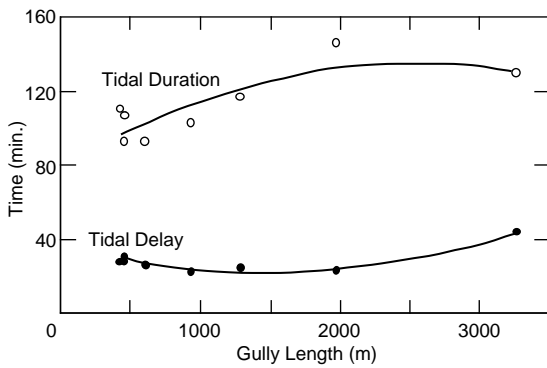
a. Gully length vs. tidal duration and delay. Regression line for tidal duration is expressed by $y = -8E-06x^2 + 0.0437x + 79.818$ ($R^2 = 0.6964$); and for tidal delay, $y = 7E-06x^2 - 0.0187x + 35.887$ ($R^2 = 0.9655$).

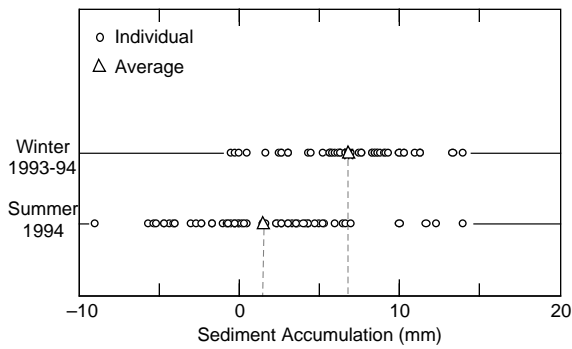
Figure 43. Net seasonal sedimentation rates at sites sprayed with paint in August 1993 (winter 93–94 represents September 1993 through May 1994, summer 94 represents May 1994 to September 1994). Circles represent individual sedimentation measurements; the triangle and dashed line show the averages.

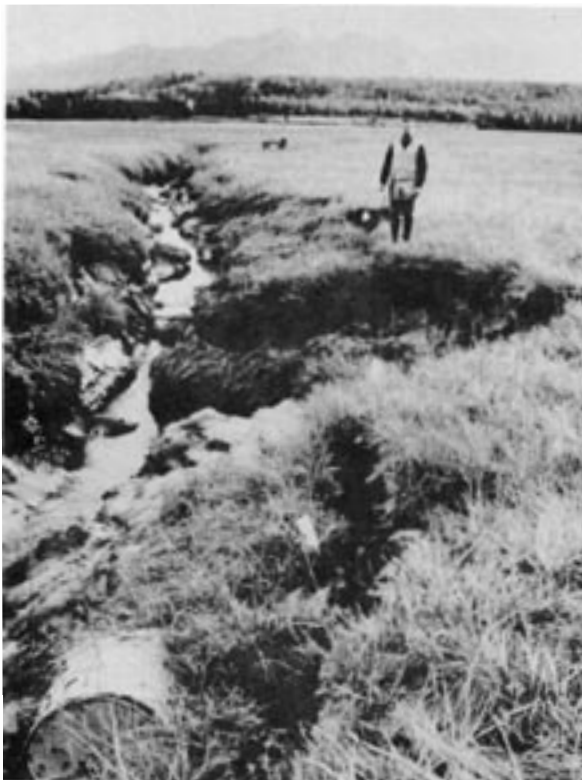
Figure 52. Eastward view of eroded cusped embayment at monitored section of B-Gully where white phosphorus was recorded in transport.

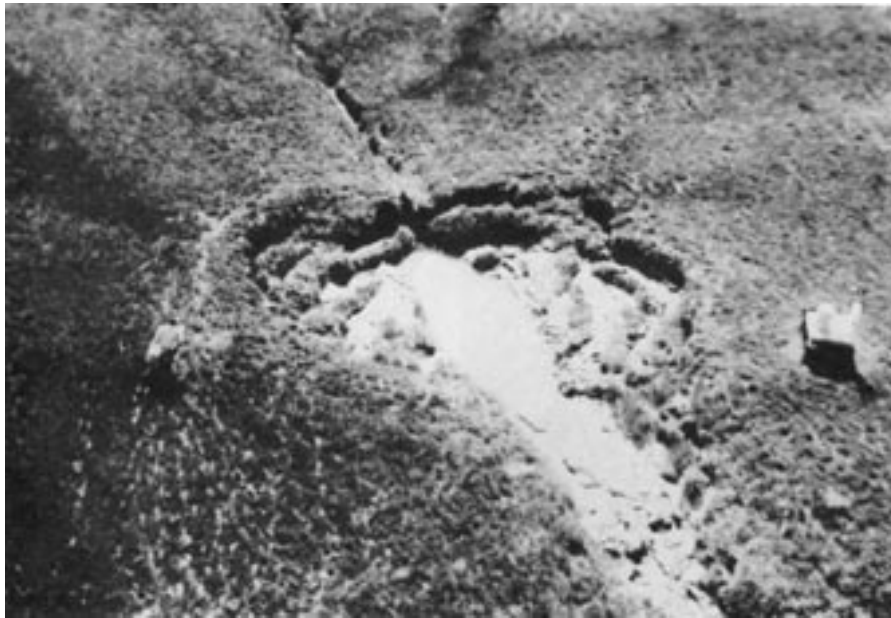
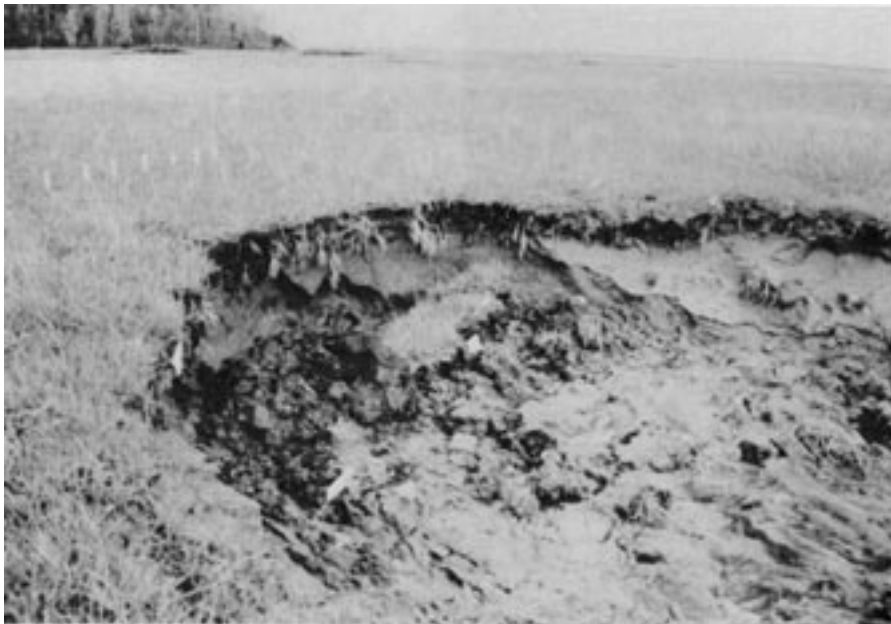
a. Plunge pool of Mortar Gully.

b. Gully scarp of Coastal 6 Gully.

Figure 53. Examples of slope failure.

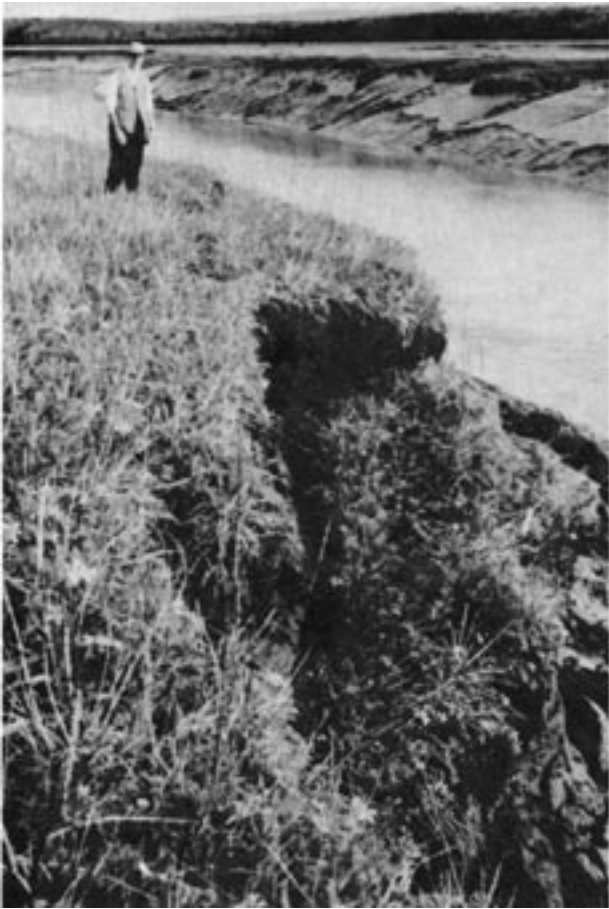
Figure 54. Rotational slump block failure at River Section-North.

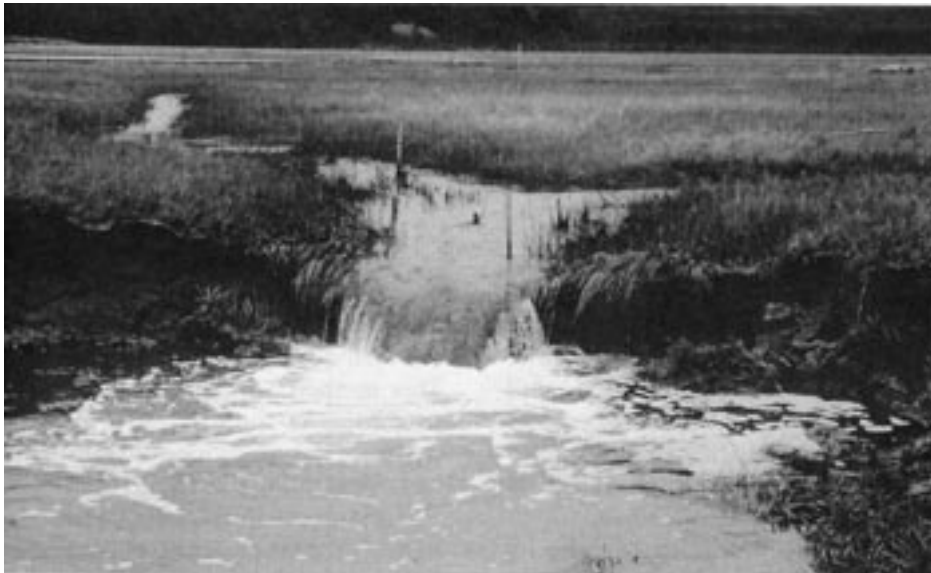
Figure 57. Water flowing over gully headwall at Parachute Gully plunge pool.

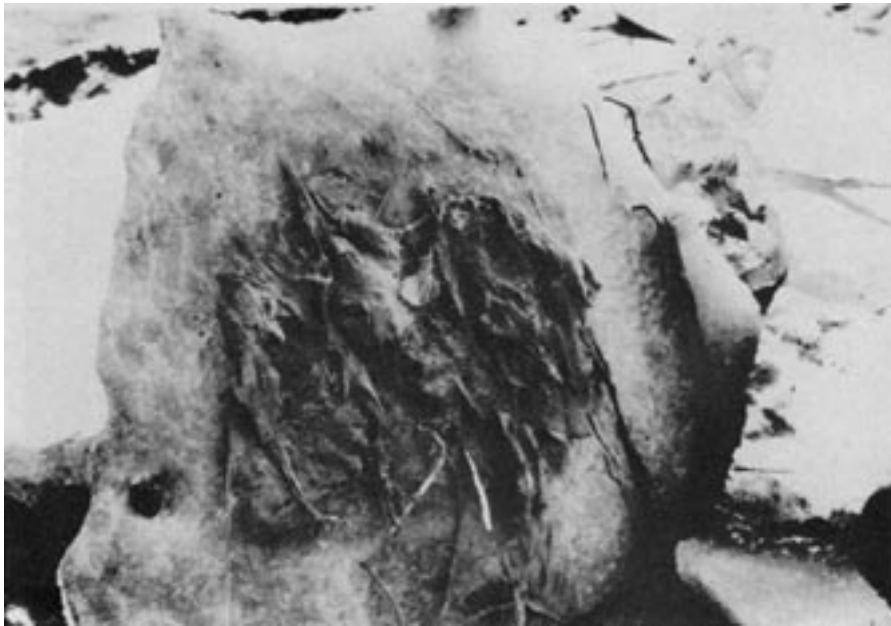
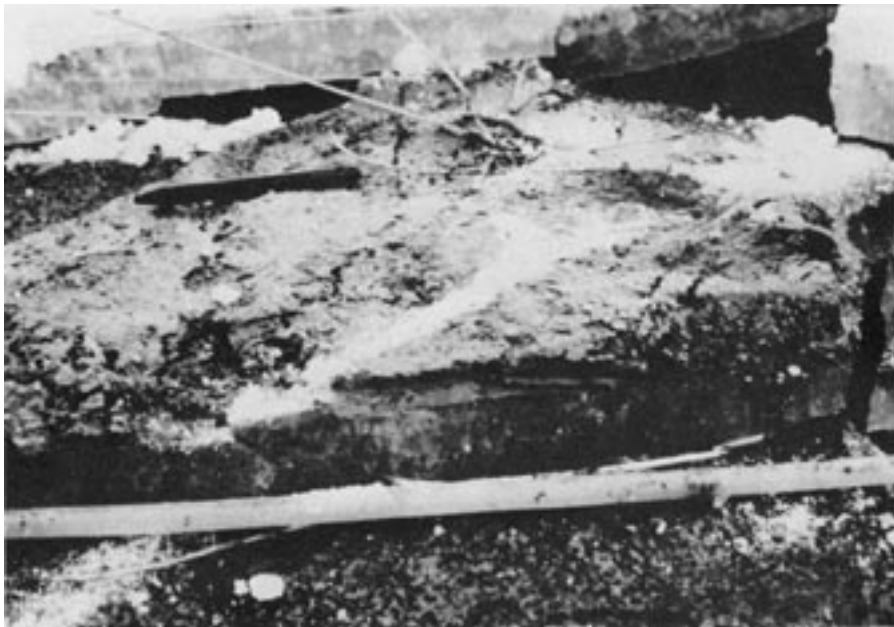
a. Vegetated pond bottom sediments frozen onto ice near the In-between Gully.

b. Sediment layer frozen onto an ice block at Otter Gully.

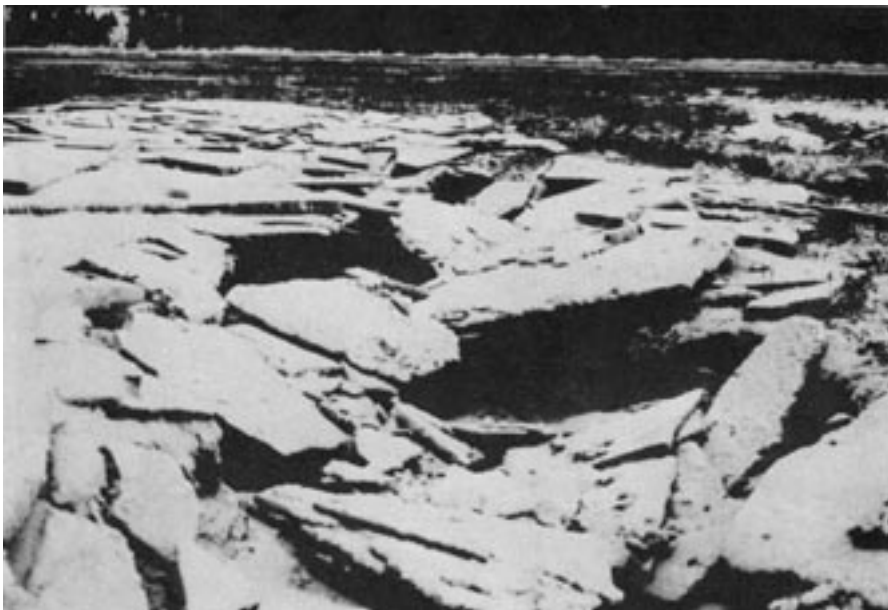
a. Aerial view showing distribution of ice blocks stranded during ebb tide.

b. Ice block pile along high point near gully margin.
