Interagency Expanded Site Investigation

Evaluation of White Phosphorus
Contamination and Potential Treatability
at Eagle River Flats, Alaska

FY 95 Final Report

U.S. ARMY COLD REGIONS RESEARCH AND
ENGINEERING LABORATORY
David W. Gate and Charles H. Racine, Report Editors

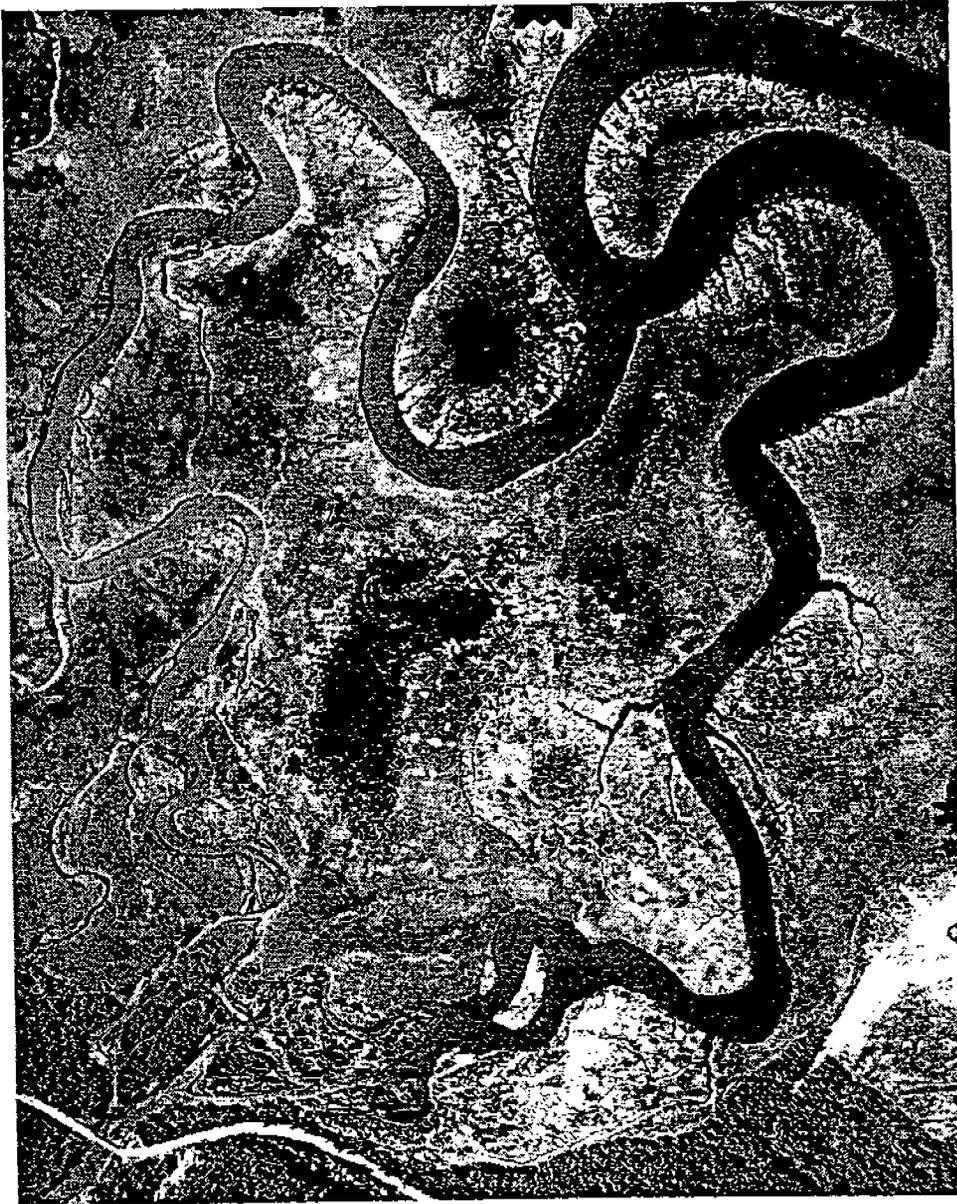
Figure II-1-5. Aerial photograph of Racine Island taken 16 August 1995 showing remnant channel surrounded by overbank deposits.

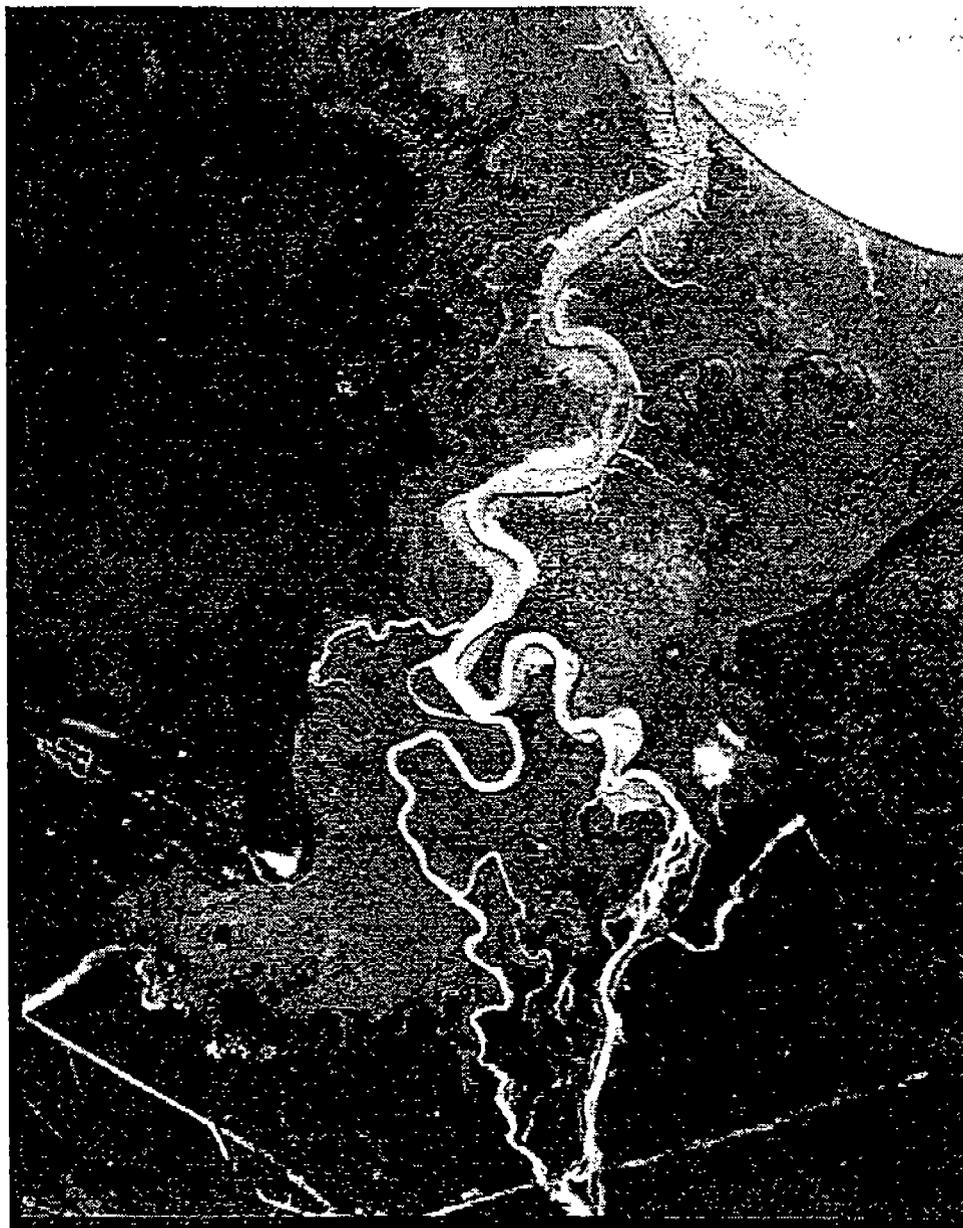
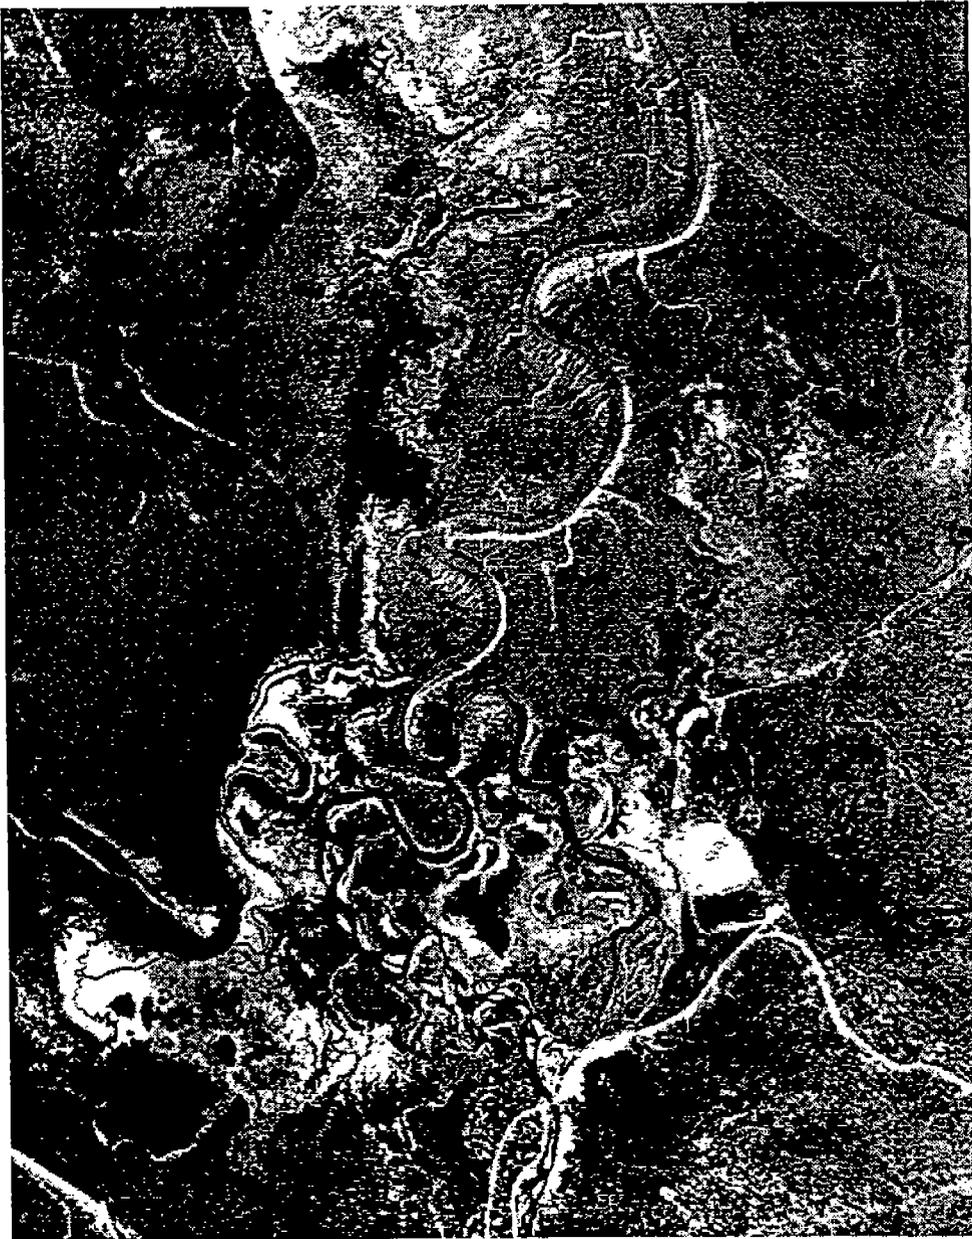
a. 1950.

Figure II-1-6. Aerial photographs of ERF.

b.1967.

Aerial photographs from 1950, 1967 and 1993 reveal changes in the distributary channel pattern entering ERF (Fig. II-1-6). Three main channels entered the Flats in 1950, but by 1967 the western most channel was abandoned and the eastern and middle channels diverged just northeast of the Route Bravo bridge. The two primary channels entering the Flats were characterized in 1967 by partial braiding and a divergent pattern characteristic of an alluvial fan (Fig. II-1-6b). Deposits in the fan area are relatively featureless overbank materials deposited by

Eagle River flooding. Only the center of the Racine Island area (Fig. II-1-5) is characterized by intertidal ponds and an abandoned gully. The westerly channel was abandoned this September (1995) during flooding of the Eagle River when channel scour and migration shifted the easterly channel further to the north-east.

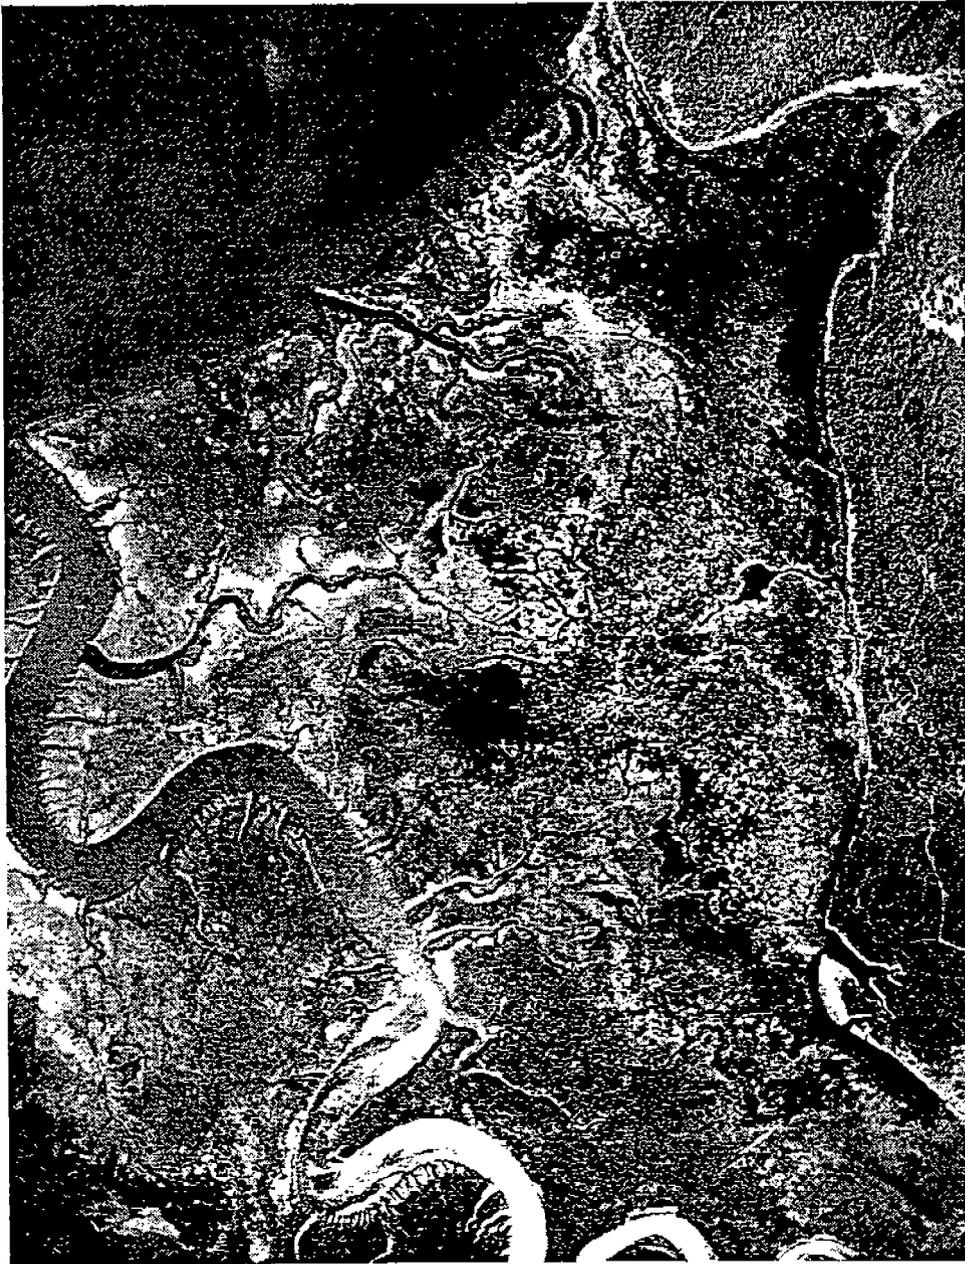
Figure II-1-7. 1992 aerial photograph of northeastern ERF.

Tributary channels with dendritic patterns, referred to as vegetated drainageways, drain water from the mudflats and ponds into the tidal gullies (Fig. II-1-3 and II-1-7). A second set of channels intercepted by the active tributary system

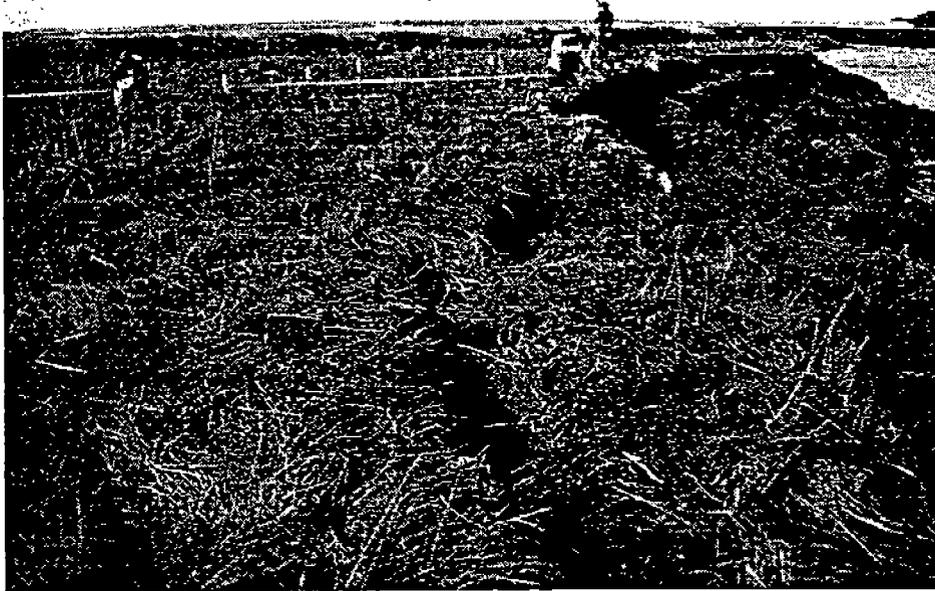
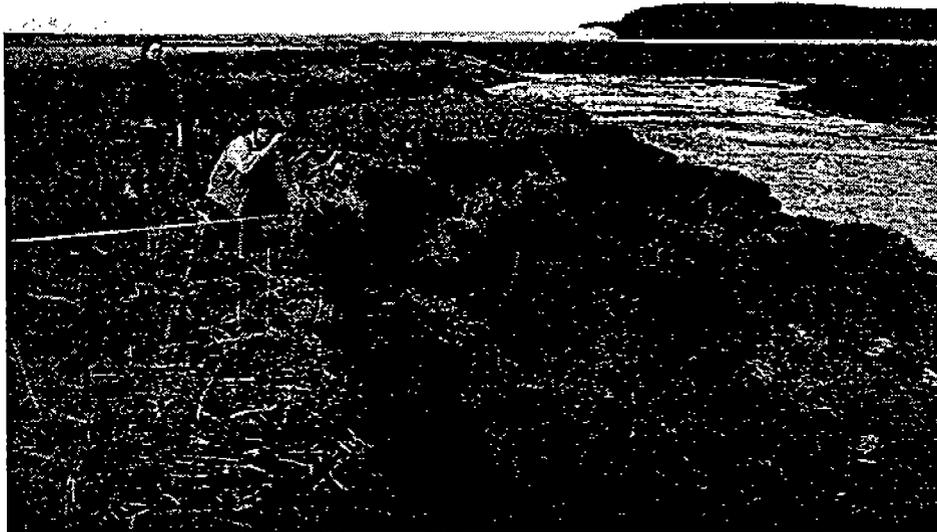
a. North view showing extension crack in foreground.

b. Rotational slump blocks visible to right of scarp.

Figure II-1-23. Measurements of bank erosion along Eagle River at the River-North site.

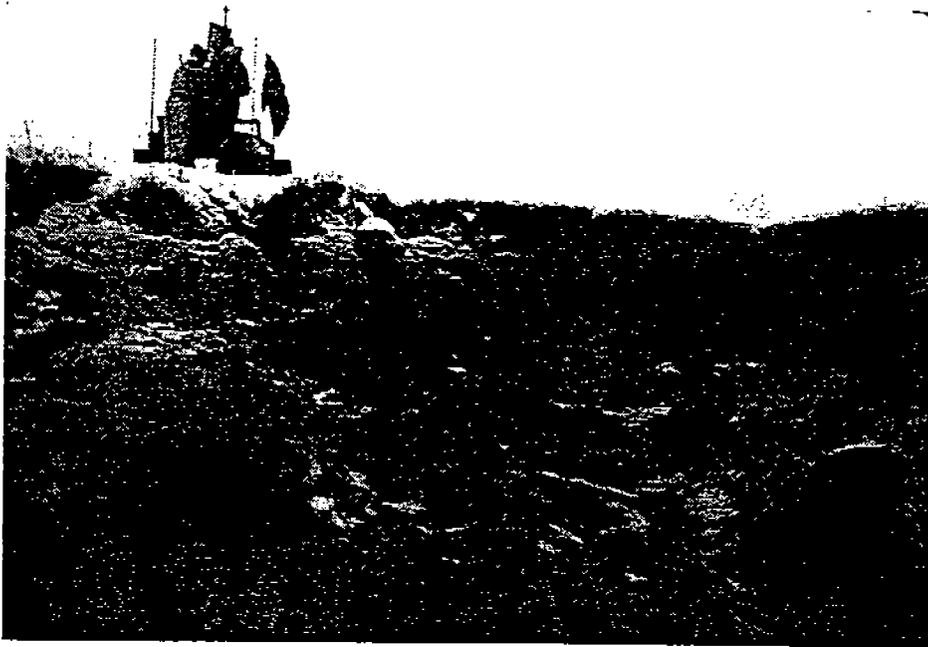
a. Lateral wall view. Ice armor caused by repeated flooding and subsequent freezing in gully.

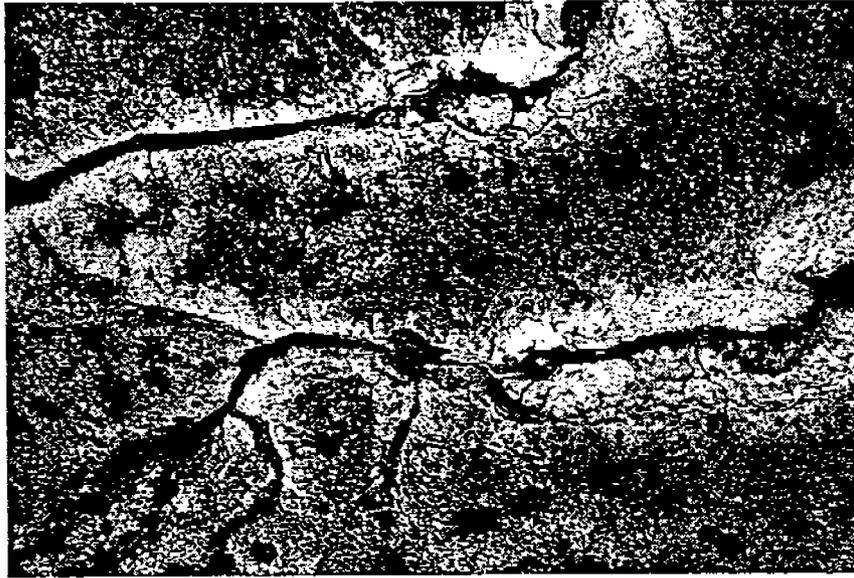
a. Area A.

b. B-Gully.

Figure II-1-26. Aerial view of gullies where recession and ebb flow have been modified by surface craters.

The spatial variability in recessional rates is evident in the plots showing the sequential recession of scarp crest location through time (Fig. II-1-22). One of the first gullies monitored at ERF is that of Parachute Gully on the west side of Area C (Fig. II-1-14). Since monitoring began in 1992, Parachute gully (Fig. II-1-22b and II-1-25) has undergone up to 12.1 m of headwall recession but only 1.8 m of lateral recession (Tables II-1-8 and II-1-9). Recession has centered around a drainageway that has become incised and enlarged where multiple mortar craters were once situated. In this instance, the craters became hydraulically connected by localized scour during ebb and the direction of gully extension is dictated by their presence. Similar enhanced erosion occurred along drainageways in Area A (Fig. II-1-26a) and B-Gully (Fig. II-1-26b).

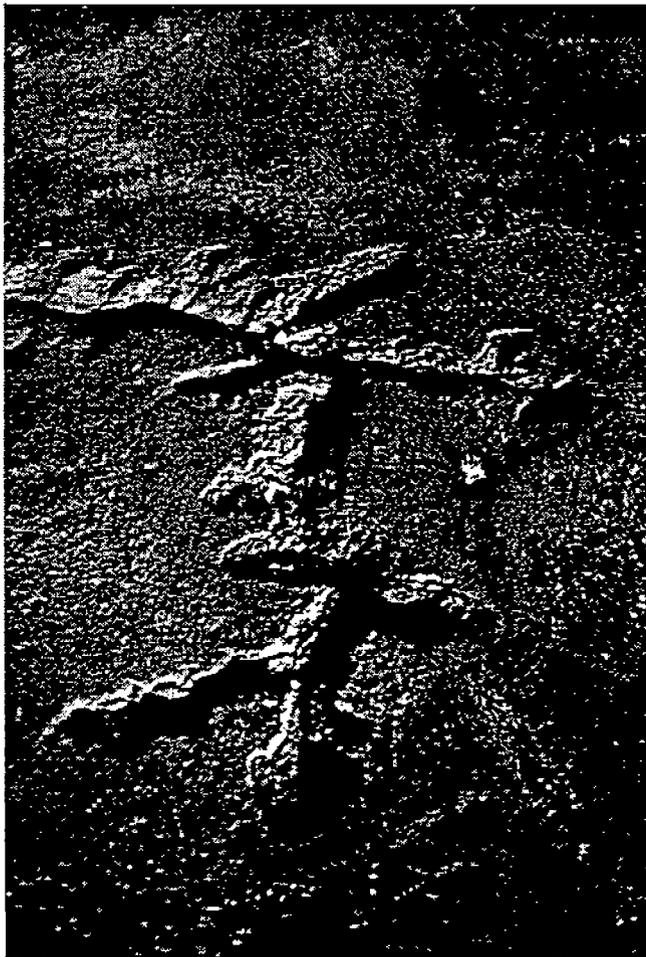
Figure II-1-27. Aerial view of Bread Truck Gully in October 1995.

Bread Truck and Coastal 5 gullies bracket the mouth of the Eagle River and are the sites with the maximum rates of headward recession (Fig. II-1-14, II-1-22a, II-1-22c). Bread Truck Gully (Fig. II-1-27 and II-1-22a) was first monitored in 1993

when headward recession ranged from 0.3 to 5.0 m and lateral recession was on the order of 0.2 to 2.2 m (Table II-1-8). In 1995, headward recession accelerated to 11.7 m during the May 1995 flooding tide (representing the winter 94/95 erosion column of Table II-1-8) and an additional 20 m during the 1995 summer season. These rates do not appear to be exceptional or unique; the Coastal 5 gully site experienced 17 m of recession during the summer of 1995 and a total of about 26 m since the hub and line stakes were established in July 1994.

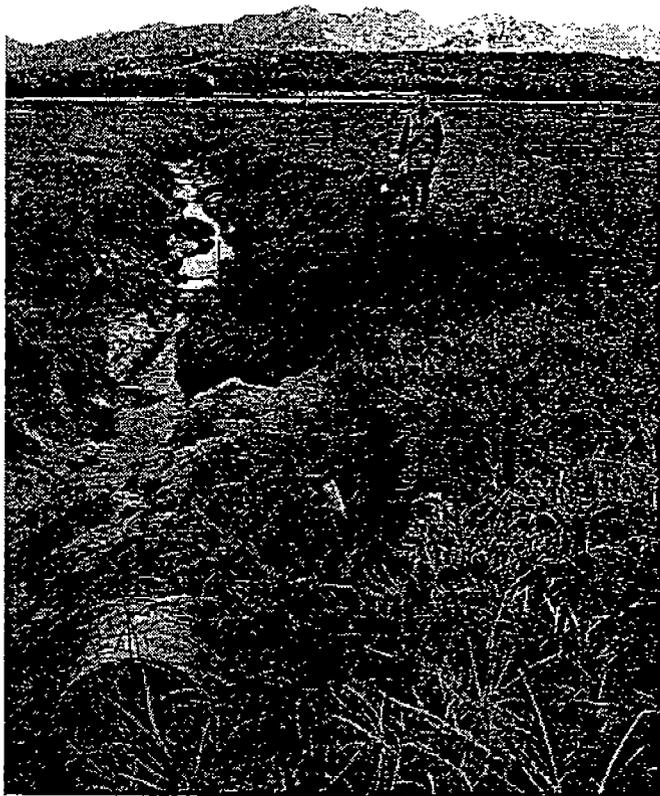
Figure II-1-28. Eastward view of eroding cusped embayments at B-Gully.

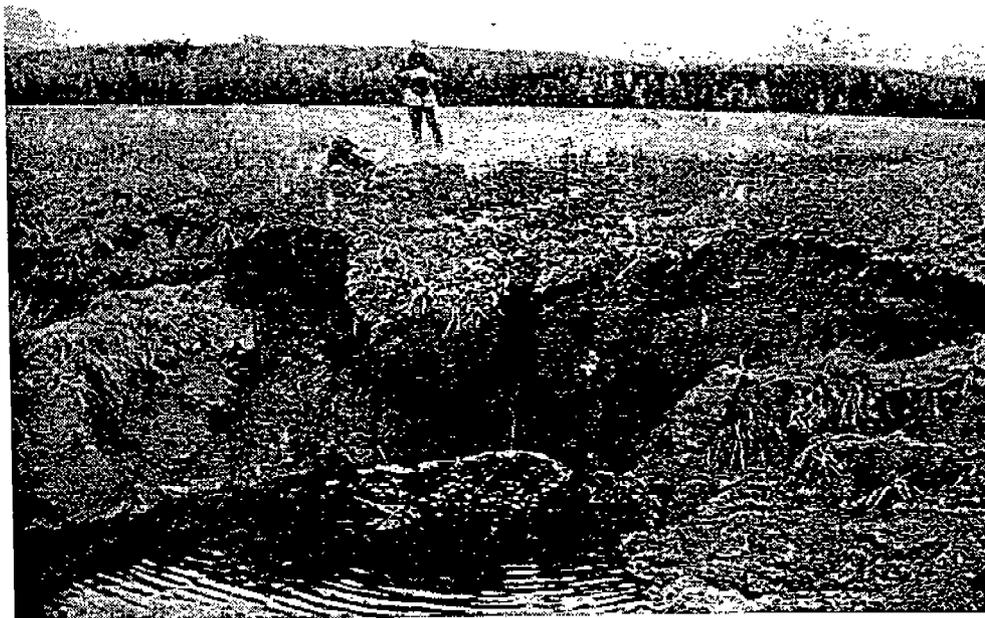
Figure II-1-30. Thick laminated peat layer at Coastal 6 forms the threshold to channel downcutting and headward recession.

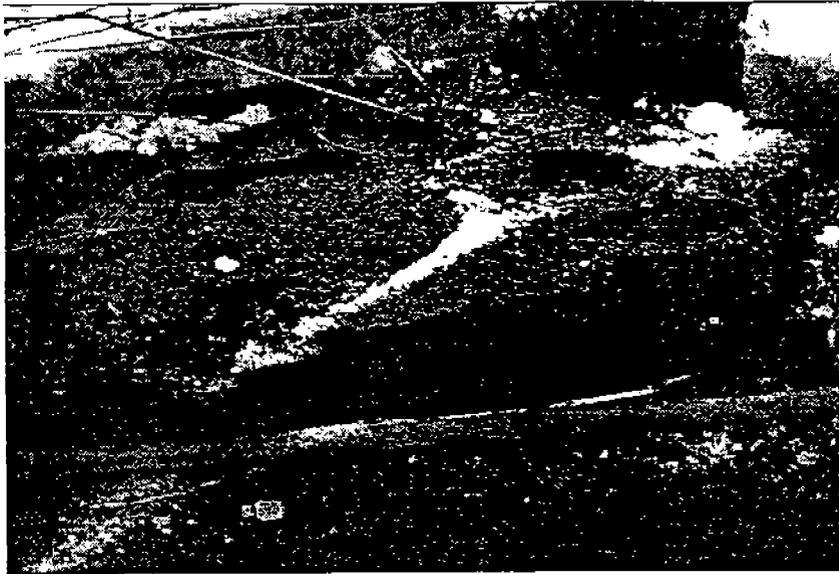
a. Sediment layer frozen onto an ice block transported during the November 1994 flooding tides.

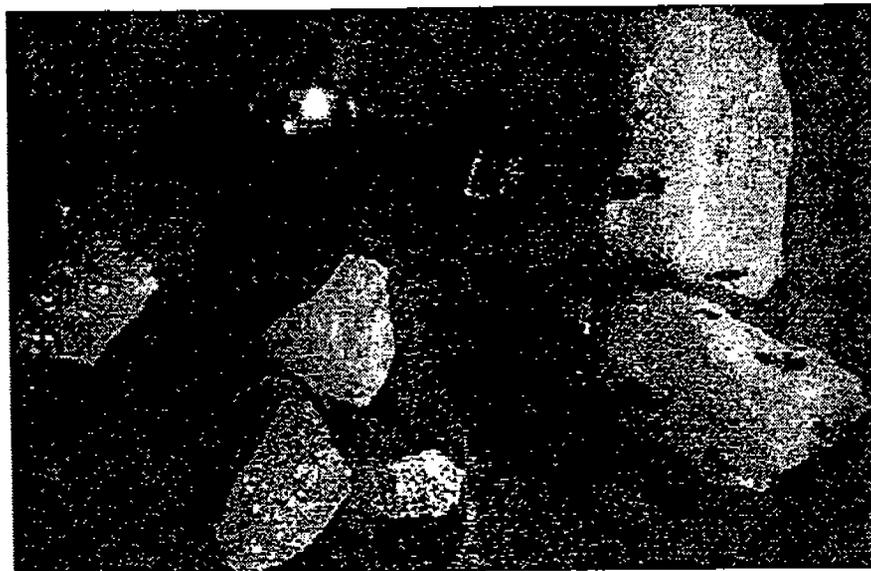
Figure IV-3-2. Particles of white phosphorus (WP) isolated from sediment collected from Racine Island in 1994. Lead shot, shown for scale, is 2.7 mm in diameter.

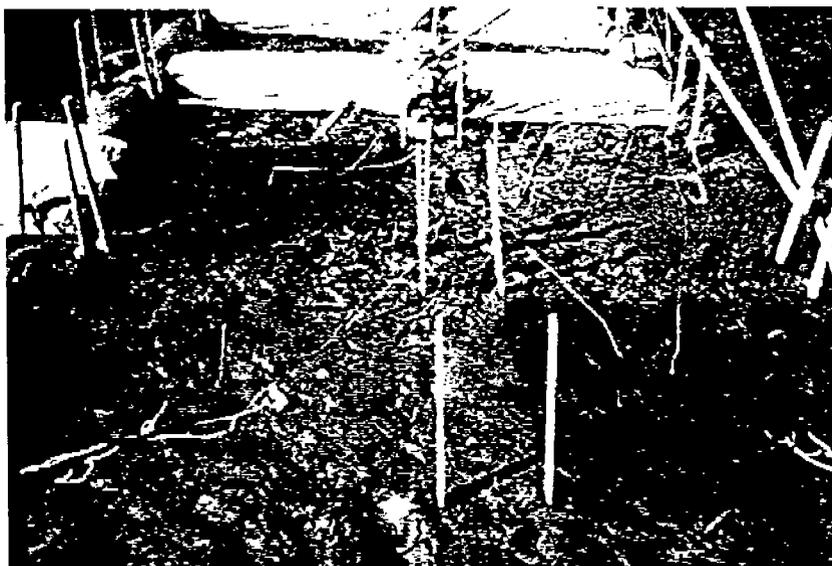
Figure IV-4-4. Control and black sand plots.

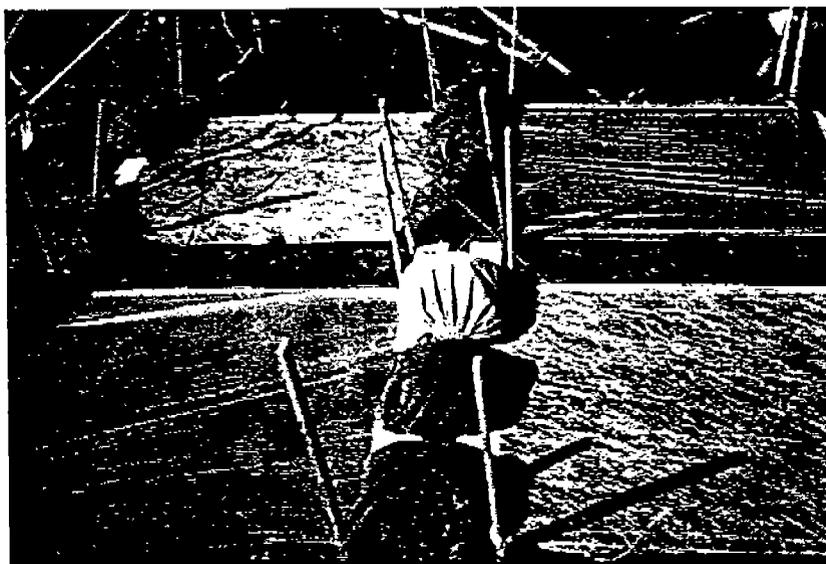
Figure IV-4-5. Reemay and Fast Start (plastic) plots.

Also evaluated were three types of synthetic row covers. The first was Reemay, a spun-bonded polyester, the second was Fast Start, a porous polyethylene, and the third was burlap. The Reemay and Fast Start were tested at the mudflat site, and the Reemay and burlap were tested at the pond site. Fabrics were held in place using two-by-fours and sand bags. The wood maintained an air gap between the fabric and the surface of the sediment (Fig. IV-4-5).

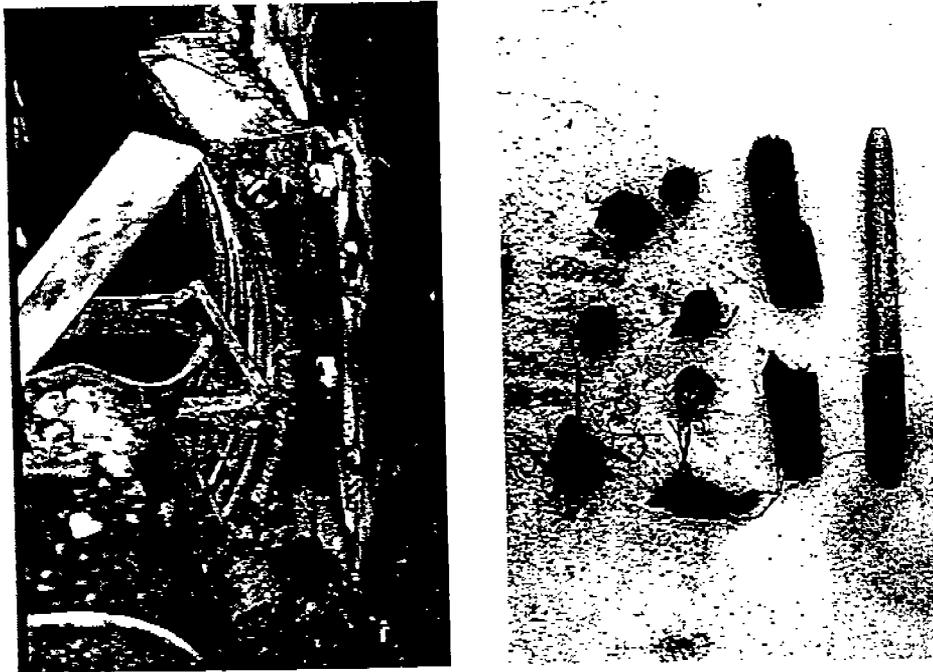
a. Side view of grates with cutter. b. Debris extracted from grates.

Figure IV-6-11. Original (Mk. I) cutter/grate system.

The solution is a cutter and grate system for the auger head. The vertical grates are attached to the front of the dredge head where the intake is located. A cutter bar, attached to the center of the auger, keeps the grates clear of vegetation by sweeping debris up the grates and cutting it at the top. A tapered transition section behind the grates smooths the flow of water from a rectangular cross-sectional opening to a \varnothing 15-cm hose adapter. Stiff tines are attached to the auger flights to augment maceration of vegetation prior to ingestion.

The original system was designed to function as a bolt-on system (Fig. IV-6-11). Operational usage of the system indicated that extended run-time was possible with the grates installed. However, some plugging of the grates was

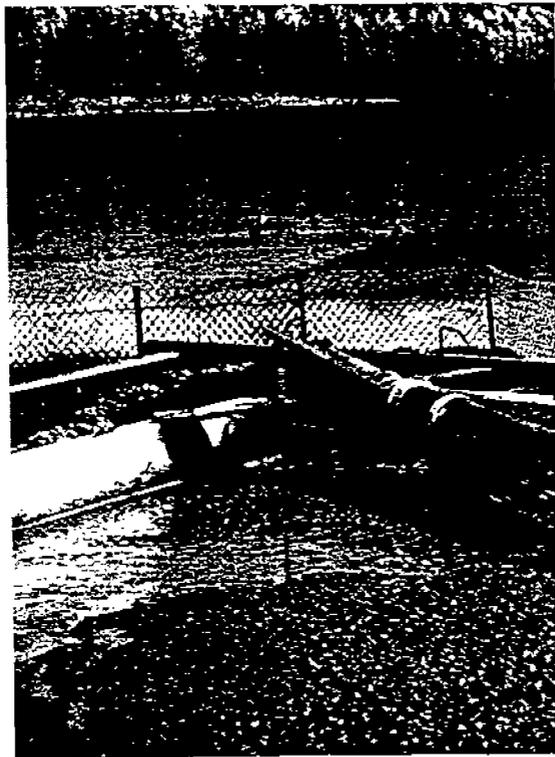
Figure IV-6-15. Pumping mud into the retention basin.

With the correction of the equipment problems and the addition of some specialized components, the dredge proved a capable remediation tool. Removal rates were not as high as originally anticipated due to the inability of the equipment to cope with the very tough vegetation found in the area dredged. Once operational experience was gained, consistent dredging action was achievable (Fig. IV-6-15).

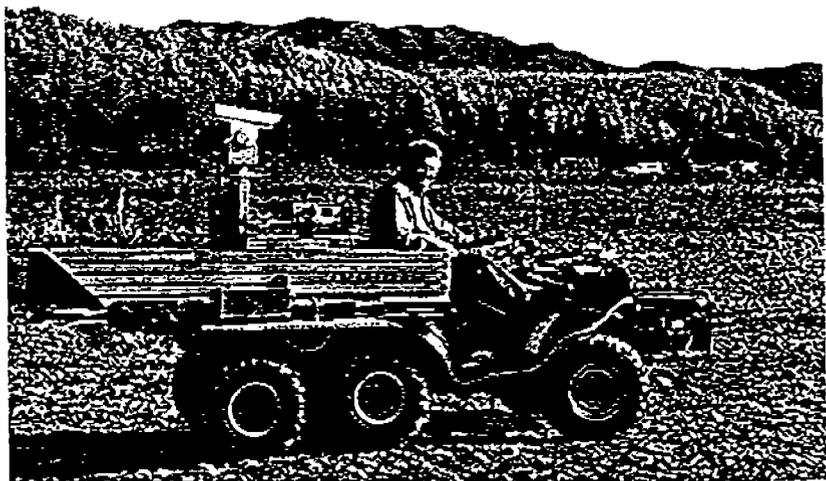
Figure IV-7-4. Drill unit on EOD Pad.

The vehicle is mounted on low-ground-pressure tires (34.5 kPa/5 psi) and has a 30-cm operating depth (Fig. IV-7-4). It should be capable of going most anywhere needed, within reason. Due to uneven weight distribution and hard rear axles, steering on the vehicle is not very responsive, so mapping out a route with the least amount of sharp corners is recommended. Climbing ability is good on dry
