Vapor Intrusion Survey/Groundwater Monitoring Well Decommissioning Final Report

**K&L Distributors
Fairbanks, Alaska**

May 31, 2016

**Alaska Resources and
Environmental Services, LLC.**

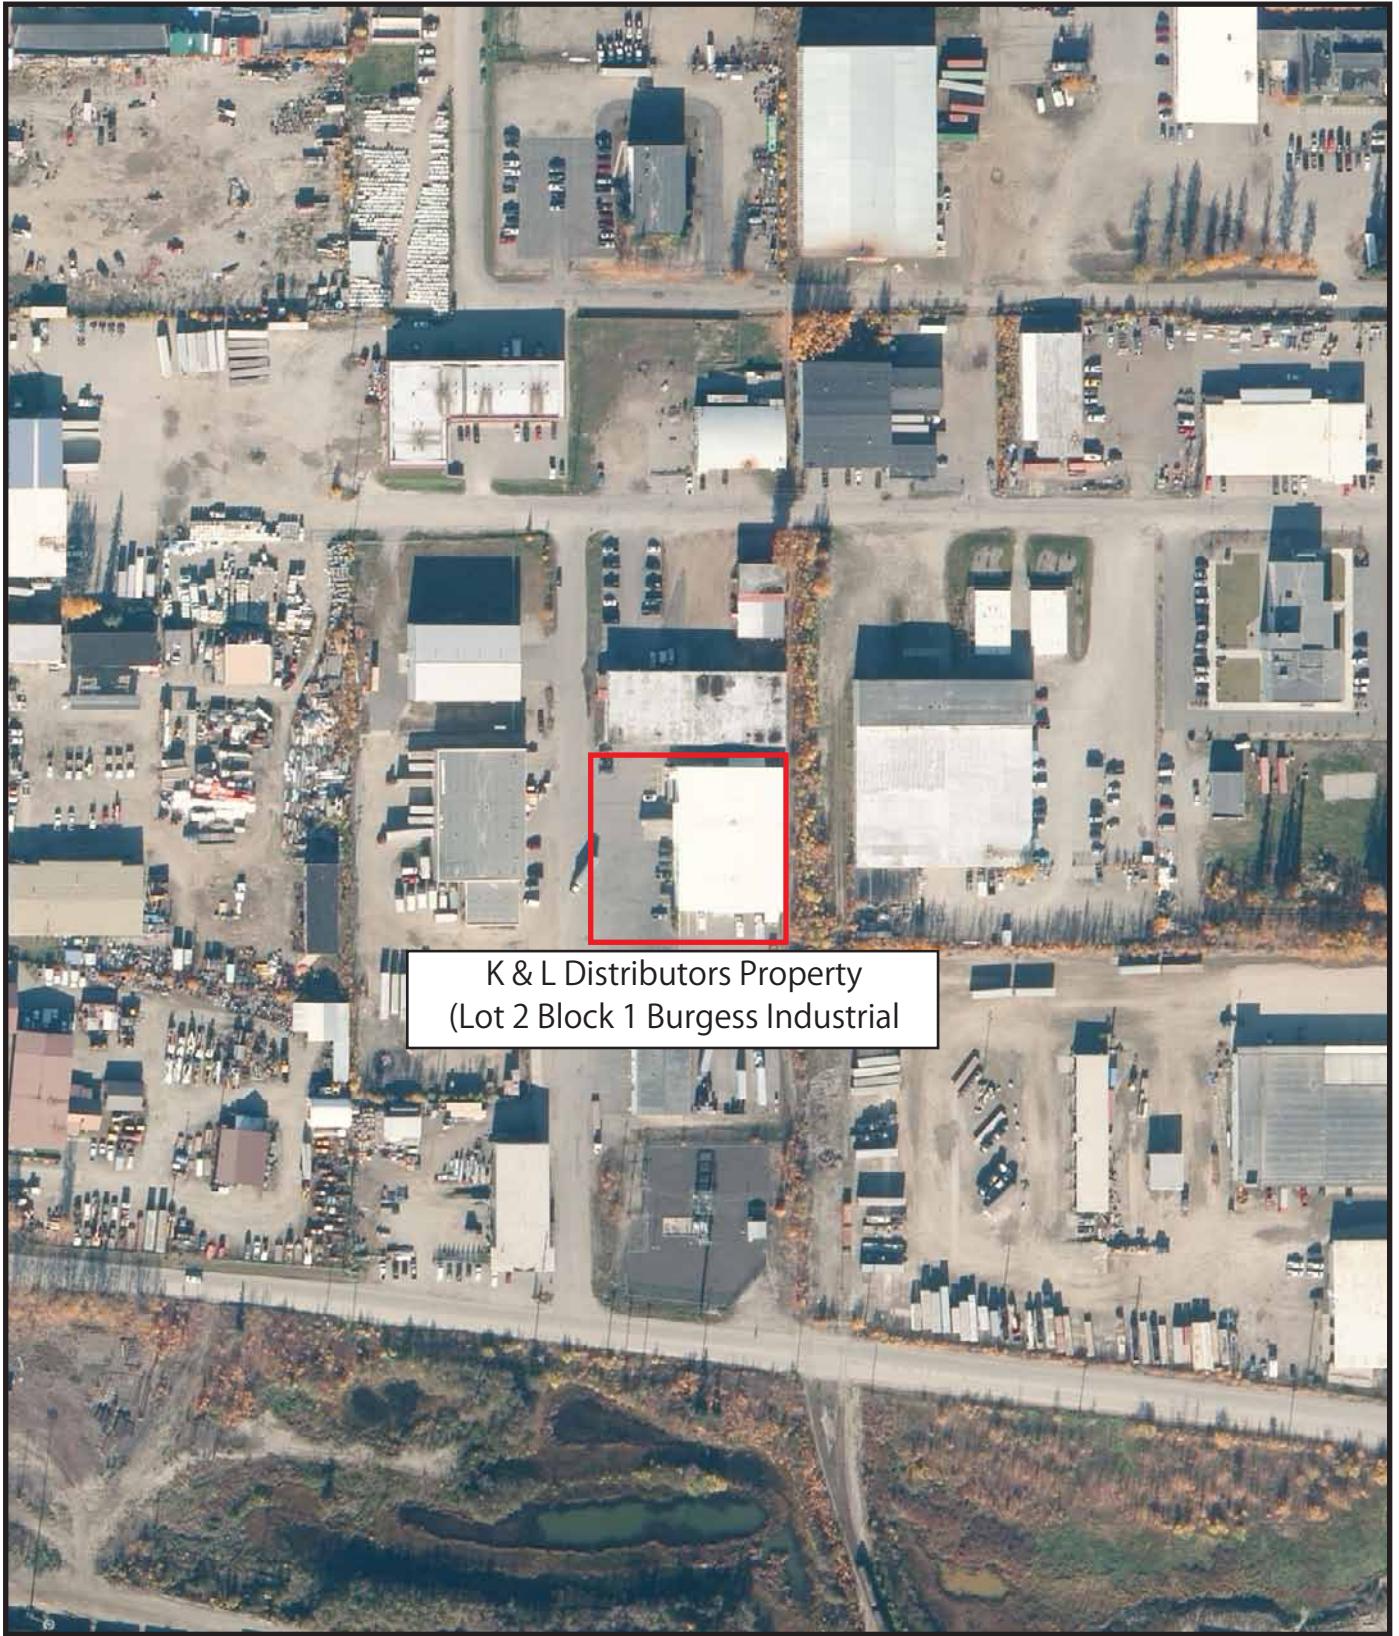
Aerial Photograph	Date: 05/20/16	Scale in Feet:		Alaska Resources and Environmental Services, LLC 284 Topside Fairbanks, AK 99701 PH. (907) 374-3226 FAX (907) 374-3219	 FIGURE 2
	Drawn: JDG				
	Project: Indoor Air Sampling K & L Distributers, Fairbanks, AK

The property located at 945 Elizabeth Street, Fairbanks, Alaska (Figures 1,2) is situated in an area primarily used for commercial and light industrial purposes in the vicinity Fairbanks, Alaska. The lot consists of one commercial building on a 1.26 acre parcel. The former 1,500-gallon UST used for the storage of heating fuel oil (# 2 diesel) was located adjacent and south of the warehouse. The legal description for the site is: Tax Lot 2, Block 1 Burgess Industrial Park. The GPS coordinates for the site are N 64° 51.181', W -147° 46.035'. The elevation of the site is 447' above mean sea level.

K & L Distributors Property
 (Lot 2 Block 1 Burgess Industrial)

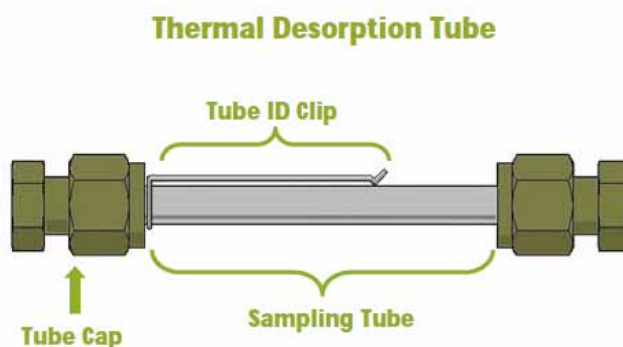
Ambient and Indoor Sampling Guidelines

Time (minutes)	Flow Rate (mL/min)					
	20	40	50	60	80	100
5	100	200	250	300	400	500
10	200	400	500	600	800	1000
15	300	600	750	900	1200	1500
20	400	800	1000	1200	1600	2000
30	600	1200	1500	1800	2400	3000
60	1200	2400	3000	3600	4800	6000

Consult with laboratory before developing a sampling plan to ensure usable results. **Do not exceed maximum recommended volume.** For other sources or applications, please consult with the laboratory to determine optimal flow rates and sampling intervals.
