# **Interagency Expanded Site Investigation**

**Evaluation of White Phosphorus  
Contamination and Potential Treatability  
at Eagle River Flats, Alaska**

**FY 96 Report**

**U.S. ARMY COLD REGIONS RESEARCH AND  
ENGINEERING LABORATORY  
Charles M. Collins and David W. Cate, Report Editors**

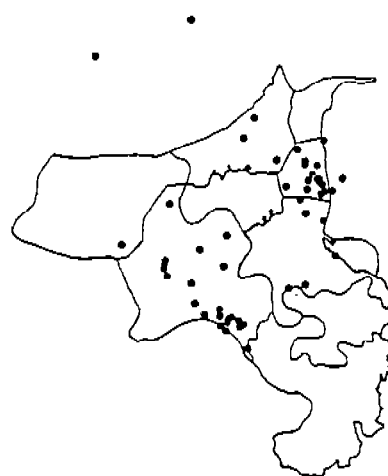
Figure II-3-3. Example of a geographic information system map depicting a radio-telemetry result of a mallard that died from ingesting white phosphorus. Light dots show the last days of movements prior to mortality.

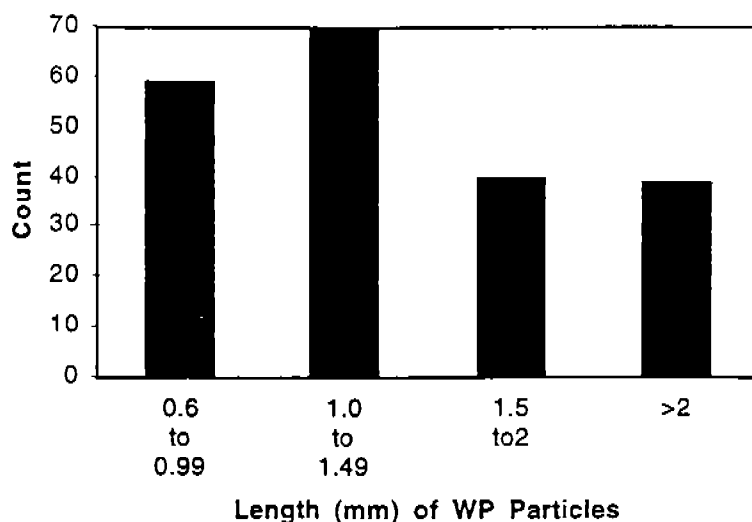
*Figure III-2-4. Size distribution of white phosphorus particles retained on a 0.59-mm mesh from composite samples taken from DWRC Pen #5.*

The particle sizes were typical of what we had observed previously in samples collected from permanently flooded areas. Of the 208 particles that were found by microscopic examination, most were between 0.59 mm (the size of the mesh used for sieving) and 2 mm in their longest dimension (Fig. III-2-4), which is equivalent to 0.2 to 7.6 mg for spherical particles. The largest particle found measured

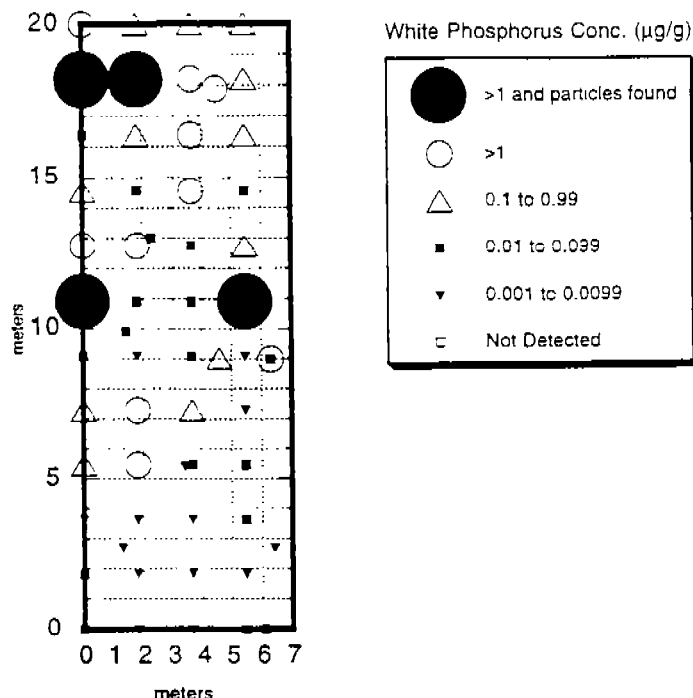
Figure III-2-5. Plot of white phosphorus concentrations found on a 1.82-m-square grid in 1996 and in samples taken by DWRC, 1992-1994. The large black circles indicate discrete samples where white phosphorus particles were found, and the diameter of the circle is proportional to the assumed hot spot diameter.

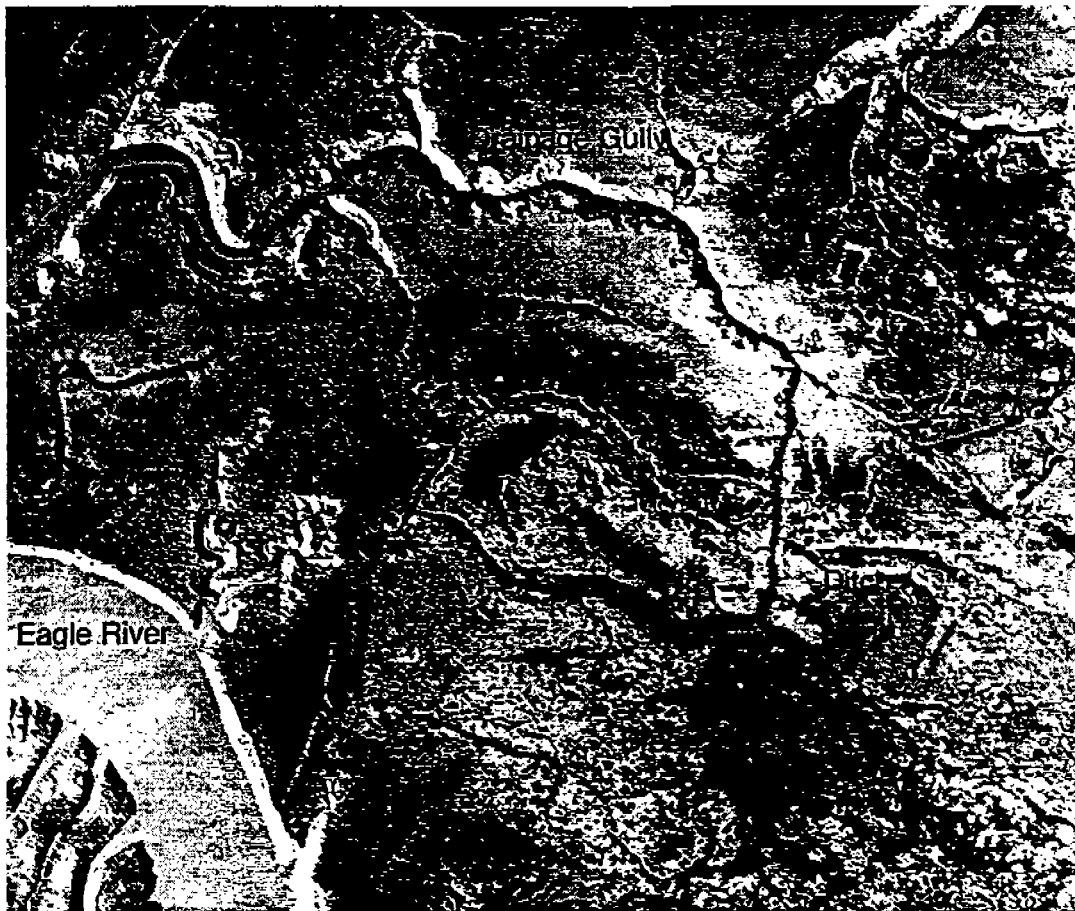
Figure II-3-1. Aerial view of region of Bread Truck Pond within Eagle River Flats.

The Bread Truck (BT) pond is an isolated pond located east of Eagle River and northwest of the Area C pond complex (Fig. III-3-1). The BT Pond consists of an inner permanently flooded pond with an area of 33,000

m<sup>2</sup> (3.3 ha). An outer intermittently flooded pond area of 5.4 ha surrounds the permanent pond, mainly on the west and south. Additional adjacent and connected intermittently flooded ponds on the north total another 1.0 ha. The pond area is surrounded on three sides by higher, vegetated mudflats (Racine et al. 1993). On the fourth side, to the east, the pond is bounded by a sedge and bulrush marsh complex called the C/D area. The elevation on this side of the BT Pond is lower than the other three sides, allowing some flow between the BT Pond and the C/D area at certain water levels. To the east of the C/D area is an upland bluff marking the eastern boundary of Eagle River Flats.

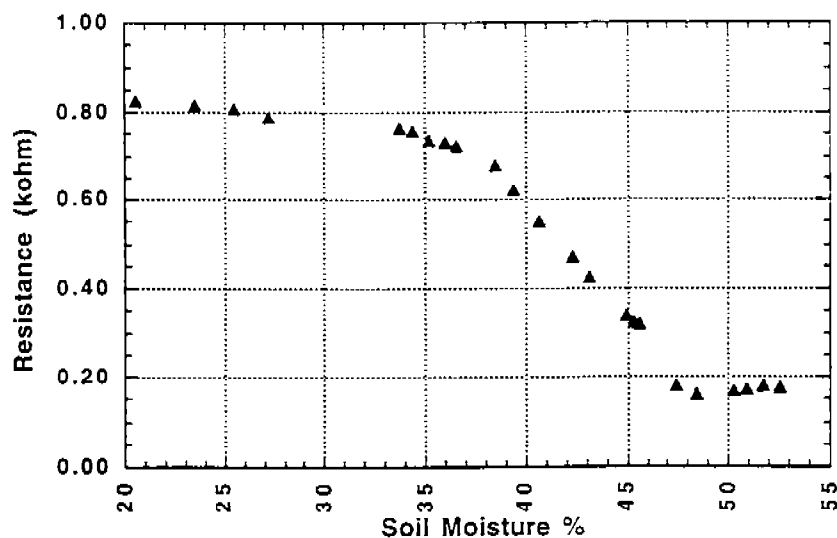
Figure II-3-4. Soil moisture probe resistance versus percent soil moisture by dry weight for a bulk sample of sediment from Bread Truck Pond.

Using a standard Tempe pressure cell (SoilMoisture Equipment Corp., Santa Barbara, CA), a moisture retention curve (Hillel 1982) for the BT Pond sediment was determined. This curve was used to estimate the air entry value, which gives an indication of how far the water table must drop before surface sediments become unsaturated. It also gives an estimate of the tensiometer reading corresponding to the onset of unsaturated conditions as sediments dry. To generate the curve, air pressure was applied to a core of saturated sediment placed on a porous ceramic plate in the Tempe pressure cell. Air

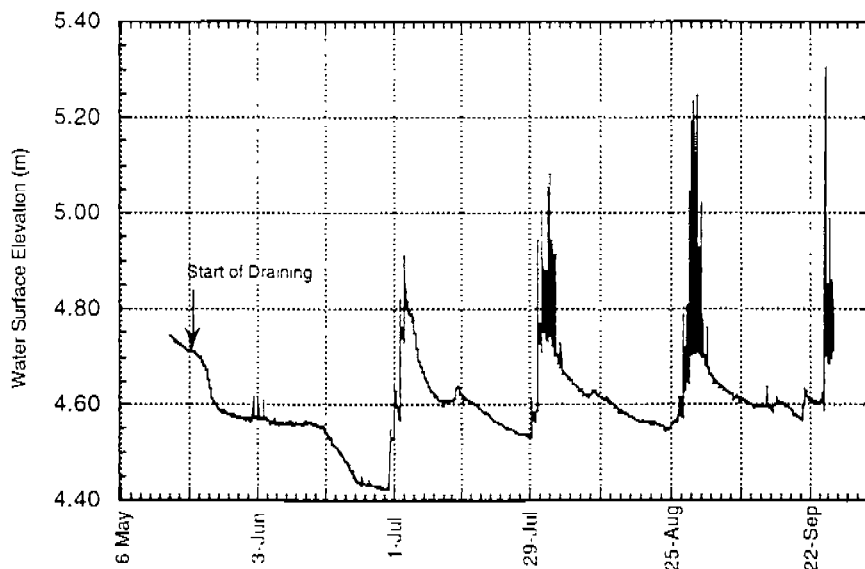
Figure II-3-10. Water surface elevation record for Bread Truck Pond (Site BT-6).

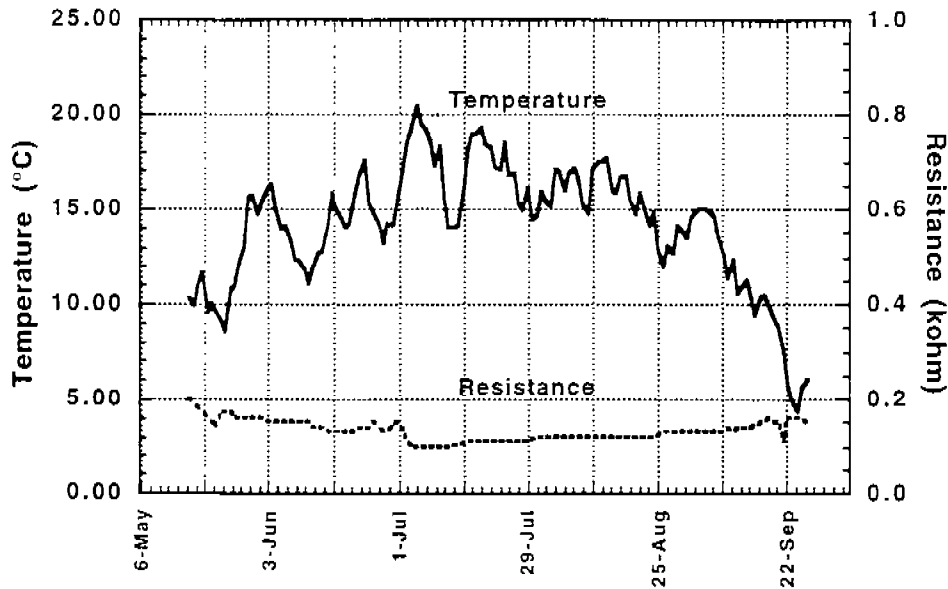
Figure II-3-13. Daily (24-hour average) temperature and moisture probe resistance at the 5-cm depth, Site BT-2.

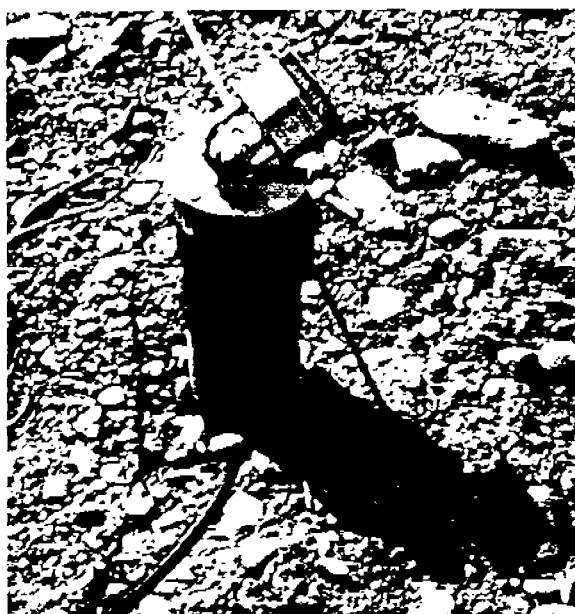
b. Close-up of wellhead.

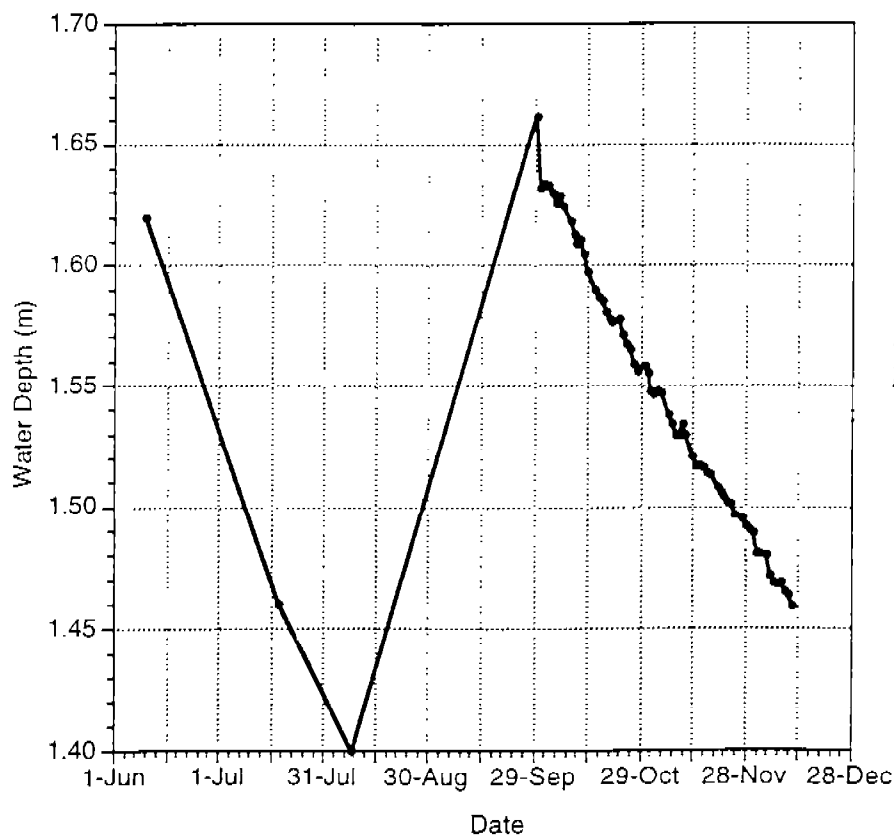
Figure III-4-12. Manual and piezometer data for well C-6.
