**Evaluation of White Phosphorus
Contamination and Potential Treatability
at Eagle River Flats, Alaska**

FY 97 Report

**U.S. ARMY COLD REGIONS RESEARCH AND
ENGINEERING LABORATORY
Charles M. Collins and David W. Cate, Report Editors**

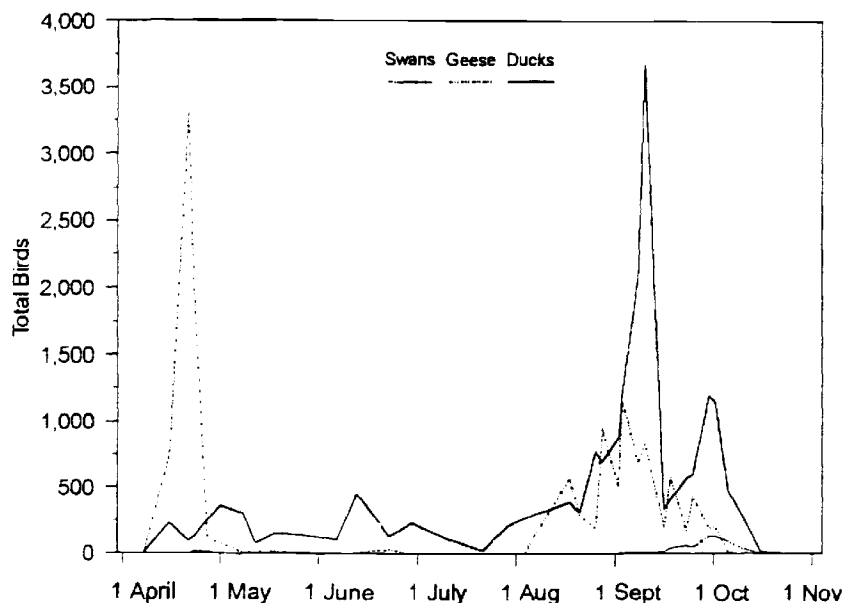
Figure II-1-3. Numbers of swans, geese, and ducks counted on ERF during aerial surveys in 1997.

Fall goose migration phenology was earlier than in other recent years, peaking in early September (Fig. II-1-3). Tule white-fronted geese comprised 7% of the fall count. Snow and Pacific white-fronted geese rarely migrate through Cook Inlet during fall and were not observed on ERF. Coastal West was the most important area for geese in fall (Table II-1-2, Fig. II-1-5).

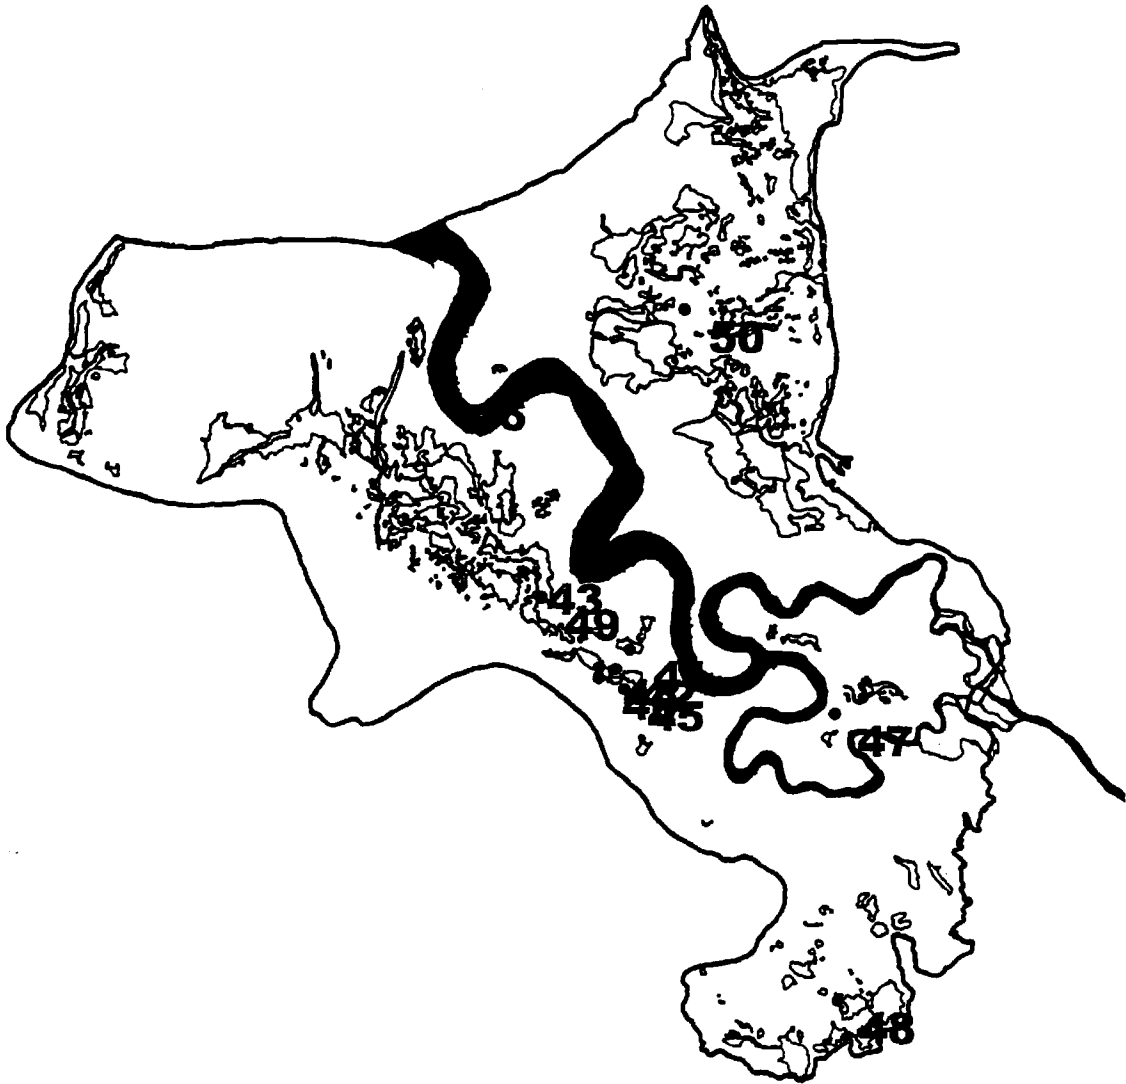
Figure II-2-3. Example of a GIS map depicting a radiotelemetry result of a mallard that died from ingesting white phosphorus. Dots (no. 40–48) show the last five days of movements prior to mortality (no. 49 died and 50 carcass recovered).

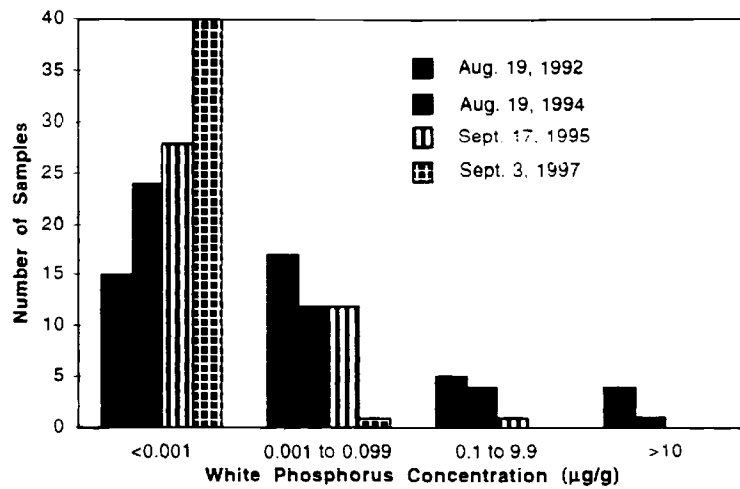
Figure III-2-4. a) Histogram showing number of samples in different concentration ranges in 1992, 1994, 1995 and 1997 around site 883 in an intermittent pond (#164) of Area C. b) Percentile plot of WP concentrations found.

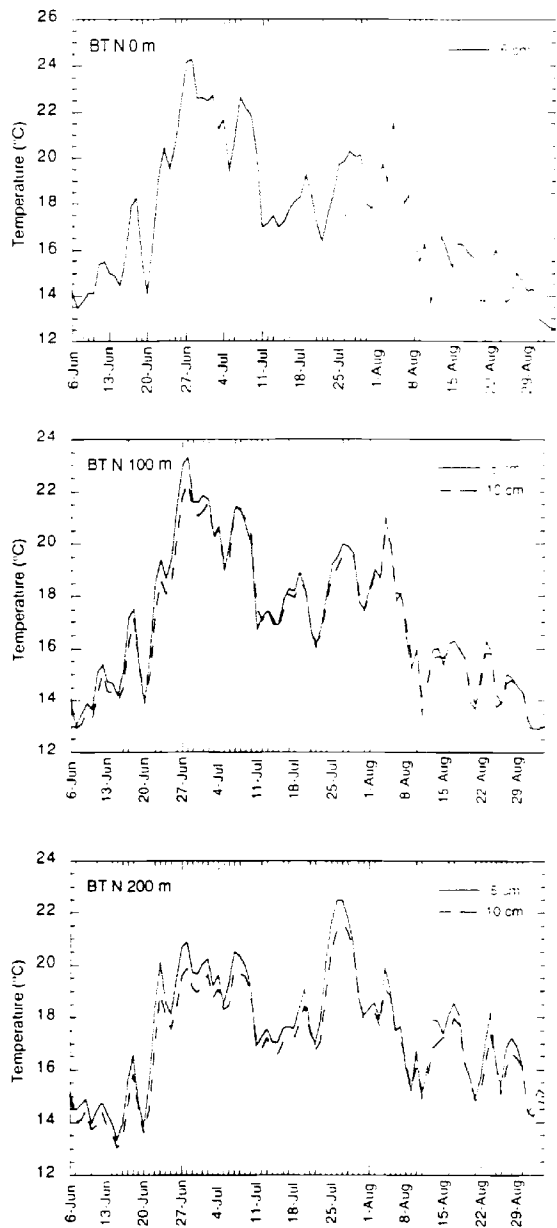
Figure III-2-7. Sediment temperature (24-hr averages) at datalogger stations in Area C and the Bread Truck Pond.

c. Bread Truck North.

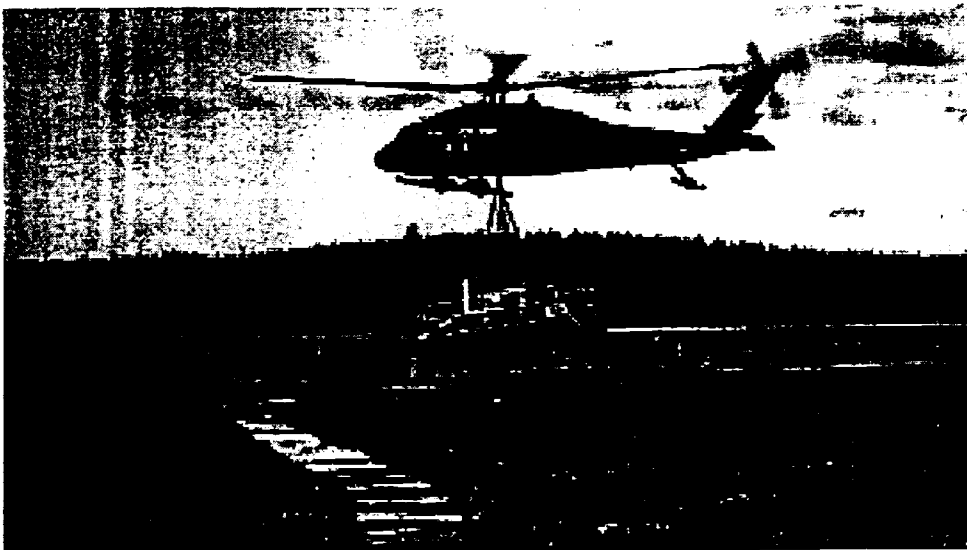
Figure III-4-8. Airlifting the genset into place using a UH-60 Blackhawk helicopter.

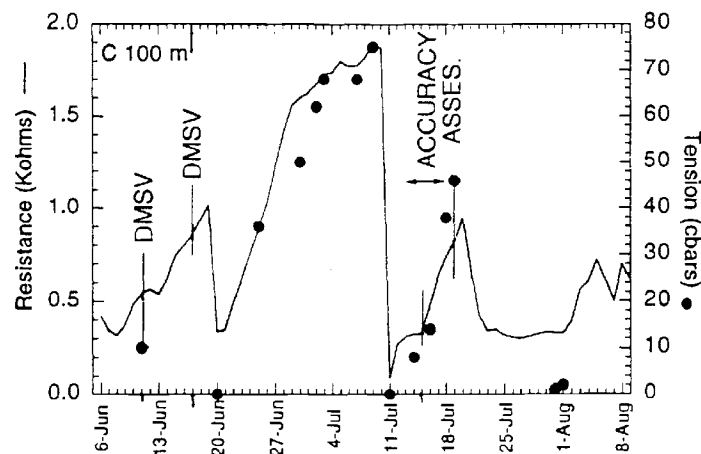
b. Tensiometer and clay block moisture probe electrical resistance in bottom sediments of C pond pumped area during summer 1997, showing decreasing soil moisture levels between 11 June and 17 June, the dates of DMSV image acquisition. (From M.E. Walsh and C.M. Collins.)
