**Evaluation of White Phosphorus
Contamination and Potential Treatability
at Eagle River Flats, Alaska**

FY 98 Report

July 1999

U.S. ARMY COLD REGIONS RESEARCH AND ENGINEERING LABORATORY
Charles M. Collins and Mark J. Hardenberg, Report Editors

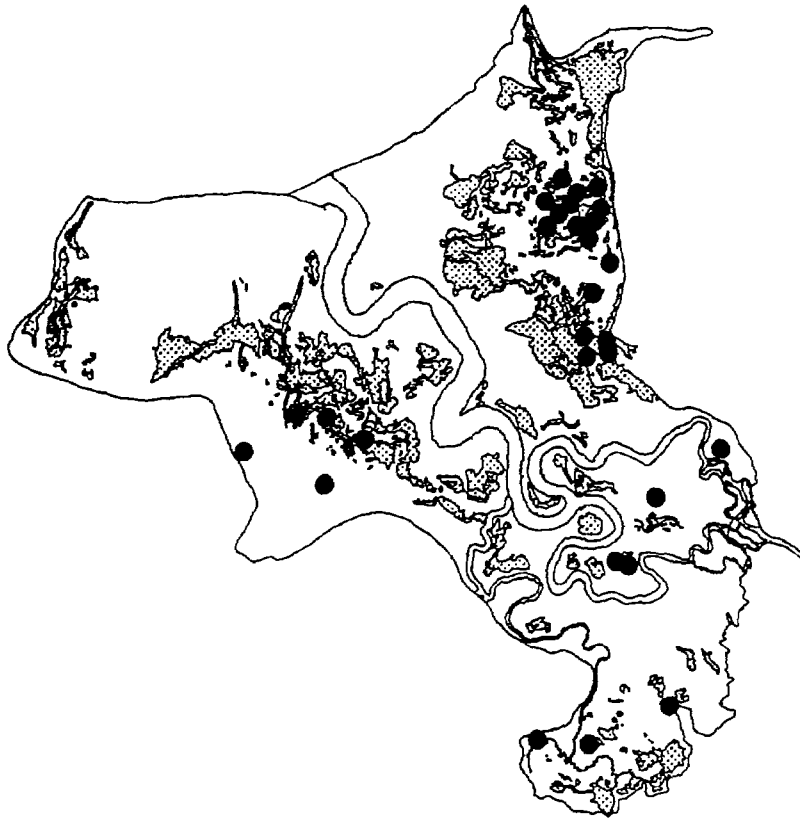
Figure II-2-6. Mallard mortality locations on Eagle River Flats in 1998.

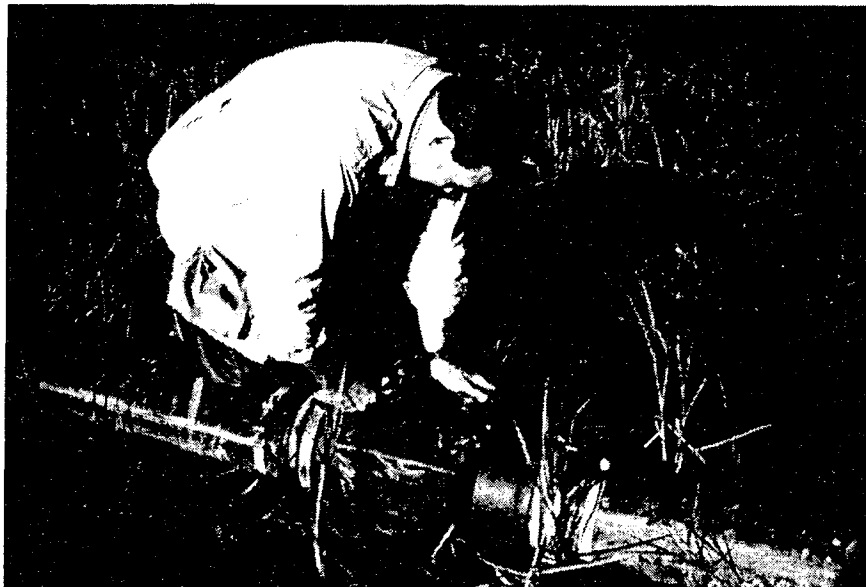
Figure III-1-6. Discharge line check valve.

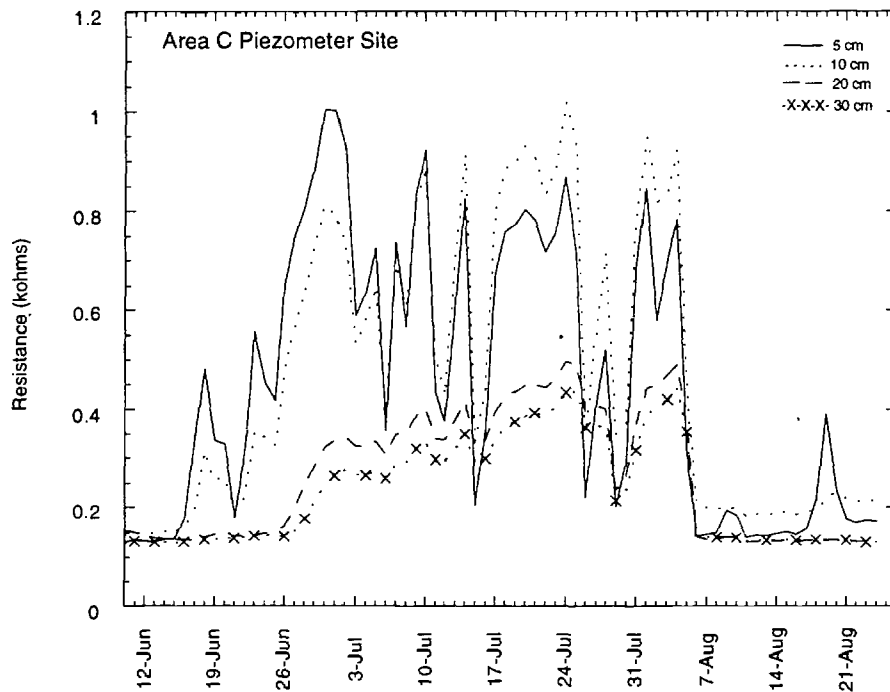
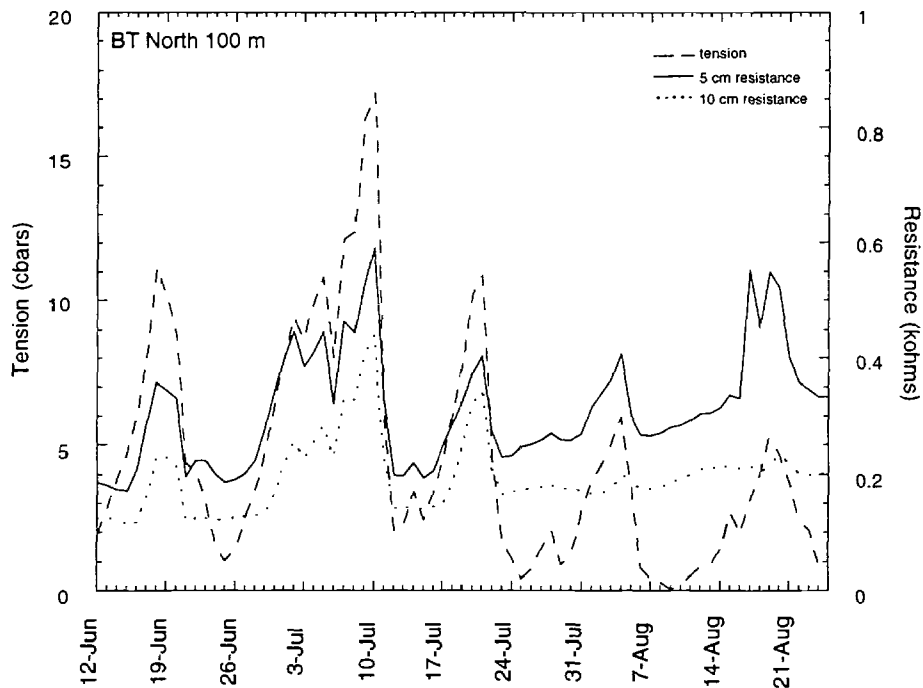
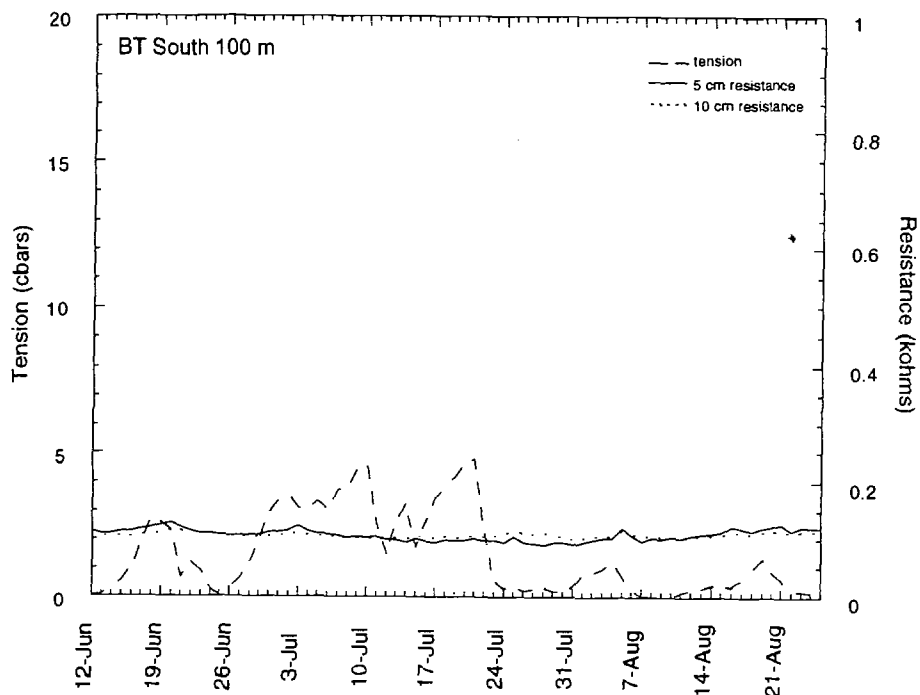
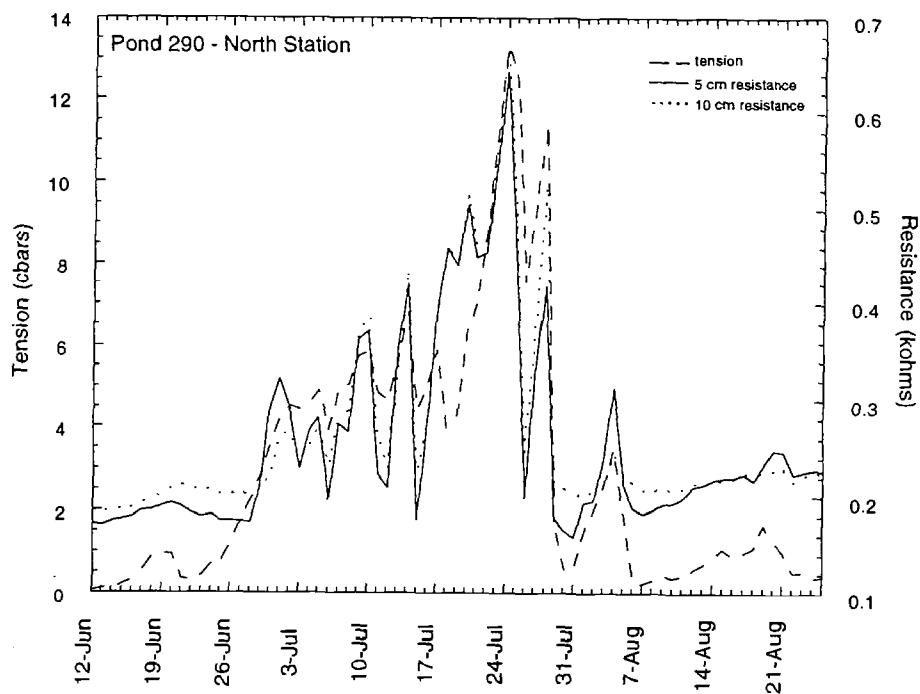
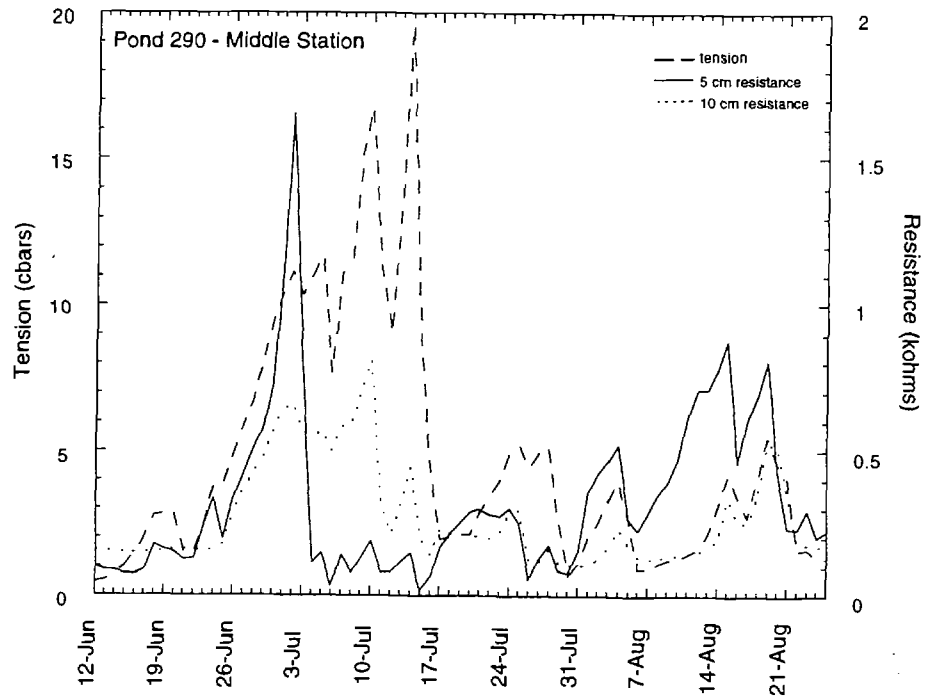
Figure III-2-12. Output from moisture sensors during summer of 1998. Increases in resistance and tension indicate drying.

Figure III-2-12 (cont'd). Output from moisture sensors during summer of 1998. Increases in resistance and tension indicate drying.

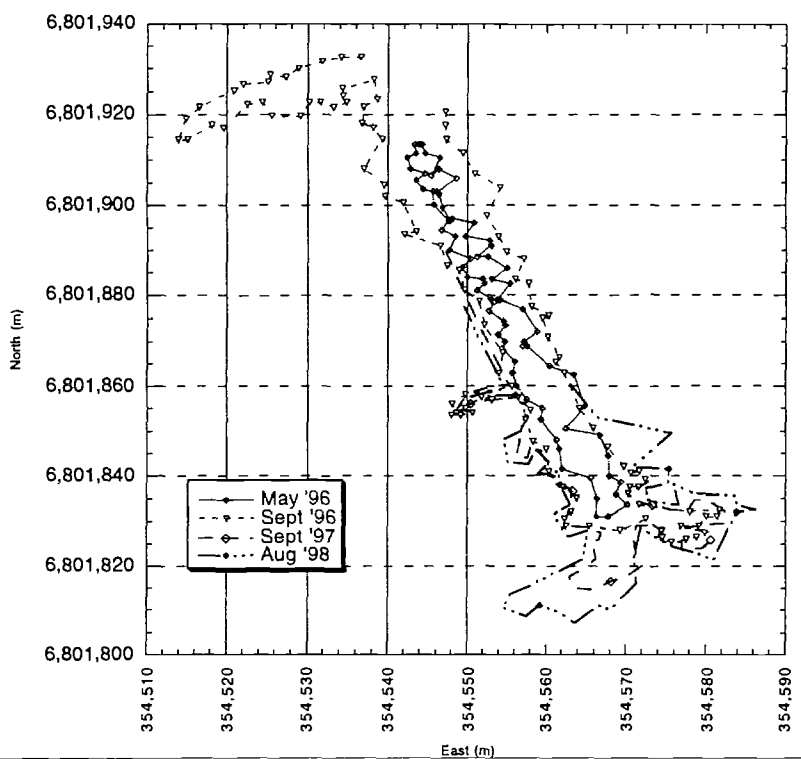
Figure III-2-15. Map showing advancement of the Bread Truck drainage ditch bank between May 1996 and August 1998.

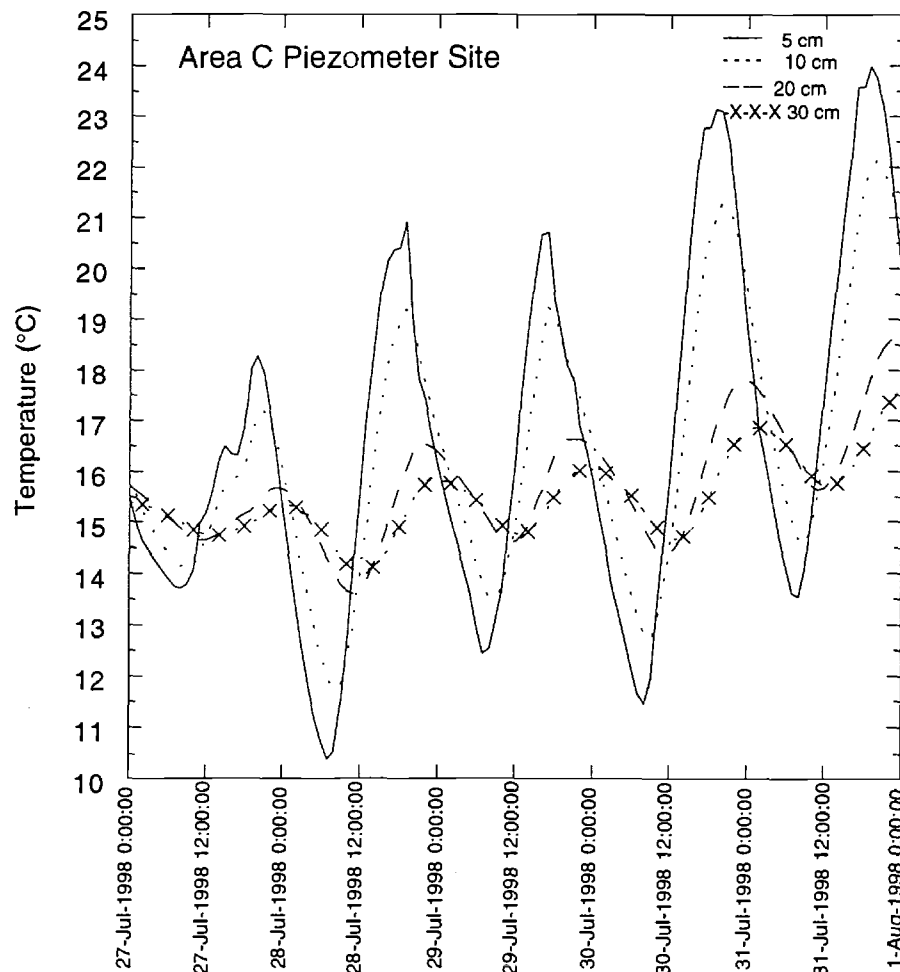
Figure III-2-17. Output from temperature sensors in Area C showing magnitude of sediment temperature fluctuations with depth.

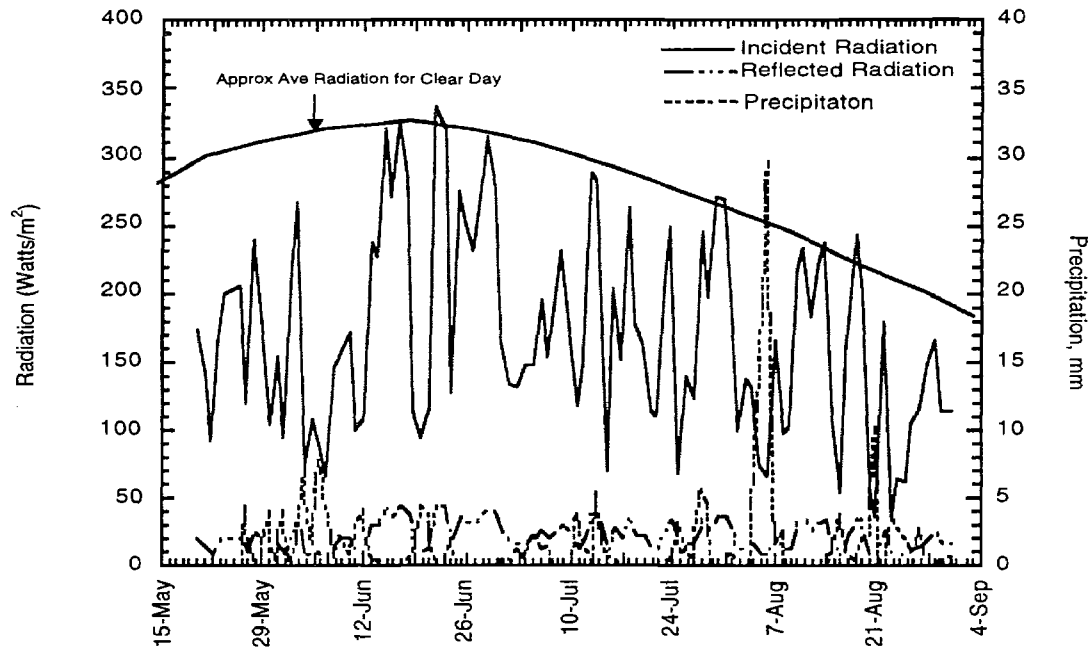
Figure III-3-3. Plot of average daily incident and reflected short wave radiation for Eagle River Flats. Also plotted is daily total precipitation. The approximate average daily incident radiation for clear sky conditions is shown as a separate curved line. For a completely sunny day, the daily average should plot near this line. The data show that there were very few sunny days during 1998.

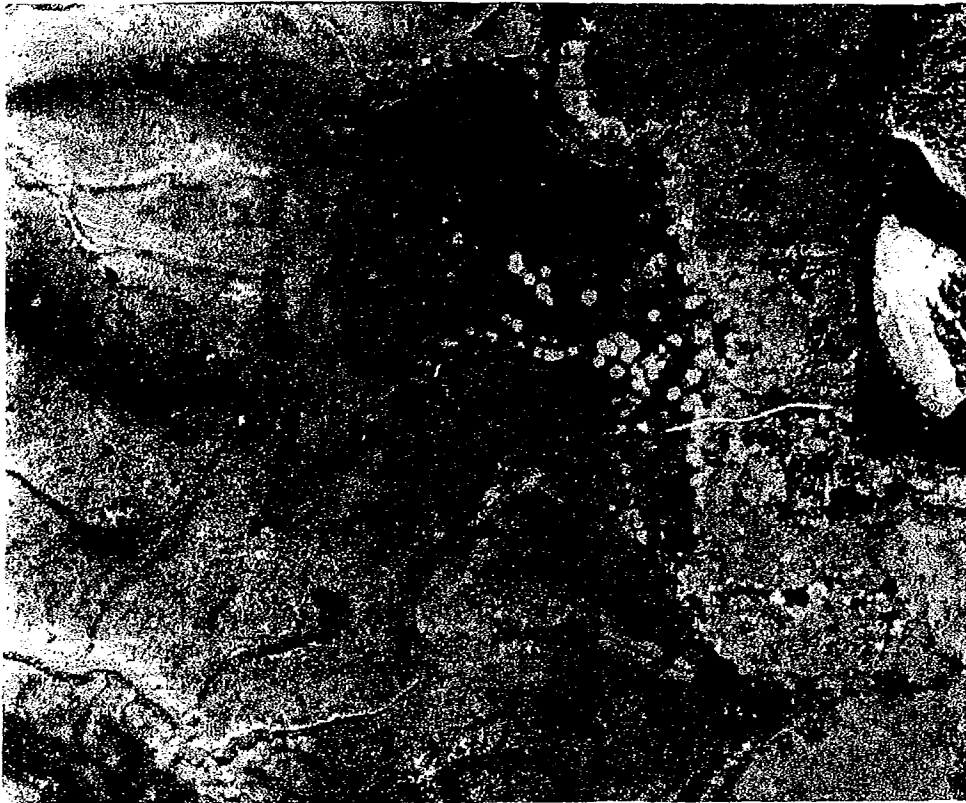
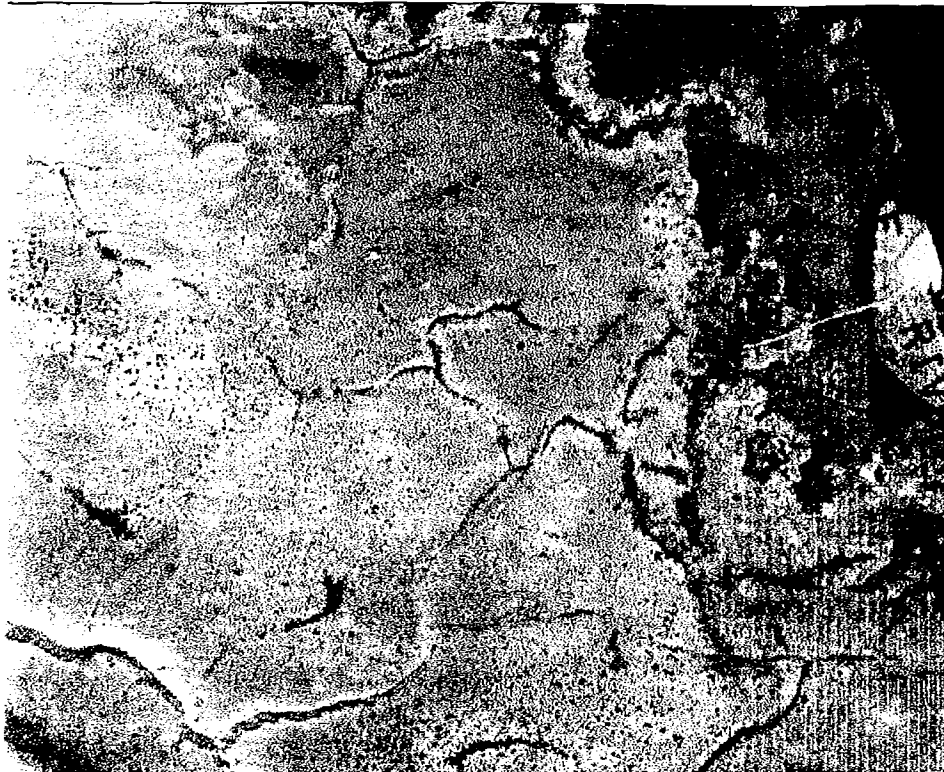
Figure IV-1-2. Color IR aerial photos of C Pond in August 1995 (top) before pumping began and in August 1998 (bottom) after two summers of pond pumping. Note loss of round colonies of four-leaved mare's tail.

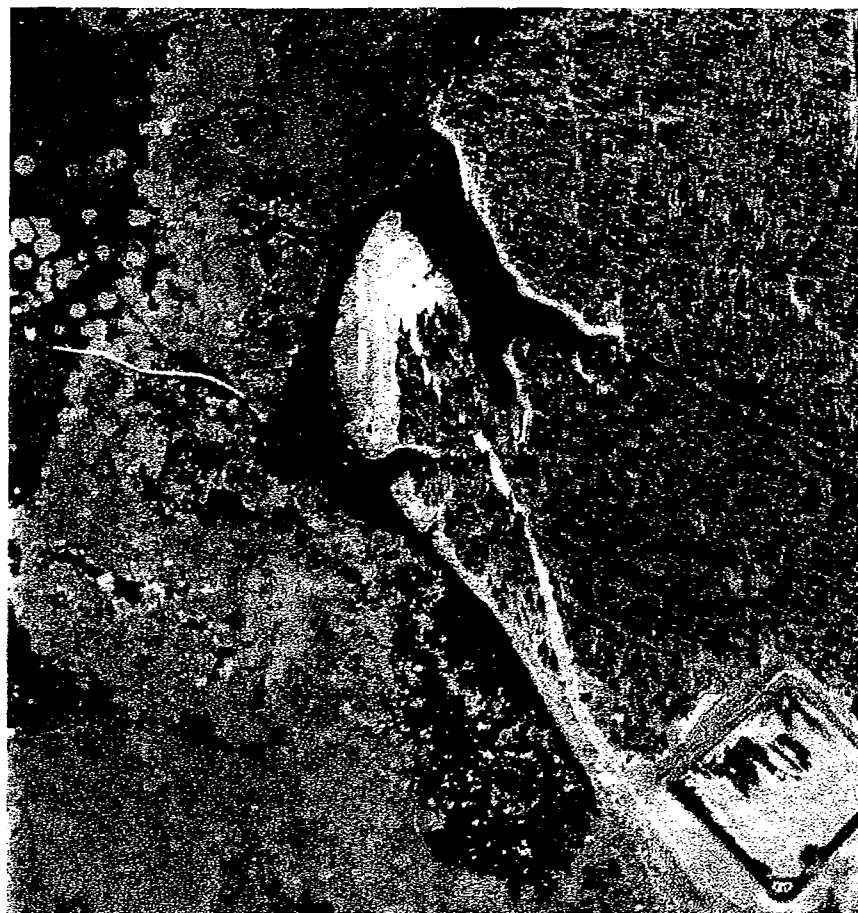
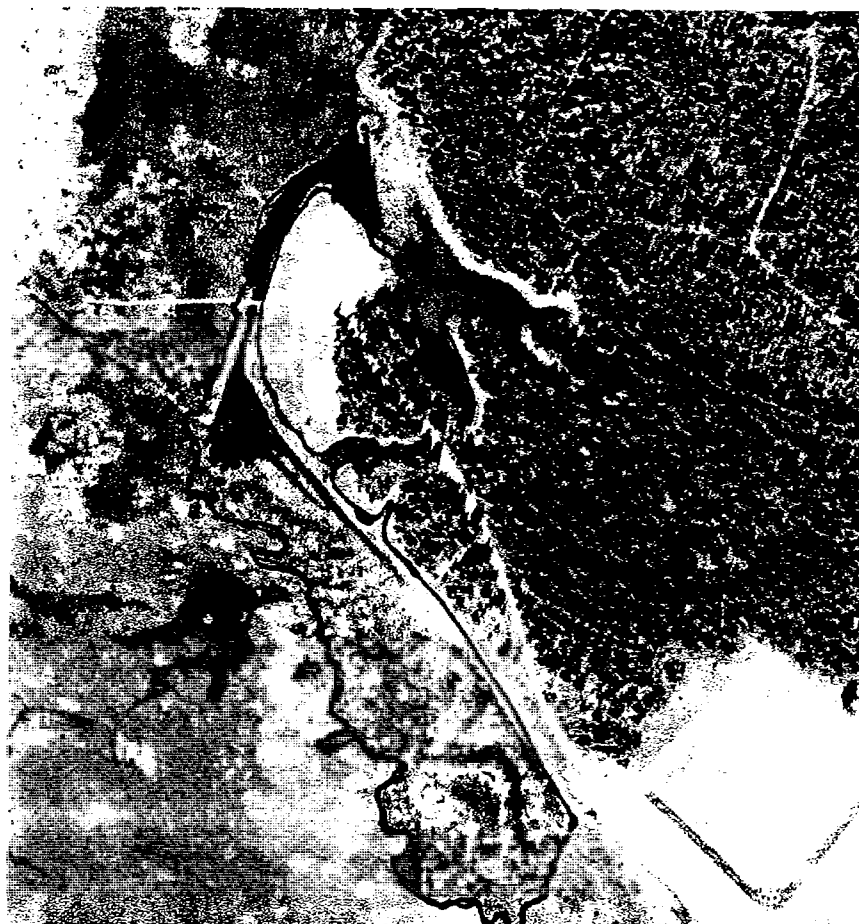
Figure IV-1-5. Color IR aerial photos of Pond 146 (Clunie Pond) in August 1995 (top) before pumping and in August 1998 (bottom) after partial dredging (area with water in bottom photo) and one summer of pumping. Note sedge vegetation expansion at the southern end of this pond. Original extent of pond is outlined on the bottom August 1998 photo.
