**Remediating and Monitoring
White Phosphorus Contamination
at Eagle River Flats
(Operable Unit C),
Fort Richardson, Alaska**

FY 00 Report

August 2001

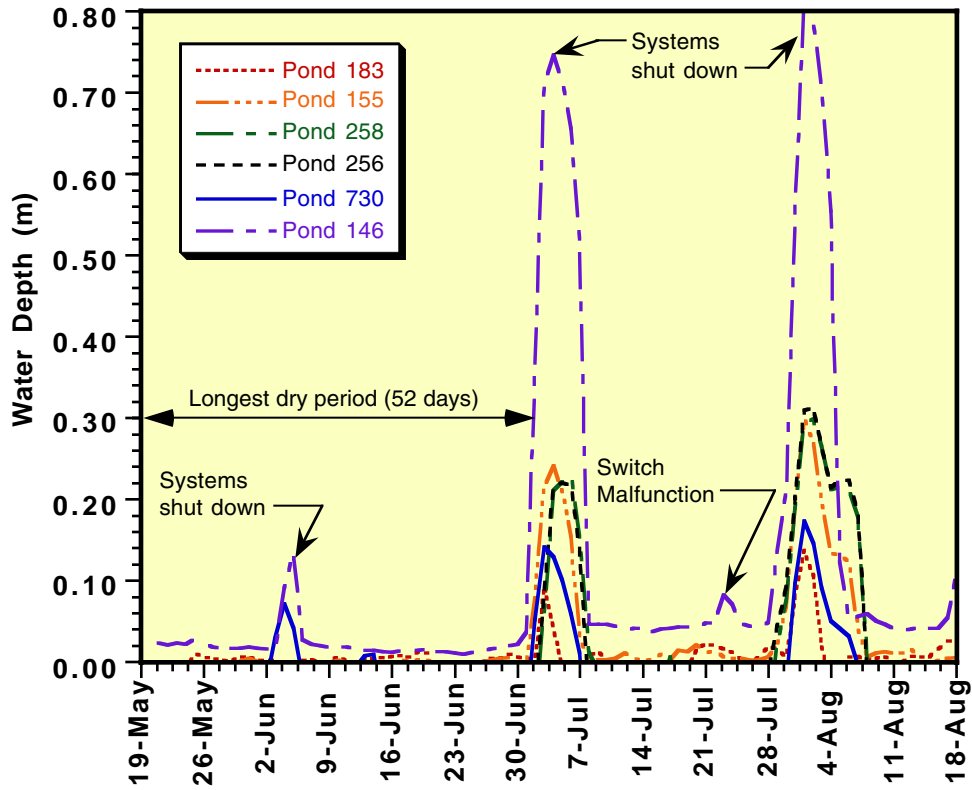
Figure III-1-5. Seasonal pond depth data for all treated ponds.

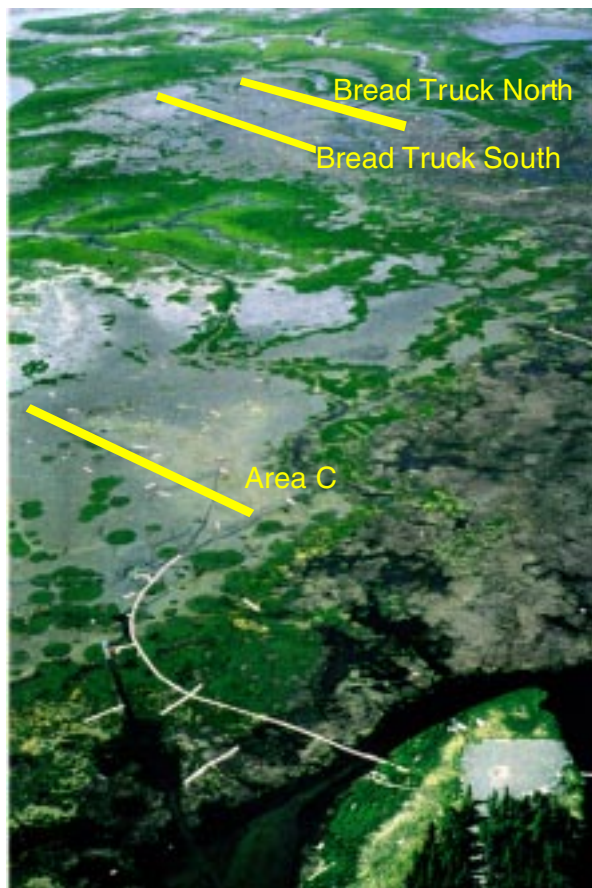
Figure III-2-2. Aerial oblique photo taken in June 1997 showing the main pond of Area C that was drained by pumping and the Bread Truck Pond that was drained by ditching. Transects were established across these ponds, and grid composite samples were collected perpendicular to the transect at 50-m intervals.

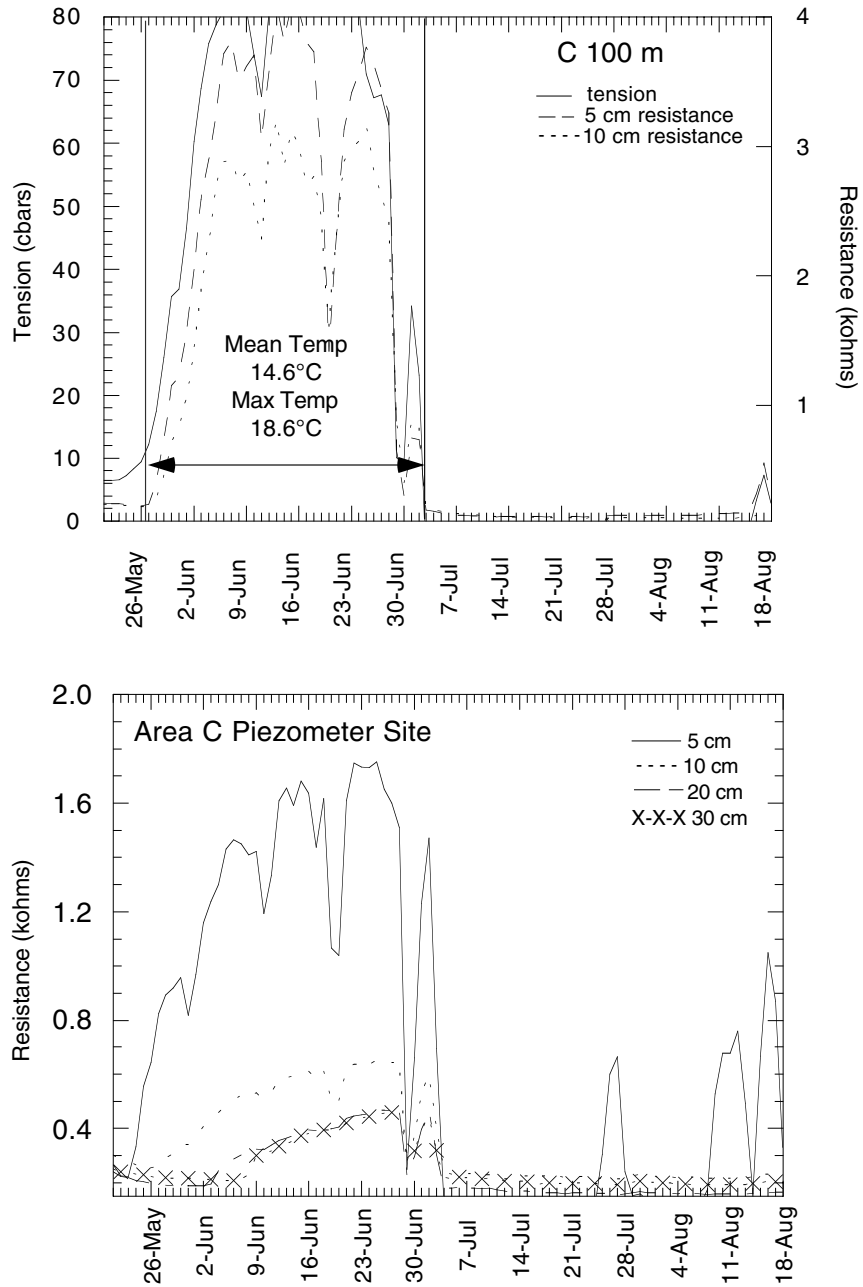
Figure III-2-9. Output from moisture sensors during the summer of 2000. Increases in resistance and tension indicate drying. Temperatures are 24-hour averages. High temperatures increase the rate of loss of white phosphorus.

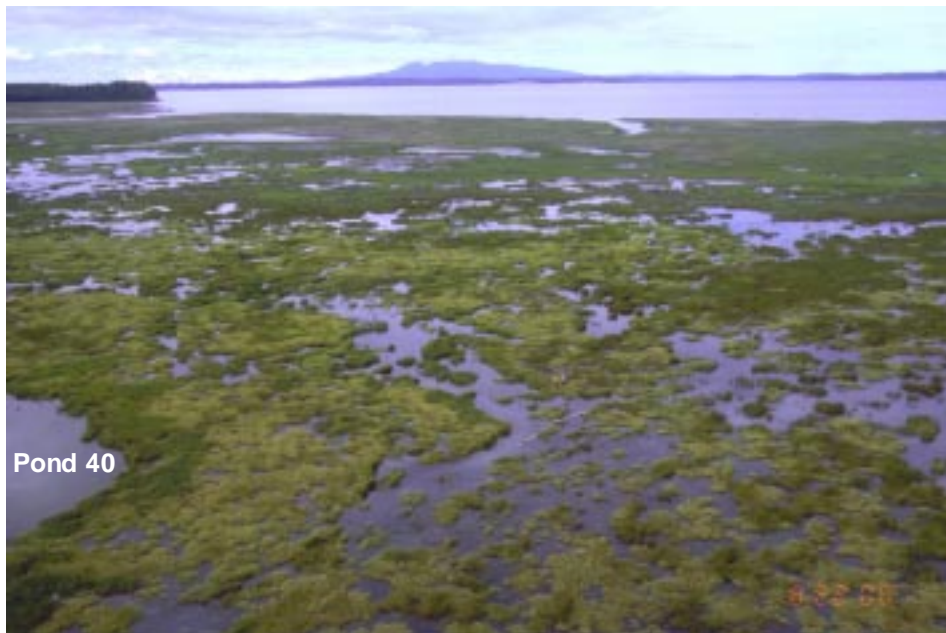
Figure III-3-4. Aerial oblique view of Area C/D north of Pond 40 from which grid composite samples were collected in 2000. No white phosphorus was found. (Photograph taken 22 August 2000.)

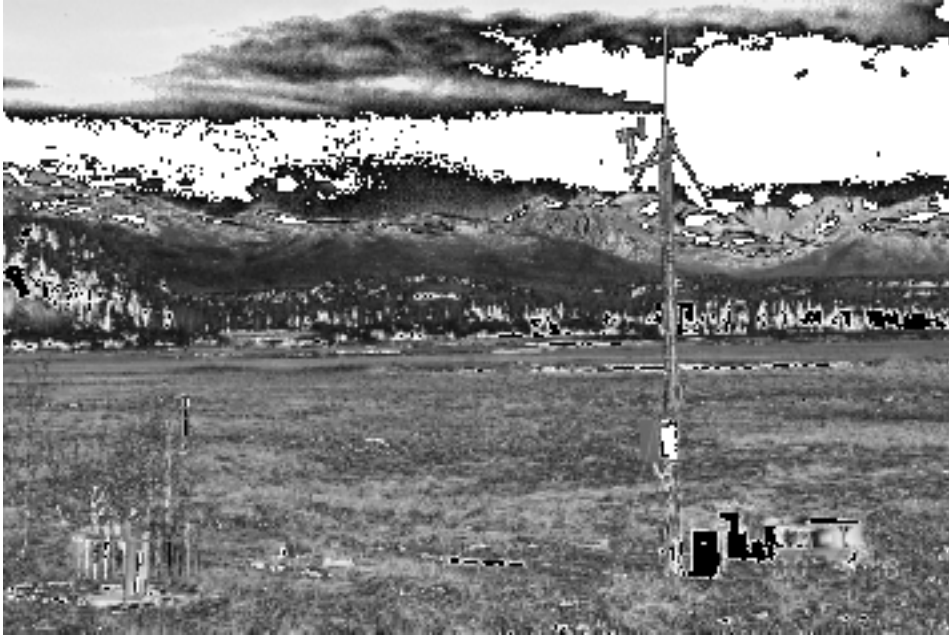
Figure III-4-1. Eagle River Flats meteorological station located off the edge of the EOD Pad. The 4-m tower is located in the right center, the 1.22-m-diameter evaporation pan is located to the right, and the shielded rain gage is located to the left.

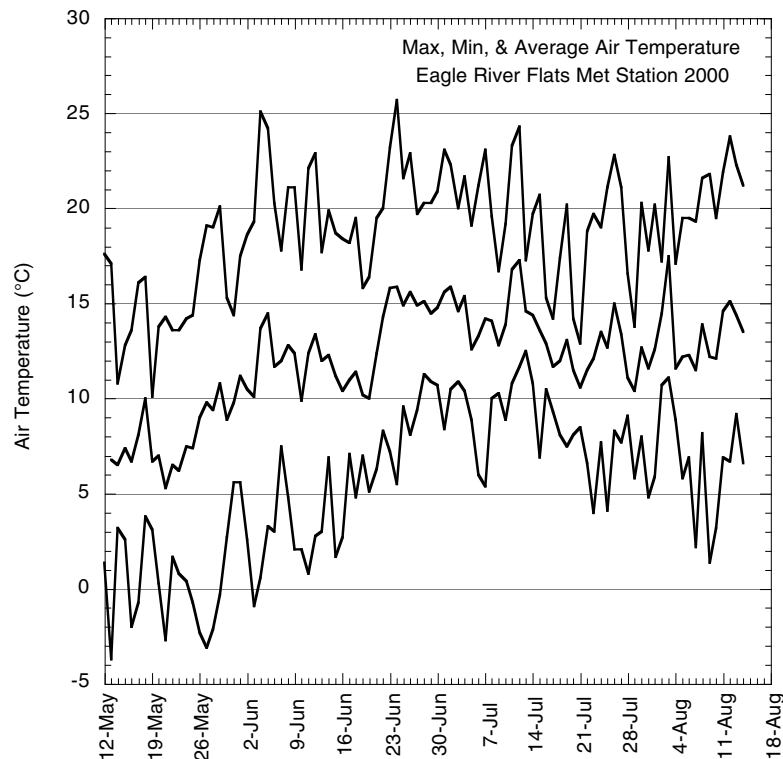
Figure III-4-2. Maximum, minimum, and average air temperatures for the Eagle River Flats meteorological station from 12 May to 15 August 2000. Thirty-eight days had maximum temperatures of 20°C or more.

Figure III-4-2 is a plot of the maximum, minimum, and average air temperatures for the summer. There were thirty-eight days

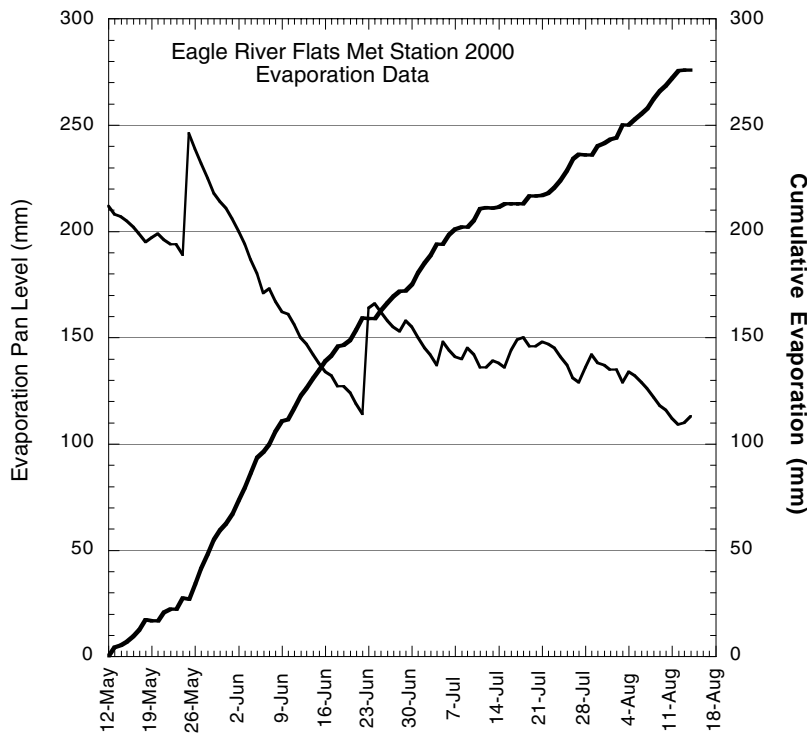
Figure III-4-5. Evaporation pan data showing the evaporation pan water level data and the net cumulative evaporation for the season. The steepness of the net cumulative curve in June reflects the warm temperatures and good drying conditions during this period. The evaporation pan water level data show the decrease in the water level due to evaporation, the addition of make-up water on 25 May and 23 June, and the contribution from periodic rainstorms throughout July.

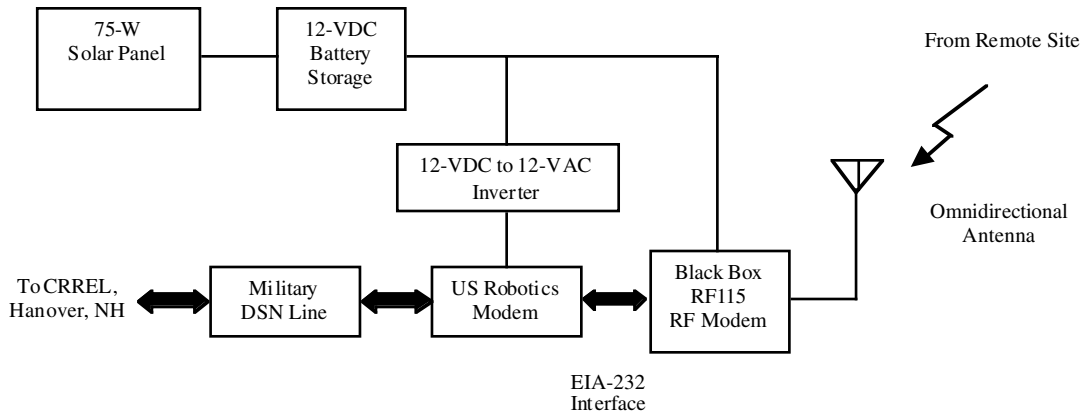
Figure III-5-4. Base station equipment.
