**Remediating and Monitoring  
White Phosphorus Contamination  
at Eagle River Flats  
(Operable Unit C),  
Fort Richardson, Alaska**

**FY 00 Report**

**Cold Regions Research and  
Engineering Laboratory  
72 Lyme Road • Hanover • New Hampshire 03755**

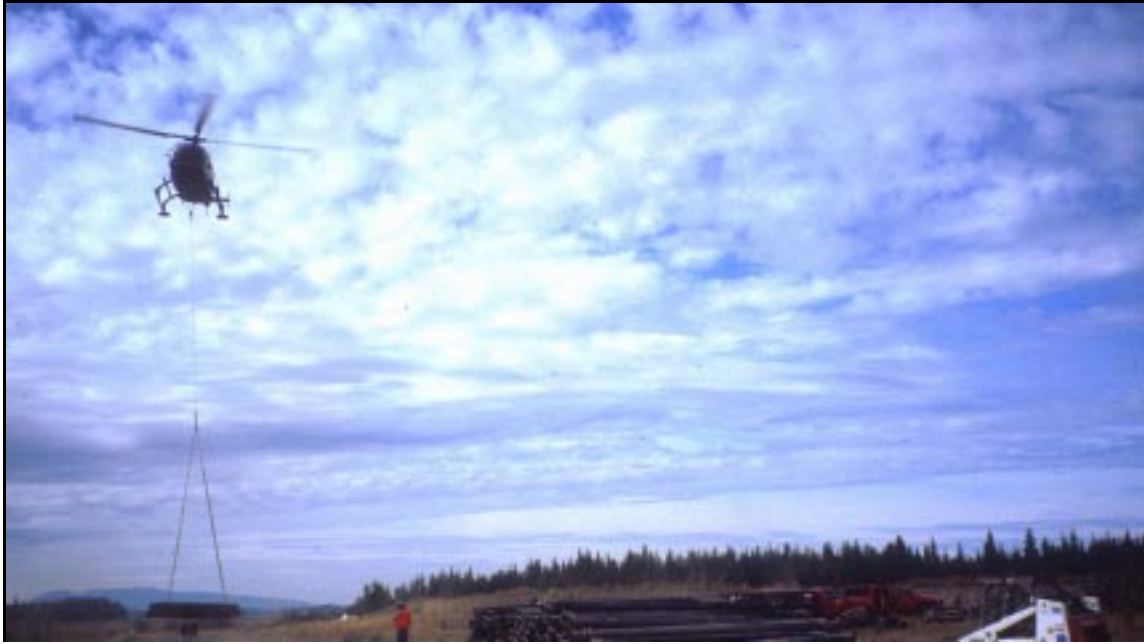
Figure III-1-3. Retrograde of pipe to EOD Pad using slings.

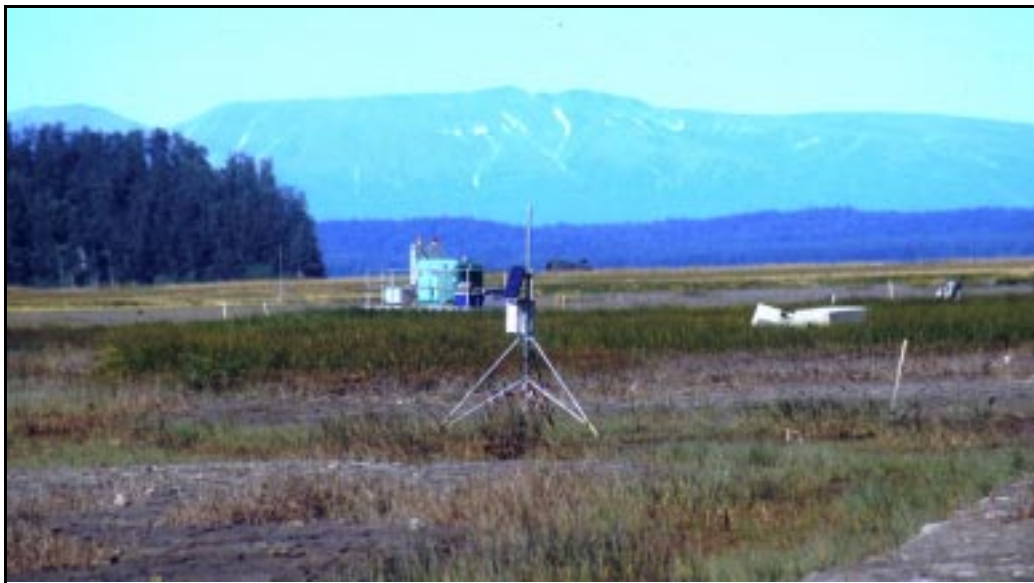
Figure III-1-4. Pond 146 off Canoe Point. Note the vegetation in the previously ponded area.

All areas experienced some drying. Area A dried more completely than in 1999, with cracks appearing throughout the affected pond areas. As mentioned, Pond 146, including Clunie Inlet, dried to a much larger extent than in 1999. Pond 183 was so dry during the latter part of June that the sensors topped out again. Pond 155 dried somewhat, and Pond 730 saw only marginal drying. Again, we should emphasize that although a maximum dry period of only 20 days was predicted because of flooding tides, we were able to achieve more than 50 contiguous days without widespread flooding (Fig. III-1-5). Rains starting in early July greatly reduced the effectiveness of the remediation method for the remainder of the season, but it was a very successful season all the same (Fig. III-1-6).

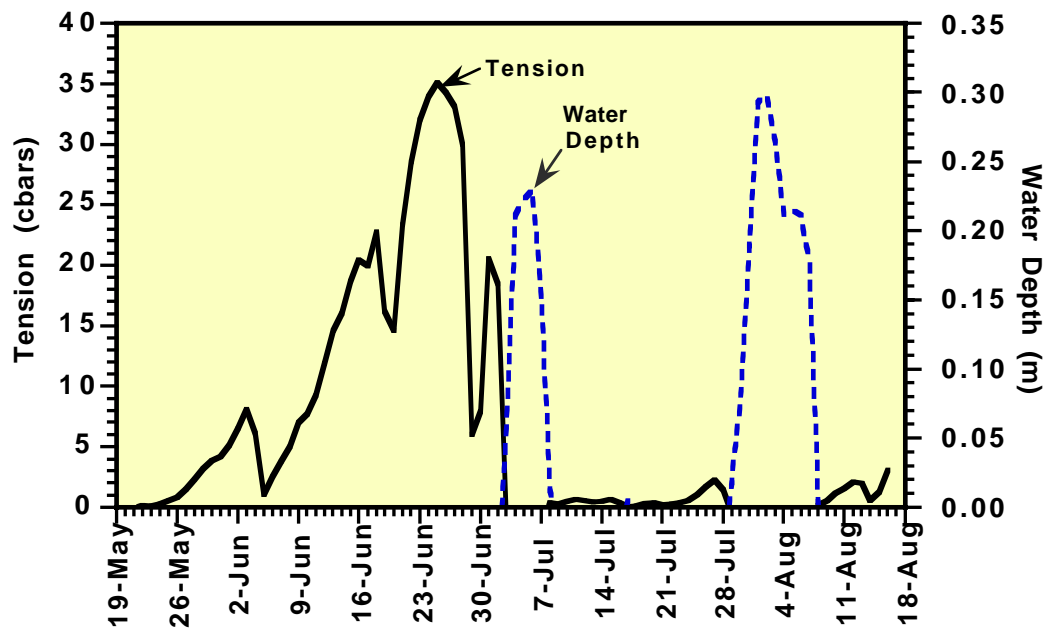
Figure III-1-6. Soil tension vs. water depth in Pond 258. Higher tension implies drier soil.

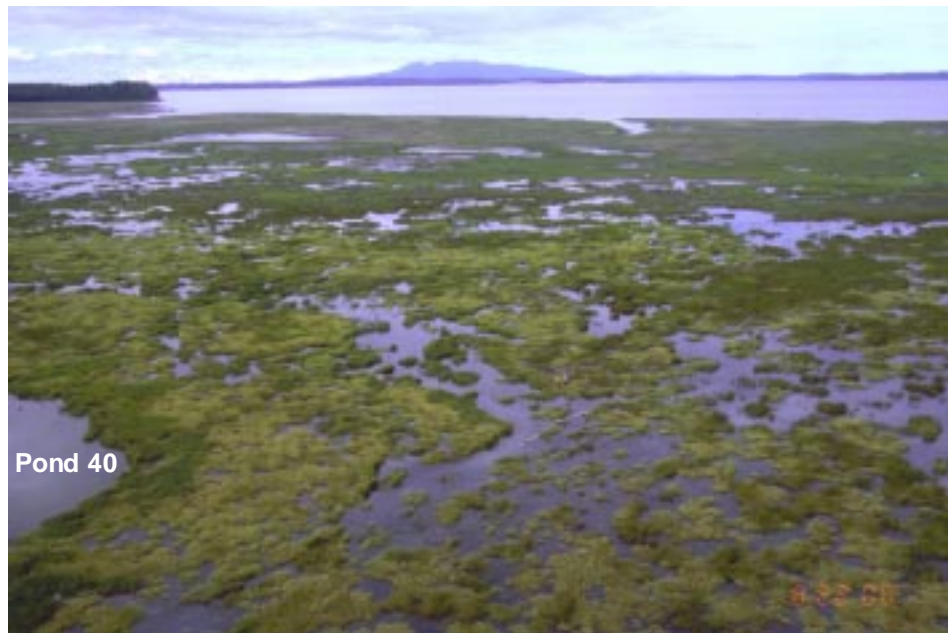
Figure III-3-4. Aerial oblique view of Area C/D north of Pond 40 from which grid composite samples were collected in 2000. No white phosphorus was found. (Photograph taken 22 August 2000.)

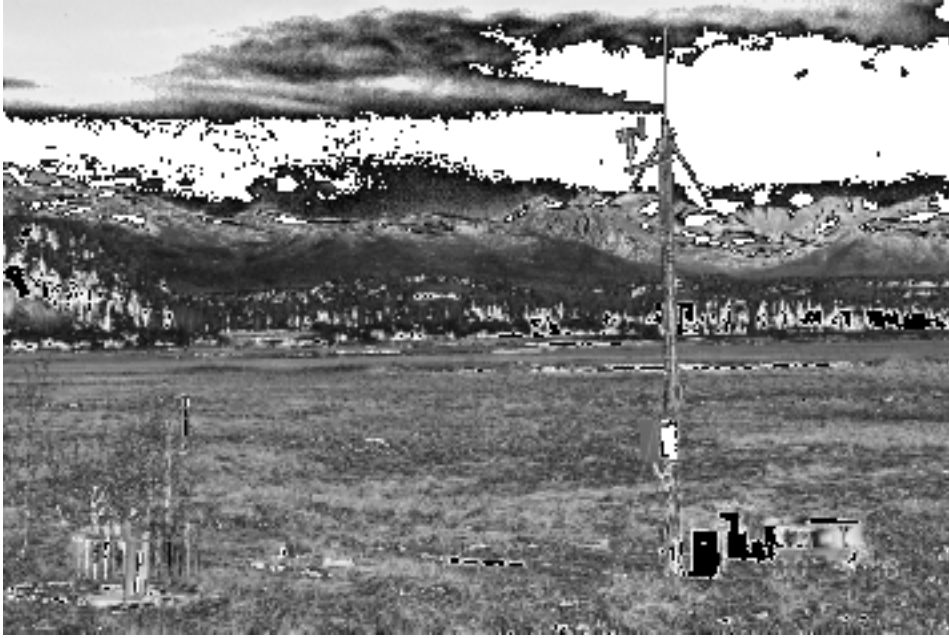
Figure III-4-1. Eagle River Flats meteorological station located off the edge of the EOD Pad. The 4-m tower is located in the right center, the 1.22-m-diameter evaporation pan is located to the right, and the shielded rain gage is located to the left.

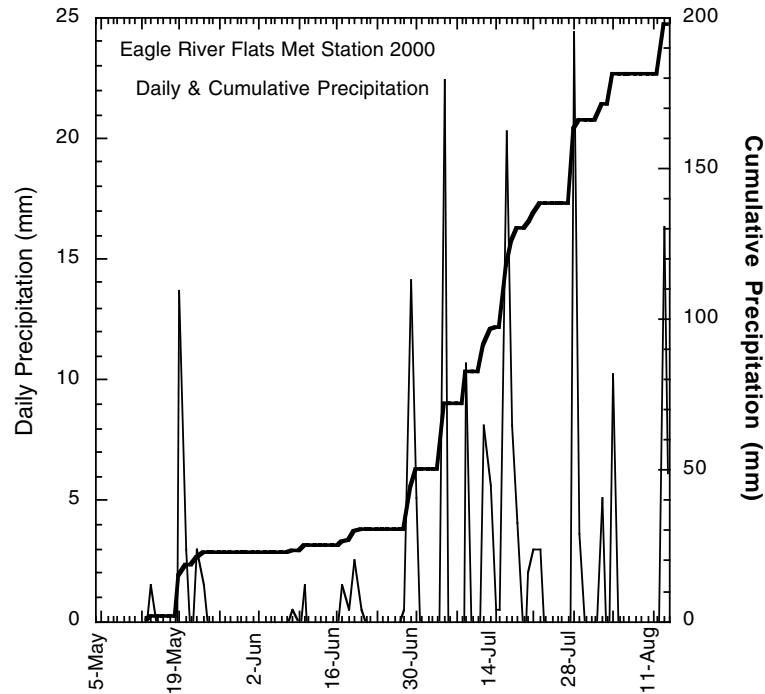
Figure III-4-3. Daily precipitation and cumulative precipitation for the season from 12 May to 15 August 2000 at the ERF meteorological station, showing the dry spell from late May through 28 June that contributed to the excellent drying conditions in the treated ponds.

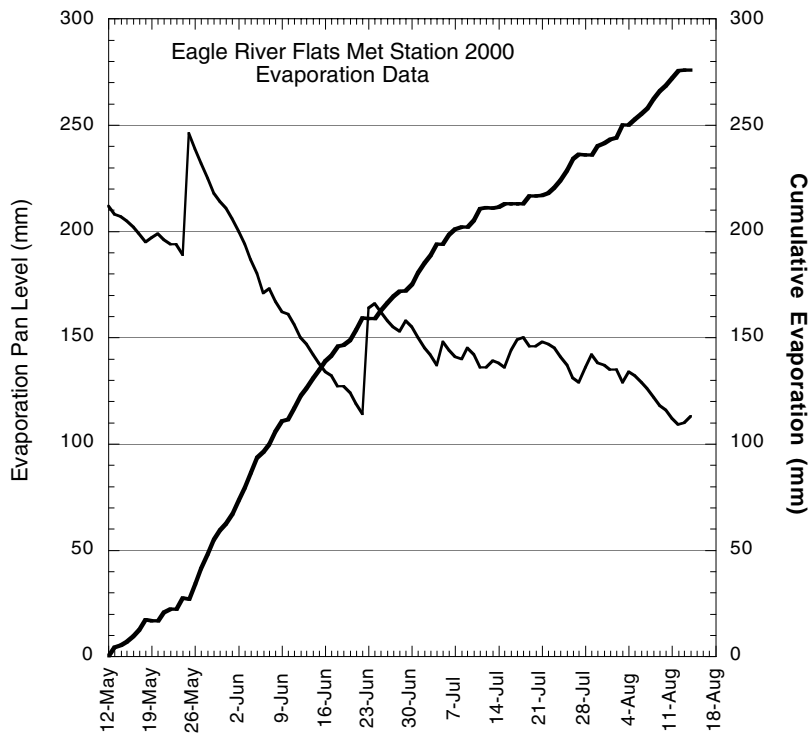
Figure III-4-5. Evaporation pan data showing the evaporation pan water level data and the net cumulative evaporation for the season. The steepness of the net cumulative curve in June reflects the warm temperatures and good drying conditions during this period. The evaporation pan water level data show the decrease in the water level due to evaporation, the addition of make-up water on 25 May and 23 June, and the contribution from periodic rainstorms throughout July.

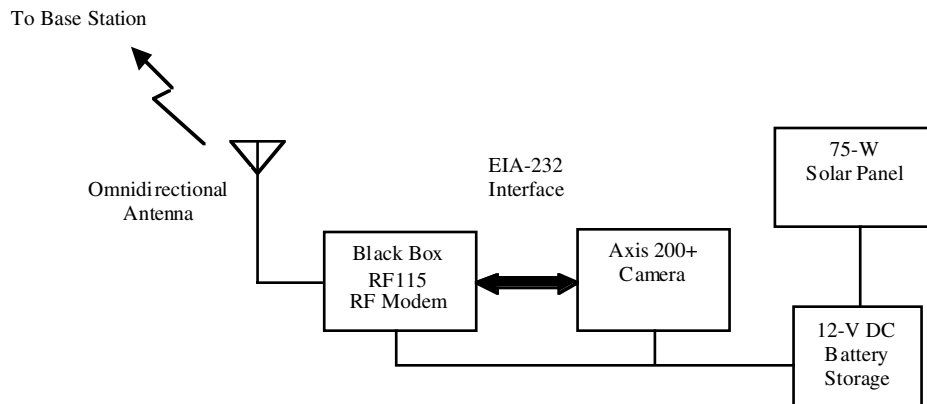
Figure III-5-1. Remote site equipment.

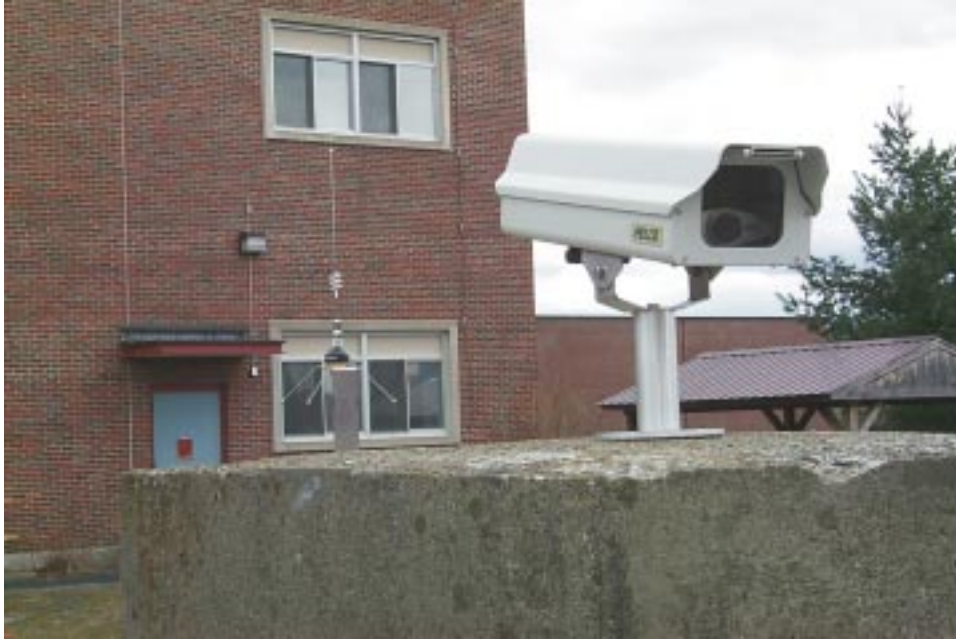
*Figure III-5-2. Axis 200+ camera.*

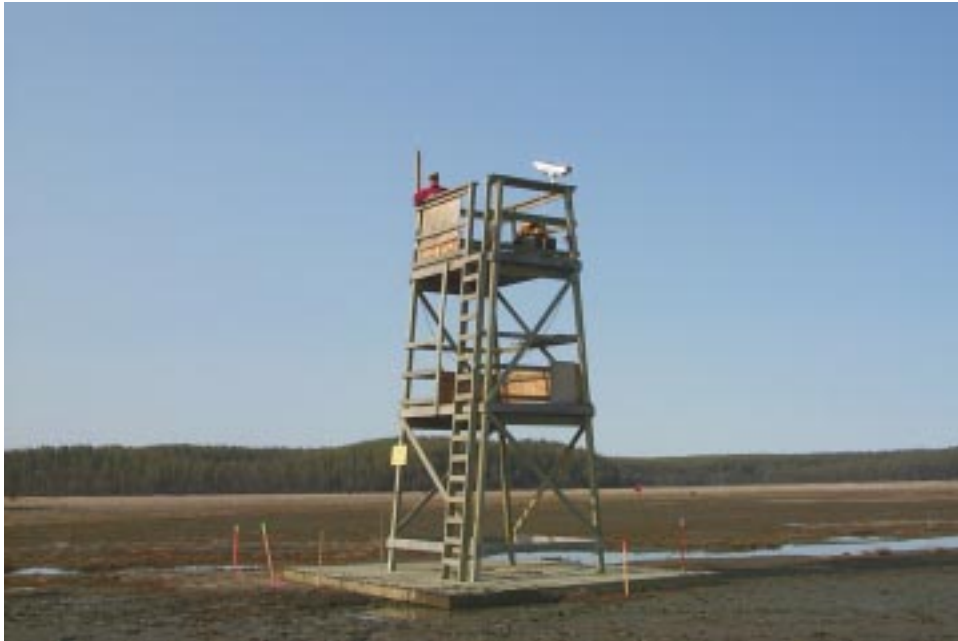
*Figure III-5-3. Placement of the remote site equipment in the field.*

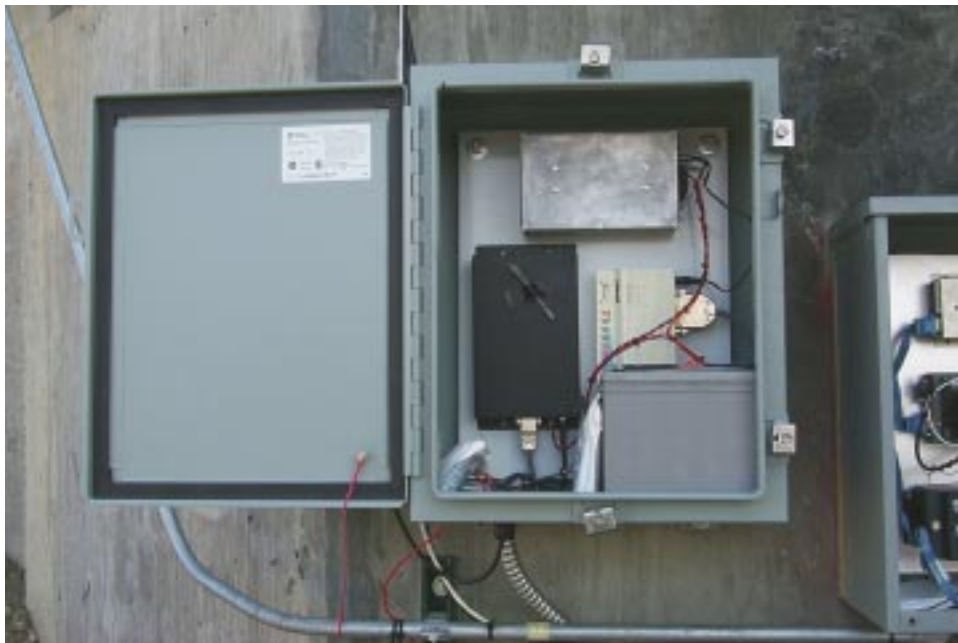
Figure III-5-5. Base station.

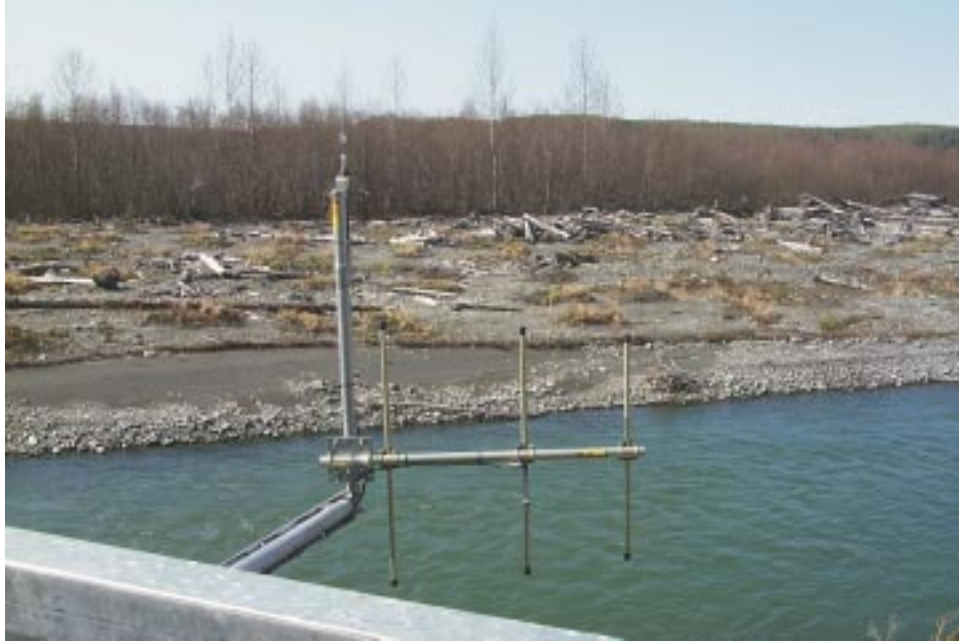
Figure III-5-6. Base station antennas.
