Remediating and Monitoring White Phosphorous Contamination at Eagle River Flats (Operable Unit C), Fort Richardson, Alaska

FY05 Data Report

Susan R. Bigl and Charles M. Collins, Report Editors

April 2006

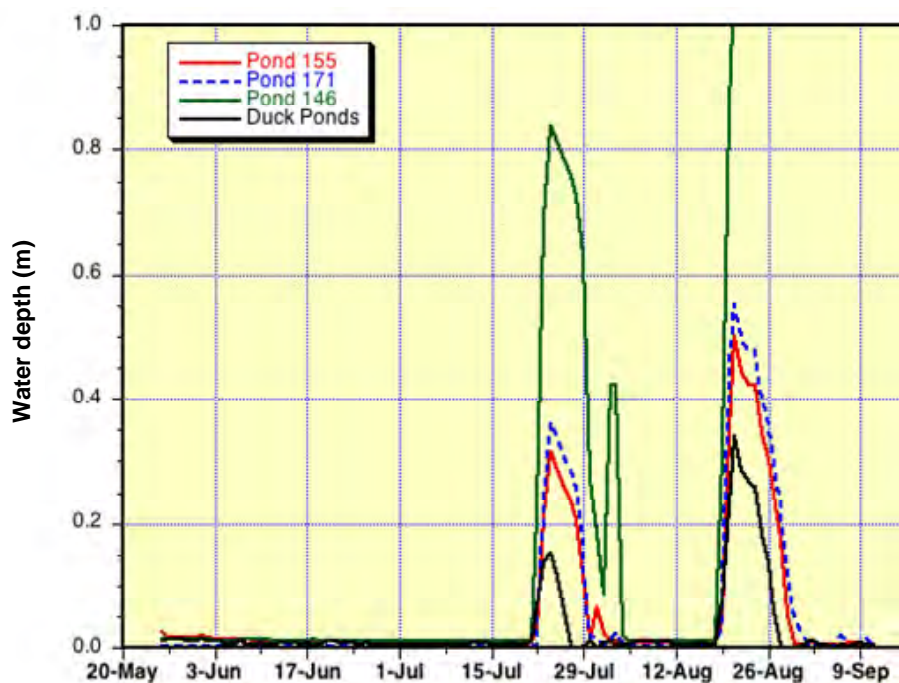
Figure III-1-5. Water levels in treated ponds.

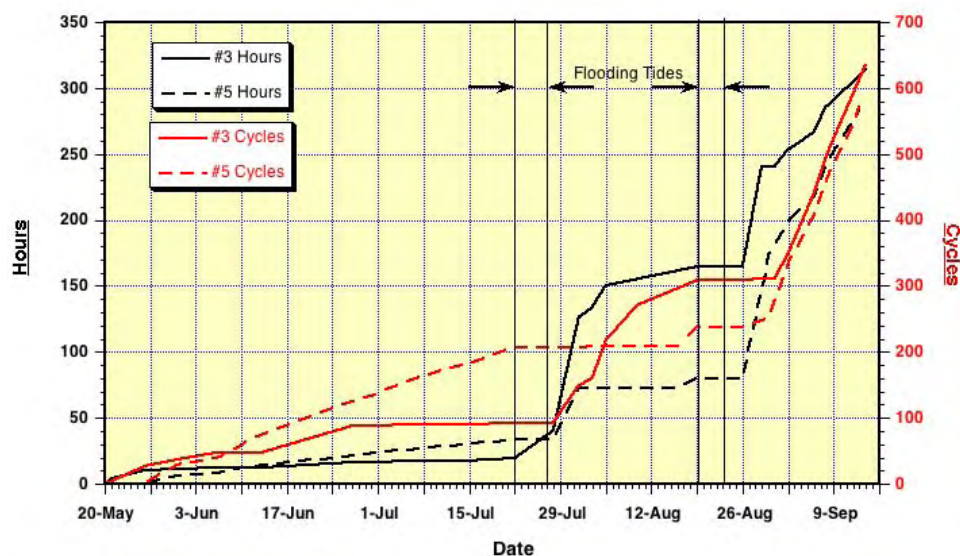
Figure III-1-6. Pump operation over the course of the 2005 season.

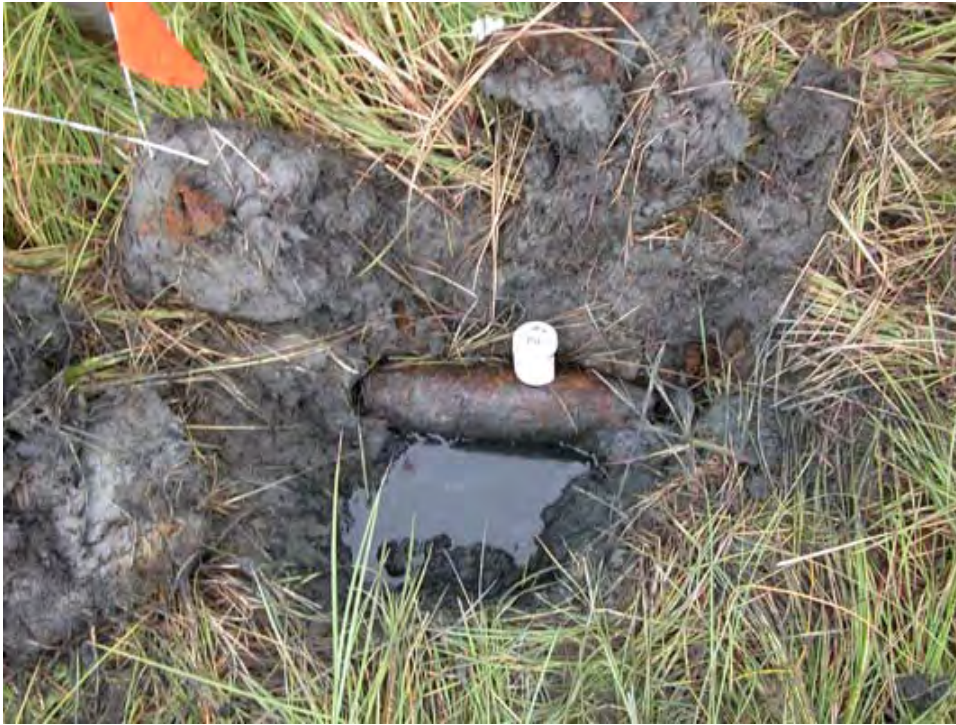
Figure III-2-3. 105-mm WP projectile found in Area C in August 2004.

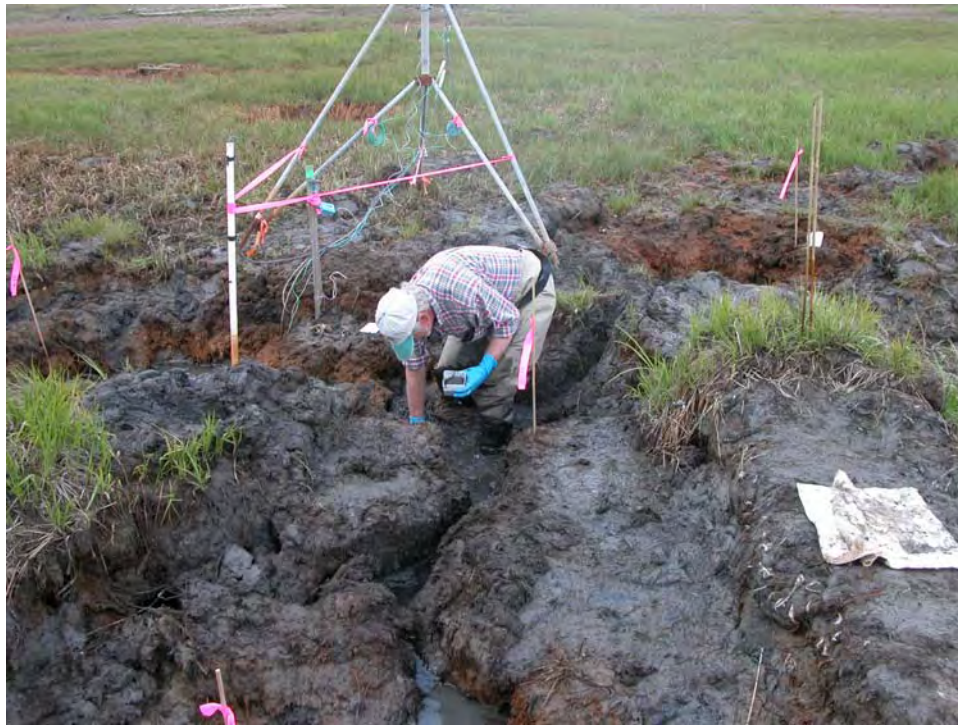
Figure III-2-5. June 2005 sampling of BIP craters in C Marsh. The craters were drained in May 2005 using a small gasoline-powered pump to facilitate remediation and sampling.

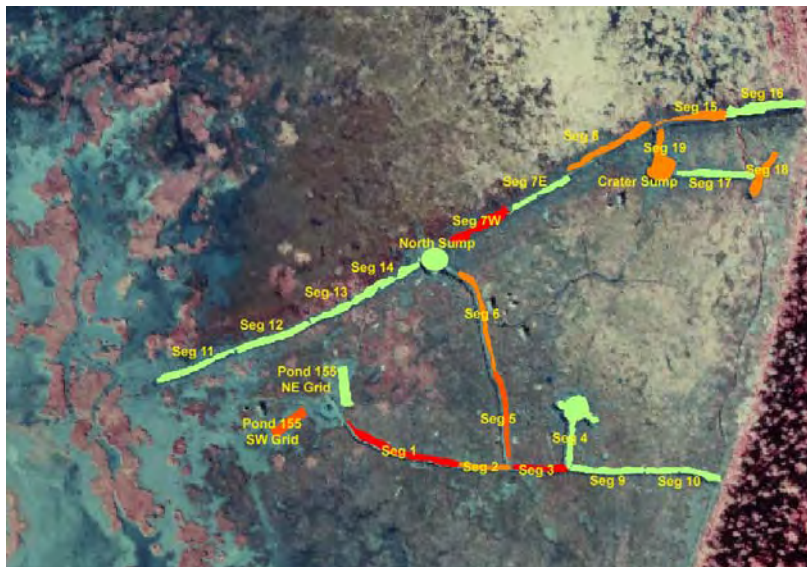
Figure III-2-7. Locations of multi-increment samples collected in C Marsh ditches in 2005. Red and orange indicate white phosphorus was detected. Green indicates that white phosphorus was not detectable in the samples.

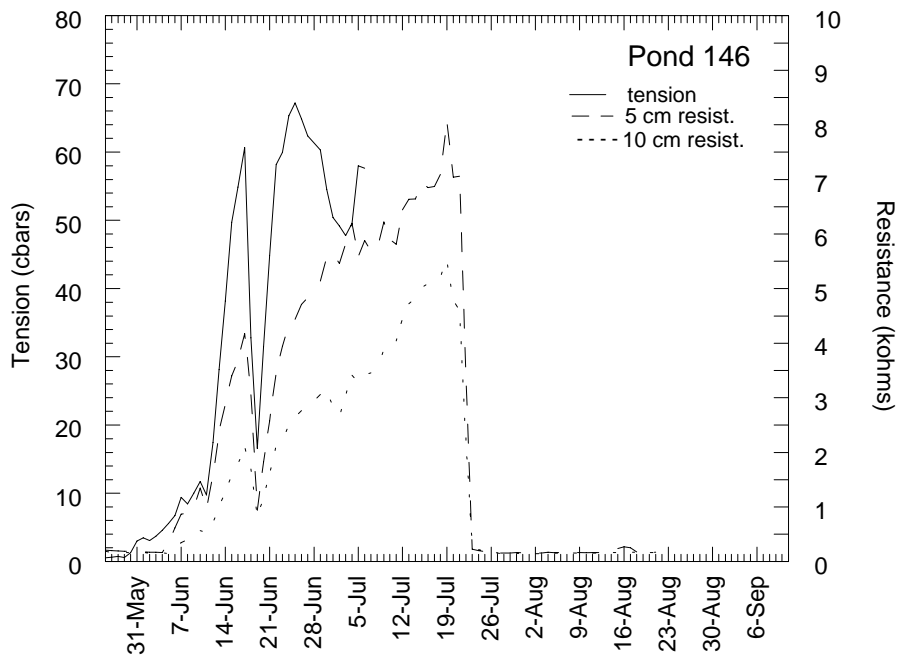
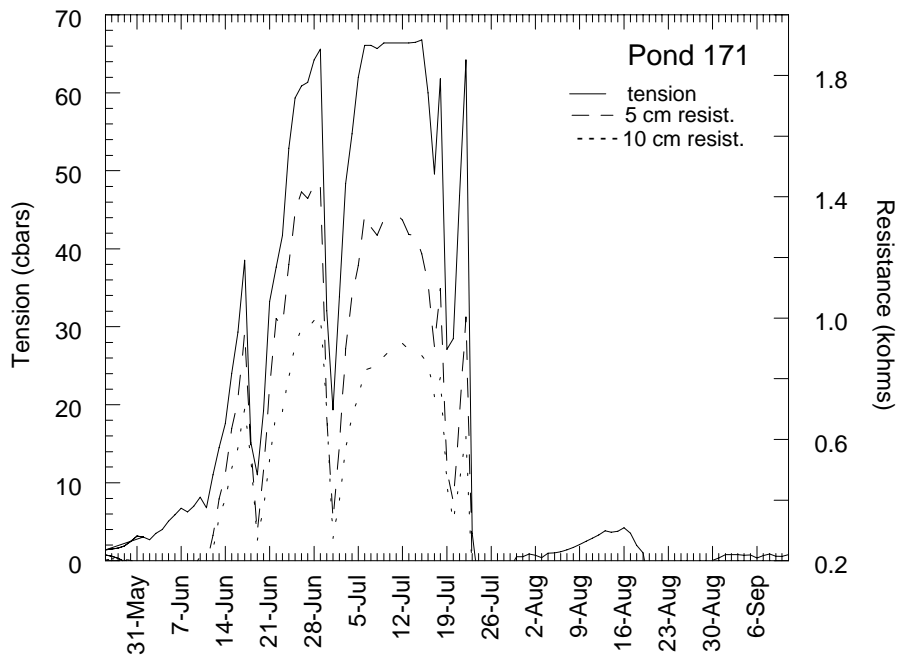
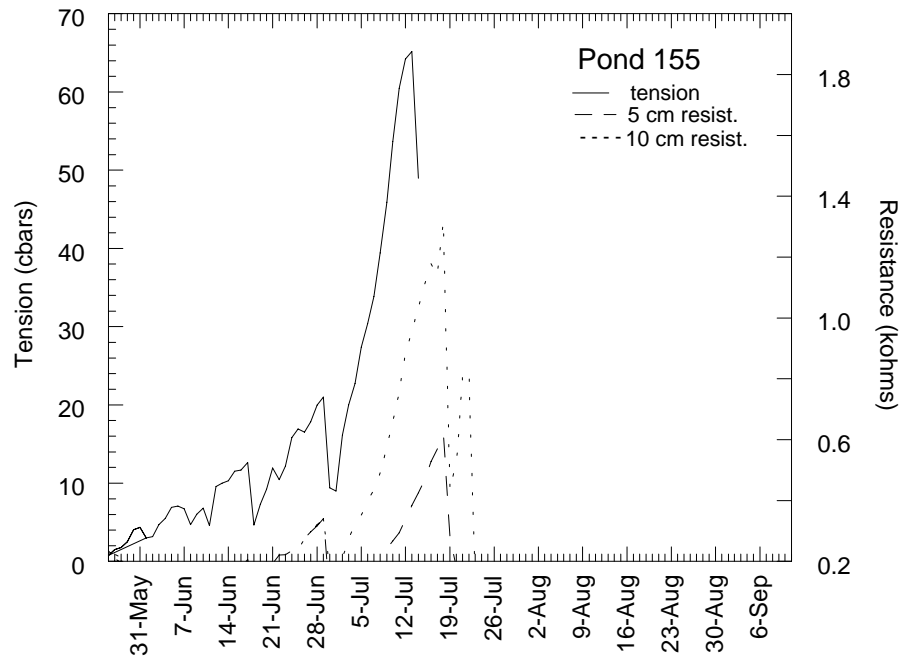
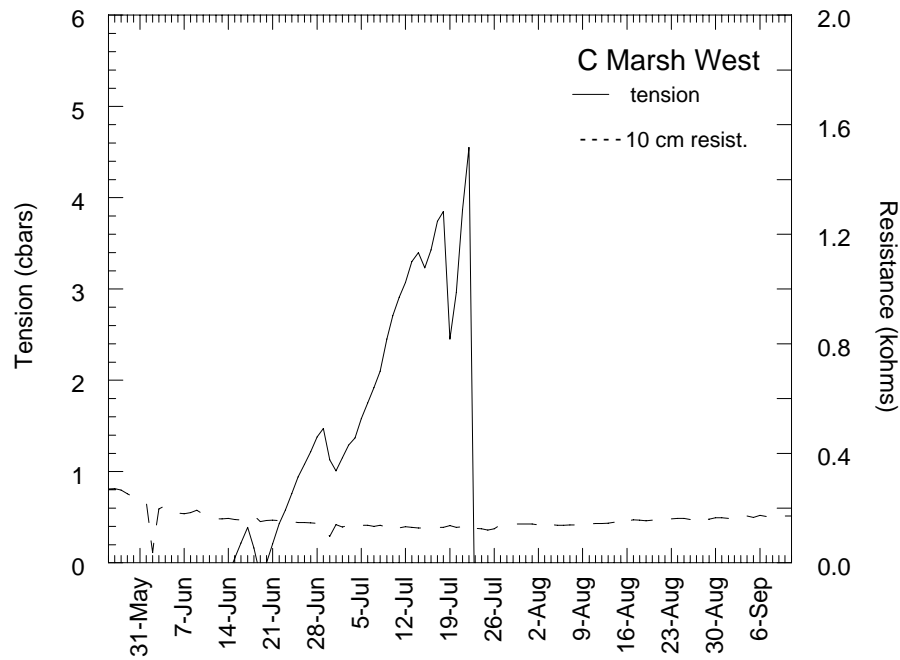
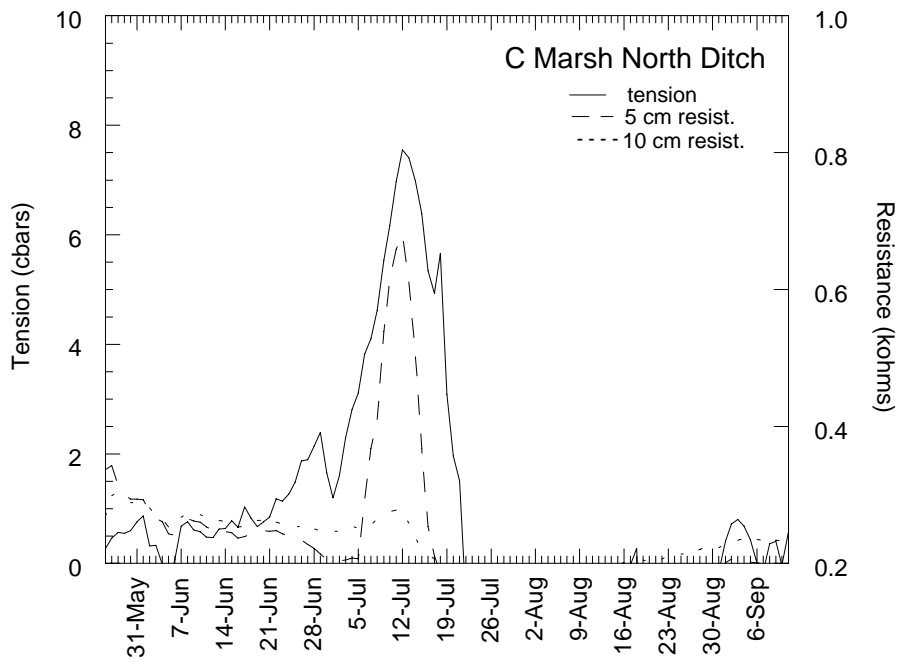
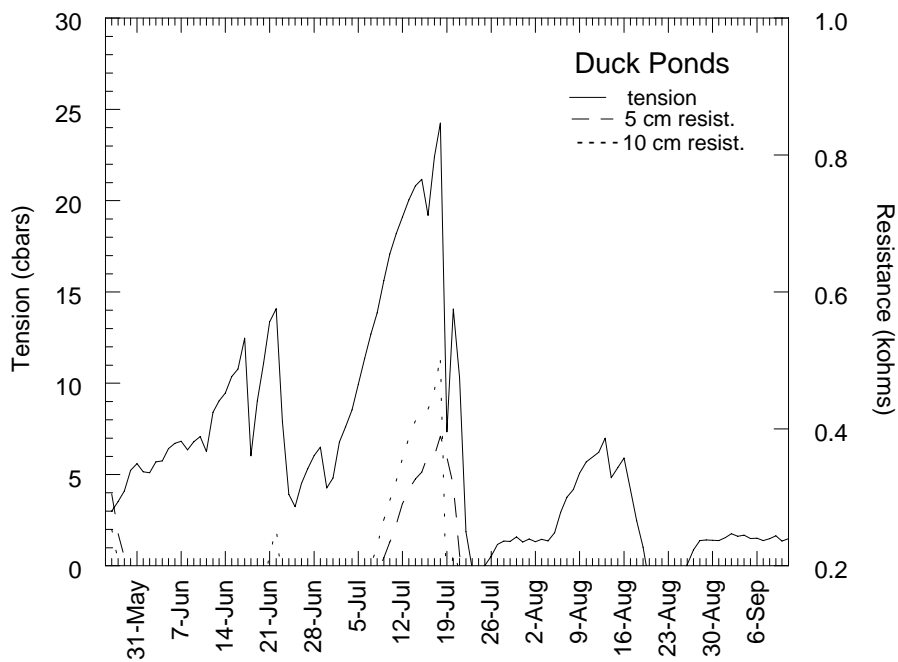
Figure III-2-10. Output from moisture sensors during the summer of 2005. Increases in tension and resistance indicate the sediment was drying.

Figure III-2-10 (cont.). Output from moisture sensors during the summer of 2005. Increases in tension and resistance indicate the sediment was drying.

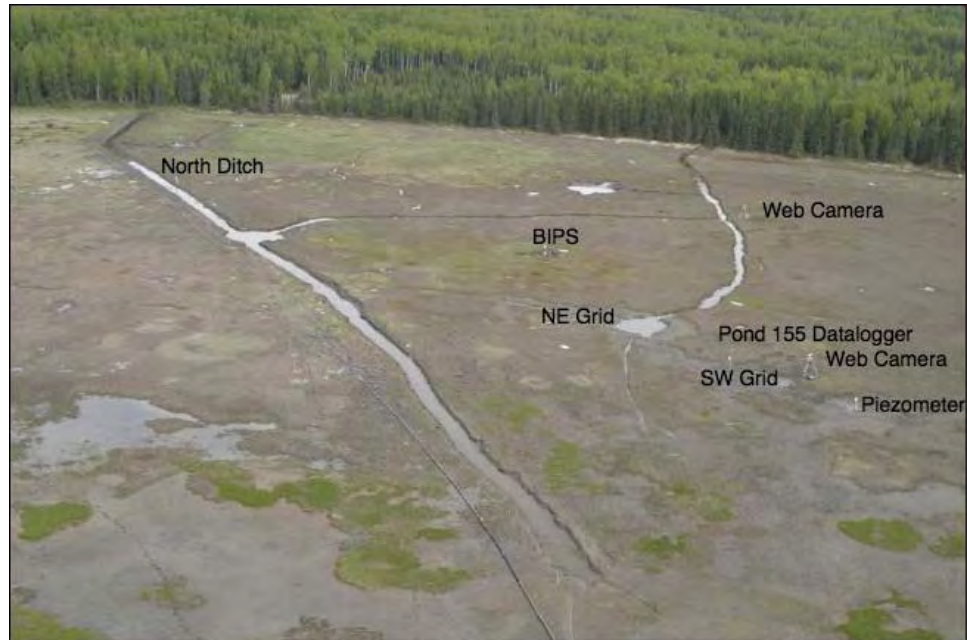
Figure III-2-11. Aerial oblique photograph taken in May 2005 looking east over C Marsh showing locations of datalogger stations, web cameras and sampling grids.

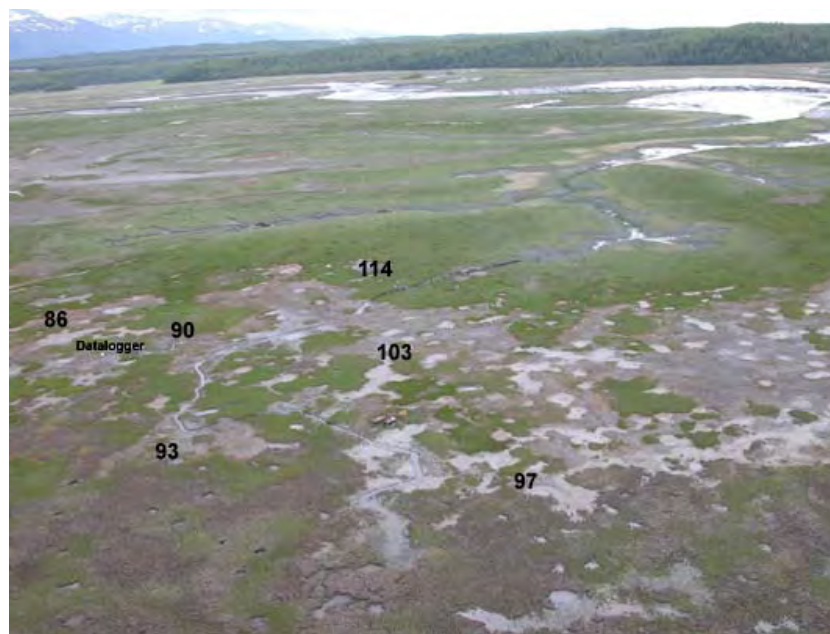
Figure III-2-15. Aerial oblique view in May 2005 looking south over the pond complex (Duck Ponds) in the SE corner of Area BT. Ponds were drained by a network of shallow ditches in July 2004. The numbers are sample identification numbers replacing XX in 04DISXX in Table III-2-1.

The last monitoring station was located within the pond complex in the southeast corner of Area BT, known as the Duck Ponds (Fig. III-2-8 and III-2-15). These ponds were sampled in 2003 after three Green-winged Teal carcasses were found. Subsequent sampling of the ponds and surrounding marsh in 2003 and 2004 detected several white phosphorus hotspots. Drainage channels and a tide gate were installed in July 2004 to remove as much surface water as possible and remove the ponds as waterfowl habitat between flooding tides. In 2005, the sediment at the monitoring station was desaturated for 22 days (Fig. III-2-10f). However, loss of mass from the planted white phosphorus particles was only 14%. In 2006, we will establish a number of gridded areas from which we will collect multi-increments samples for future monitoring following the sampling methods we used in the large waterfowl feeding ponds of Area C and BT. In these ponds, white phosphorus became undetectable after several seasons in gridded areas that contained significant concentrations prior to treatment.

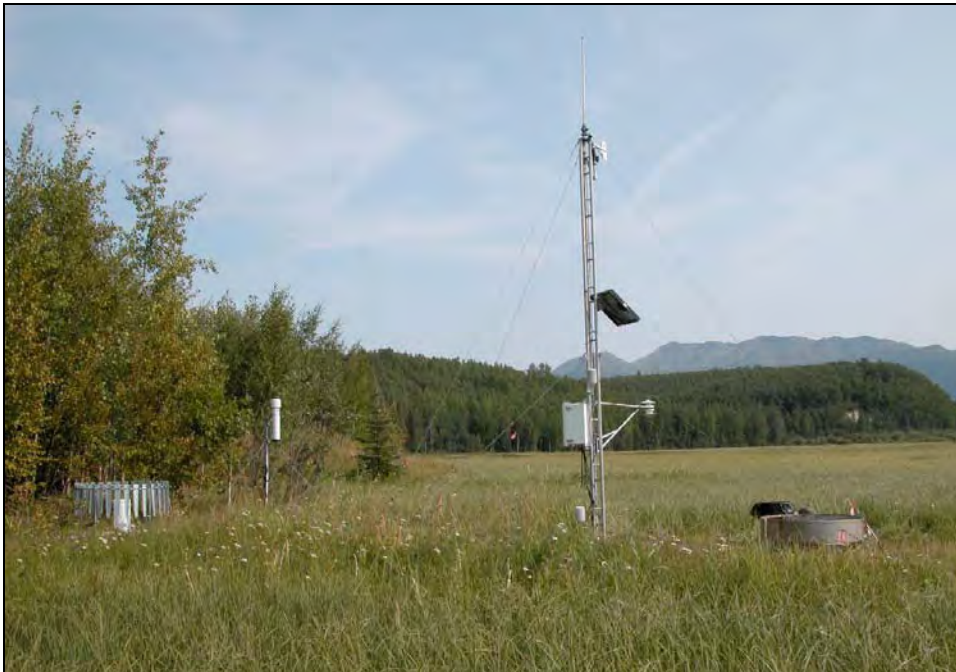
Figure III-3-1. Eagle River Flats meteorological station located along the edge of EOD pad in Area C. Note the 4-m tower in right center, the evaporation pan to the right, and the shielded rain gage to the left.

reflected short wave radiation (0.3 to 3 μm). A white fiberglass enclosure mounted on the tower contains the Campbell Scientific CR10 datalogger system, consisting of a CR10 Measurement and Control Module and a SM716 Storage Module. All meteorological data collected for the season are stored on the storage module. Also mounted in the enclosure is a radio modem for communicating between the met station and the Ethernet RF modem base station at Building 724. The radio antenna is attached to the top of the tower. A wind-shielded precipitation gage is located 5 m east of the tower. A second backup unshielded precipitation gage is located nearby. A standard 1.22-m- (48-in) diameter evaporation pan is located 2 m west of the tower. A Druck pressure transducer at the bottom of the evaporation pan measures water depth. The station is powered with a 12-V battery, which is charged by a solar panel mounted on the tower. Table III-3-1 summarizes the instruments and parameters measured at the ERF meteorological station.

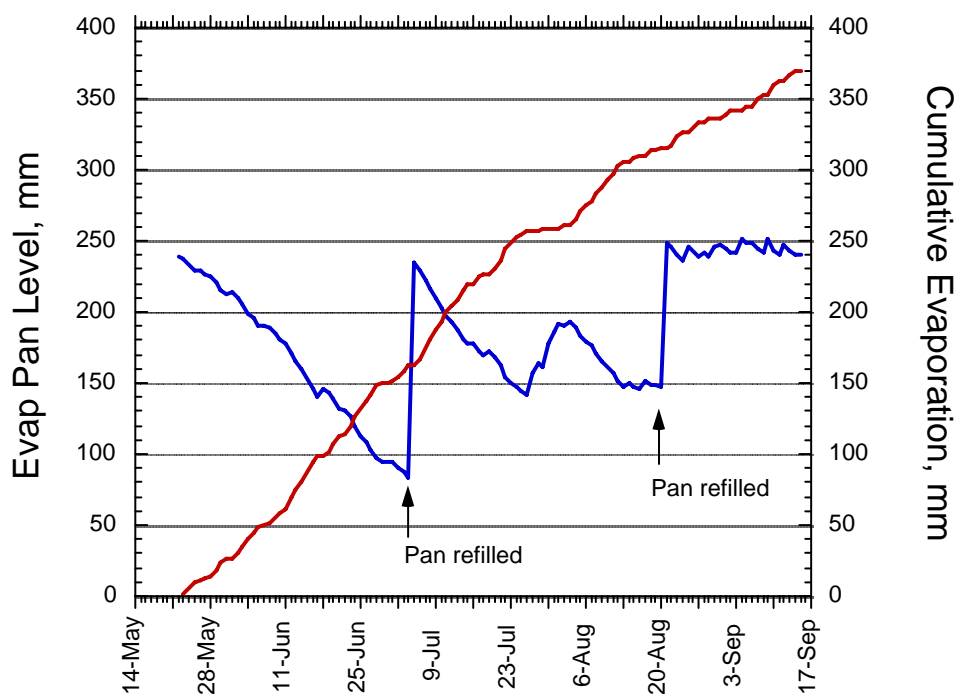
Figure III-3-5. Evaporation pan data showing the evaporation pan water level data (blue) and the net cumulative evaporation (red) for the season. The evaporation rate is consistent over the season, reflecting the normal to slightly above normal temperatures. Evaporation pan water levels show decreases due to evaporation, the addition of make-up water on 5 July and 21 August, and increases due to major rain events on 27 July–3 August, and steady rains from 21 August–12 September.
