ERDC/CRREL LR-11-04

# Remediating and Monitoring White Phosphorus Contamination at Eagle River Flats (Operable Unit C), Fort Richardson, Alaska

FY10 Data Report

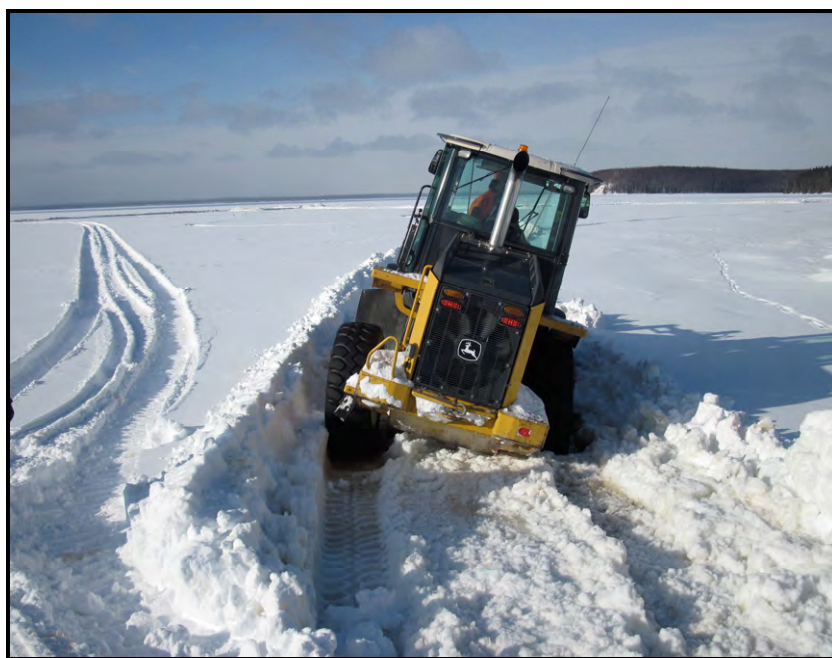
In anticipation of the capping work, about 300 cubic meters of 3" (8-cm) minus clean crushed ballast had been stockpiled at the entrance to the EOD Pad. Prior to the heavy equipment arrival, access lanes to the various sites were swept with a magnetometer by a UXO technician. Ice thickness was measured at several locations using a manual auger and tape measure. Water lenses within the ice off Clunie Point caused some concern but it was felt that the overall ice thickness was sufficient to attempt a deployment. Snow cover was unusually thick this year (March 2010). The snow both weighed down the ice, causing minor flooding, and insulated the underlying ice and water, preventing quick freeze back. The dozer was sent out ahead to plow the access lanes over the ice because of its low ground pressure. After it was out about a half hour, the loader was taken out to widen the plowed roads. The loader almost immediately broke through a thin section of ice (Figure III-1-2). The dozer returned and winched the loader back

**Figure III-1-2. Loader off Clunie Point with wheels through the ice.**

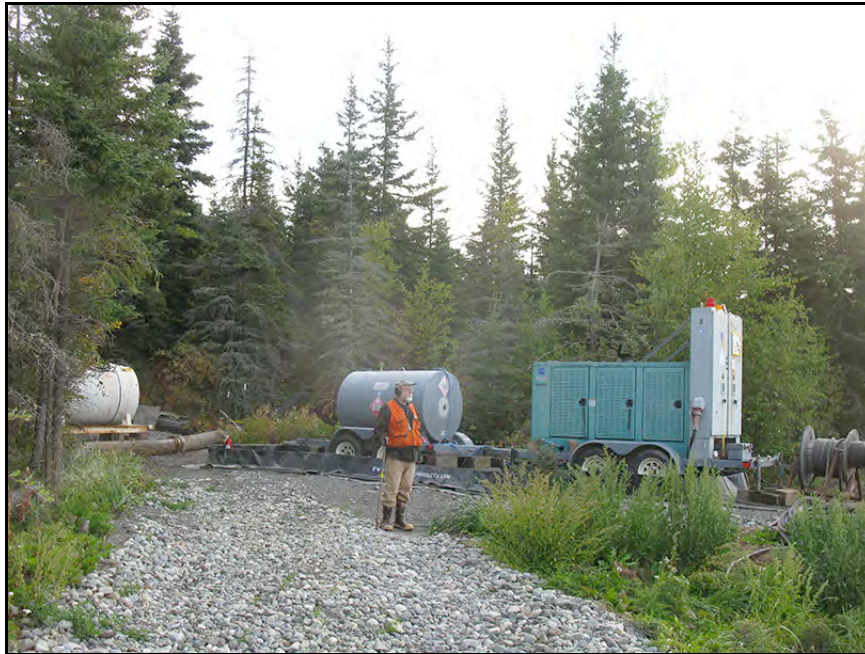
**Figure III-1-3. Leveled genset pad from Spur Road extension.**

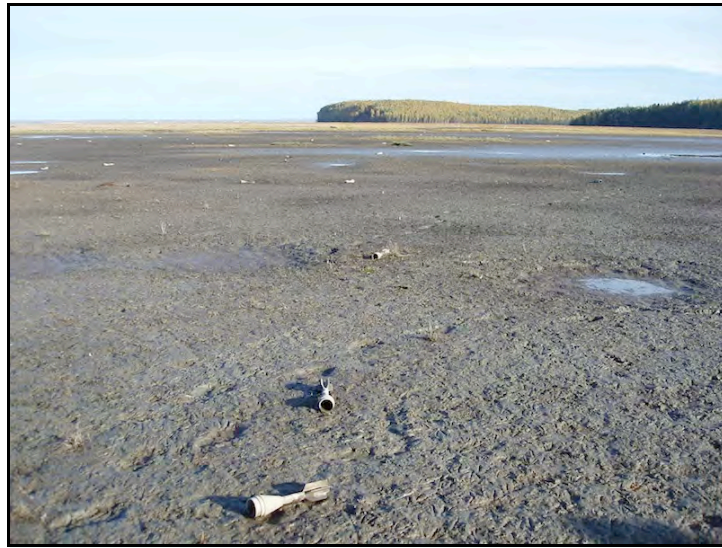
**Figure III-2-2. Evidence of winter training on the west side of Pond 183 (image from 2009)**

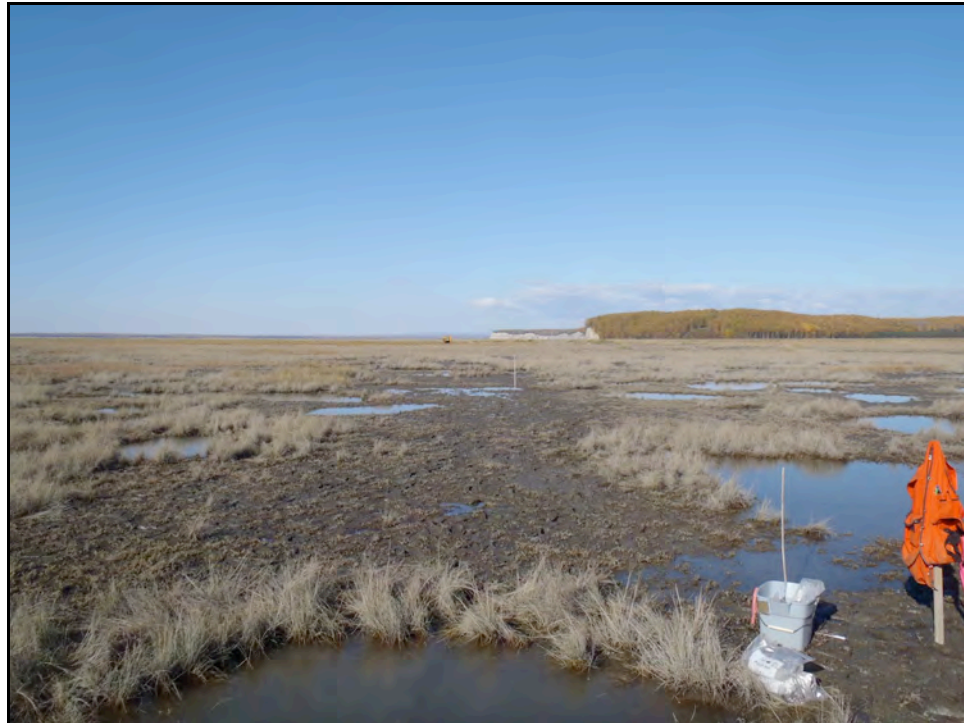
**Figure III-2-5. View across former Pond 109 looking north over BT South 100-m decision unit in September 2010.**

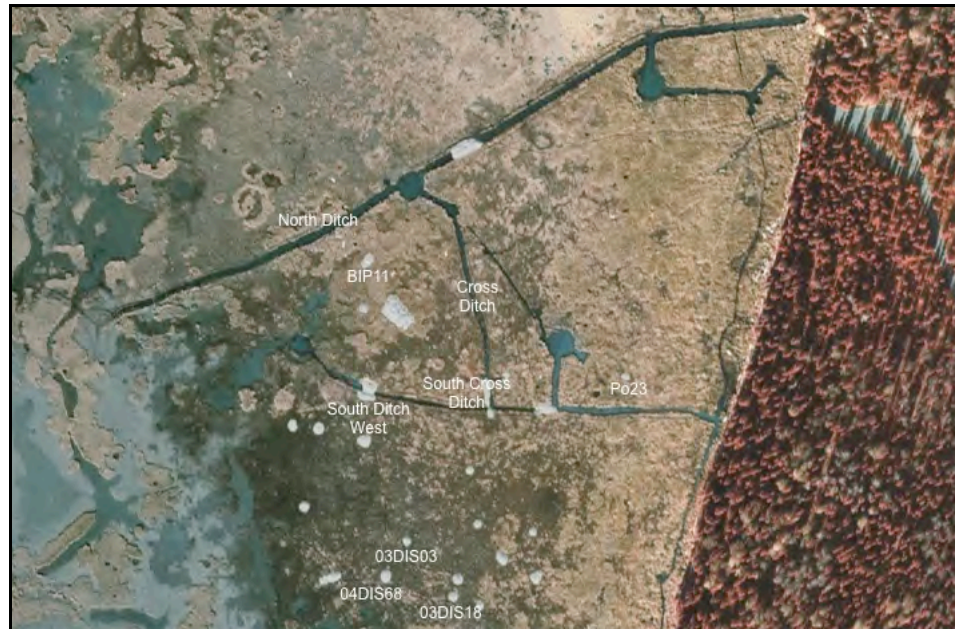
**Figure III-2-9. Location of gravel caps and sample identification numbers. Sediment around the perimeters of the caps were sampled in May 2009. The aerial image was taken on 20 August 2009 (Aero-Metric).**

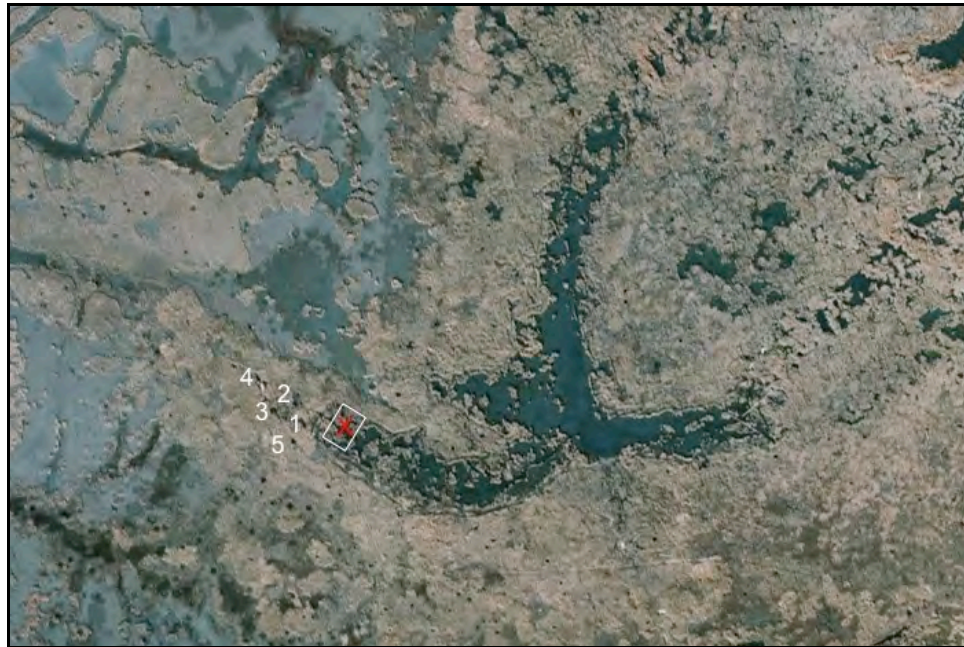
a. Locations in or near Pond 730 that were sampled in 2010. The numbers are small pools, none of which had detectable white phosphorus. The rectangle corresponds to the area resampled in 2010 and white phosphorus was detected. The red X is the location of white phosphorus ordnance scrap found in 2010.

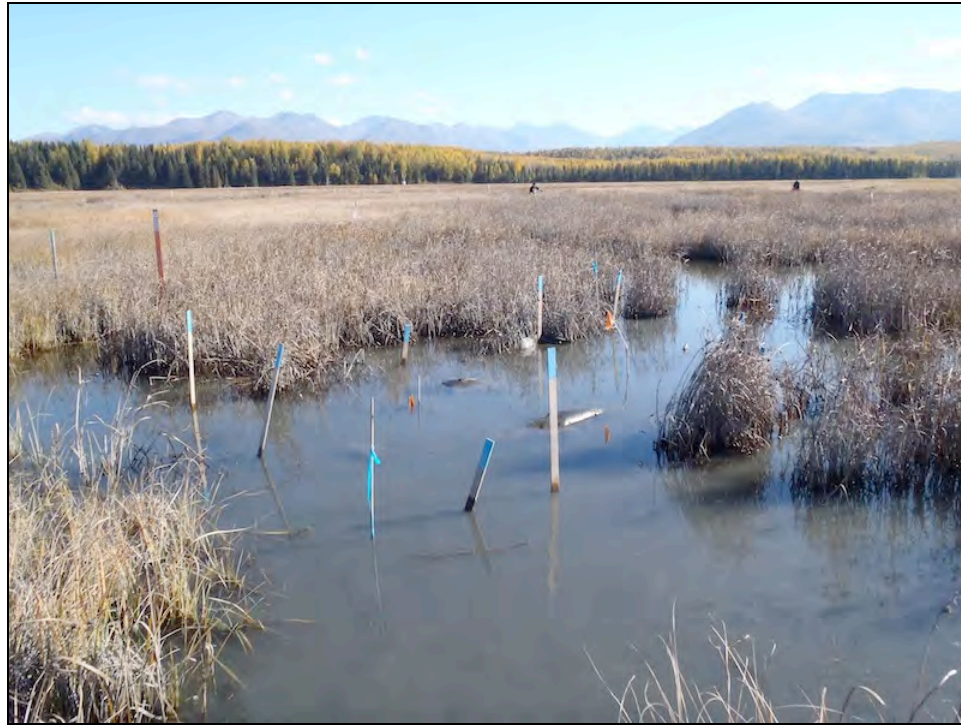
**Figure III-2-12. Ground view of the southwest arm of Pond 730 where white phosphorus ordnance scrap was found in May 2010 and a temporary geotextile/gravel cap put in place in July 2010.**

During the 2010 transect surveys six mortalities (three carcasses and three feather piles) were found around the Pond 730 transect. This is a noticeable reduction from the 21 mortalities found in 2009 (Table II-2-2). The reductions can be attributable to several factors. Last year was a very dry year up until mid-September 2009 and most of the mortalities occurred before mid-September when water levels were low. We are hypothesizing that because of the shallower than normal water levels, ducks were able to access small unknown hot spots of contamination in the Pond 730 area that would normally have been in deeper water and inaccessible to dabbling ducks (Collins et al. 2010). This year was a more normal year and water levels were higher throughout the fall migration period. Secondly, a previously unknown white phosphorus-contaminated hot spot was identified in May 2010 in the western end of Pond 730 (Walsh, M.E. et al., this volume). A temporary 4.5-m by 6-m geotextile cap was placed over the hot spot in June to keep waterfowl from feeding there through the fall. The temporary cap may have prevented additional mortality in this area during the fall migration period. This temporary geotextile cap was replaced with a permanent gravel cap in March 2011.

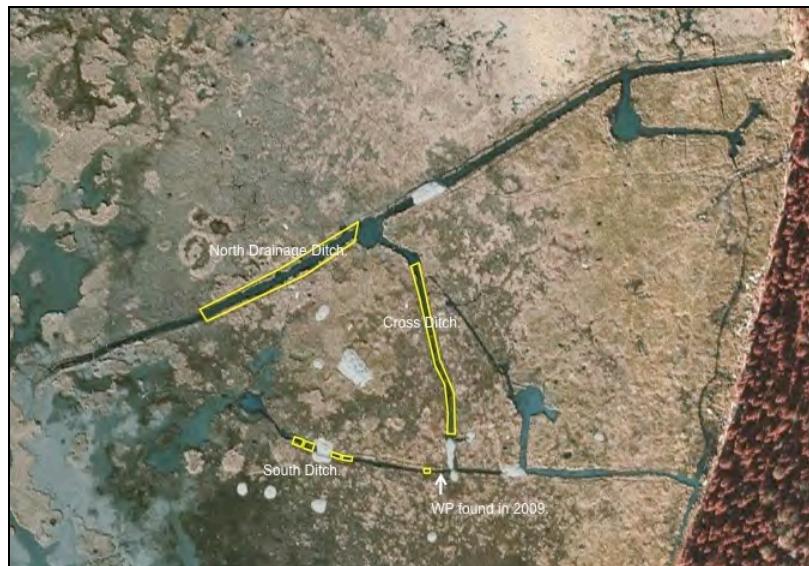
**Figure III-2-13. Aerial image showing locations (outlined in yellow) within the drainage ditches that were sampled in 2010. White phosphorus was not detected.**

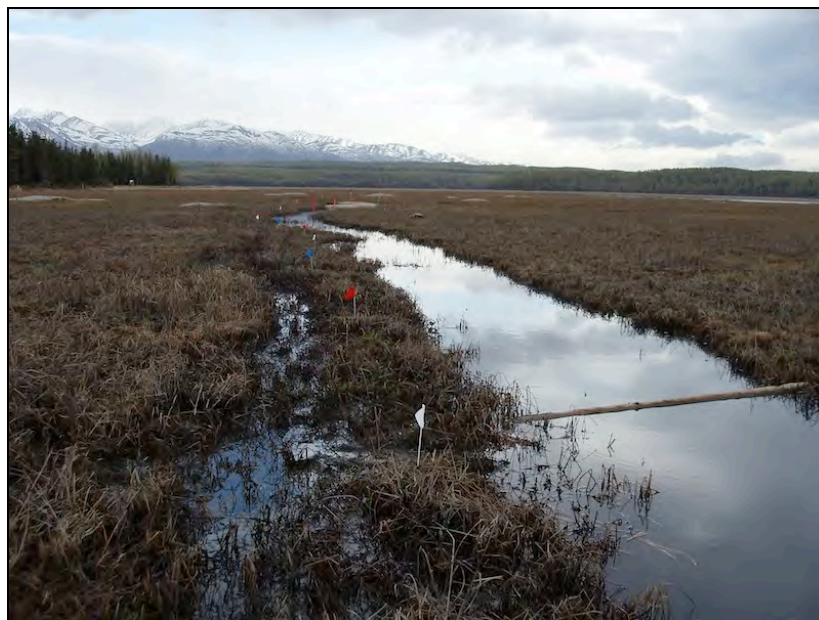
**Figure III-2-14. View looking south down the cross ditch. A 70 m long area was subdivided into 5-m long sampling units. White phosphorus was not detected in any sample.**

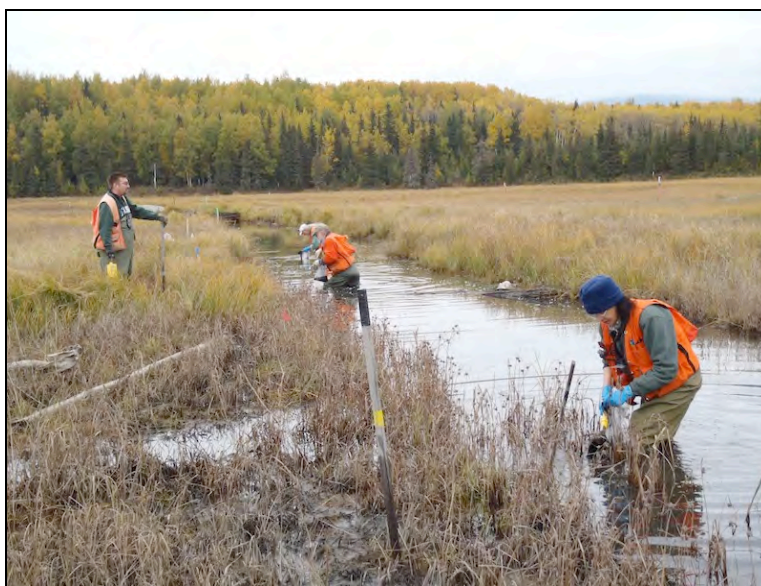
**Figure III-2-15. View looking east along the North Ditch. An 80-m long area was subdivided into 10-m long sampling units. White phosphorus was not detected in any sample.**

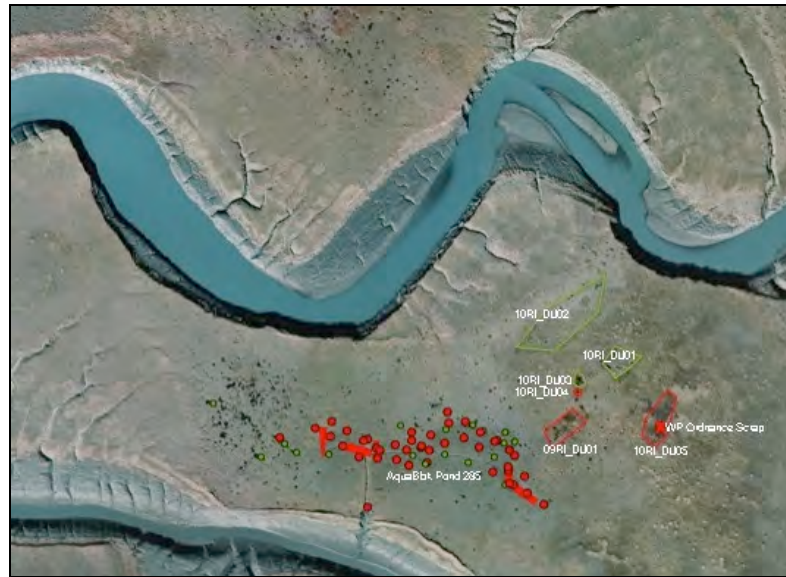
Figure III-2-16. Aerial image showing previous sample locations in Pond 285 on Racine Island and sampling units in 2010. The red color corresponds to samples with white phosphorus. White phosphorus was not detectable in the green colored units.

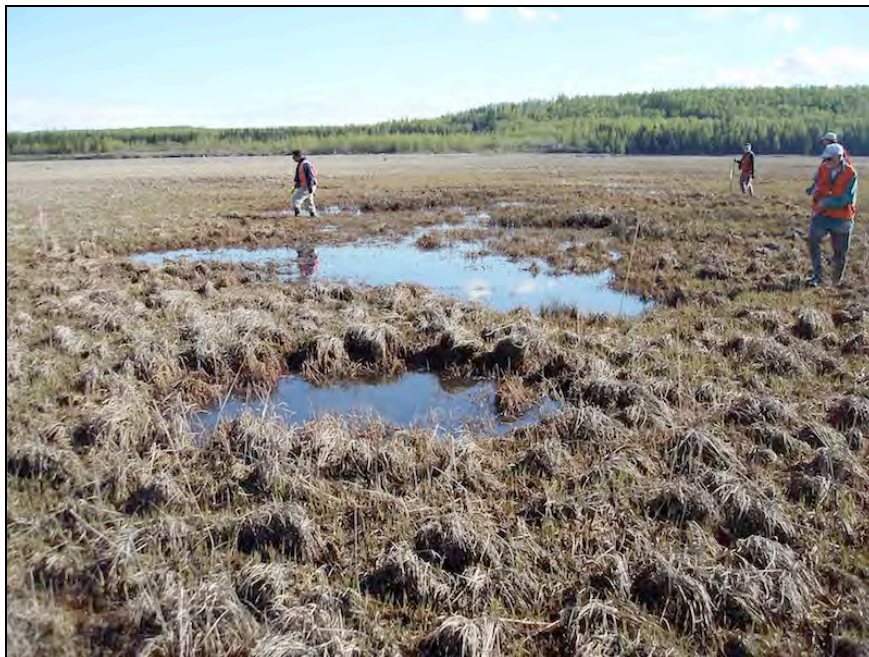
Figure III-2-17. Ground view on Racine Island of 09RI\_DU01 (image taken in May 2010) where white phosphorus was detected in 2009.

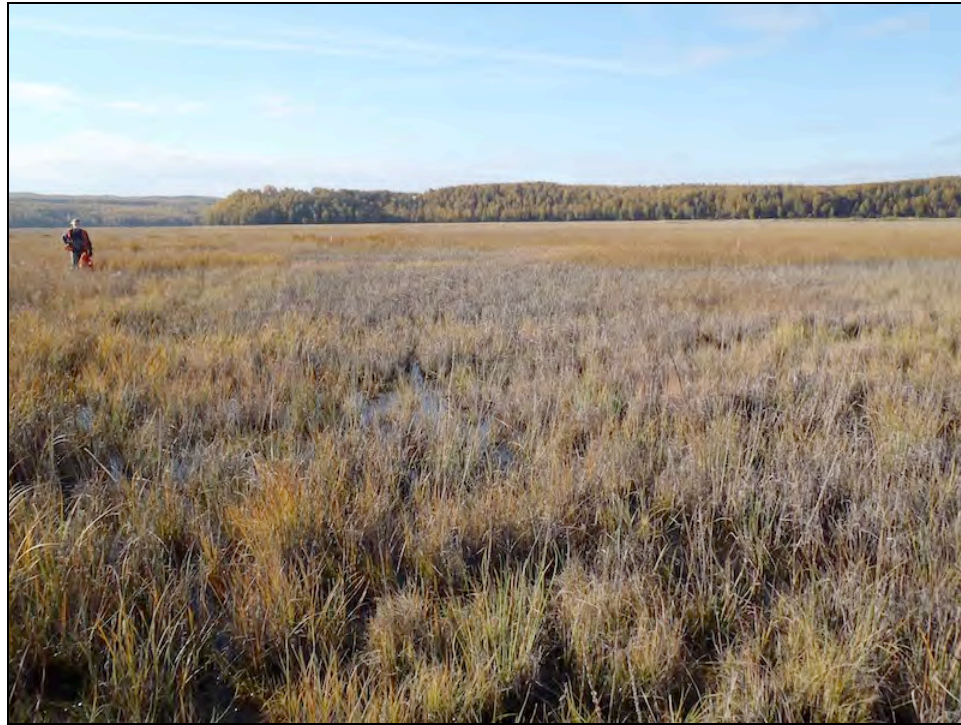
**Figure III-2-19. Ground view of the area (10RI\_DU05) on Racine Island in September 2010 where white phosphorus ordnance scrap was found and white phosphorus was detected.**

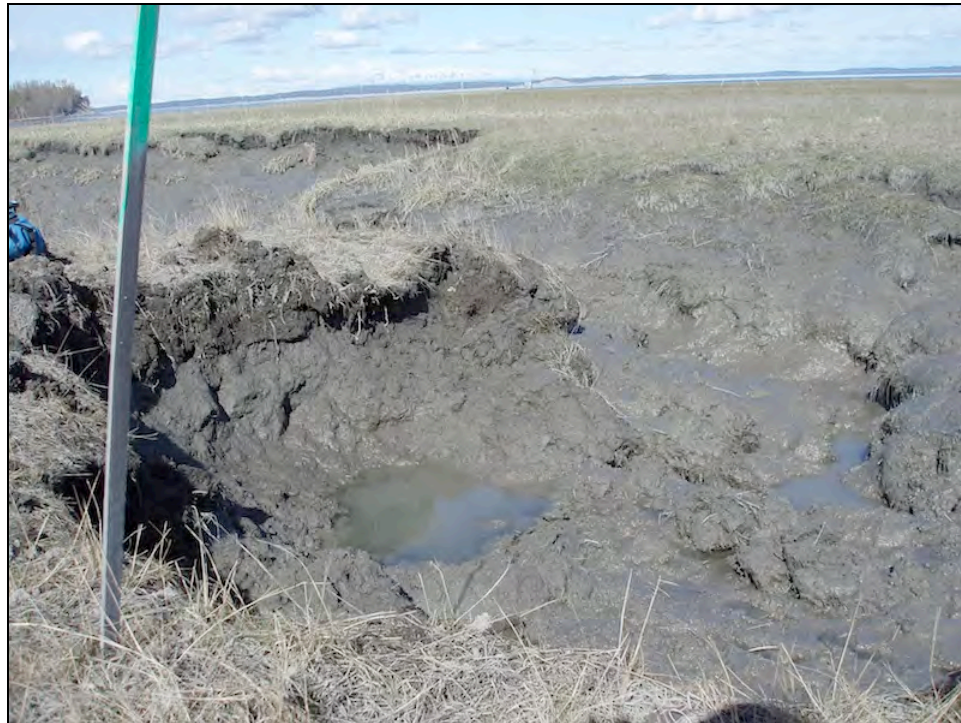
**Figure III-2-20. Ground view crater from the detonation of a 4.2-inch WP mortar projectile in a gully in May 2010.**

Ordnance scrap continues to erode out the bank of Coastal East and Coastal West. A 4.2-inch white phosphorus mortar projectile was detonated by EOD in a gully near the river mouth May 2010. A protocol is needed to safely dispose of ordnance items that are found along the inlet so that contamination is not introduced into the river or inlet.

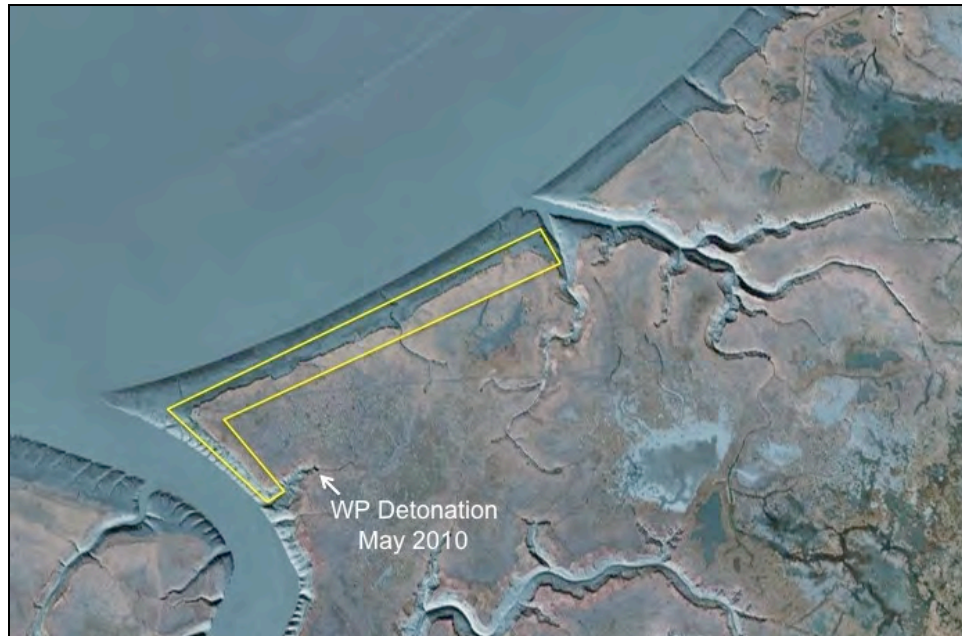
Figure III-2-21. Aerial image of the bank of Coastal East (area outlined in yellow) that was monitored for ordnance in May 2010. The length along the north shore was 600 m and along the river was 180 m. Also shown is the detonation site for a 4.2-inch WP mortar projectile.

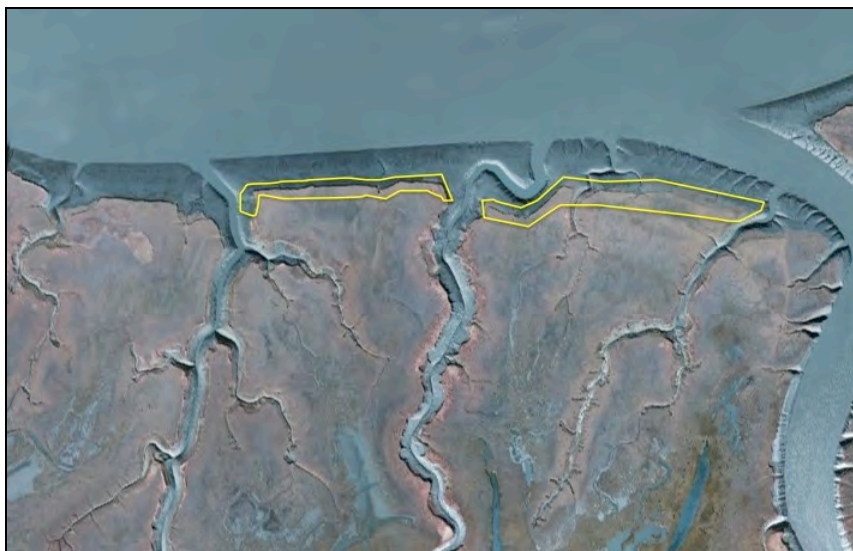
Figure III-2-23. Aerial image of the bank of Coastal West (area outlined in yellow) that was monitored for ordnance in May 2010. The lengths along the shore were 350 m between the gullies and 500 m between the gully and river.

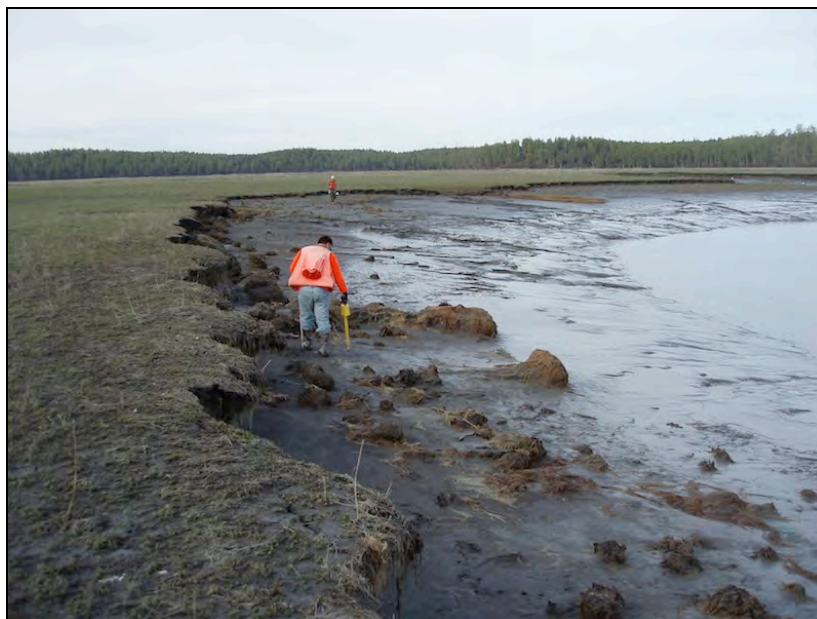
Figure III-2-24. Ground view of the bank of Coastal West showing erosion similar to that in Coastal East.

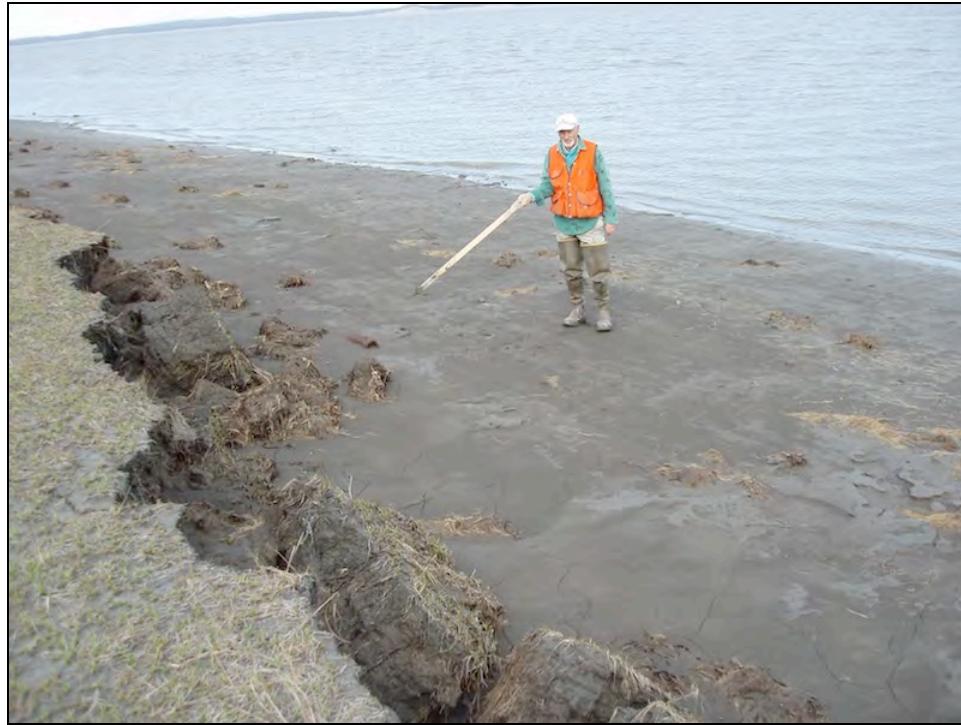
**Figure III-2-25. Example of ordnance scrap found along the bank of Coastal West where an empty Illumination projectile was found.**

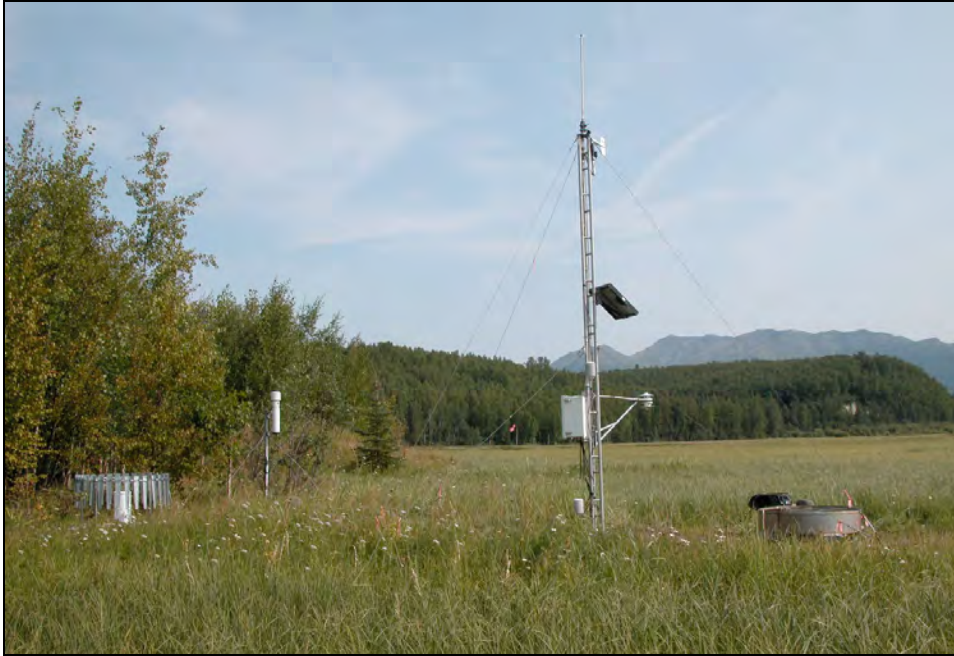
**Figure III-3-1. Eagle River Flats meteorological station located along the edge of the OB/OD pad in Area C. The 4-m tower is located in the right center, the 1.22-m-diameter evaporation pan is located to the right, and the shielded rain gage is located to the left.**

The Eagle River Flats meteorological station monitored the local wind speed and direction, air temperature, radiation, relative humidity and precipitation from 20 May to 19 September 2010. In the fall, instruments for precipitation were removed, but other measurements were continued over the winter.

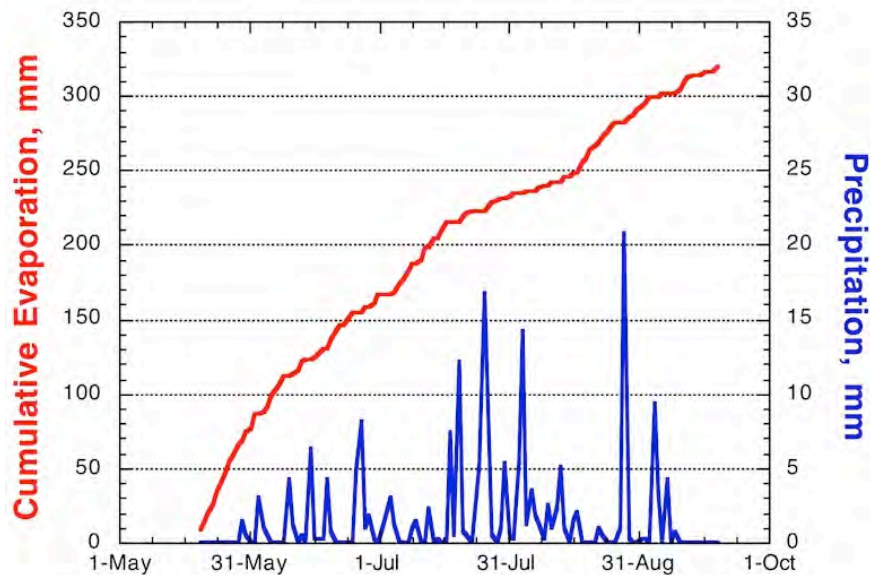
**Figure III-3-3. Net cumulative evaporation for the season and precipitation data showing the wetter than normal precipitation conditions throughout June and July. Precipitation was near normal for August and below normal for the first half of September.**
