# Resumption of Live-fire Training Exercises at XU022 – Eagle River Flats Impact Area, Operable Unit C

## Joint Base Elmendorf-Richardson, Alaska

**Date:** September 2015

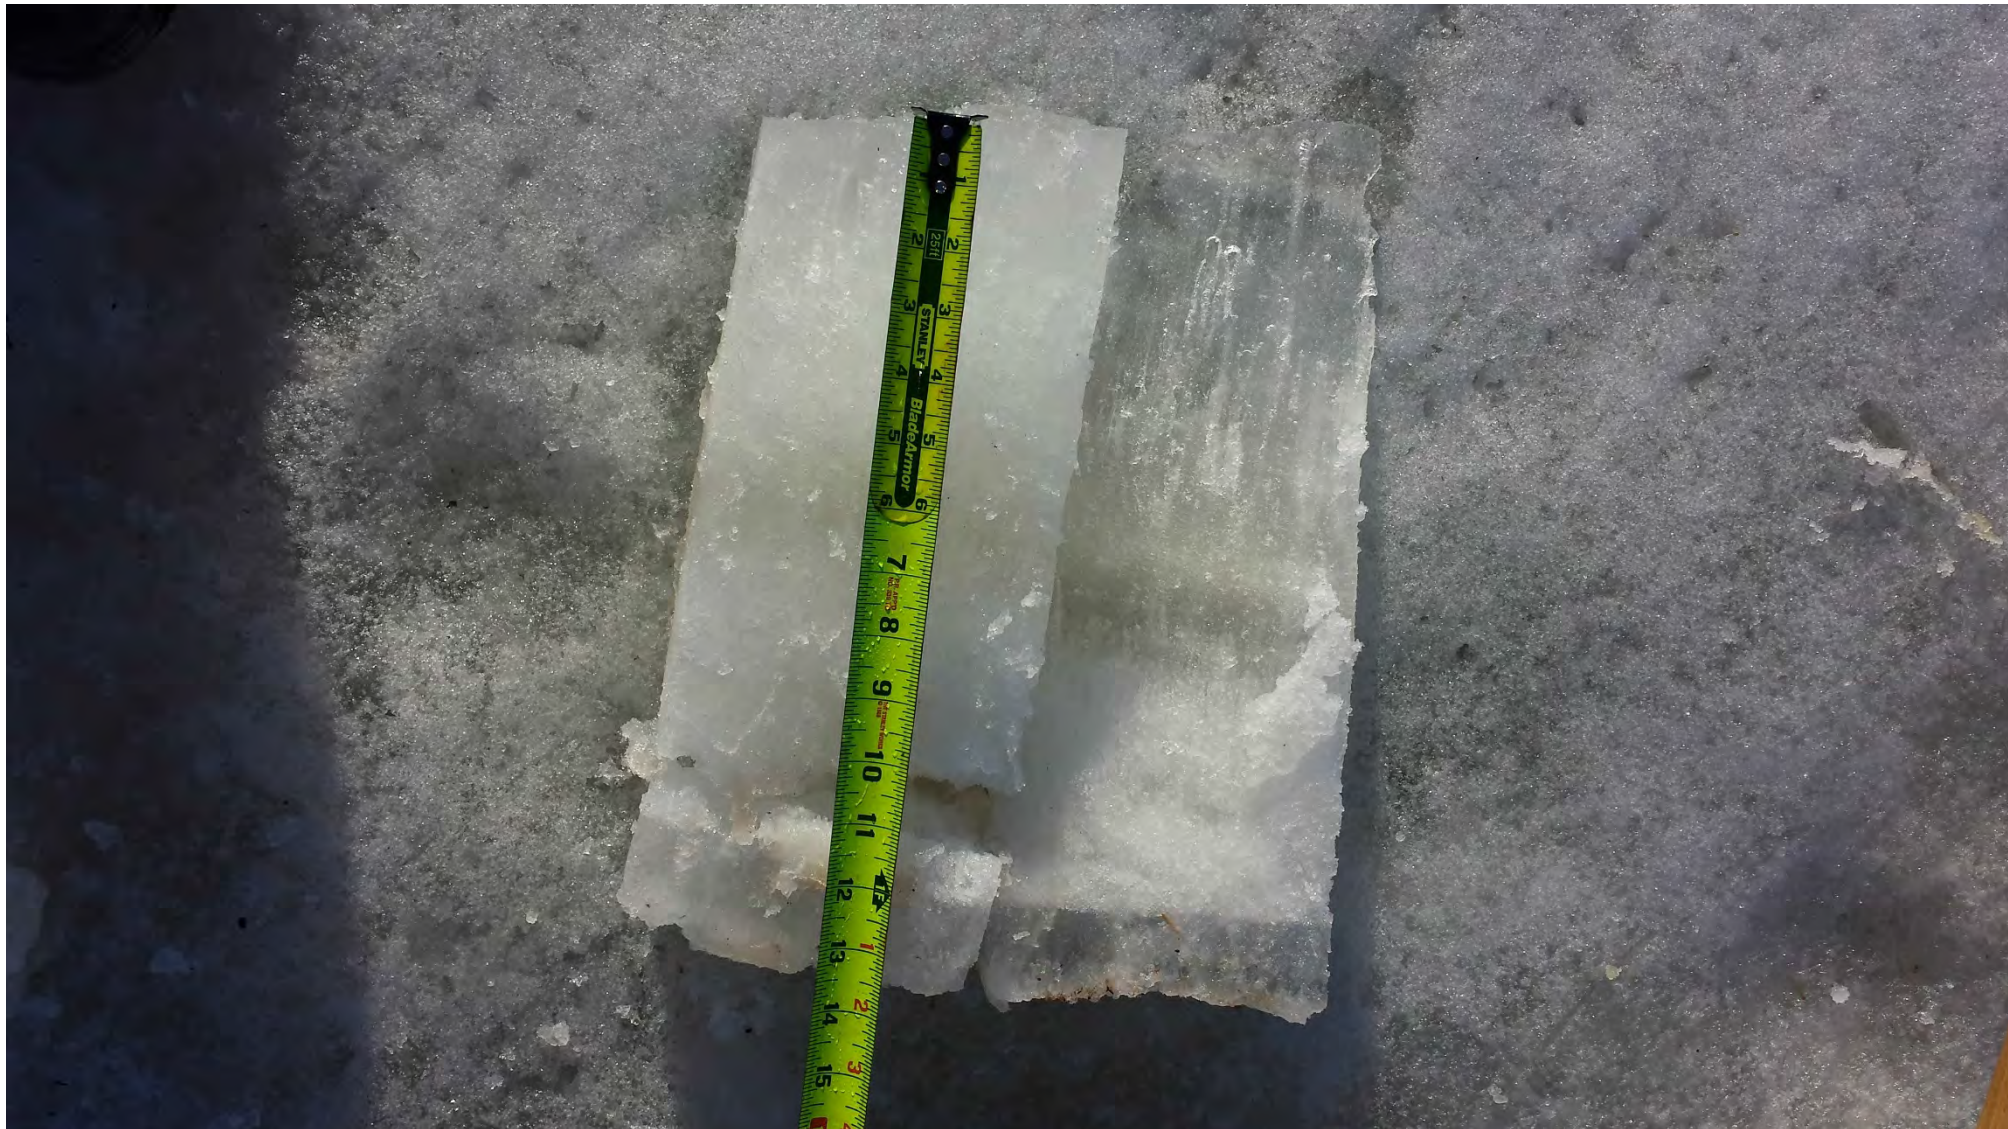
Figure 2

ICE THICKNESS  
XU022 – Operable Unit C, Eagle River Flats  
Joint Base Elmendorf-Richardson, Alaska

for Measuring Ice Thickness at Eagle River Flats (ERF) Impact Area, Fort Richardson, Alaska (FRA) (USAF, 2007) (see Attachment 4). The ice conditions for the firing events were characterized as “hard” with measured thicknesses of 24 and 12 inches on March 30 and April 13, 2015, respectively (see Table 1). In both events, the ice thickness was considered protective for the type of munitions fired. In addition, a Range Control Facility Operations Specialist verified that safety measures were in place and monitored initial firing to observe effects on the ice. A photograph of the ice thickness measurement at one of the three measured locations (EOD Area) on April 13, 2015, is provided as Figure 2.

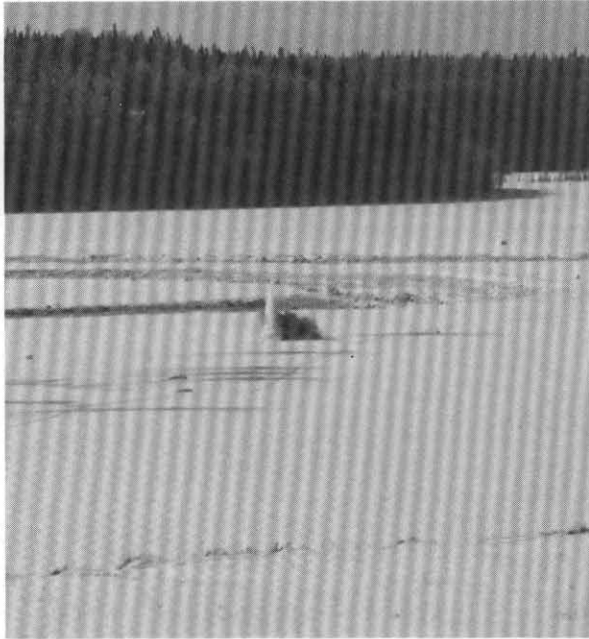
*Figure 5. Ricocheting projectile exploding near the ice surface. The white plume of snow and ice shows where the projectile initially hit, and the explosion was just beyond it.*

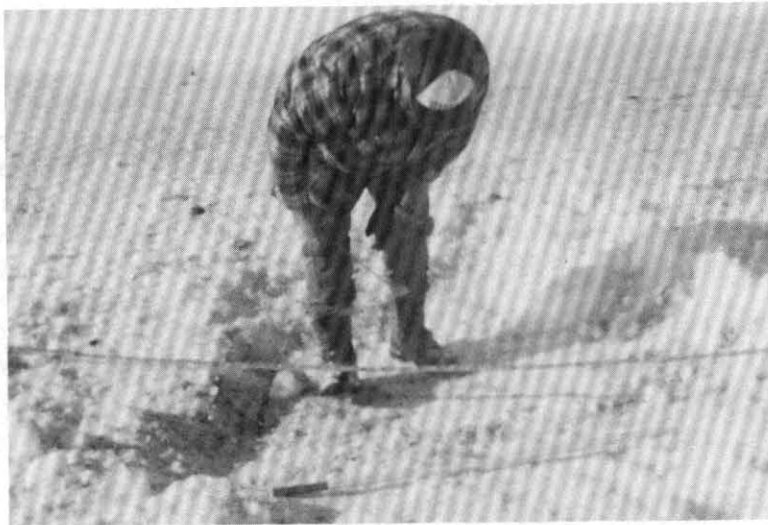
Figure 8. Crater formed by a point-detonating 81-mm mortar projectile on grounded ice.

The mean depth of the craters was 0.16 m, with most of the depth caused by removal of the 0.15-m-thick snow cover. A shallow depression was blown in the underlying ice cover in the center of the craters,

but the ice was not broken or penetrated by the explosions (Fig. 8).

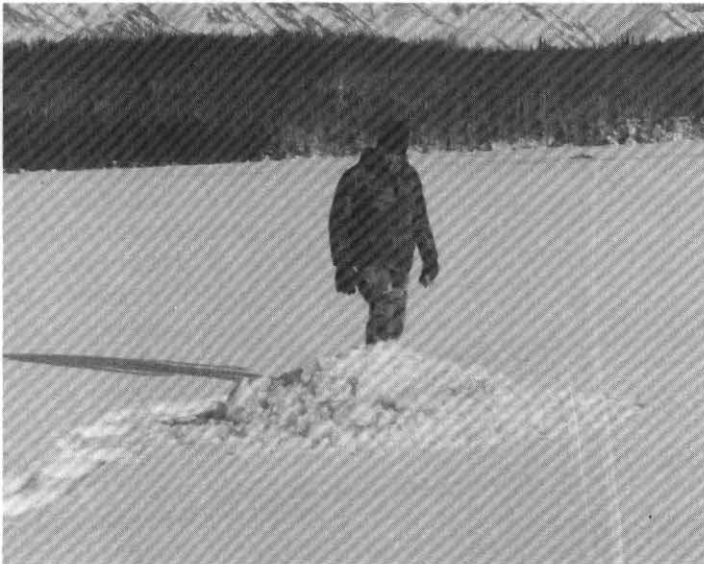
*Figure 10. Camouflet formed by a delay-fused 81-mm mortar projectile.*

The second and third delay-fused projectiles each produced a camouflet, or a hidden crater. The projectiles penetrated the ice cover and the underlying frozen and unfrozen sediments before exploding. The confining strengths of the ice, the upper seasonally frozen sediment and the underlying saturated unfrozen sediment allowed the explosion to be confined and prevented it from ejecting material and producing a surface crater. The only evidence of the two camouflets was conical mounds of broken ice rubble, one of which measured 0.6 m high and 2 m in diameter (Fig. 10). Closer inspection and judicious digging into the mound by the EOD escort revealed a nearly vertical hole 30 cm in diameter and 1.5 m deep (Fig. 11).

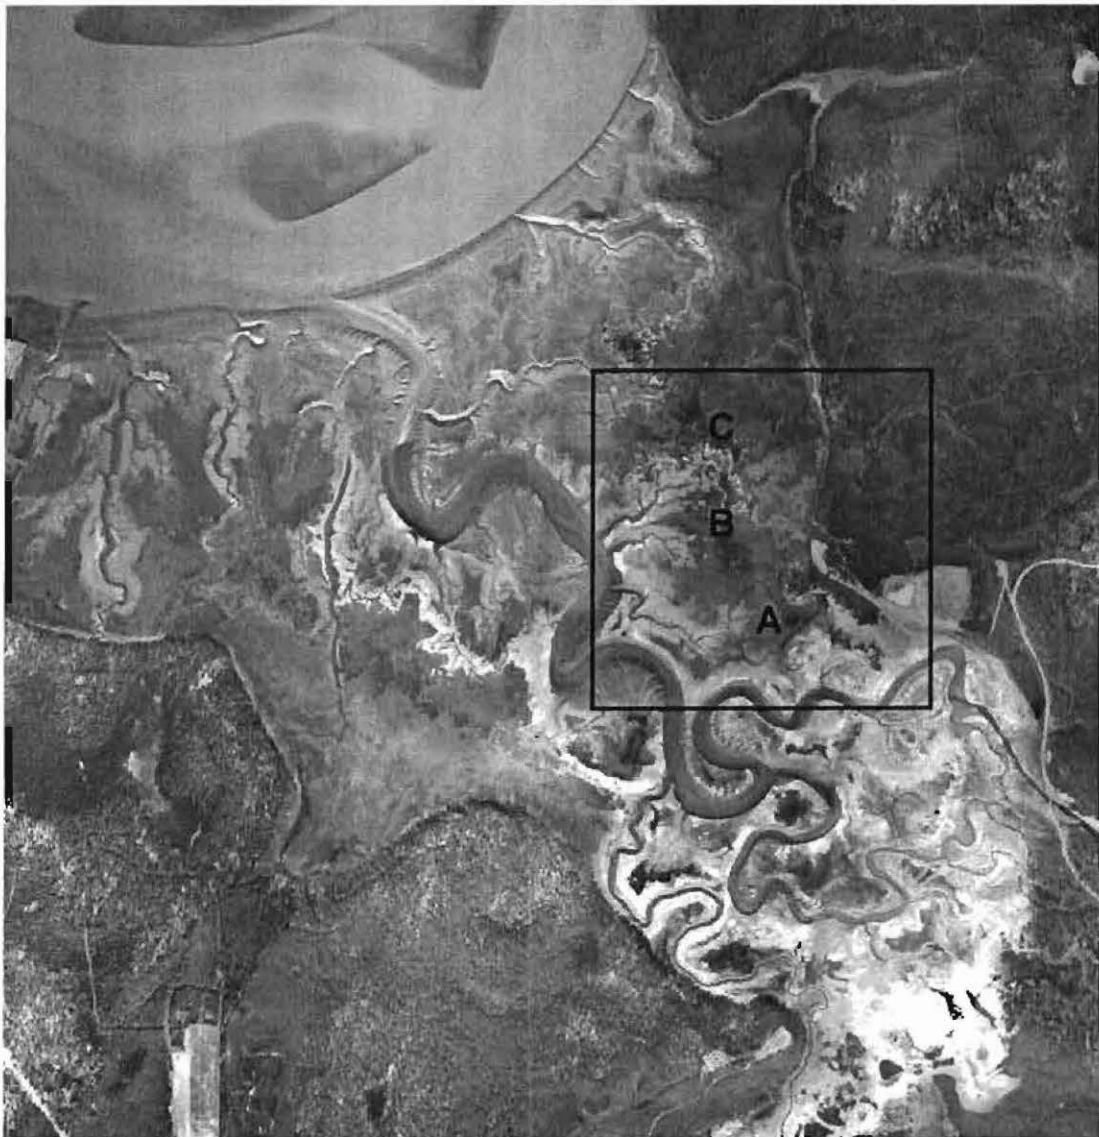
Figure 1A: General Location of Ice Thickness Survey Points.

a. Three locations have historically been used to assess ice thickness within the ERF impact area. Those locations are shown on Figures 1A and 1B and are designated locations Alpha, Bravo and Charlie. All three locations can be easily accessed from the trail system, provide adequate characterization of the ERF area and must be cleared by EOD prior to personnel entering the Permanent Impact Area. All three sites are located over ponds that are representative of open water conditions elsewhere in the ERF Impact Area. The ponds, when flooded, are at least five feet deep.

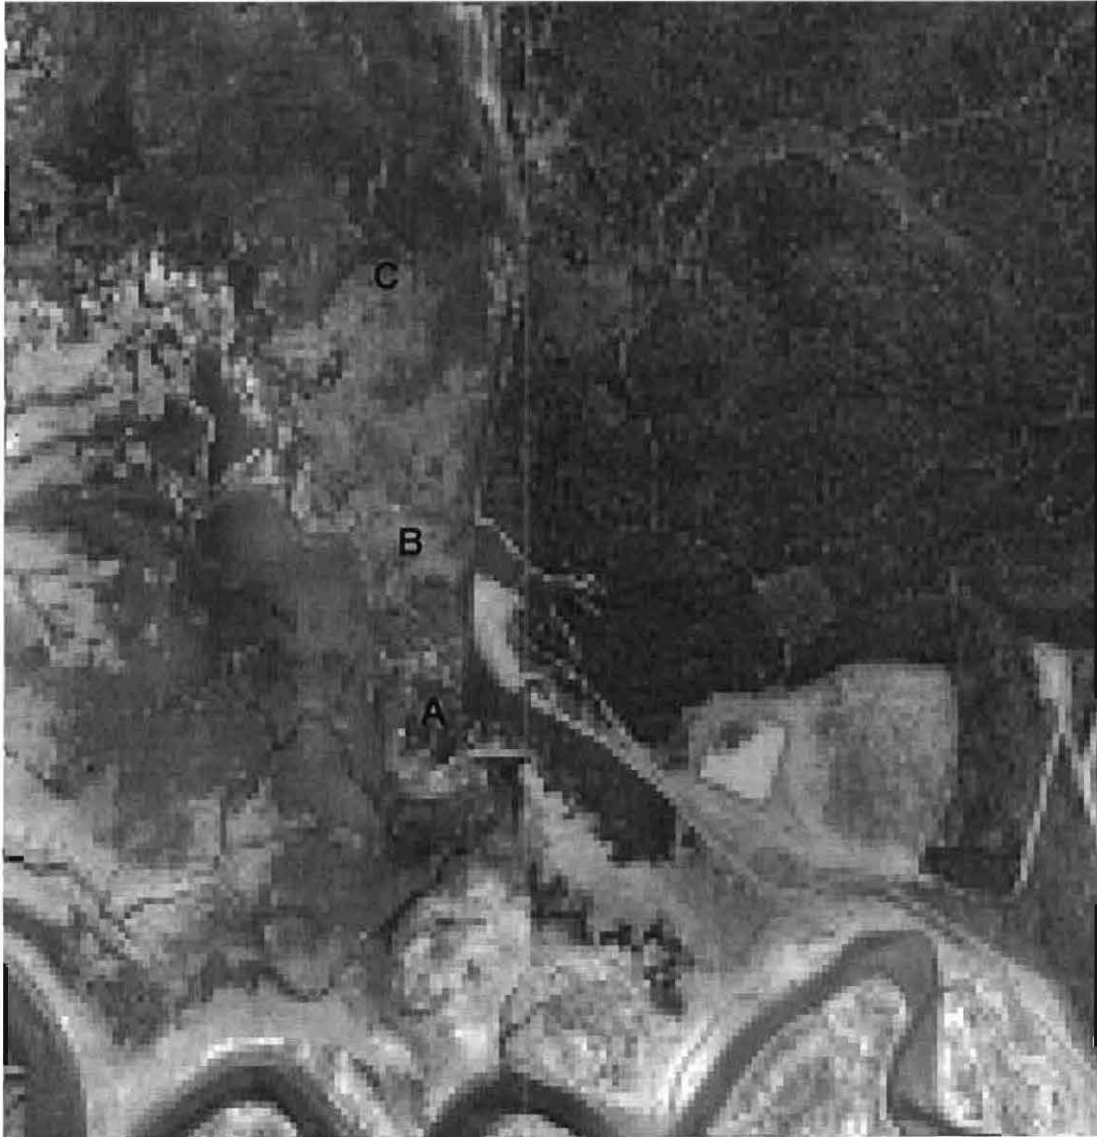
Figure 1B: Location of Ice Thickness Survey Points
