**FINAL  
ENVIRONMENTAL MONITORING REPORT  
FOR  
LANDFILL 2 (LF03)  
AND  
SPILL SITES SS13 AND SS15**

**CAPE ROMANZOF LRRS, ALASKA**

**JUNE 14, 2005**

Paug-Vik Development Corporation  
1600 A Street, Suite 306  
Anchorage, AK 99501

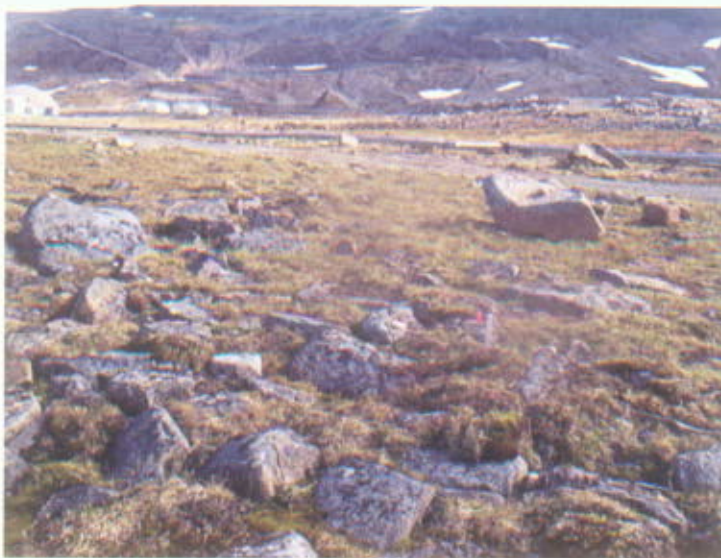
Above: SS13 sampling site LB-03. Photograph taken facing northwest. Lower Camp in background.

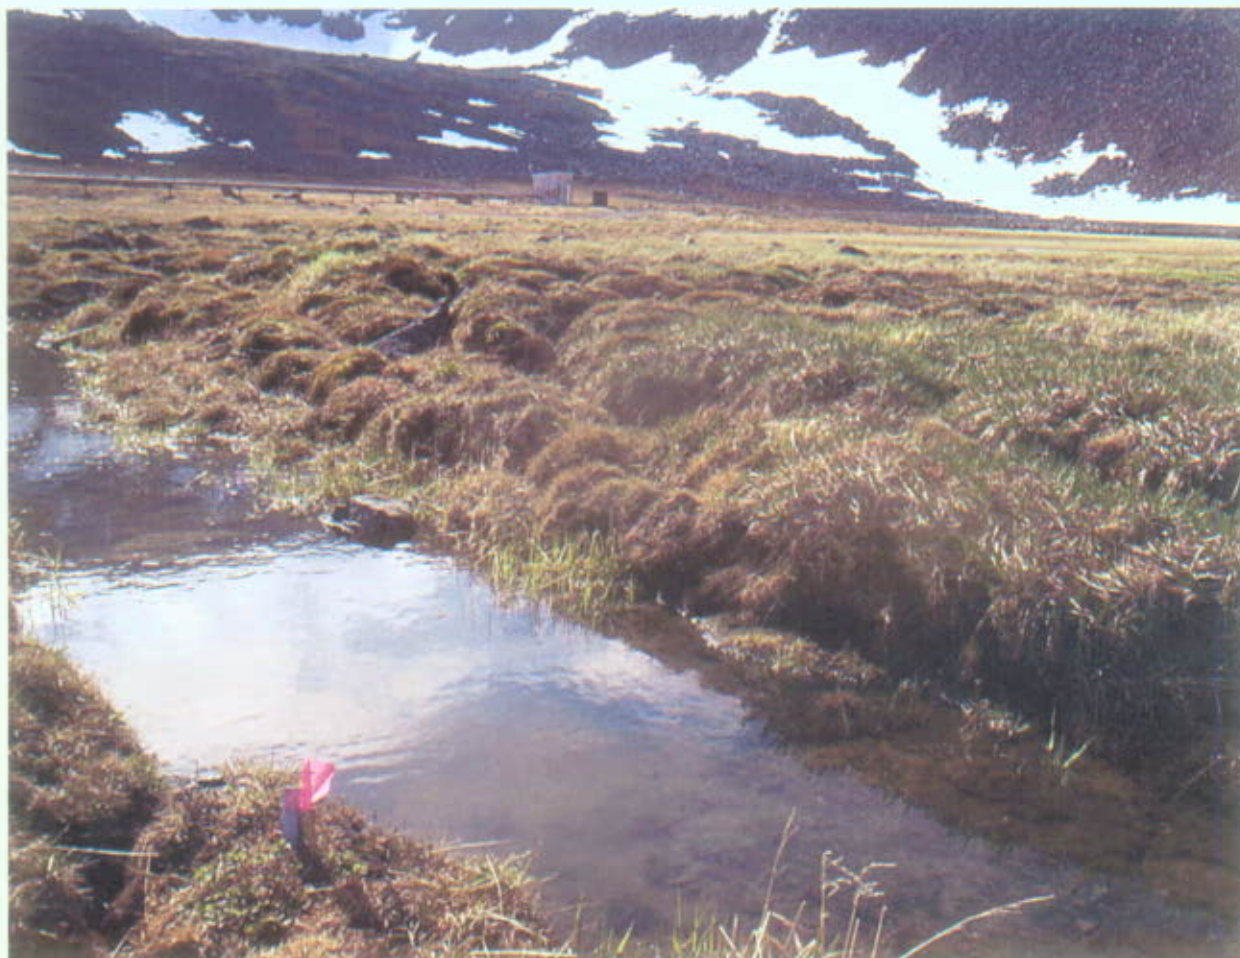
Above: SS13 sampling site SS-01. Photograph taken looking northeast. Water transmission line in background

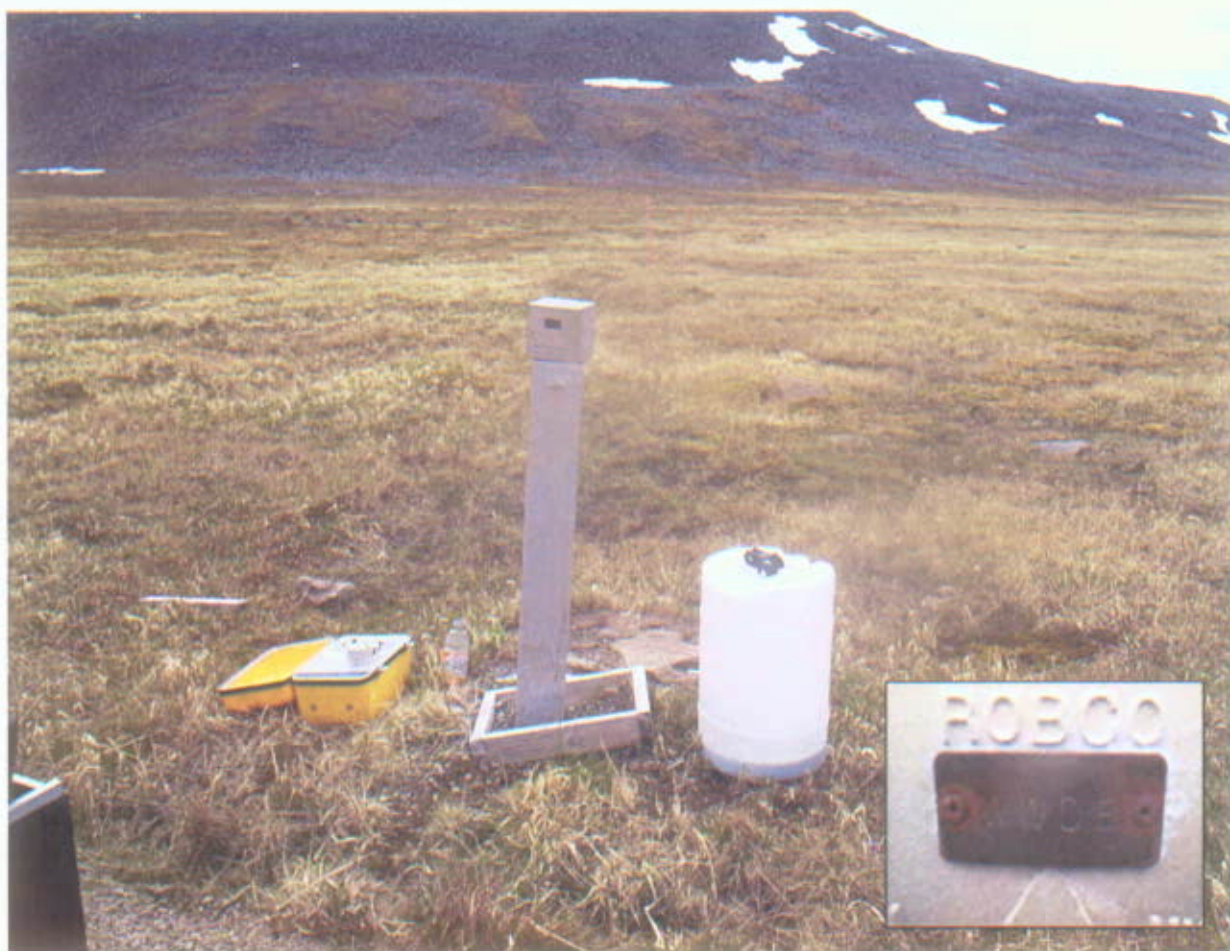
WW-08, which was dry in June, was later sampled in August when groundwater levels had risen. Table 3-6 provides available information for the wells sampled at SS15 in 2004. It should be noted that WW-08 had been incorrectly labeled "WW-09" on previous reports and work plans. The well number was clearly marked on the well as "WW-08" and was reported as such.

Above: SS15 well WW-08. This well had been mismarked as WW-09 in previous reports, but is clearly labeled WW-08 (see inset). Photograph taken looking southwest.

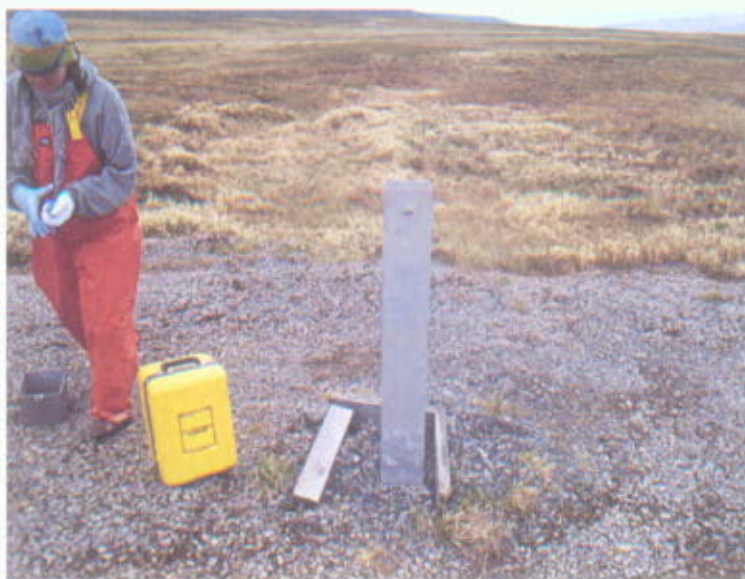
Well WW-02 was the only well sampled at this site during the June 2004 sampling event. A fuel odor was noted when the field team opened well WW-02. Using a product interface probe lowered into the well, the field team did not note the presence of any free product in the well. Sheen was noted during purging and sampling of groundwater from the well.

Above: SS15 well WW-02.

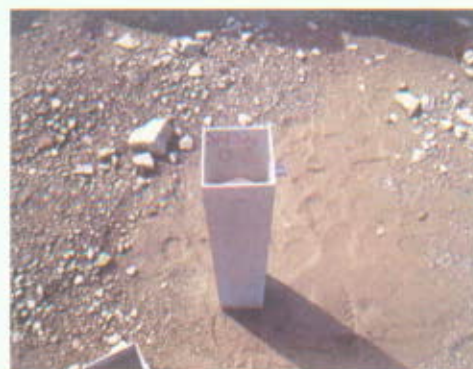
Only groundwater samples were collected at the SS15 site in 2004. Waterra® inertial pumps were found in wells WW-02, WW-07, and WW-08 at SS15. The pumps were removed from WW-02 and WW-08 prior to sampling. However, the pump in WW-07 could not be removed despite repeated attempts. The pumps consist of half-inch-diameter plastic tubes with foot valves that, when oscillated up and down in the well, produce a flow of water. However, the foot valves had silted up because of noncontinuous use and were no longer operational. The pumps were cut and disposed of with other sampling debris.

Left: SS15 well WW-07.  
Photograph taken looking southwest.

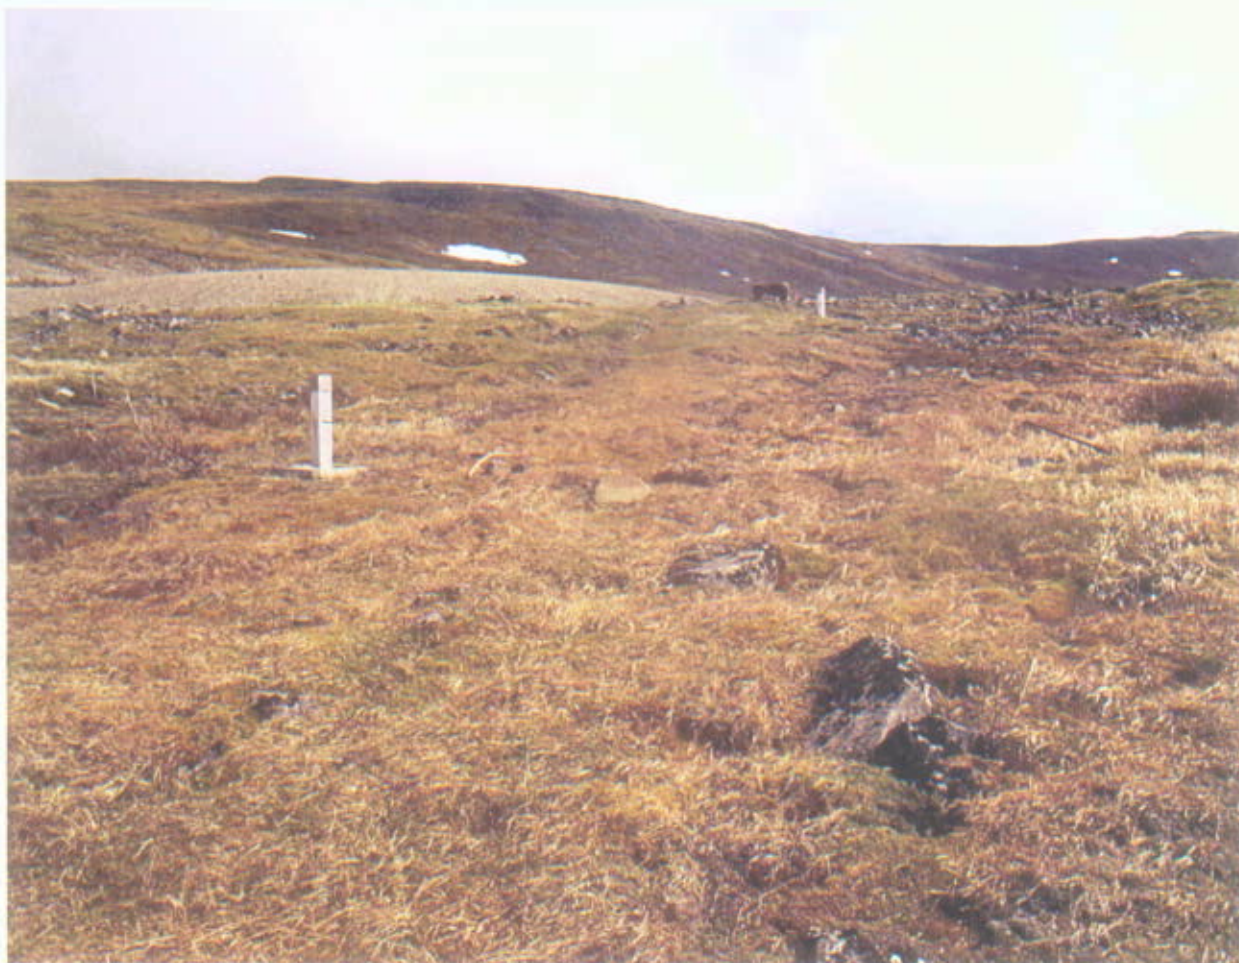
Above: LF03 wells CMW-6 and CMW-7. Photograph taken looking northwest.

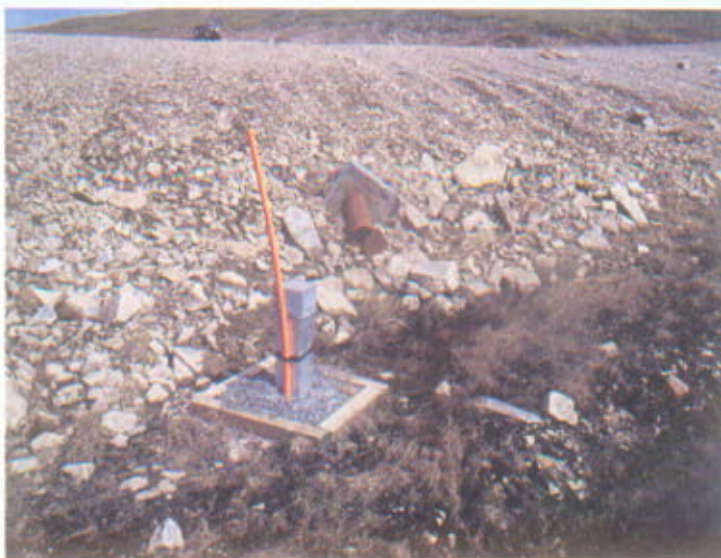
Above: LF03 well MW-01.

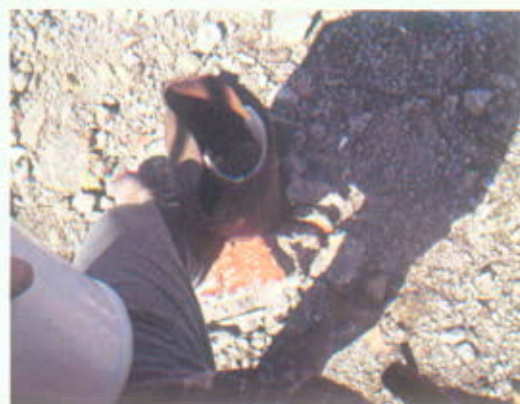
Left: LF03 well CMW-2.  
 Photograph taken looking north.  
 ATV parked on top of landfill for scale.
