**FIRE TRAINING PIT SITE CHARACTERIZATION REPORT
FAIRBANKS INTERNATIONAL AIRPORT**

SLR Ref: 105.01288.18002

ADEC File Number: 100.38.070

December 2018

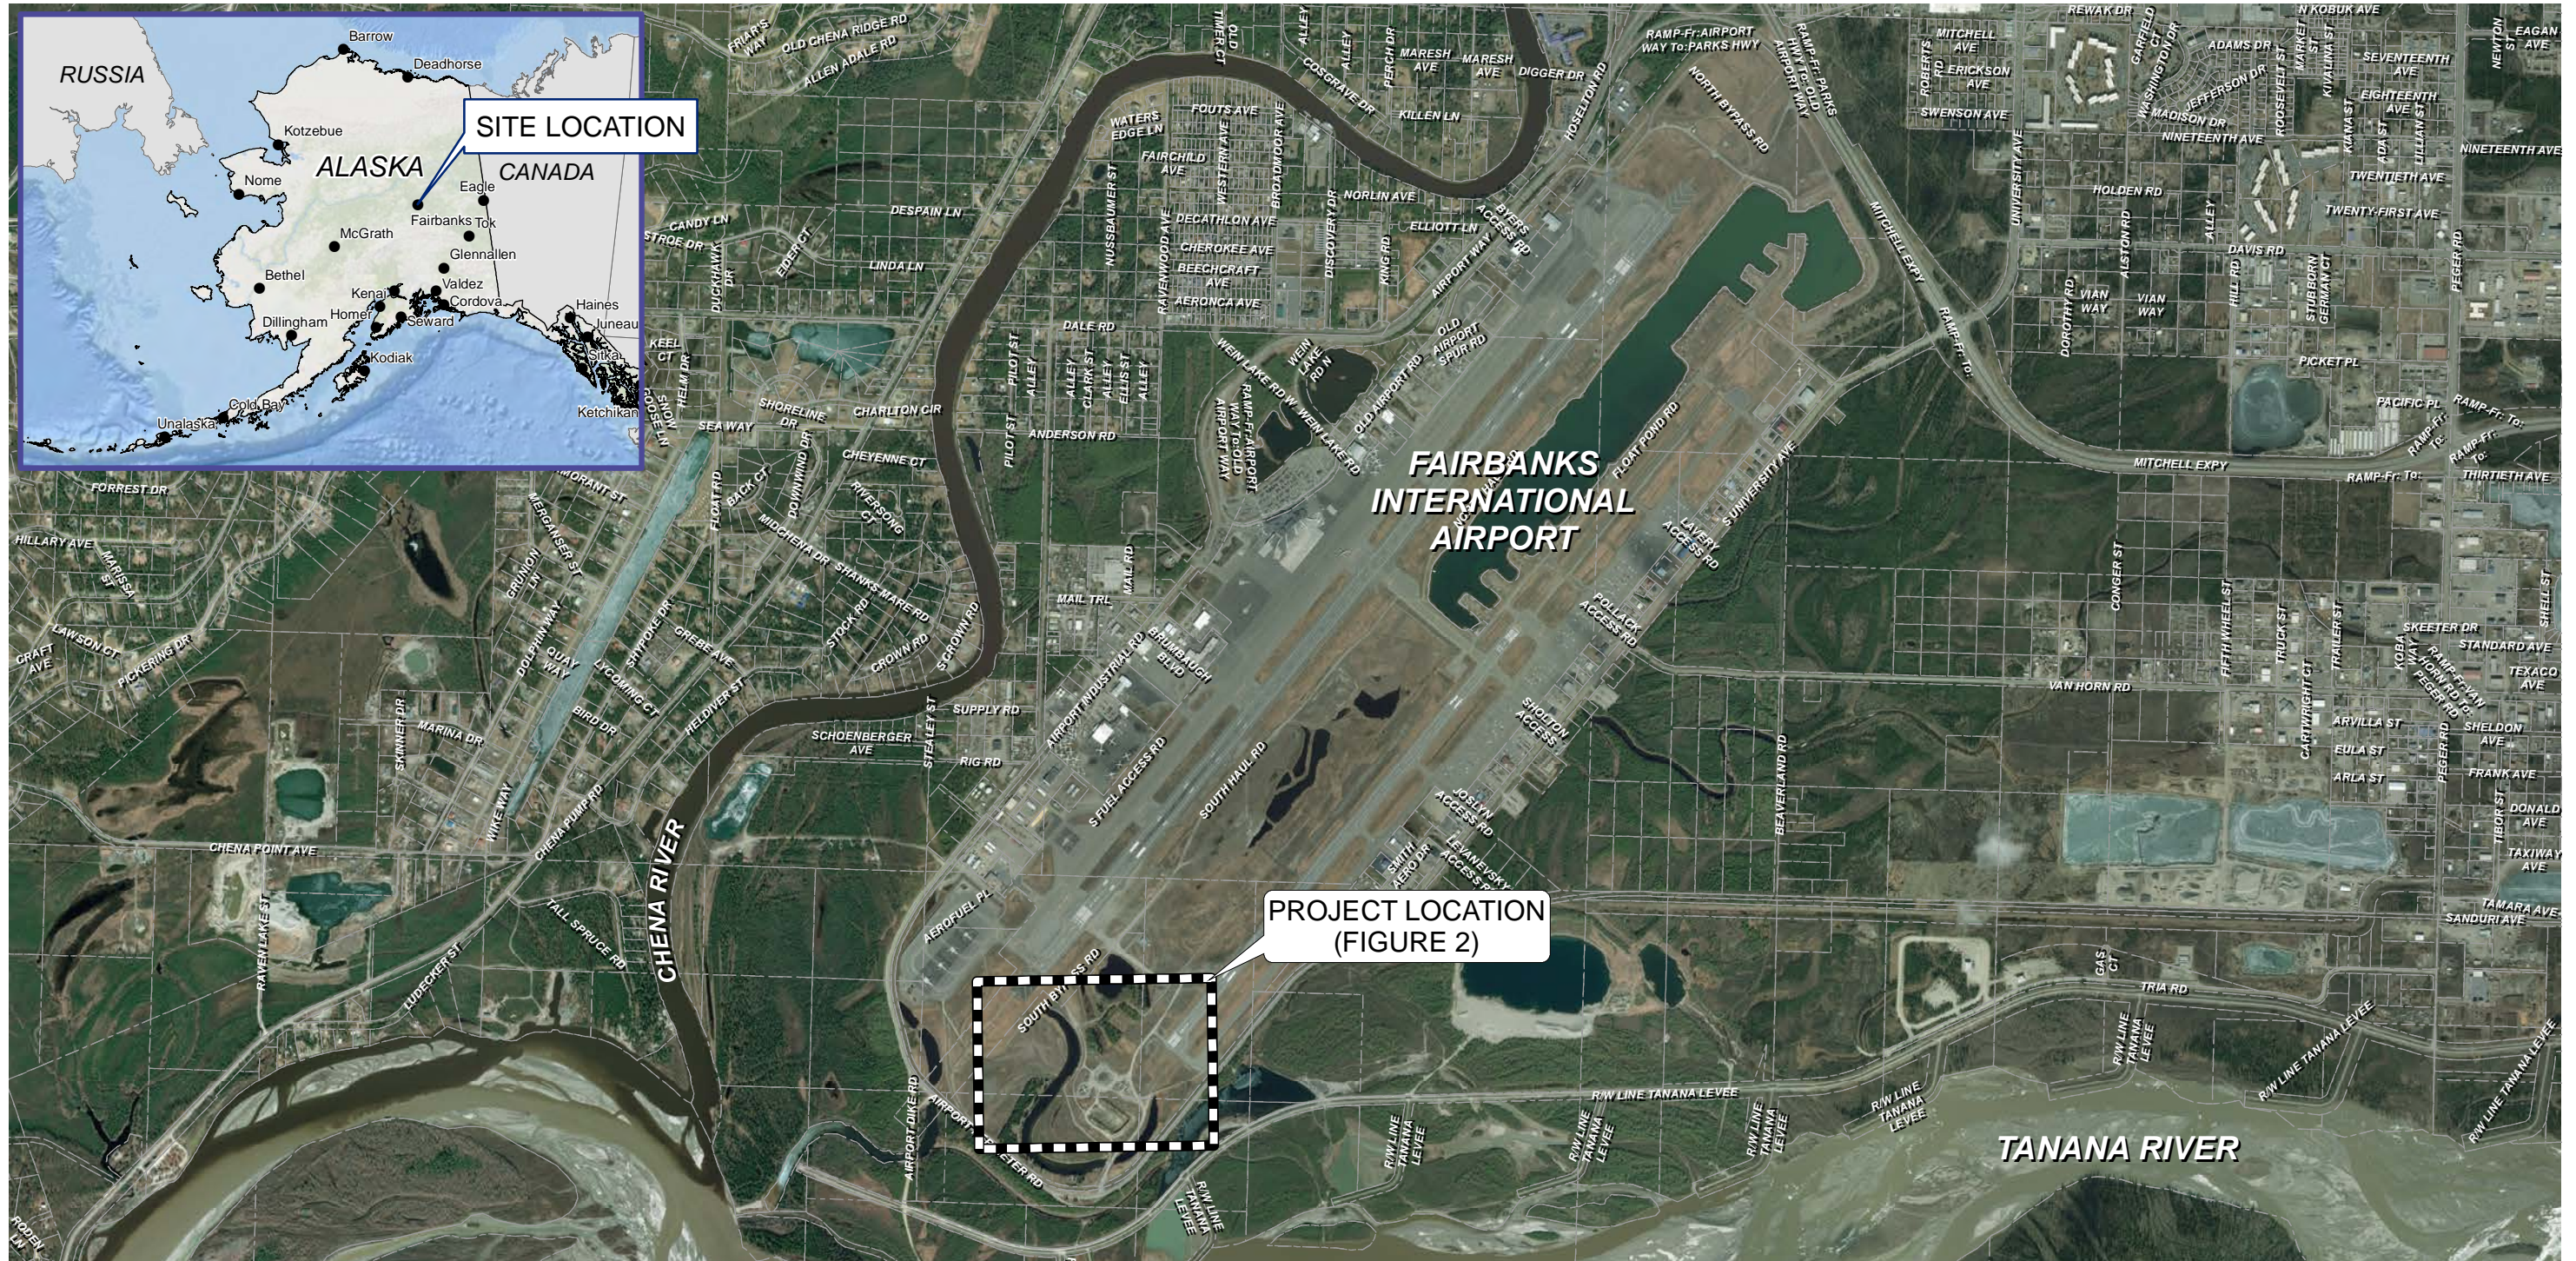
FIRE TRAINING AREA FAIRBANKS INTERNATIONAL AIRPORT FAIRBANKS, ALASKA		
Report	2018 FIRE TRAINING PIT SITE CHARACTERIZATION	
Drawing	SITE LOCATION	
Drawing	August 2018	Scale 1 in = 2,000 feet
File Name	F1 Site Location RPT_18.mxd	Project No. 105.00184.18002
Fig. No.	1

This report presents the findings from SLR International Corporation's (SLR) site characterization of the FAI FTP (Figure 1) completed in June of 2018. This work was conducted on behalf of the DOT&PF to assess current conditions at the FTP and estimate the volumes of environmental media (i.e., FTP berm soil, and fill and ponded water within the pit) exceeding applicable ADEC cleanup levels in support of future remediation. The site characterization was conducted consistent with the ADEC-approved *Fire Training Pit Site Characterization Work Plan* (Work Plan; SLR, 2018a).

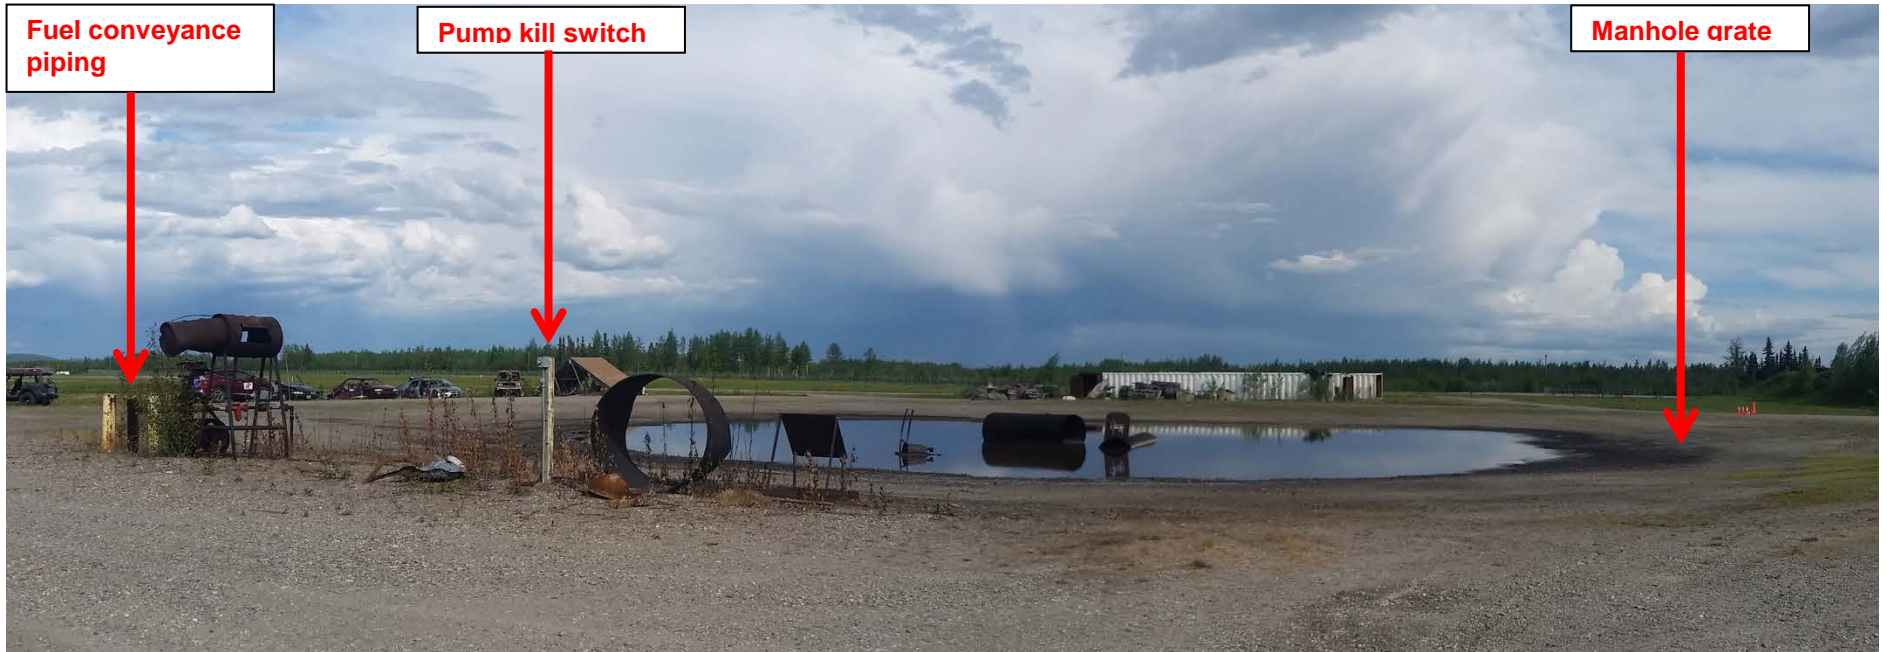
- **Pit Stained Soil:** A ring of dark, stained soil was observed, extending approximately 10 ft to 15 ft outwards from the edge of the ponded water within the FTP (Photographs 1, 2, and 4). Soil samples SS2 (Photograph 15) and SS3 were collected from the stained soil on opposite sides of the ponded water. Staining at the sample locations extended into the saturated layer. No staining was observed above perimeter of the stain ring or at soil sample SS1 collected near the liner monitoring point (Photograph 14).

- **Pit Ponded Water:** Dark colored water was present within the pit with diameter of approximately 115 ft and covering approximately 32 percent of the pit area inside the berm crown. Droplets of non-aqueous phase free product were observed along the pond edges and a strong hydrocarbon odor was present. The depth of water in the center of the pond was estimated to be 1.5 ft, decreasing outwards with the slope of the berm. The depth of water likely fluctuates with precipitation and evaporation as suggested by the extent of smeared soil above the water line (Photographs 1 and 2).

- **Pit Structures:** Structures observed within the FTP included two large steel pipes present near the center of the pit within the area of ponded water (Photographs 1 and 2). Additionally, the outlines of submerged concrete pads were observed; the pads are shown on the as-built layout on Figure 3.

Photo 1: Fire Training Pit (FTP) area and associated features, view to east (June 5, 2018).

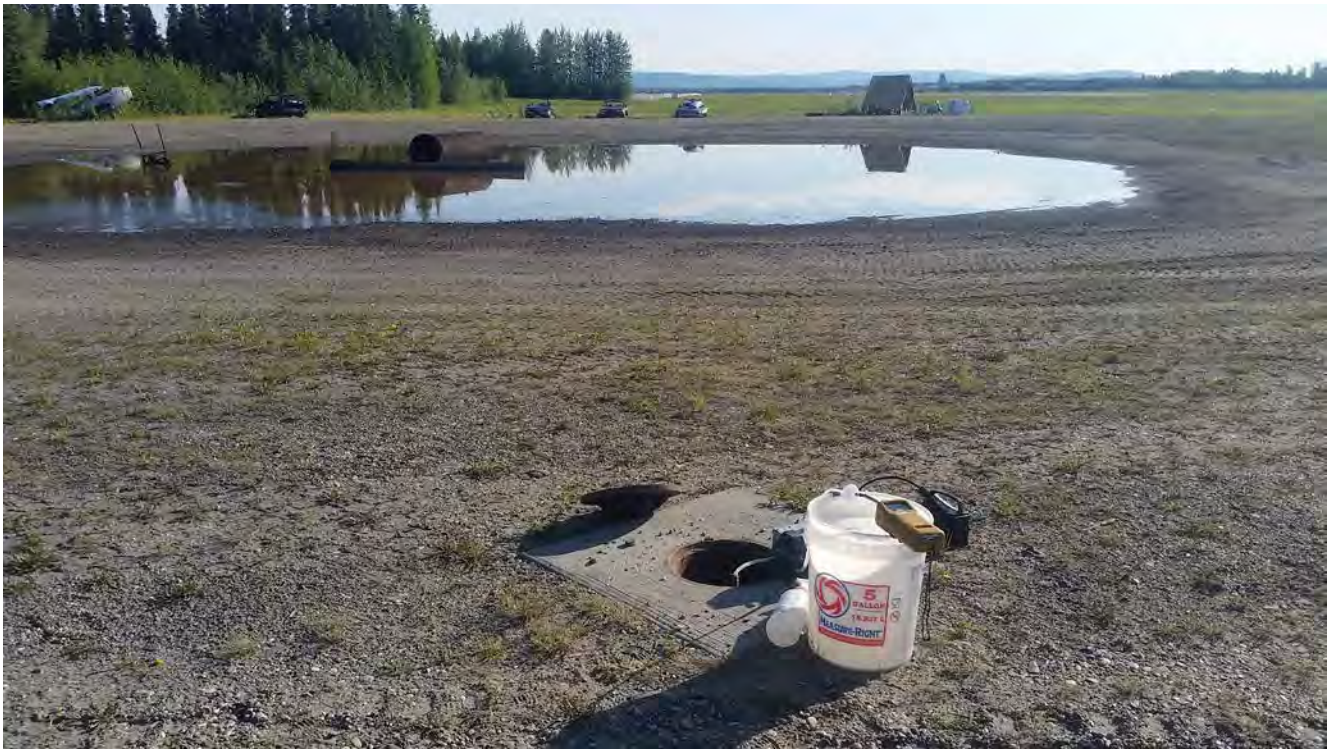
The liner monitoring system port indicated on as-built drawings was found on the south edge of the FTP berm (Figure 4). A peristaltic pump was used to attempt to collect a water sample from the ¼ inch polyethylene tubing present in the port; however, only air could be pumped from the monitoring system. The air was screened for VOCs using a PID. A PID reading of 3.4 ppm from the monitoring system was similar to ambient air levels, suggesting either that hydrocarbon impacts from diesel fuel are not present beneath the liner or that the liner monitoring system is compromised, and only ambient air was being screened.

Photo 3: Purging soil gas from liner monitoring system sample port to south of the FTP pond (June 7, 2018).

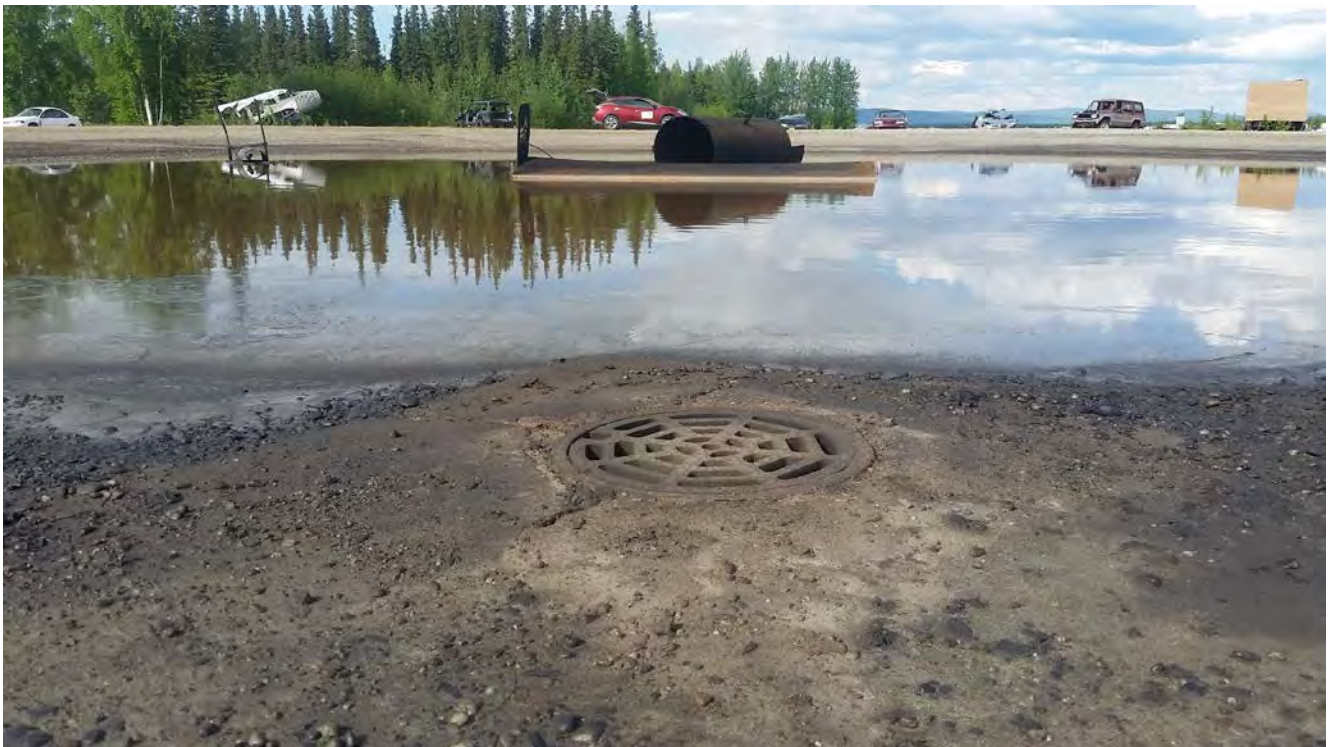
- **Liner Manhole Grate:** A 2 ft diameter metal sewer-type grate was observed at the edge of the ponded water and within the stained soil area (Photographs 4 and 15). The grate may correspond with a “sump” as shown on Figure 4. Water was visible beneath the grate at a depth corresponding to the surface of the pit ponded water.

Photo 4: Liner system manhole grate along north edge of FTP pond (June 5, 2018)

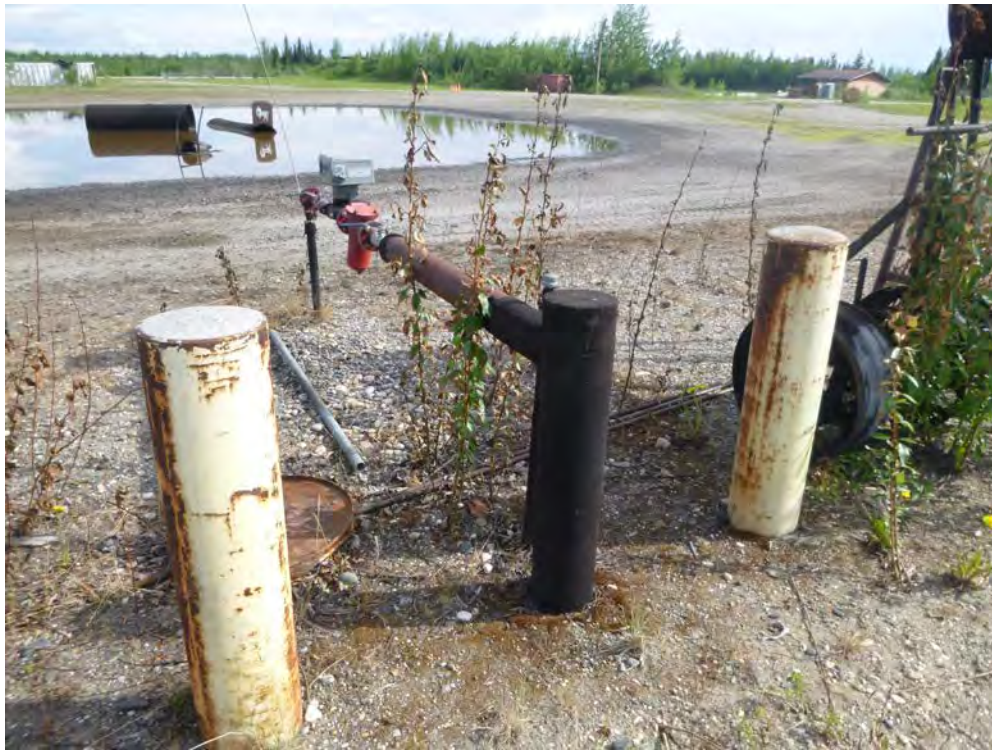
Photo 5: Fuel conveyance piping and flow meter to the north of the FTP pond (June 5, 2018).

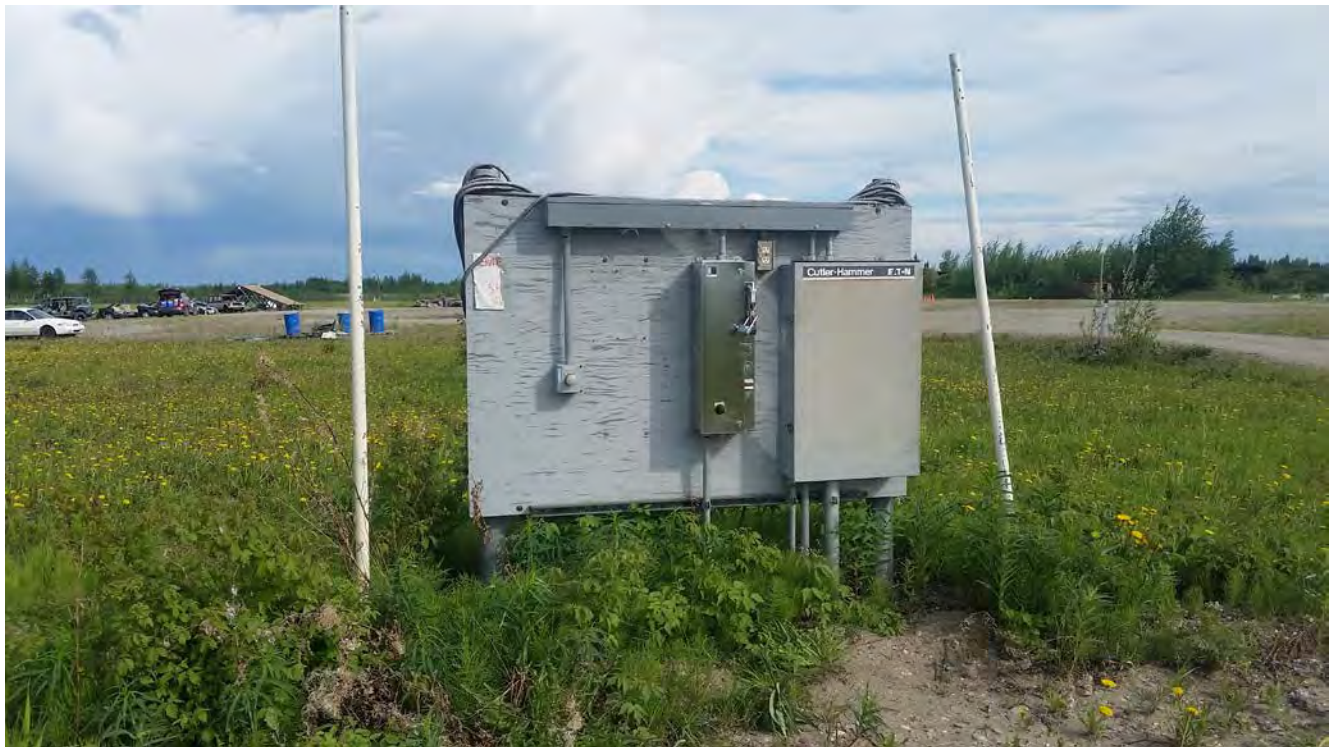
Photo 6: Fuel tank pump electric control panel, view to south east (June 5, 2018).

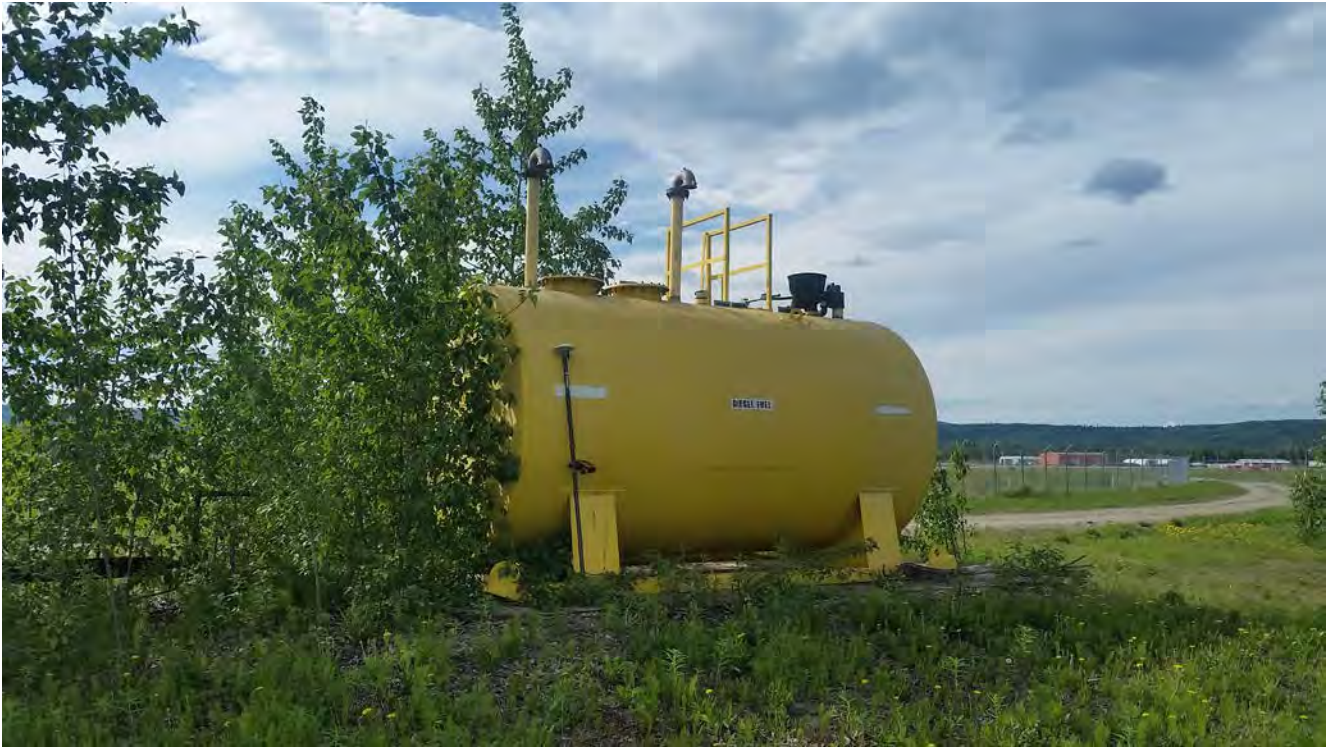
Photo 7: Diesel supply tank for FTP, view to north (June 5, 2018).

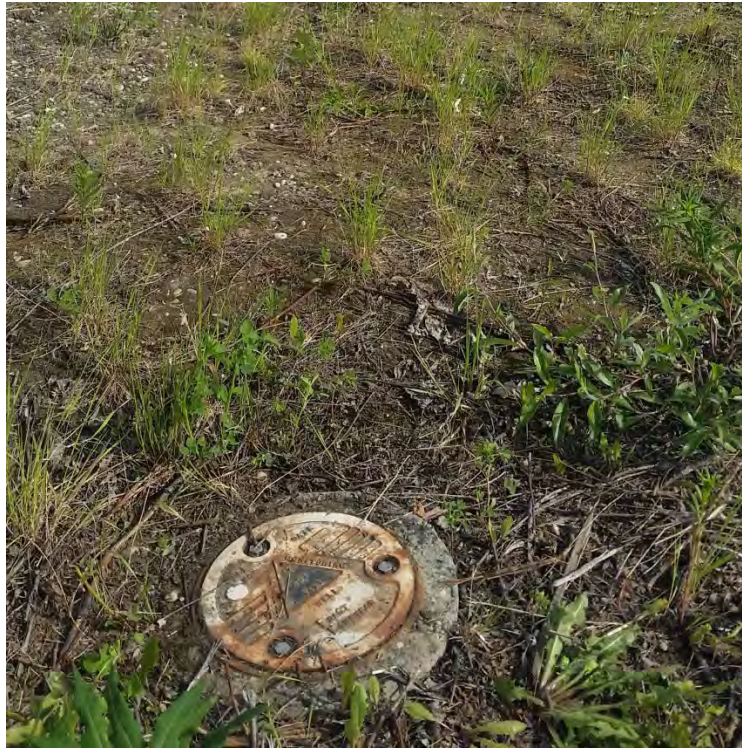
- **Monitoring Well:** an unmarked monitoring well was found near boring BH7. The well appeared to be in good condition and was assigned the identification “MW-A,” (Photograph 9). No other monitoring wells were observed within the project area as shown on Figure 4.

Photo 9: Unknown monitoring well “MW-A” located to the north of the FTP pond (June 5, 2018).

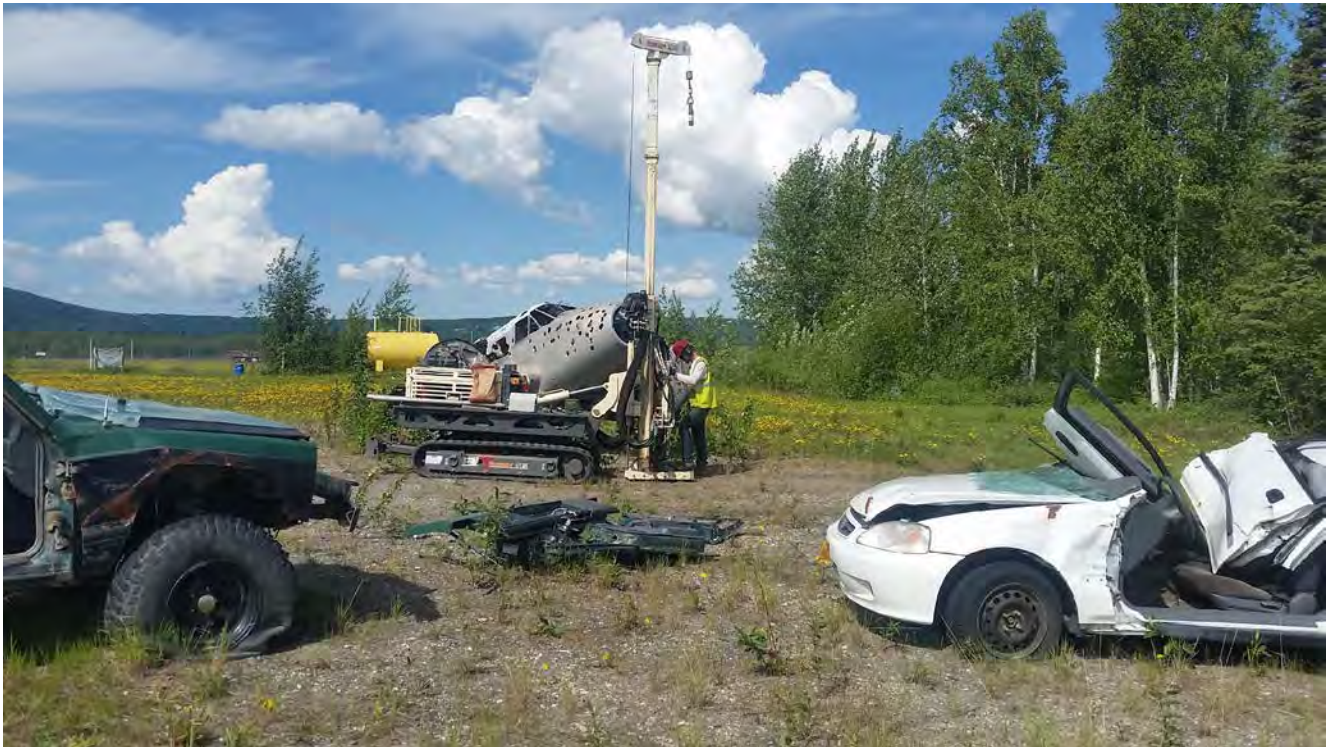
Photo 10: Drilling perimeter boring location BH8 near cars and an airplane fuselage used for rescue training, view to north (June 7, 2018).

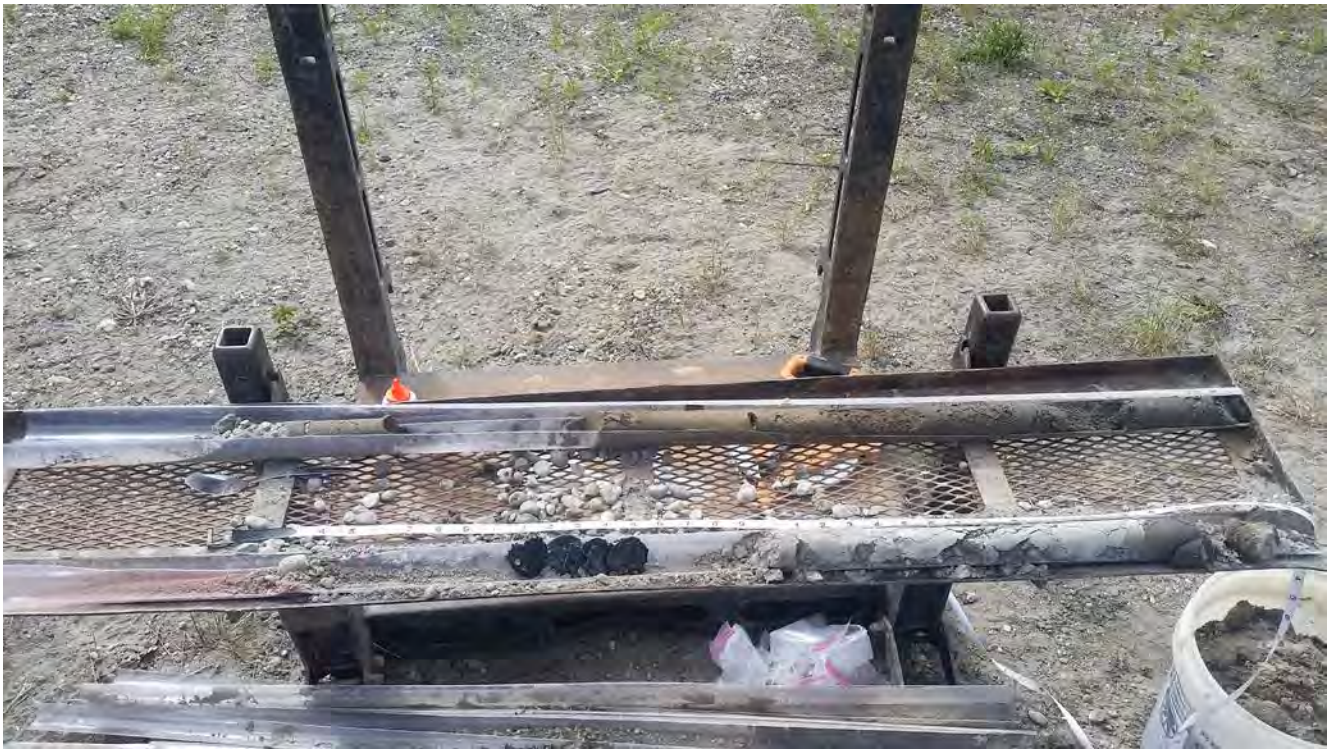
Field observations suggest that the FTP liner is not compromised because it retains rainwater, snowmelt, and water used during fire training exercises, at a static water level above the natural water table. Additionally, inspection of liner material collected from berm crown boring BH10 shows that the main, 1/4-inch thick plastic liner is not degraded near the berm crown. Protective geotextile fabric and plastic mesh layers were also present immediately above and below the liner.

Photo 11: Boring BH1 0 to 4 foot (ft) soil core with FTP liner components visible at approximately 1.5 ft below ground surface (June 7, 2018).

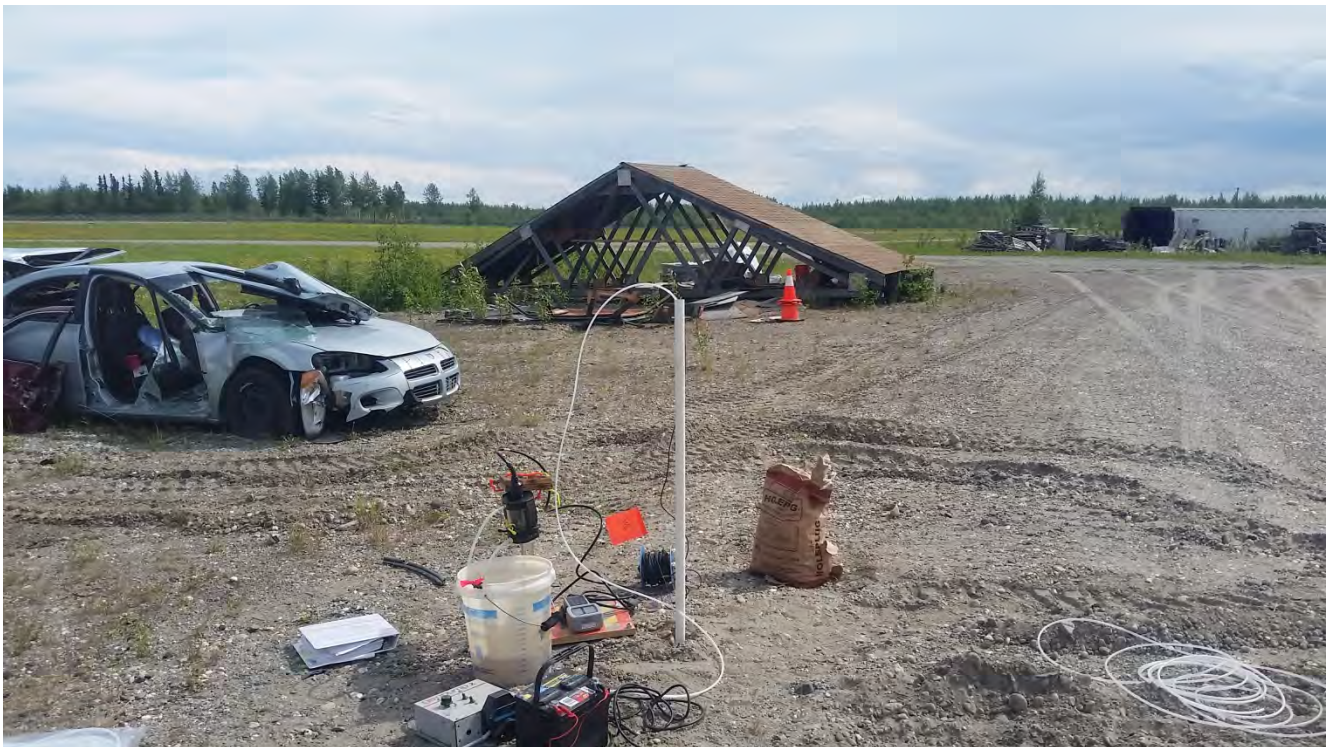
Photo 12: Temporary well BH3 during groundwater sample purge, view to southeast (June 7, 2018).

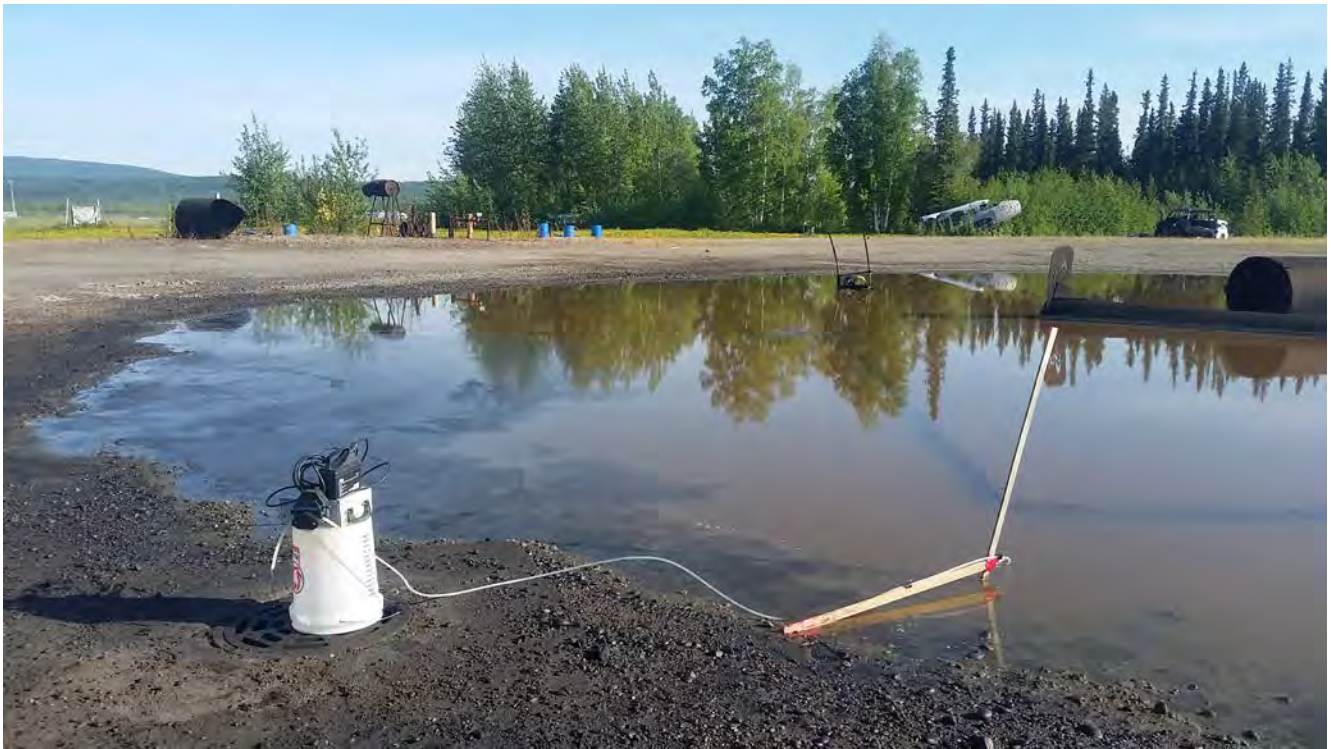
Photo 13: Surface water sampling of the FTP pond using a peristaltic pump (June 8, 2018).

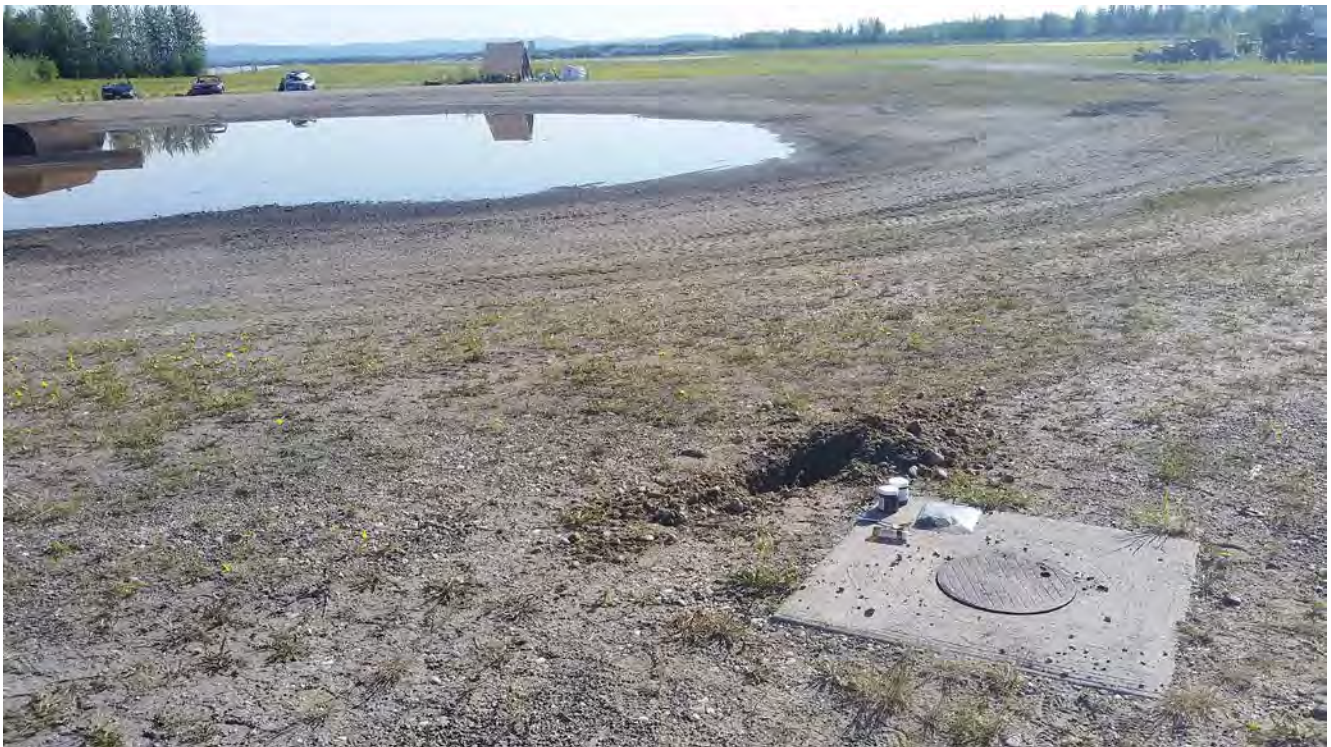
Photo 14: Surface soil sample SS1 collection adjacent to liner monitoring port, view to northeast (June 8, 2018).

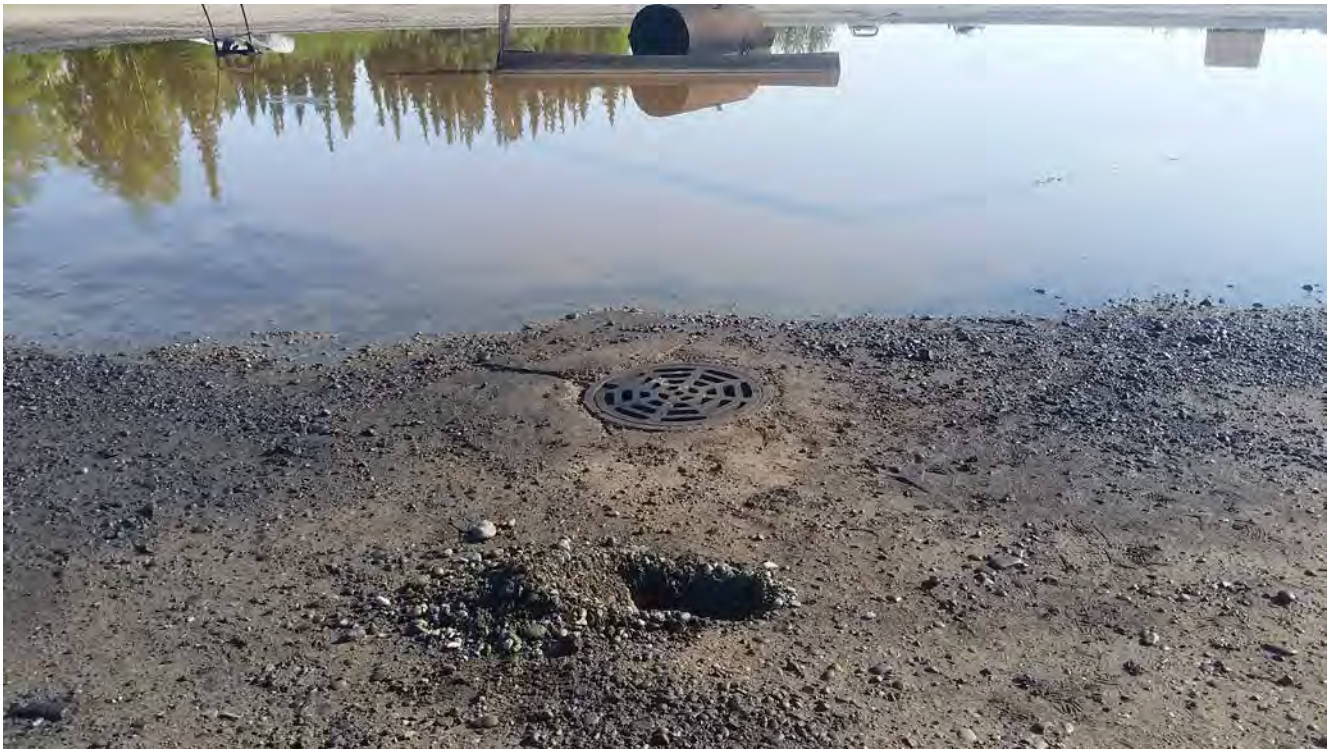
Photo 15: Surface soil sample SS2 located in stained soil adjacent to FTP manhole (June 8, 2018).

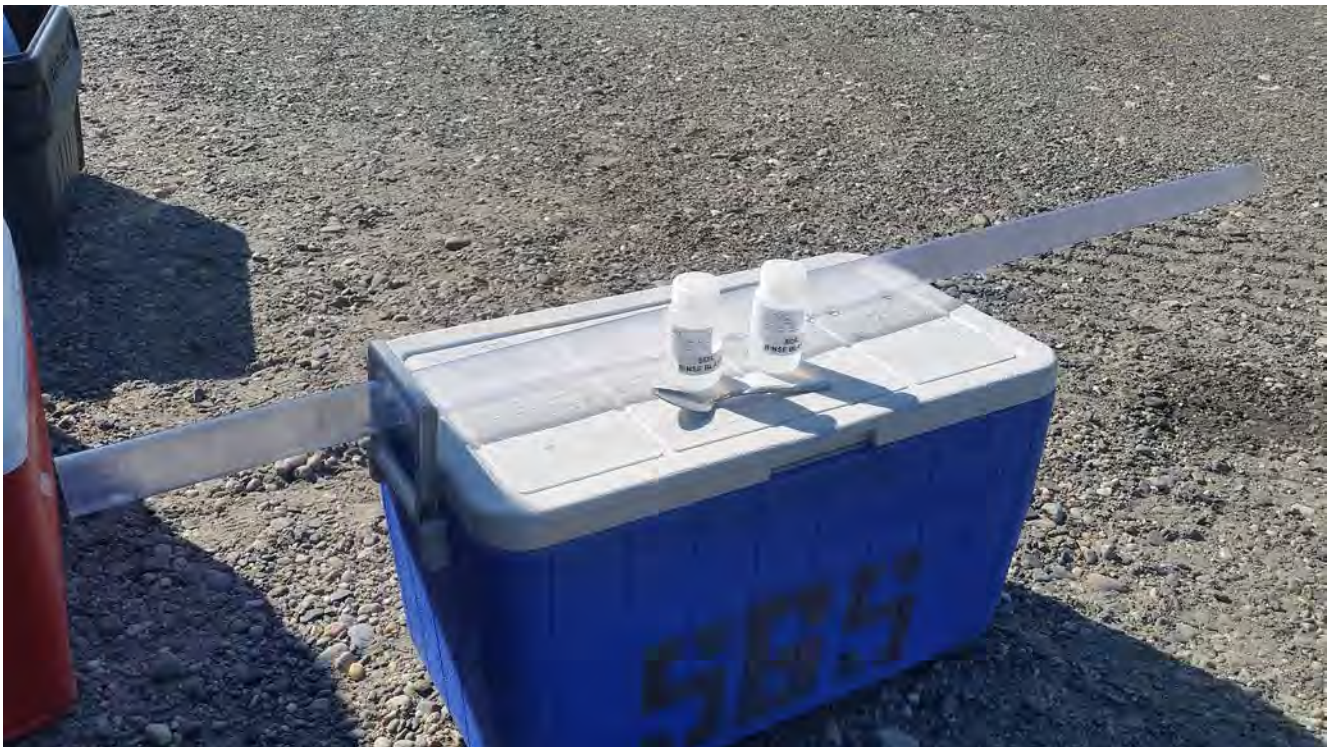
Field equipment rinsate samples were collected to evaluate potential cross-contamination during the collection and handling PFAS soil samples. Equipment rinsate samples were collected by pouring laboratory-provided PFAS-free water over a new, disposable drill core liner and a stainless sampling spoon and collecting the rinsate into a 250 mL sample container.

Photo 16: Field equipment rinsate sample collection from acetal Macro Core drill liner (June 7, 2018).

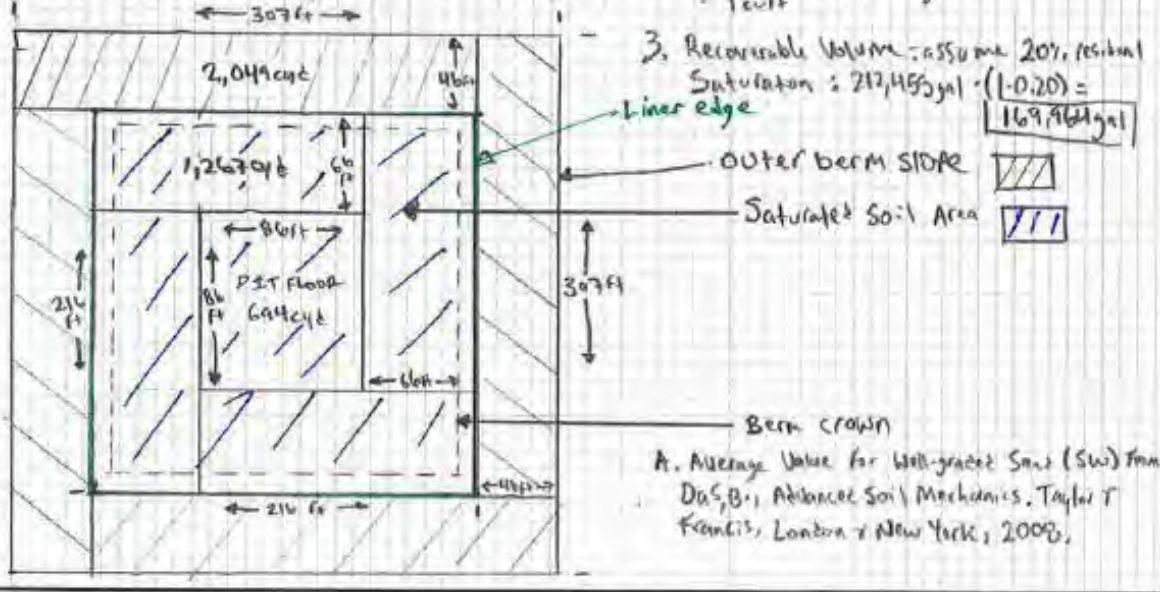
SATURATED SOIL RECOVERABLE WATER VOLUME = 169,964 gal

1. Volume of saturated soils = Area x width = $453 \text{ sq ft} \cdot 140 \text{ ft} = 63,420 \text{ cu ft} \cdot \frac{1 \text{ cu ft}}{27 \text{ sq ft}} = 2,349 \text{ cyd}$
2. Volume of water = soil volume x porosity = $63,420 \text{ cu ft} \cdot 0.33 \cdot \frac{7.48 \text{ gal}}{1 \text{ cu ft}} = 212,455 \text{ gal}$
