## **CORRECTIVE ACTION REPORT**

**239 INA STREET  
FAIRBANKS, ALASKA 99701  
BLOCK 4 LOT 14 CHARLES SLATER**

**FACILITY No. 0-000425  
ADEC FILE No. 100.26.141**

November 10, 2000

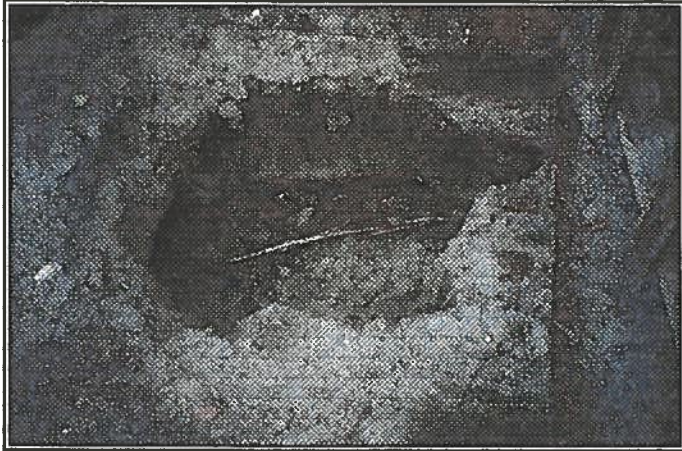
**Fuel lines that were broken & repaired on 12/10/00, by I.C.C.  
Photo date 8/1/00 shows no significant staining from any leaks  
in the pit, showing fuel line repair.**

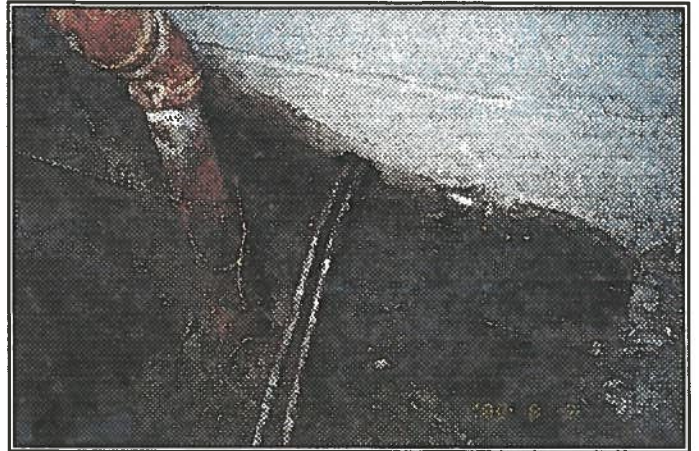
**Vent Pipe for UST, 8/2/00.  
Fuel Lines going through foundation wall.**

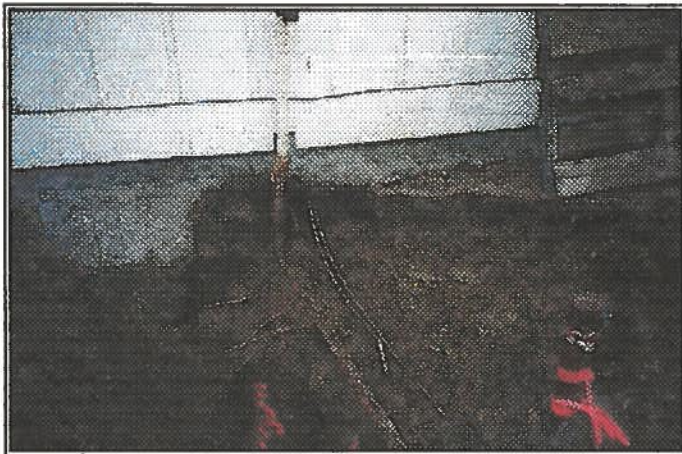
**Lines & vent pipe, 8/3/00.**

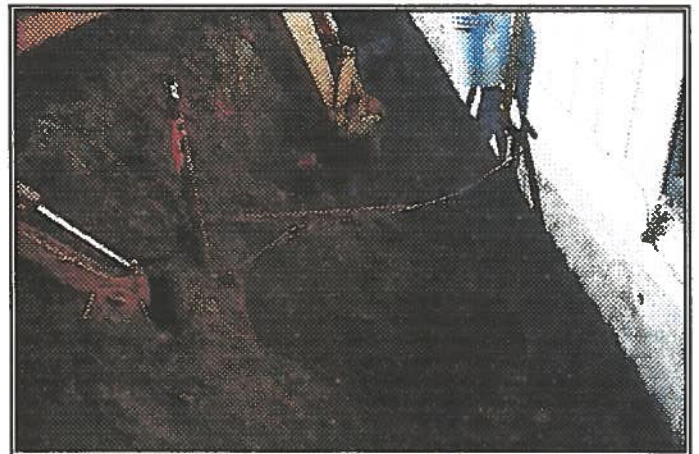
**Another view of fuel lines & vent pipe.  
Excavating contaminated soil from area on 8/3/00.**

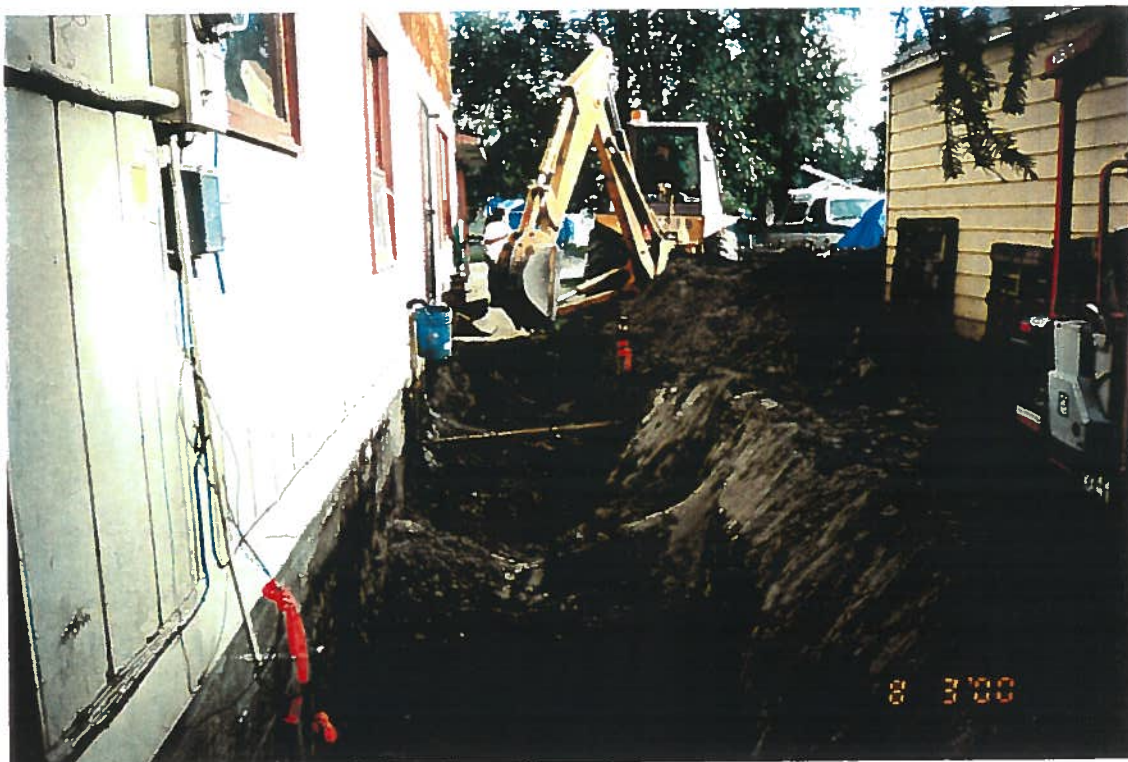
Photo 3: Looking north on August 3, 2000 at excavation in the vicinity of the former underground storage tank.

the level of contaminated material removed. Headspace sampling occurred under the house with readings ranging from 20.7 to 1537 ppm, highest along the east wall (HD #s 40-43). Two trucks of contaminated material were removed and sent to OIT, Inc. The former UST was emptied and removed.

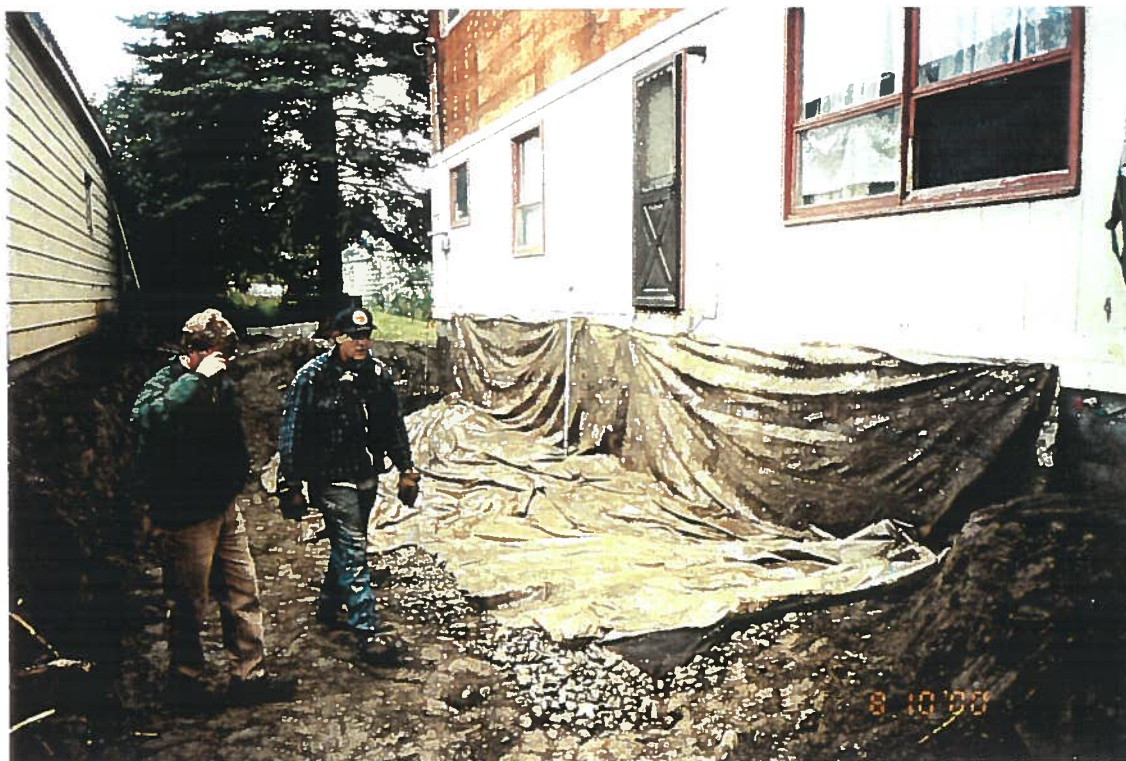
Photo 4: Installation on August 10, 2000 of the plastic and liner overlying the intake pipe for the vapor recovery system

*On August 16.* the vent pipe under the crawlspace plastic was installed for the vapor extraction system. Excavation of the top of the tank occurred and the lines were connected. The new single section lines were run under the house and into the garage where the furnace is located. The topsoil was graded. The old tank and drums were removed from the location and other miscellaneous items were loaded onto a trailer.

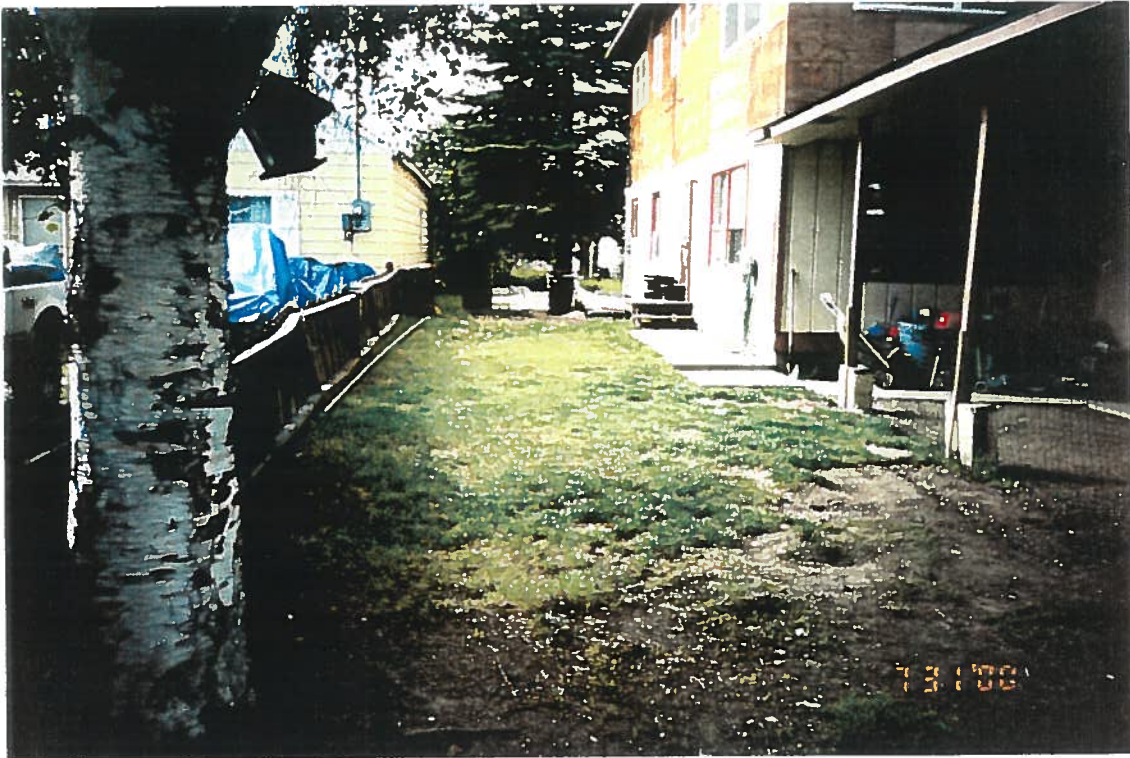
Photo 1: Appearance of site looking south on July 31, 2000 before excavation and removal of contaminated material. Drums in the background contain soil from previous investigation.

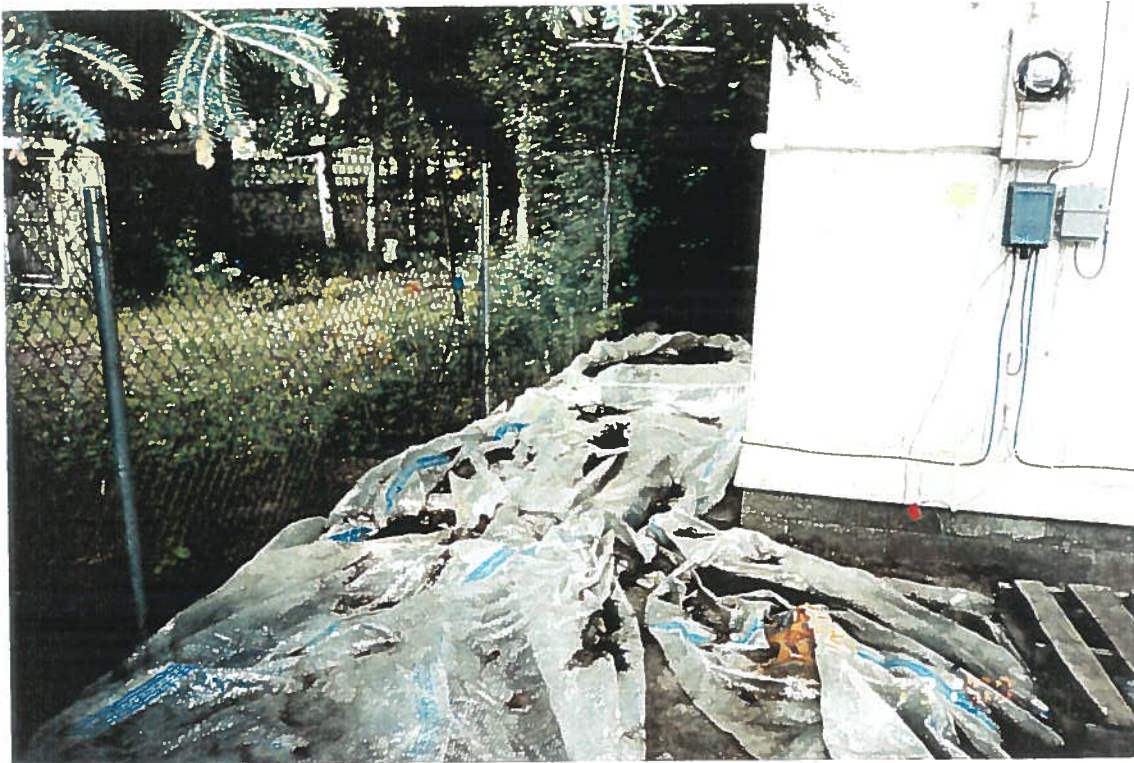
Photo 2: Initial view looking west along back of house on July 31, 2000 showing plastic in place.

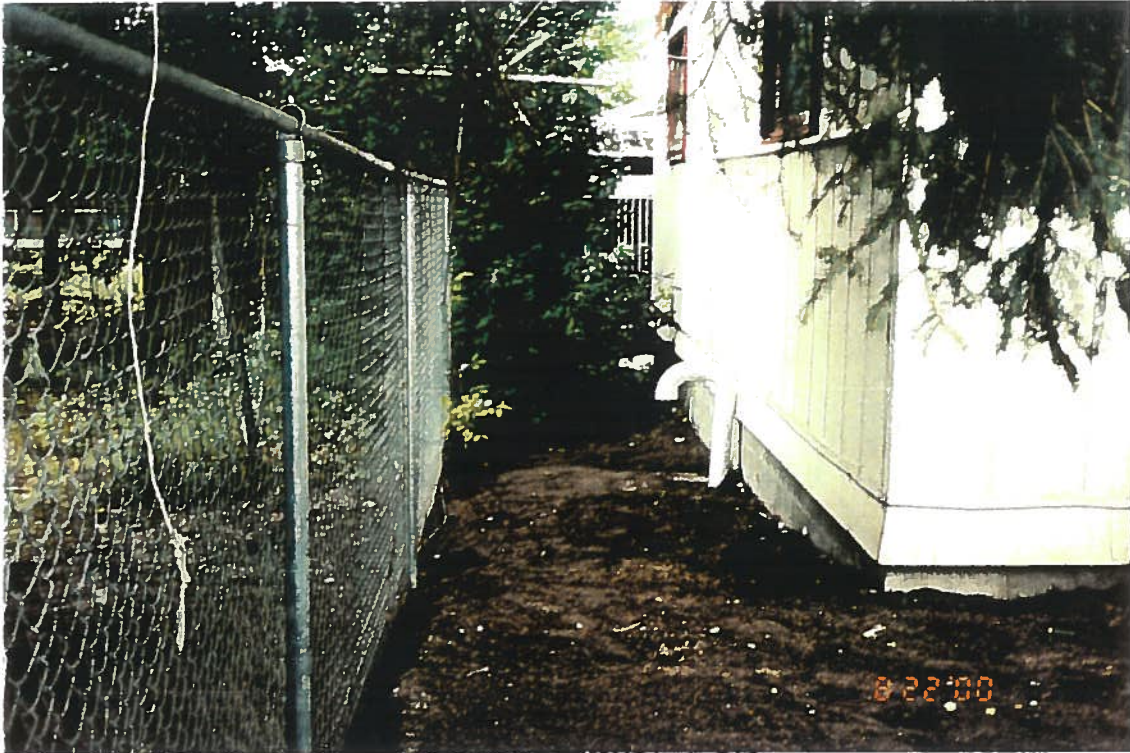
Photo 7: View of back of the house on August 22, 2000 after installation of intake vent and backfilling.

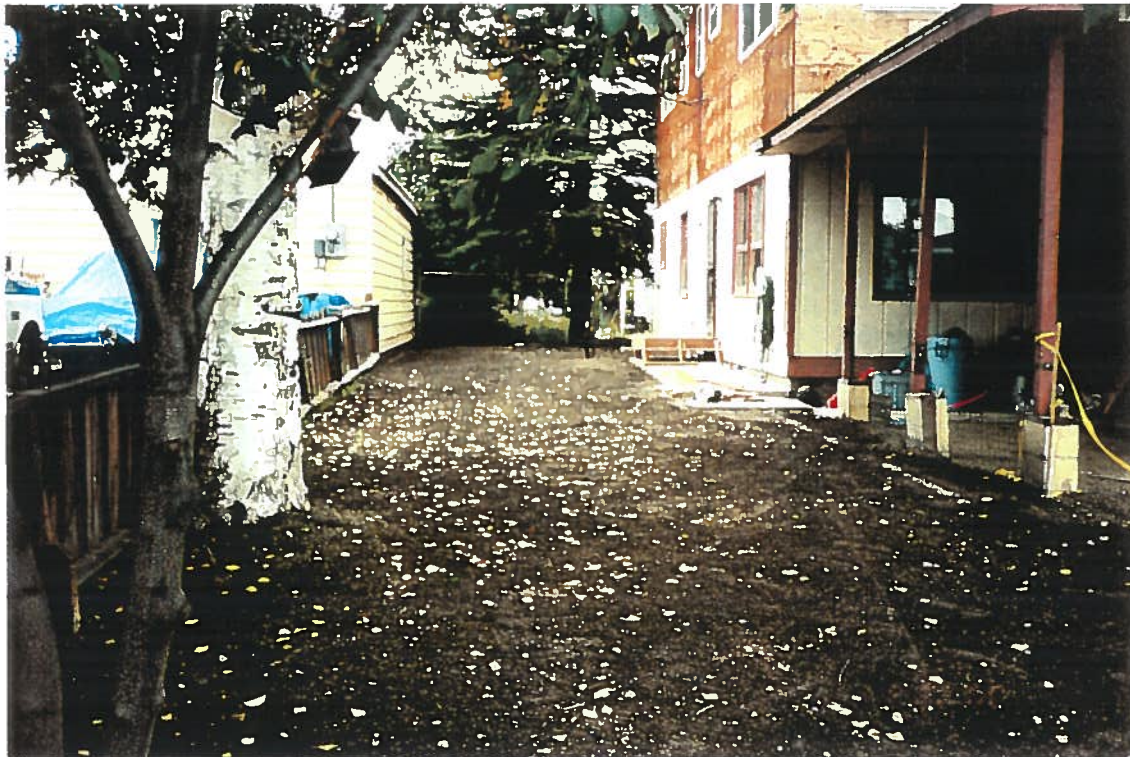
Photo 8: Appearance of site on August 22, 2000 after completion of landscaping and seeding. To the side of the house is the new sidewalk and porch.

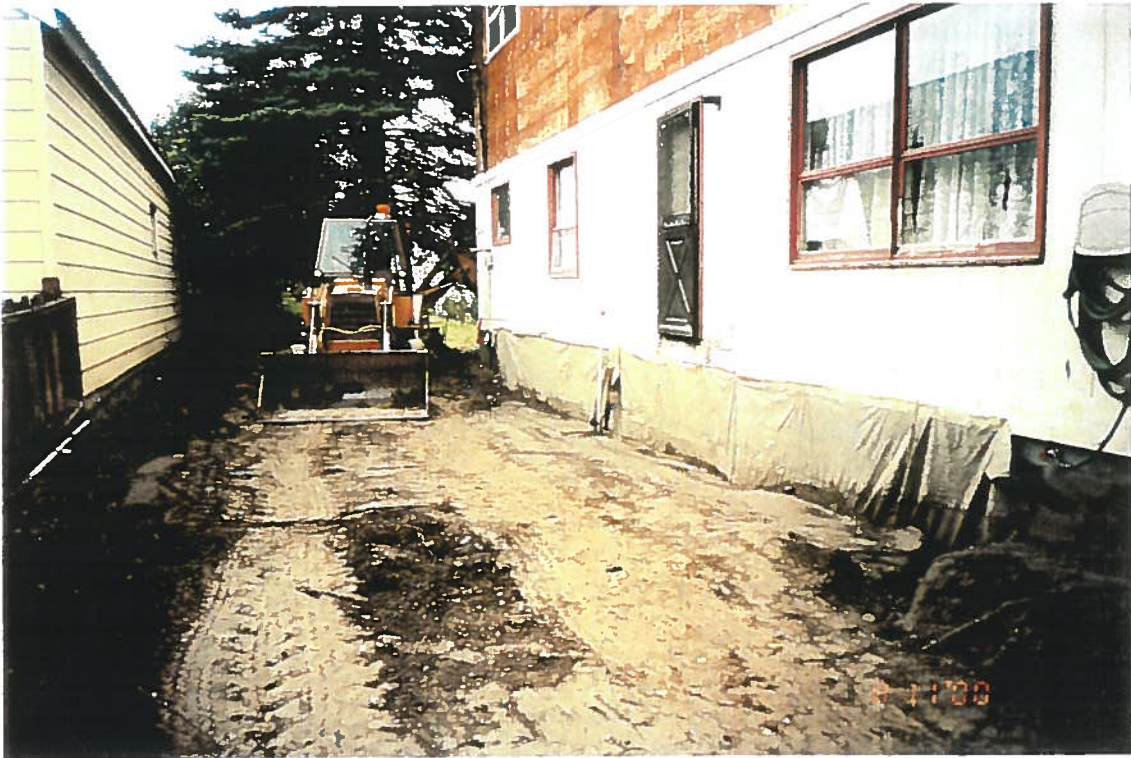
Photo 5: View of backfilling on August 11, 2000. Pipe near the side door of the house is monitoring well #1.

*On August 11.* backfilling continued and the new UST was buried. Compaction occurred in sequence with the backfilling.

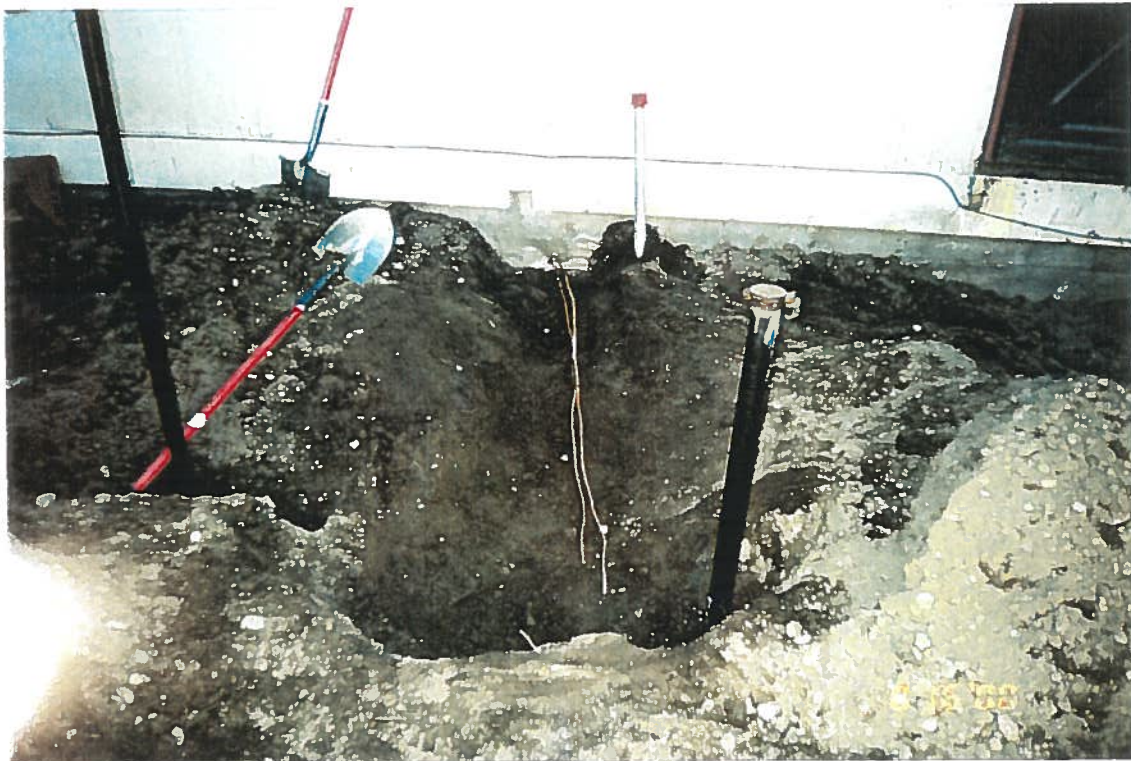
Photo 6: Close up view of installation of the new underground storage tank and fuel lines.
