R&M No. 2186.01

RE: Port of Anchorage Marine Storage Building
Anchorage, Alaska

**Contaminated Soil Assessment
New Marine Storage Building
Port of Anchorage, Alaska**

**CONTAMINATED SOIL ASSESSMENT
NEW MARINE STORAGE BUILDING
PORT OF ANCHORAGE, ALASKA**

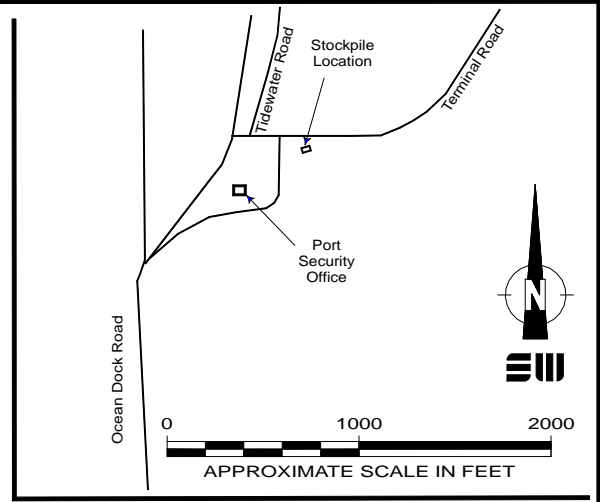
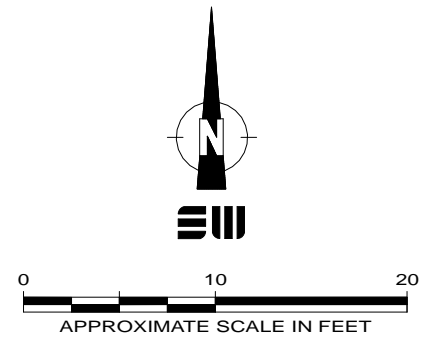
New Marine Storage Building Port of Anchorage, Alaska	
STOCKPILE SAMPLE LOCATIONS	
December 2014	32-1-02381-002
SHANNON & WILSON, INC. Geotechnical & Environmental Consultants	Fig. 4

* SS5	10/24/2014	Southern end of potentially-contaminated soil stockpile	1.5	32	Dark gray, Silt with Sand and Gravel (ML); moist; hydrocarbon odor
SS6	10/24/2014	Center of potentially-contaminated soil stockpile	1.5	18	Dark gray, Silt with Sand and Gravel (ML); moist; hydrocarbon odor
Quality Control Samples

SS1 Approximate location of field screening Sample SS1.

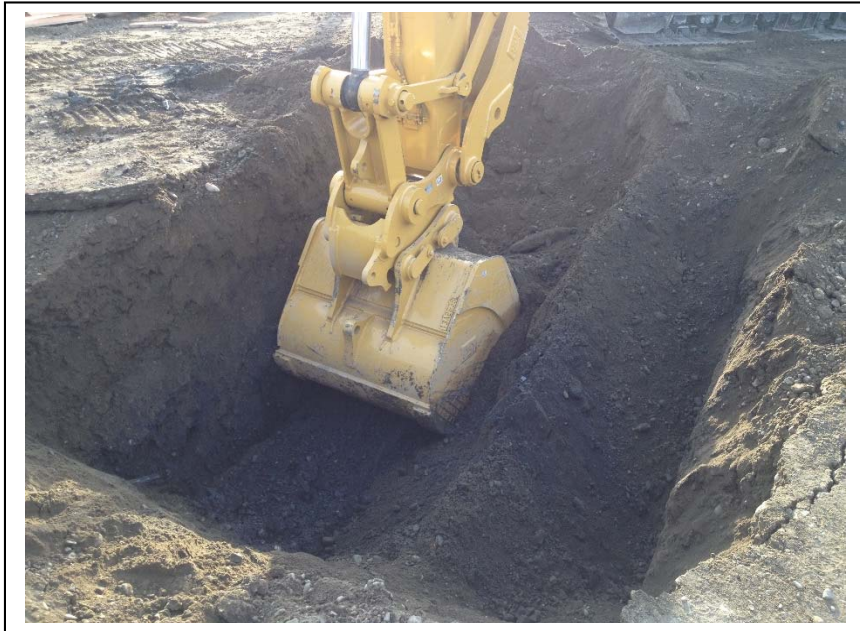
Photo 1: Looking southeast while excavating potentially contaminated soil at the TP-3/B-3 excavation. (October 24, 2014)

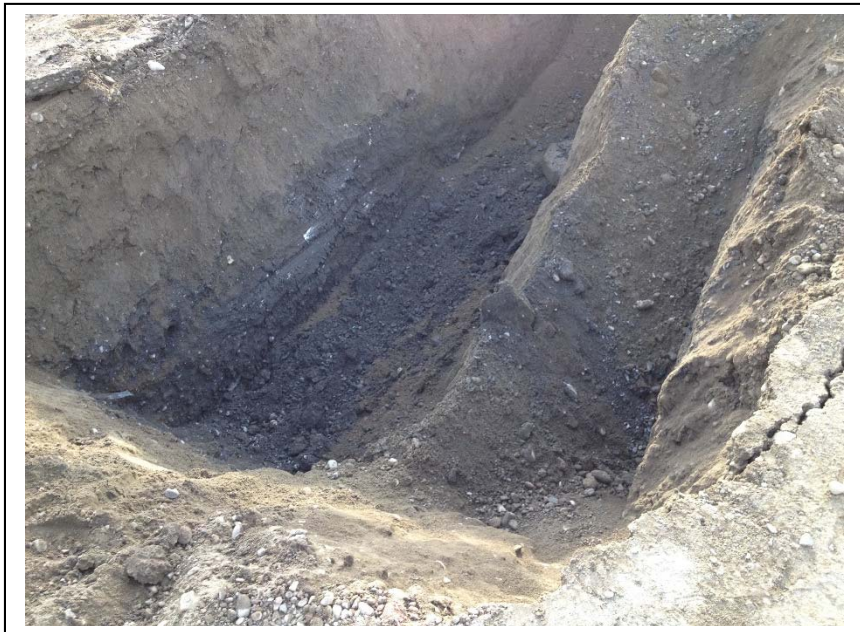
Photo 2: Looking southeast at the final depth of the TP-3/B-3 excavation. Note discolored soil in the lower portion of east sidewall. (October 24, 2014)

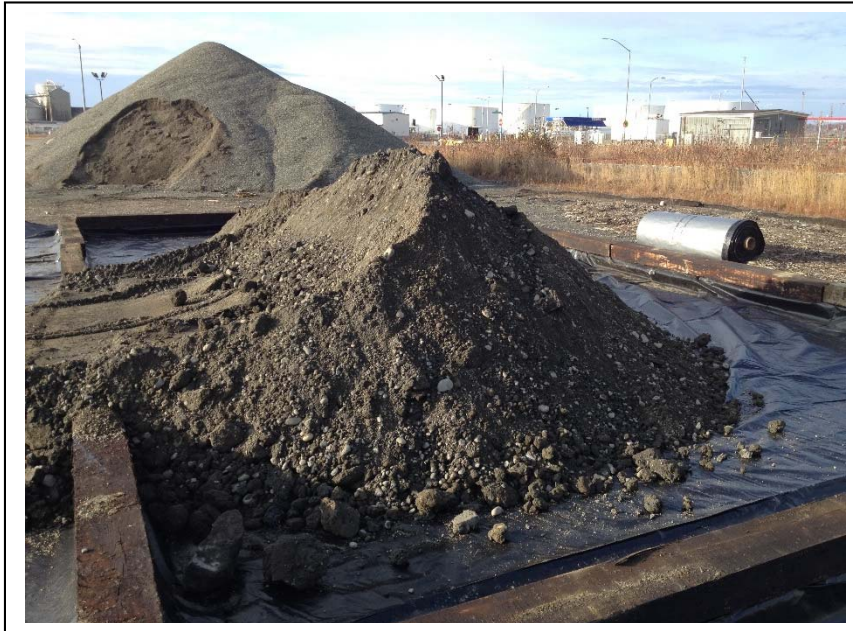
Photo 3: Looking west at approximately 25-cubic yard stockpile of contaminated soil placed on 20-mil petroleum resistant liner and surrounded by timbers. (October 24, 2014)

1. *Transport and dispose of the excavated soil at the Anchorage Regional Landfill.*
Analytical results were received on 11 November 2014. The two samples collected from the soil stockpile, SS2 and SS5, exceeded the ADEC cleanup level of 250 mg/kg for Diesel Range Organics (DRO) at 354 mg/kg and 303 mg/kg, respectively. No other analytes were detected in the soil stockpile samples. The analytical results indicate that the contaminated soil is below the 1,000 mg/kg threshold and would be acceptable for disposal at the Anchorage Regional Landfill (ARL) (S&W, 2014).

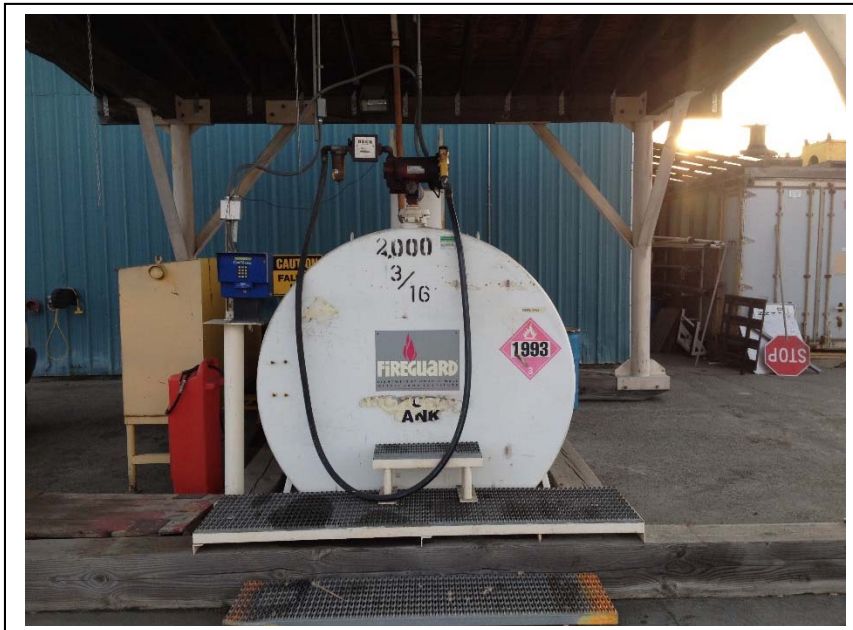
Photo 4: This 2,000-gallon, diesel, aboveground storage tank fueling facility was formerly located at the northwest corner of the proposed New Marine Storage Building. (October 24, 2014)
