**PORT HEIDEN RRS
ALASKA**

Preliminary Assessment Port Heiden

January 1994

Contract No. DACA85-92-D-0007
Delivery Order 0007

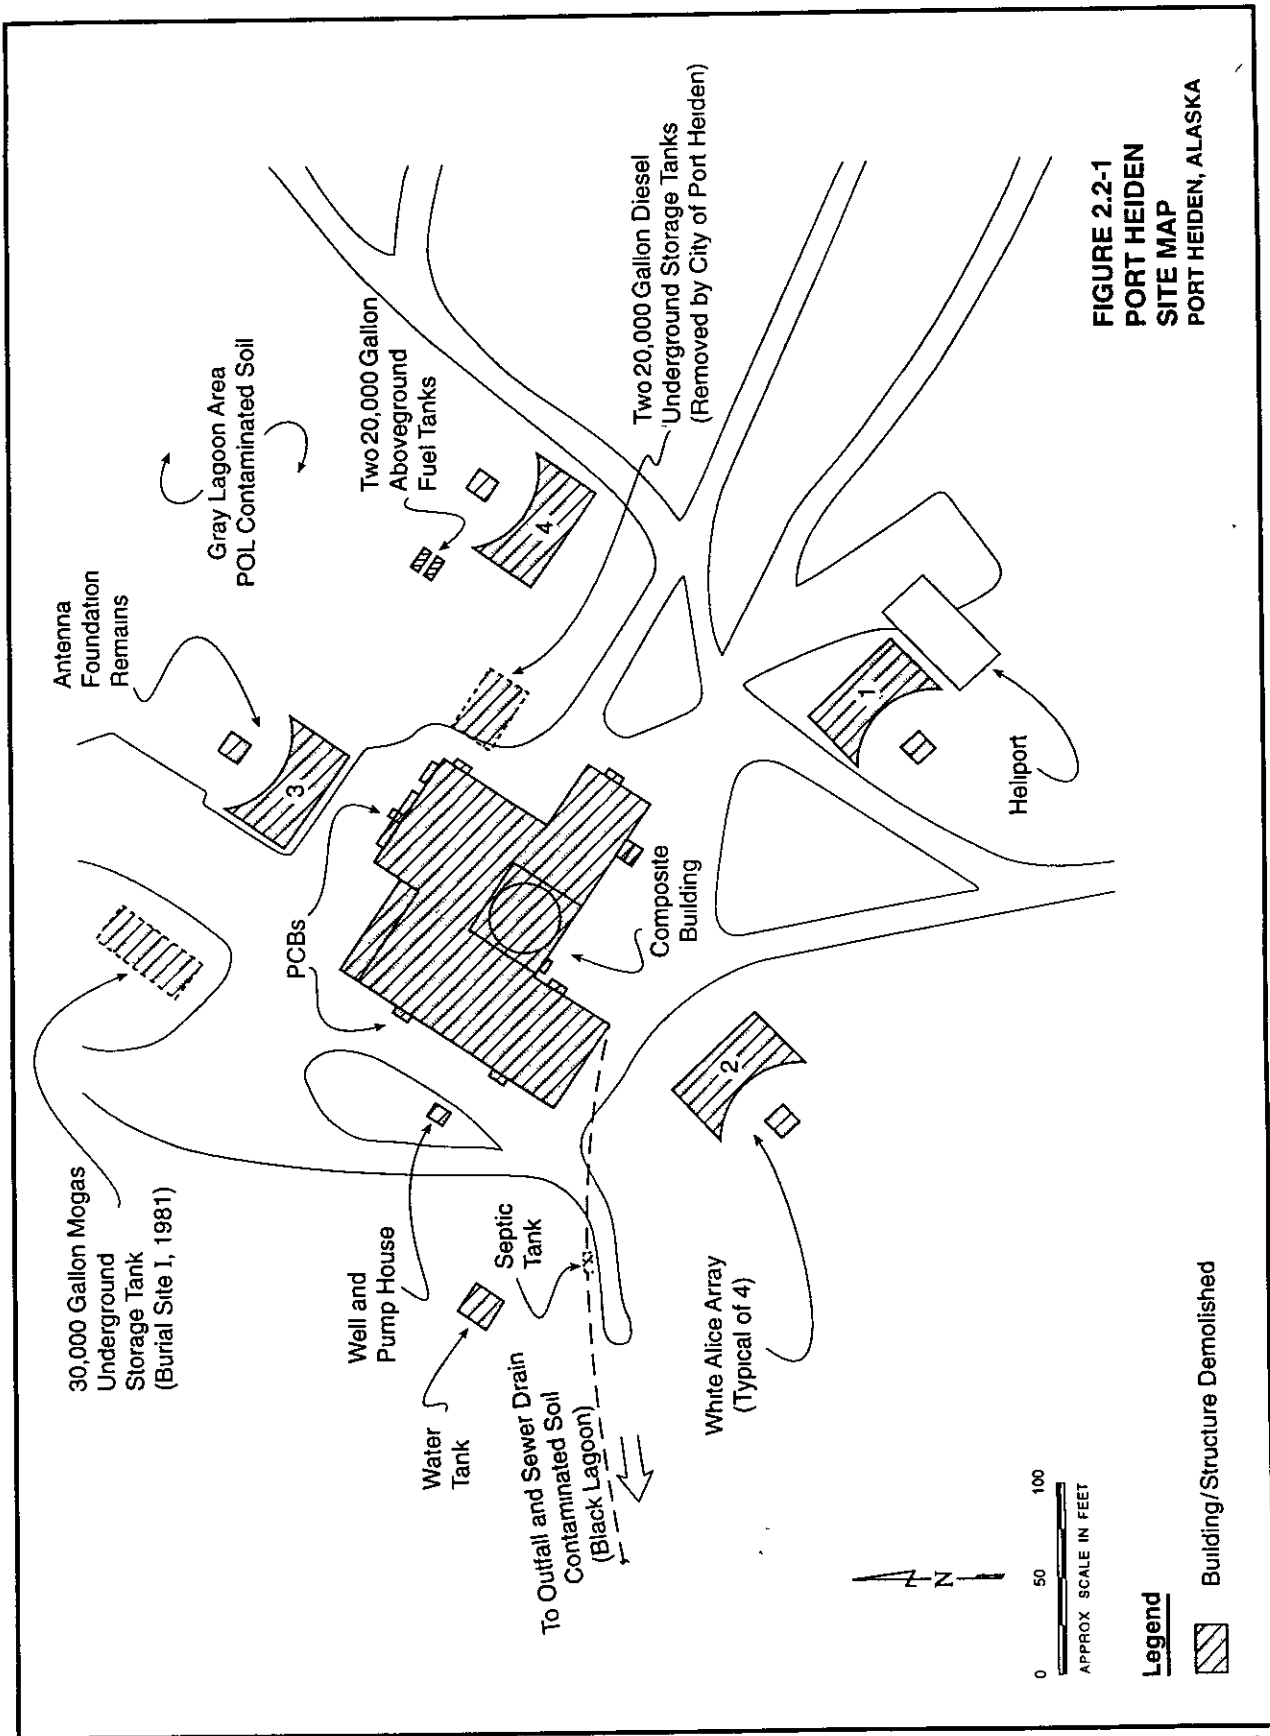
**FIGURE 2.2-1
PORT HEIDEN
SITE MAP
PORT HEIDEN, ALASKA**

At the time of the demolition of the WACS site, Reeve Aleutian Airways had reconnected the pipeline to new tanks and was using the segment of pipeline from Meshik to the airfield. Pipeline ownership of that segment was changed from DOD to Reeve Aleutian Airways. Diesel fuel was stored onsite in two 20,000-gallon underground storage tanks (USTs) shown in Figure 2.2-1.

The gray lagoon is the area near the diesel tank excavation northeast of the composite building (Figure 2.2-1). Underground utility lines may have provided channels for fuels to flow to the north of the excavation and Antenna Pad 3. The highest concentration of TPH was 8,600 ppm in a trench dug north of the source. High concentrations were also found around the antenna pad. The concrete antenna pad is the only structure remaining at the WACS site. It was not removed because of the surrounding soil contamination. According to the COE project manager, soil removals were based on PCB concentrations below 10 ppm in remaining soil.

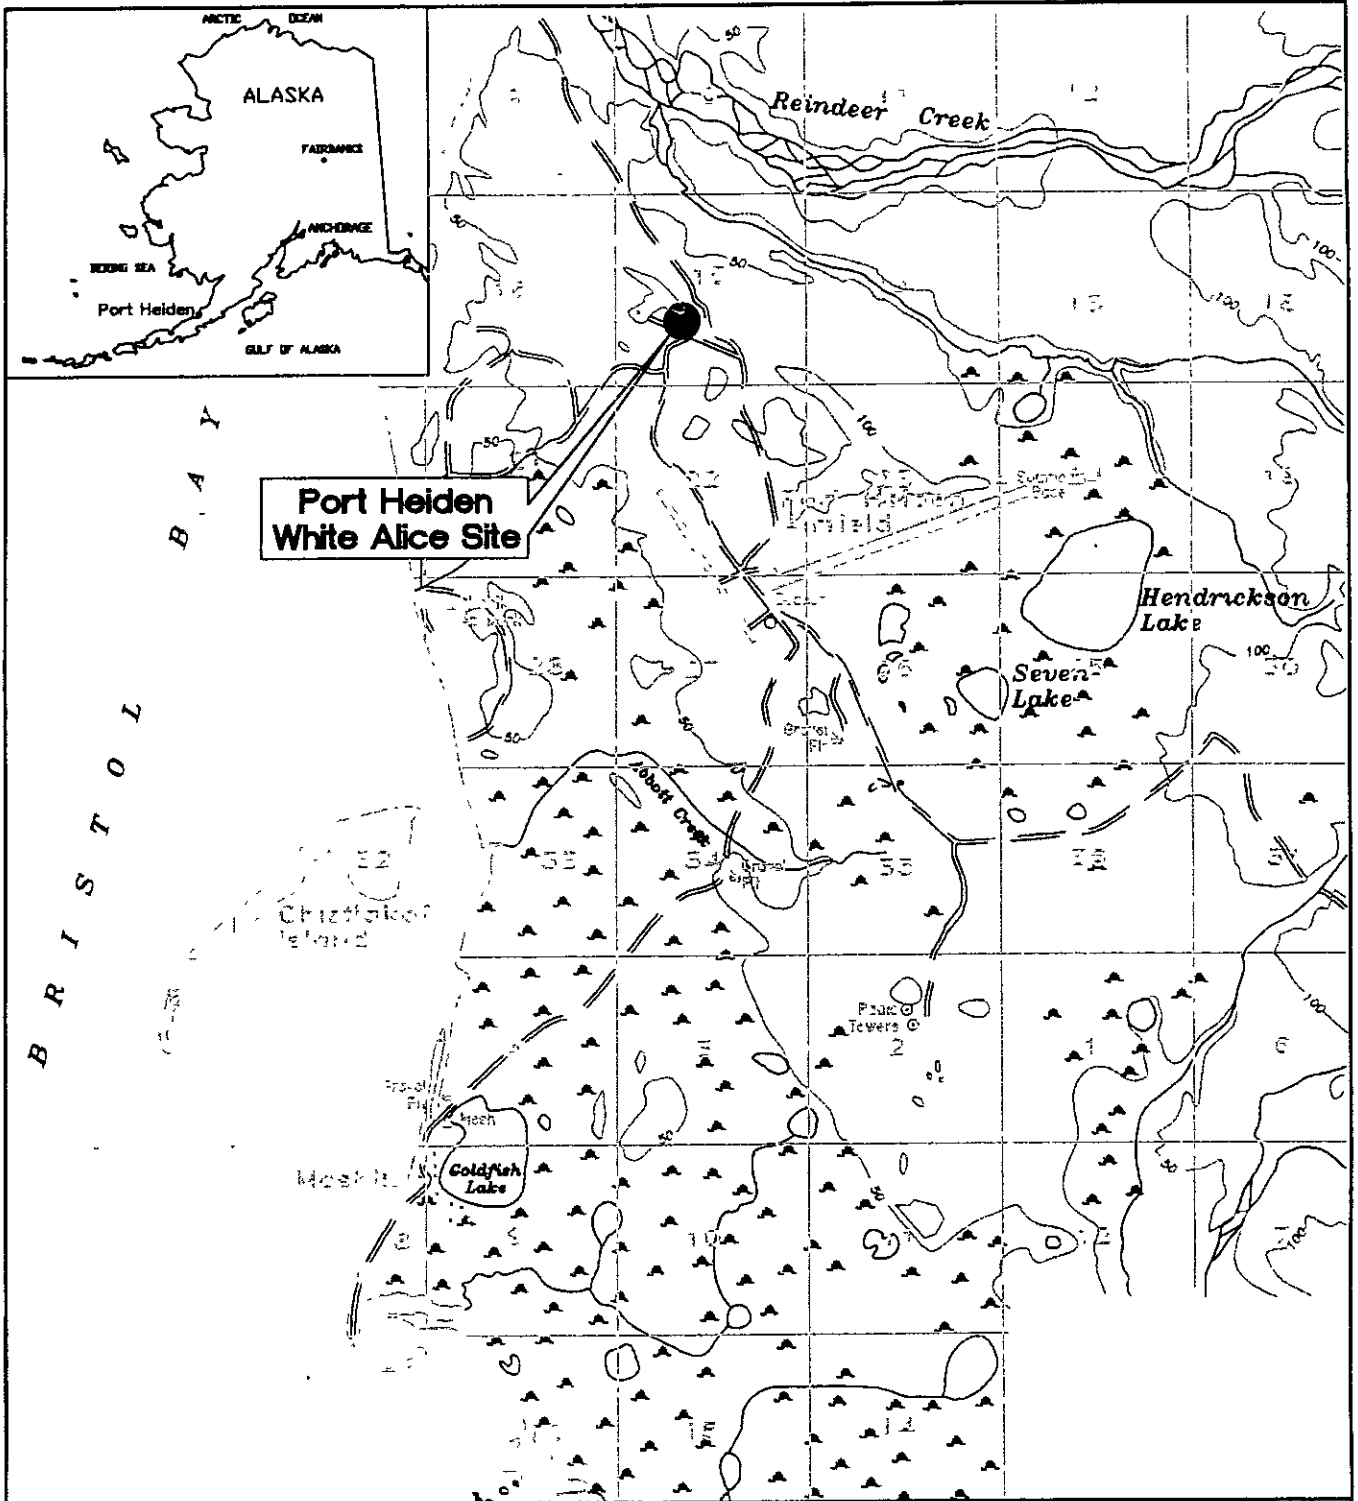
**Port Heiden
White Alice Site**

The terrestrial environment of the northern side of the Alaska Peninsula is very diverse. Habitats include the open, low-shrub, and ericaceous tundra found on the tops and windward sides of the small hills, ridges, and exposed sites. This habitat type is dominated by heaths and includes crowberry, bearberry, lichens, dwarf willows, and mosses. Additional species include low-bush cranberry, yarrow, fireweed, grasses, and sedges. The leeward sides of the hills and protected areas support the same species; however, growth is taller
