**PORT HEIDEN RRS  
ALASKA**

# Preliminary Assessment Port Heiden

**CH2M HILL**

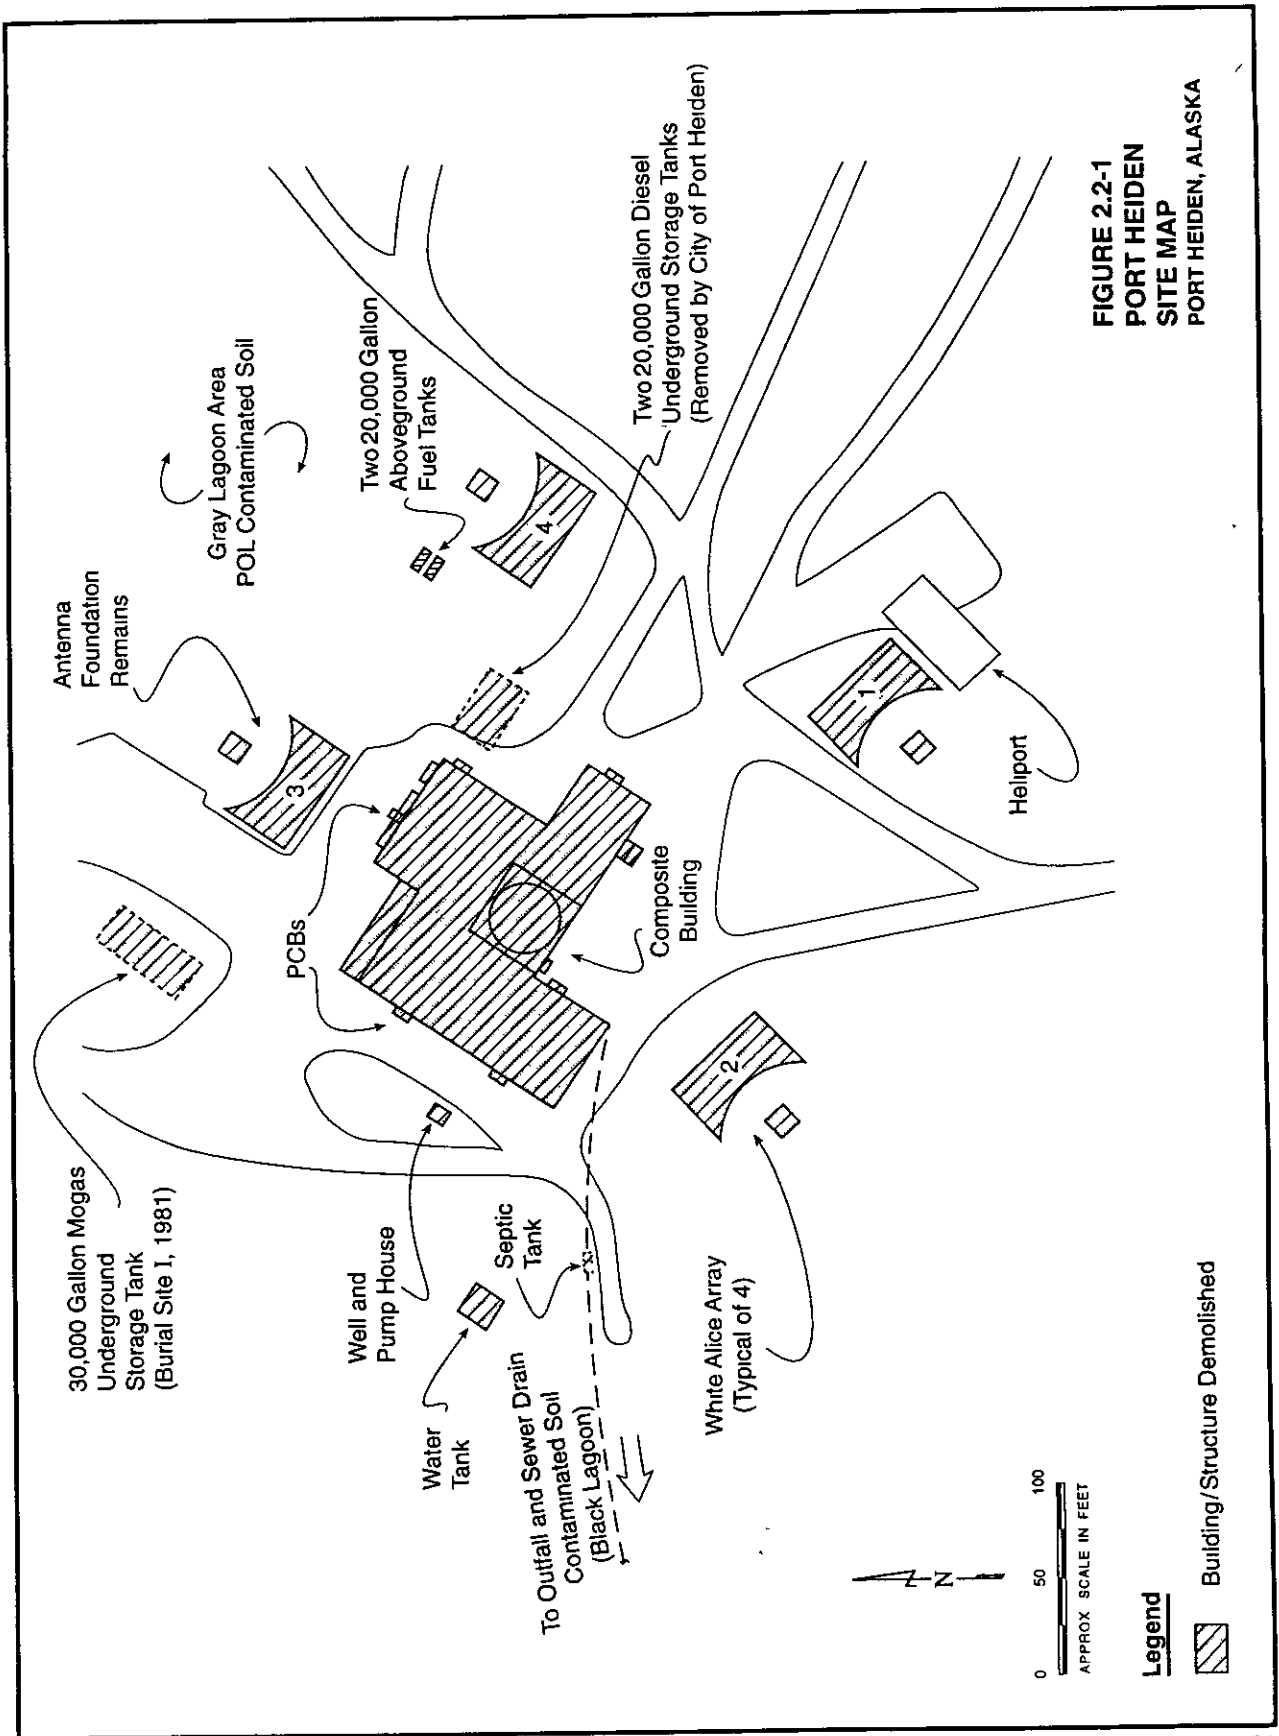
**FIGURE 2.2-1**  
**PORT HEIDEN**  
**SITE MAP**  
 PORT HEIDEN, ALASKA

At the time of the demolition of the WACS site, Reeve Aleutian Airways had reconnected the pipeline to new tanks and was using the segment of pipeline from Meshik to the airfield. Pipeline ownership of that segment was changed from DOD to Reeve Aleutian Airways. Diesel fuel was stored onsite in two 20,000-gallon underground storage tanks (USTs) shown in Figure 2.2-1.

The gray lagoon is the area near the diesel tank excavation northeast of the composite building (Figure 2.2-1). Underground utility lines may have provided channels for fuels to flow to the north of the excavation and Antenna Pad 3. The highest concentration of TPH was 8,600 ppm in a trench dug north of the source. High concentrations were also found around the antenna pad. The concrete antenna pad is the only structure remaining at the WACS site. It was not removed because of the surrounding soil contamination. According to the COE project manager, soil removals were based on PCB concentrations below 10 ppm in remaining soil.
