Re: Happy Valley West Monitoring Well Decommissioning Report

2019 Happy Valley Well Decommissioning Report

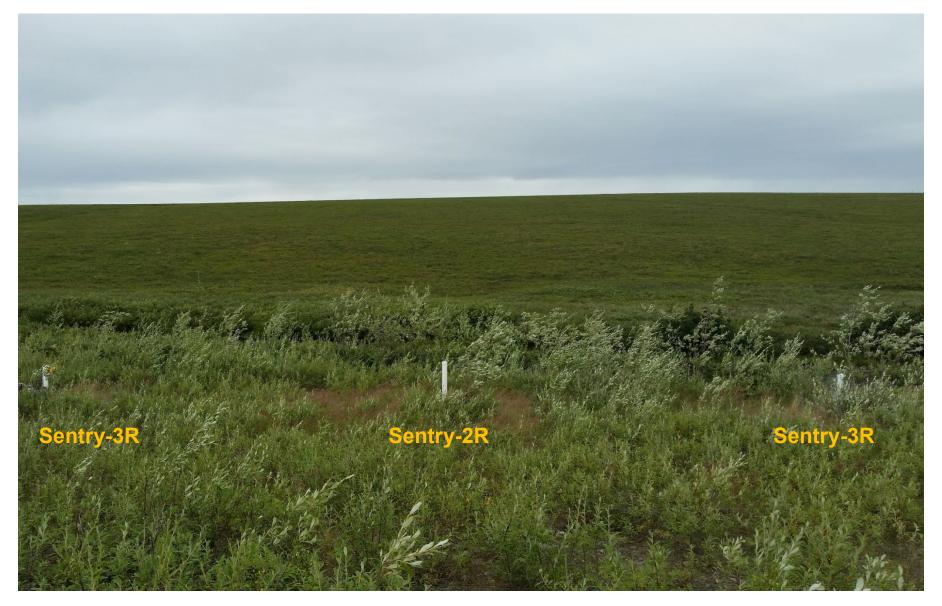
Photograph 1: Monitoring wells prior to decommissioning, view facing north (August 1, 2017).

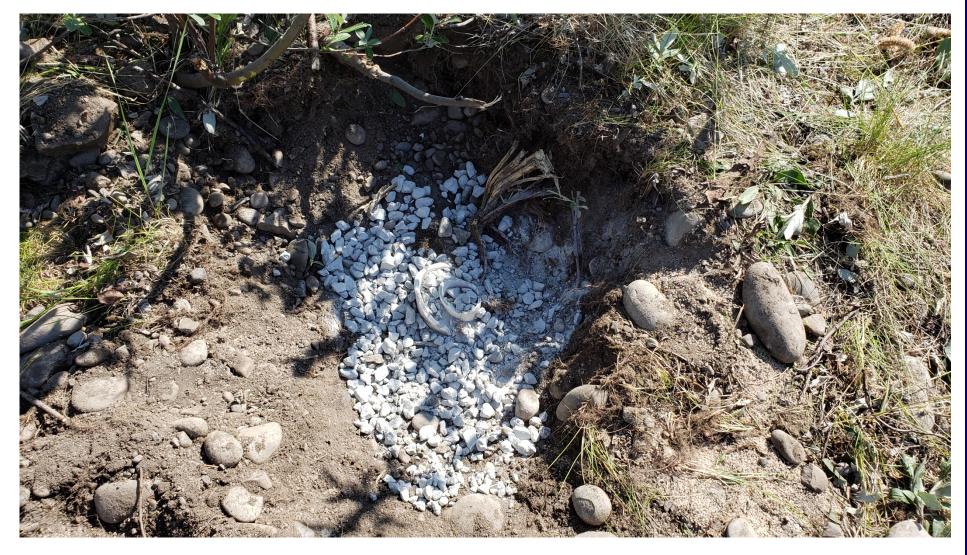
Photograph 2: Monitoring well Sentry-1R following removal of above-grade PVC and backfilling with bentonite chips (July 11, 2019)

Monitoring well decommissioning was conducted in accordance with the ADEC *Monitoring Well Guidance* (ADEC, 2013). Decommissioning included removal of 4-inch polyvinyl chloride (PVC) outer casing 2-inch inner well casing to approximately 0.5 feet below ground surface. The casings were backfilled with 3/8'-inch bentonite chips, with an additional layer of chips added as a surface seal (Attachment 1, Photograph 2). Bentonite was hydrated with water before adding gravel until flush with the surrounding grade. Decommissioning was documented in the field notebook (Attachment 2).
