**PACIFIC AIR FORCES
REGIONAL SUPPORT CENTER**

**2016–2018 PCB-CONTAMINATED SOIL
REMOVAL ACTION REPORT**

PORT HEIDEN, ALASKA

**FINAL
JANUARY 2019**

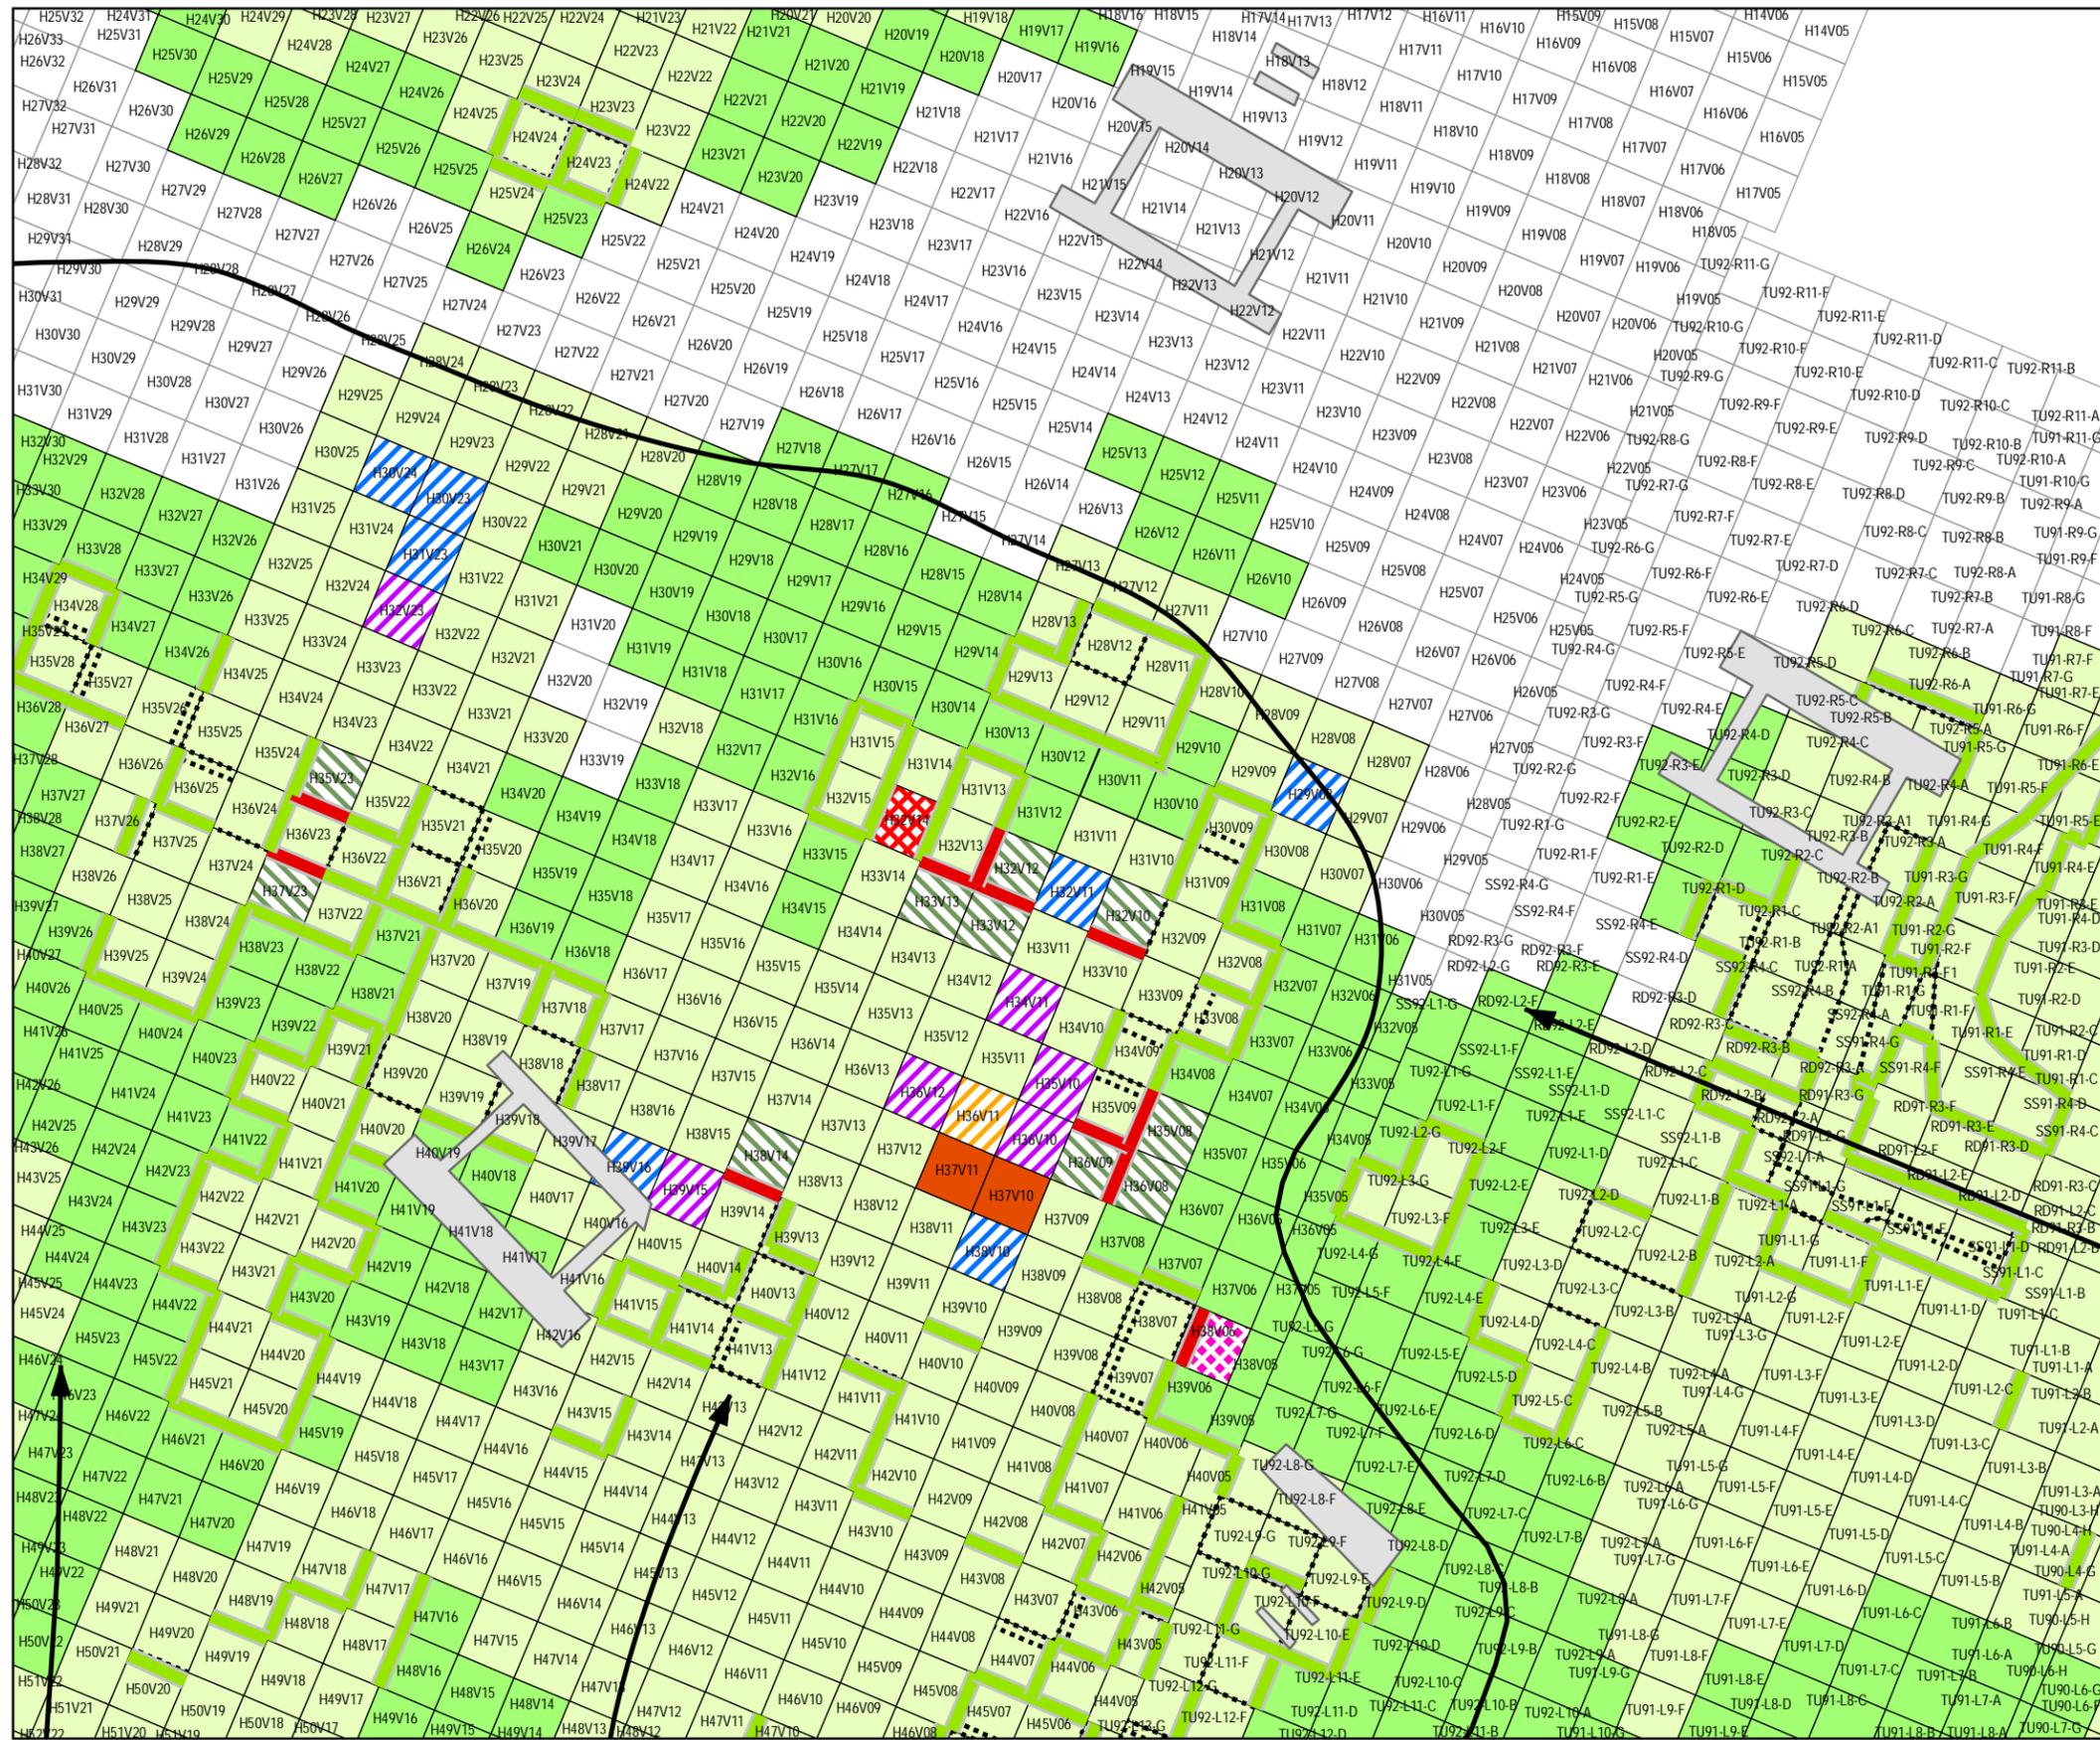
DATE:	PROJECT MANAGER:	FIGURE NO.:
	06 NOV 2017	G. Rutkowski	A-4

Soil Removal Area 2 Northeast
 Radio Relay Station PCB Removal Action
 Port Heiden, Alaska

- Soil Removal Area 2 (SRA2) (Figures A-3 through A-6)
- North and south Upper Site Road areas (Figures A-7 and A-8)
- Access Road (Figure A-9)
- Sections 89-92 along Upper Site Road and the associated tundra (Figure A-10)
- Drum Storage Area (DSA) (Figure A-11)
- North Landfill and North Landfill Road (Figures A-12 and A-13)
- Septic Lagoon (Figure A-14)
- Sections along Lower Site Road (Figures A-15 and A-16)

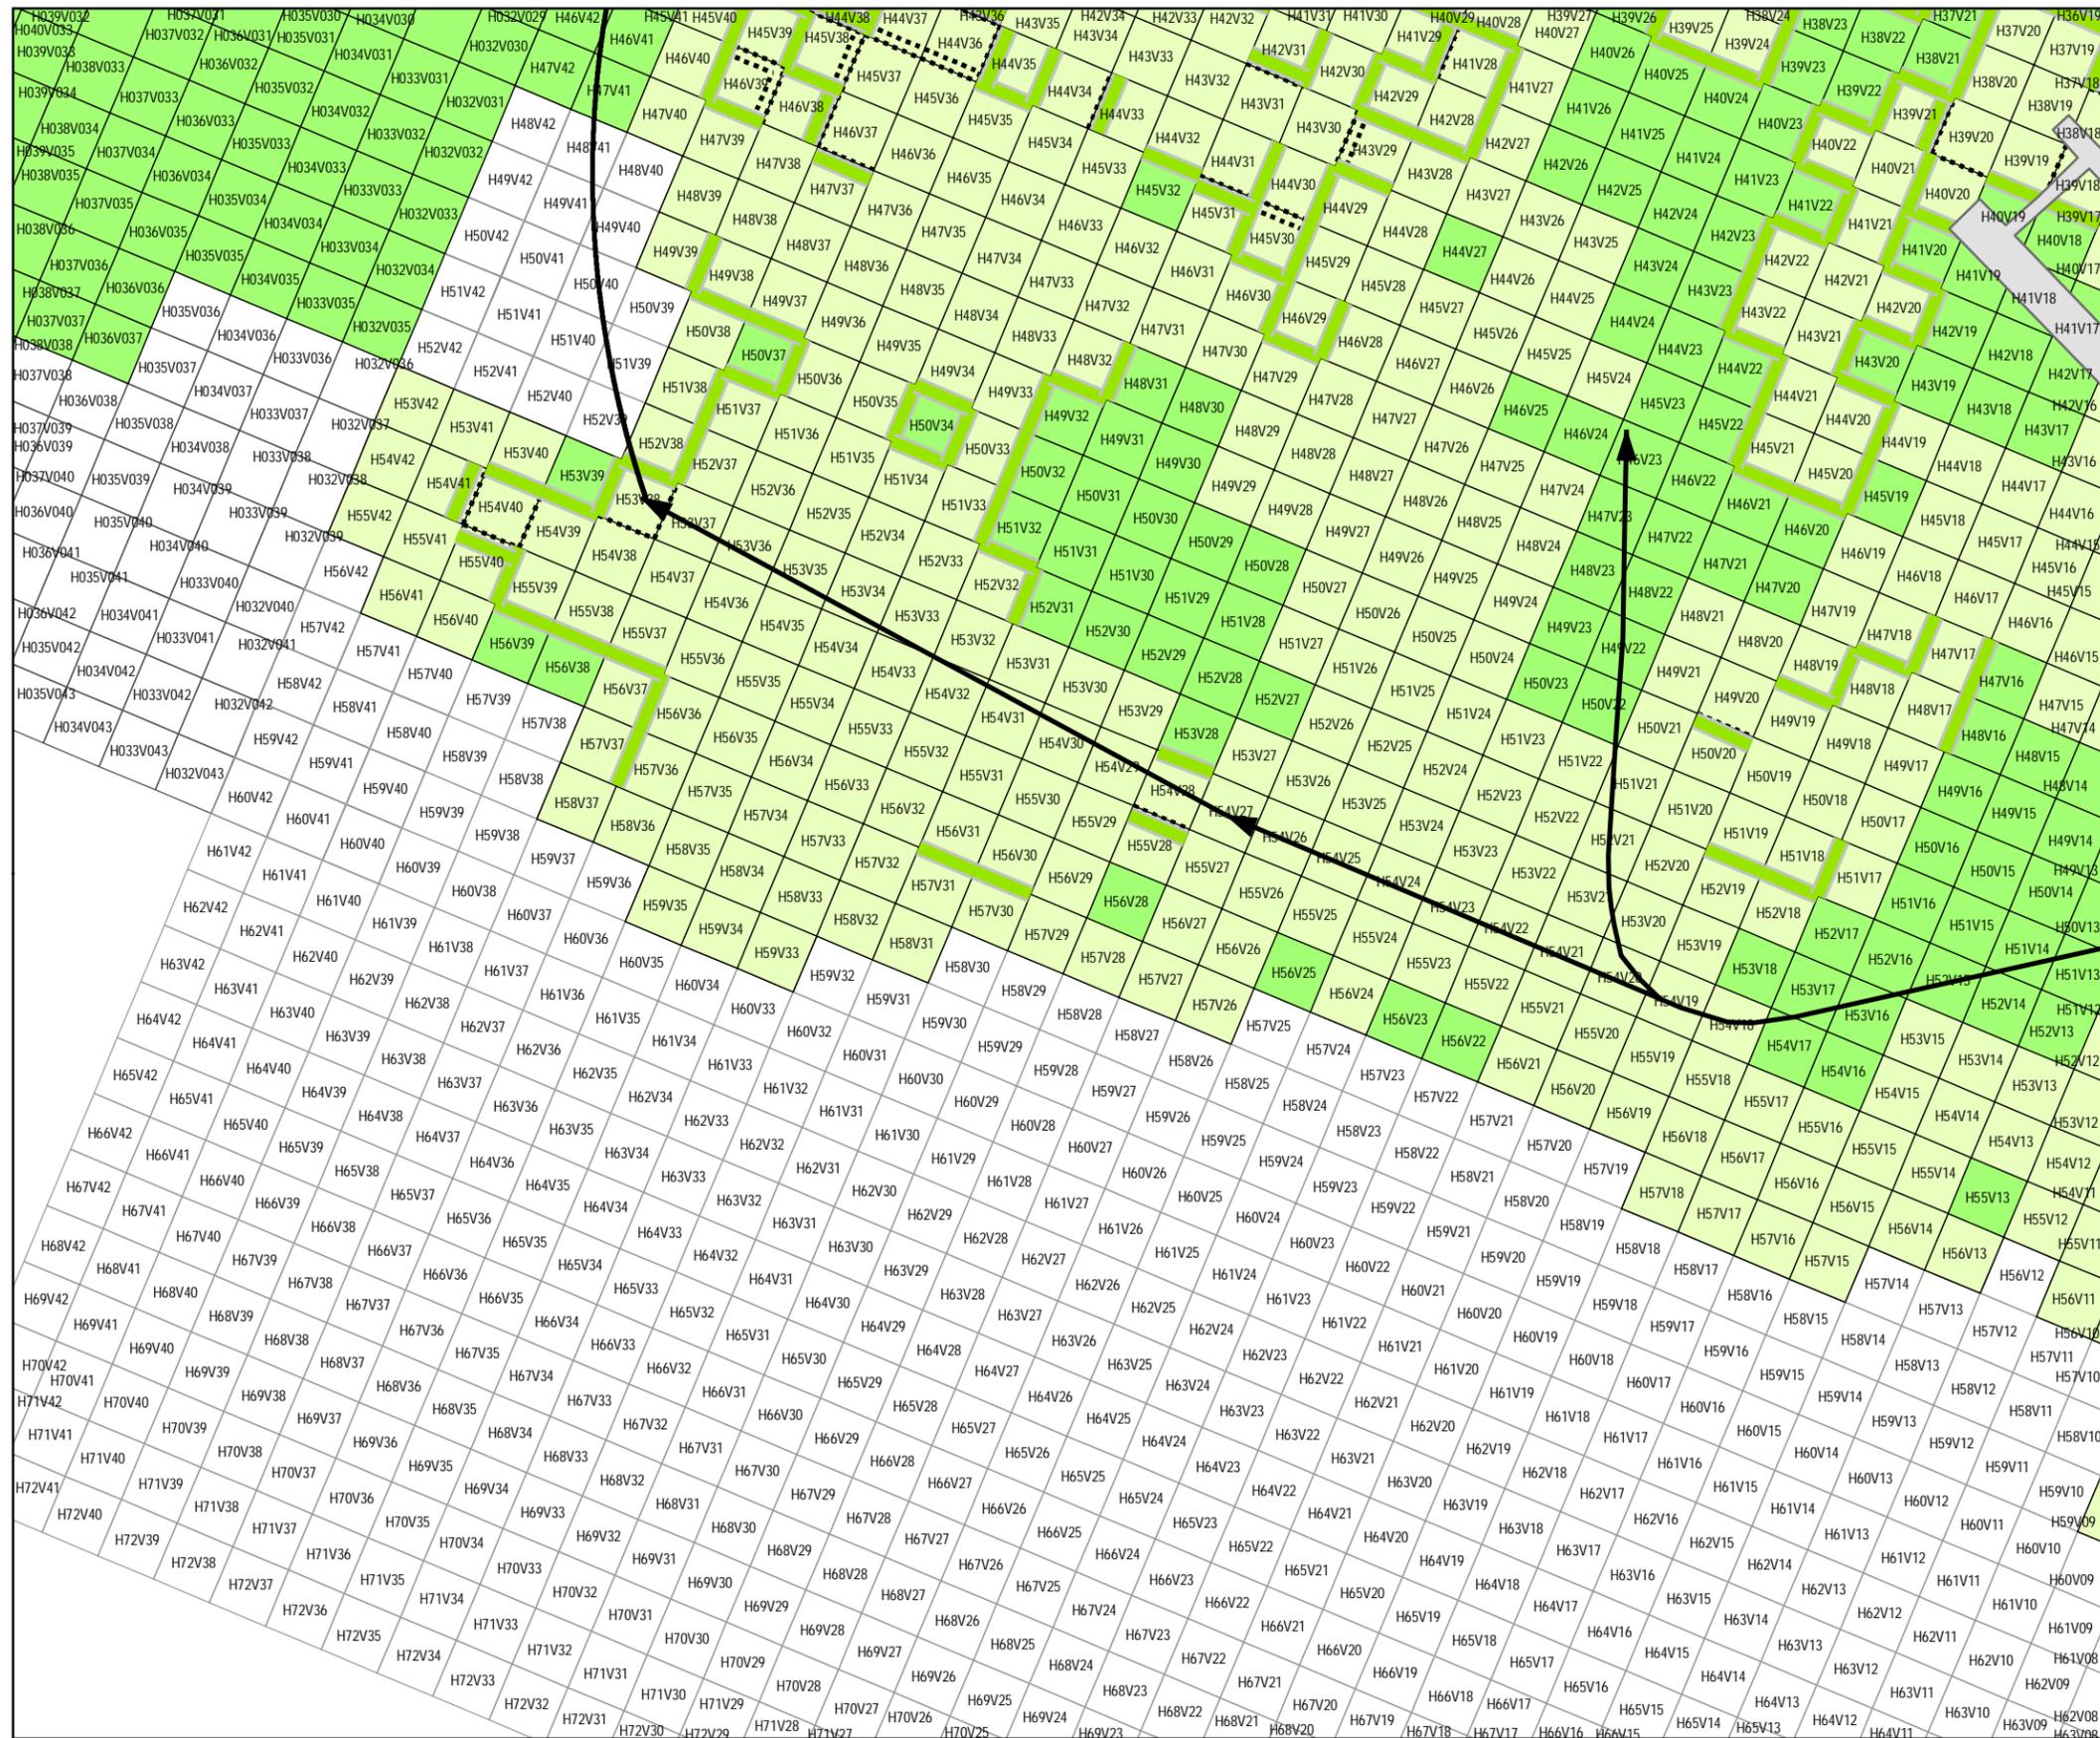
DATE:	PROJECT MANAGER:	FIGURE NO.:
	06 NOV 2017	G. Rutkowski	A-6

Soil Removal Area 2 Southwest
Radio Relay Station PCB Removal Action
Port Heiden, Alaska

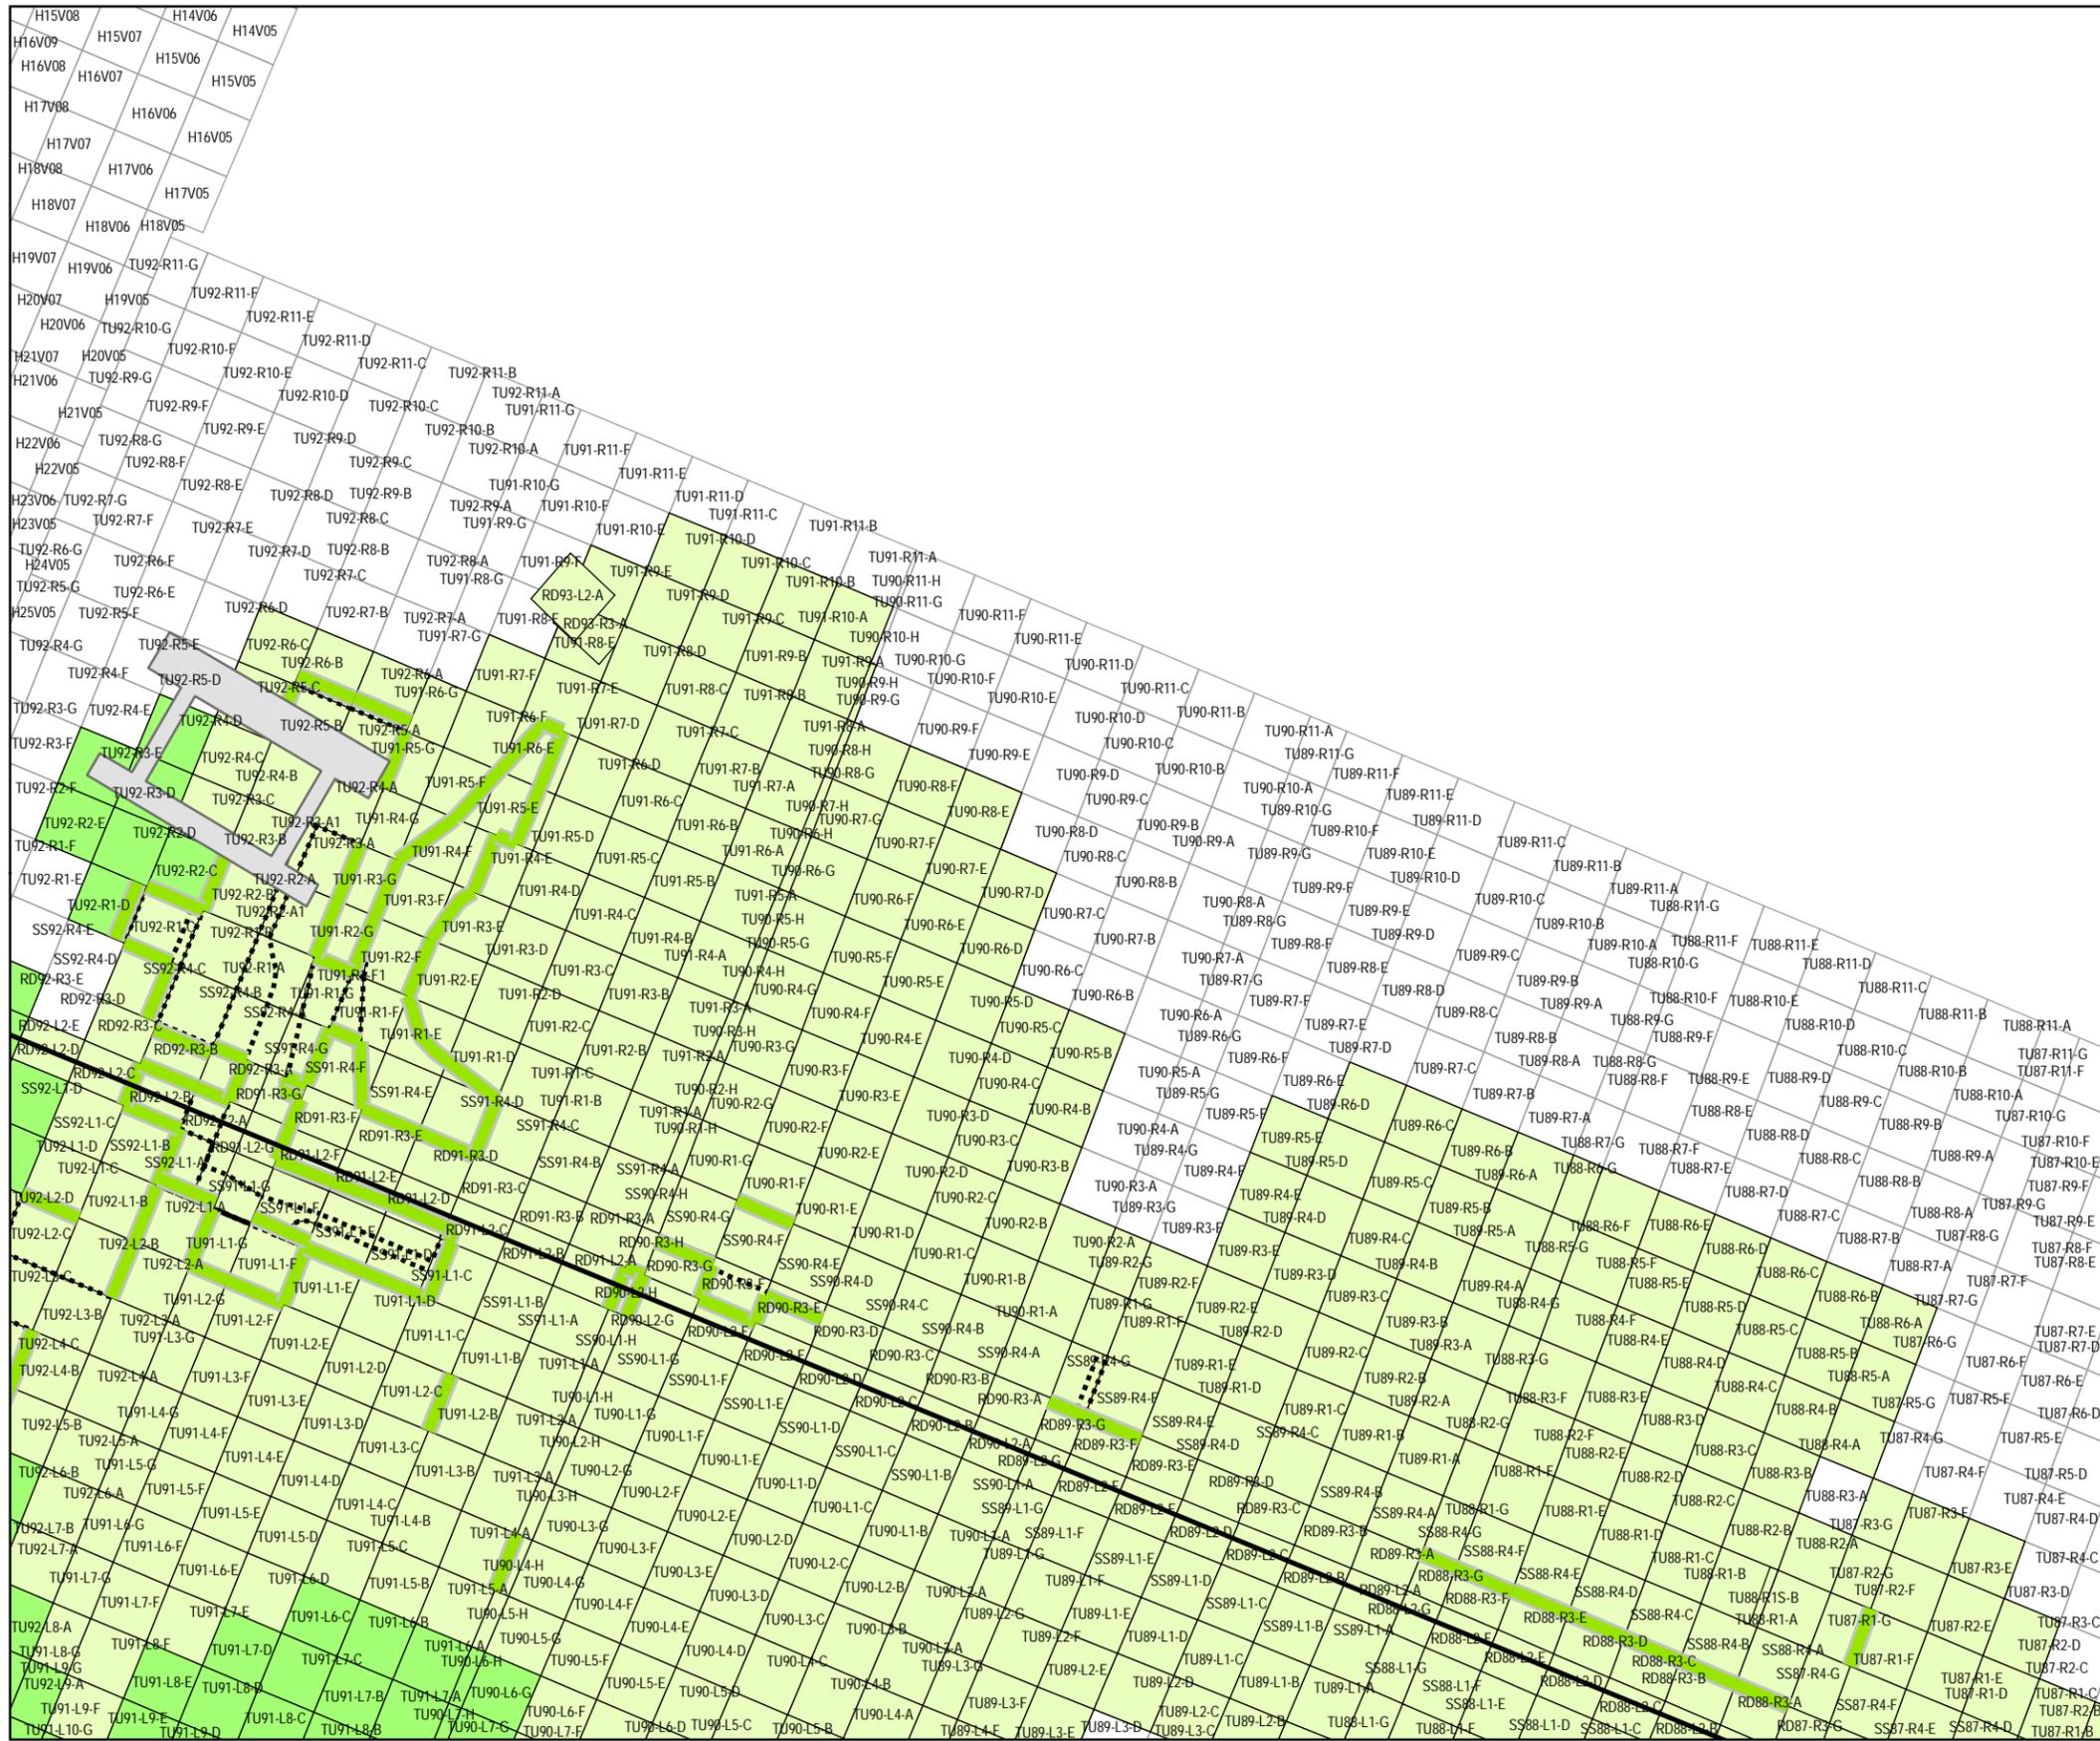
JACOBS	DATE:	PROJECT MANAGER:	FIGURE NO.:
	06 NOV 2017	G. Rutkowski	A-7

North Upper Site Road
Radio Relay Station PCB Removal Action
Port Heiden, Alaska

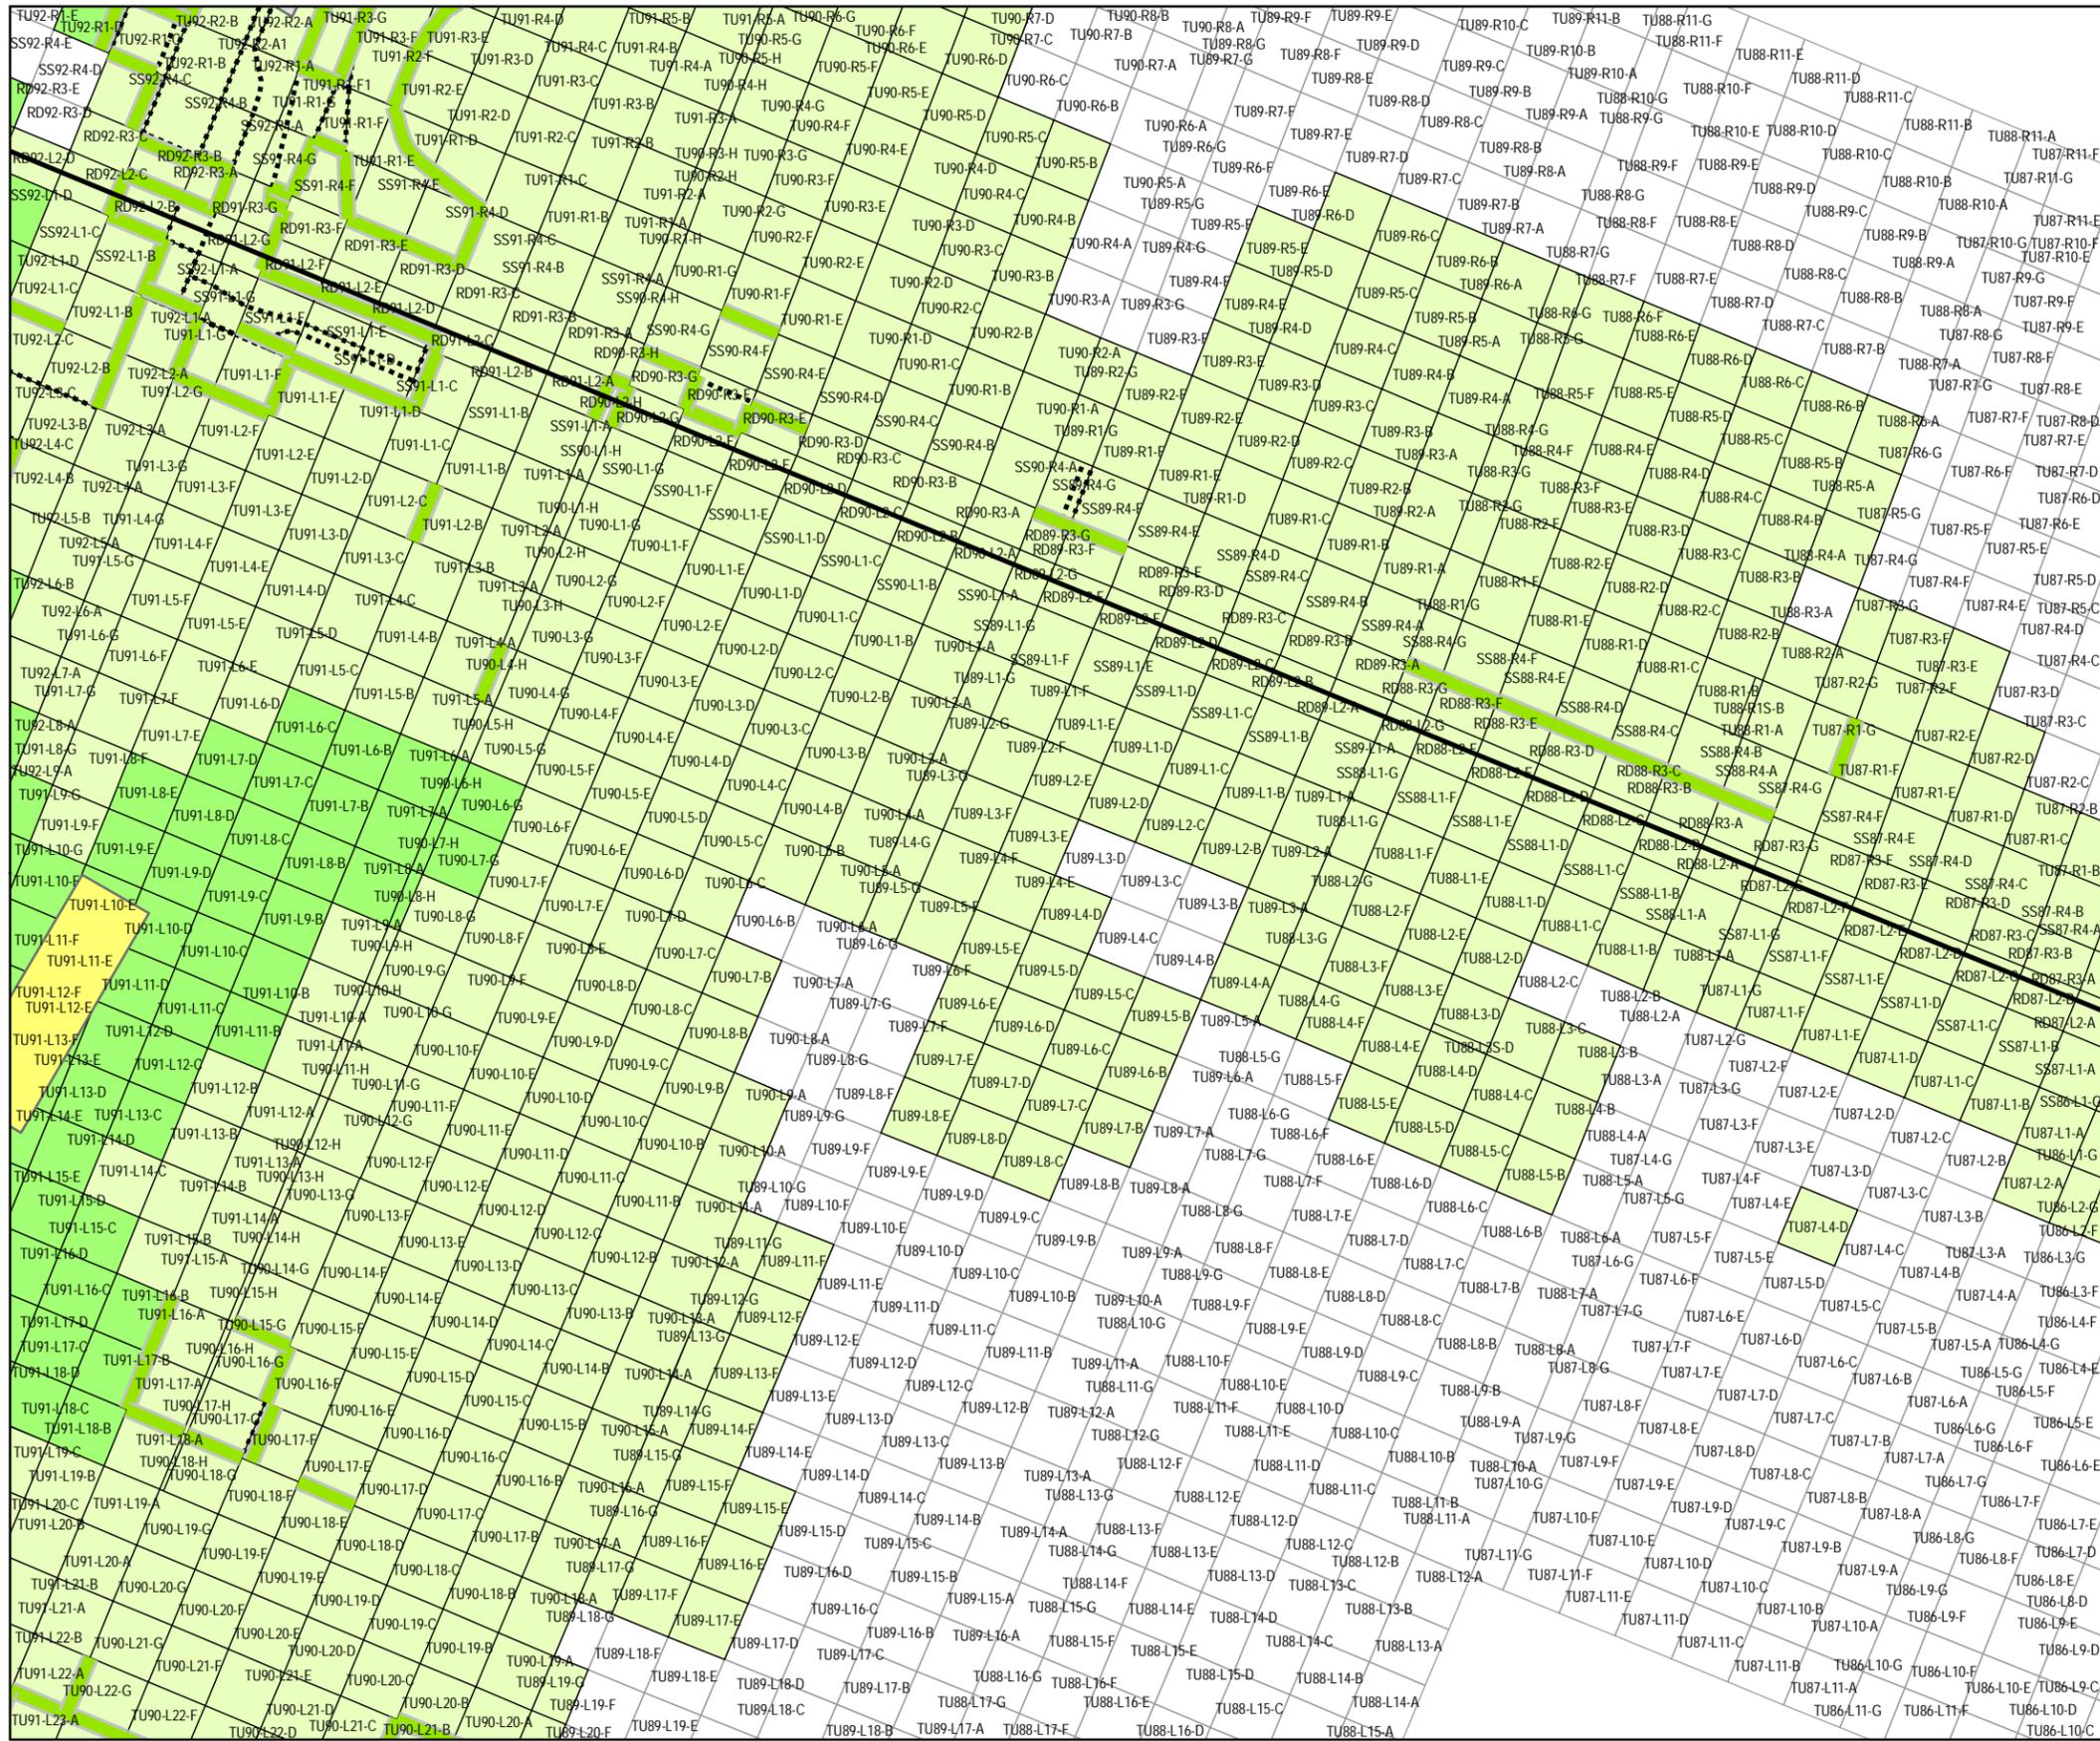
JACOBS	DATE:	PROJECT MANAGER:	FIGURE NO.:
	06 NOV 2017	G. Rutkowski	A-8

South Upper Site Road
Radio Relay Station PCB Removal Action
Port Heiden, Alaska

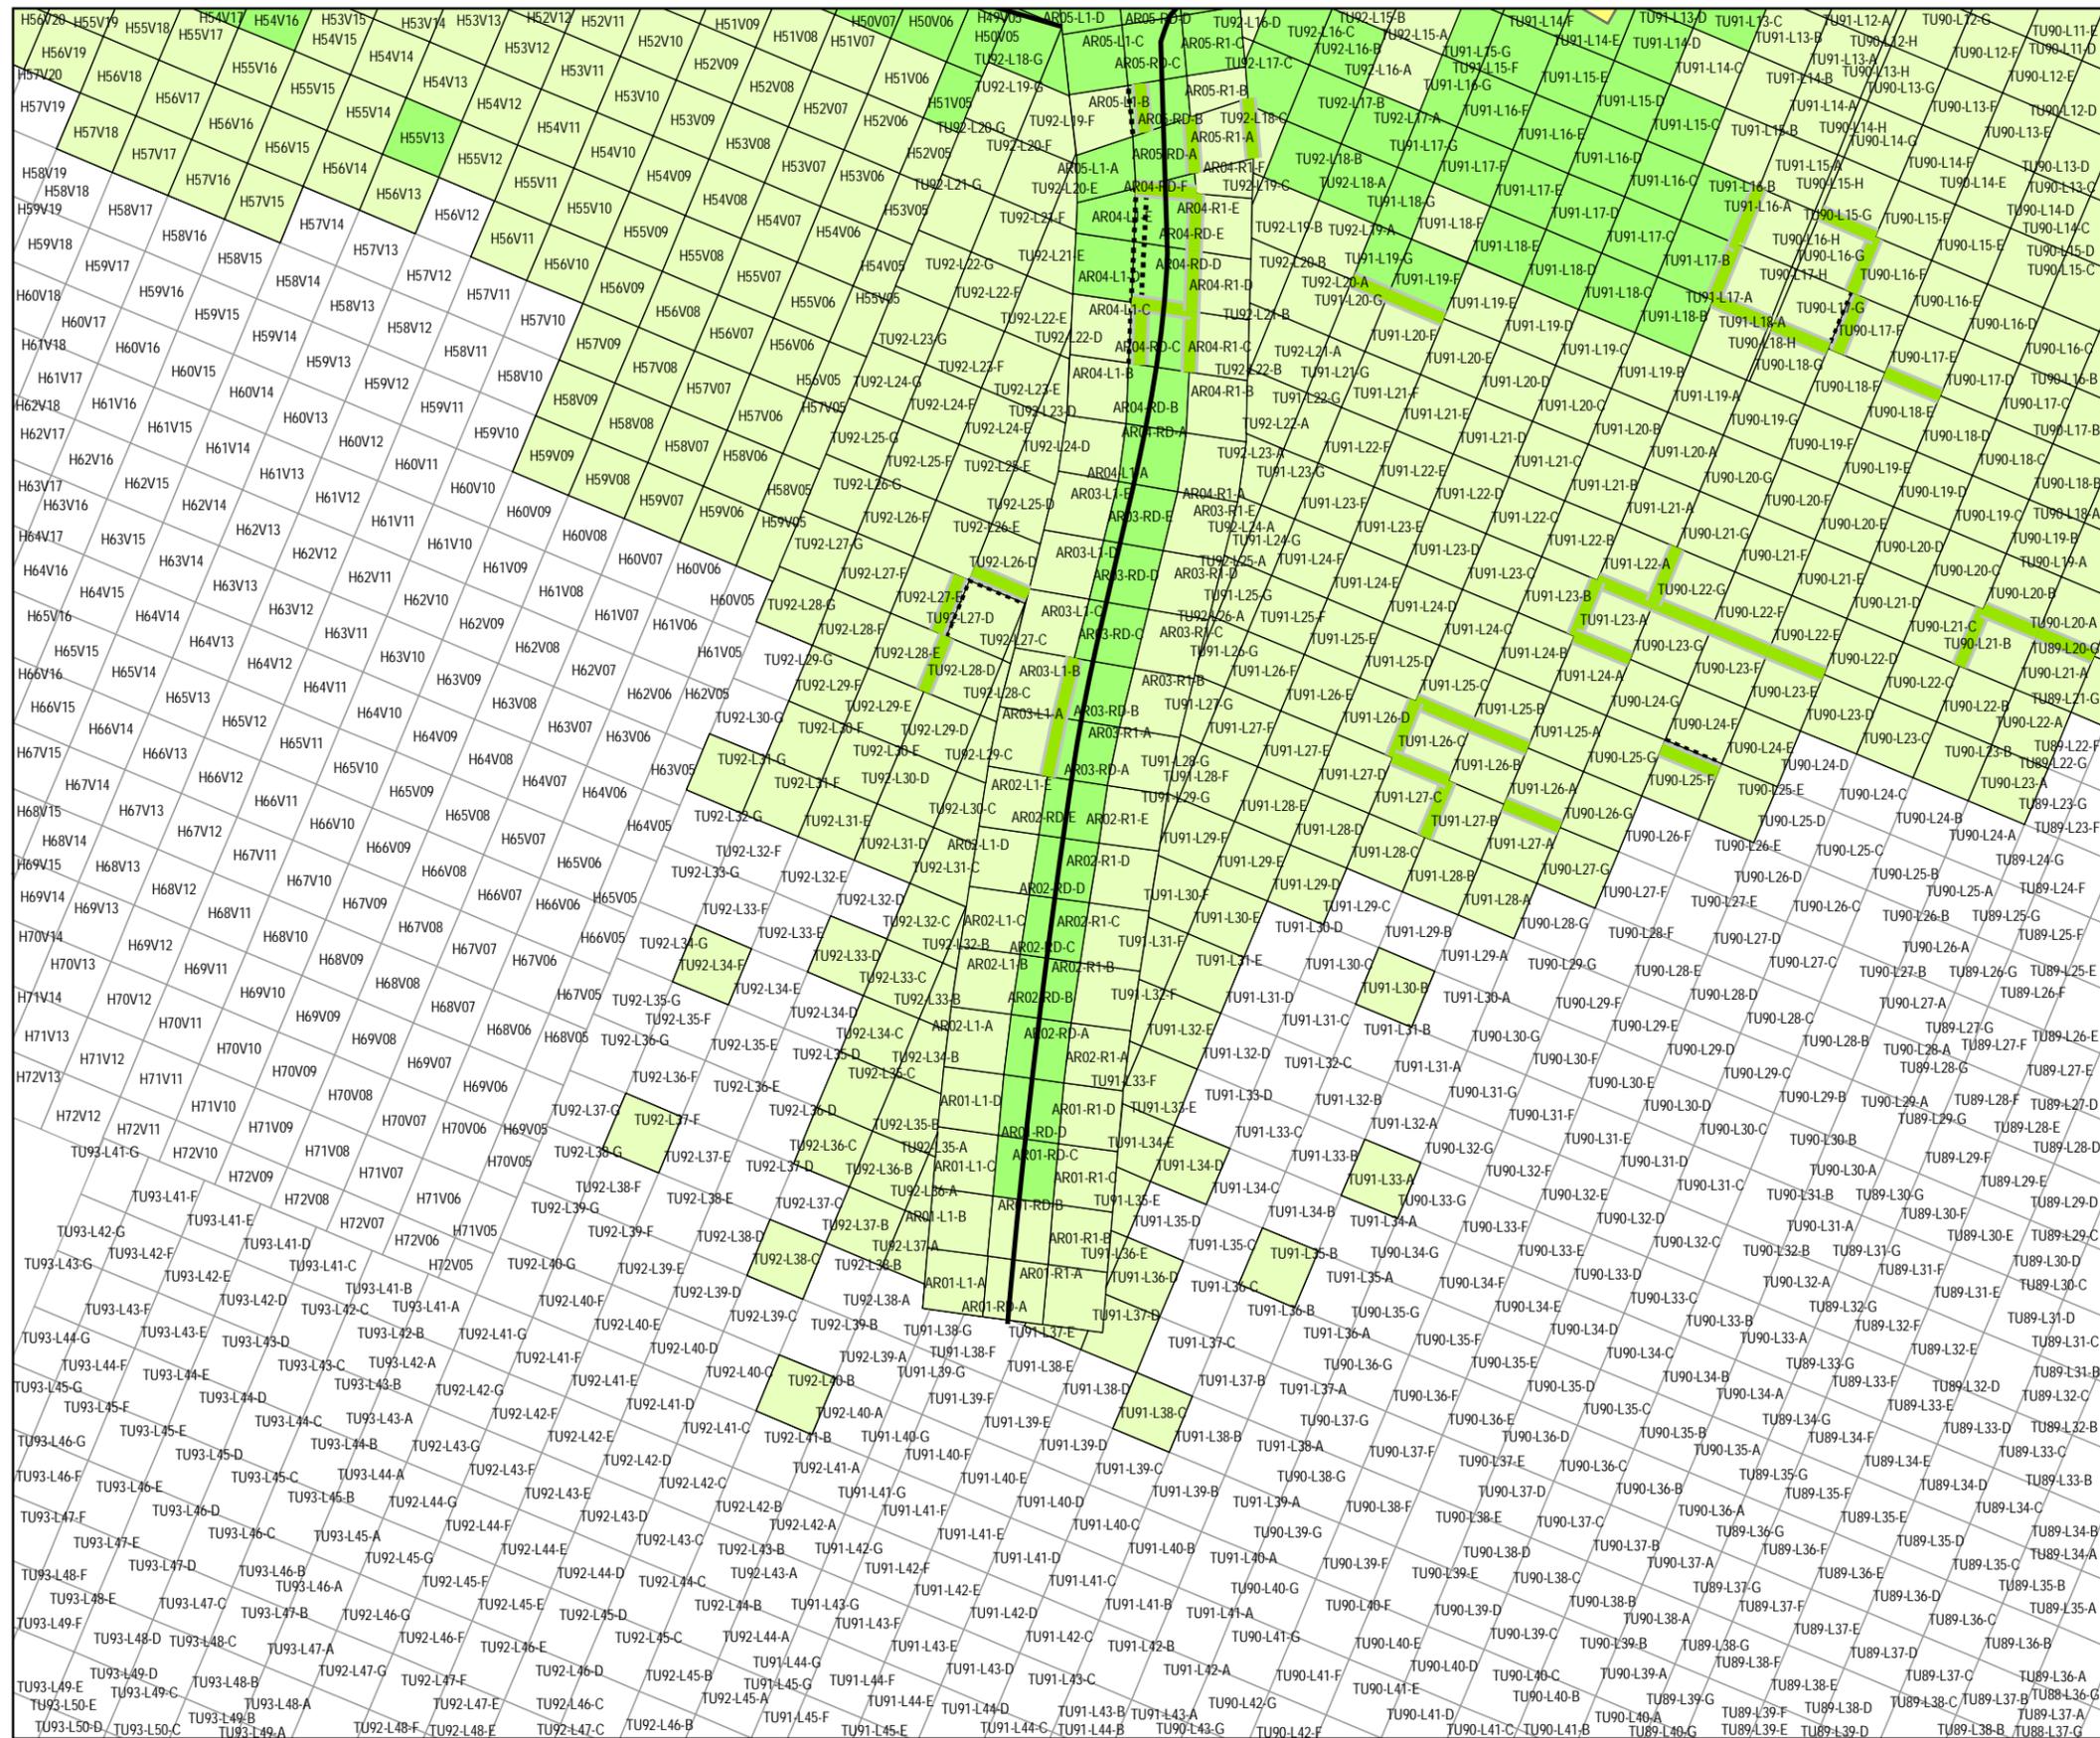
DATE: 06 NOV 2017	PROJECT MANAGER: G. Rutkowski	FIGURE NO.: A-9
--	----------------------	----------------------------------	--------------------

Access Road

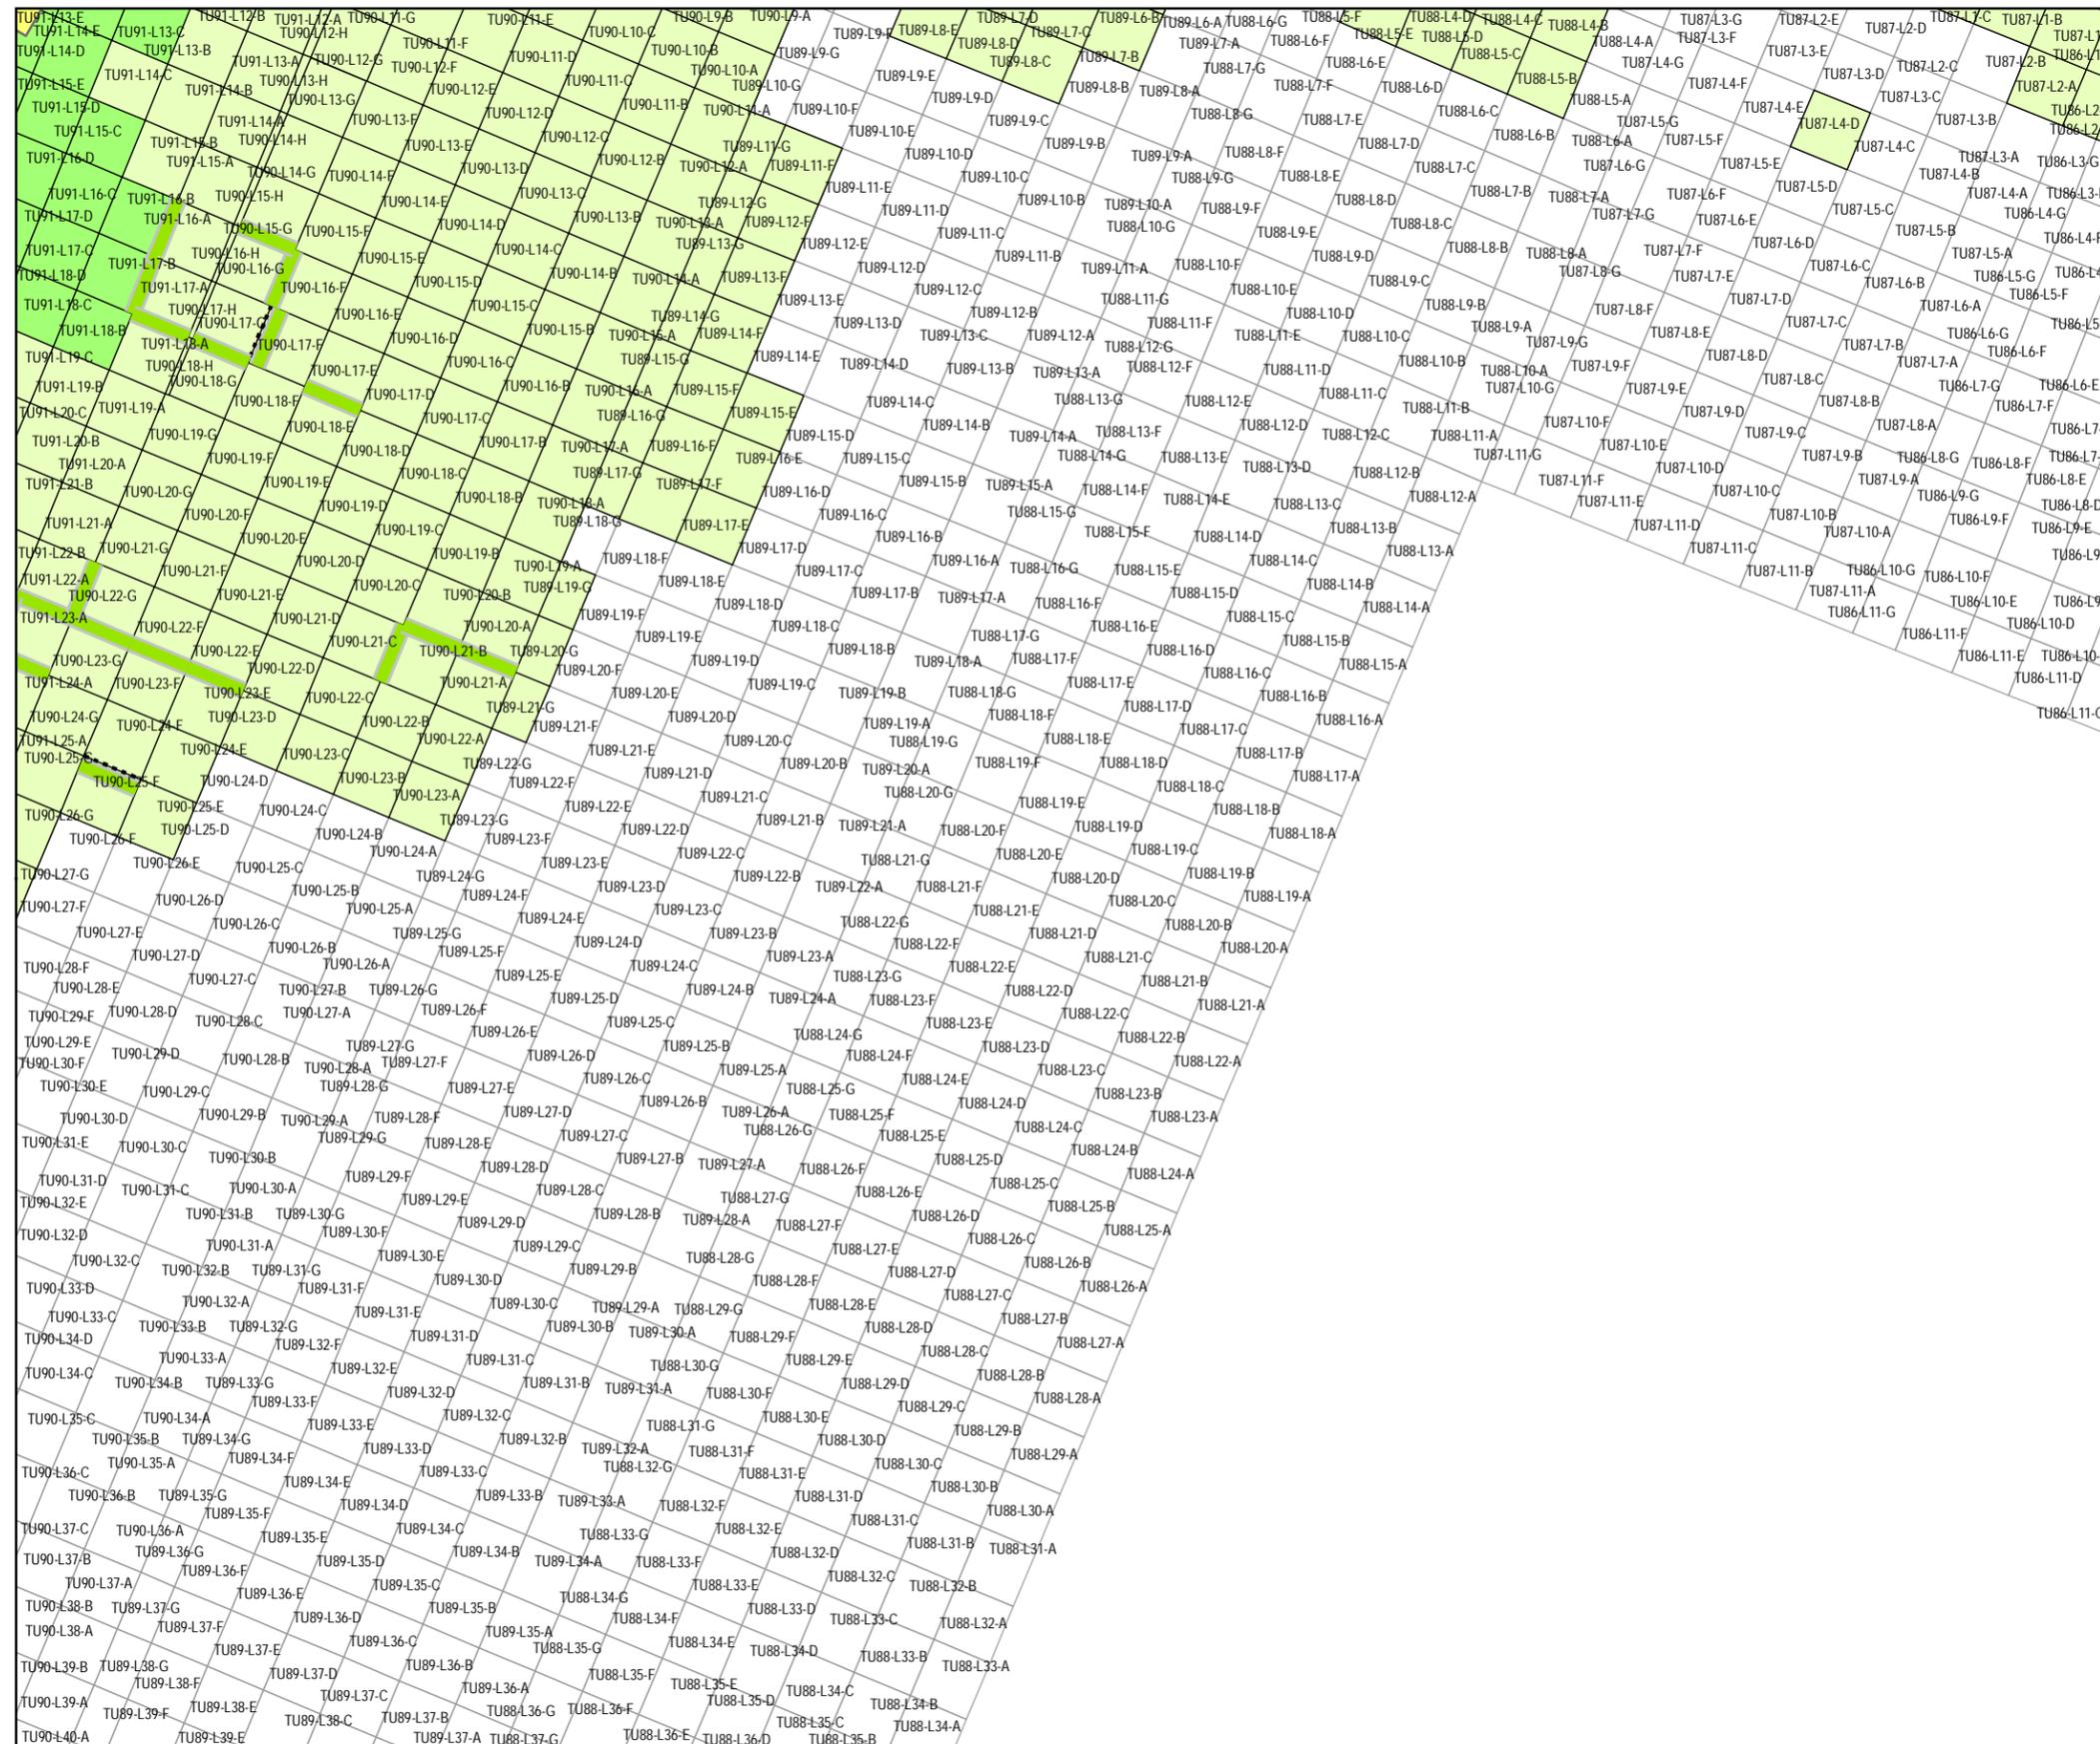
DATE:	PROJECT MANAGER:	FIGURE NO.:
	06 NOV 2017	G. Rutkowski	A-10

Tundra Area
Radio Relay Station PCB Removal Action
Port Heiden, Alaska
