**PACIFIC AIR FORCES
REGIONAL SUPPORT CENTER**

**2016–2018 PCB-CONTAMINATED SOIL
REMOVAL ACTION REPORT**

PORT HEIDEN, ALASKA

**FINAL
JANUARY 2019**

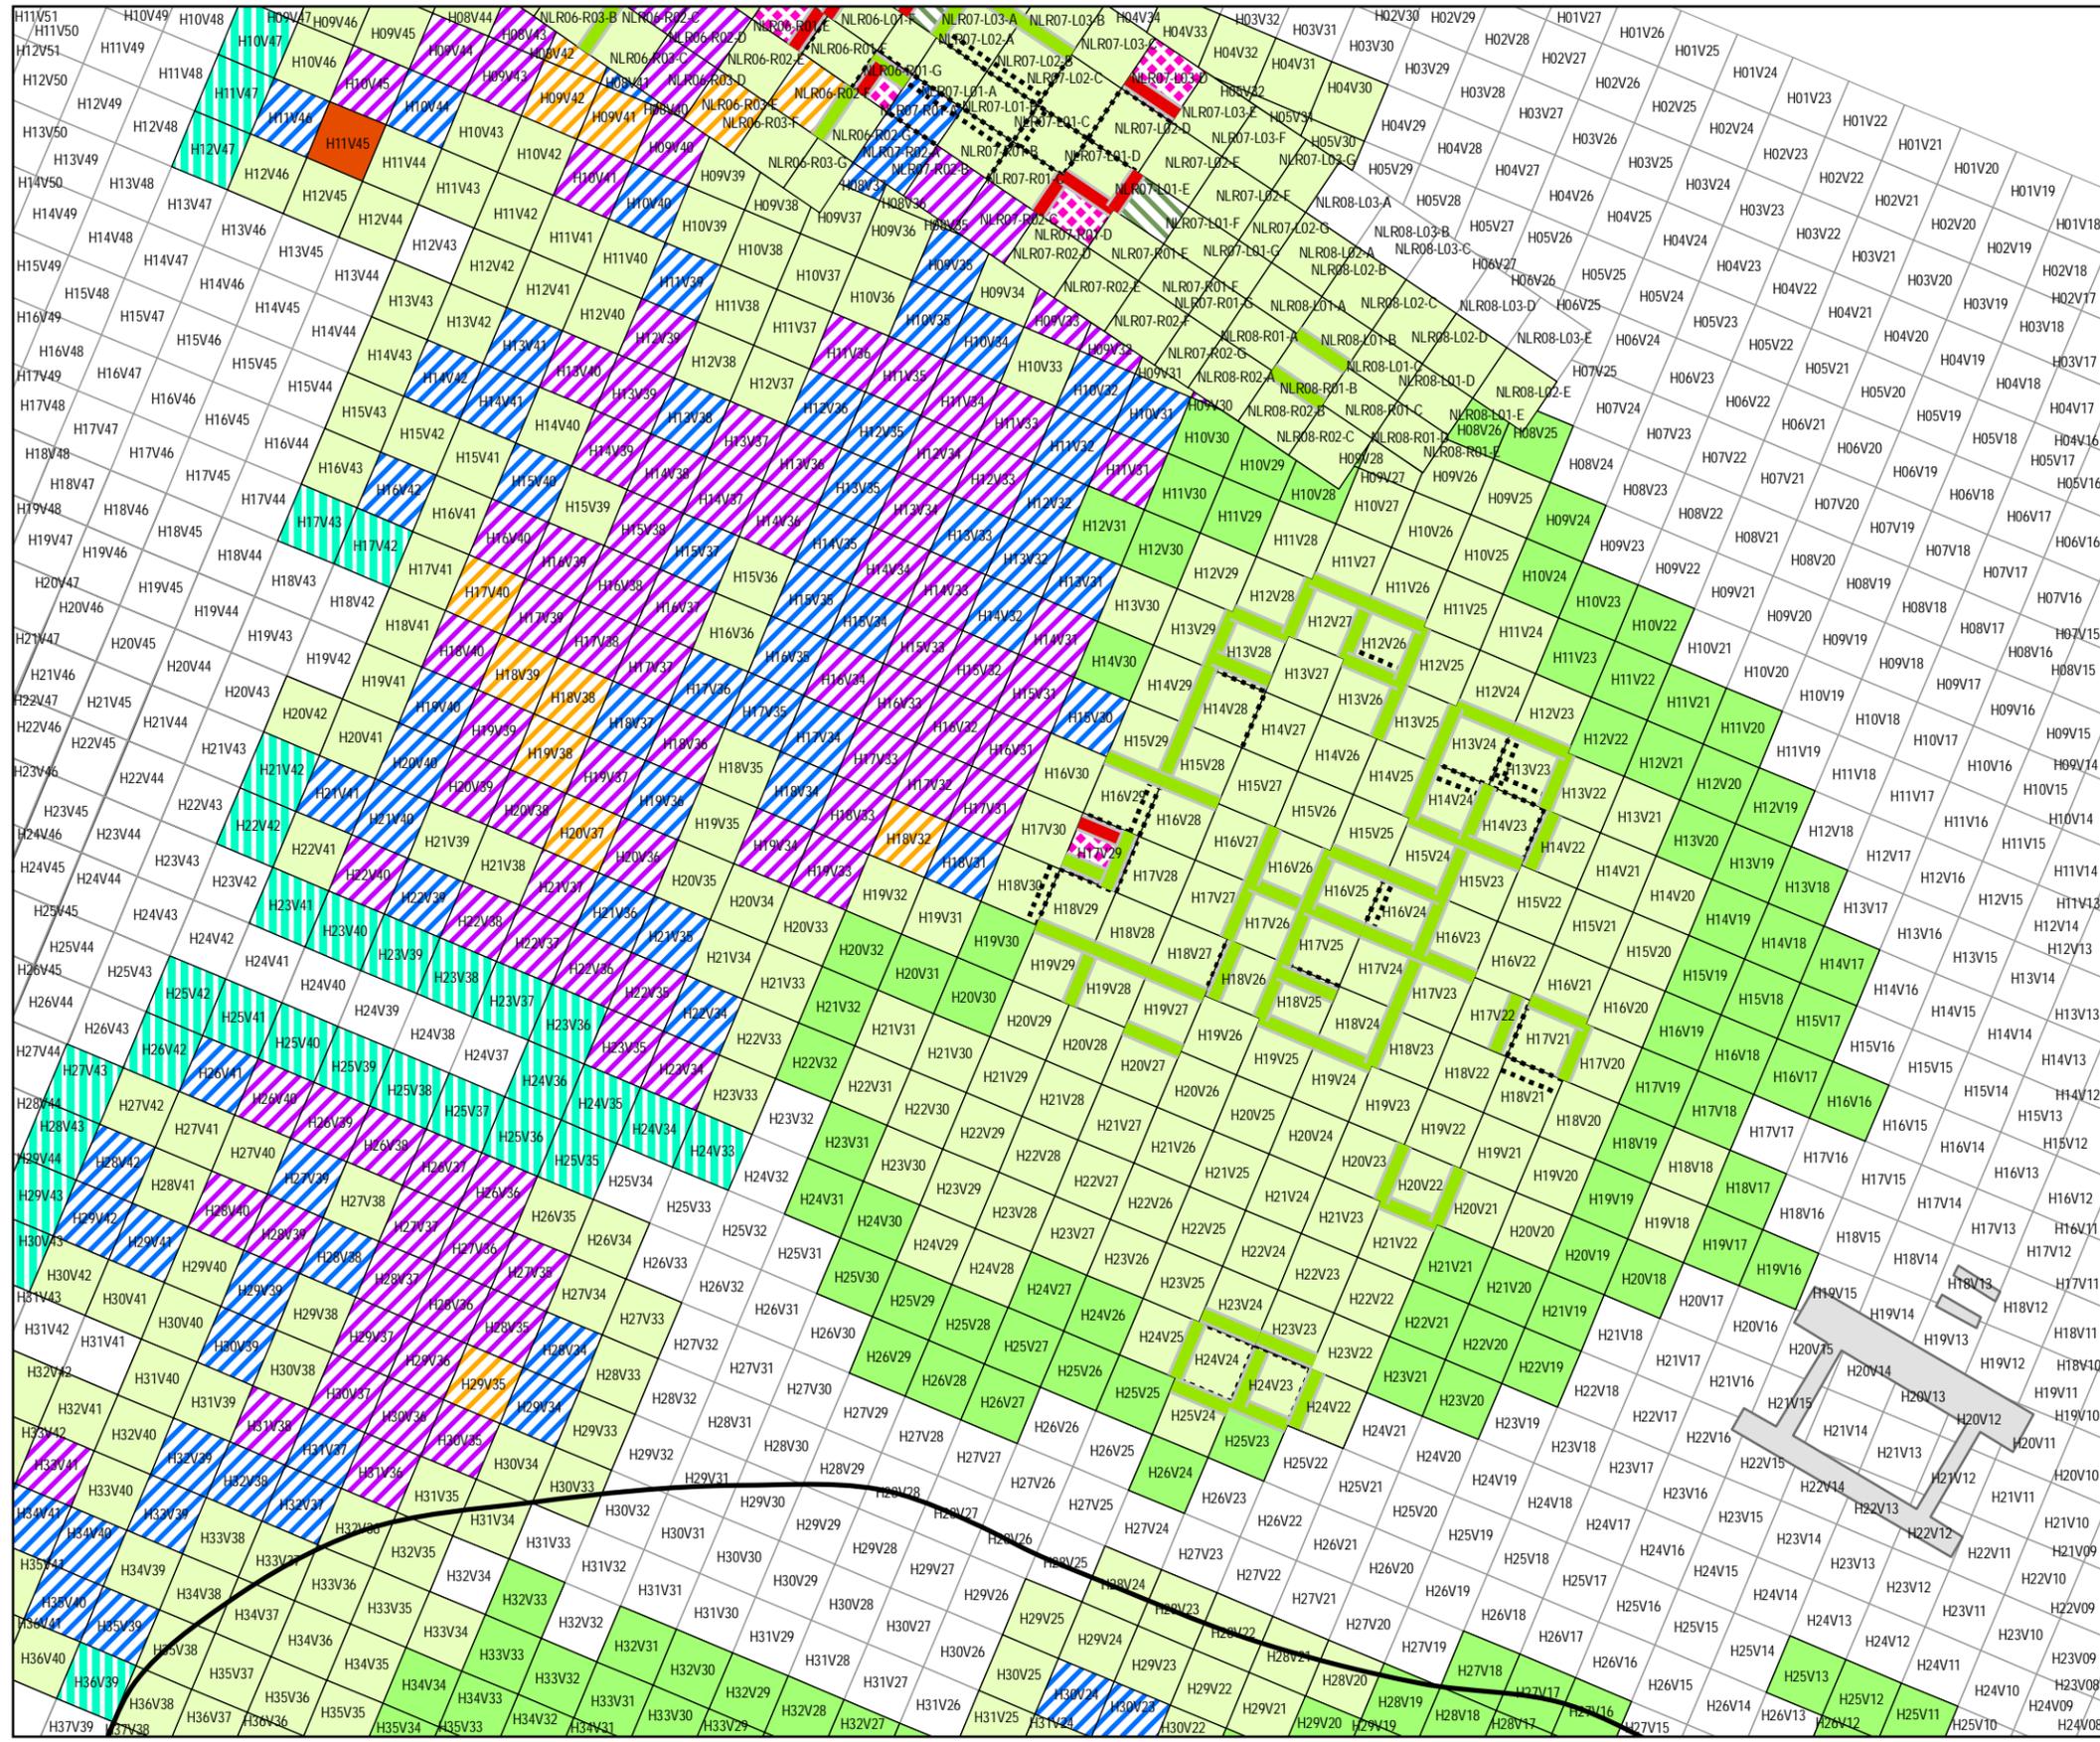
DATE:	PROJECT MANAGER:	FIGURE NO.:
	06 NOV 2017	G. Rutkowski	A-11

Drum Storage Area
Radio Relay Station PCB Removal Action
Port Heiden, Alaska

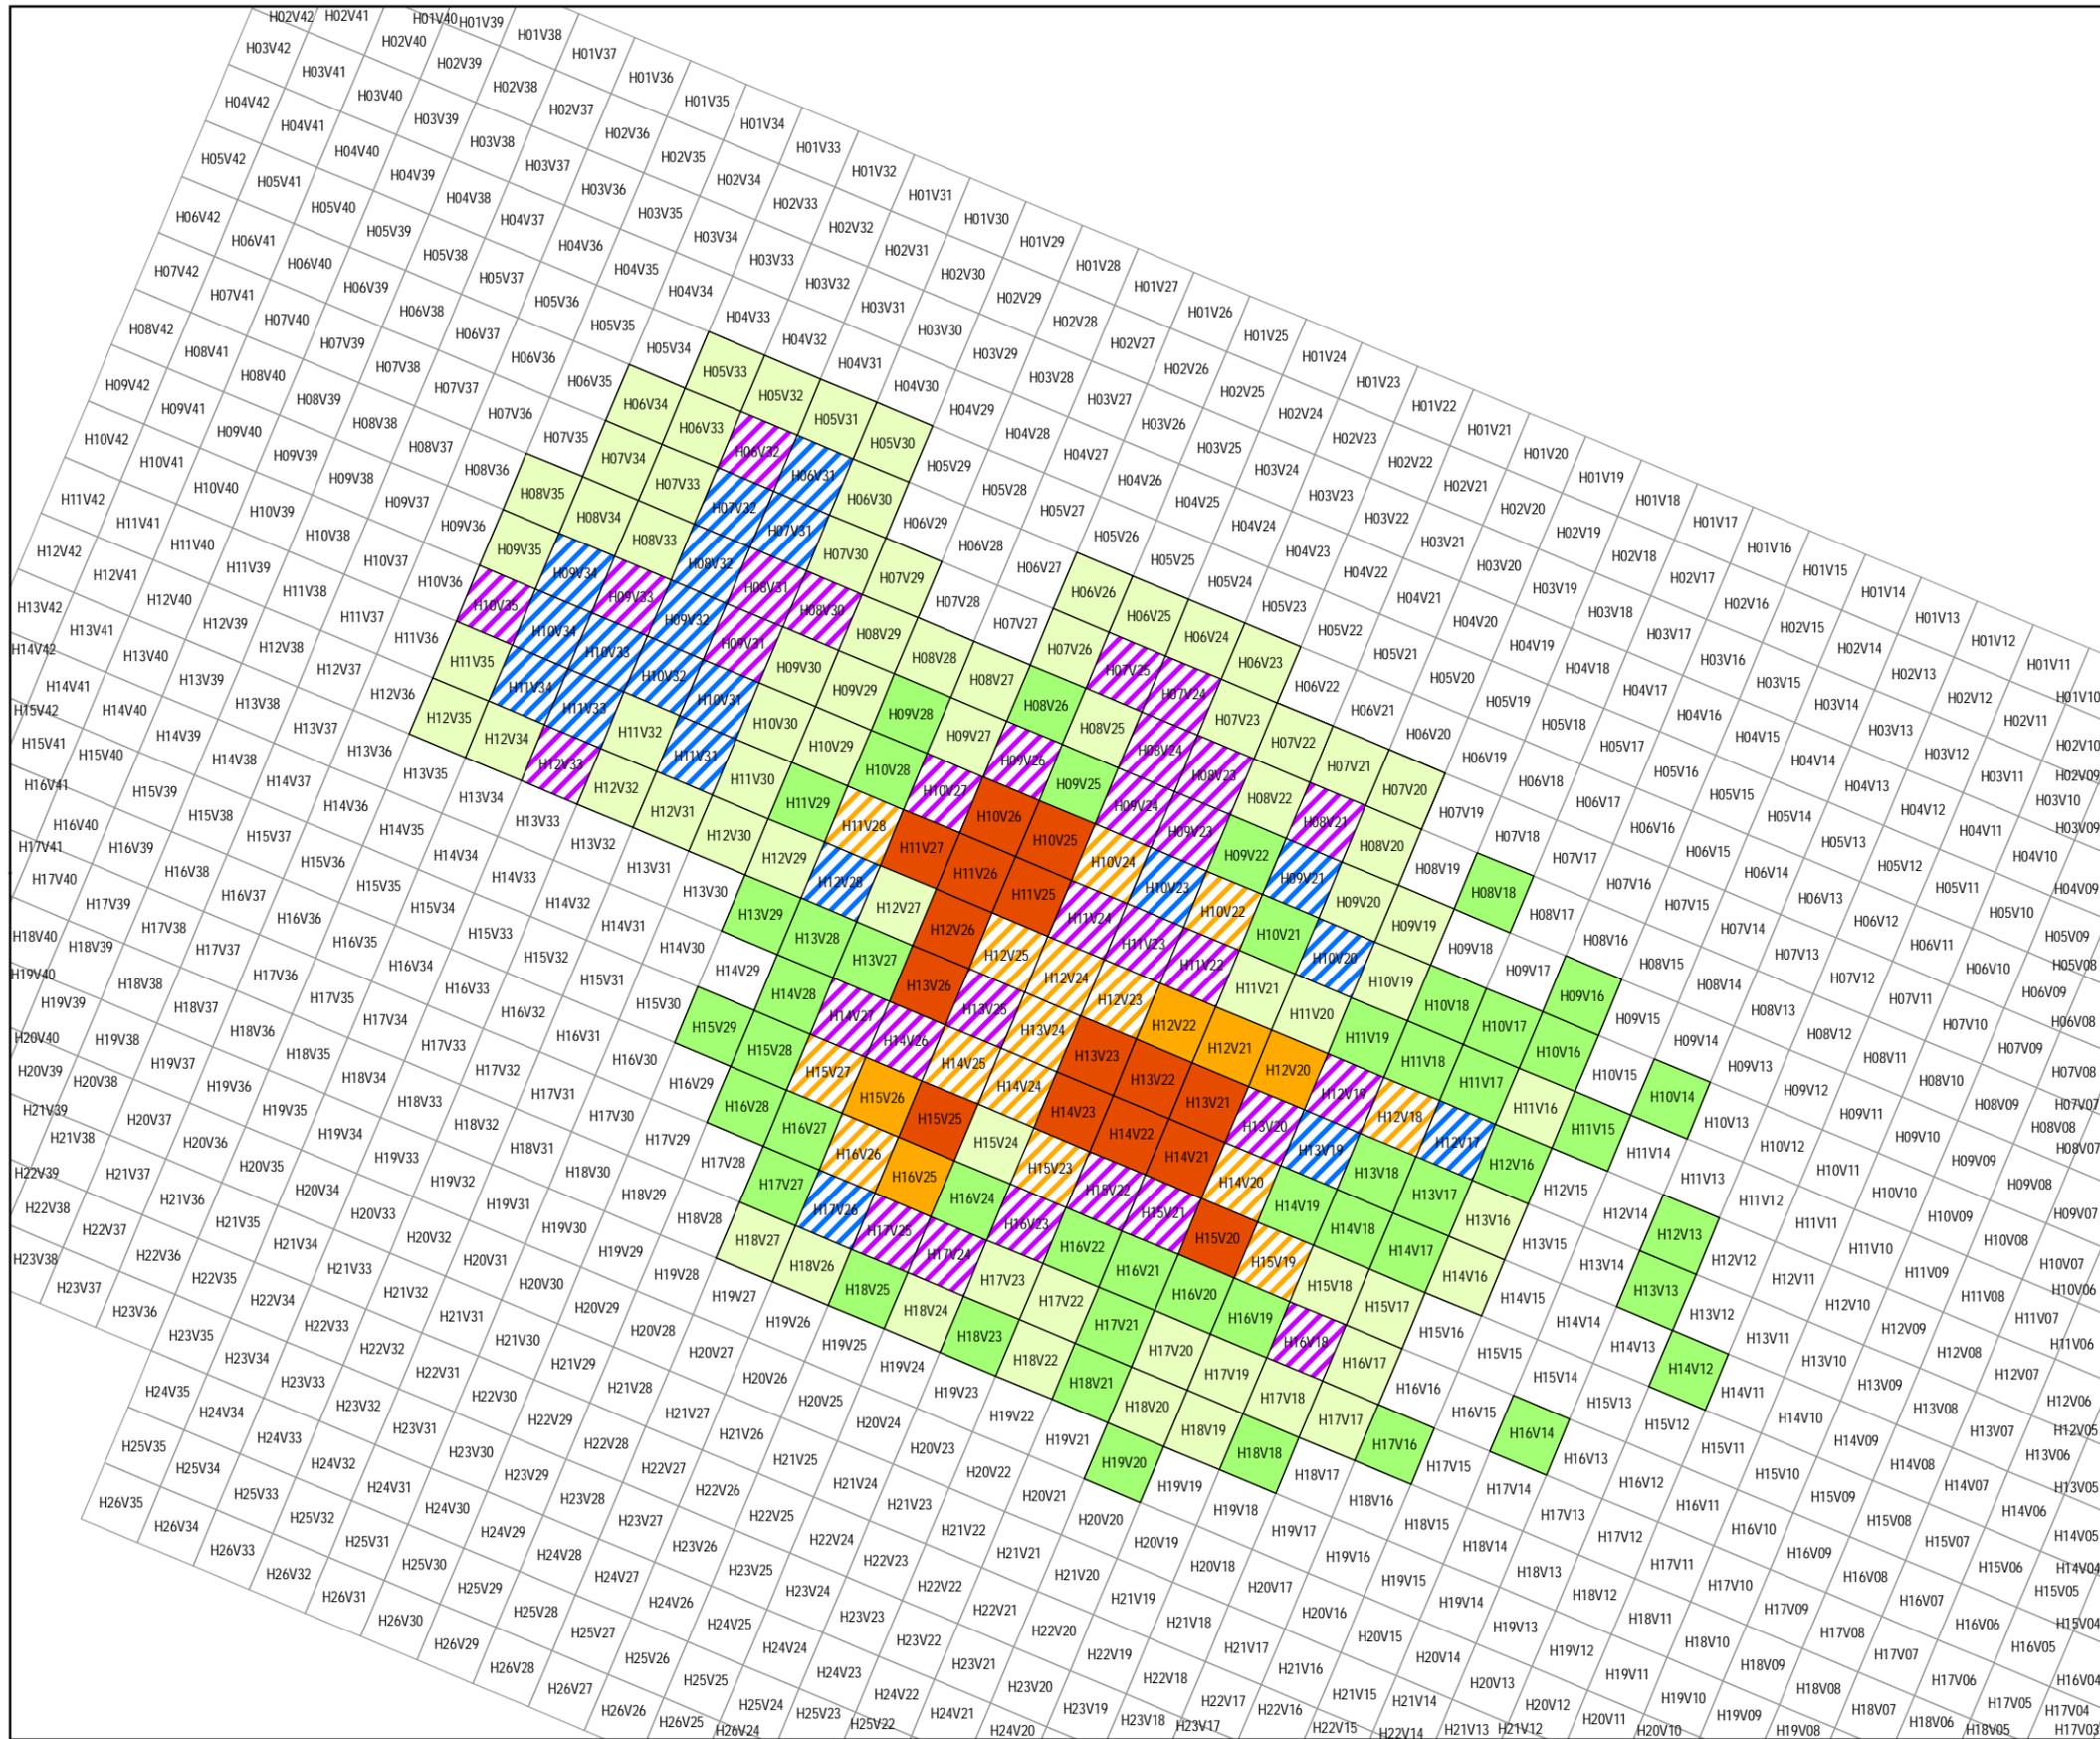
DATE: 06 NOV 2017	PROJECT MANAGER: G. Rutkowski	FIGURE NO.: A-12
--	----------------------	----------------------------------	---------------------

North Landfill
Radio Relay Station PCB Removal Action
Port Heiden, Alaska

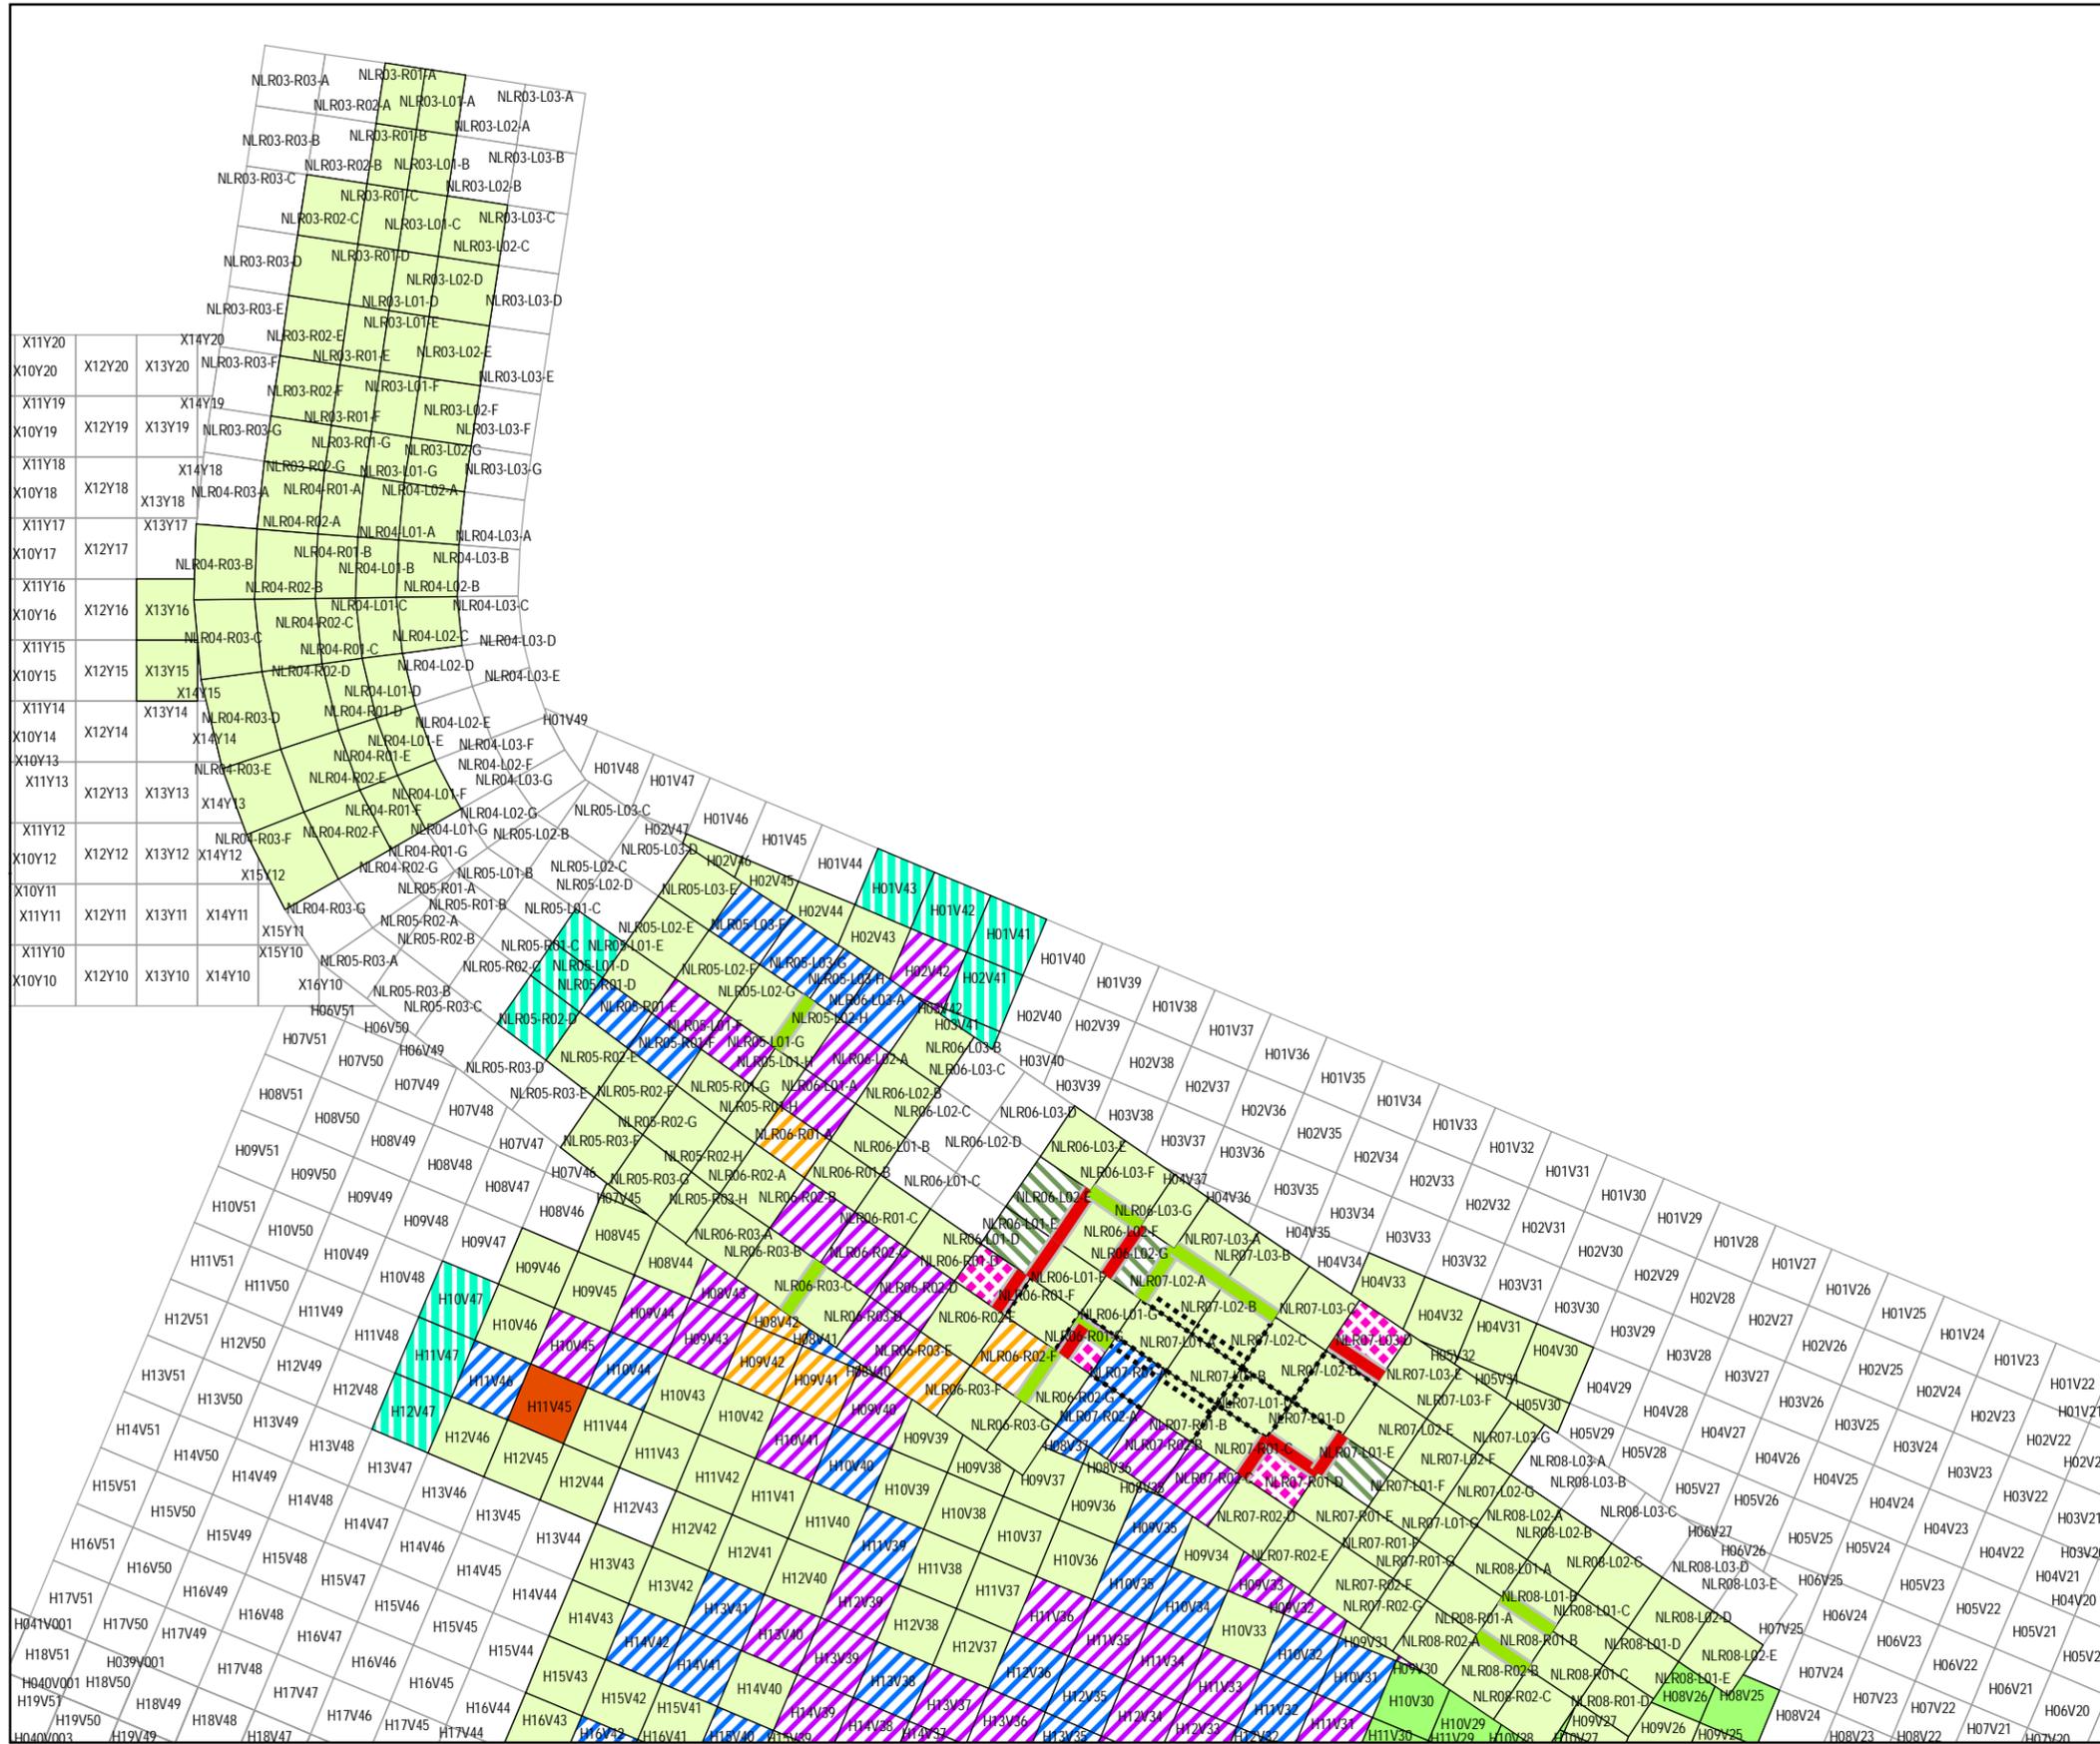
DATE: 06 NOV 2017	PROJECT MANAGER: G. Rutkowski	FIGURE NO.: A-13
--	----------------------	----------------------------------	---------------------

North Landfill Road
Radio Relay Station PCB Removal Action
Port Heiden, Alaska

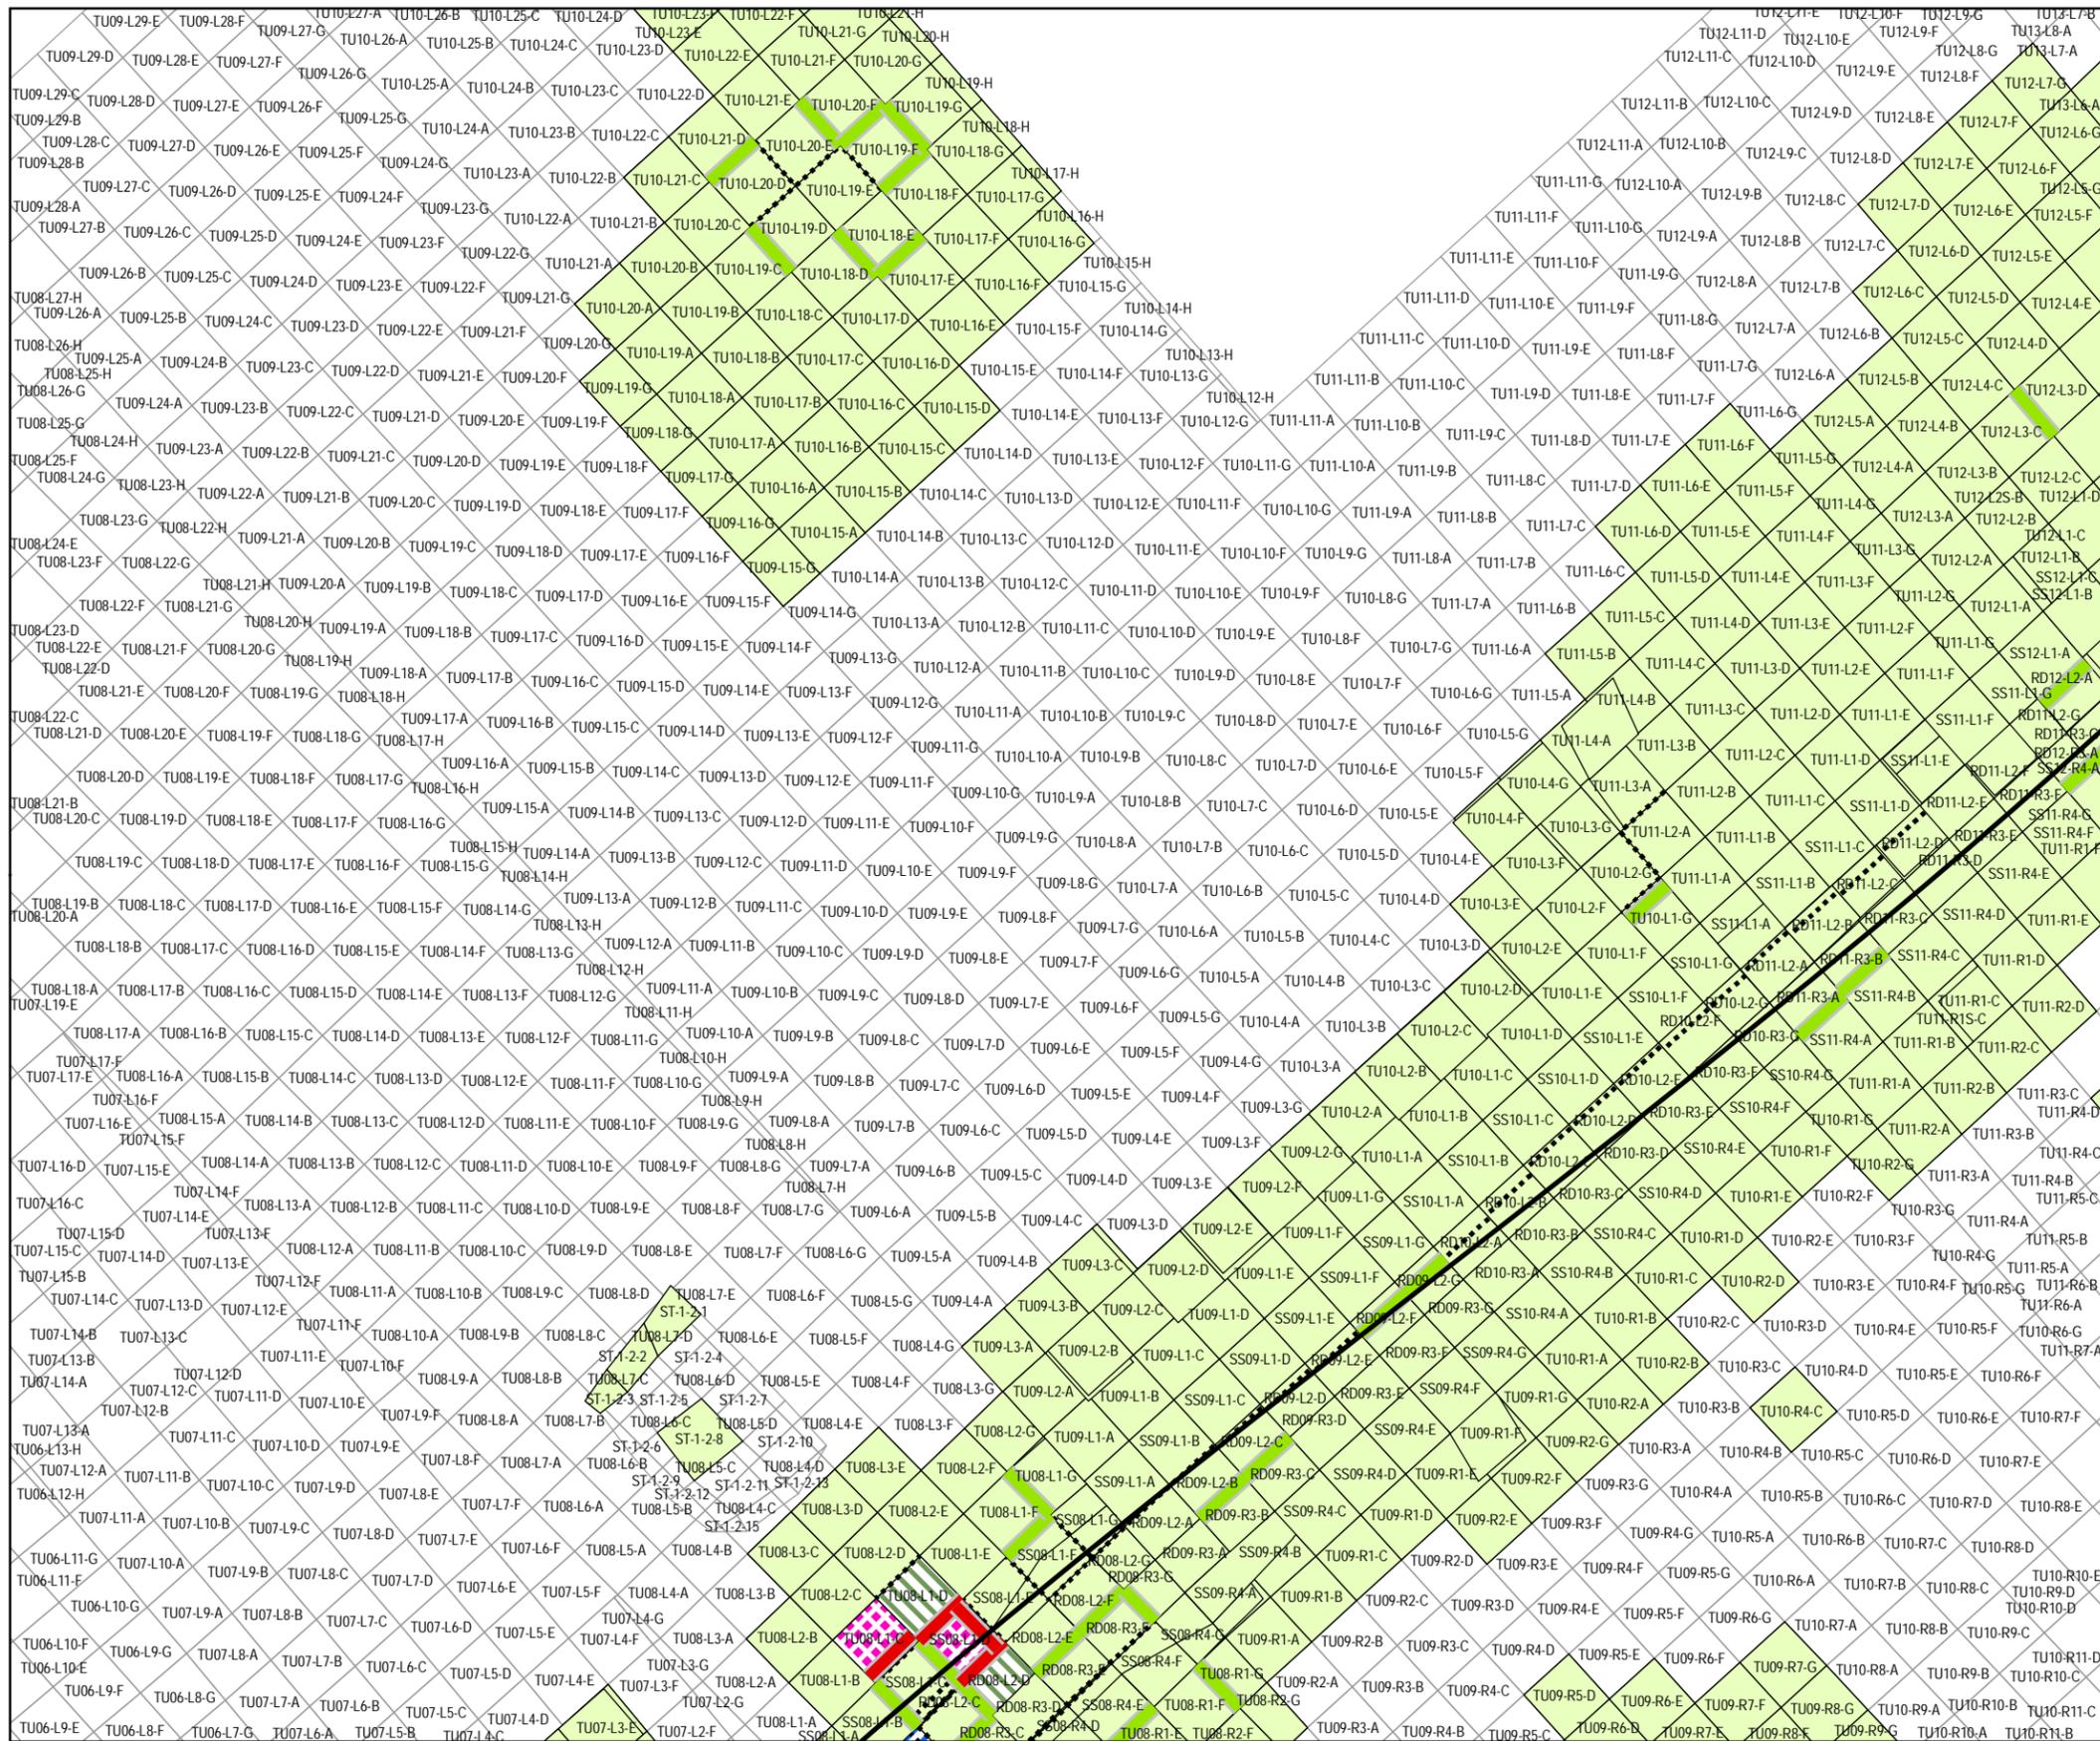
DATE: 06 NOV 2017	PROJECT MANAGER: G. Rutkowski	FIGURE NO.: A-15
--	----------------------	----------------------------------	---------------------

Lower Site Road 1
Radio Relay Station PCB Removal Action
Port Heiden, Alaska

- Soil Removal Area 2 (SRA2) (Figures A-3 through A-6)
- North and south Upper Site Road areas (Figures A-7 and A-8)
- Access Road (Figure A-9)
- Sections 89-92 along Upper Site Road and the associated tundra (Figure A-10)
- Drum Storage Area (DSA) (Figure A-11)
- North Landfill and North Landfill Road (Figures A-12 and A-13)
- Septic Lagoon (Figure A-14)
- Sections along Lower Site Road (Figures A-15 and A-16)

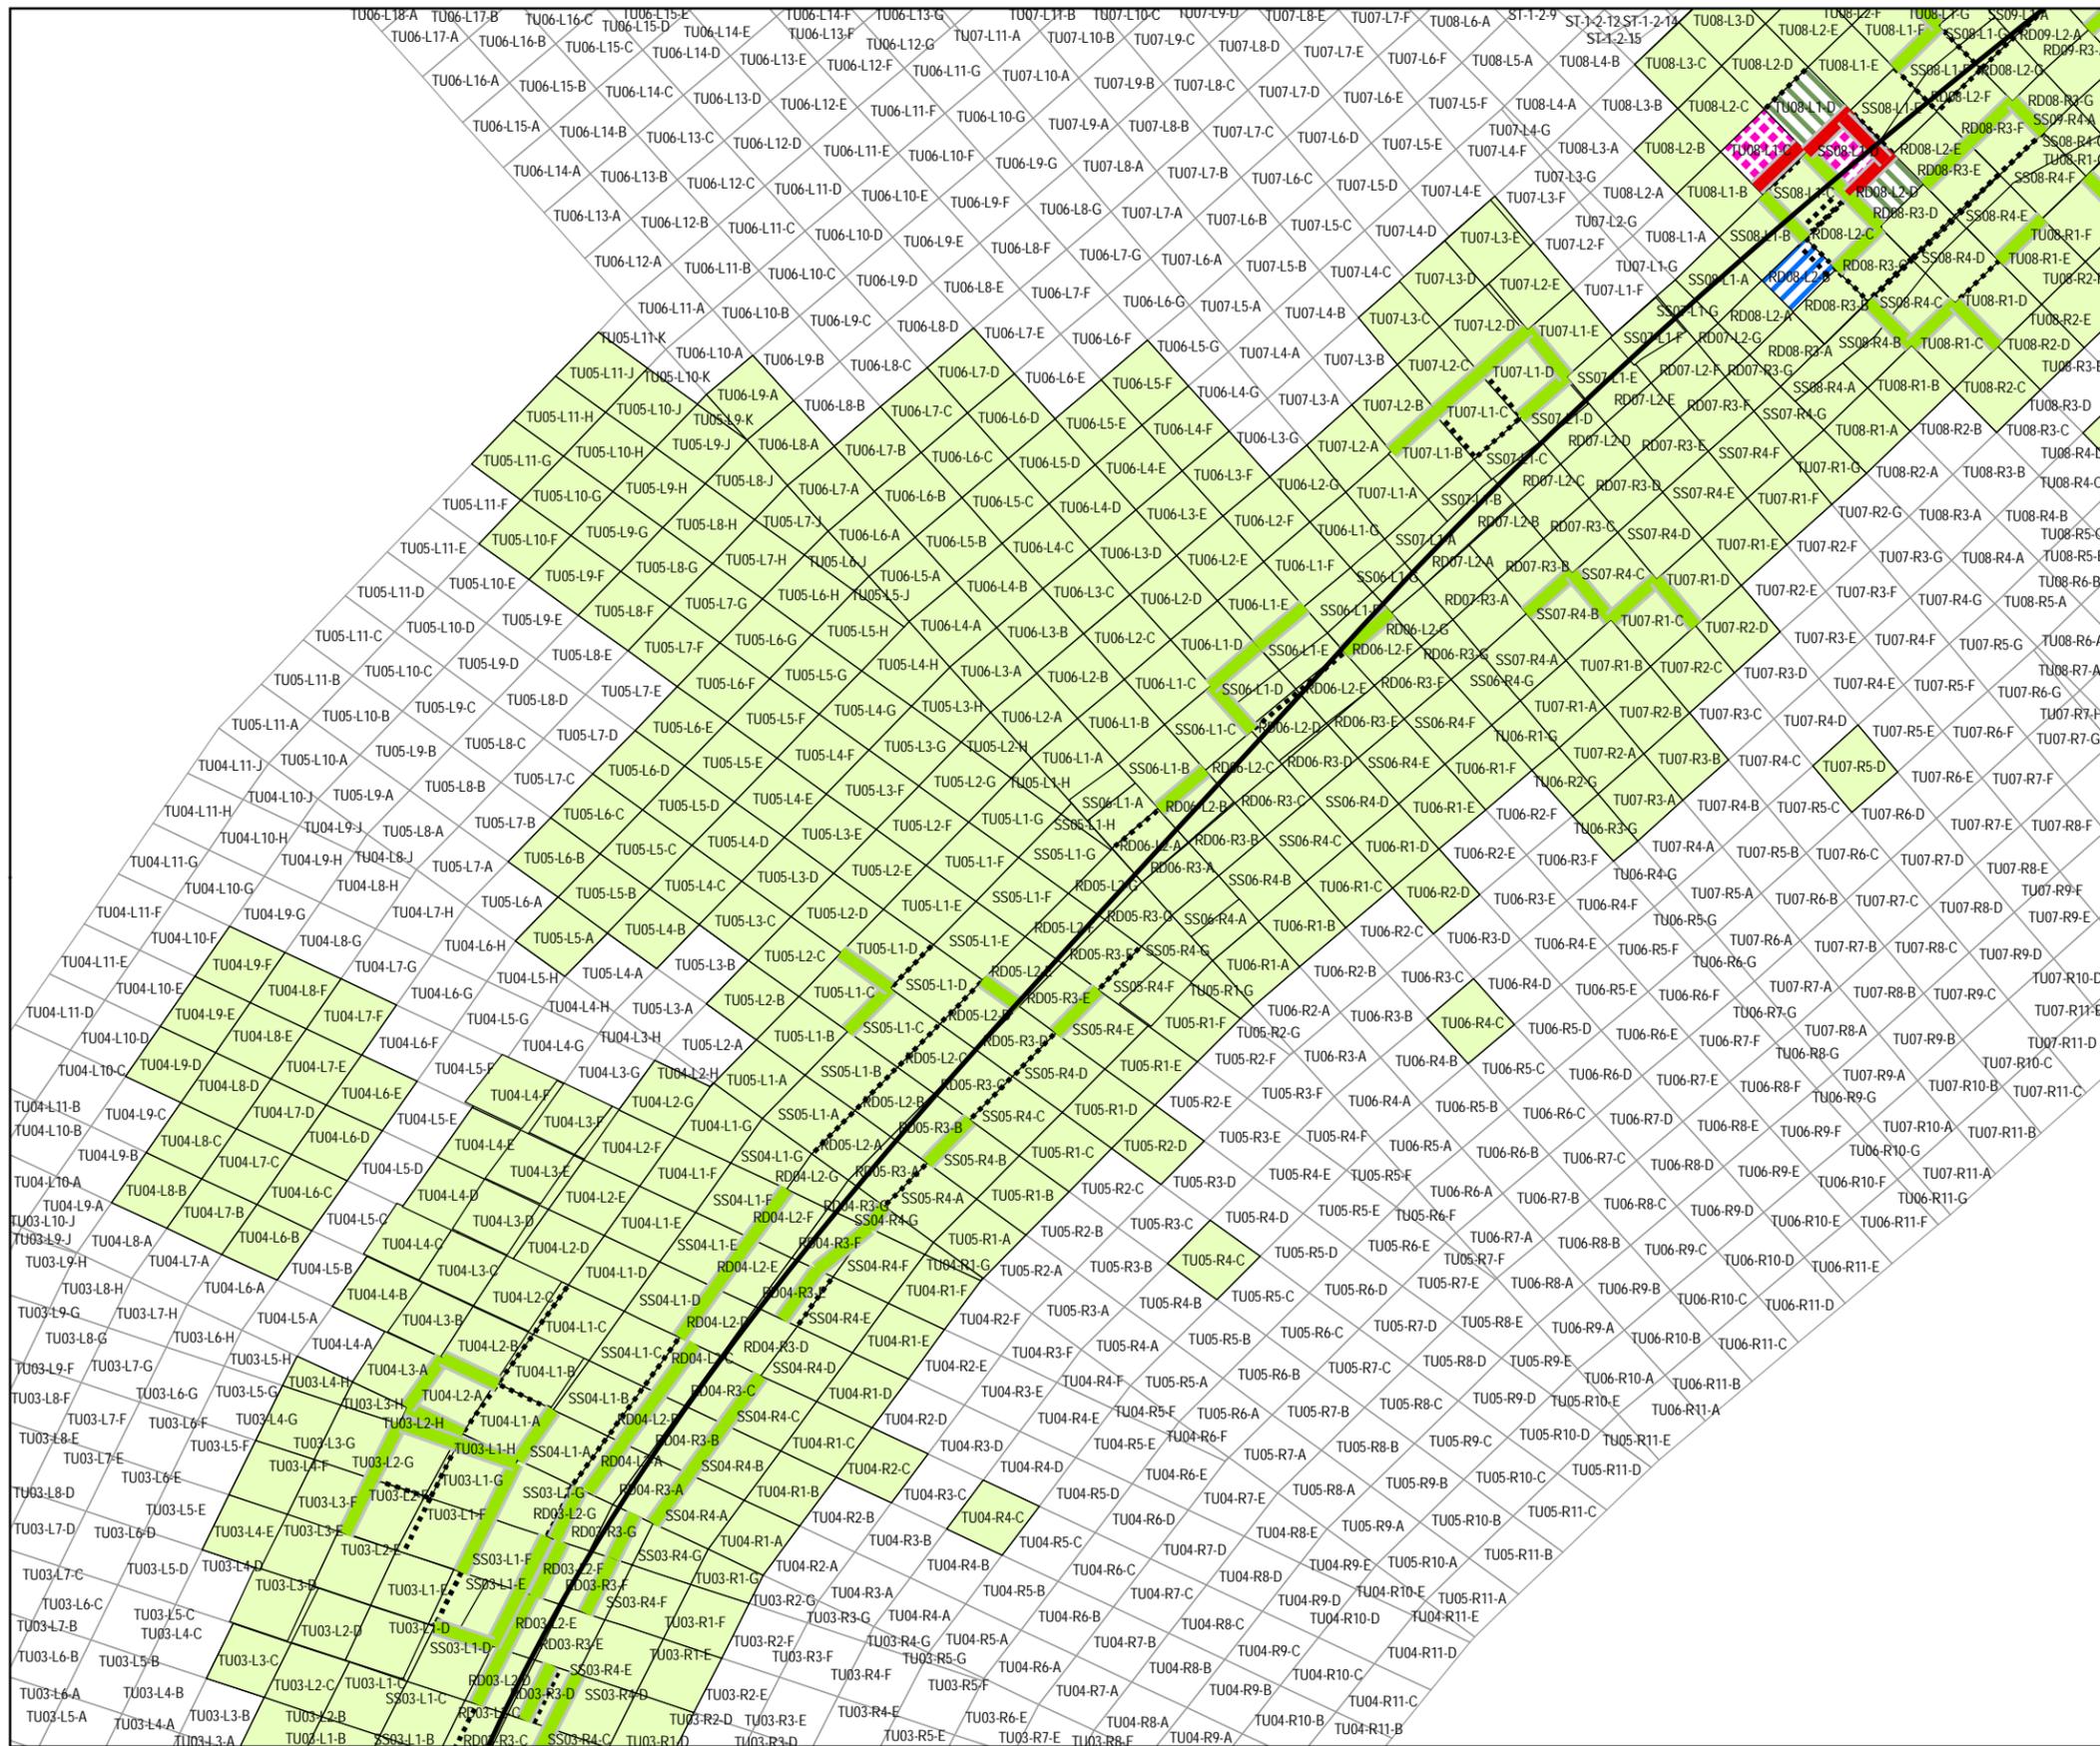
DATE: 06 NOV 2017	PROJECT MANAGER: G. Rutkowski	FIGURE NO.: A-16
--	----------------------	----------------------------------	---------------------

Lower Site Road 2
Radio Relay Station PCB Removal Action
Port Heiden, Alaska

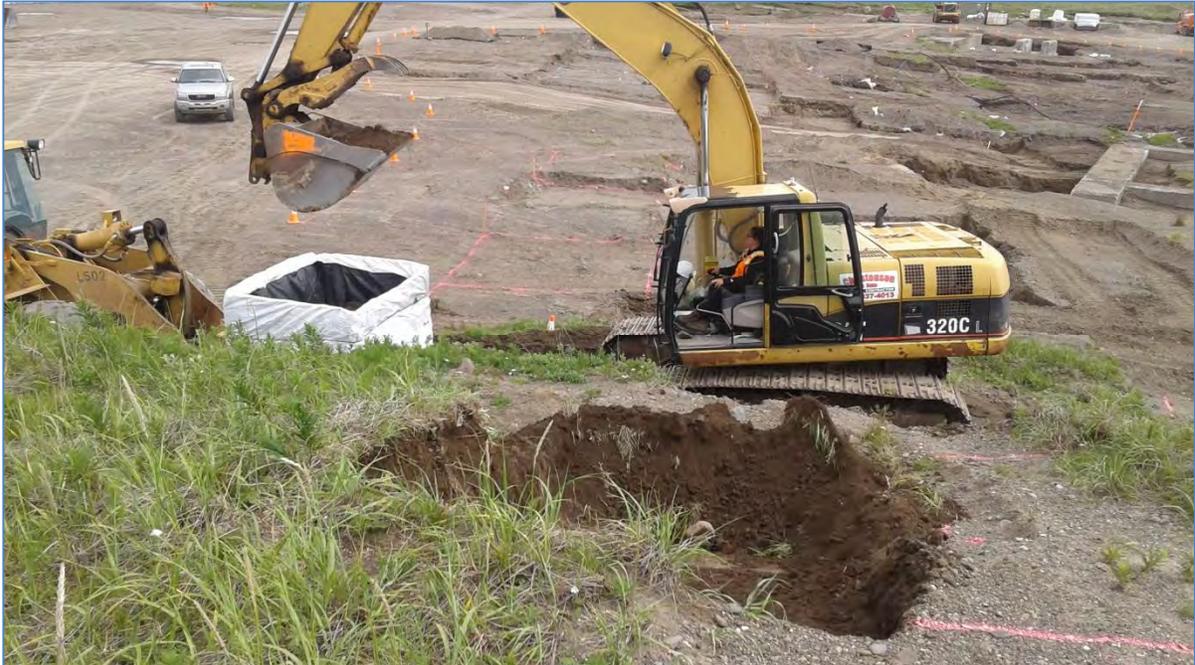
Photo No. 1 – 30 June 2016

Excavation at Soil Removal Area 2; contaminated soil being transferred into bags.
View facing east.

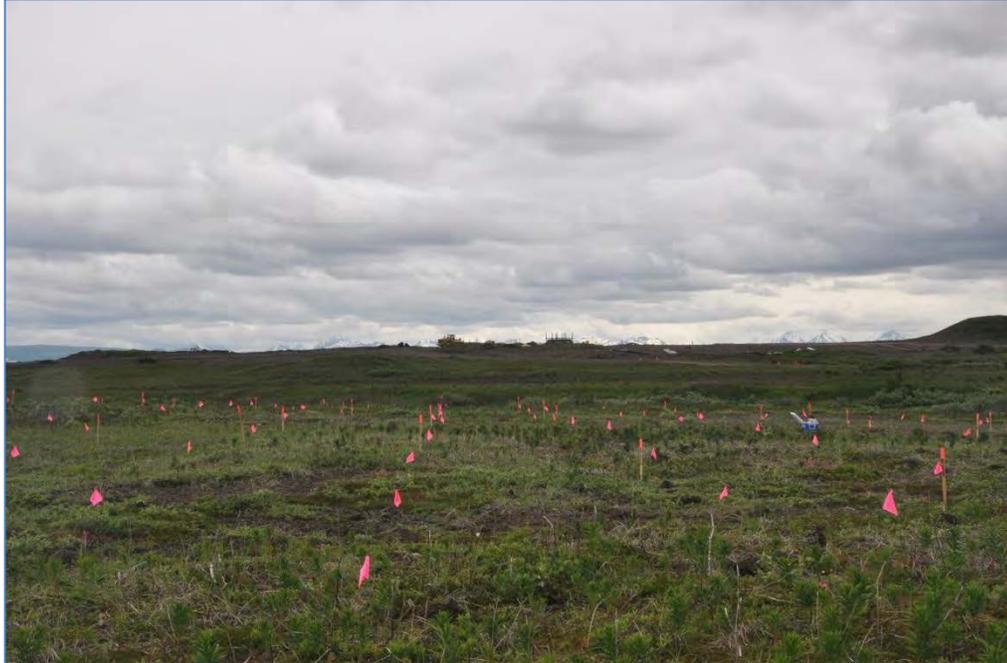
Photo No. 3 – 11 June 2016

North Landfill grids established ready for characterization sample collection. Soil Removal Area 2 excavation in the background. View facing south.

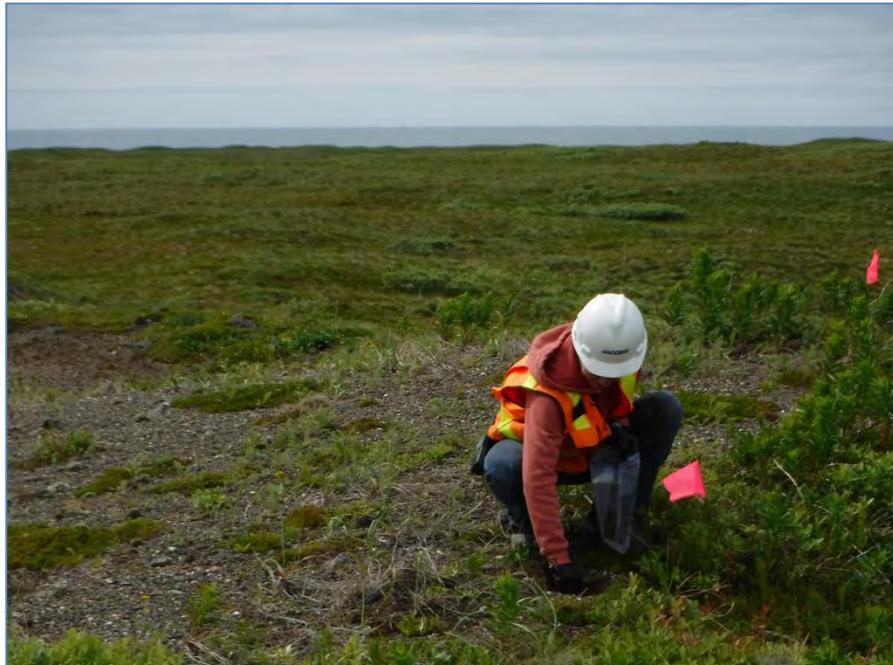
Photo No. 4 – 22 June 2016

Collection of characterization samples at North Landfill. View facing west.

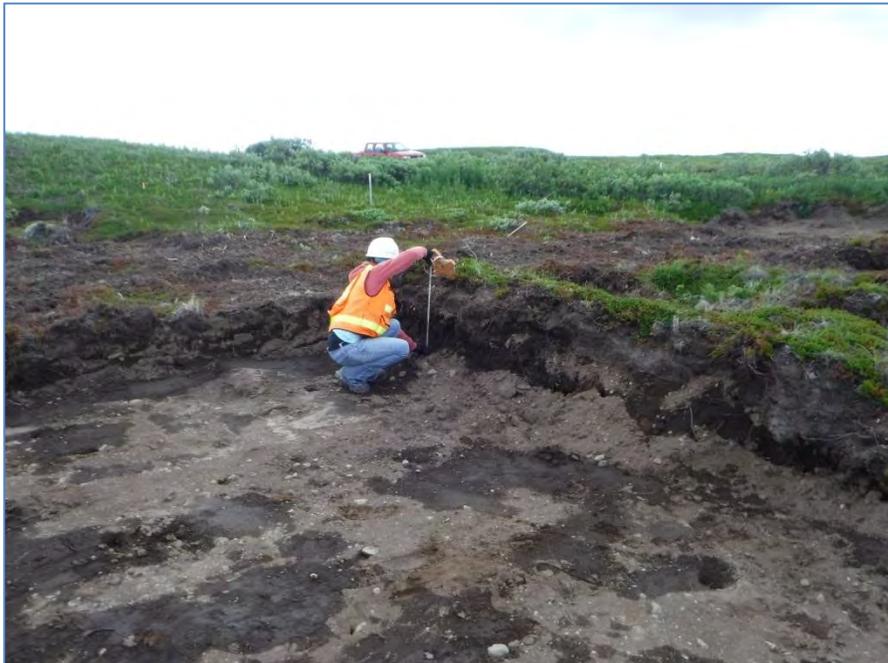
Photo No. 6 – 29 June 2016
Measuring walls within the tundra area to determine if wall sample collection needs to occur.
View facing west.

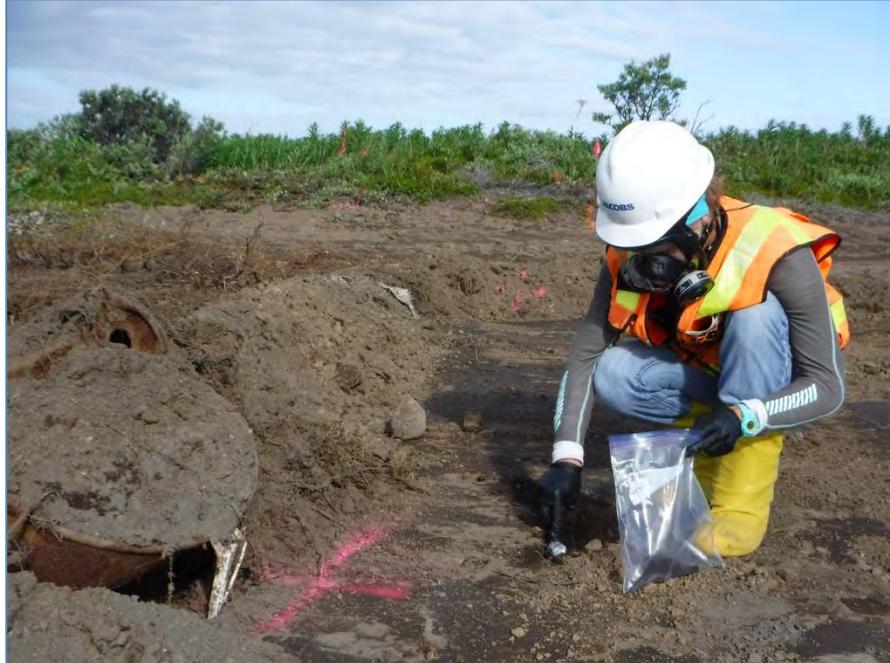
Photo No. 7 – 29 June 2016

Sample collection of confirmation samples post excavation at the North Landfill adjacent to drums. View facing east.

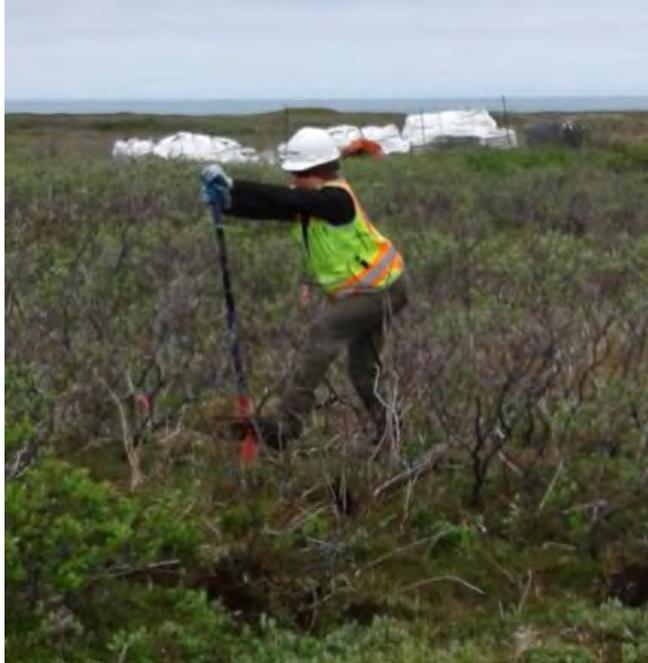
Photo No. 8 – 21 June 2017

Hand excavation for characterization sampling within the Soil Removal Area 2. View facing east.
