**PACIFIC AIR FORCES
REGIONAL SUPPORT CENTER**

**2016–2018 PCB-CONTAMINATED SOIL
REMOVAL ACTION REPORT**

PORT HEIDEN, ALASKA

**FINAL
JANUARY 2019**

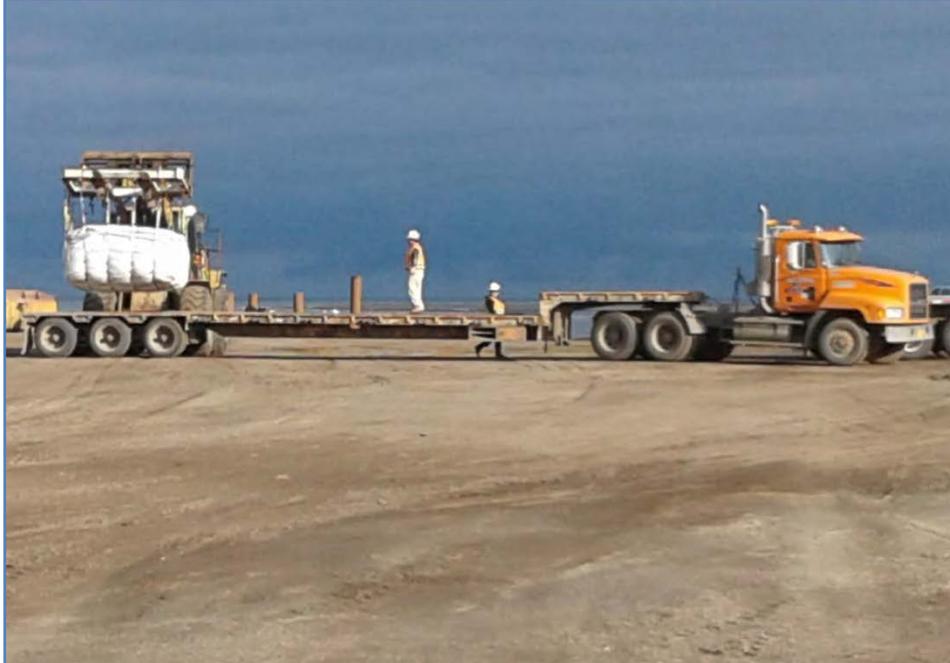
Photo No. 11 – 19 August 2016
Loading bags onto flatbed for waste transport. View facing northwest.

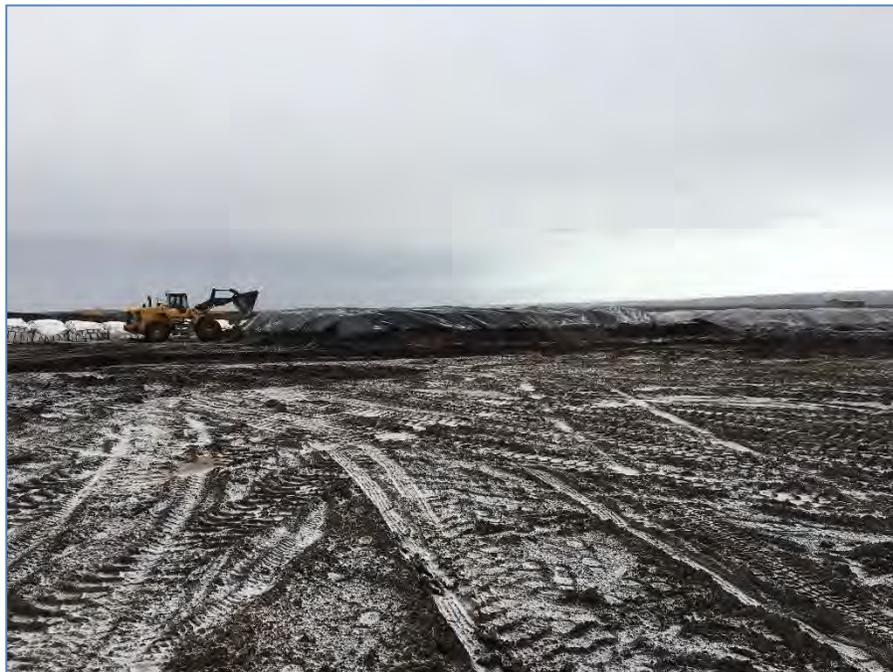
Photo No. 12 – 23 February 2018
Repairing top cover over the super sacks after winter storm. View looking northeast.
