Re: CIP No. 63-204  
Phase I ESA for South Pad Final Report

**PHASE I ENVIRONMENTAL SITE ASSESSMENT  
SOUTH PAD**

**NORTH SLOPE BOROUGH  
DEPARTMENT OF CAPITAL IMPROVEMENT PROGRAM MANAGEMENT  
P.O. Box 350  
Barrow, Alaska 99723**

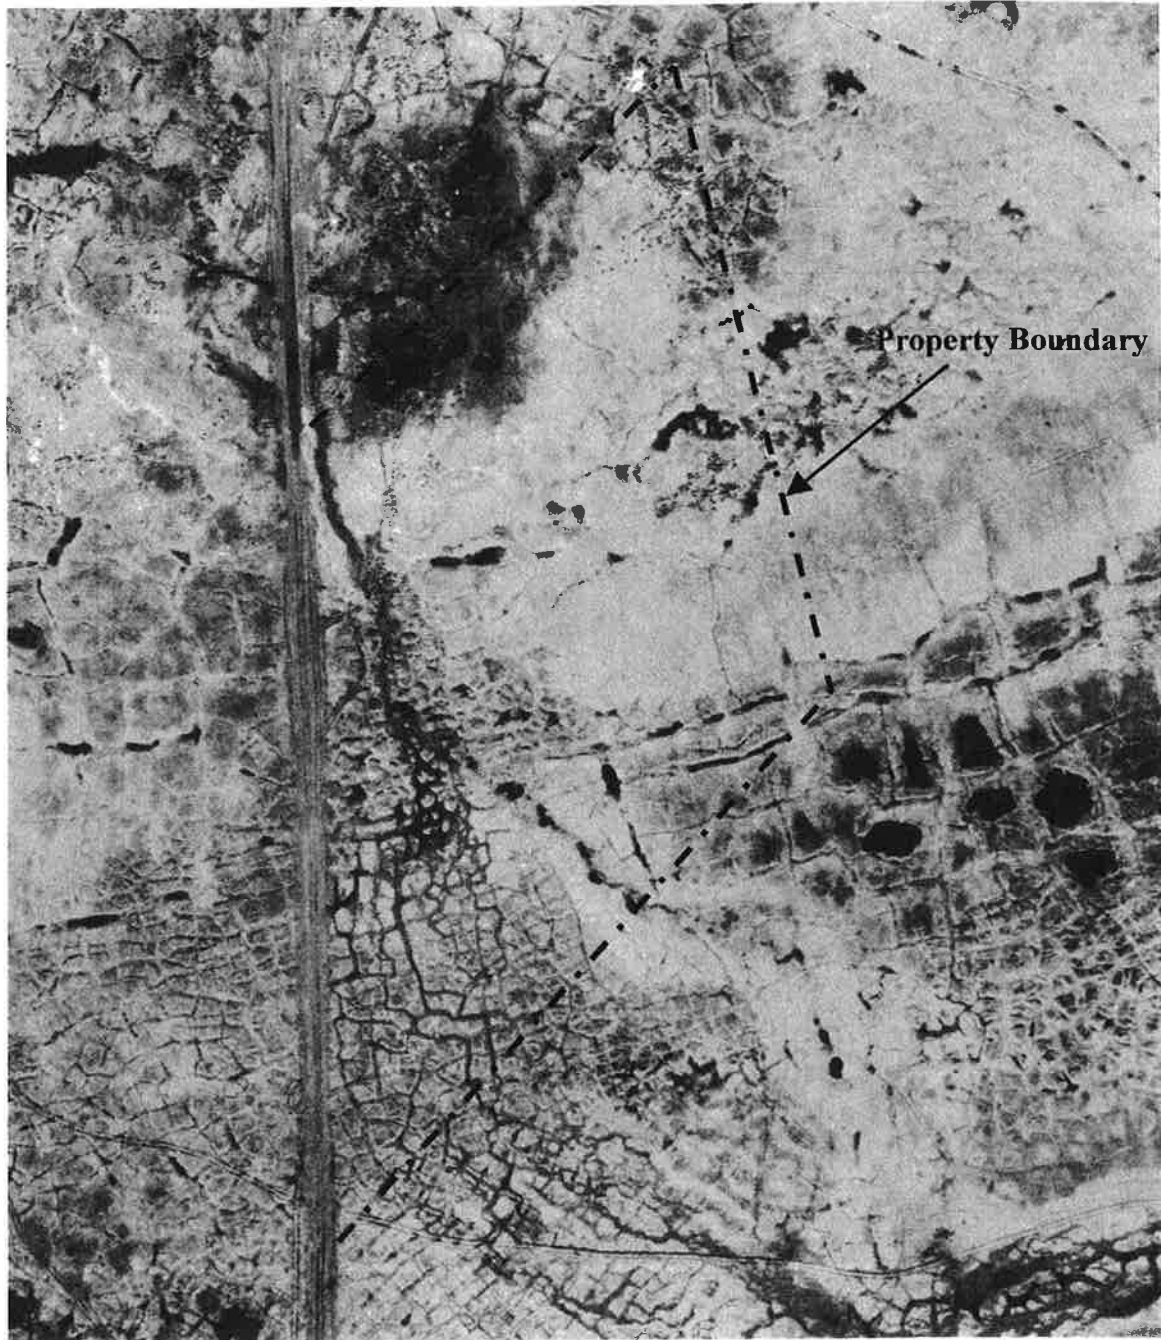
**1971 AERIAL PHOTOGRAPH OF SOUTH PAD, BARROW ALASKA**

The 1971 aerial photograph shows no development of the subject property (Appendix A). The site location is dominated by permafrost and wetland areas. Characteristics of the permafrost shown are indicative of wetlands and include patterned ground, permafrost islands, and thaw lakes. The photograph revealed no areas of stressed vegetation.

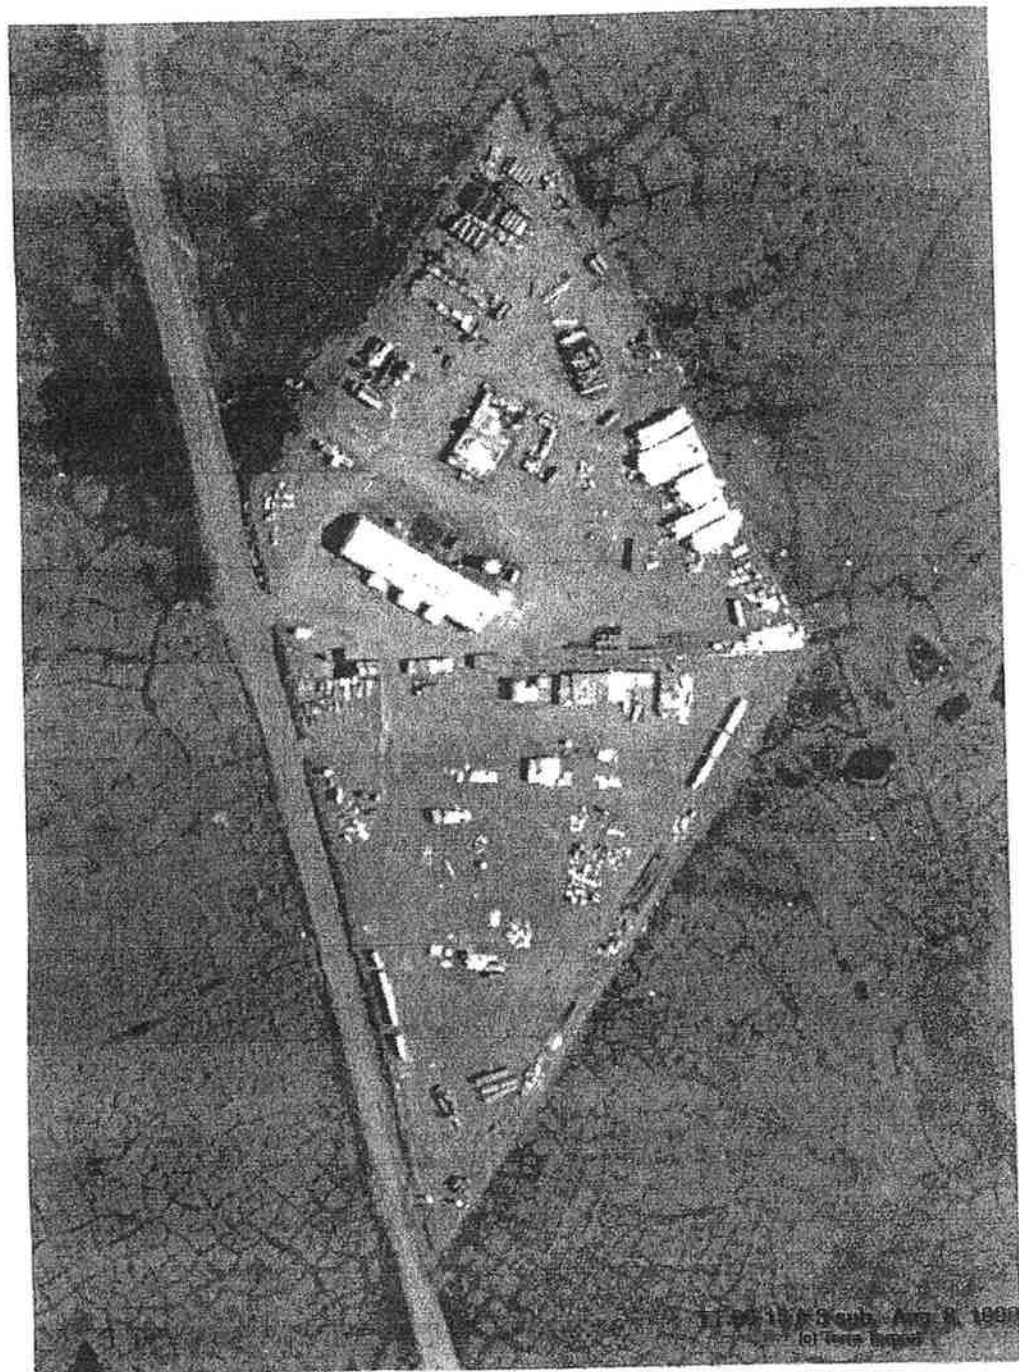
**1999 AERIAL PHOTOGRAPH OF SOUTH PAD, BARROW ALASKA**

The 1999 aerial photograph shows the site conditions as they exist currently. The large debris fields along the eastern margin of the site have been cleaned-up. The outbuilding on the east side of the service shop has been removed and the site appears to be used for material storage. Overall, the materials stored on site appear to have decreased between 1991 and 1999. The numerous vehicles present in 1991 have been removed from the site. Much of the material
