# SITE CHARACTERIZATION FINAL REPORT

## FORMER KONGIGANAK SCHOOL TANK FARM KONGIGANAK, ALASKA

FINAL  
August 2009

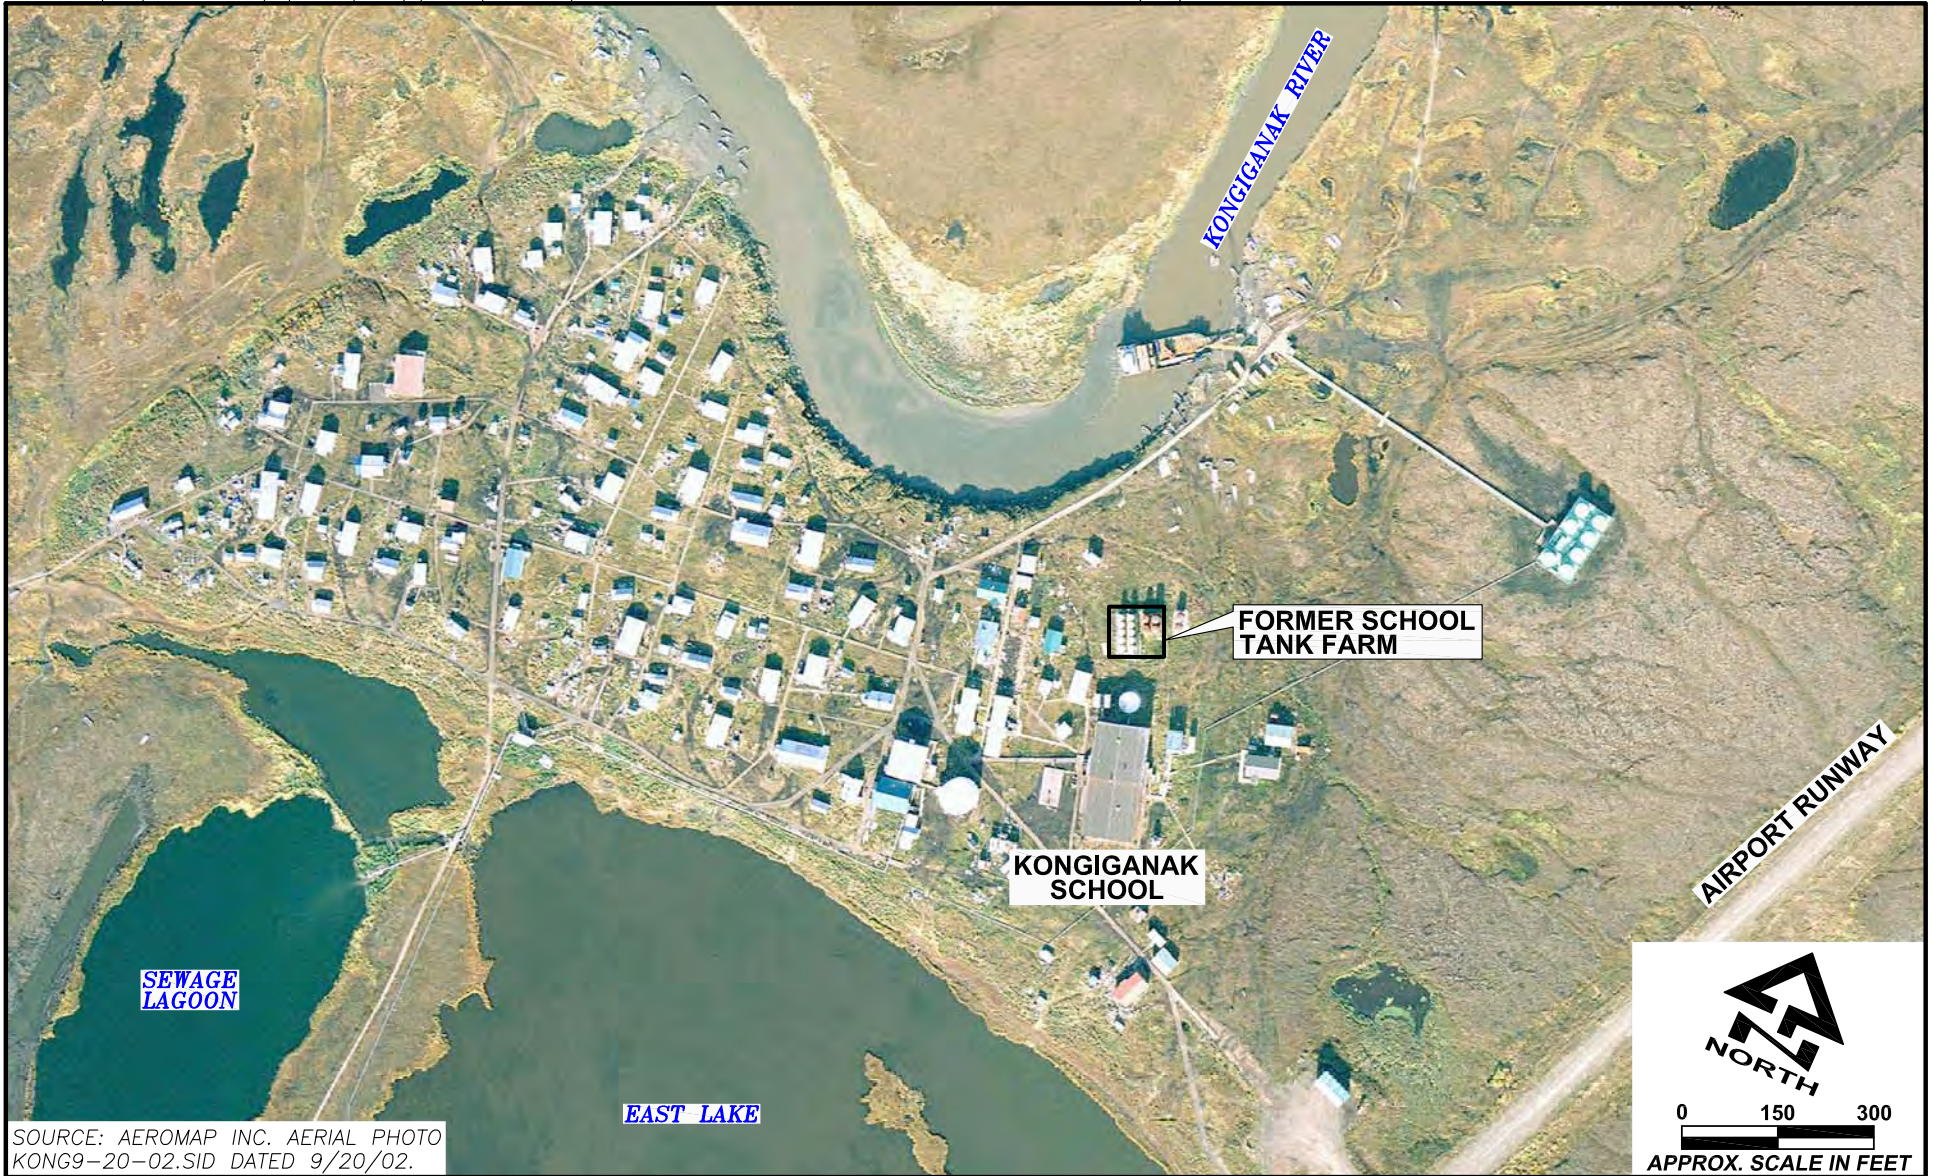
## SITE PLAN

The aerial photograph dated September 17, 2004 (Figure 3), shows the remaining former tank farm infrastructure consisting of a roughly 40 by 40 foot deck and a 40 by 85 foot deck. At the time of the site visit, only the larger of the two decks was standing. The wooden pilings that supported the smaller deck remain in place. A berm partially enclosing an area south of the smaller deck and east of the large deck was found at the southeast corner of the site. Debris consisting of old sections of pipe, liner remnants, lumber, and miscellaneous household items were found on-site.

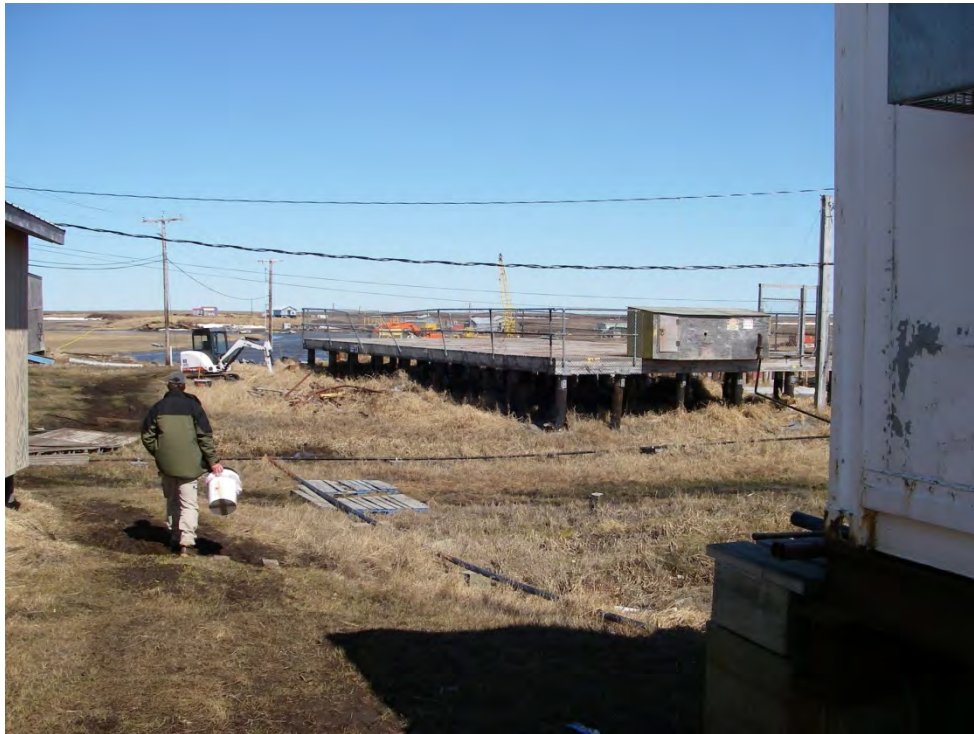
**PHOTO 2: VIEW TO THE NORTH OF FORMER TANK FARM DECK**

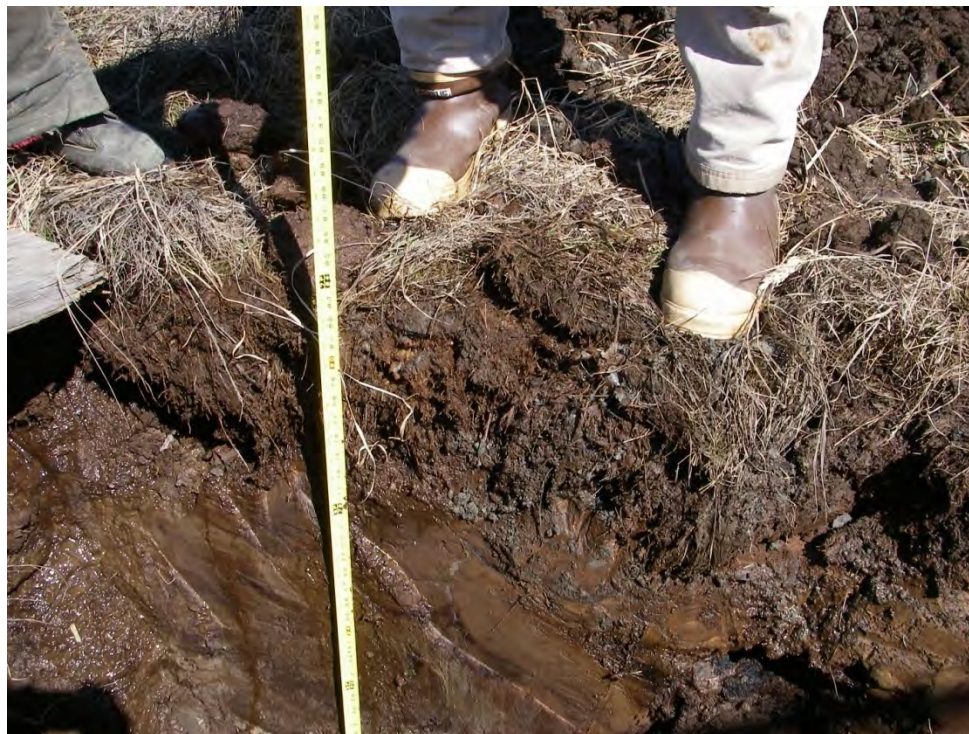
An approximately 1-foot-thick layer of frozen soil was encountered at 8 to 10 inches bgs. The backhoe was able to scratch through the frozen layer and dig to a maximum of 6 to 8 feet bgs, depending on the terrain. Ten test pits were excavated before a clogged fuel line shut down the excavator. Between three and six field screenings were obtained from each test pit at varying depths. Heated headspace photo-ionization detector (PID) analyses helped field personnel determine which samples would be submitted for GRO, BTEX, and DRO analysis. In addition, the two screenings with the highest PID values were also selected for volatile organic compound (VOC) and PAH laboratory analysis. The samples collected from the two hand-dug test pits were not submitted for laboratory analysis due to low PID readings.

**PHOTO 3: FROZEN LAYER, 1 FOOT BELOW GROUND SURFACE**

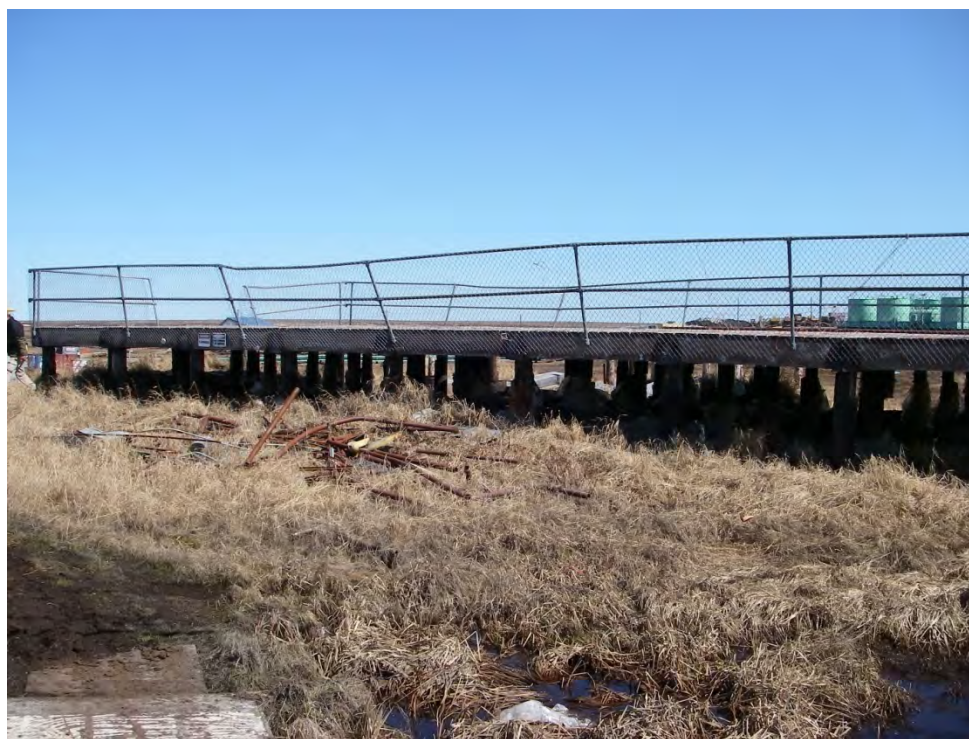
**PHOTO 4: DEBRIS AND OLD TANK FARM DECK, VIEW TO THE NORTH FROM EAST SIDE OF SITE**

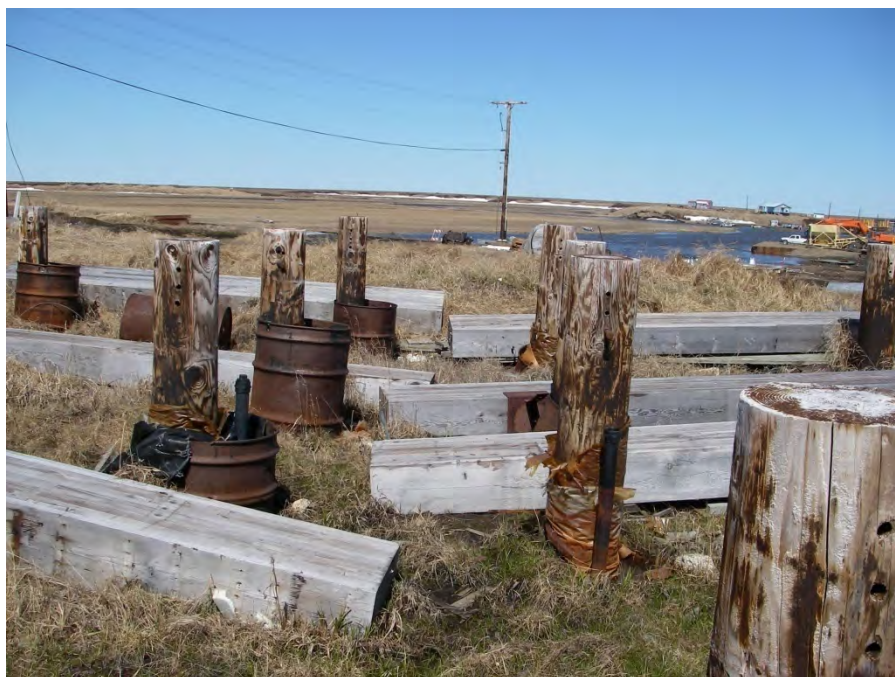
**PHOTO 6: PILINGS FROM SMALLER OLD TANK FARM DECK AT NORTH CORNER OF SITE,  
VIEW TO THE NORTHEAST, TEST PIT TP-3 LOCATED TO THE RIGHT OF THE PHOTO**

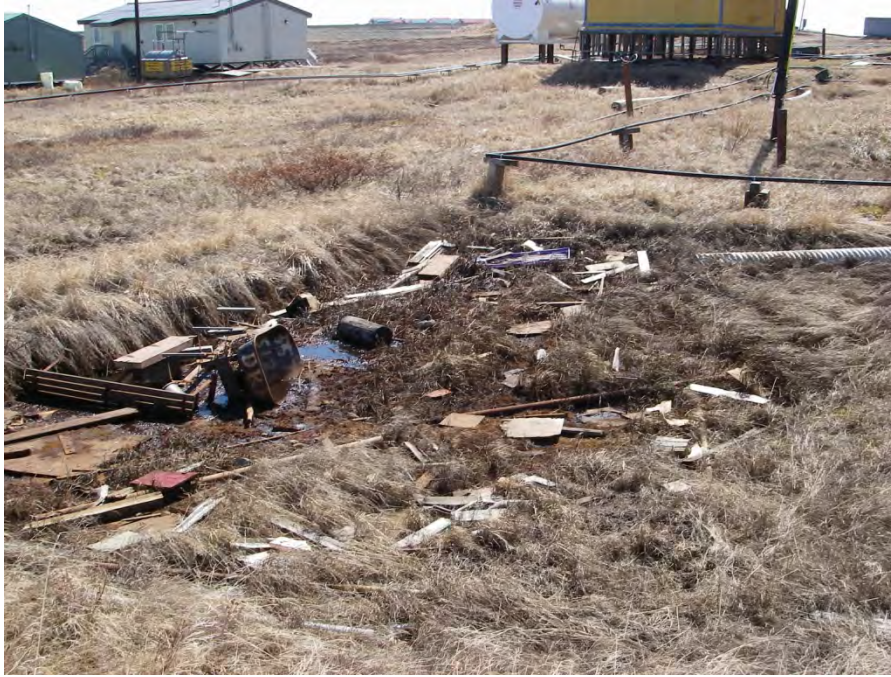
**PHOTO 7: DEBRIS AND BERM AT SOUTHEAST CORNER OF SITE, VIEW TO THE SOUTHEAST, TEST PIT TP-4 IS LOCATED AT THE PHOTOGRAPHER'S LOCATION, TEST PIT TP-6 IS LOCATED JUST OUTSIDE THE BERM**

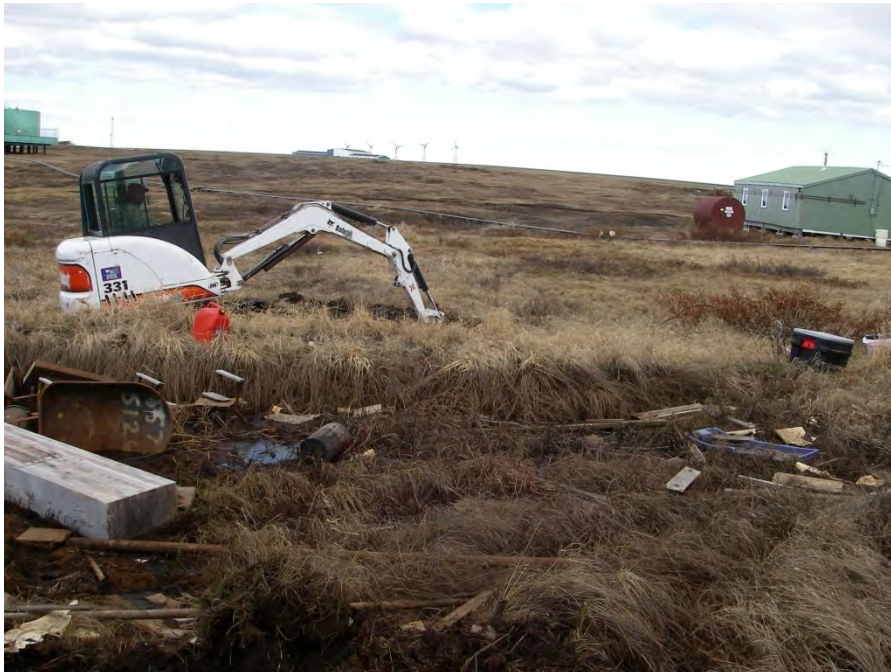
Test pit TP-6, located outside the old berm at the southeastern corner of the site, was sampled at 3.5 feet bgs (09-KON-111-SB) and 7 feet bgs (09-KON-122-SB). The shallower sample had a DRO result of 1,460 mg/kg. Its corresponding headspace value was only 14 ppmv. The deeper sample had a headspace reading of 8.2 ppmv and no detectable DRO values.

**PHOTO 8: DIGGING TP-6 OUTSIDE OF BERM AT SOUTHEASTERN CORNER OF SITE; VIEW TO THE SOUTHEAST.**

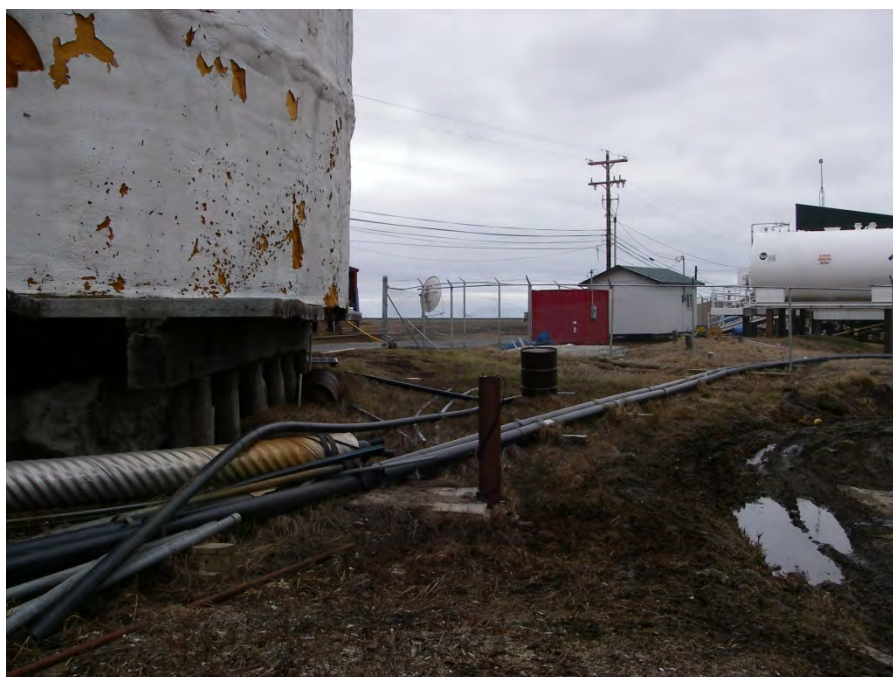
- A well was installed in town near the water treatment plant, but it was not used due to high salinity. Photograph 10 in the Photographic Log (Appendix B) shows the old drinking water well casing. The old well is approximately 350 feet south of the former tank farm. No depth or installation date was found for the old well.

**PHOTO 10: CASING IN CENTER OF PHOTO IS OLD WELL LOCATED NEAR WASHETERIA, APPROXIMATELY 350 FEET SOUTH OF THE FORMER SCHOOL TANK FARM, VIEW TO THE NORTH**
