SITE CHARACTERIZATION FINAL REPORT

FORMER KONGIGANAK SCHOOL TANK FARM KONGIGANAK, ALASKA

FINAL
August 2009

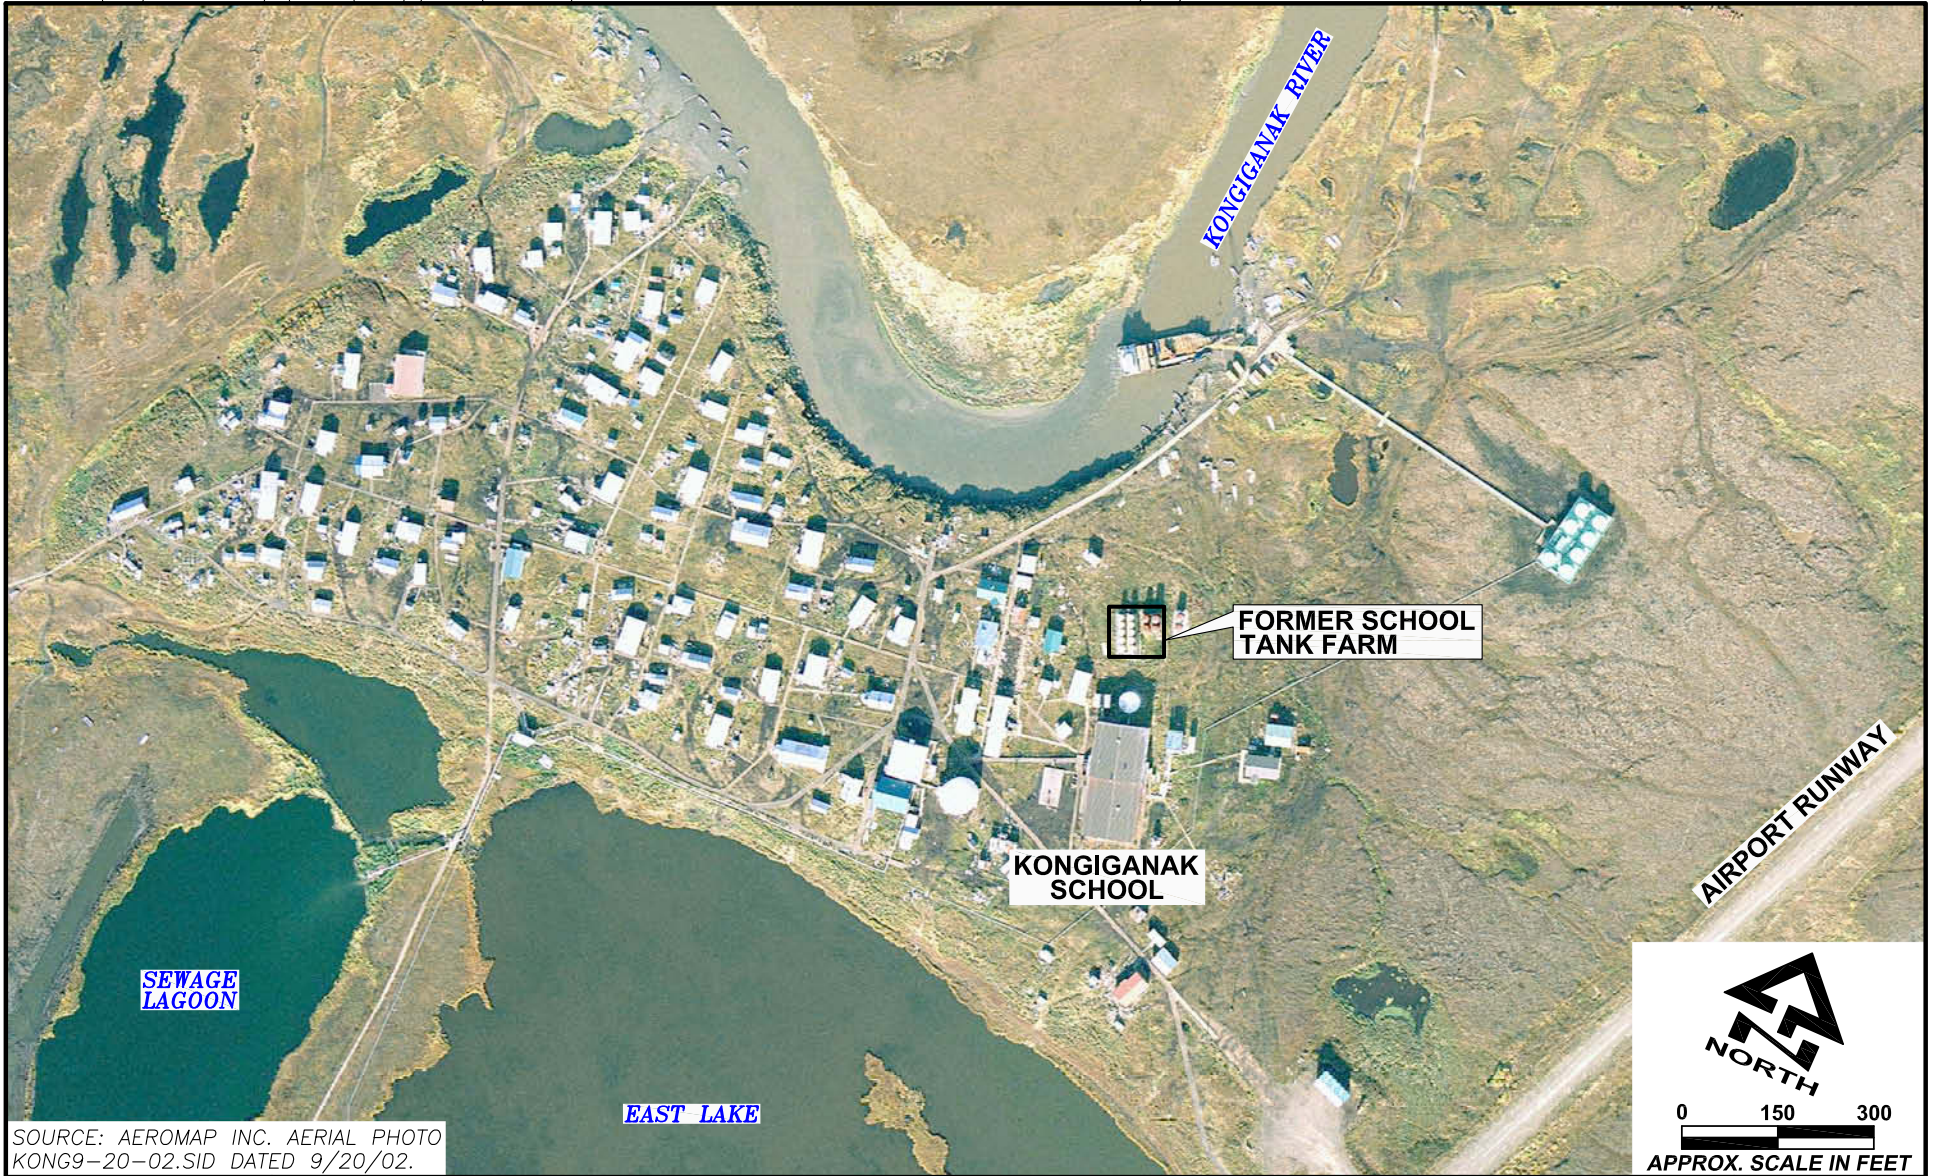
2

SITE PLAN

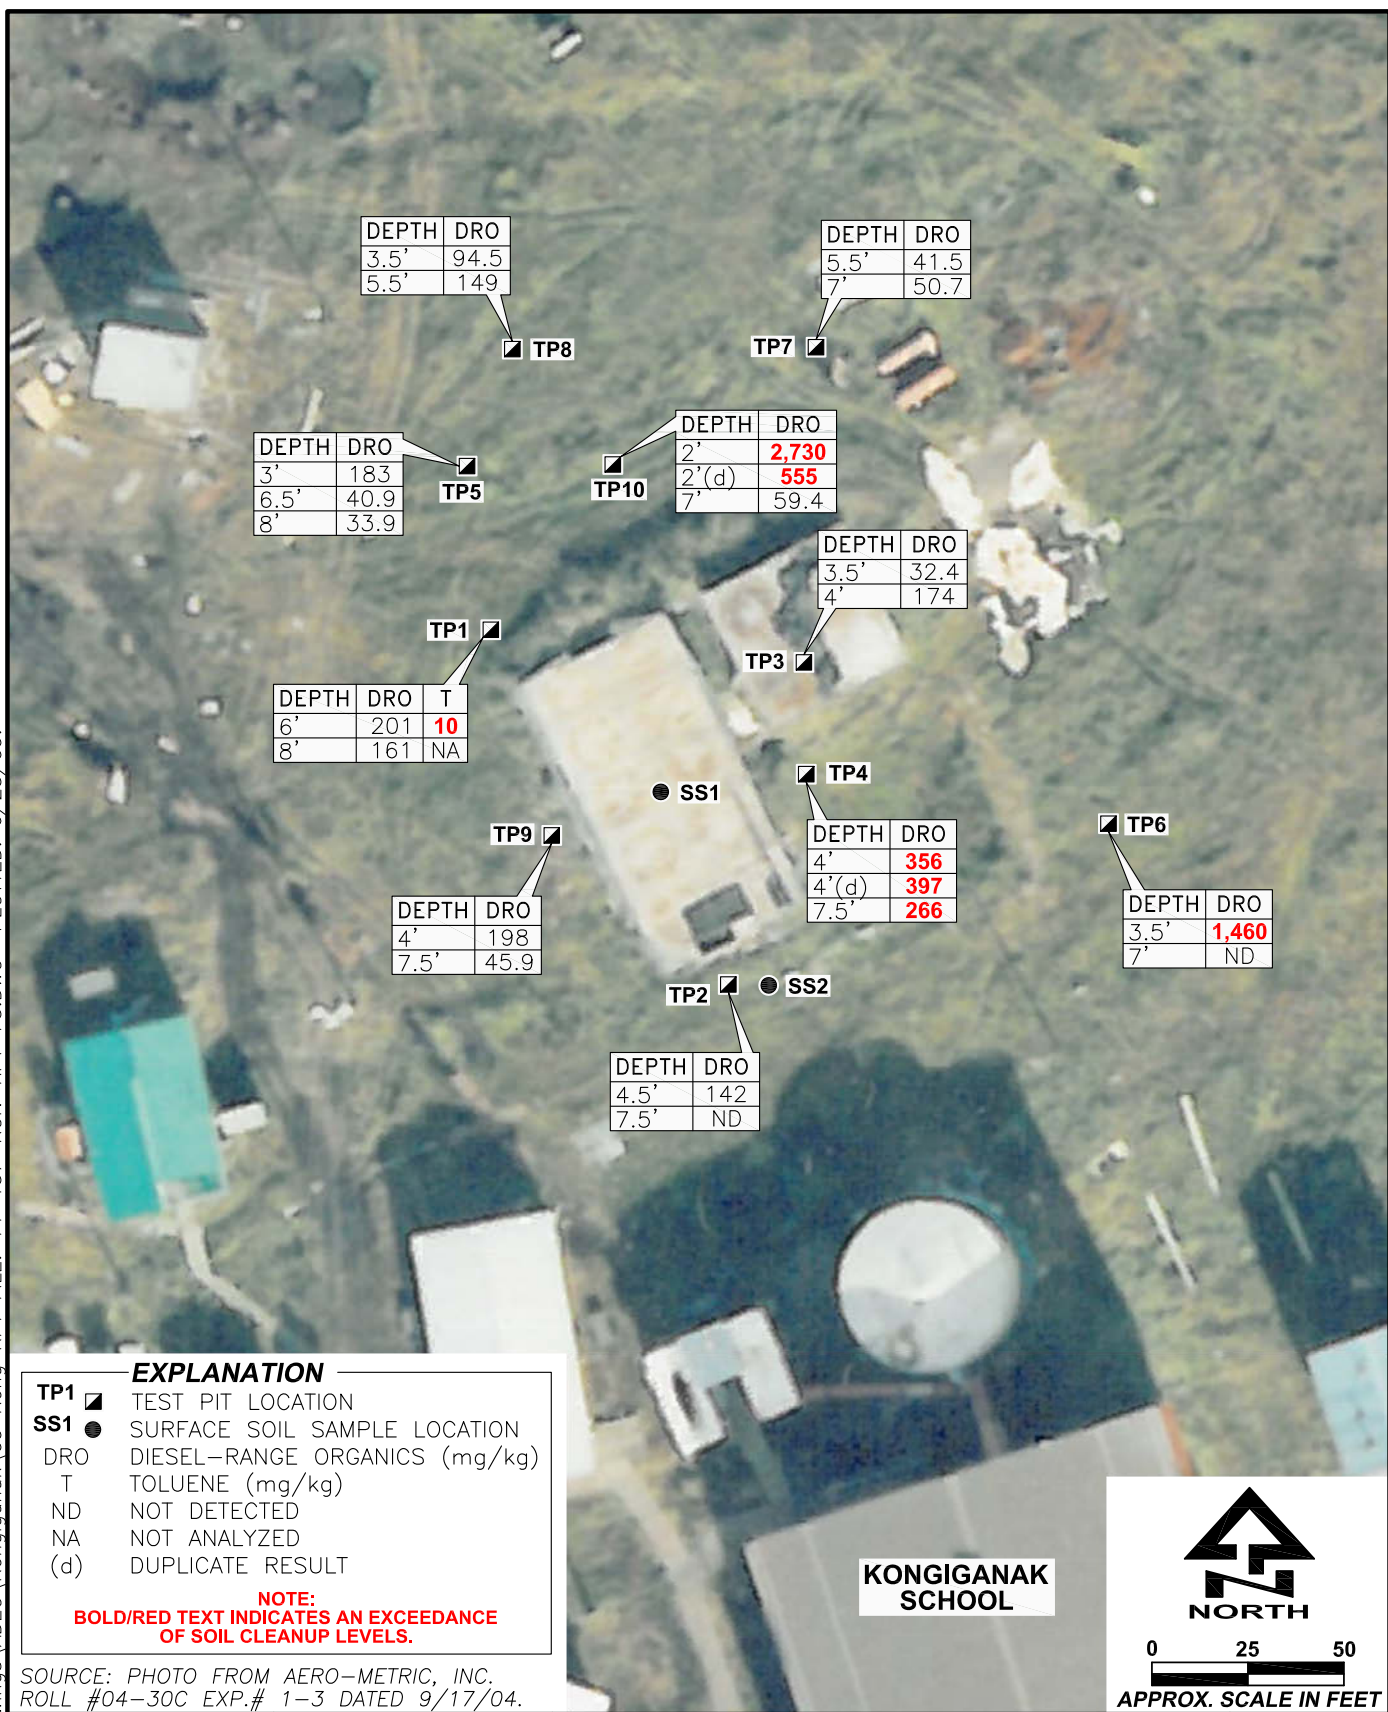
TP1 TEST PIT LOCATION

Test pit TP-4, located just east of the large platform, had the highest PID headspace reading of all test pit samples. The PID results were 715 and 376 parts per million by volume (ppmv) at 4 and 6 feet bgs, respectively. Sample 09-KON-106-SB and field duplicate 09-KON-107-SB were collected from TP-4 at 4 feet bgs and submitted for GRO, BTEX, DRO, VOC, and PAH analysis. DRO results for the sample and the duplicate both exceeded ADEC SCLs with values of 356 and 397 mg/kg, respectively. All other analyses from TP-4 at 4 feet bgs had values below the SCLs. The shallowest screening sample from TP-4 at 2.5 feet bgs had a headspace of 68.7 ppmv. At 7 and 7.5 feet bgs, headspace readings were 44.5 and 43.4 ppmv, respectively. The DRO concentration in sample 09-KON-108-SB, collected at 7.5 feet bgs in TP-4, was 266 mg/kg, which is above the ADEC SCL.

Test pit TP-1, located at the northeastern corner of the old tank platform, had the second highest headspace reading from the test pits. Samples were submitted from TP-1 at 6

Test pit TP-6, located outside the old berm at the southeastern corner of the site, was sampled at 3.5 feet bgs (09-KON-111-SB) and 7 feet bgs (09-KON-122-SB). The shallower sample had a DRO result of 1,460 mg/kg. Its corresponding headspace value was only 14 ppmv. The deeper sample had a headspace reading of 8.2 ppmv and no detectable DRO values.

Test pit TP-10, located just north of the large platform, was sampled at 2 feet bgs (09-KON-113-SB and duplicate 09-KON-114-SB) and at 7 feet bgs (09-KON-112-SB). The headspace reading from the shallower sample was 59.1 ppmv and had corresponding DRO concentrations of 2,730 and 555 mg/kg for the duplicate pair. The deeper sample had a headspace reading of 15.4 ppmv and a DRO concentration of 59.4 mg/kg.

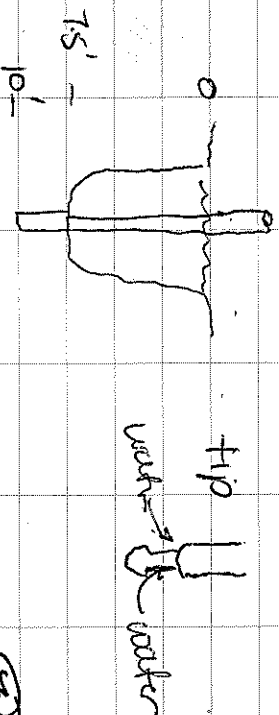
The probe can be pushed wd by hand down to 7.5 feet. Drive from 7.5-10'. Back off probe about 3-4" to allow water to come with open tip (see illustration below).

Let probe sit to allow water to infiltrate into rod.

Due to the difficulty of hand-driving a temporary well point through frozen soil, the backfilled test pit, TP-4, was selected as the initial location to install a temporary well point. TP-4 was also lower in elevation than other test pits; therefore, groundwater should have been closer to surface. The temporary well point was initially driven from

7.5 feet bgs (undisturbed soil at the base of the TP-4 excavation) to a depth of 10 feet bgs. The probe was backed off 4 inches to expose the open tip. The probe was allowed to sit for two hours while the rod was periodically checked for groundwater intrusion with a water level indicator. No groundwater entered the rod tip. The rods were pulled from the hole, cleaned, and driven down the same hole to 12 feet bgs. The probe was backed off 4 inches to allow for water infiltration. The water level indicator was used periodically for 30 minutes to check for groundwater influx. No groundwater was found at a depth of 12 feet bgs; therefore, no groundwater samples were collected.

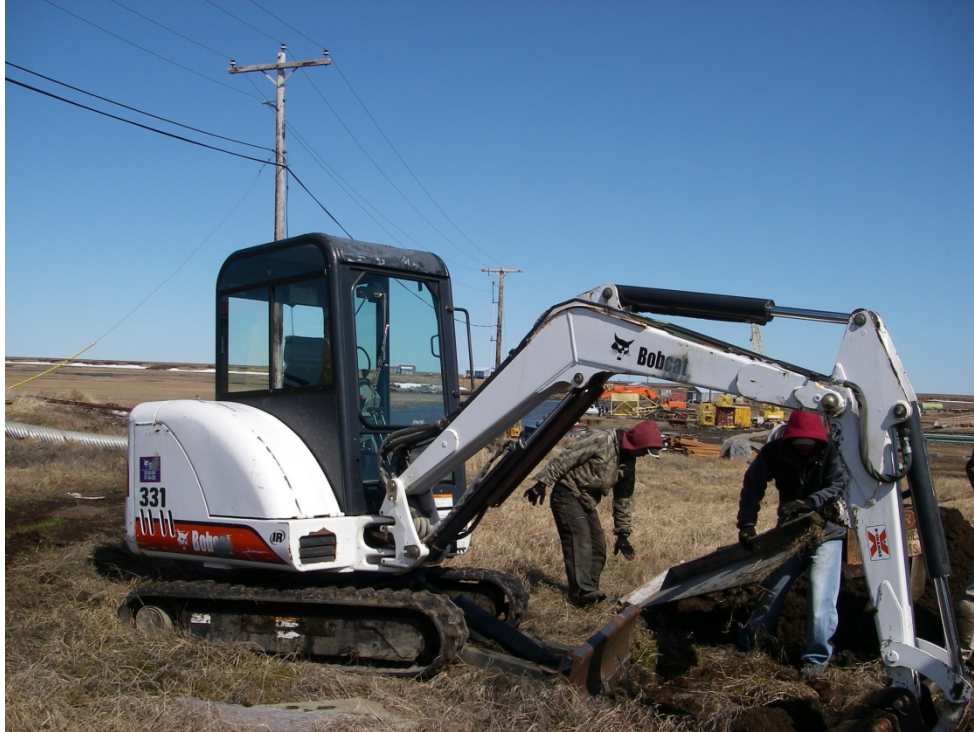
PHOTO 1: BACKHOE, OPERATOR, AND LABORER REMOVING DEBRIS BEFORE DIGGING TEST PIT TP-1, VIEW TO THE NORTH

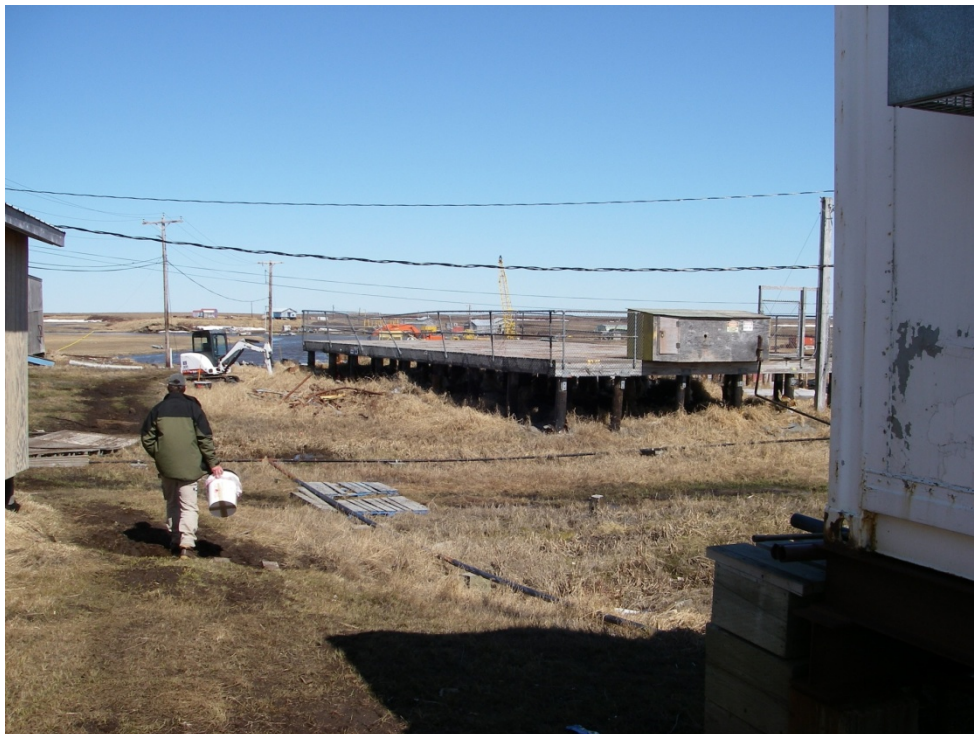
PHOTO 2: VIEW TO THE NORTH OF FORMER TANK FARM DECK

The aerial photograph dated September 17, 2004 (Figure 3), shows the remaining former tank farm infrastructure consisting of a roughly 40 by 40 foot deck and a 40 by 85 foot deck. At the time of the site visit, only the larger of the two decks was standing. The wooden pilings that supported the smaller deck remain in place. A berm partially enclosing an area south of the smaller deck and east of the large deck was found at the southeast corner of the site. Debris consisting of old sections of pipe, liner remnants, lumber, and miscellaneous household items were found on-site.

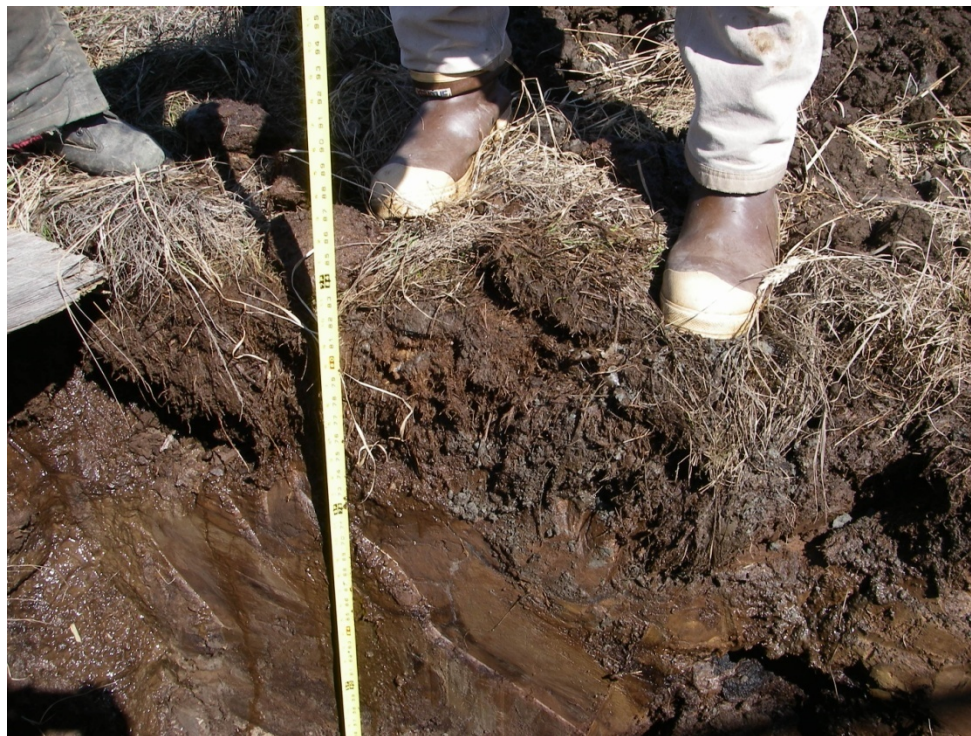
PHOTO 3: FROZEN LAYER, 1 FOOT BELOW GROUND SURFACE

An approximately 1-foot-thick layer of frozen soil was encountered at 8 to 10 inches bgs. The backhoe was able to scratch through the frozen layer and dig to a maximum of 6 to 8 feet bgs, depending on the terrain. Ten test pits were excavated before a clogged fuel line shut down the excavator. Between three and six field screenings were obtained from each test pit at varying depths. Heated headspace photo-ionization detector (PID) analyses helped field personnel determine which samples would be submitted for GRO, BTEX, and DRO analysis. In addition, the two screenings with the highest PID values were also selected for volatile organic compound (VOC) and PAH laboratory analysis. The samples collected from the two hand-dug test pits were not submitted for laboratory analysis due to low PID readings.

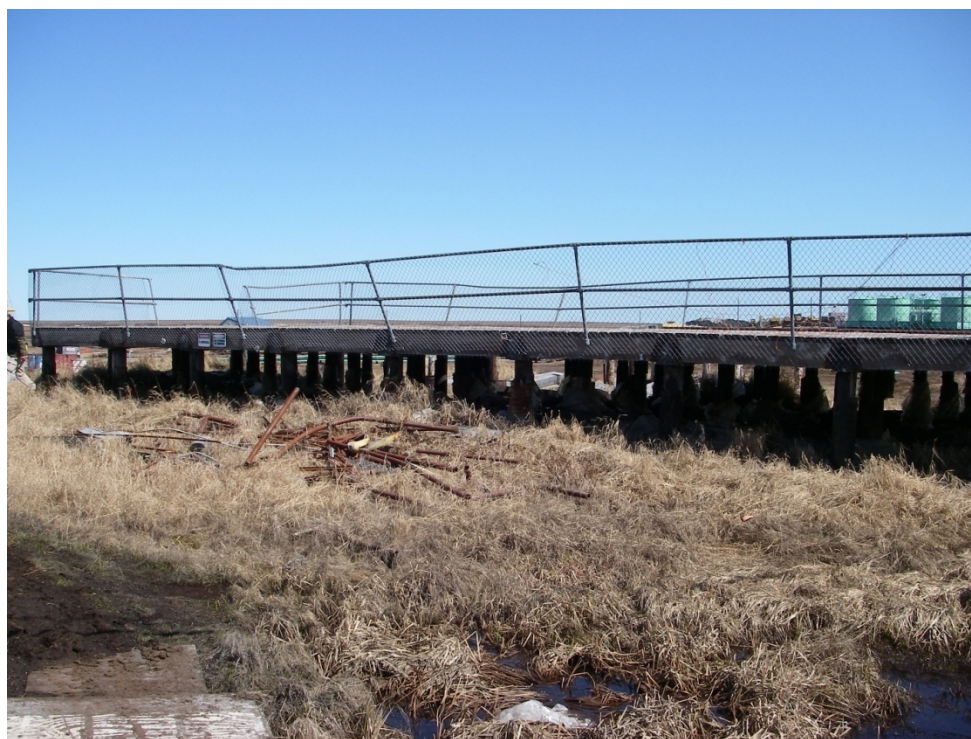
PHOTO 4: DEBRIS AND OLD TANK FARM DECK, VIEW TO THE NORTH FROM EAST SIDE OF SITE

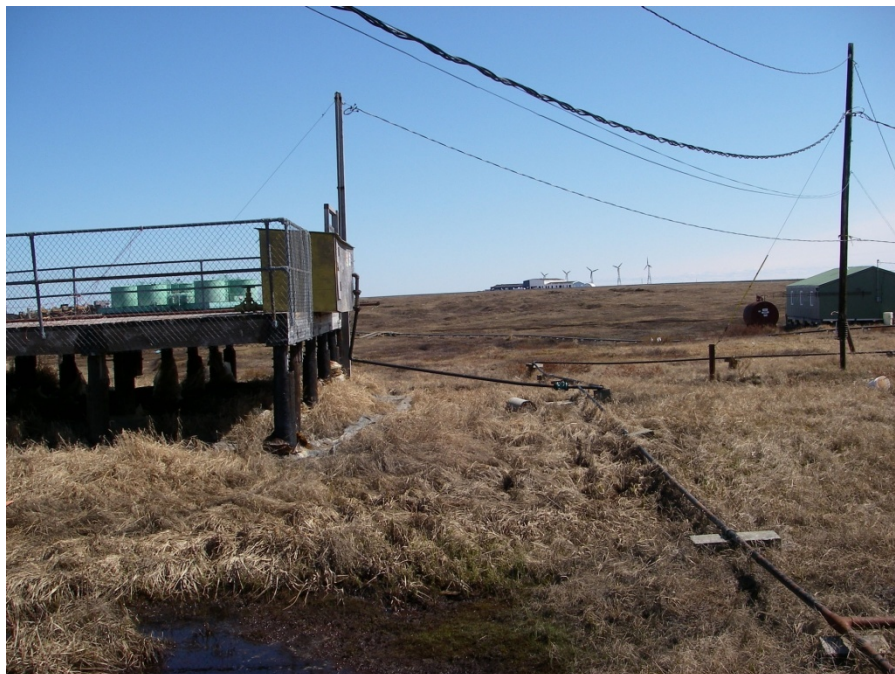
PHOTO 5: VIEW TO NORTHEAST FROM SOUTHWEST CORNER OF SITE

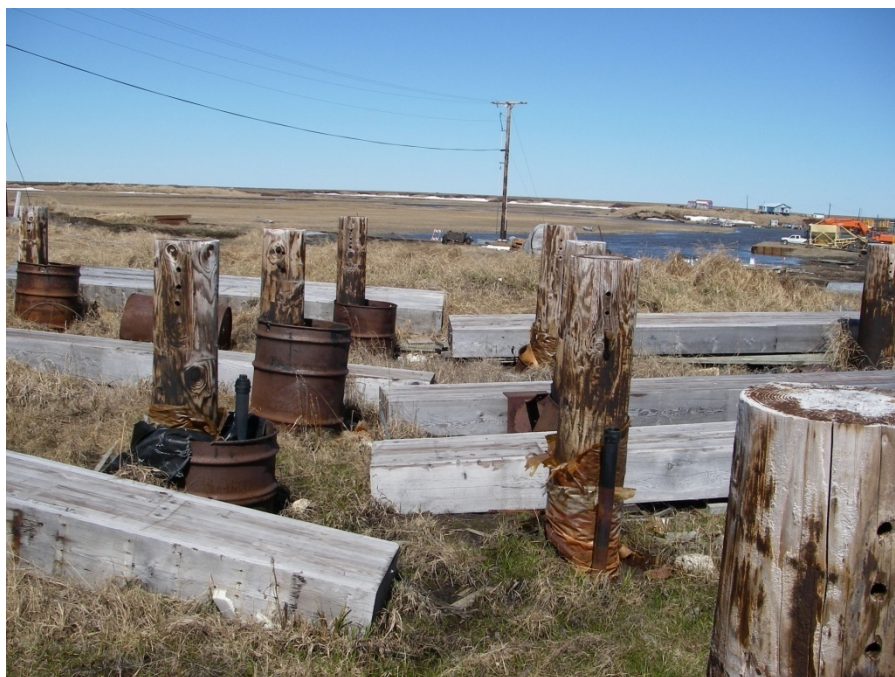
**PHOTO 6: PILINGS FROM SMALLER OLD TANK FARM DECK AT NORTH CORNER OF SITE,
VIEW TO THE NORTHEAST, TEST PIT TP-3 LOCATED TO THE RIGHT OF THE PHOTO**

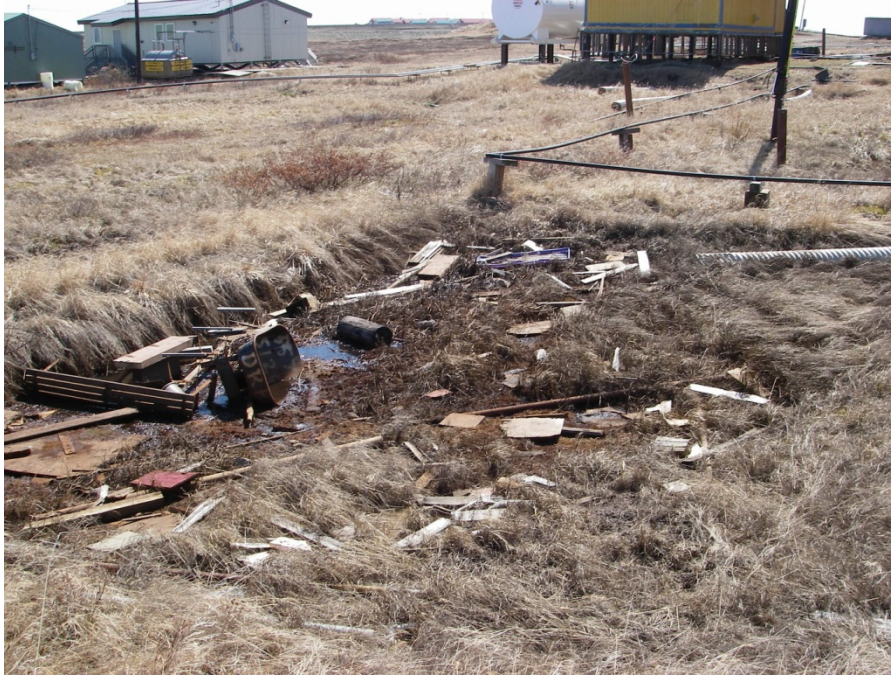
PHOTO 7: DEBRIS AND BERM AT SOUTHEAST CORNER OF SITE, VIEW TO THE SOUTHEAST, TEST PIT TP-4 IS LOCATED AT THE PHOTOGRAPHER'S LOCATION, TEST PIT TP-6 IS LOCATED JUST OUTSIDE THE BERM

Test pit TP-4 had DRO results above ADEC SCLs in all samples, including the deepest sample collected from the pit at 7.5 feet bgs. The DRO results in the surrounding test pits were all below the ADEC SCL. The vertical extent of DRO contamination in TP-4 was not determined as all samples collected from the test pit, including the deepest sample, exceeded ADEC SCLs for DRO. The northern extent of the DRO contamination was determined by the clean samples in TP-3. The eastern extent is between TP-4 and TP-6. No test pits were advanced to the south-southeast of TP-4 or to the west, due to the presence of the large tank deck.

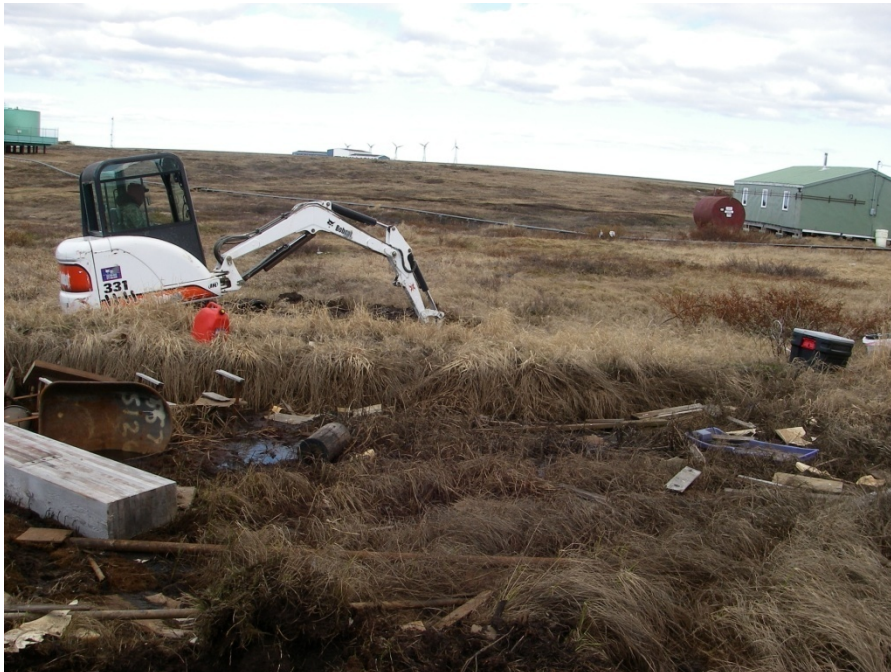
PHOTO 8: DIGGING TP-6 OUTSIDE OF BERM AT SOUTHEASTERN CORNER OF SITE; VIEW TO THE SOUTHEAST.

Test pit TP-6 had a DRO result of 1,460 mg/kg at 3.5 feet bgs, although the PID result was only 14 ppmv. The field notes state that this sample had high organic content. An OASIS chemist reviewed the chromatogram from this DRO sample and noted that the response in the DRO range was due to biogenic interference. It is unlikely that this location is impacted by petroleum hydrocarbons. The chromatogram for this DRO sample is included at the end of the laboratory report in Appendix C.

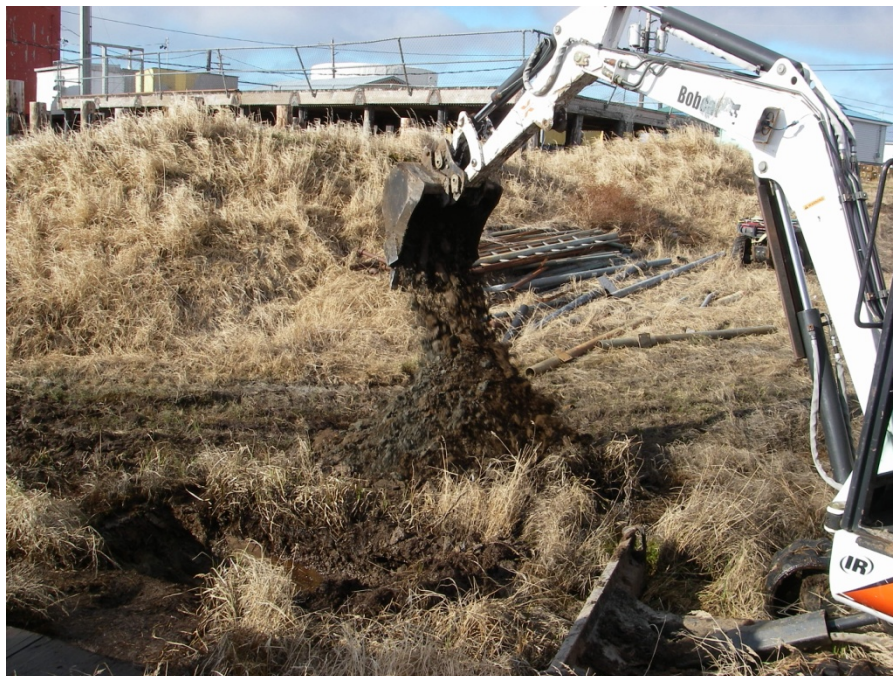
PHOTO 9: DIGGING TEST PIT TP-7, VIEW TO THE SOUTH FROM THE NORTHERN CORNER OF THE SITE

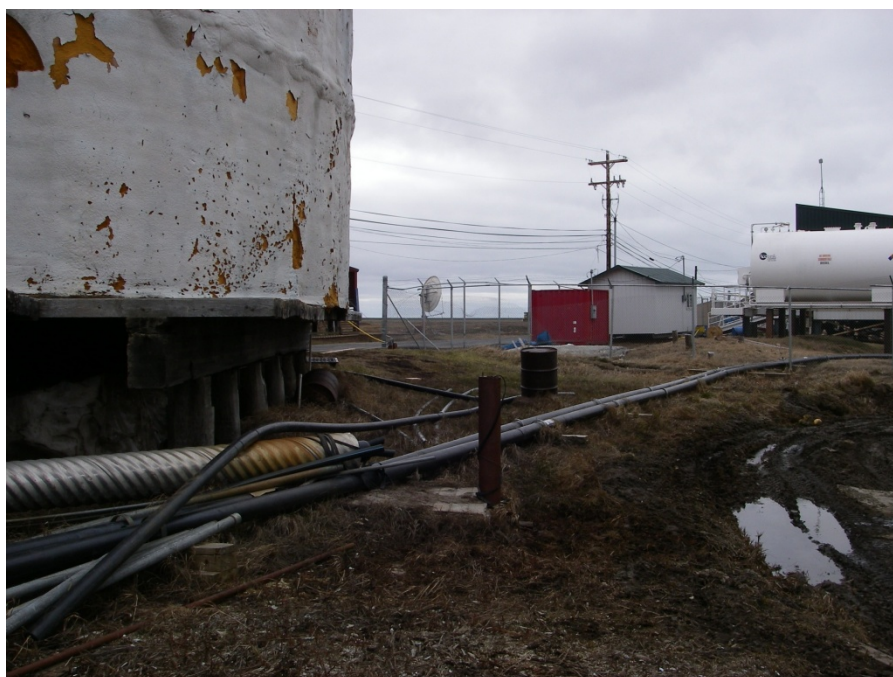
- A well was installed in town near the water treatment plant, but it was not used due to high salinity. Photograph 10 in the Photographic Log (Appendix B) shows the old drinking water well casing. The old well is approximately 350 feet south of the former tank farm. No depth or installation date was found for the old well.

PHOTO 10: CASING IN CENTER OF PHOTO IS OLD WELL LOCATED NEAR WASHETERIA, APPROXIMATELY 350 FEET SOUTH OF THE FORMER SCHOOL TANK FARM, VIEW TO THE NORTH
