CORRECTIVE ACTION SUMMARY REPORT
TYONEK NORTH FORELANDS FACILITY
TYONEK, ALASKA
ADEC Spill No. 2337.38.042
July 2015

CORRECTIVE ACTION PLAN

Tyonek North Forelands Facility

Tyonek, ALASKA

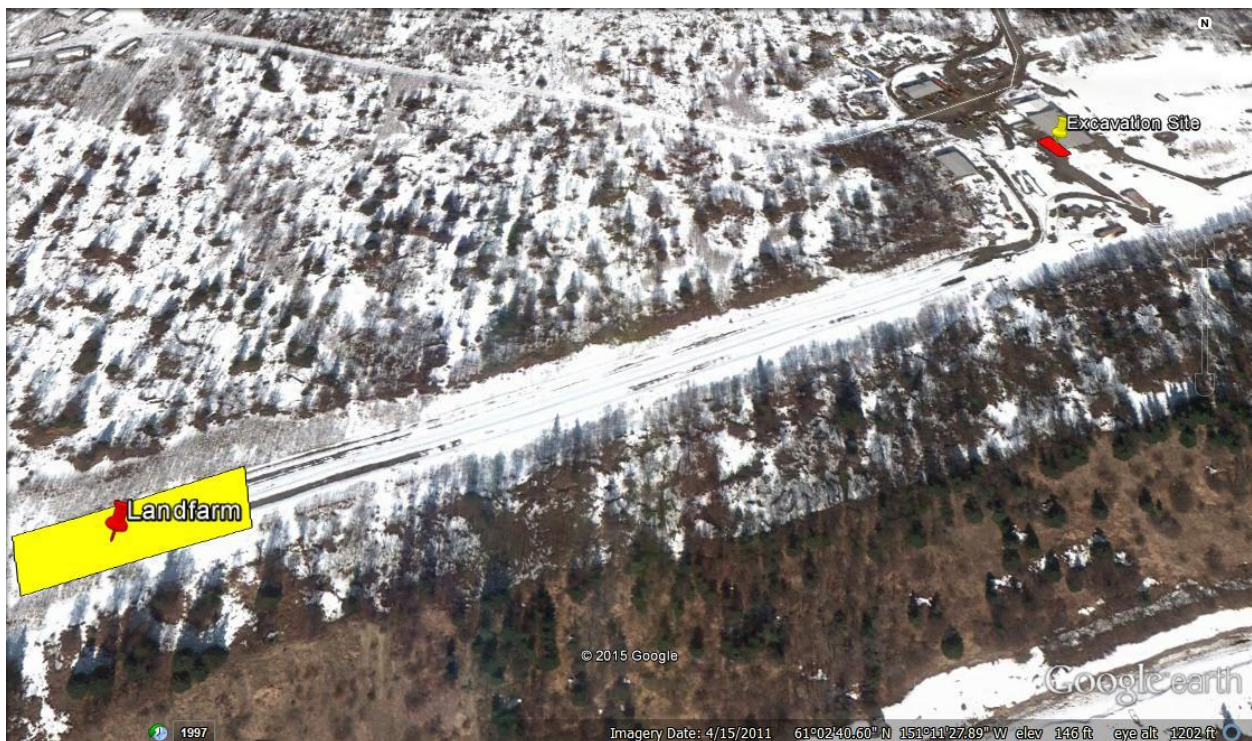
Prior to placement of contaminated soil, the landfarm was prepared by removing vegetation, leveling, and compacting the site. The dimensions of the landfarm perimeter berm are 90 feet by 325 feet. GPS coordinates of each corner of the landfarm area as follow: NW corner - 61° 02' 37.98" N 151° 11' 42.9" W; SW corner - 61° 02' 37.26" N 151° 11' 42.27" W; NE corner - 61° 02' 39.12" N 151° 11' 36.80" W; and SE corner 61° 02' 38.33" N 151° 11' 36.49" W. The perimeter berm is constructed 16" to 18" high and has no openings. Contaminated soil was spread to approximately 6" thick. We estimate that the volume of impacted soil being treated in the landfarm is approximately 540 cubic yards. Landfarmed soil was placed directly on the ground surface with no bottom liner.

Figure 4 – The constructed landfarm site relative to the excavation site.

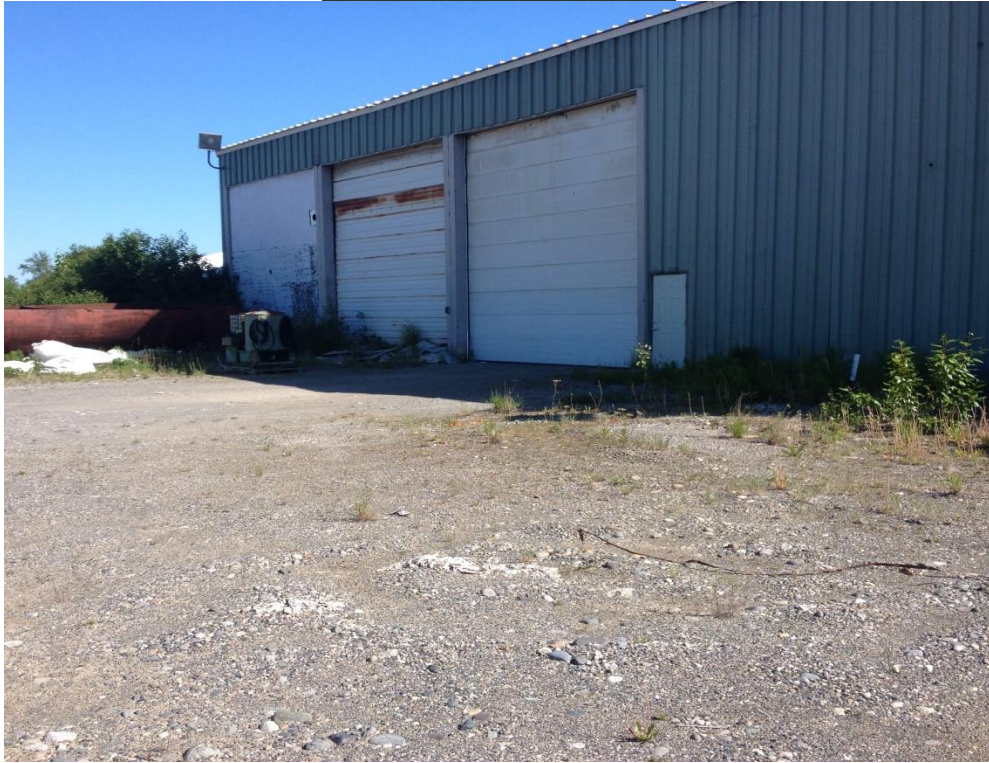
Photo 1 – site prior to excavation work

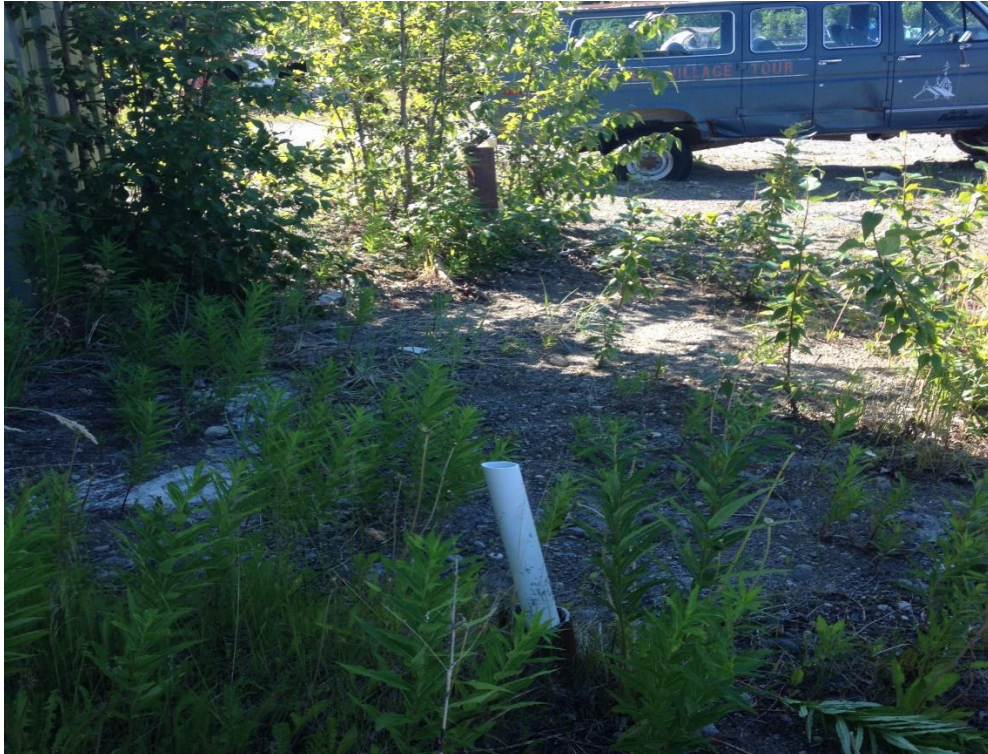
Photo 2 – Old air sparging placed in the original borings from the 1998 ESA.

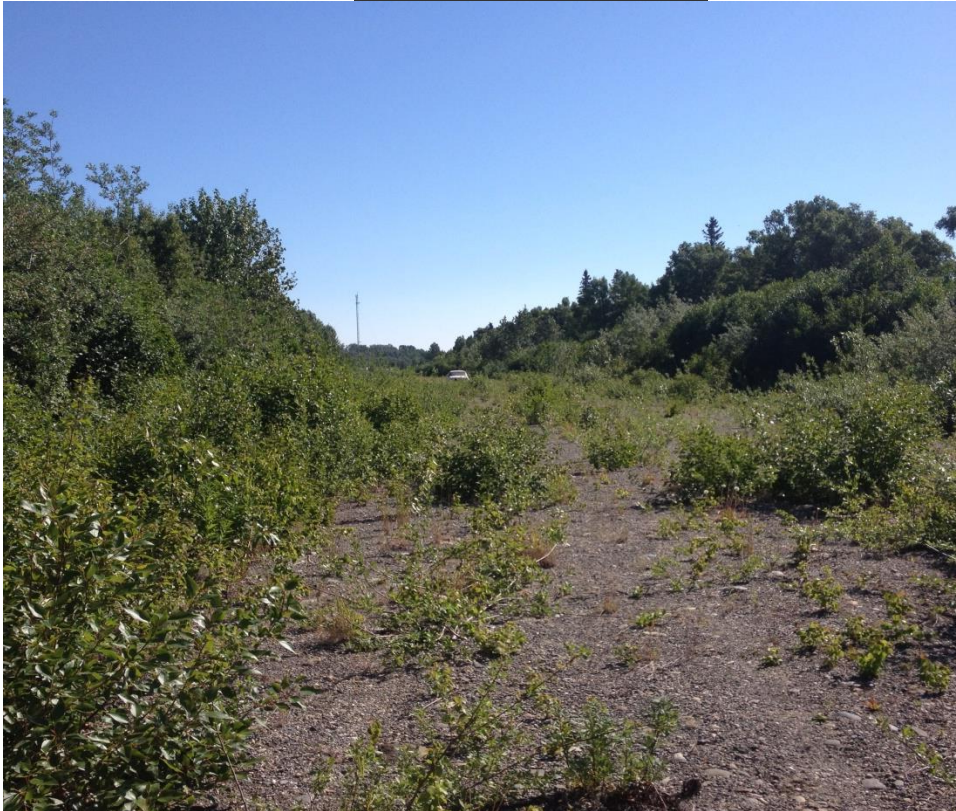
Photo 3 – Landfarm site at the old airstrip prior to brush removal and construction of perimeter berms.

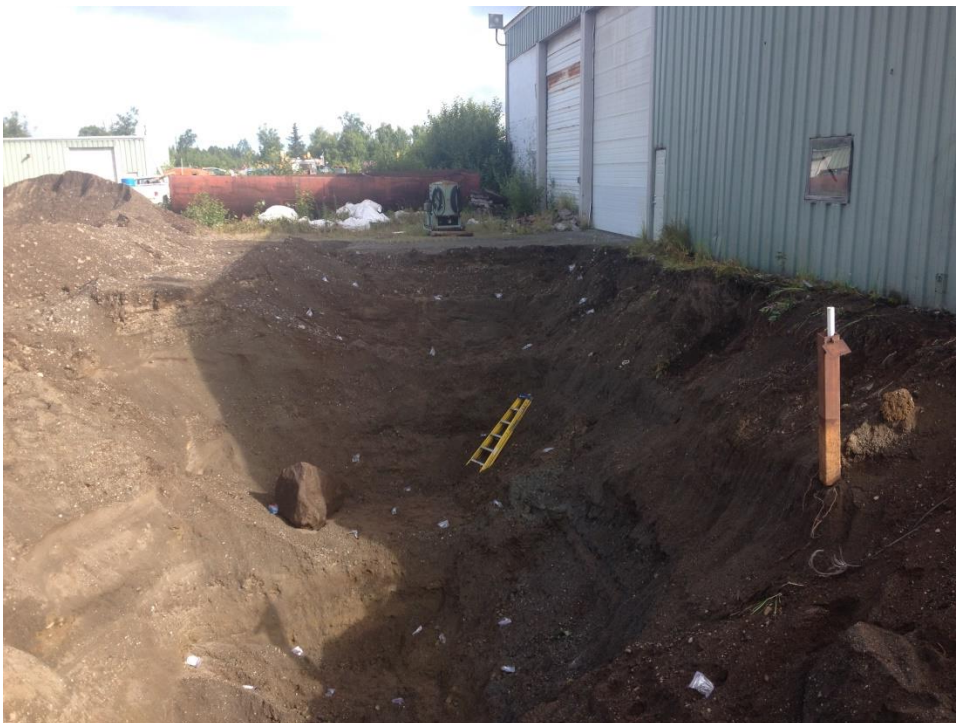
Photo 4 – Confirmation field screen sampling in the tiered excavation.

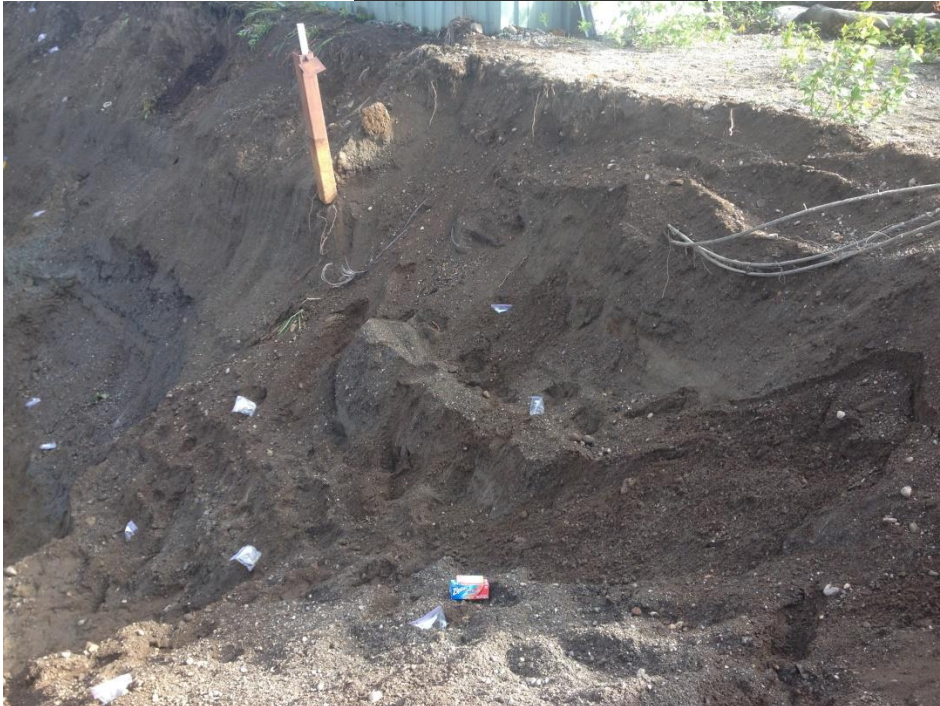
Photo 5 – Field screen and laboratory sample locations. Boring B-1 from 1998 ESA and the electrical power cables are visible in the photograph.

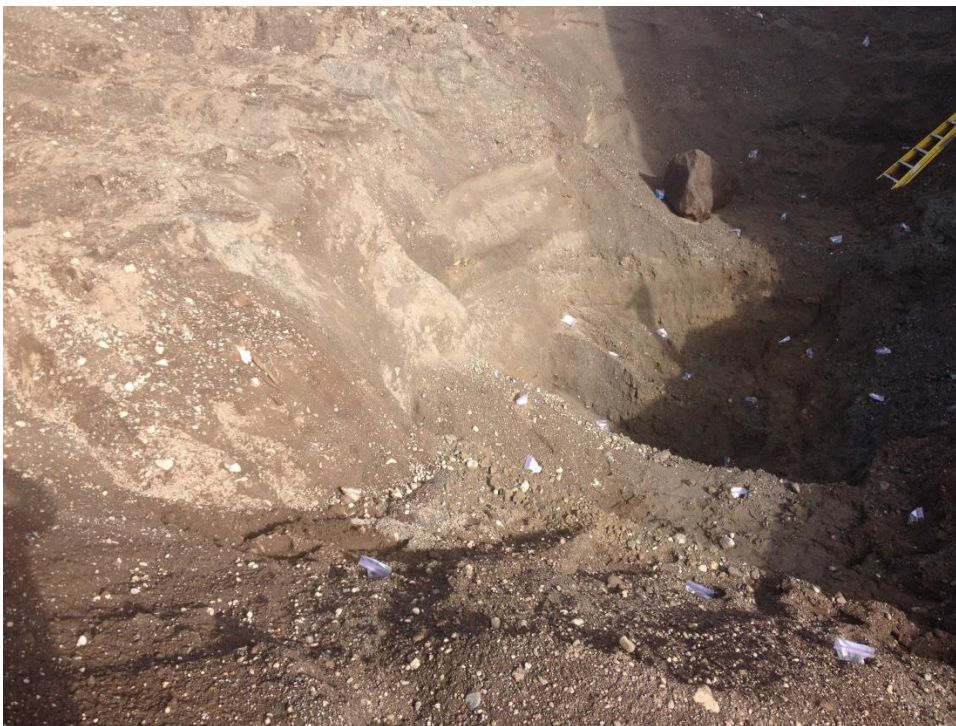
Photo 6 – A large boulder was uncovered during the excavation. The depth of the hole was approximately 17' deep at the deepest tier.

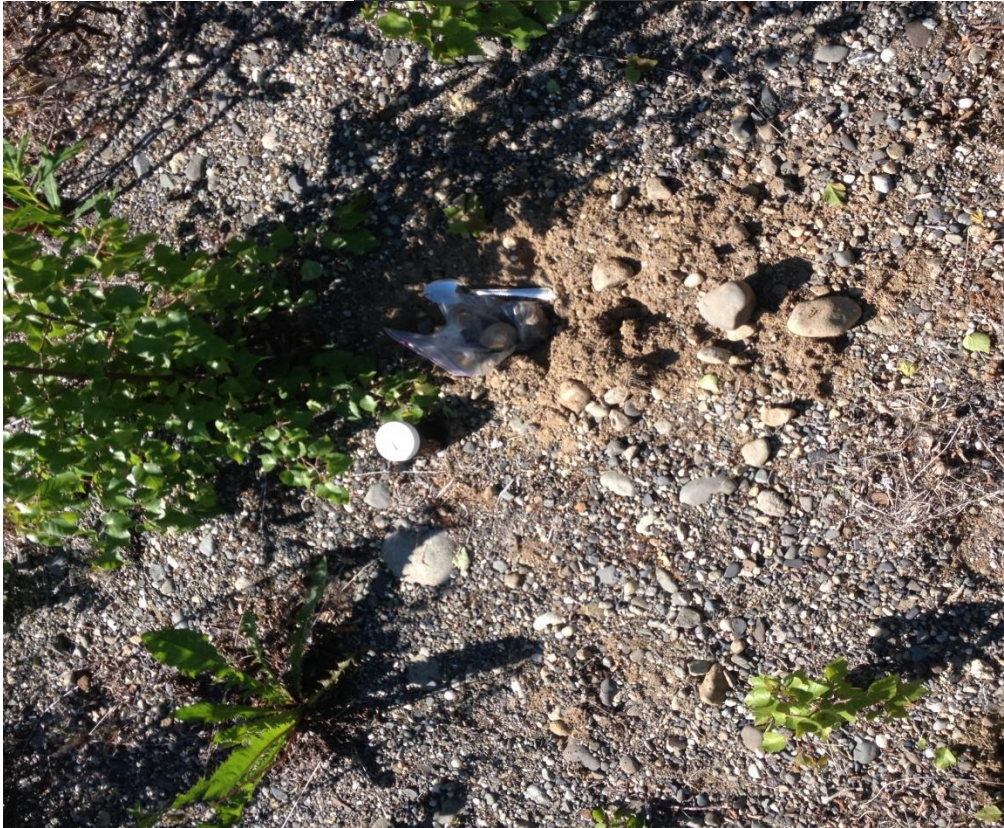
Photo 7 – Landfarm baseline field screen and laboratory sample location - typical.
